Engineering Aspects of the Qir Earthquake of 10 April 1972 in Southern Iran: A Report to the National Science Foundation (1973)

Size
8.5 x 11

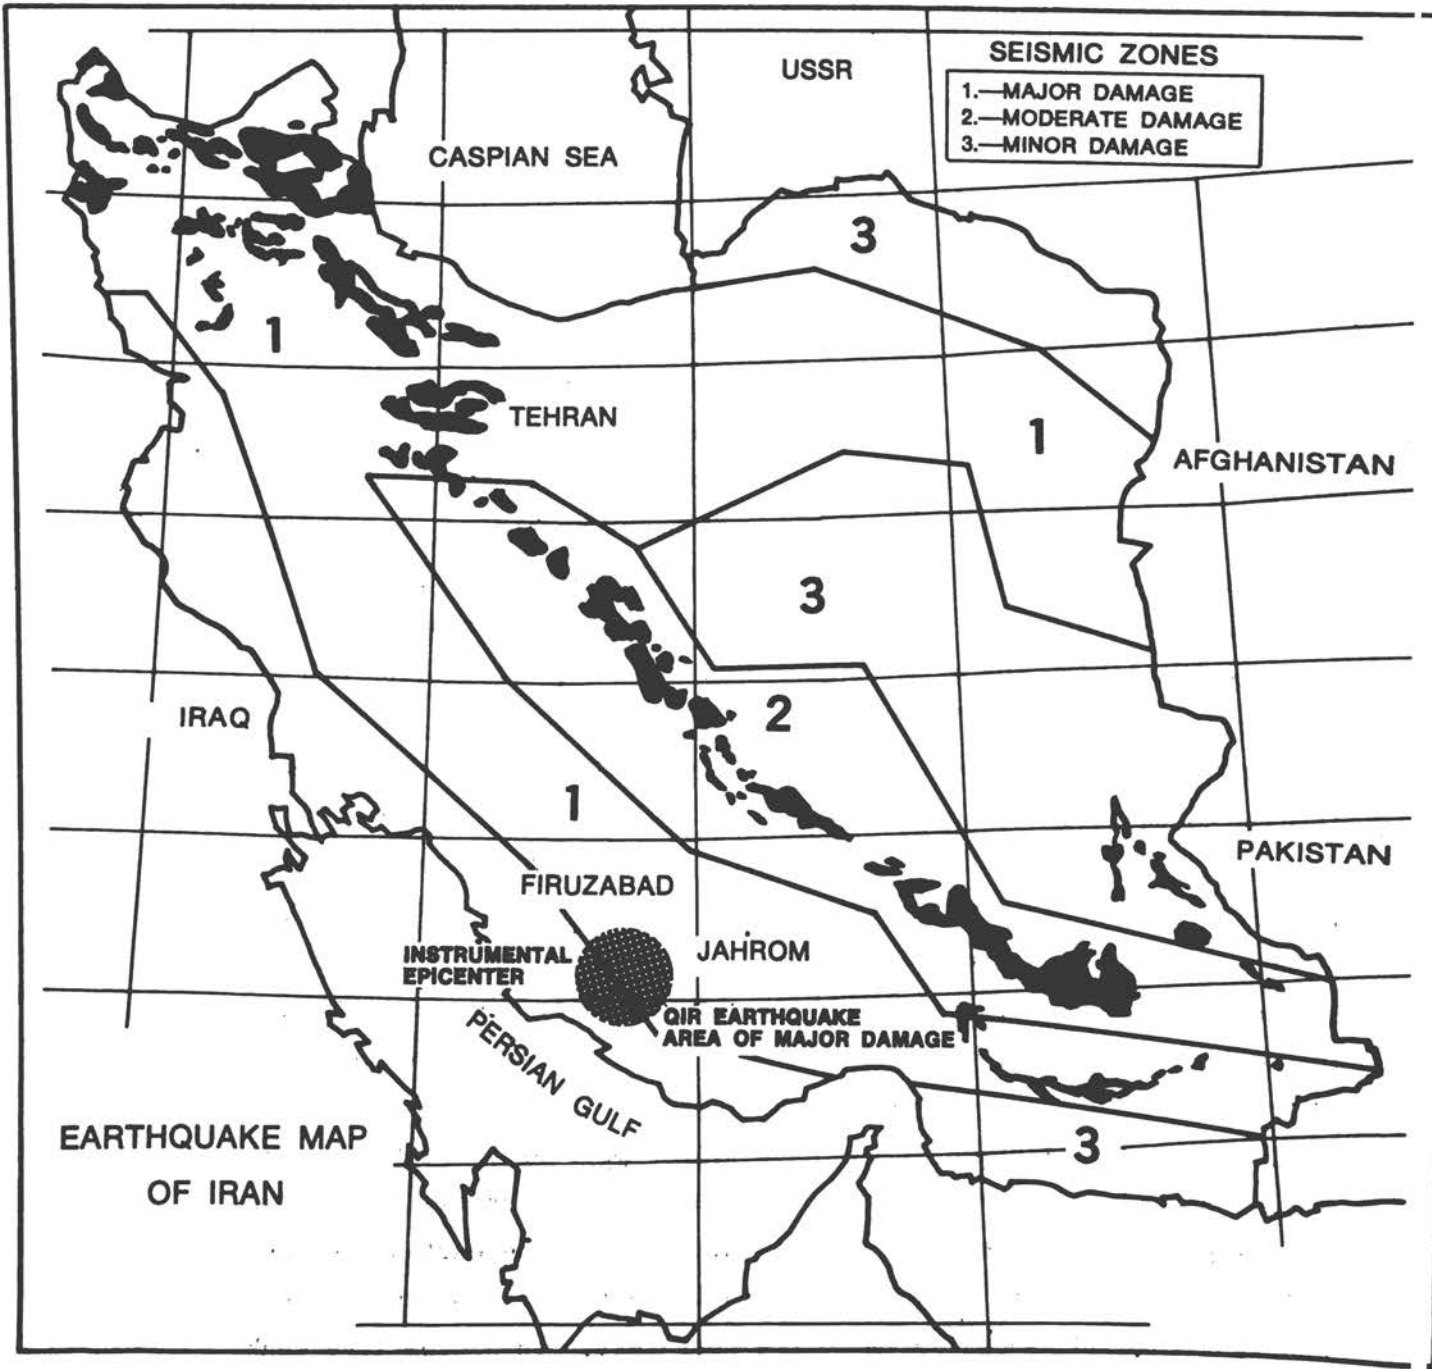
Fig. 1.1—Map of Iran showing the location of the Earthquake Zone.

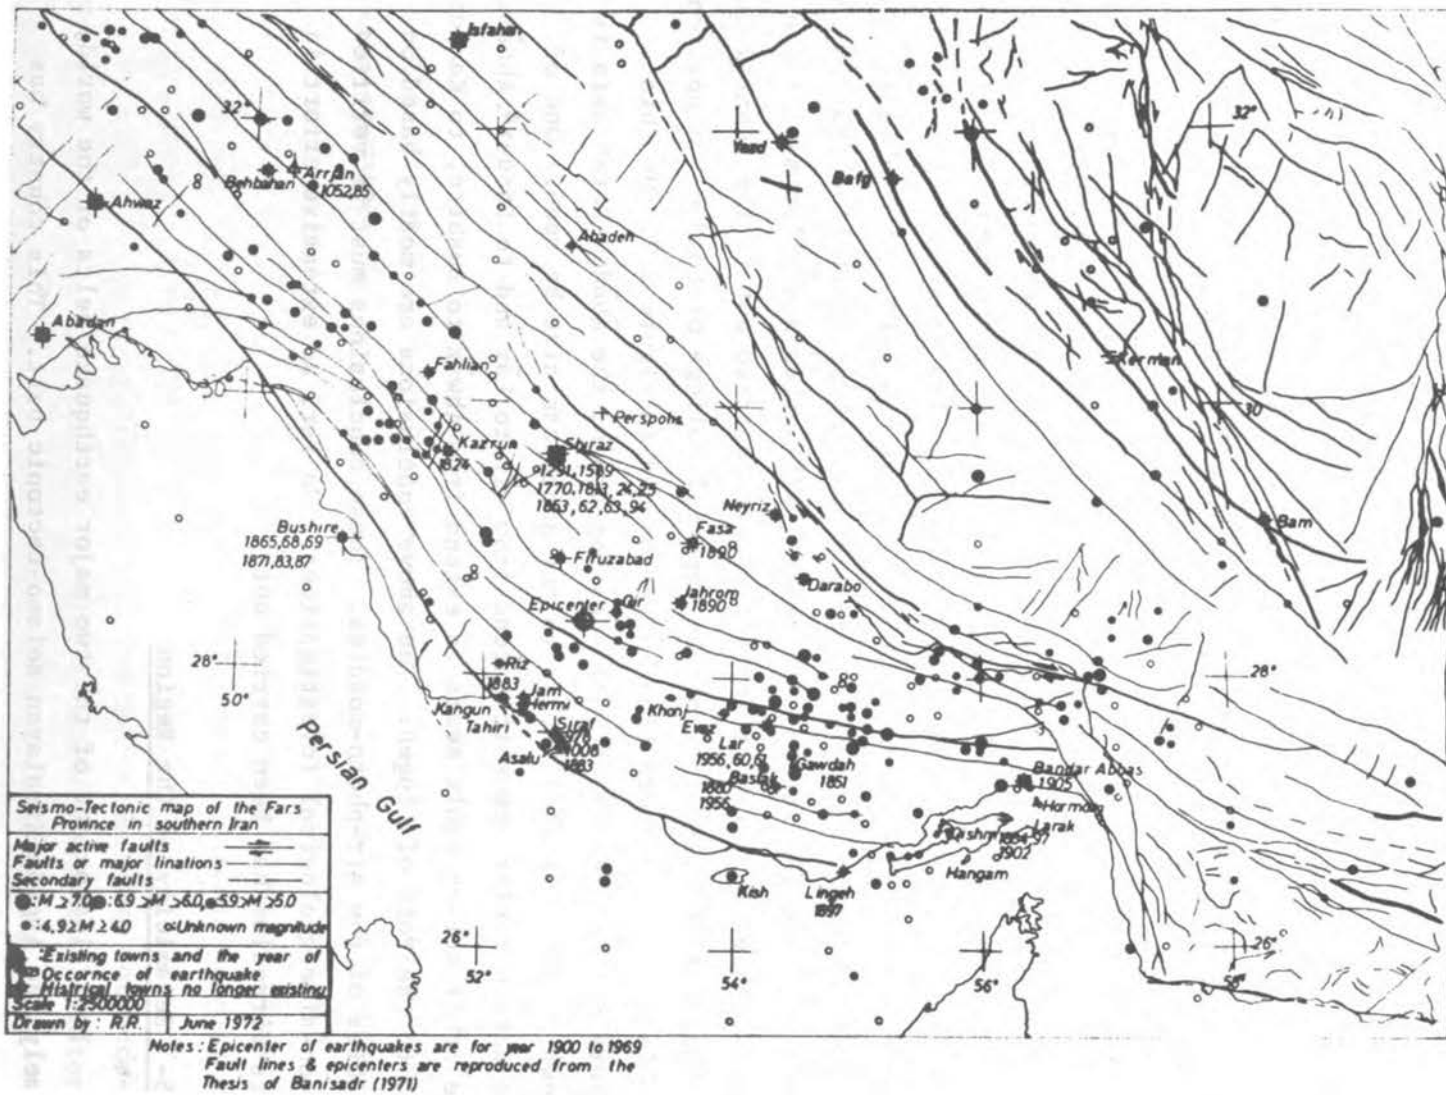
FIGURE 2.2 Seismo-Tectonic Map of the Fars Province in Southern Iran.

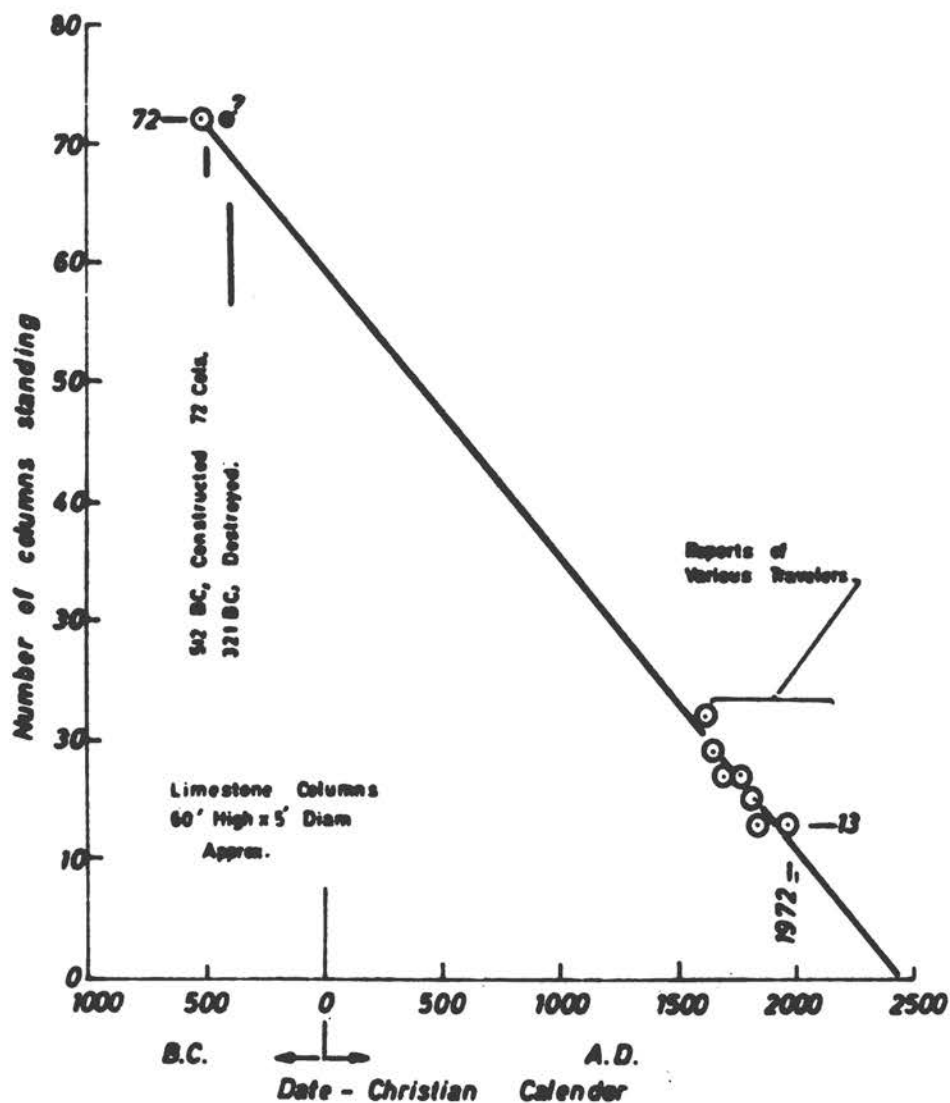
FIGURE 2.3 Diminution of the Number of Columns Standing at the Apadana Palace, Persepolis, Iran, During the Past Centuries.

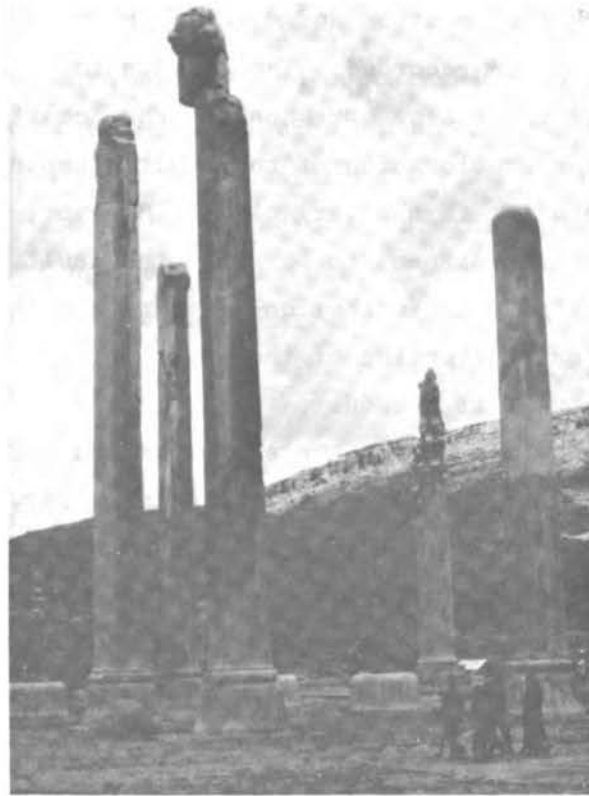
FIGURE 2.4 Displacement and Rotation of the Top Portion of a Column at Persepolis, Iran, Possibly Due to the Past Earthquakes.

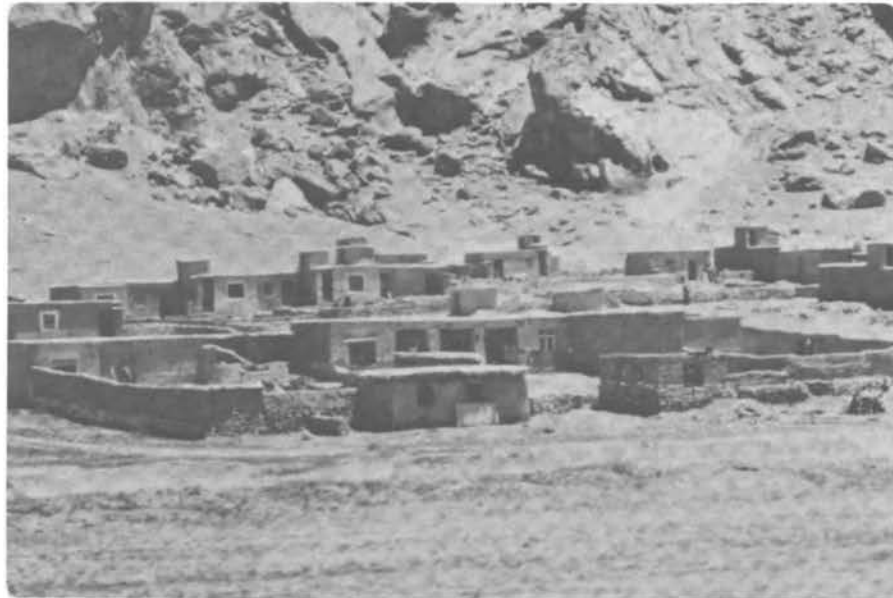
FIGURE 3.1 A Typical Village Located at the Foot of a Mountain.

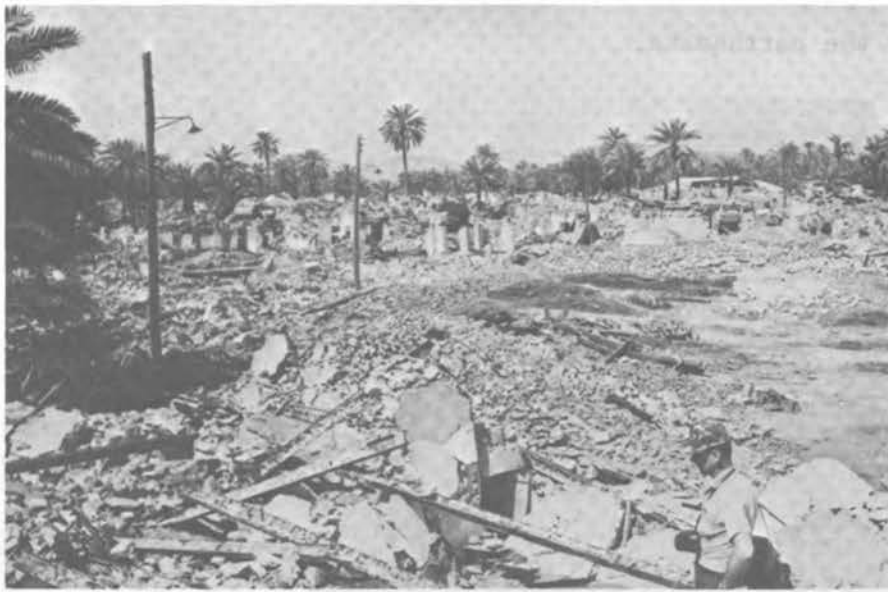
FIGURE 3.5 Destruction in the Town of Qir.

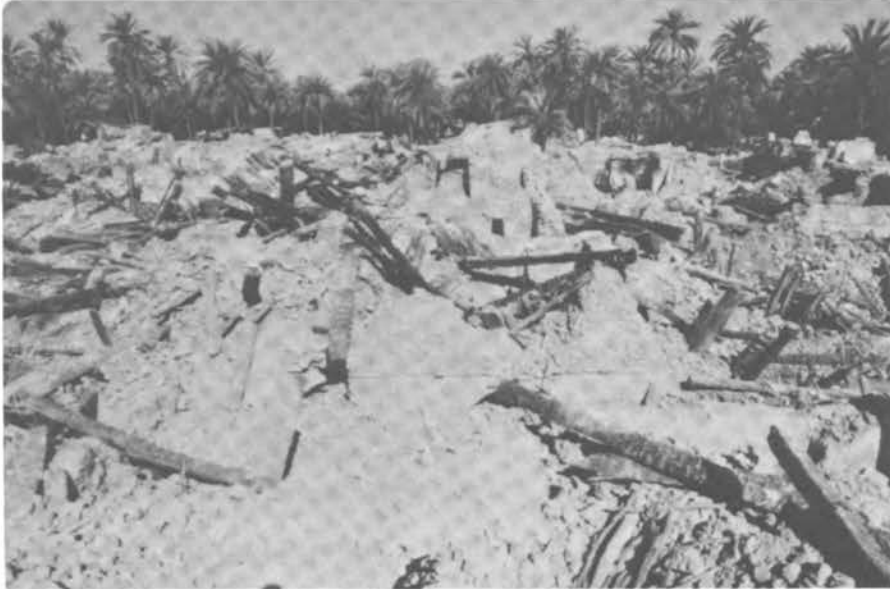
FIGURE 3.6 Destruction in the Village of Sekehravan.

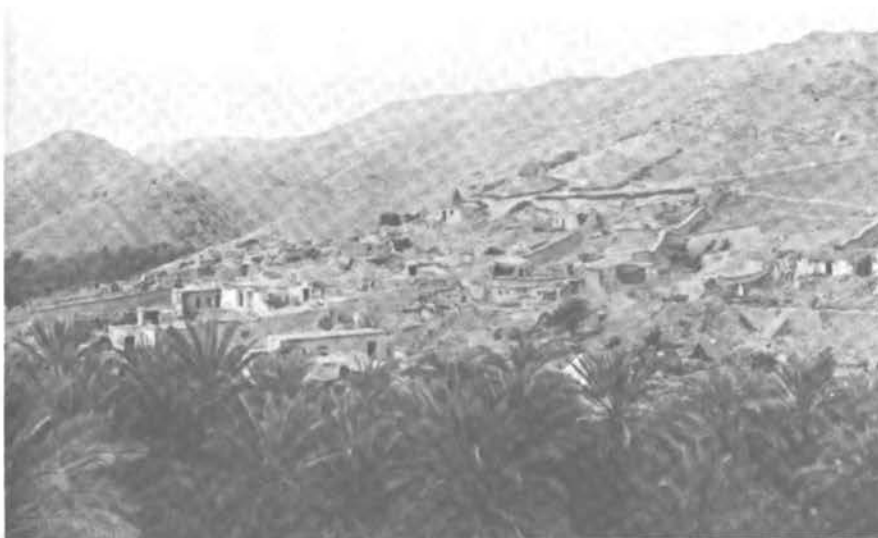
FIGURE 3.7 The Village of Baghe-Now.

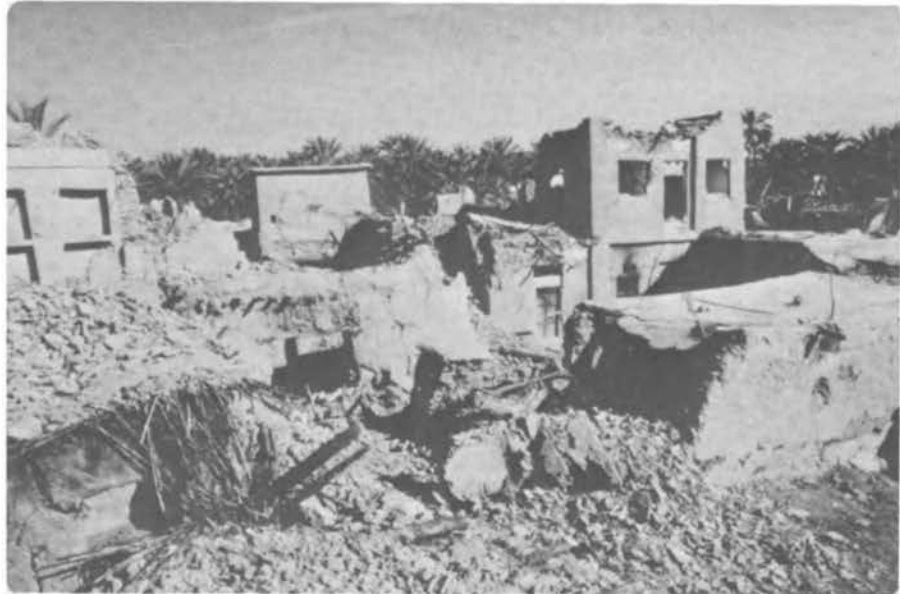
FIGURE 3.8 Destruction in the Lower Liferjān Village (Located in the Valley).

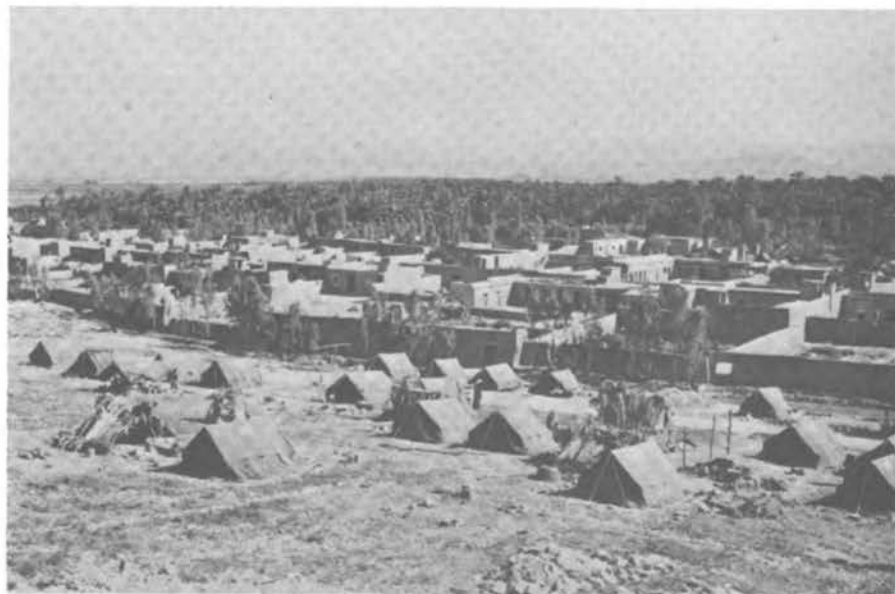
FIGURE 3.9 The Village of Upper Liferjān (Located on the Foot of the Mountain).

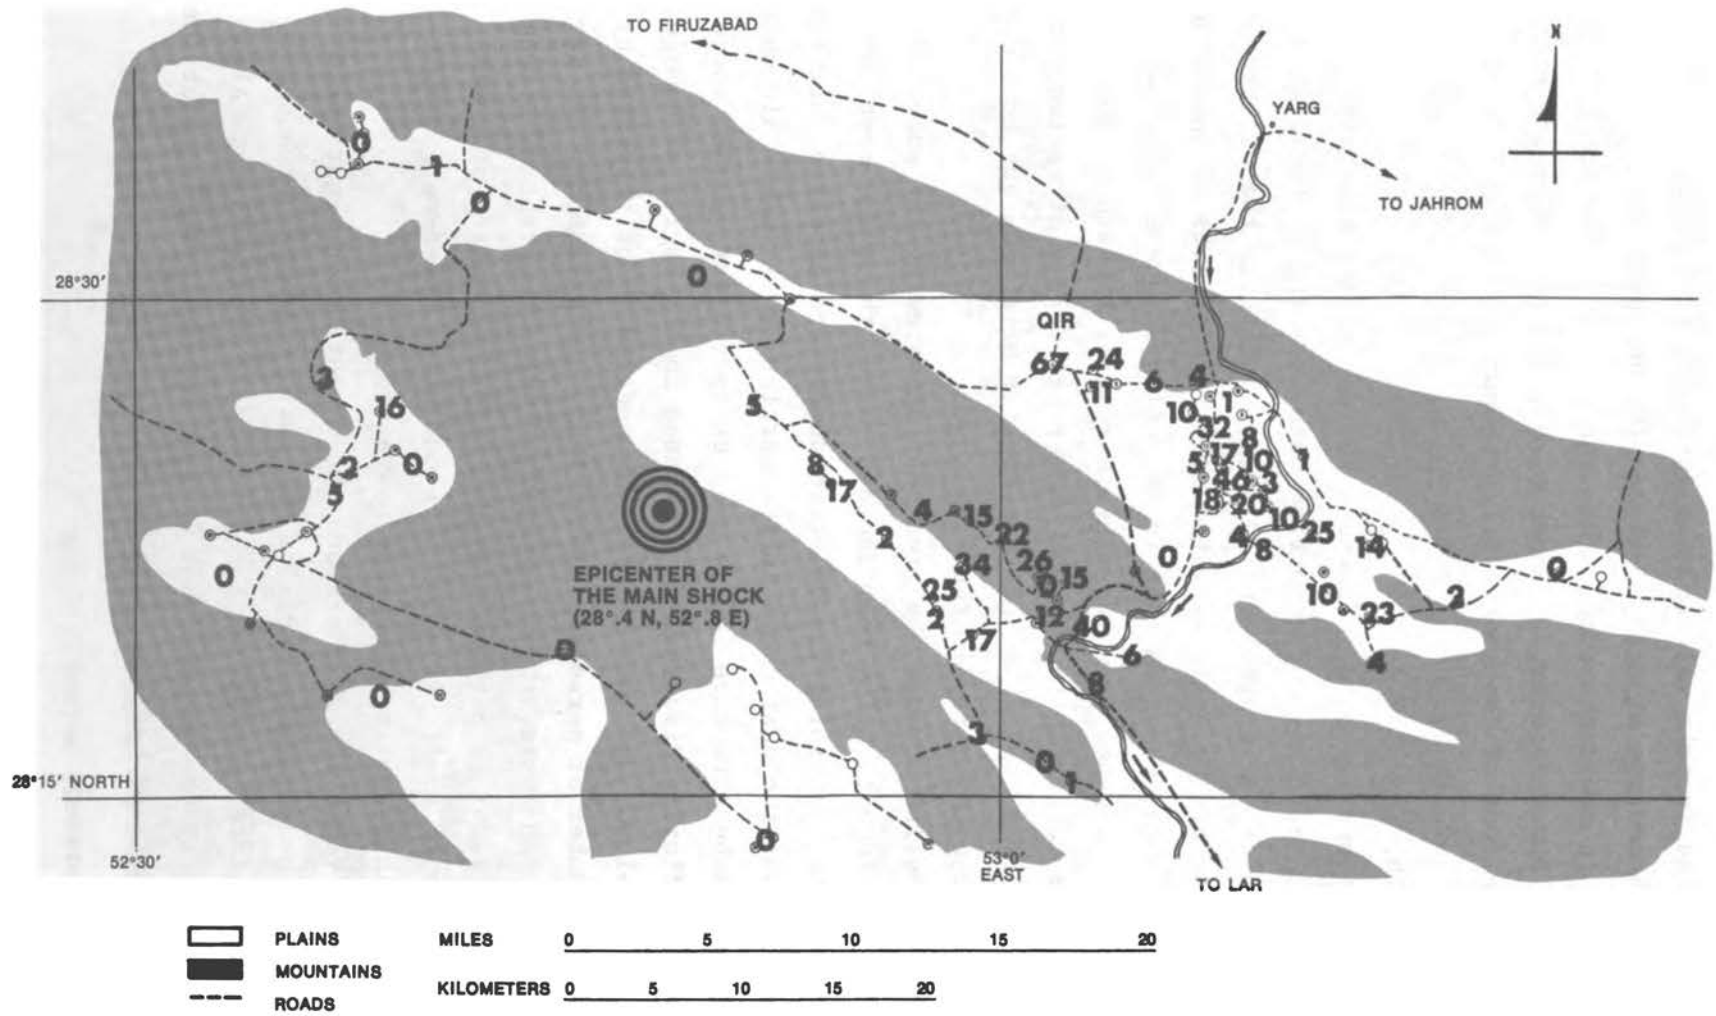
Fig. 3.10: Percentage of Earthquake Fatality In Each Village. (Use This Figure With Figure 2.1 and Table I)

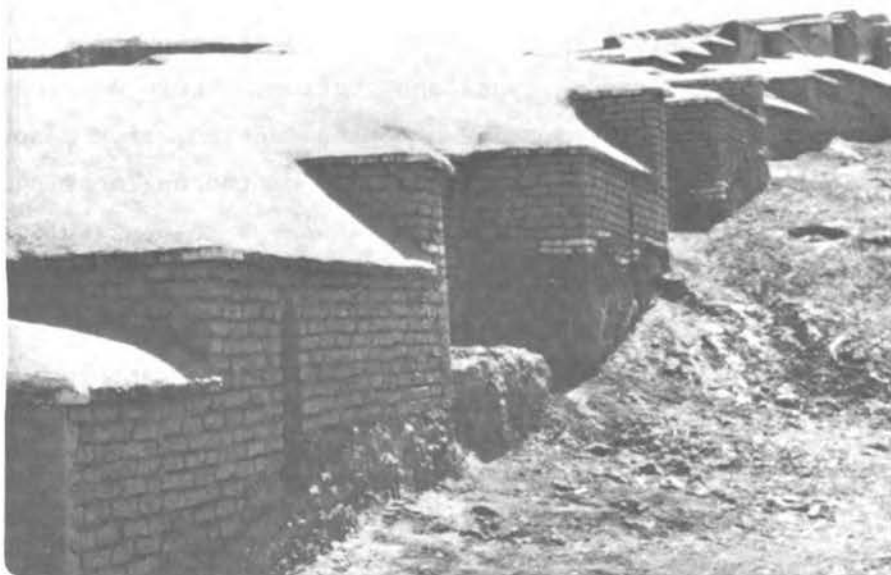
FIGURE 3.11 Some Typical Adobe Houses.

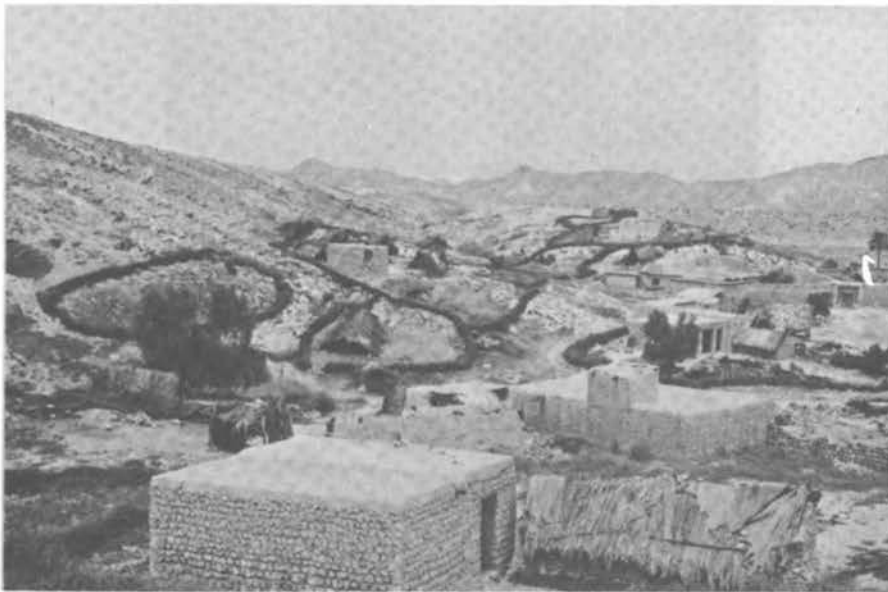
FIGURE 3.15 A Typical Building with Flat Timbered Roofs and Stone-Masonry Walls with Mud Mortar in the Village of Kamasej.

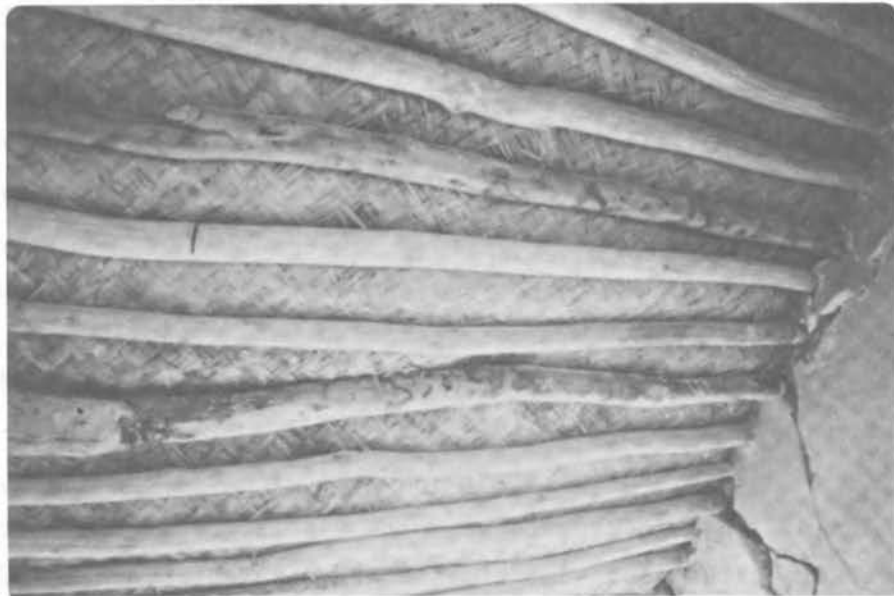
FIGURE 3.16 Inside View of a Typical Flat Timbered Roof in Qīr.

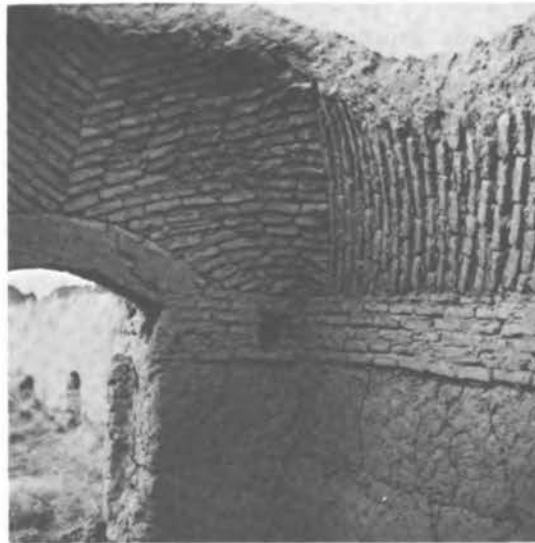
FIGURE 3.17 Inside View of a Typical Adobe Cylindrical Vault Roof Showing the Curved End Sections.

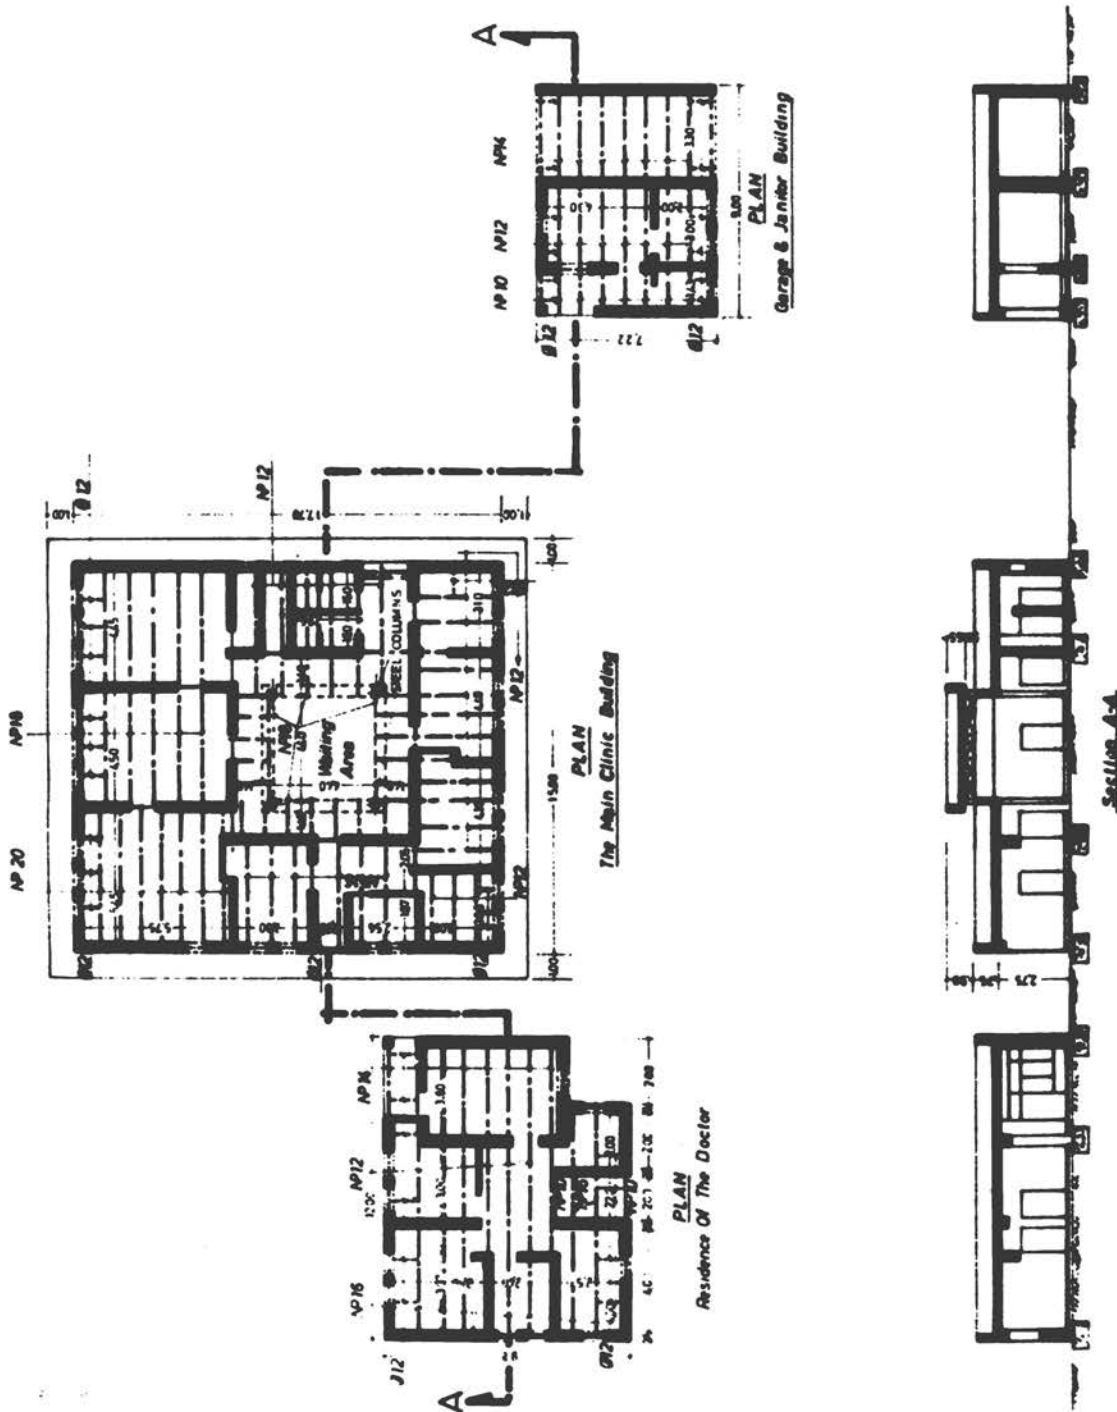
FIGURE 3.19 Clinic Buildings of the Town of Qir.

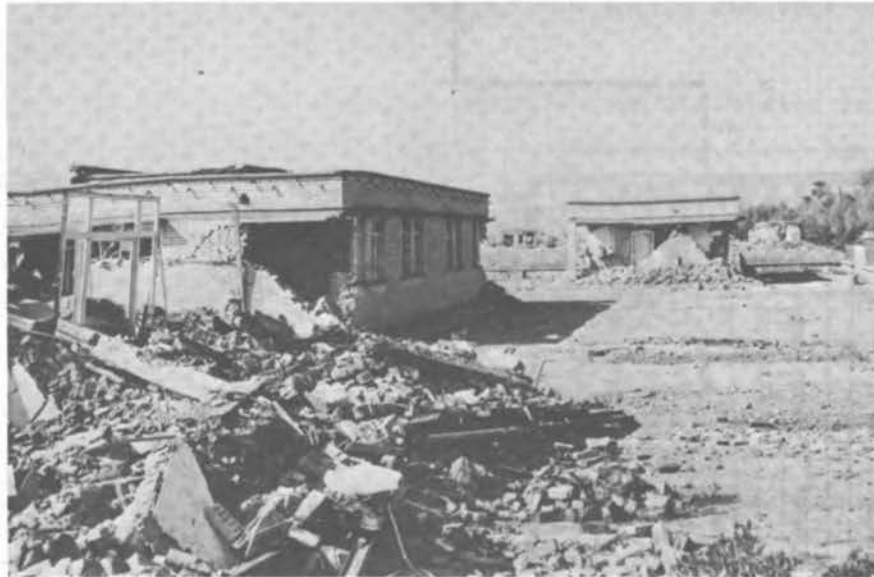
FIGURE 3.20 General View of the Qir Clinic After the Earthquake.

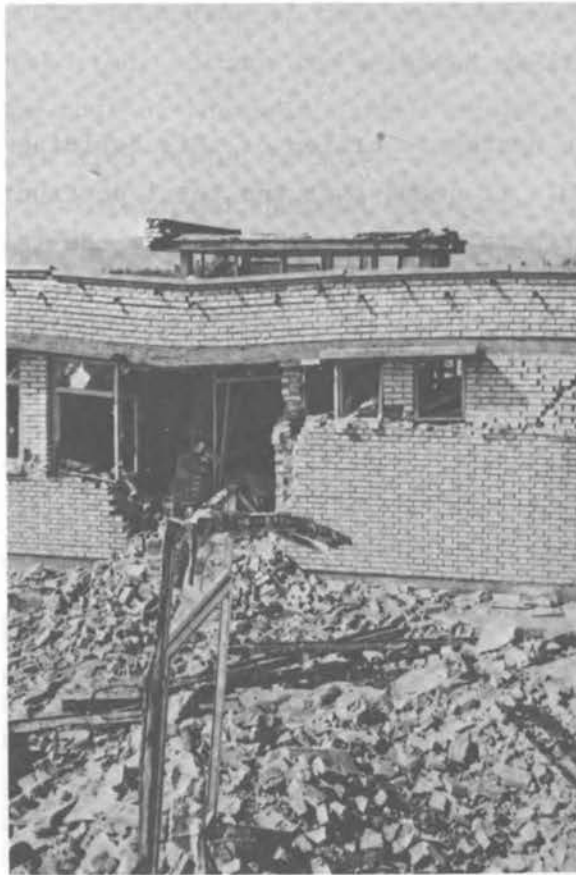
FIGURE 3.22 Western End of the Main Clinic Building.

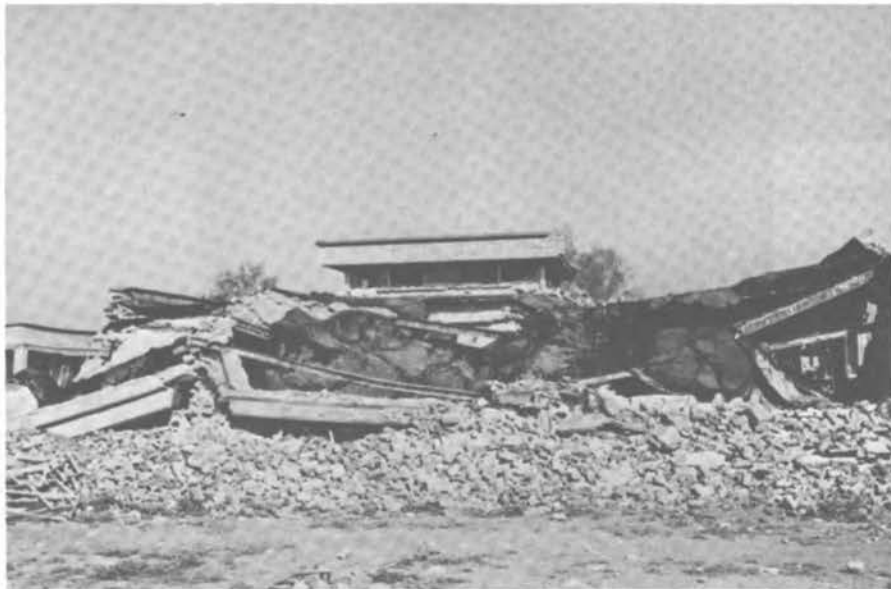
FIGURE 3.23 Northern End of the Main Clinic Building.

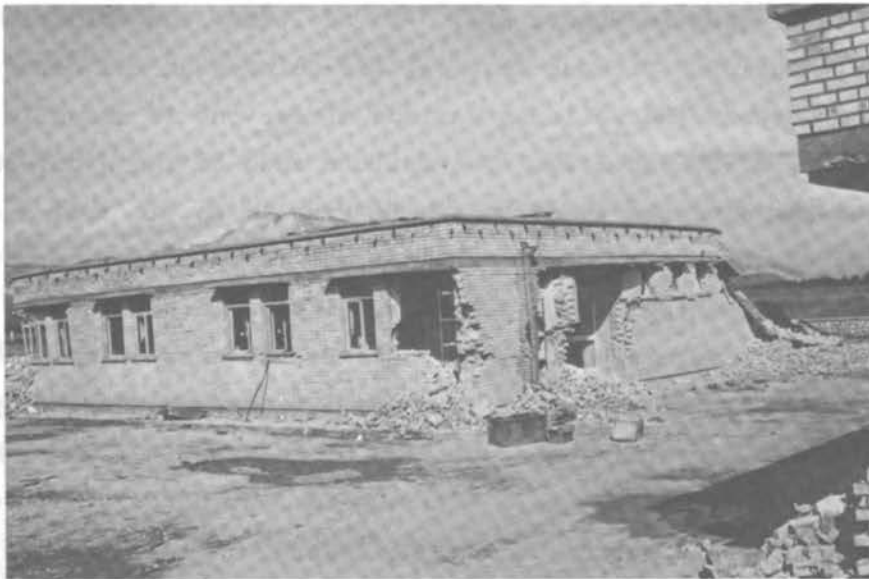
FIGURE 3.24 The View of the Eastern and Southern Sides of the Main Clinic Building.

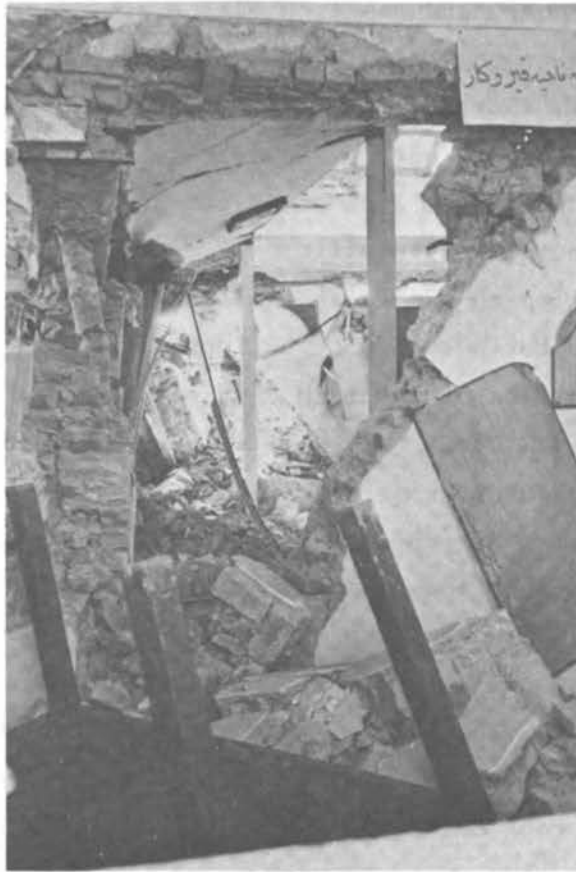
FIGURE 3.25 A View of the Interior Steel Columns Supporting the Roof of the Main Waiting Hall and the Adjacent Roofs.

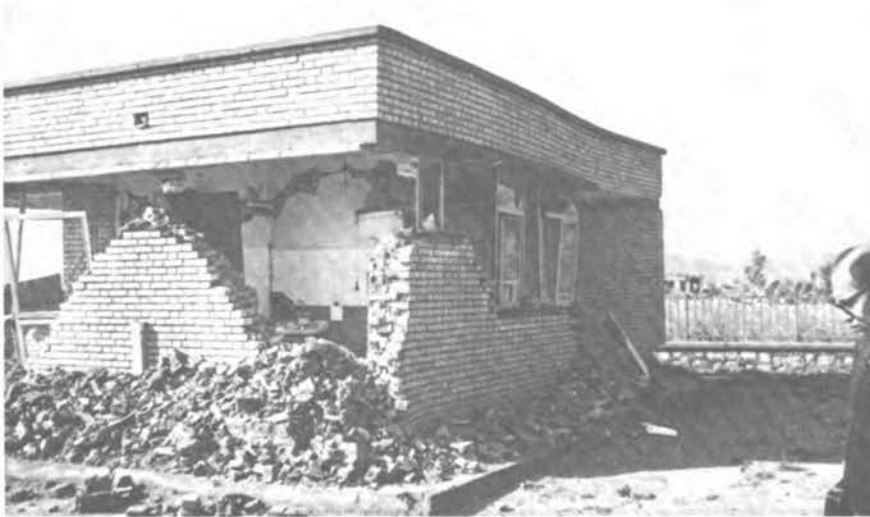
FIGURE 3.26 The Southwest Corner of the Garage-Janitor Building.

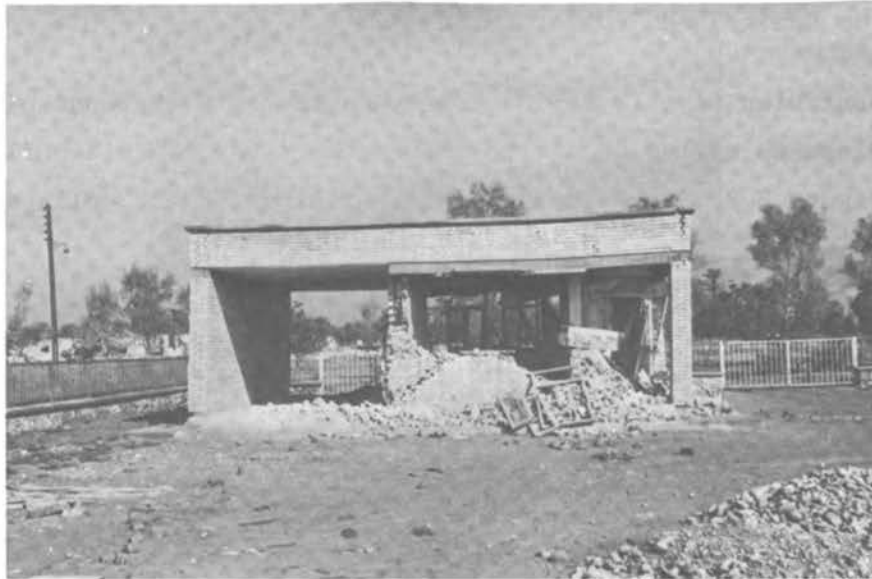
FIGURE 3.27 The Northern End of the Garage-Janitor Building.

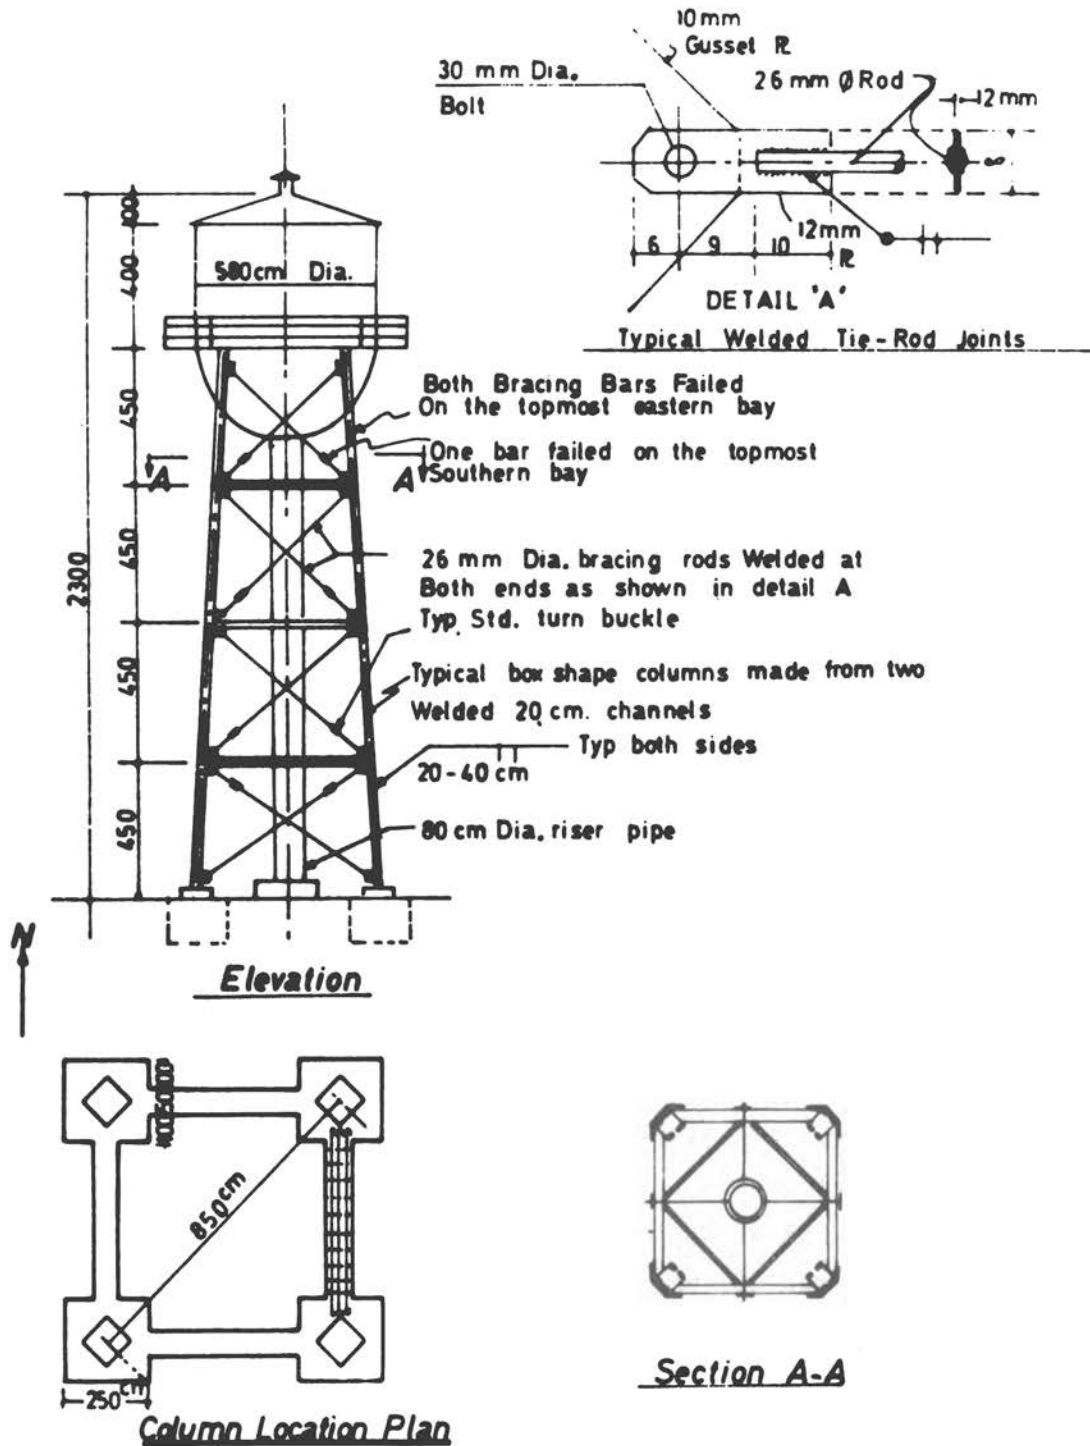
FIGURE 3.31 Summary Details of the Elevated Steel Water Tank of Qir.

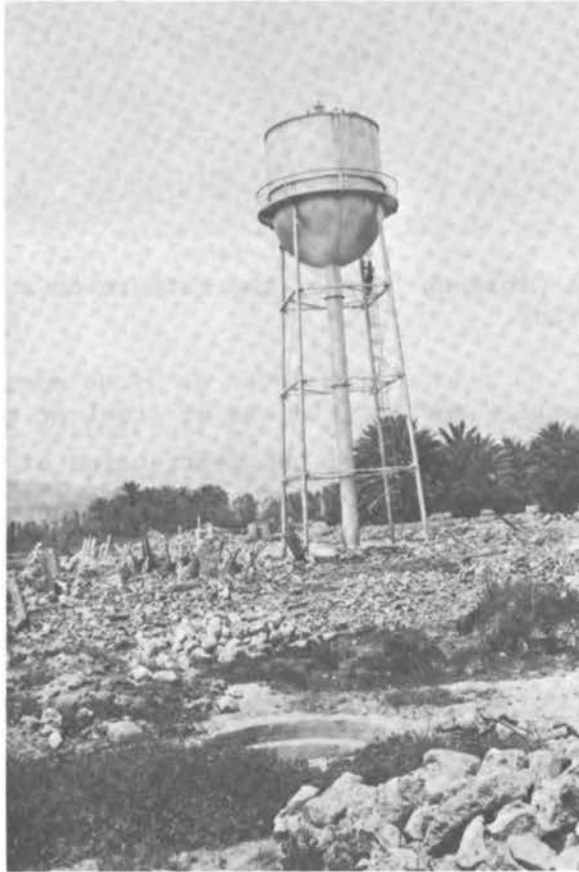
FIGURE 3.32 Q̄ir Water Tank After the Earthquake.

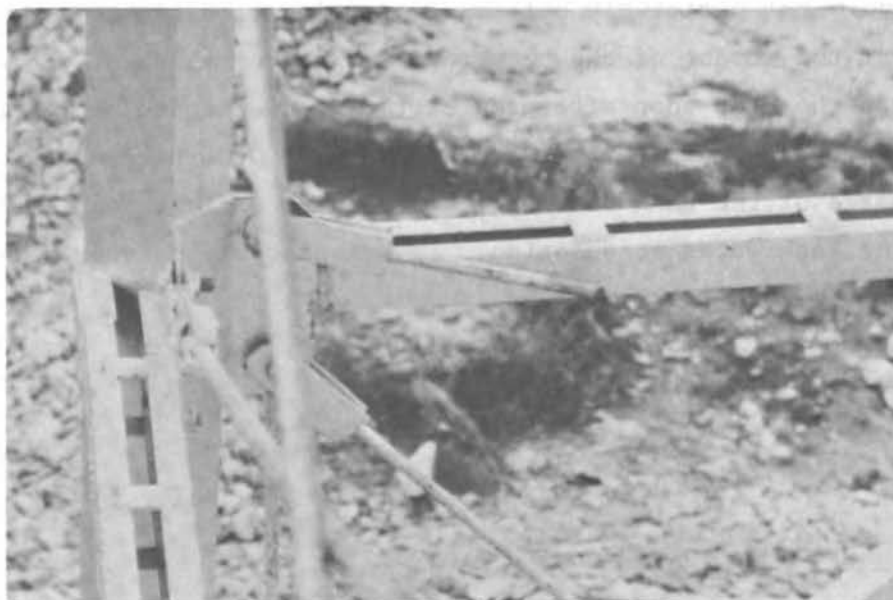
FIGURE 3.33 A Close-up View of the Failure of a Bracing Bar of Qir Water Tank.

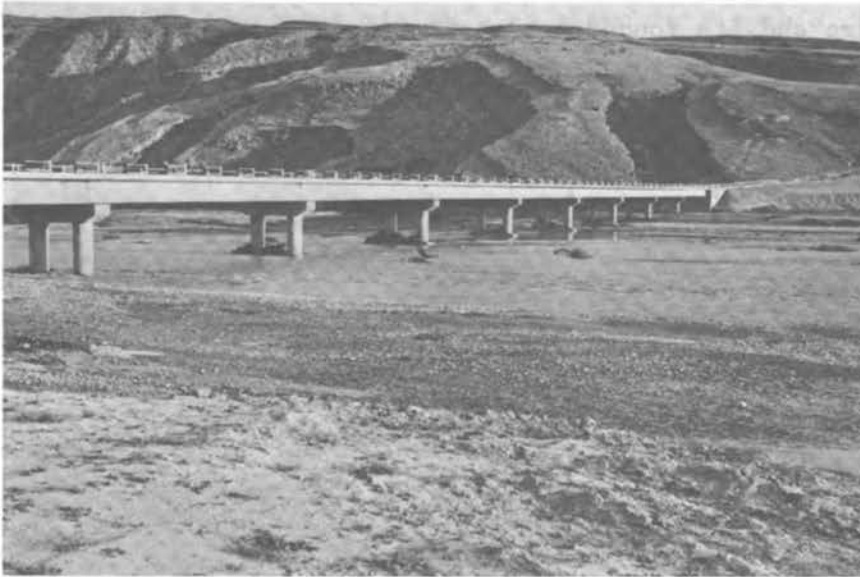
FIGURE 3.34 A General View of the Shāhābād Bridge on the River Qara-Aqaj.

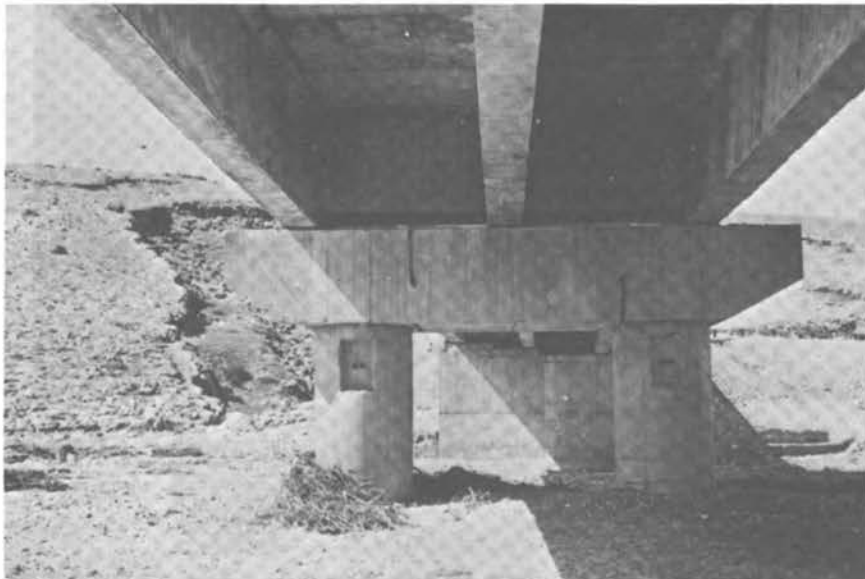
FIGURE 3.35 First Interior Support from the Eastern Abutment. The Locations of Hair Cracks are Marked.

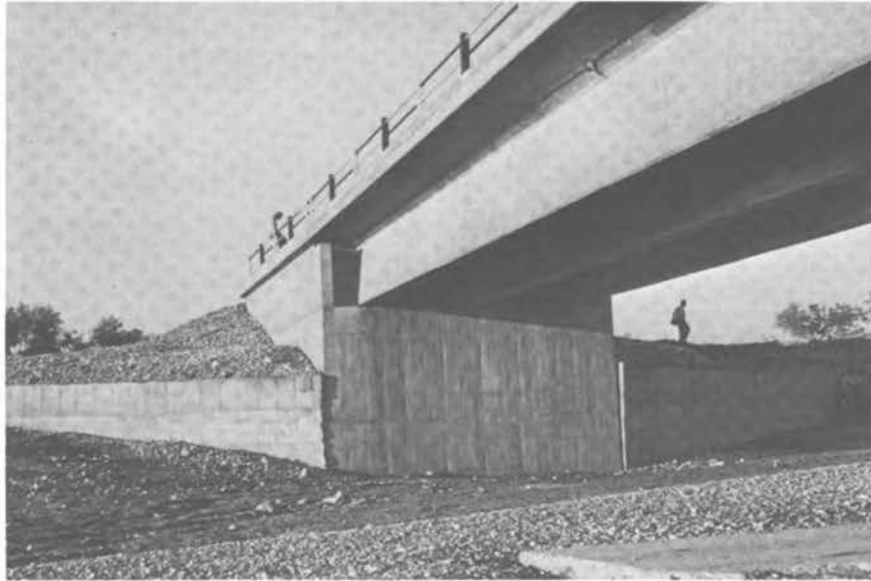
FIGURE 3.36 The Western Abutment of the Bridge and the Retaining Walls.

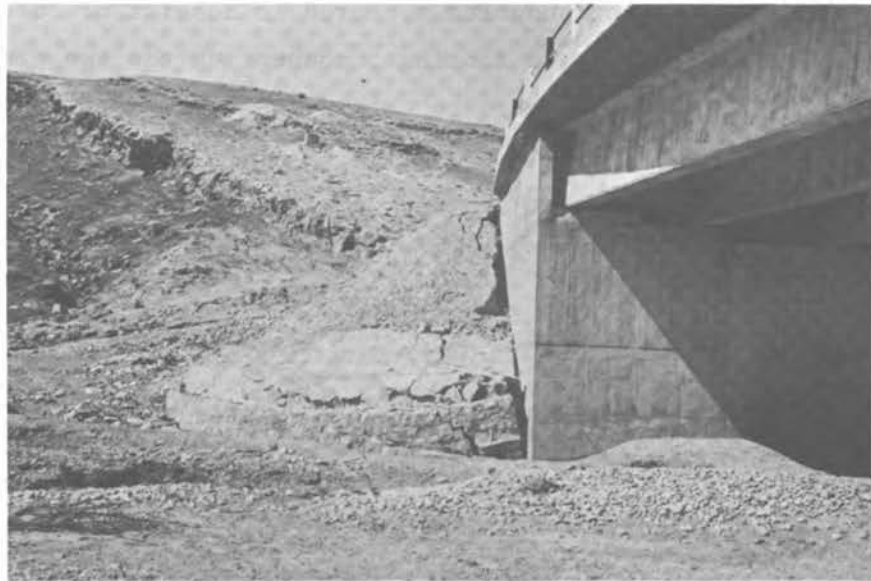
FIGURE 3.37 The Eastern Abutment of the Bridge and the Retaining Walls.

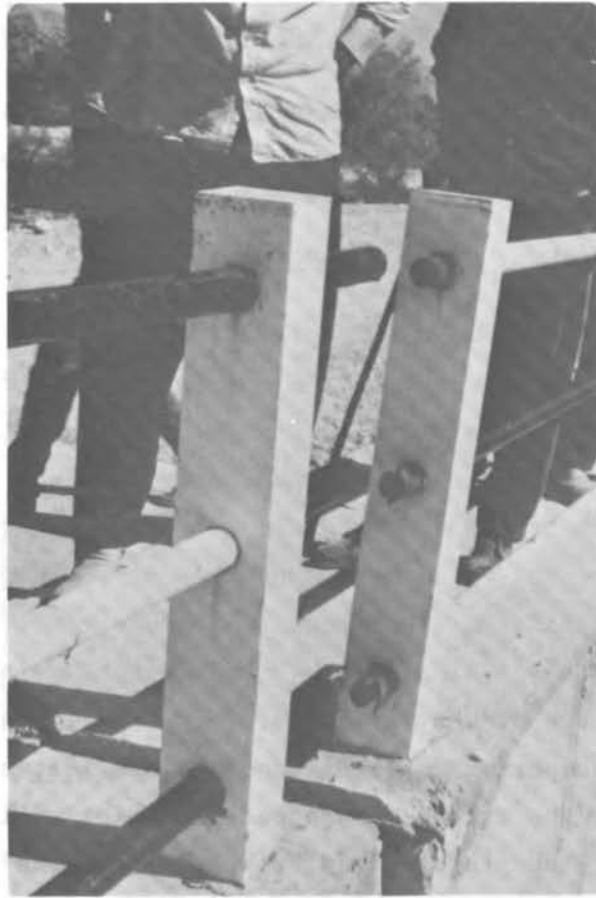
FIGURE 3.38 Movement of the Bridge Deck and its Railing with Respect to the Western Abutment.

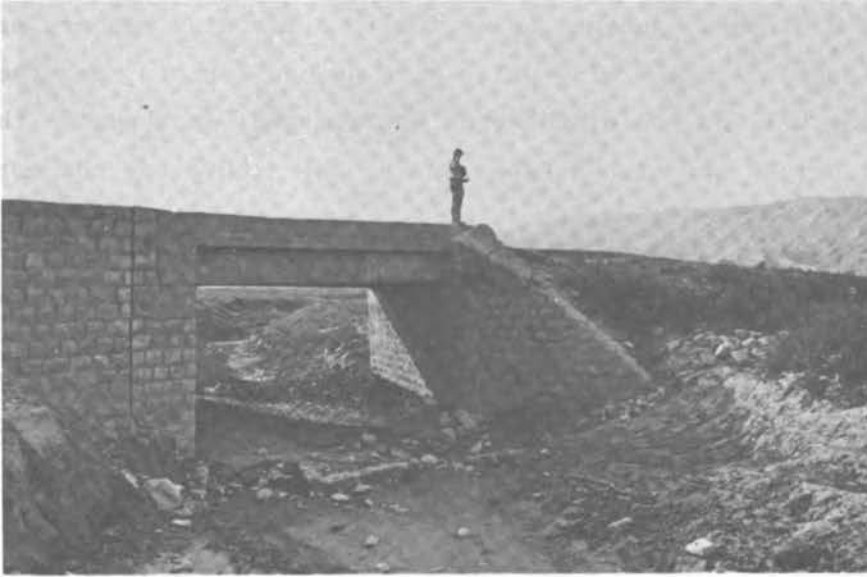
FIGURE 3.39 Failure of the Wing Wall of a Small Bridge near the Village of Khayrābād (No. 3).
