Engineering Aspects of the Qir Earthquake of 10 April 1972 in Southern Iran: A Report to the National Science Foundation (1973)

Size
8.5 x 11

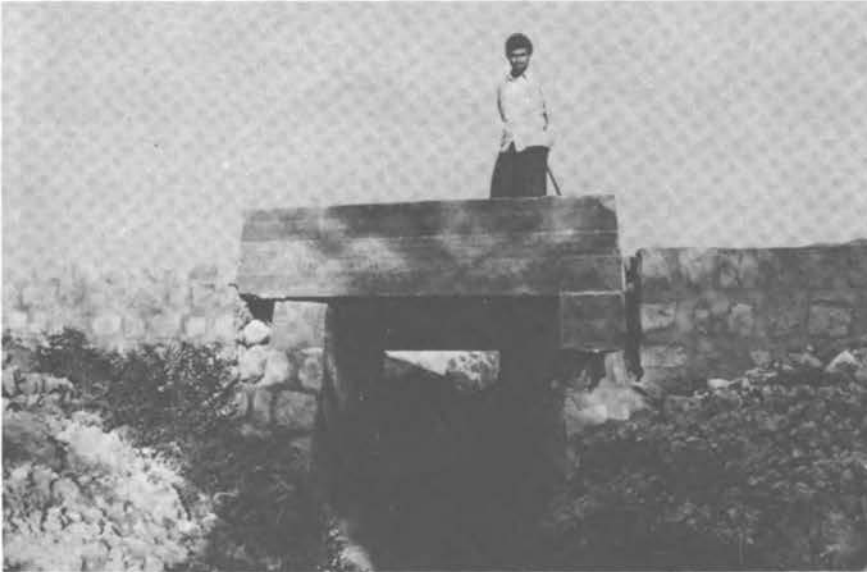
FIGURE 3.40 Failure of a Culvert near the Shāhābād Bridge.

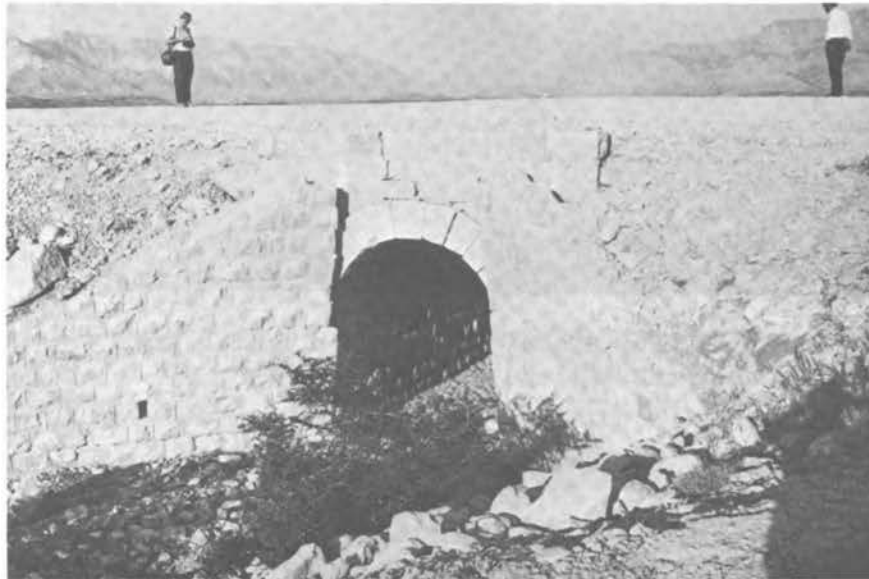
FIGURE 3.41 Damage to a Circular Culvert and its Retaining Walls near the Village of Shāhābād.

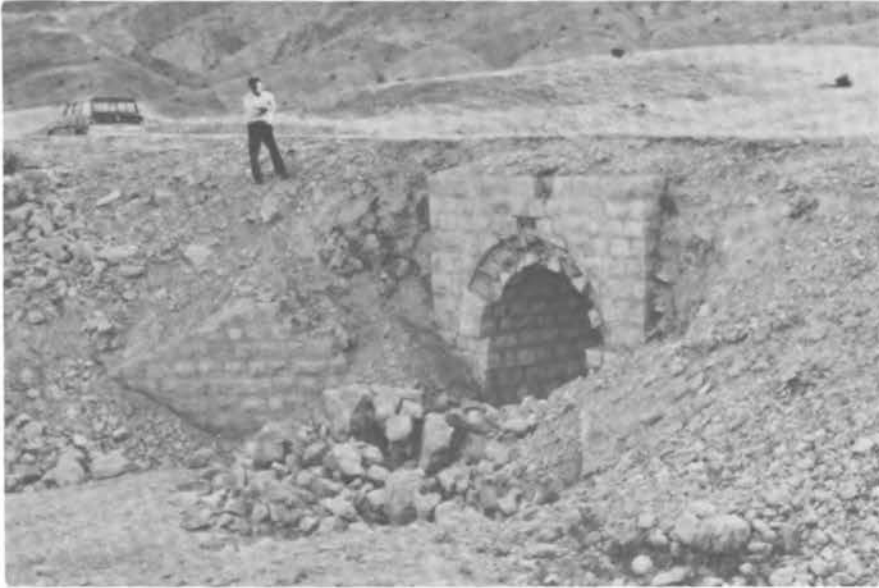
FIGURE 3.42 Damage to a Masonry Circular Culvert and its Wing Walls, near the Village of Shahabad.

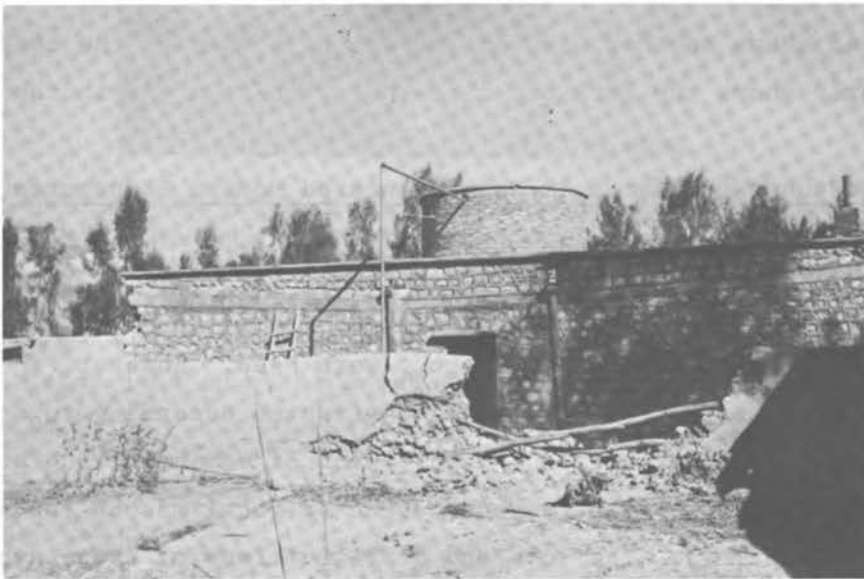
FIGURE 3.43 Western View of the Public Bathing House of the Village of Upper Liferjān.

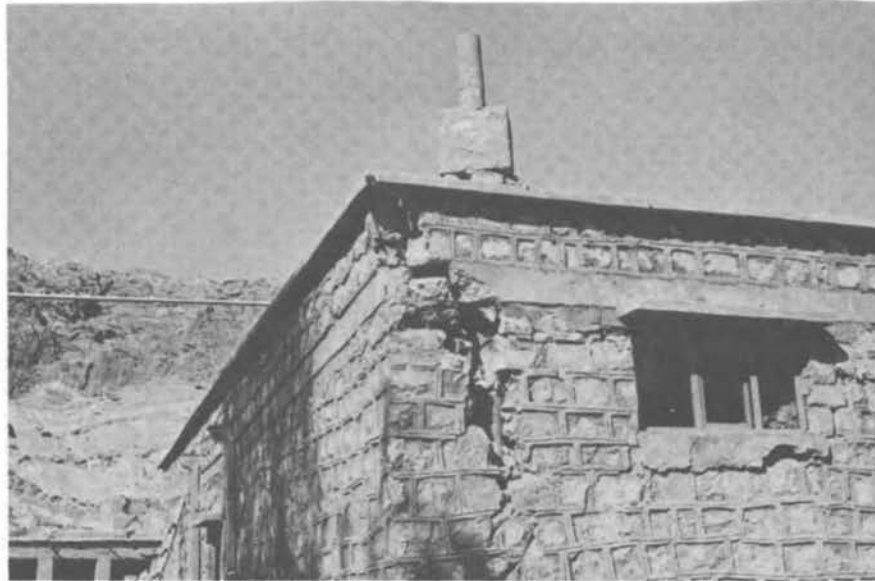
FIGURE 3.44 Failure of the Structure at the Corner Due to the Weakness in the Tie-beam and Existence of a Weak Line Along the Chimney Inside the Wall.

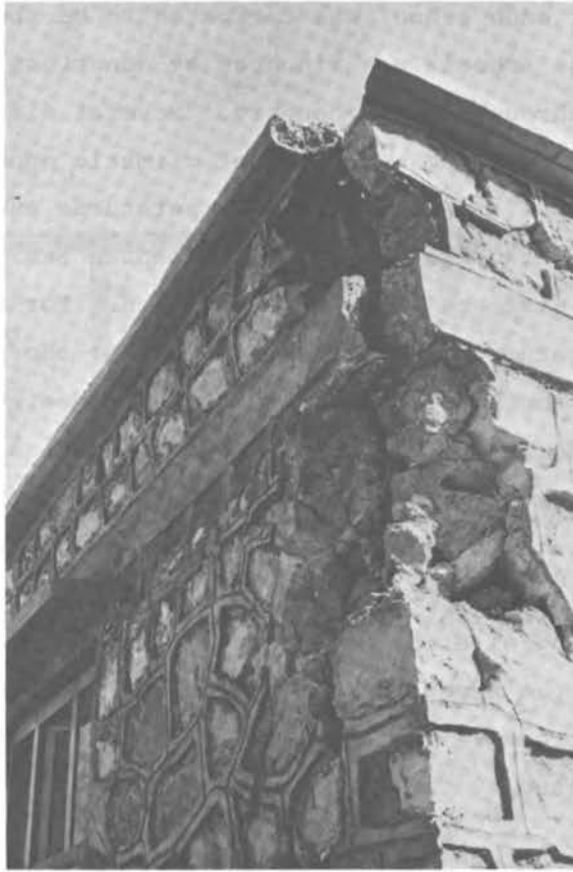
FIGURE 3.45 Failure of the Tie-beam at a Corner
Due to the Lack of Corner Reinforcement.

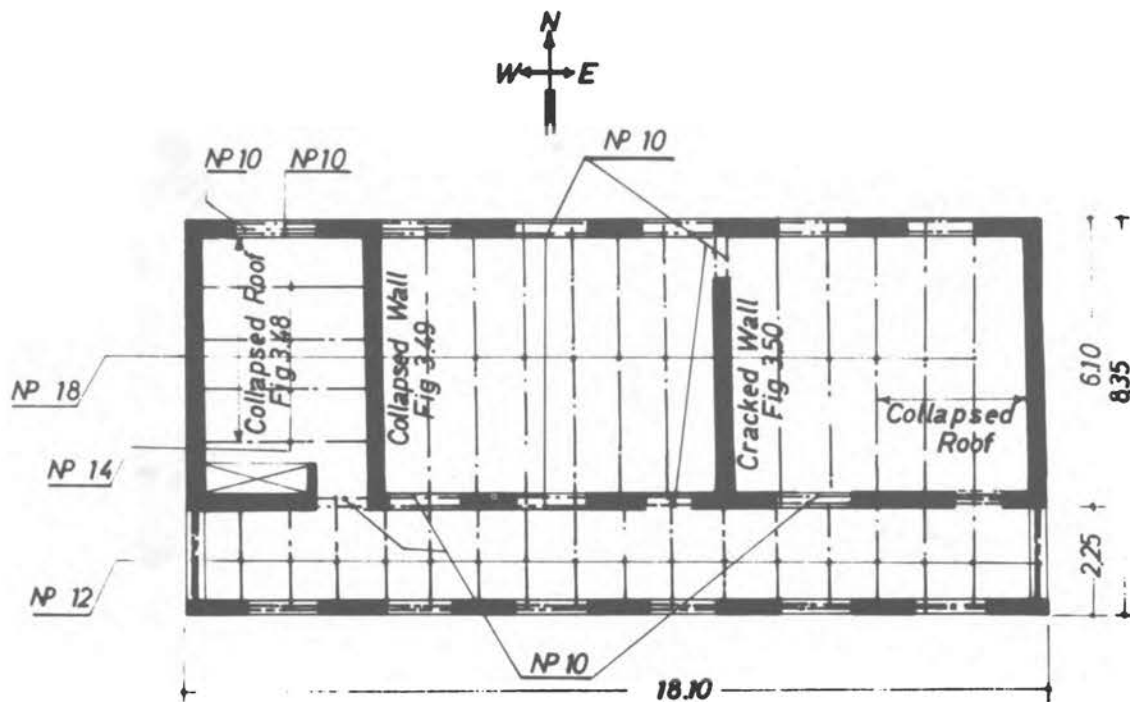
FIGURE 3.46 A Sketch of the Plan of the 2500 Years Anniversary School of the Village of Ābe Garm.

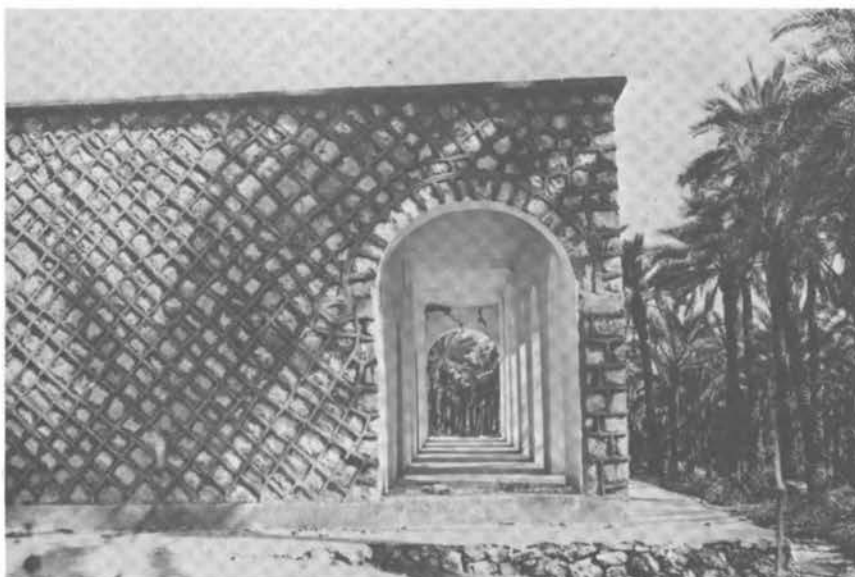
FIGURE 3.47 West-end View of the Ābe Garm School.

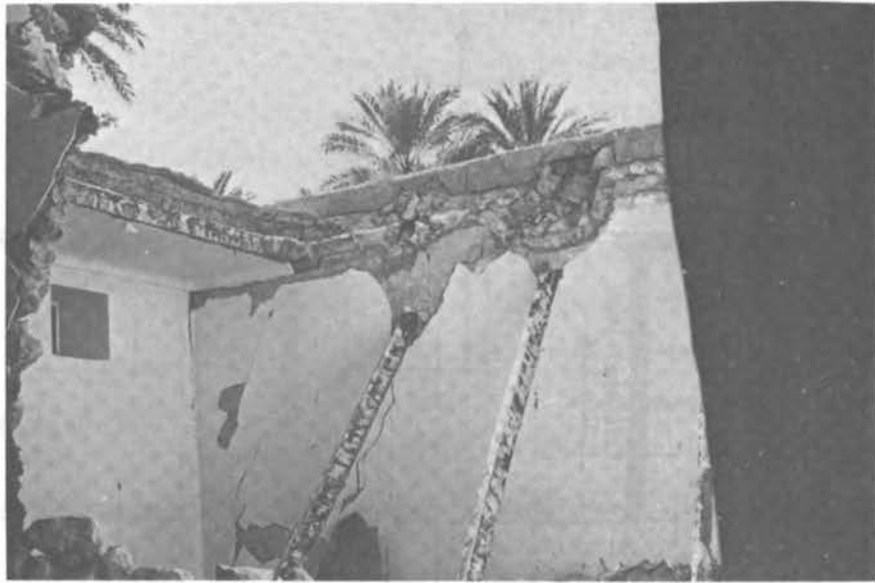
FIGURE 3.48 Interior View of the West-end Class of the Abe Garm School.

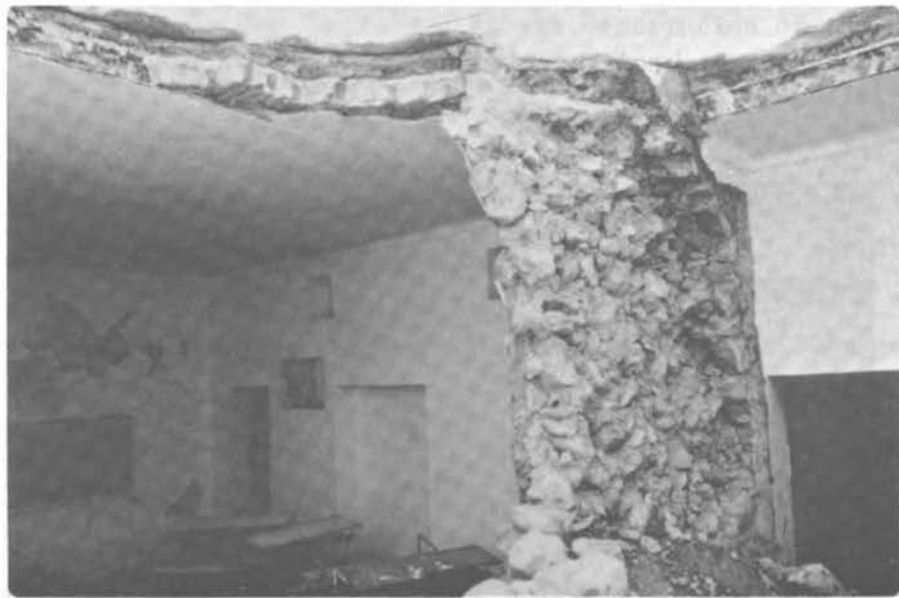
FIGURE 3.49 Interior View of the Central Classroom. Note the Mode of Failure of the Interior Load-bearing Stone Masonry Wall.

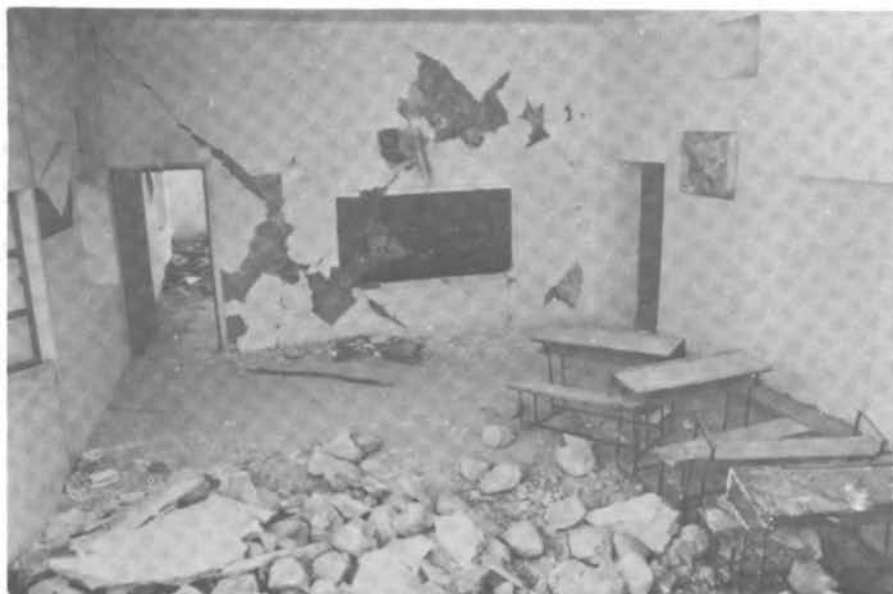
FIGURE 3.50 A View of the Cracked East-end Interior Partition Wall of the Ābe Garm School.

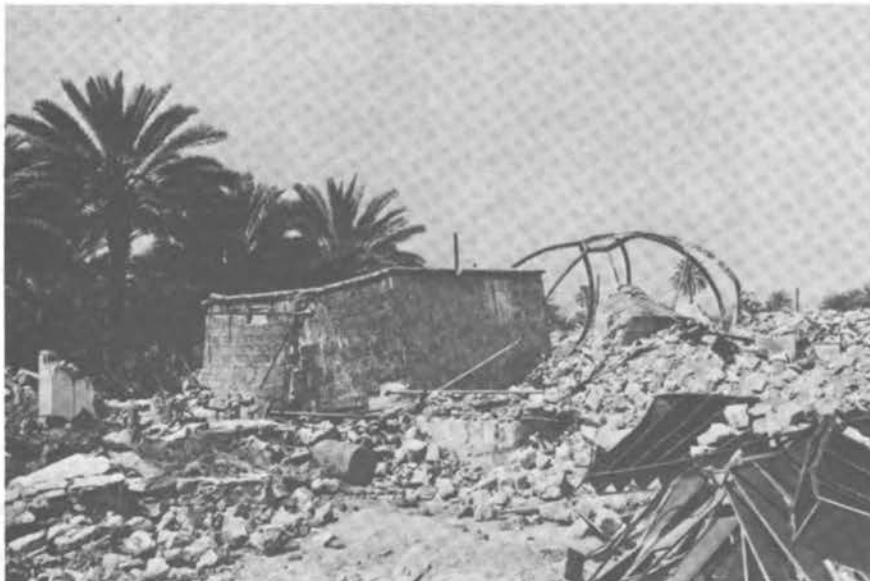
FIGURE 3.54 The Ruins of the Public Bathing House in Q̄ir.

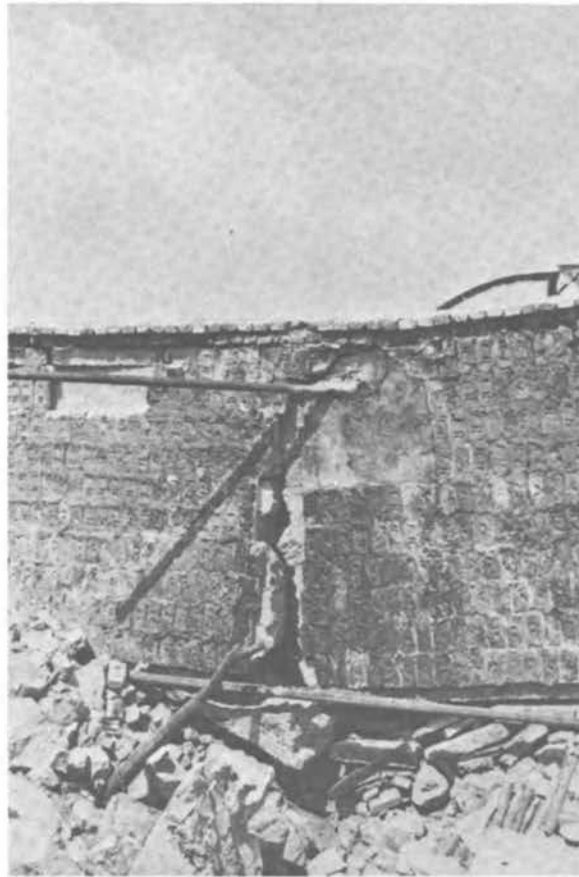
FIGURE 3.55 A Close-up View of the Central Crack in the Water Tank of the Qir Bathing House.

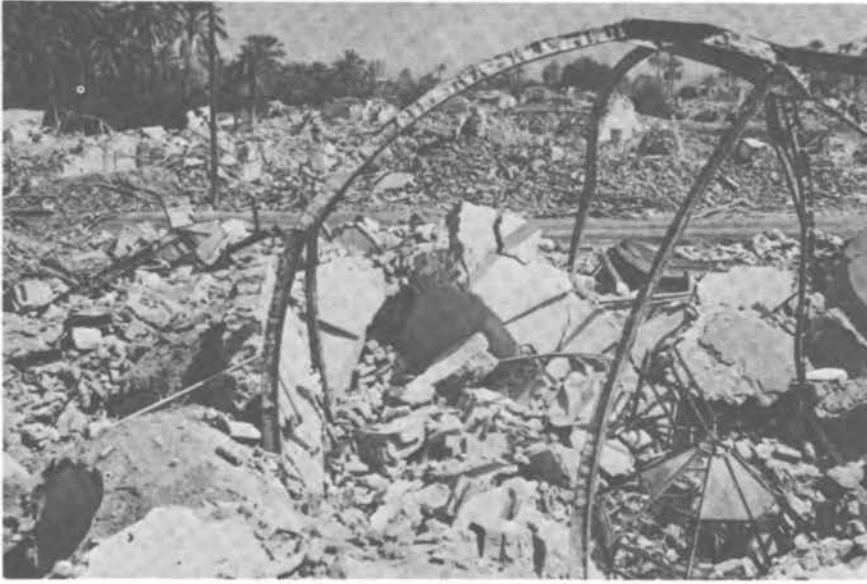
FIGURE 3.56 A Close-up View of the Destroyed Dome of the Qir Bathing House.

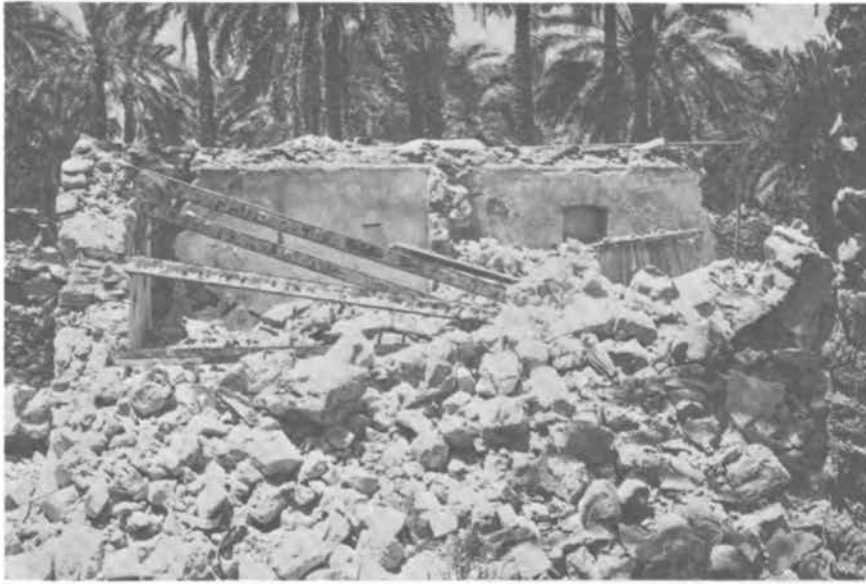
FIGURE 3.57 The Ruins of a Typical Building with Steel Beams and Shallow Brick Arches (SBABA) Roofing System.

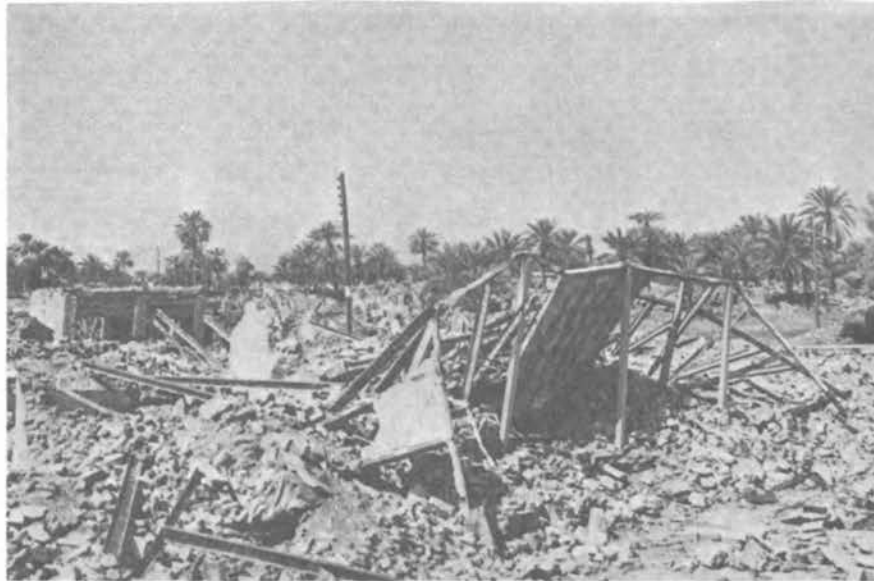
FIGURE 3.59 The Ruins of a Building in Qir Where Part of its Roof was Supported by Steel Columns.

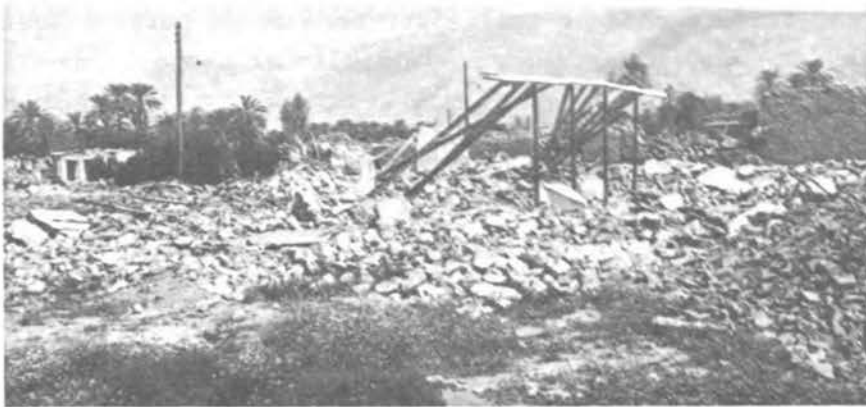
FIGURE 3.60 The Ruins of Another Building in Qir Where a Portion of the Roof was Supported by Steel Columns.

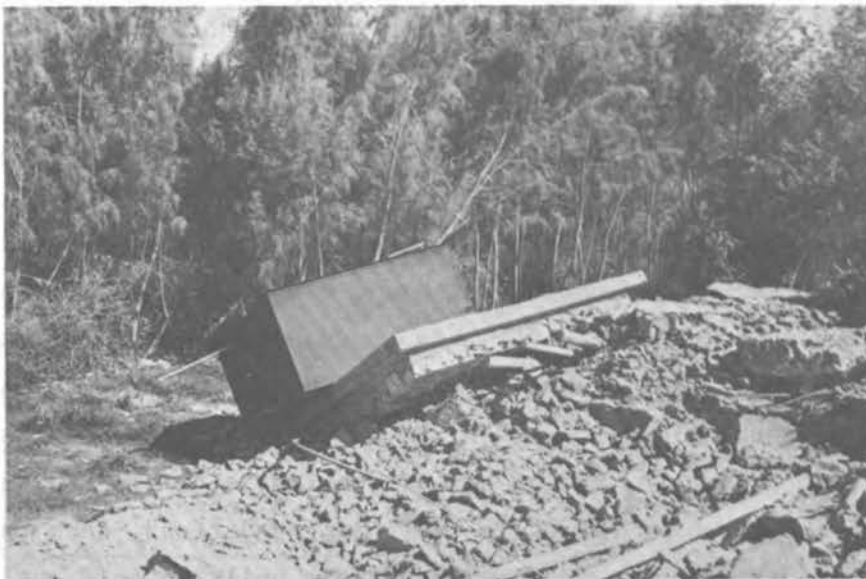
FIGURE 3.61 The Ruins of a Reinforced Concrete Slab Supported by Adobe Walls.

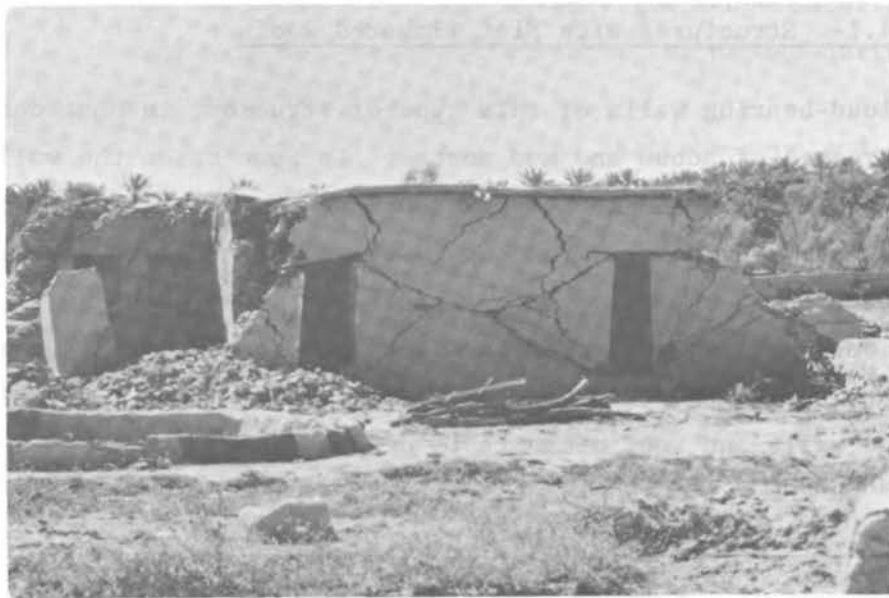
FIGURE 3.62 Typical X-shaped Shear Cracks on a Wide Adobe Wall.

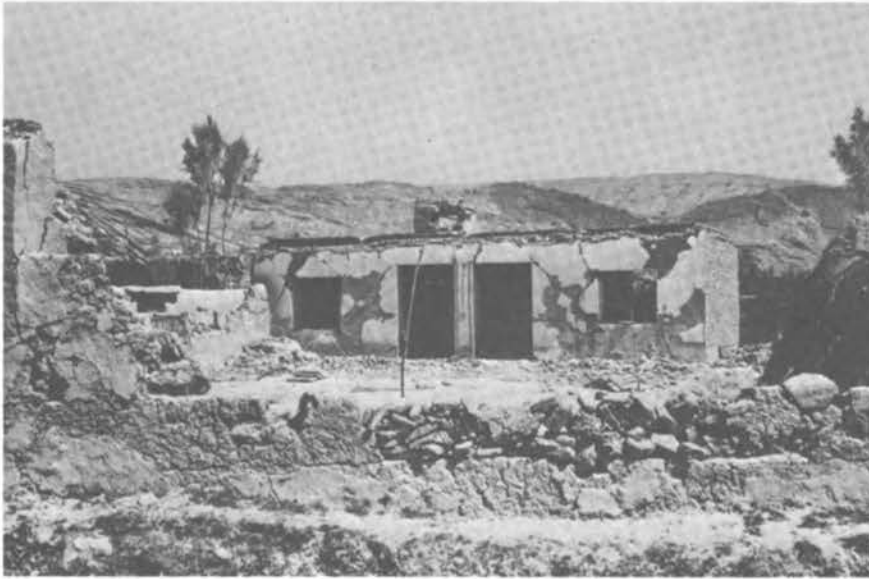
FIGURE 3.63 Typical X-shaped Shear Cracks and Flexural Cracks on the Walls of a Symmetrical Adobe Building.

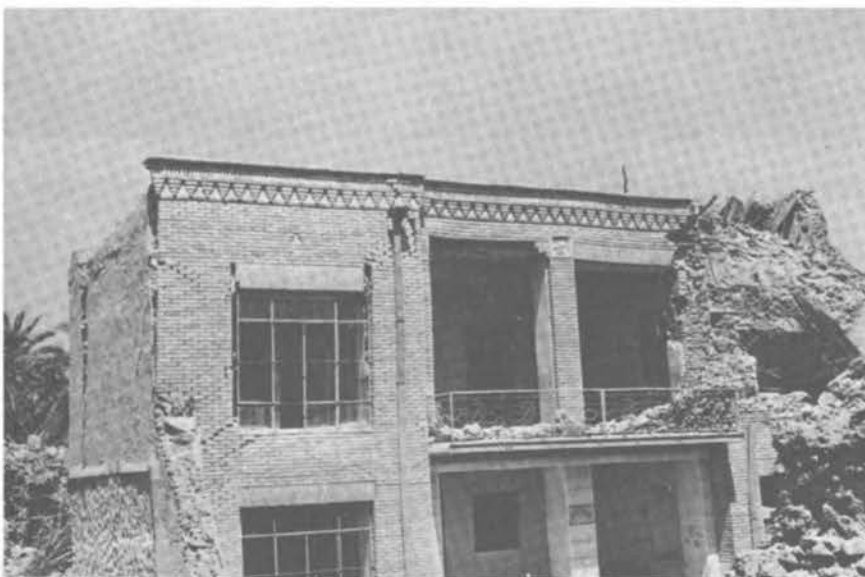
FIGURE 3.64 A Brick-masonry Building in the Village of Deh-beh.

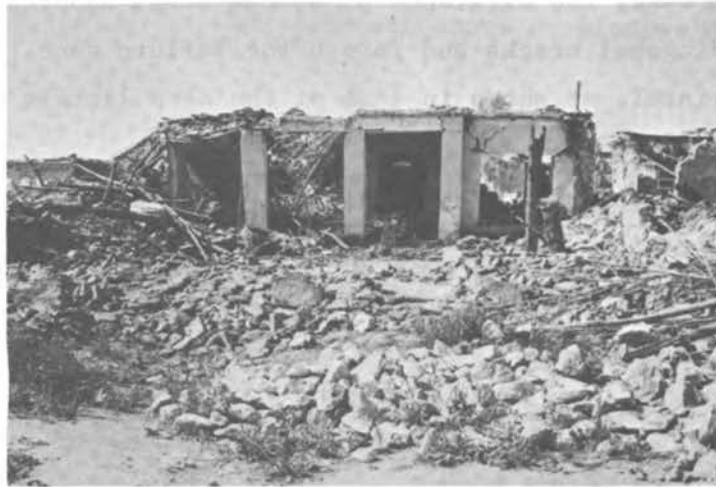
FIGURE 3.65 Flexural and Shear Cracks at the End of Lintels and Columns (Village of Deh-beh).

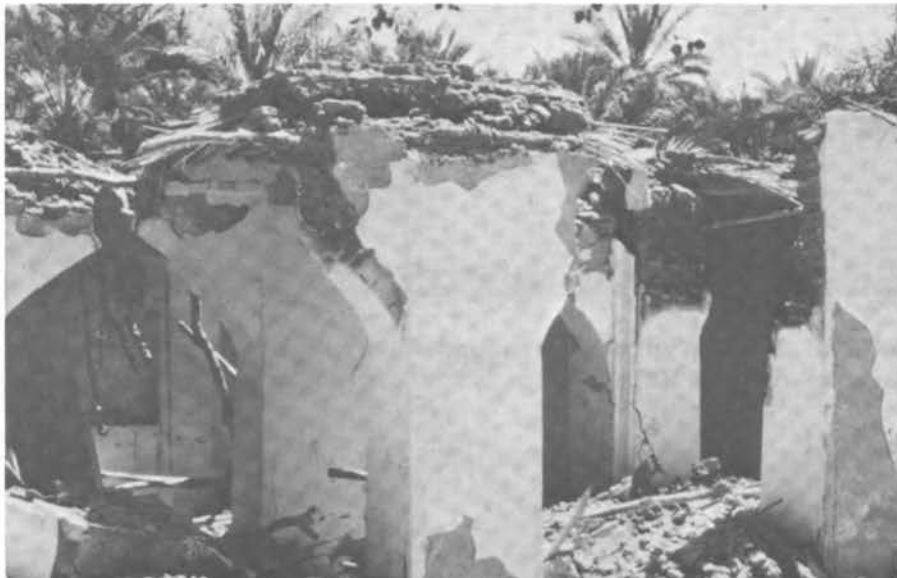
FIGURE 3.66 Typical Shear Failure of the Arched Lintels of a Mosque in Qir.

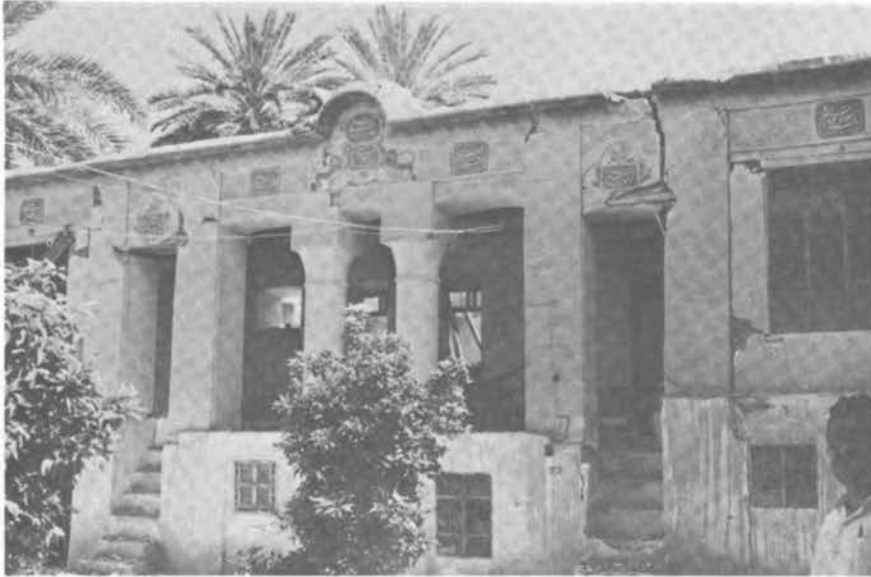
FIGURE 3.67 A Brick-masonry House in the Village of Deh-beh.

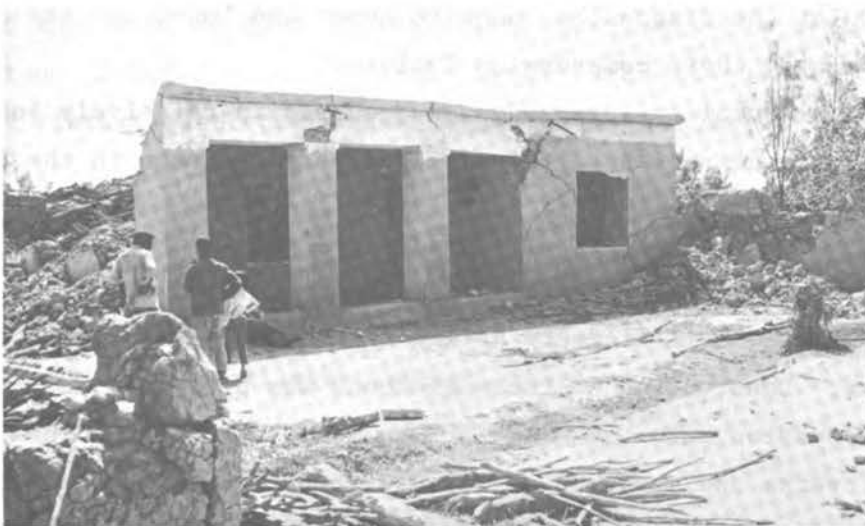
FIGURE 3.68 Shear and Flexural Cracks in the Load-bearing Wall Elements and Lintels of an Adobe Building.

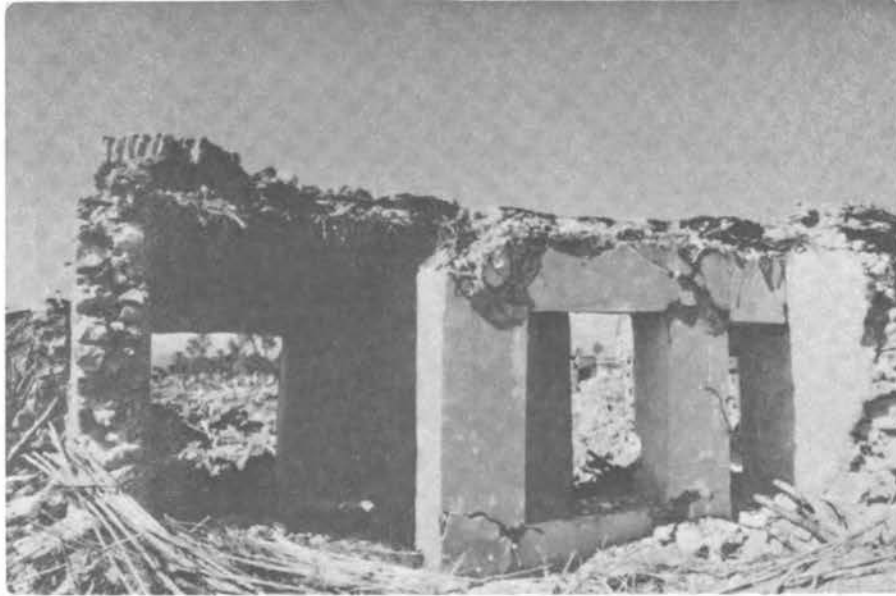
FIGURE 3.69 Typical Failure Mode and Crack Shapes of Lintels and Wall Elements.

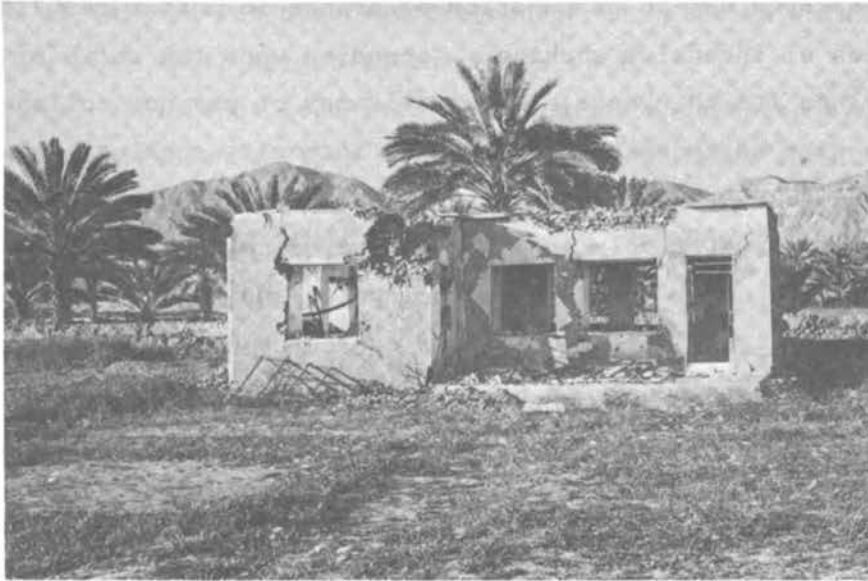
FIGURE 3.70 Typical Failure Mode and Crack Shapes of Lintels and Wall Elements.

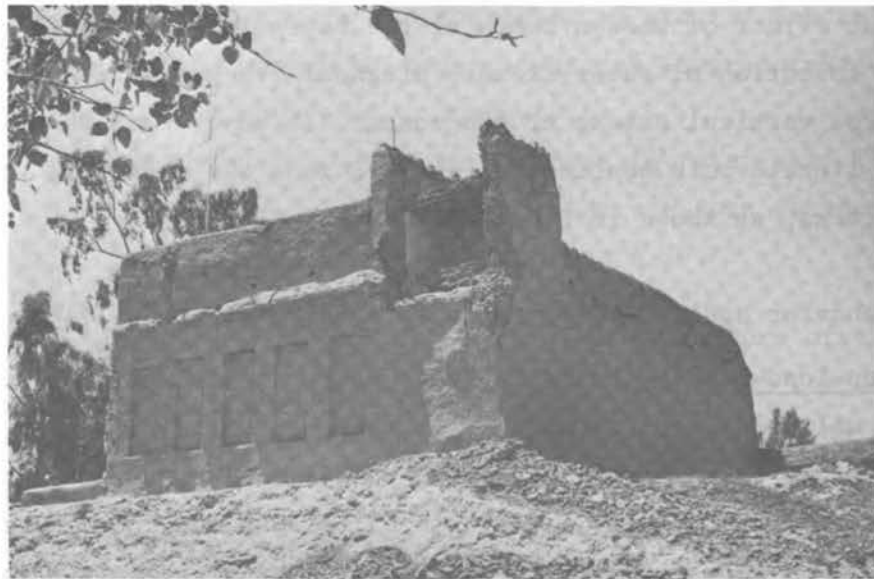
FIGURE 3.71 Collapse of One of the Upper-story Non-load-bearing Walls of the Gendarmeri (Rural Police) Station at the Village of Laghar.

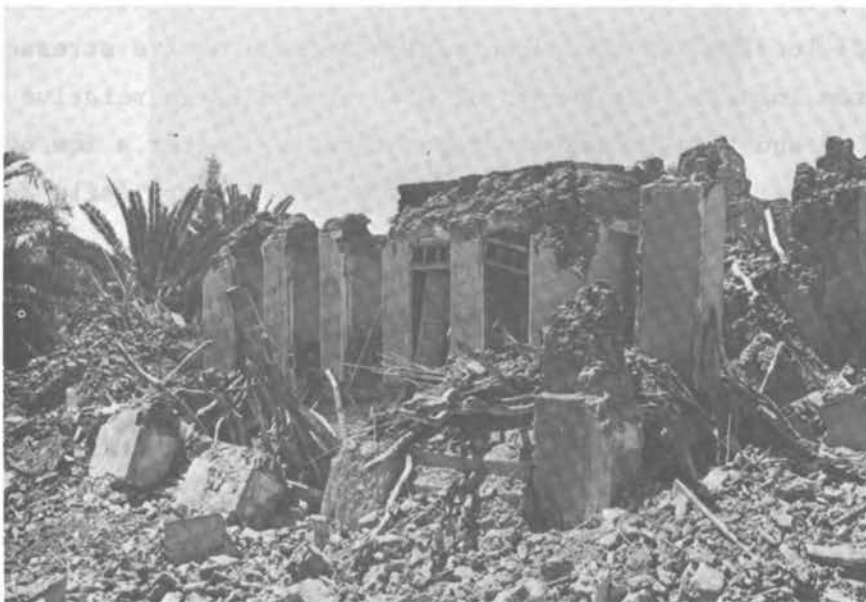
FIGURE 3.72 Typical Failure of the Arched or Timbered Lintels with Insufficient Bearing Length on the Supporting Walls.

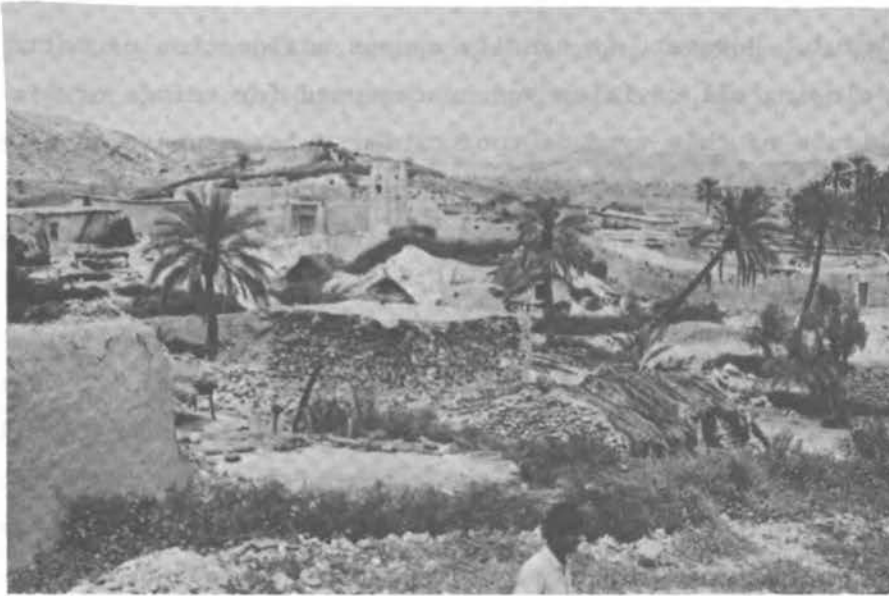
FIGURE 3.73 Typical In-Plane Failure of the Exterior Walls of a Stone-Masonry Building in the Village of Kamasej.

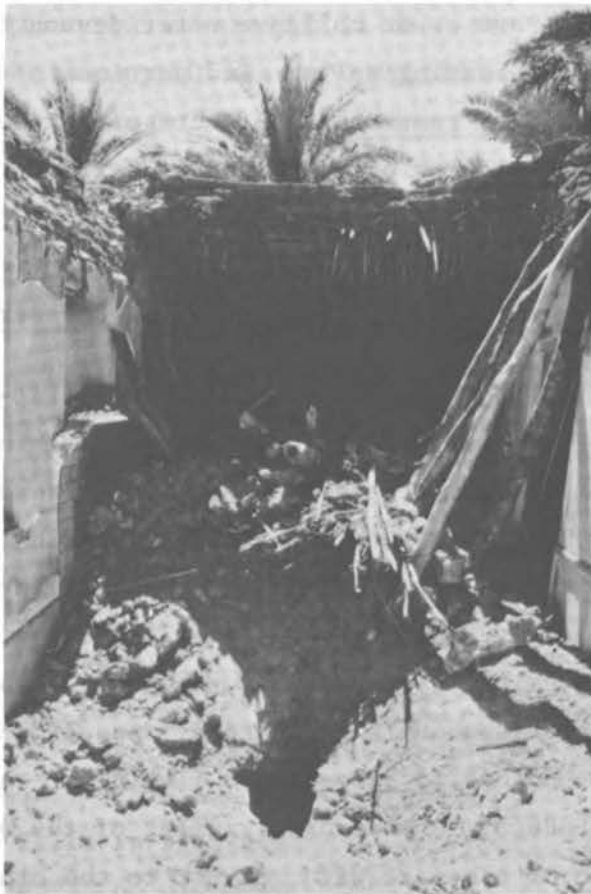
FIGURE 3.74 Typical Failure of a Roof Due to Insufficient Length of Bearing of the Timbers (Village of Deh-beh).

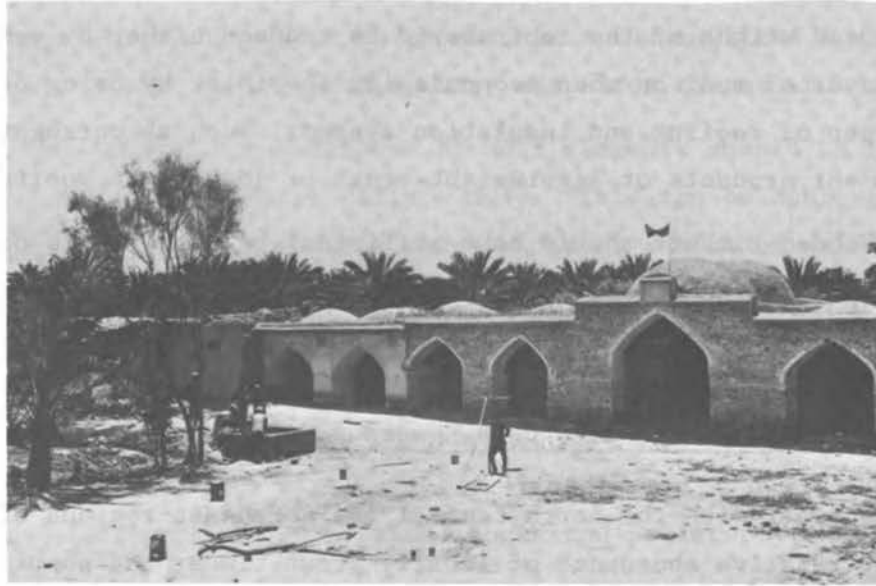
FIGURE 3.75 South-end View of the Friday Mosque of the Village of Biān (Karzin).

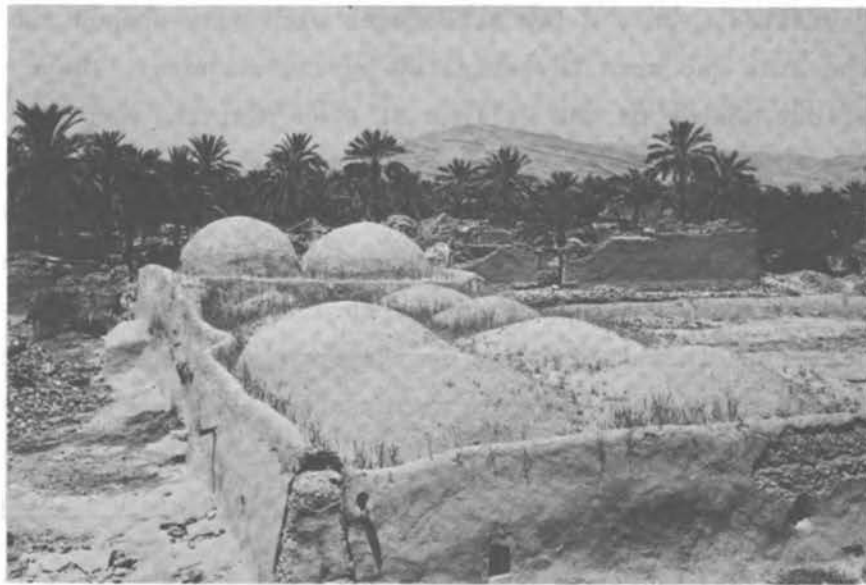
FIGURE 3.76 A View of the Domed Roof of the Friday Mosque of the Village of Biān.

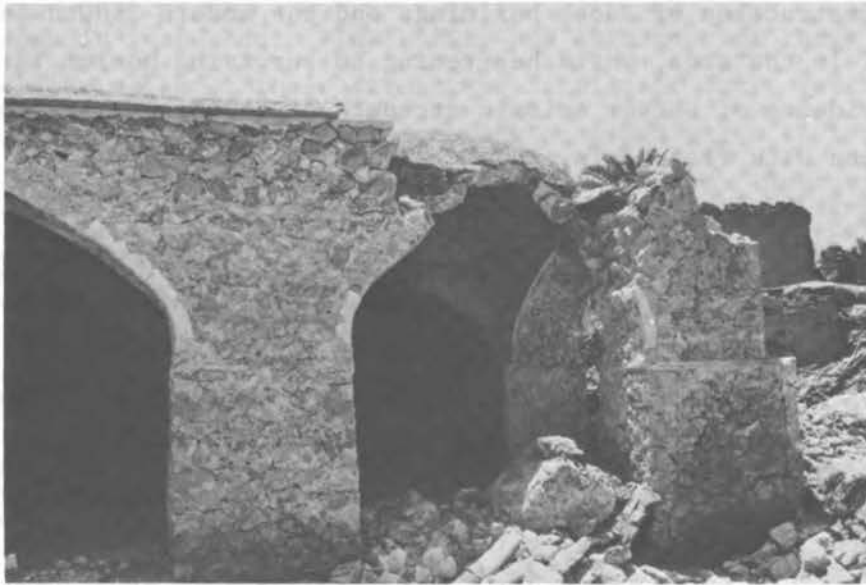
FIGURE 3.77 Damage to the Southeast Corner of the Friday Mosque of Bian.

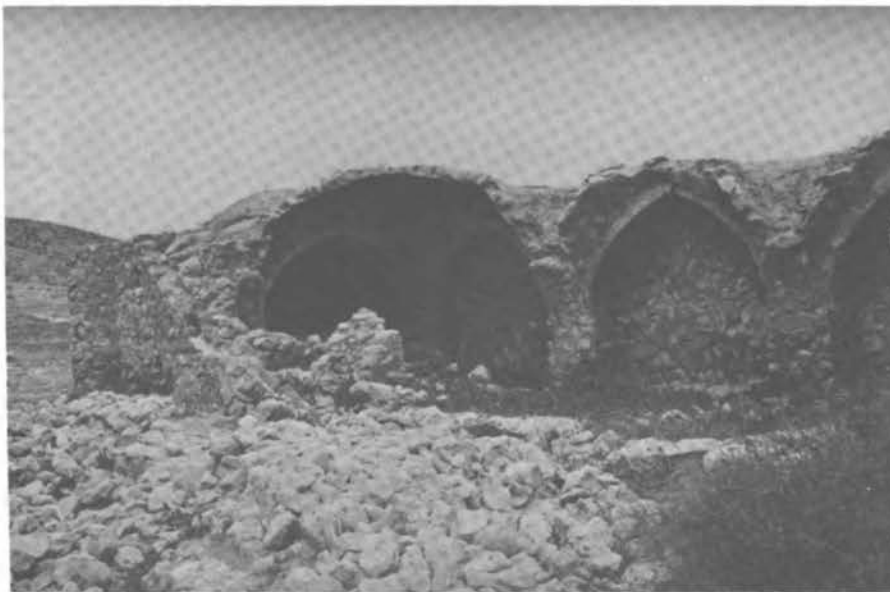
FIGURE 3.78 Ruins of a Caravansary on the Qir-Jahrom Road, Showing the Method of Construction of the Dome-Shaped Roofs.

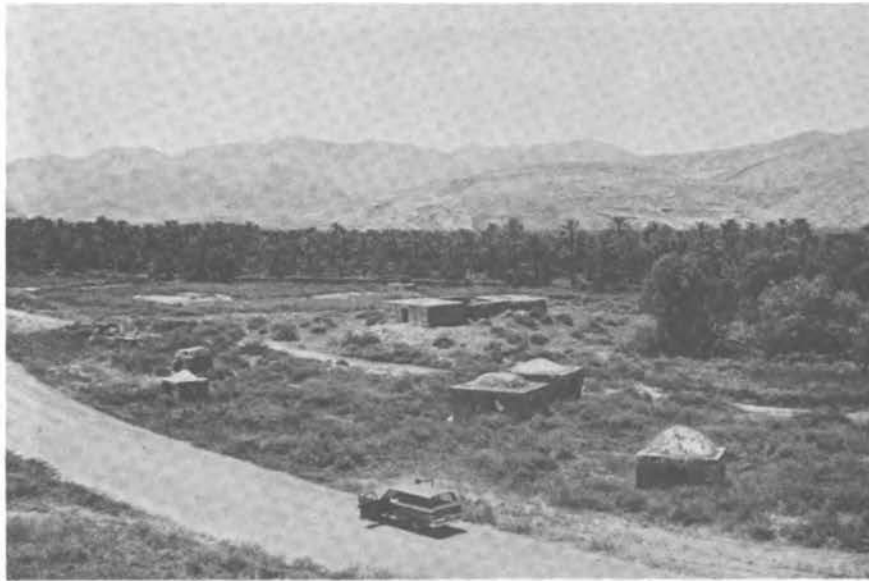
FIGURE 3.79 A Few Mausoleums in the Ābe Garm Cemetery. Note that Those with Dome-Shaped Roofs are Standing While Some of Those with Flat Timbered Roofs have Collapsed.

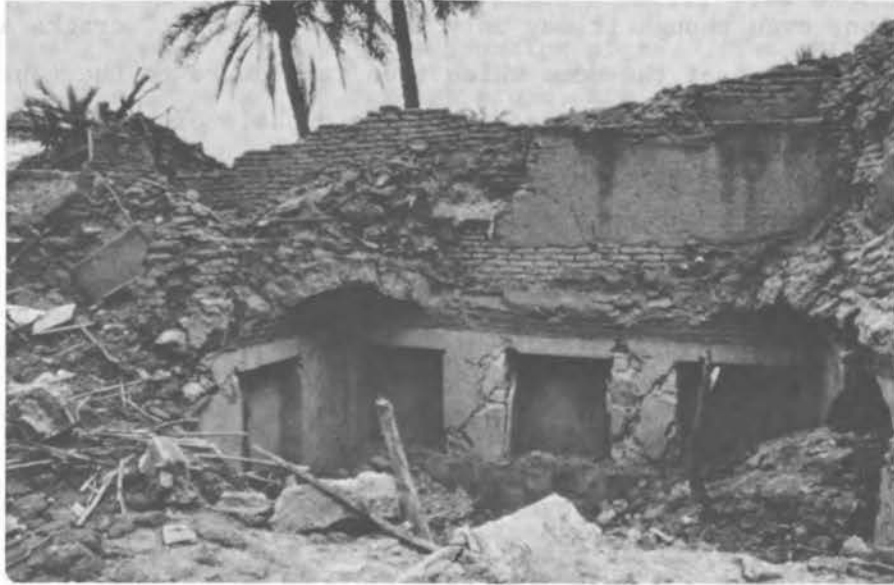
FIGURE 3.80 The Ruins of a Structure with Cylindrical Vault in Qir.

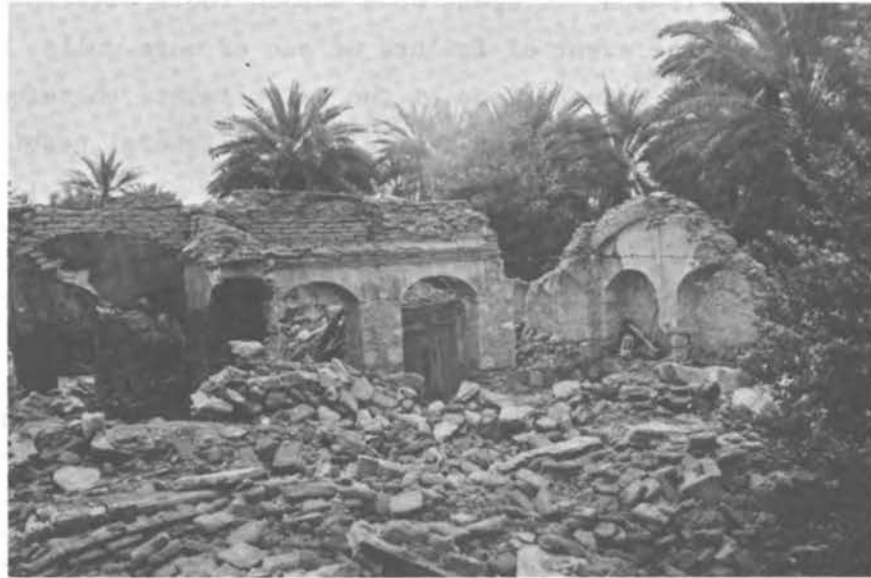
FIGURE 3.81 The Ruins of Another Structure with Cylindrical Vault in Qir.

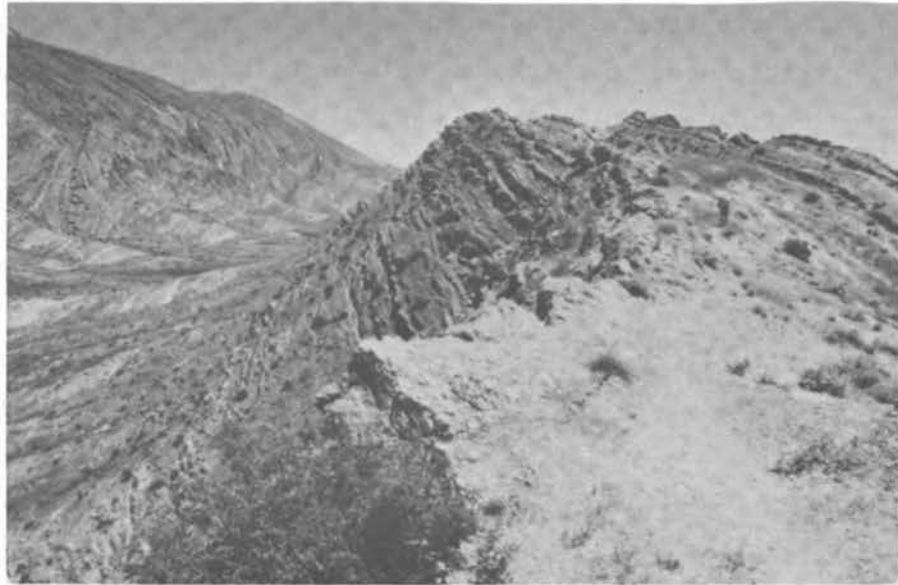
FIGURE 3.82 Typical Cracks at the Crest of the Mountains Near the Village of Ābe Garm.

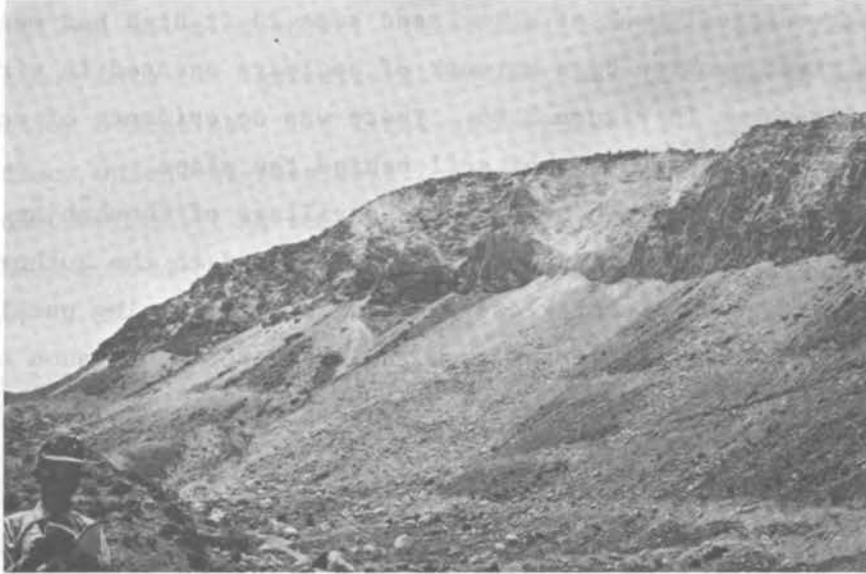
FIGURE 3.83 Rock Slide at Jalalie Pass Near the Village of Kamasej.

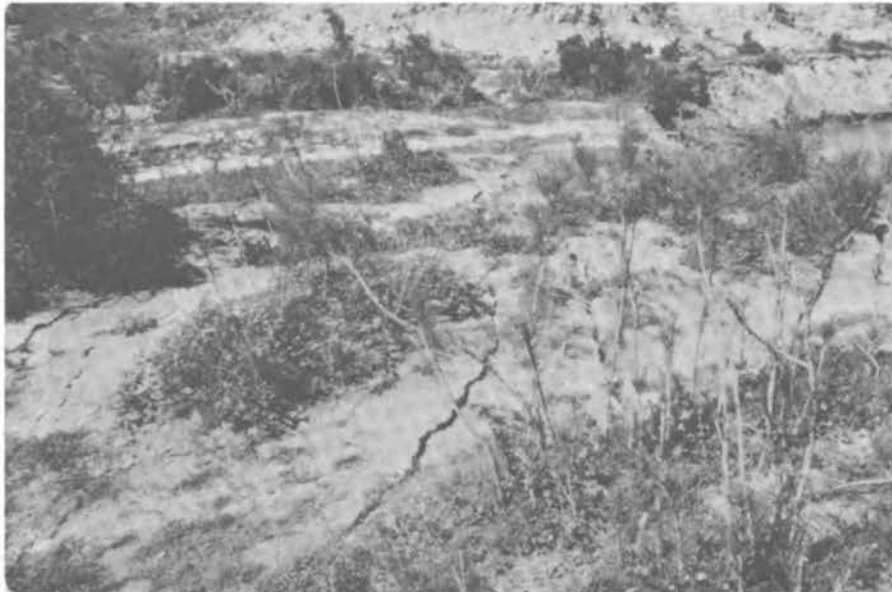
FIGURE 3.84 Typical Cracking and Slumping of the Banks of the River Qara-Aqaj Near the Shāhābad Bridge.

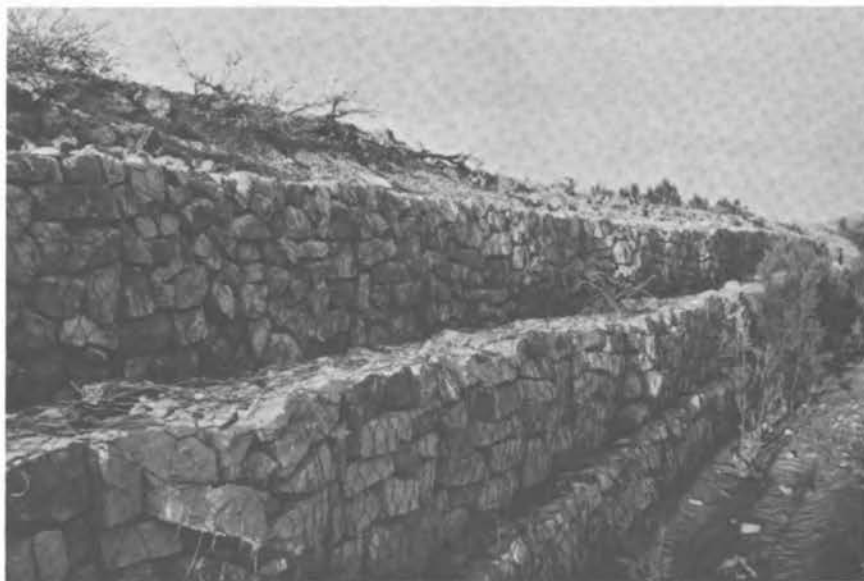
FIGURE 3.85 A Retaining Wall Made of Boulders Encased in a Wire Mesh (French Gabion System) Near Shāhābād Bridge at the West Bank of the River Qara-Aqaj.

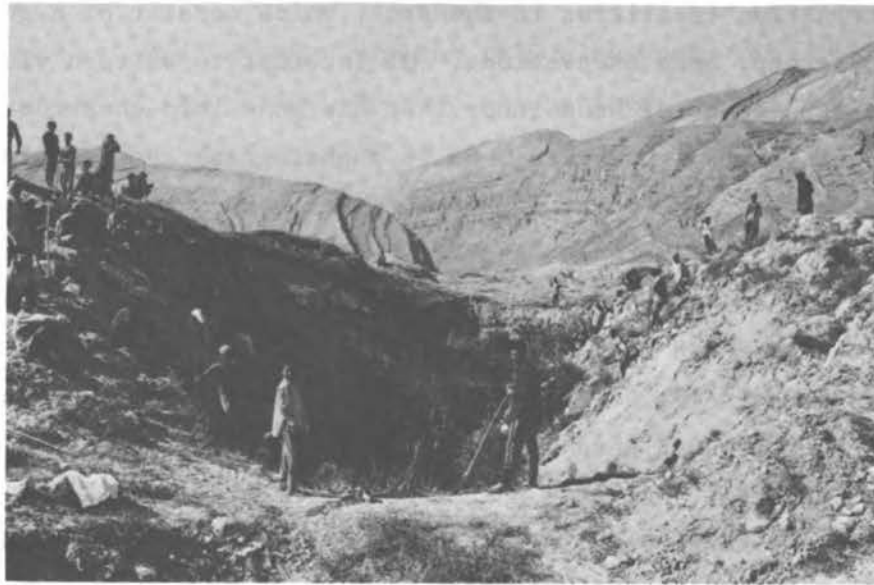
FIGURE 3.87 A Team of Laborers Cleaning Out One of the Slumped-in Open Excavations.
