Engineering Aspects of the Qir Earthquake of 10 April 1972 in Southern Iran: A Report to the National Science Foundation (1973)

Size
8.5 x 11

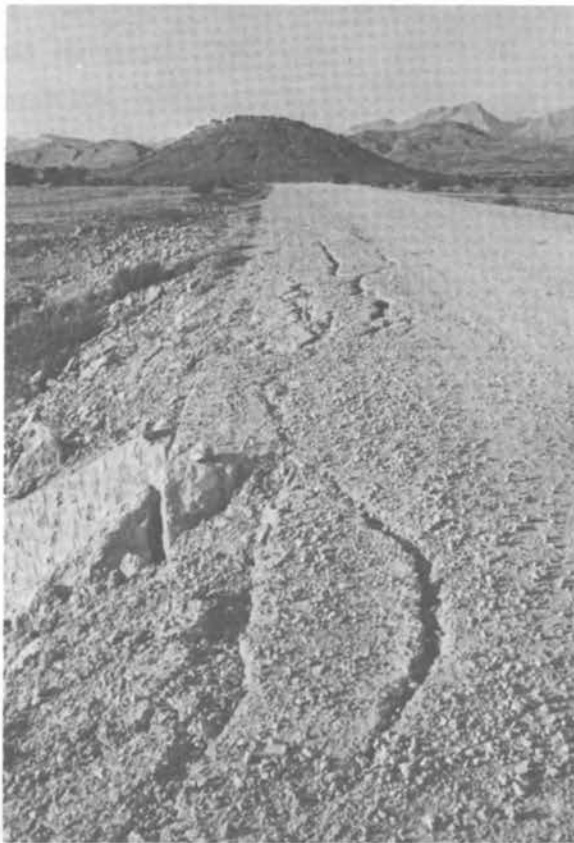
FIGURE 3.88 Damage to the Road Embankments Near a Small Culvert.

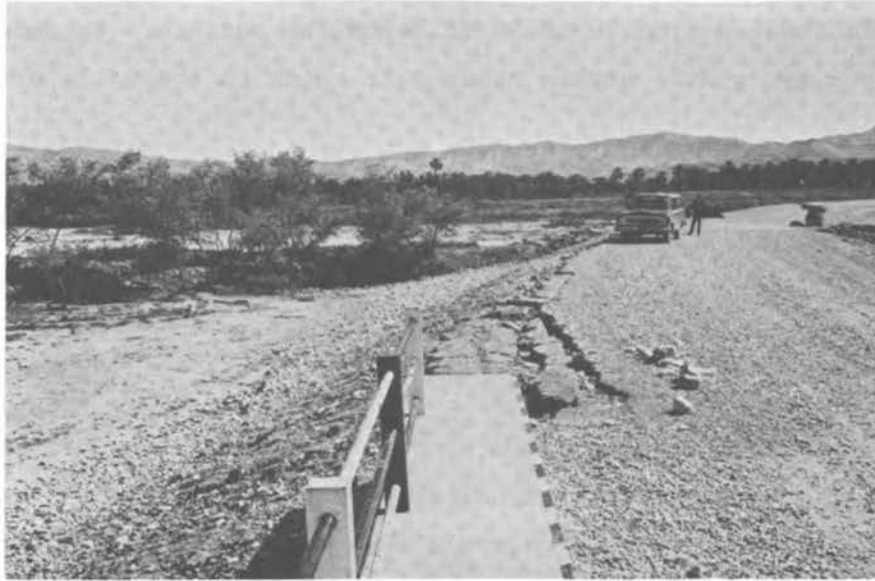
FIGURE 3.89 Damage to the Road Embankment Near the Eastern End of the Shāhābād Bridge.

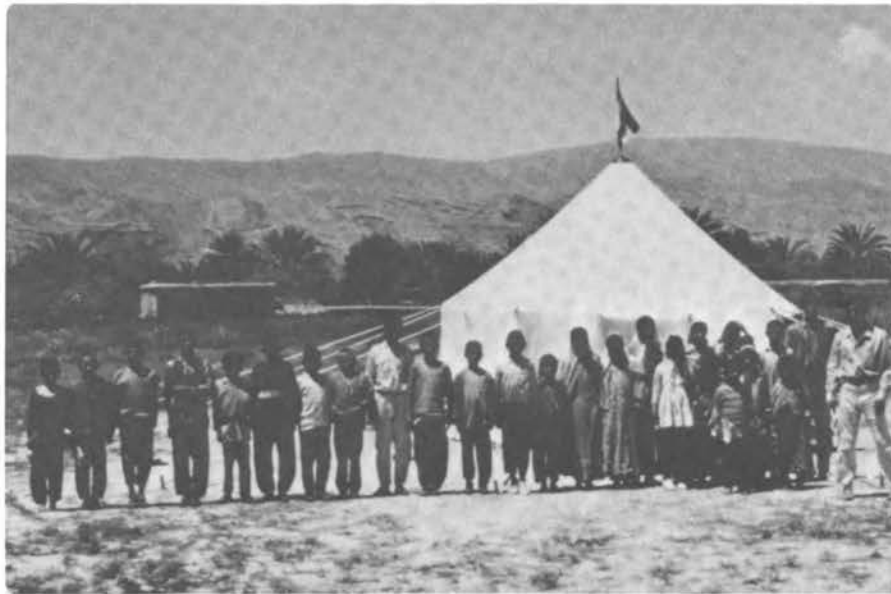
FIGURE 4.2 A School under the Tent in the Village of Seif-abad.

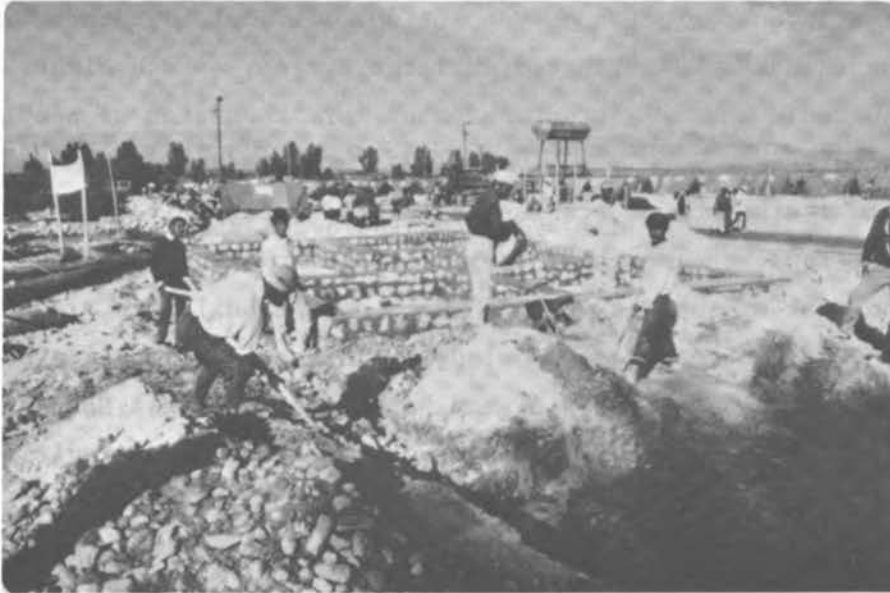
FIGURE 4.3 The Foundation of a New Structure Being Built Again with Rubble Stone.

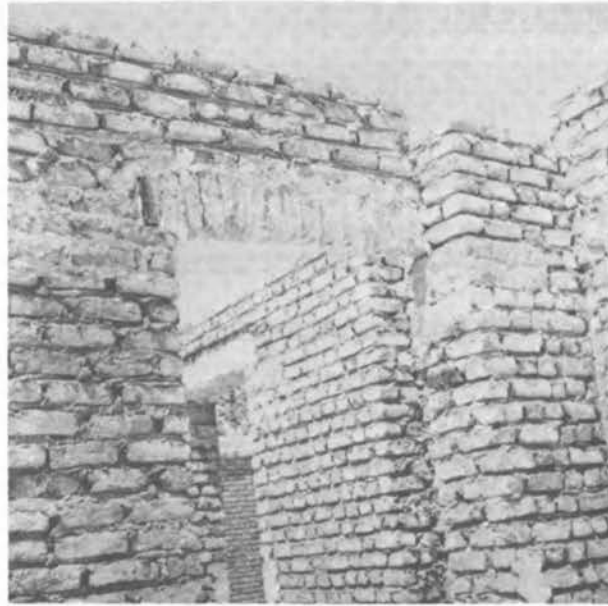
FIGURE 5.2 A Typical Brick-Masonry Wall of a Residential Building in Shiraz.

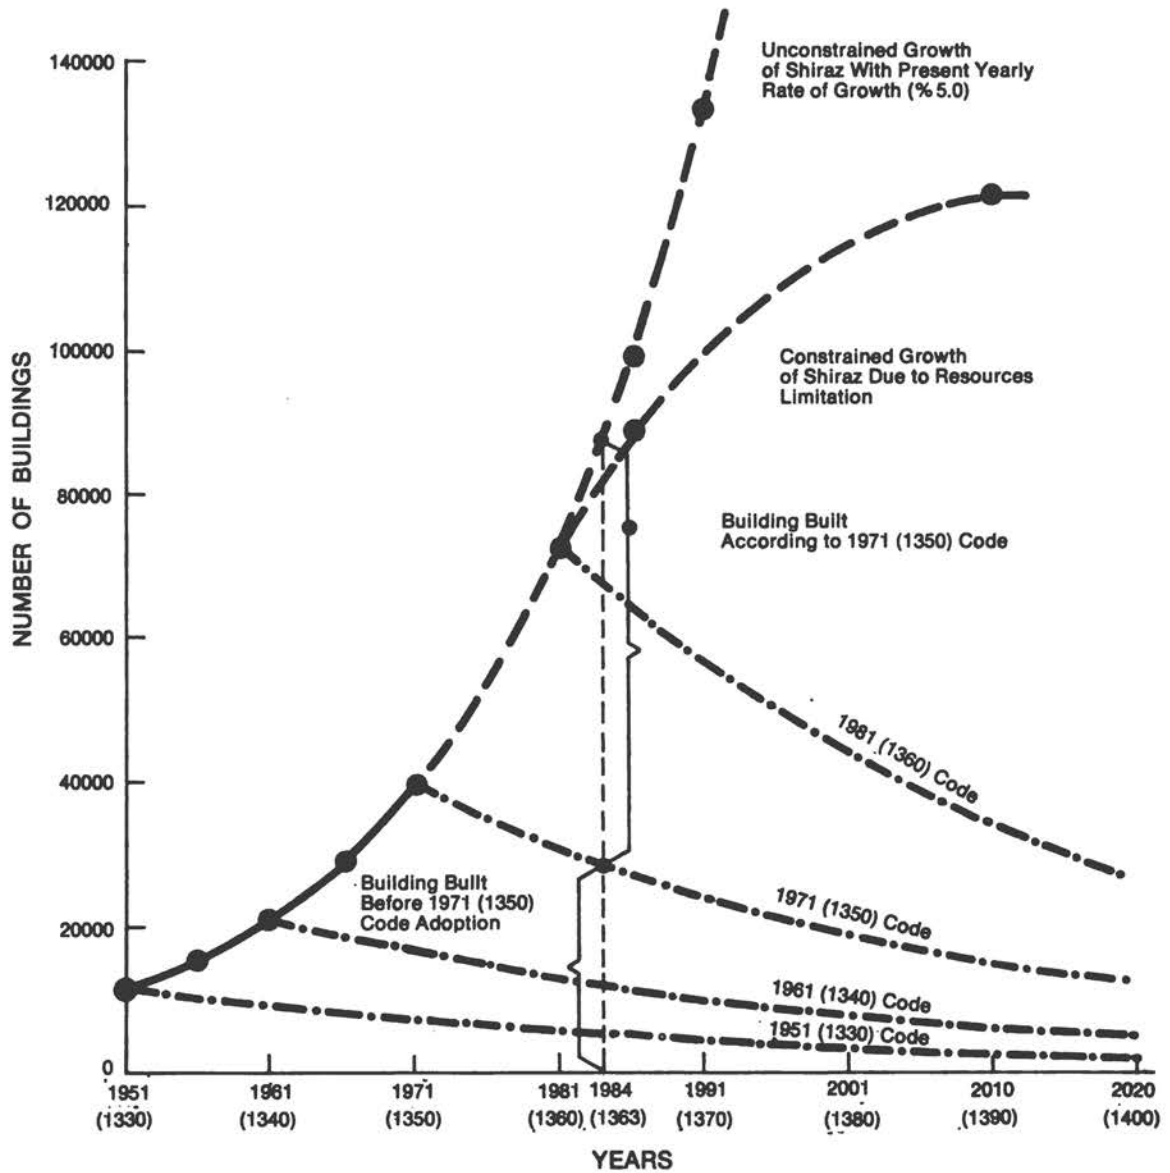
Fig. 5.6: Growth of the Number of Buildings In the City of Shiraz, Iran and the Effect of Delay In Adopting a Seismic Code In the Condition of Buildings.
