RECONNAISSANCE REPORT ON THE FAILURE
OF
KELLY BARNES LAKE DAM, TOCCOA FALLS, GEORGIA

George F. Sowers
Senior Geotechnical Consultant
Law Engineering Testing Company
Regents Professor of Civil Engineering
Georgia Institute of Technology

Committee on Natural Disasters
' Commission on Sociotechnical Systems
NATIONAL RESEARCH COUNCIL

National Academy of Sciences
Washington, D.C.
1978

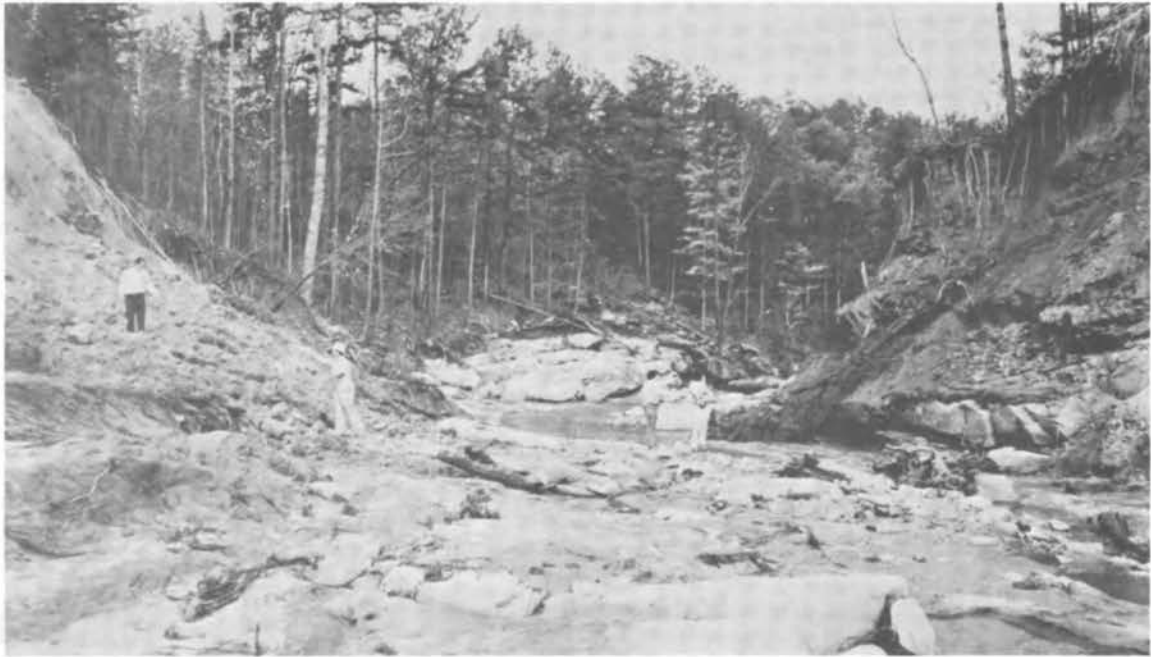
FIGURE 4a Dam looking downstream through breach

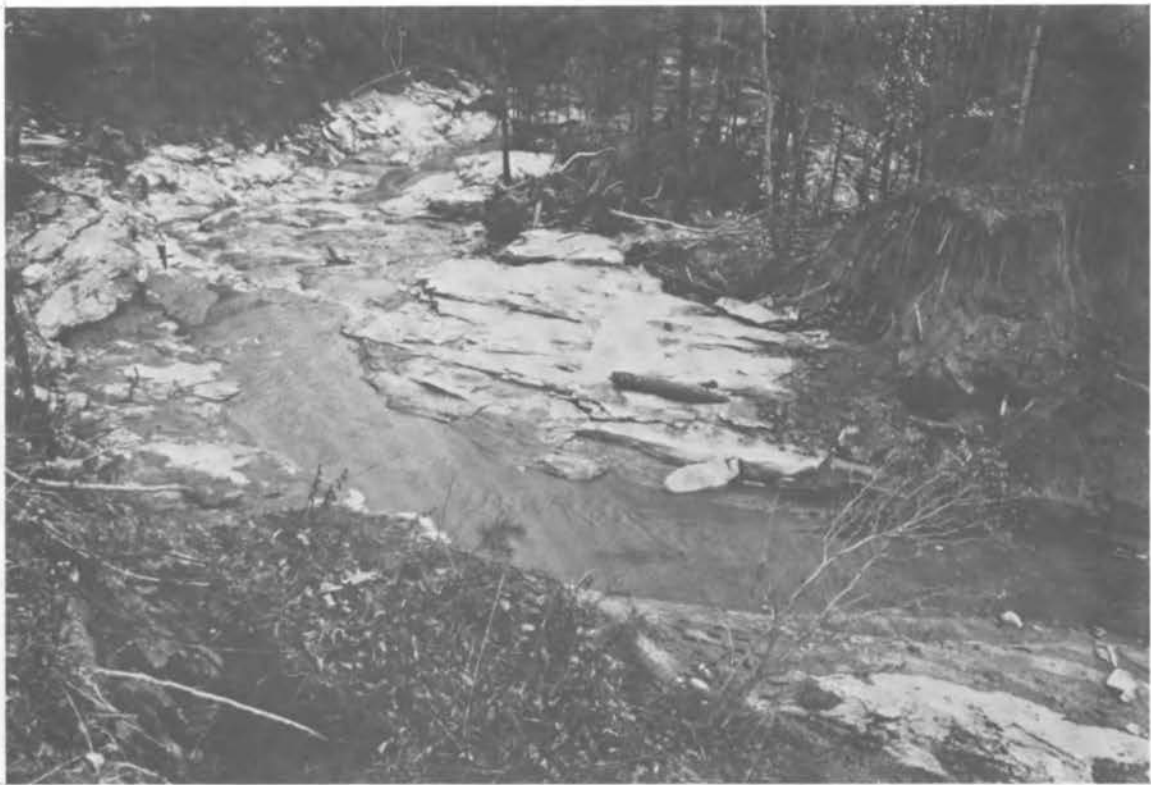
FIGURE 4b Scoured creek immediately downstream from dam looking downstream

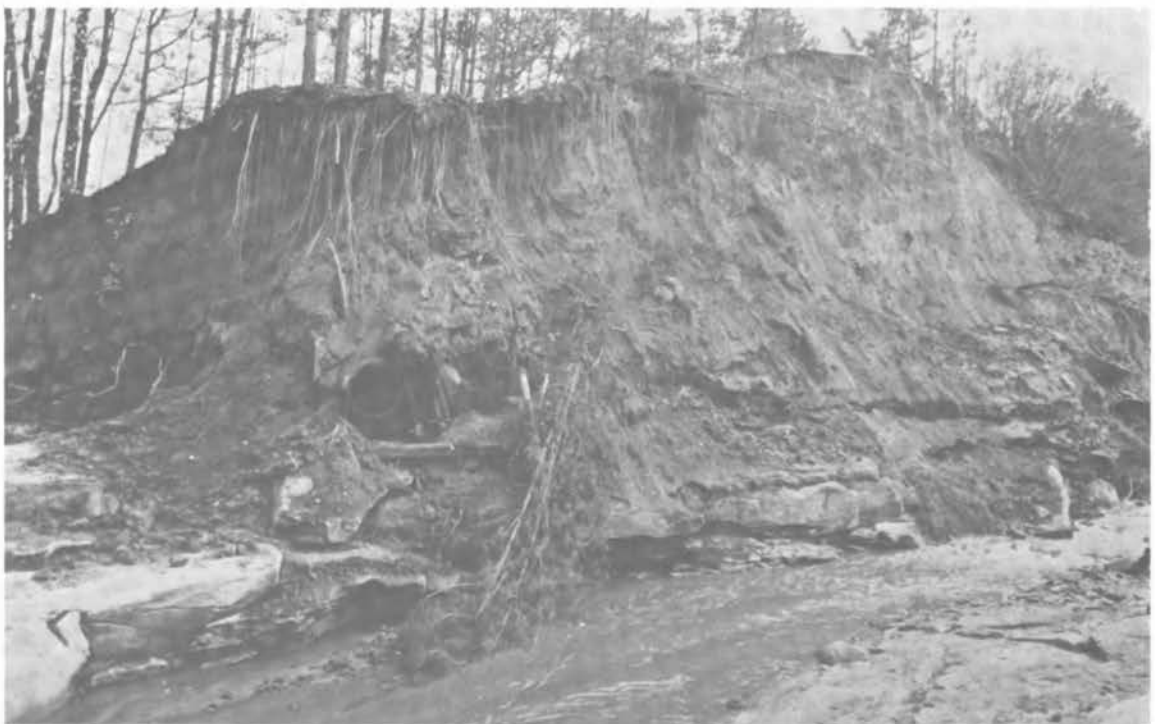
An old 30-inch conduit or penstock leading to the abandoned power plant is exposed in the southeast face of the breach (Figure 6). The steel appears to be in good condition. Further down the stream near the toe of the dam the pipe had been cut. It appears to be in good condition considering its age.

FIGURE 6 Face of breach on right side looking southwest, showing old penstock and remains of 1899 crib dam at downstream toe on left

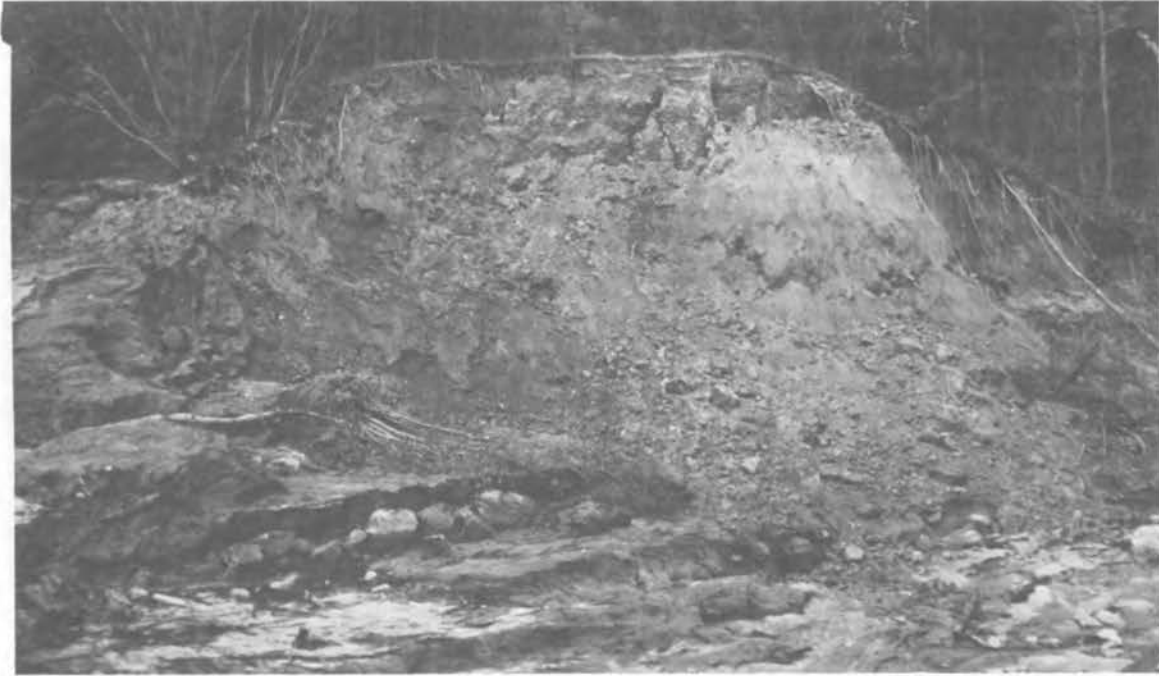
FIGURE 7 Face of breach on left side, looking north, upstream to left

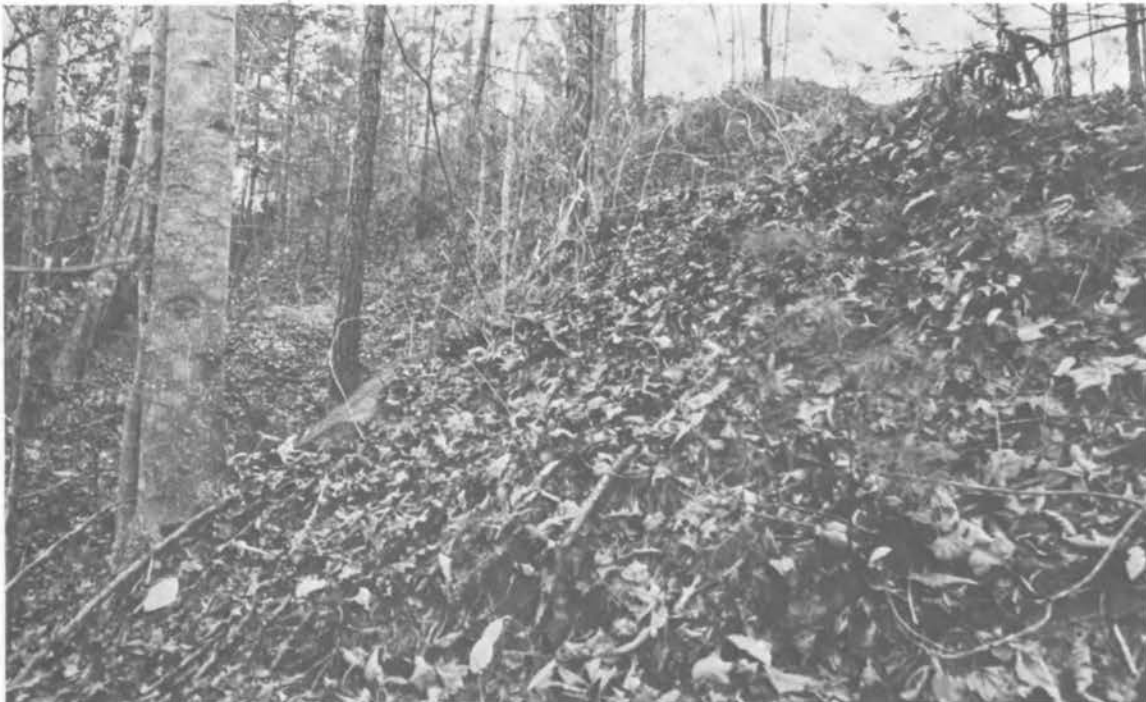
The downstream face of the intact portions of the dam are covered with brush and trees up to 8 inches in diameter (Figure 8). The size and species of the largest trees suggest that they are 20 to 25 years old. The upstream face of the dam was covered by small trees and brush. The absence of stumps and large trees suggests that the dam face had been well maintained until about 20 years ago. This coincides with the abandonment of power generation in 1955 or 1957.

There is a sharp irregularity on the downstream face of the southeast end of the dam near the creek. The topography and the attitude of the trees suggest that this irregularity was caused by a small slump or landslide in the steep downstream face of the dam. If so, the vegetation surrounding it suggests that it is several years to tens of years old.

The steep slope of the dam and the suggestion of an earlier slide on the southeast downstream face support the concept of a slide in the downstream face initiating failure. The micaceous soils of which the dam is built are susceptible to weakening upon saturation from rain. The 5 days of continuous rain would have saturated the somewhat porous micaceous soils, and the final intense rain the night of failure would have provided a trigger. Saturation could have been aggravated by leakage of the old penstock or by piping along it.

FIGURE 8 Right downstream face, 10-in. tulip poplar,
6 to 8-in. pines, old slide scar

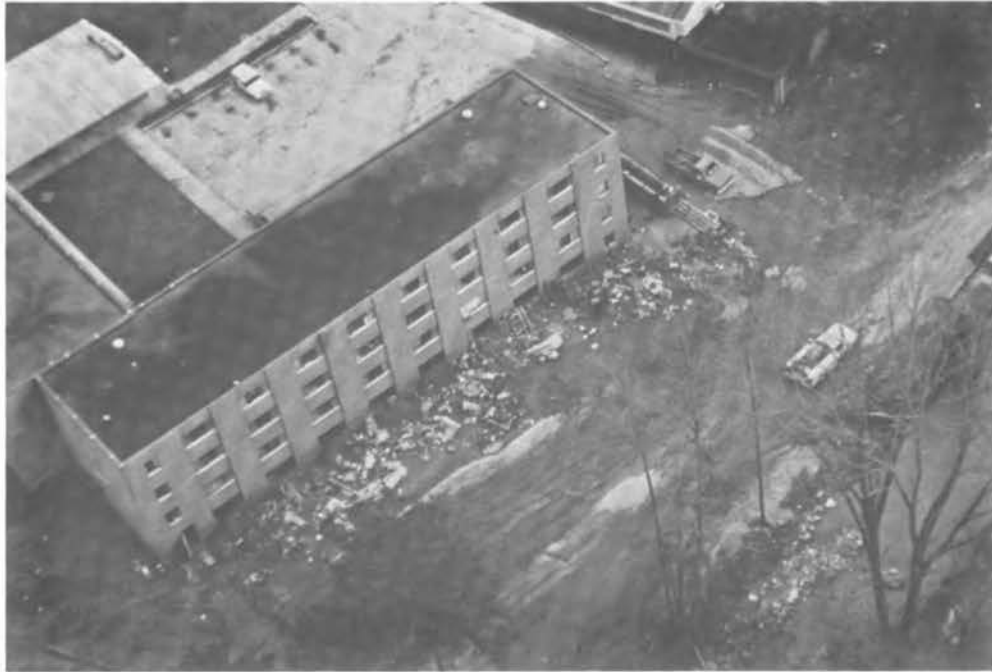
A few hundred feet further downstream is a college dormitory building, partially in the floodplain. The flood wave reached a height of about 8 feet in the ground floor. Three of the students occupying this floor were drowned; others were able to swim or scramble to safety. The upper floors were not damaged.

FIGURE 9a Dormitory on left bank of flood plan; high water line in parking lot behind dormitory, creek in right corner

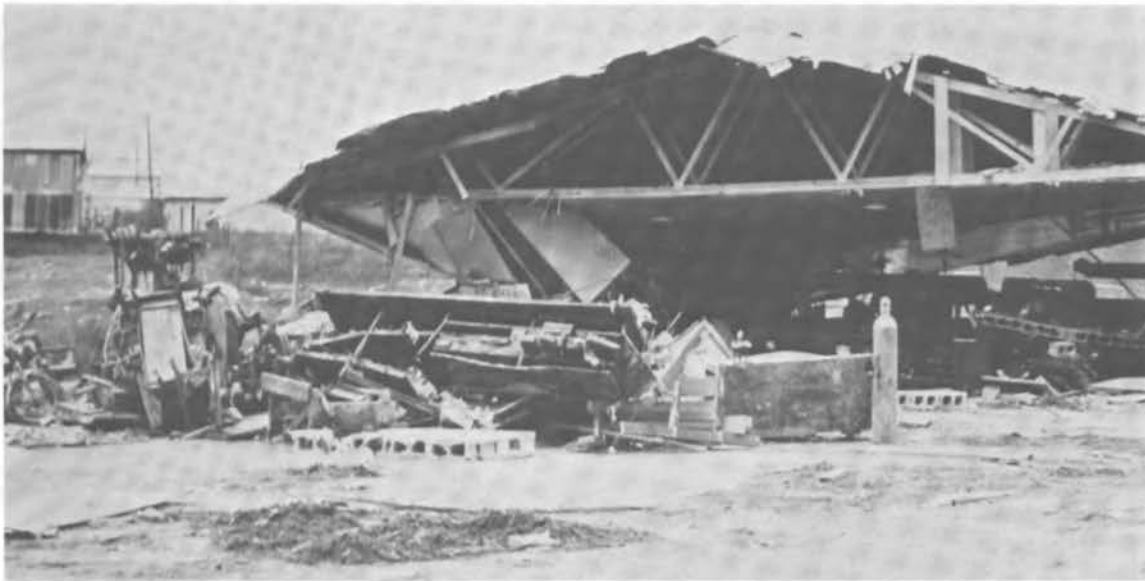
About 3/4 mile downstream from the falls, the floodplain width increases somewhat and the slope becomes flatter where a tributary joins the creek. In this area a wood-frame garage and maintenance building was partially demolished by water impact. A trailer park on the right floodplain near the garage was demolished. Debris marks in this area indicate that the water depth was about 10 feet. Some of the trailers floated away, others were smashed. Most of the fatalities were to the occupants of this trailer village: married students, children, faculty, and some employees of the college. The flood velocity at this point was great enough to carry a large intercity bus nearly 1/2 mile downstream.

FIGURE 10a Maintenance garage and shop 1/2 mile downstream from dormitory looking downstream; creek to left

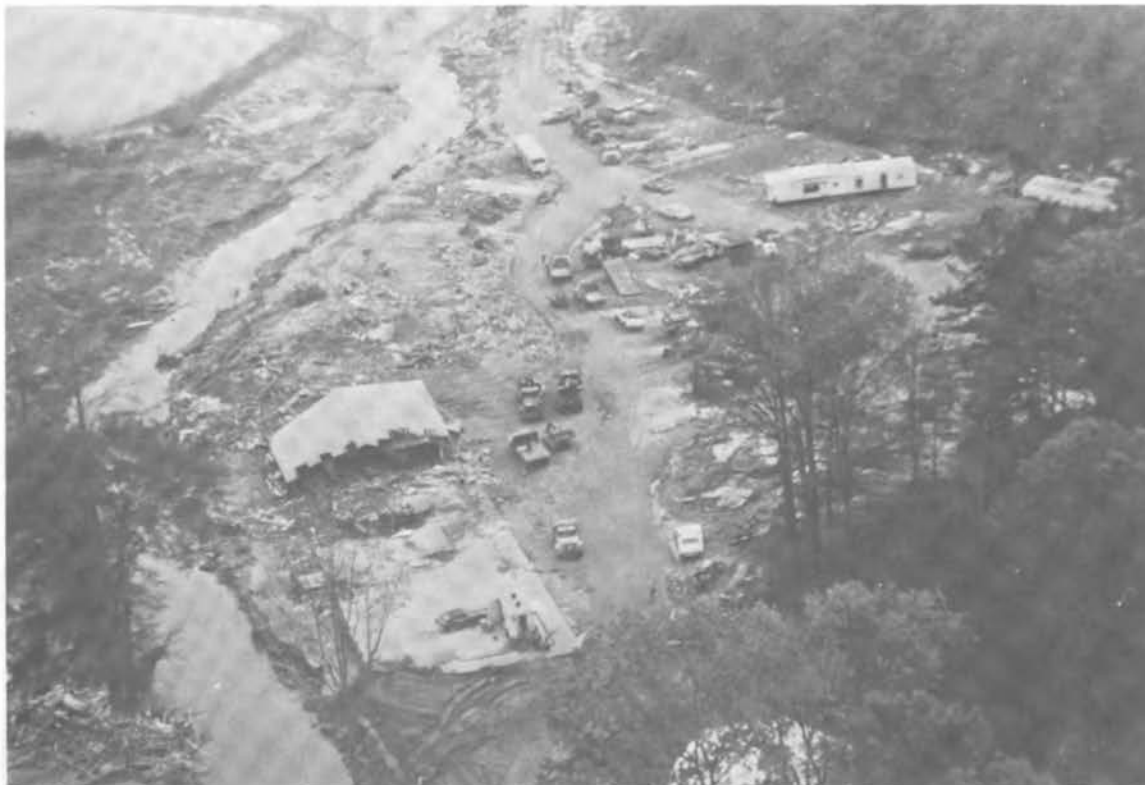
FIGURE 10b Aerial view of trailer court area on right with maintenance garage near center. Tributary enters valley on right
