Earthquake Engineering and Hazards Reduction in China: A Trip Report of the American Earthquake Engineering and Hazards Reduction Delegation Submitted to the Committee on Scholarly Communication With the People's Republic of China (1980)

Earthquake Engineering and Hazards Reduction in China

A Trip Report of the American Earthquake Engineering and
Hazards Reduction Delegation

Edited by Paul C. Jennings

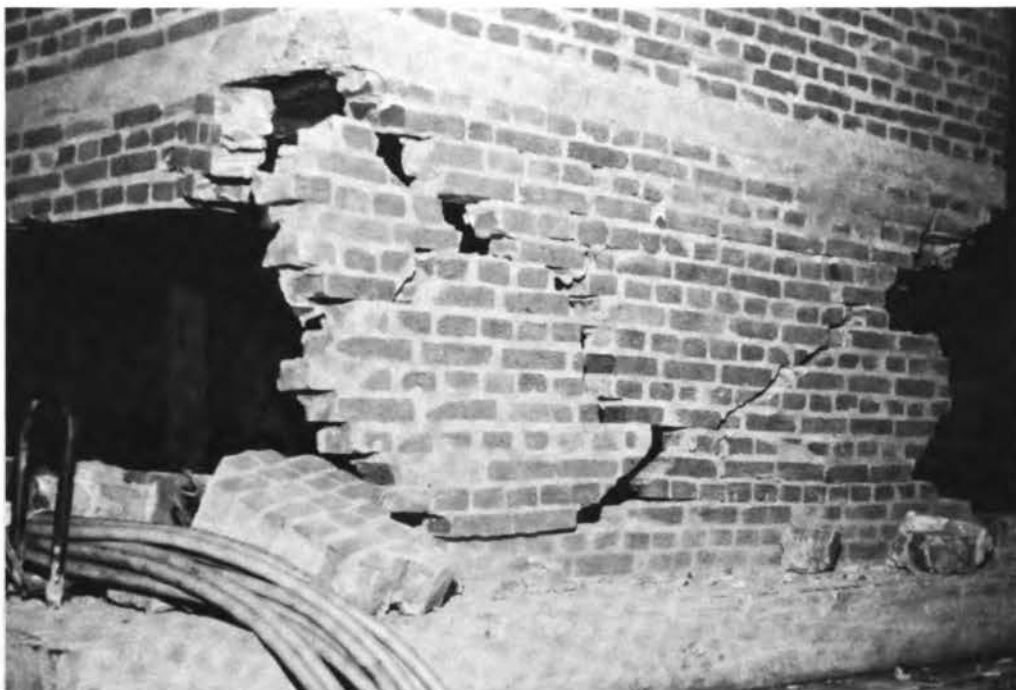
FIGURE 3.13 Close-up view of the lower floor of the end wall of the model shown in the previous figure. The end wall has failed in shear, with fracture occurring mainly through the bricks, rather than the grout.

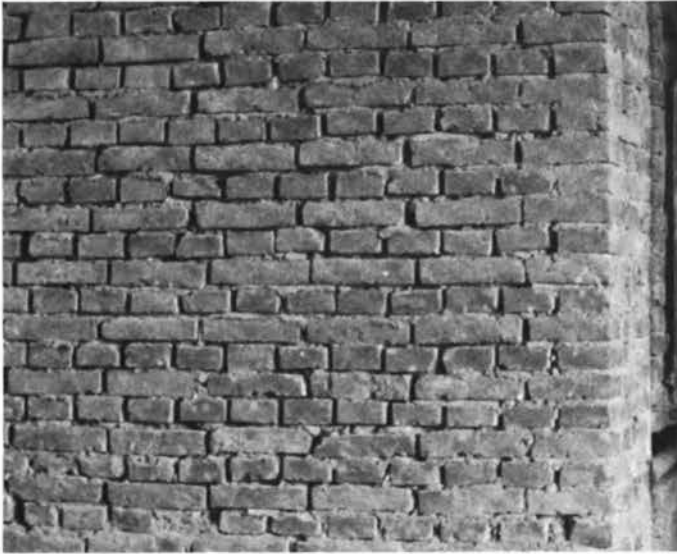
FIGURE 3.26 Typical brick wall construction, Harbin electronics factory. Note that head joints are typically not filled.

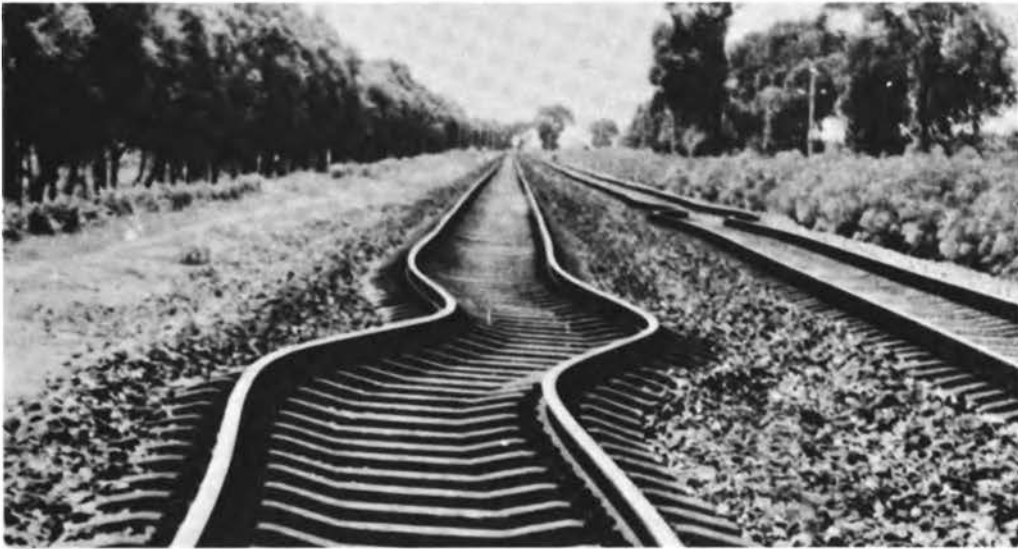
FIGURE 4.3 Buckling of rail lines due to ground deformations. The general Tangshan region had many soft soils that behaved poorly during the earthquake.

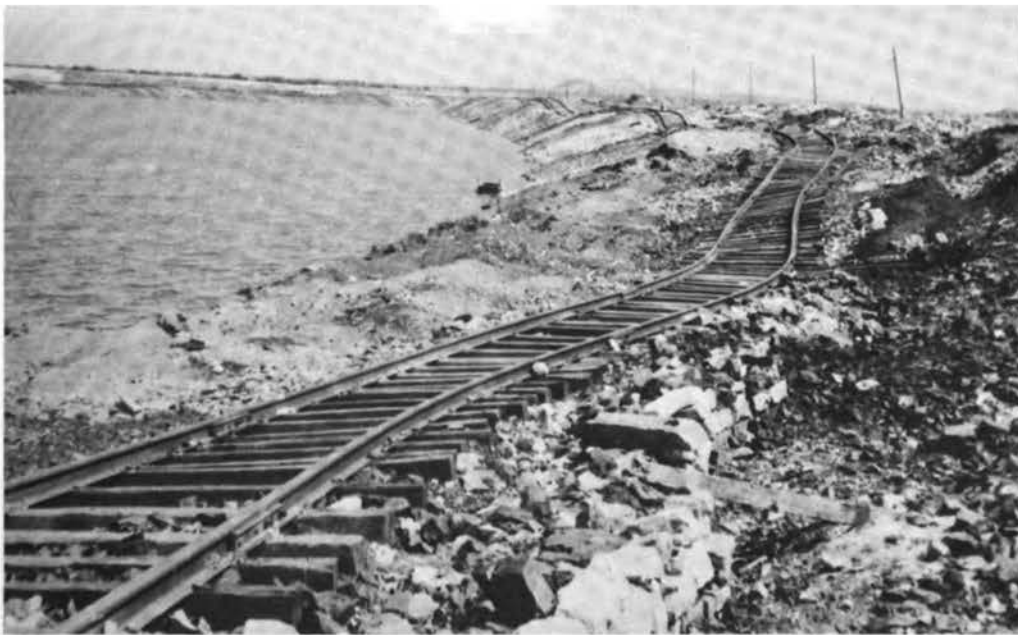
FIGURE 4.4 Failure of ground under railway line. Extensive damage was done to the rail system in the Tangshan region.

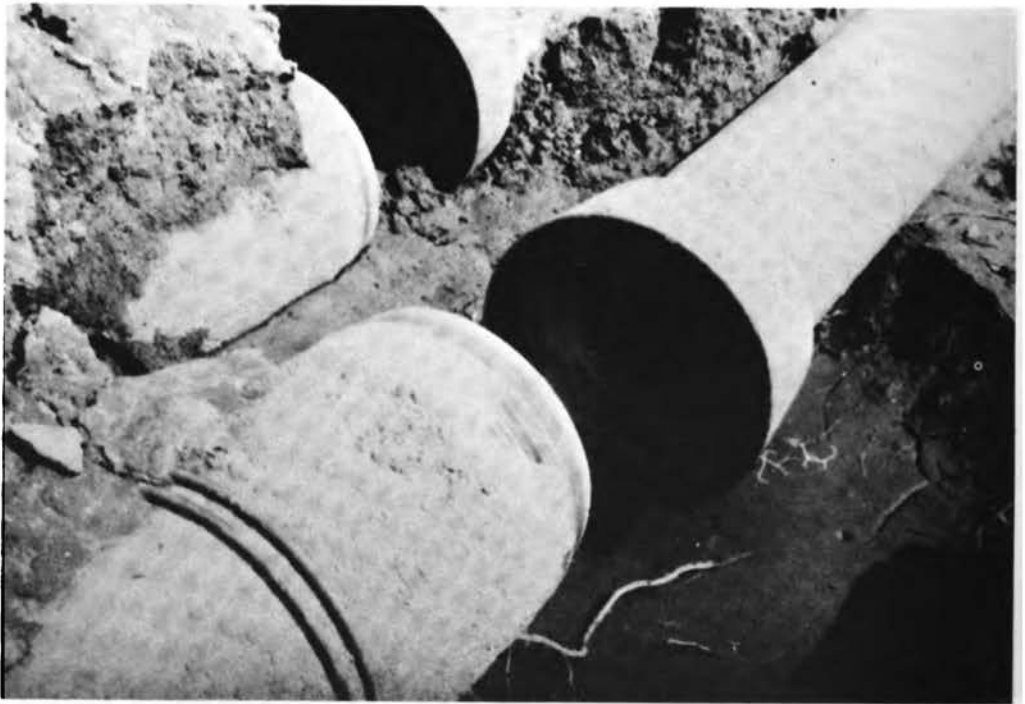
FIGURE 4.6 Underground pipes separated by extensional ground deformation.

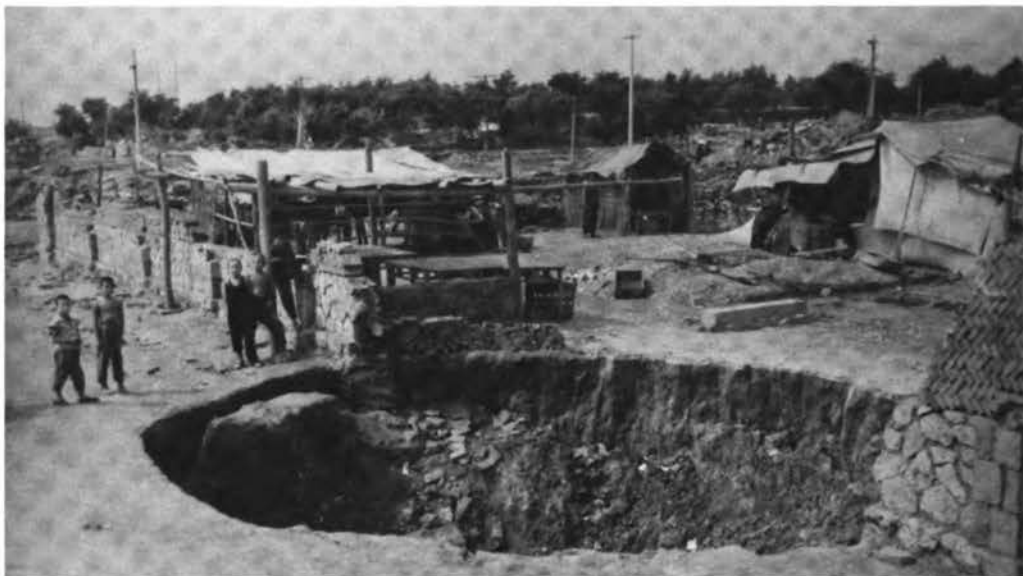
FIGURE 4.7 Ground collapse near Tachuangtuo Commune, Kuyeh Hsien. The Tangshan earthquake triggered the formation of a number of such craters. Geological investigations had not yet determined the underlying cause of these craters.

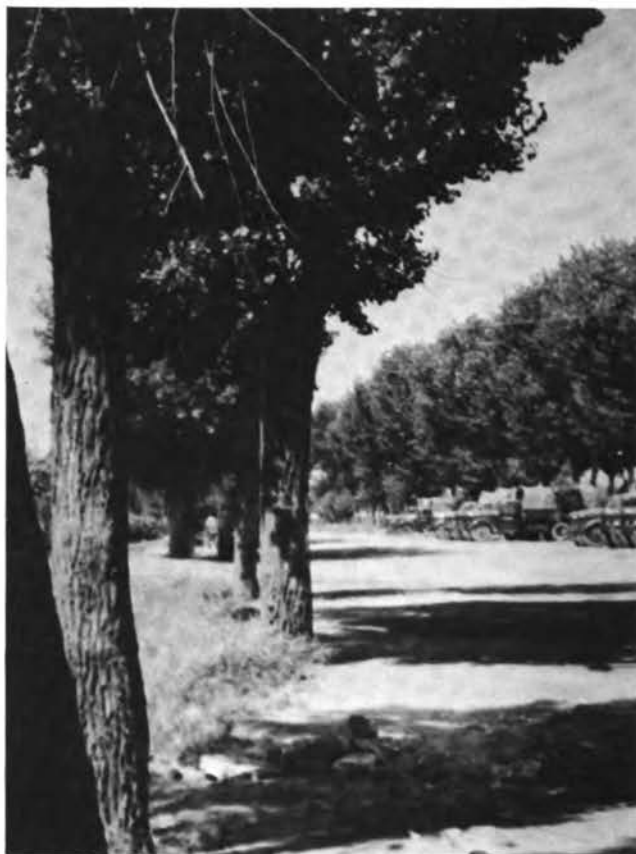
FIGURE 4.20 Offset in row of trees due to horizontal tectonic movement, in Tangshan.

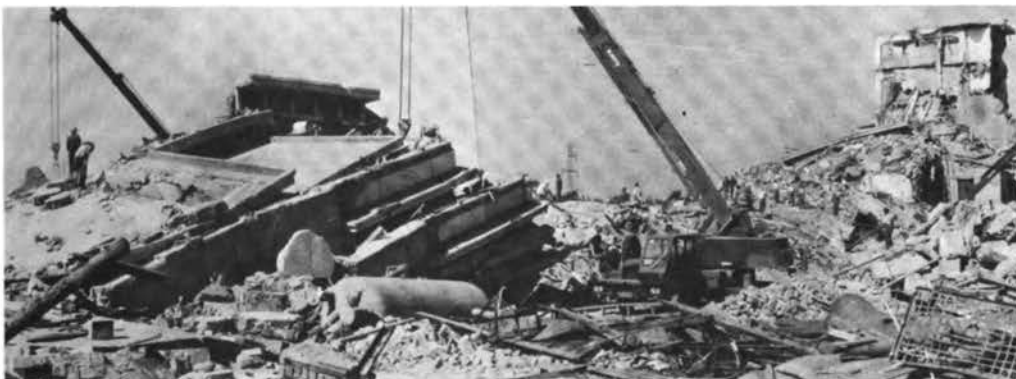
FIGURE 4.24 Collapsed out-patient service building of the Kailuan coal mine general hospital, Tangshan.

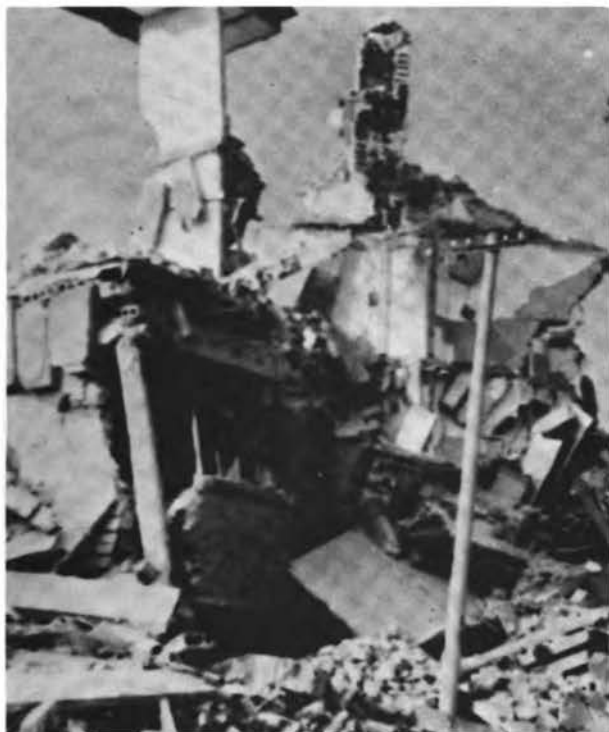
FIGURE 4.31 Collapsed building, Tangshan.

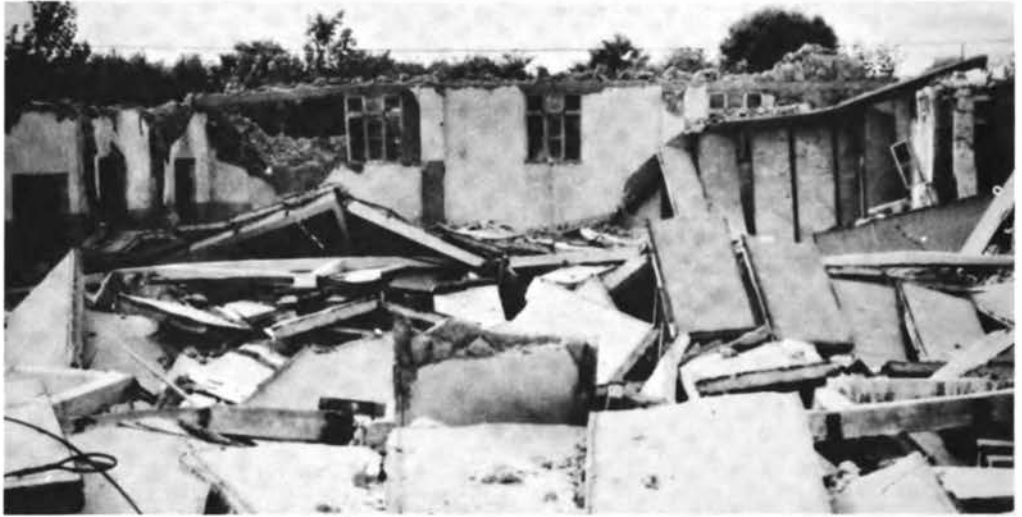
FIGURE 4.33 Collapsed workers' cafeteria building of the Chinkechuang coal mine.

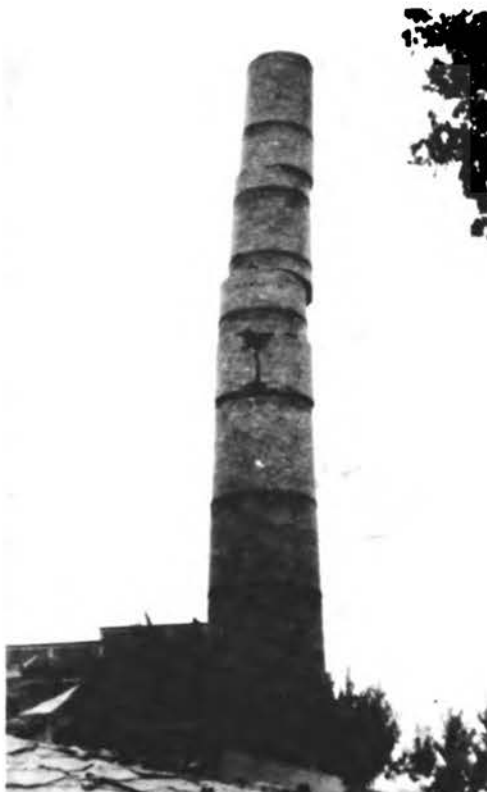
FIGURE 4.40 Damaged brick chimney at Chaokenchuang mine. The top of the chimney fell off, and four horizontal cracks appeared in the remaining portion.

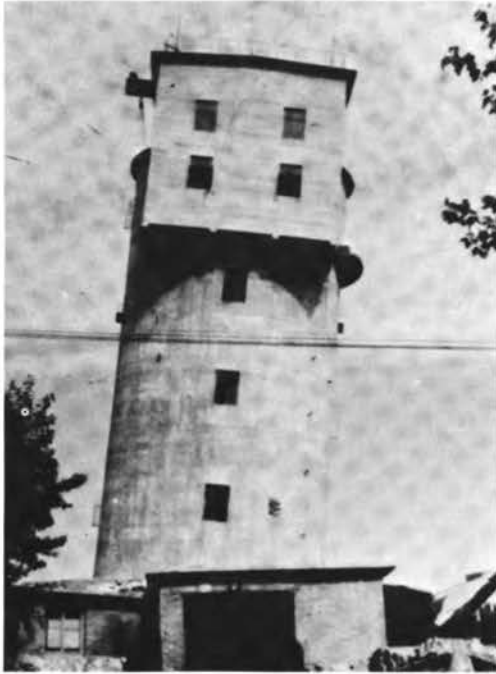
FIGURE 4.42 Tilted ventilation tower at Tangshan coal mine.

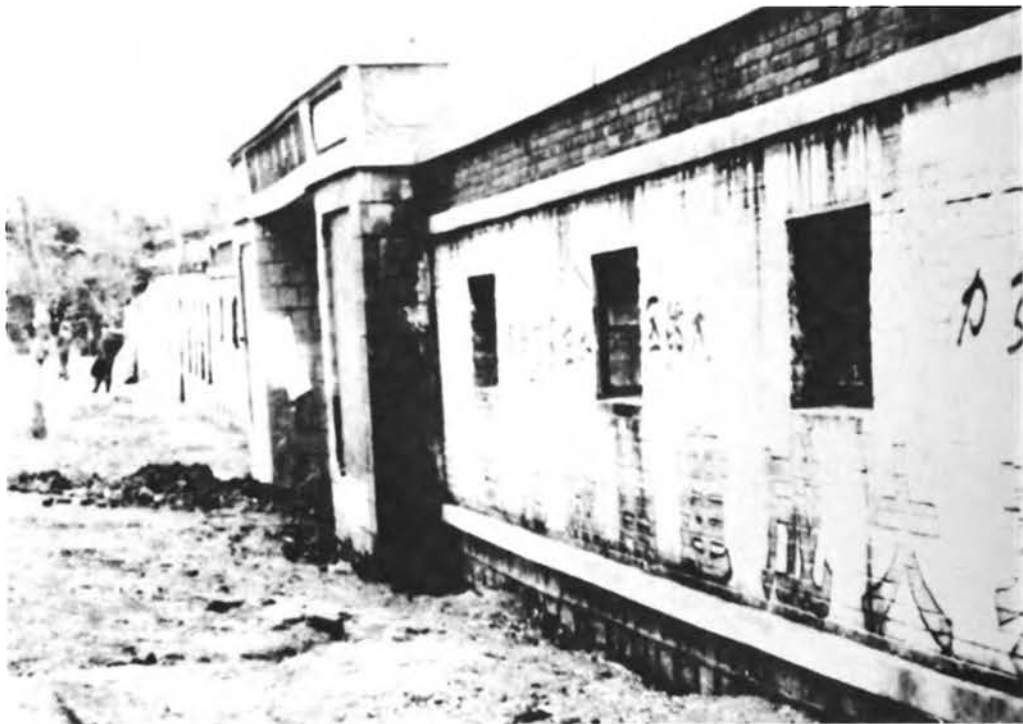
FIGURE 4.47 Uneven settlement of office building, Fankenchuang Commune, Luan-nan Hsien.

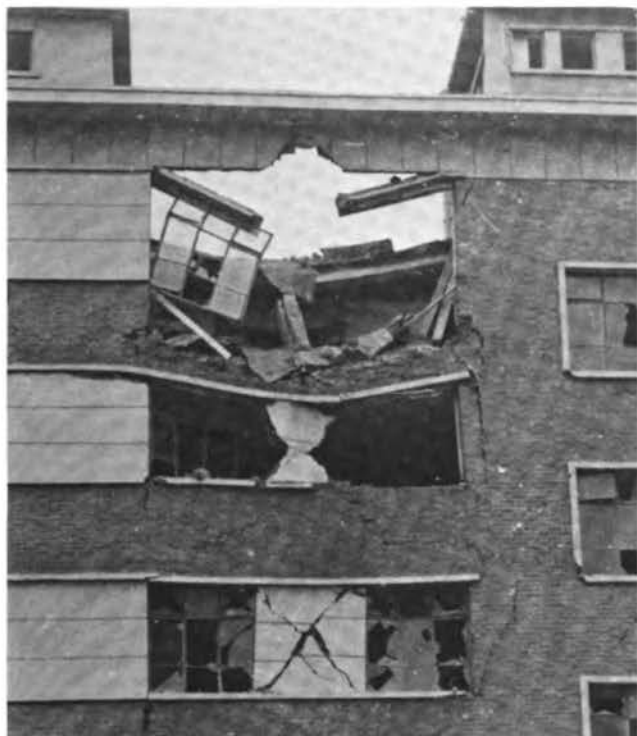
FIGURE 4.49 Damaged reception building in Tangshan.

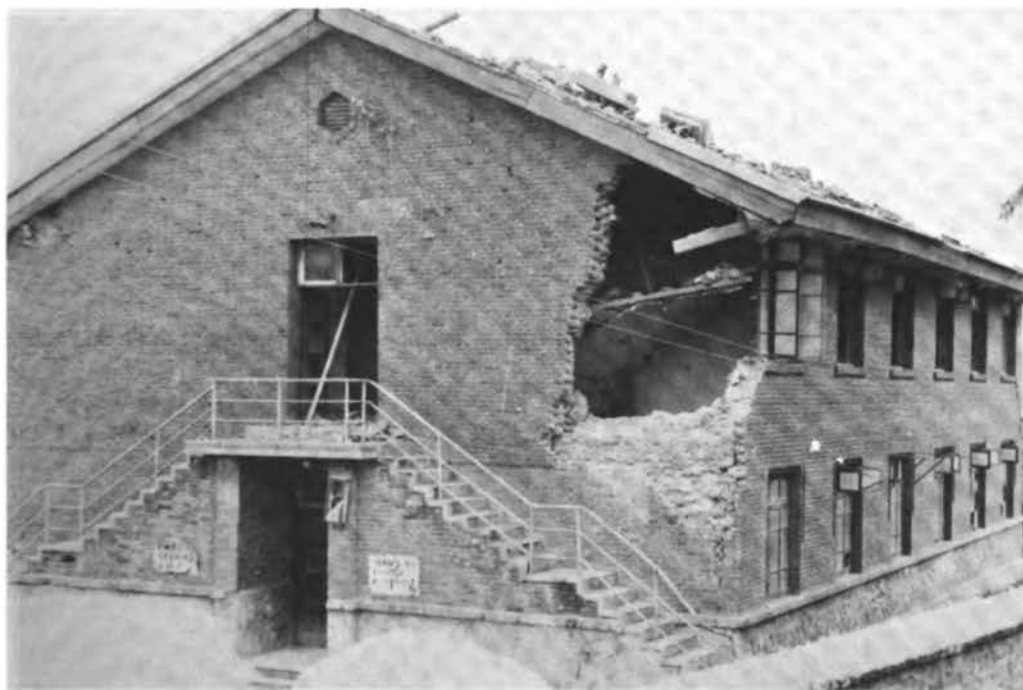
FIGURE 4.51 Damaged car factory dormitory building in Tangshan. The first story was most severely damaged but the building remained standing.

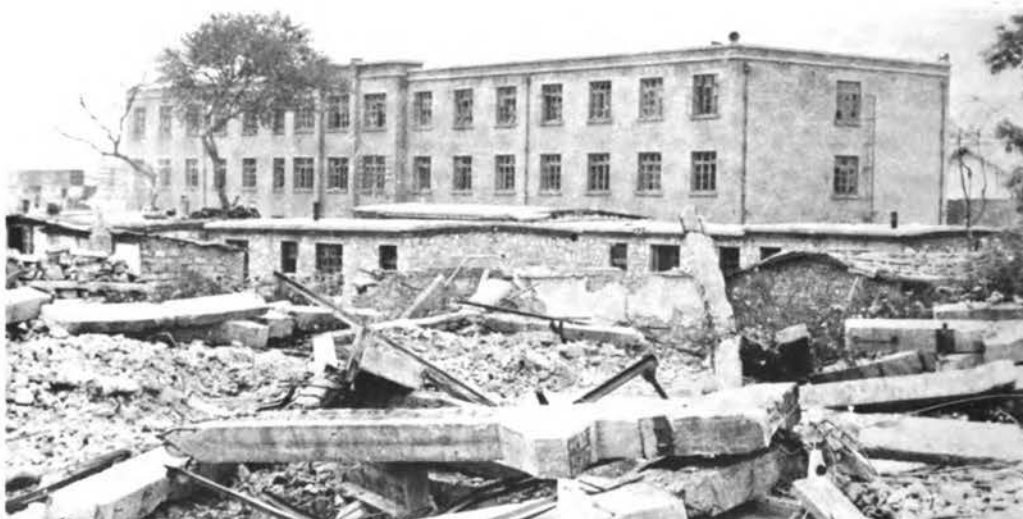
FIGURE 4.52 Tangshan light-machine plant official building. This structure, which was located in district 13 of Figure 4.21, was only slightly damaged. The remains of a collapsed building can be seen in the foreground.

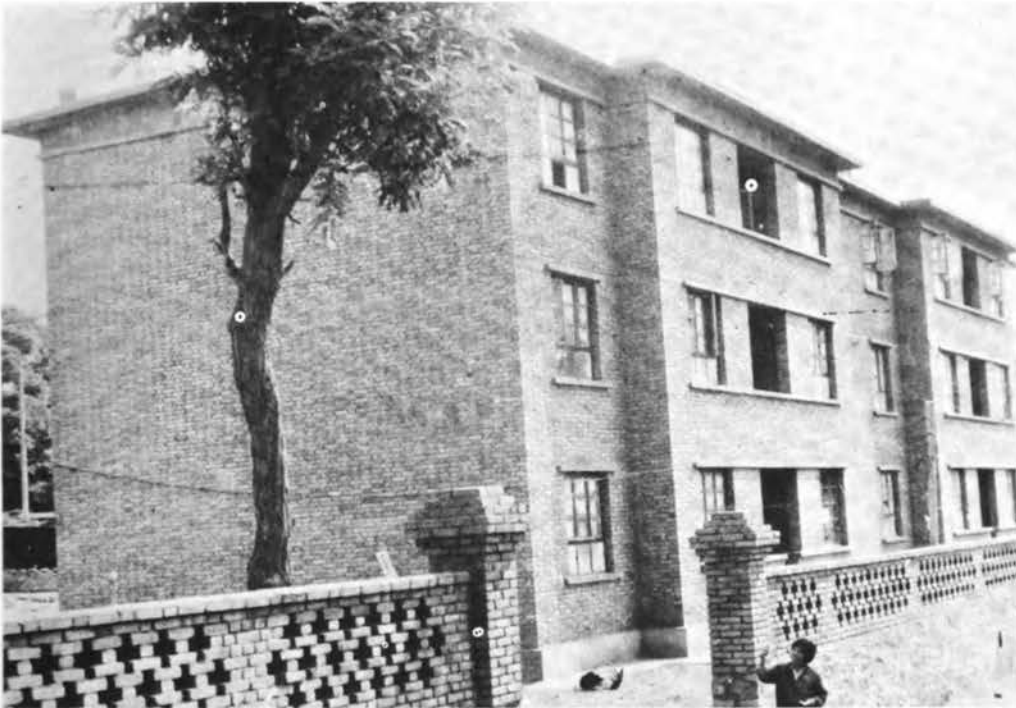
FIGURE 4.53 Cement factory worker apartment building 422. This structure was located on bedrock north of Tangshan and received only slight damage.

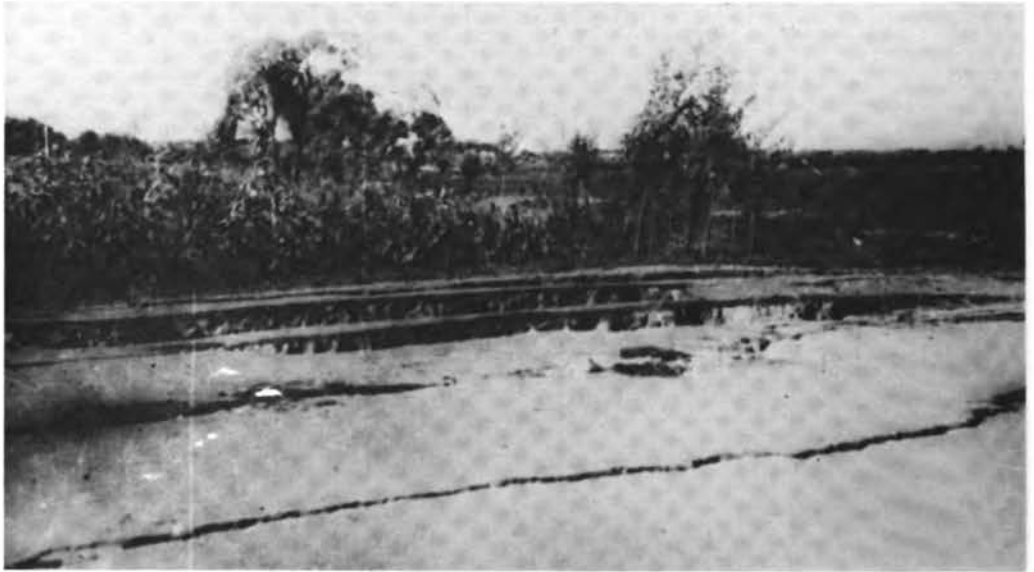
FIGURE 4.54 Large landslide at east bank of Tanshan River, which caused damage to the Yenchuang Bridge.

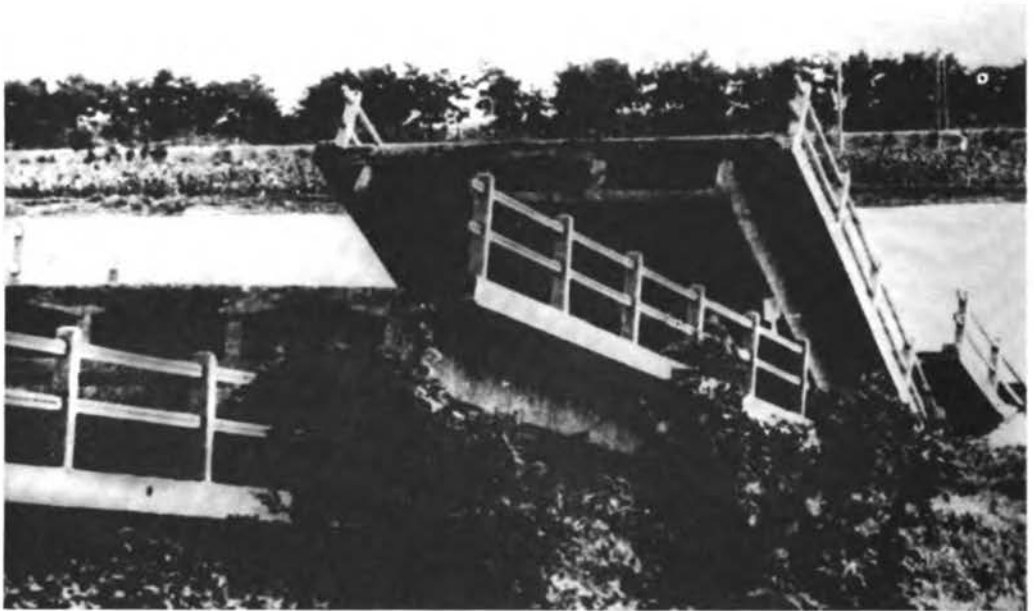
FIGURE 4.55 Deck spans of Yenchuang Bridge were pushed off their supports by the landslide.

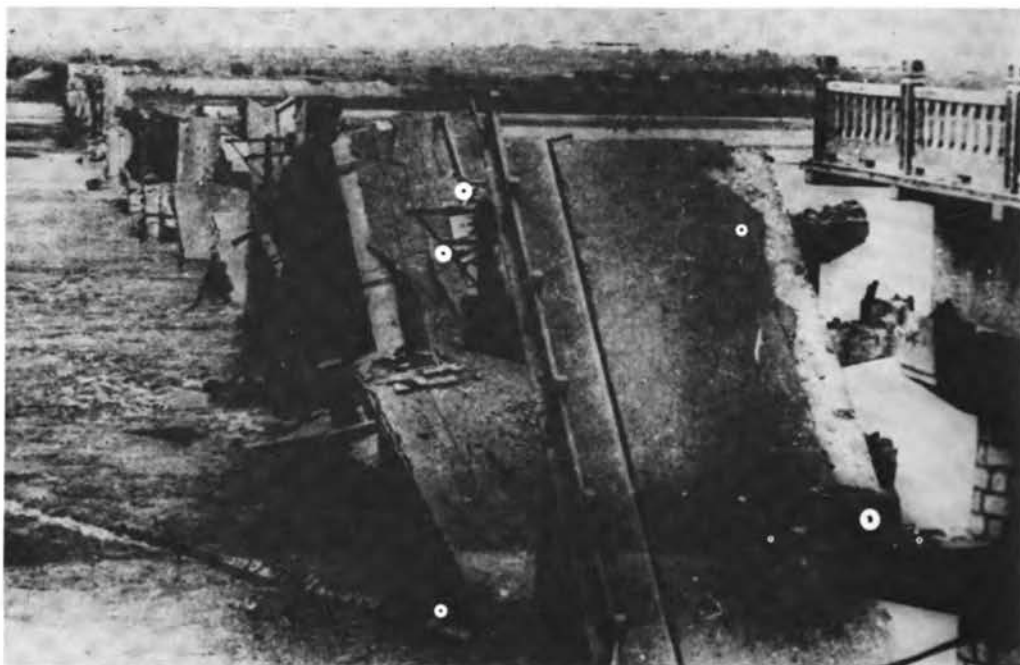
FIGURE 4.56 Fallen spans of the Janshan Bridge.

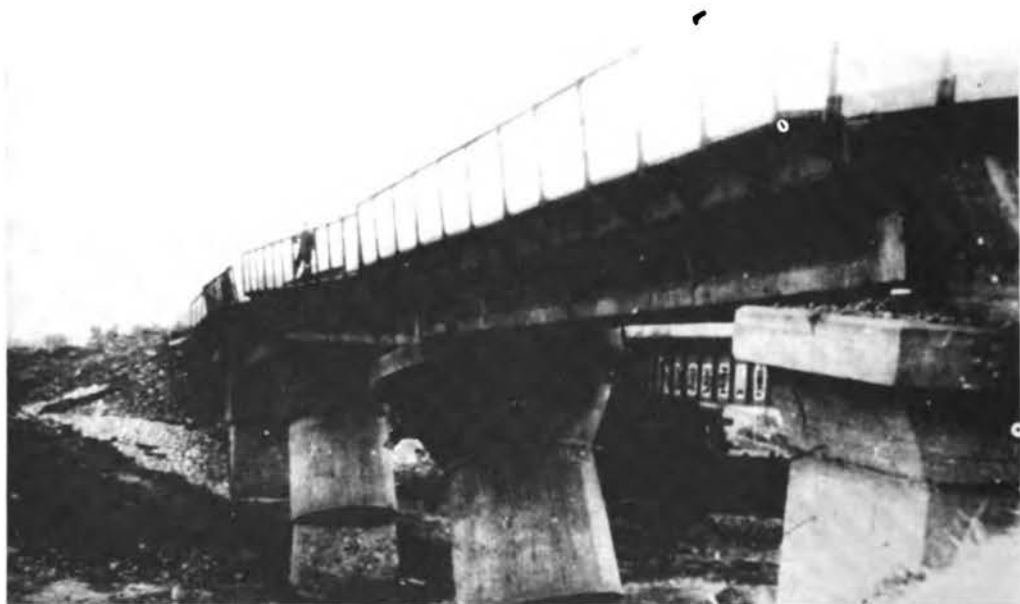
FIGURE 4.57 Tilted piers and broken abutment of the railway bridge on Tangshan-Kenhua Line.

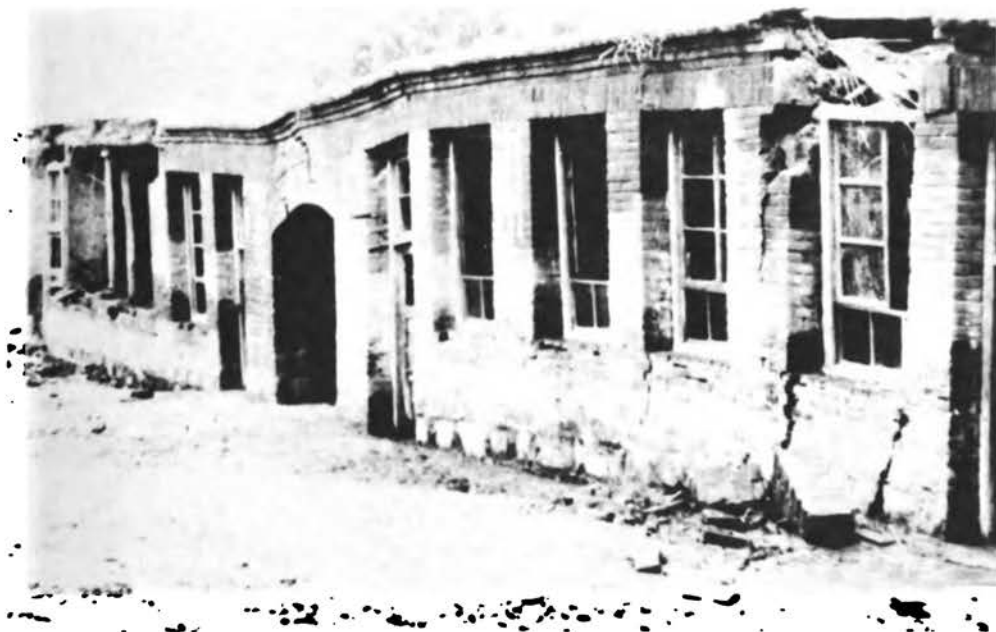
FIGURE 4.61 Structure damaged by unequal ground settlement.

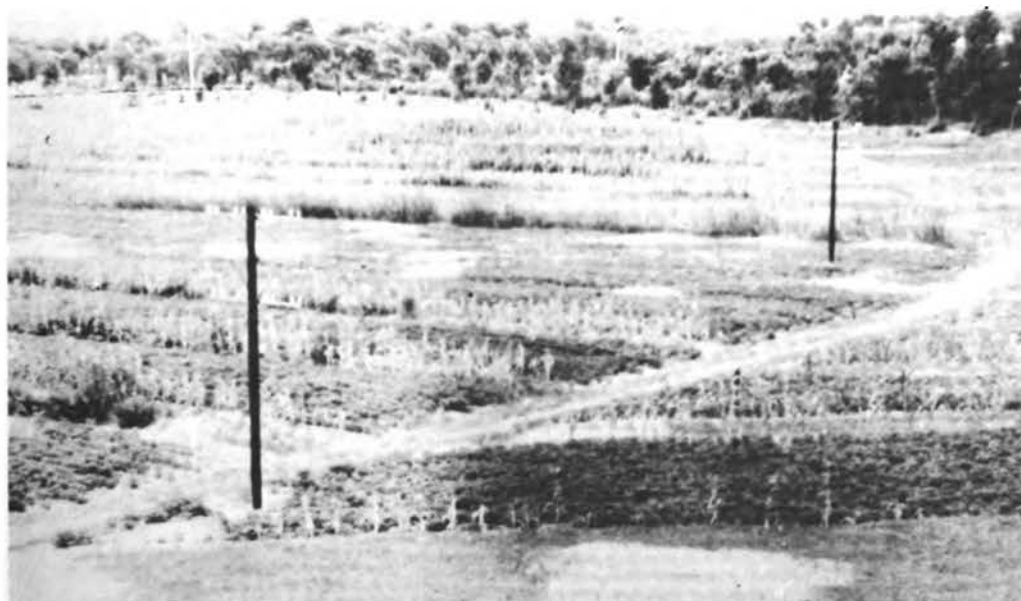
FIGURE 4.62 View of sandblows in a field.

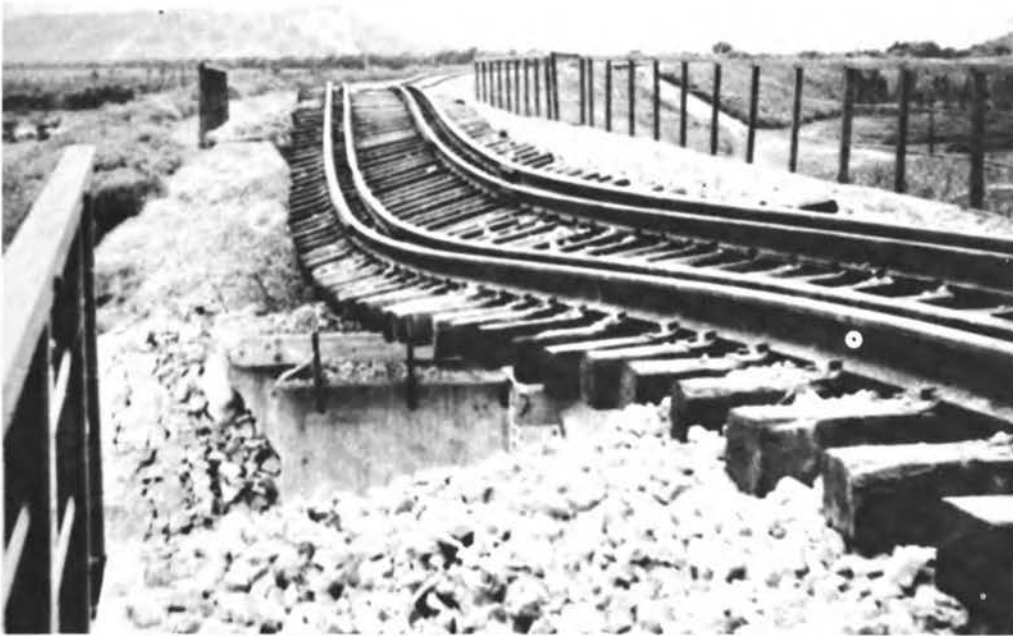
FIGURE 4.64 Damage to railway line caused by loss of support.

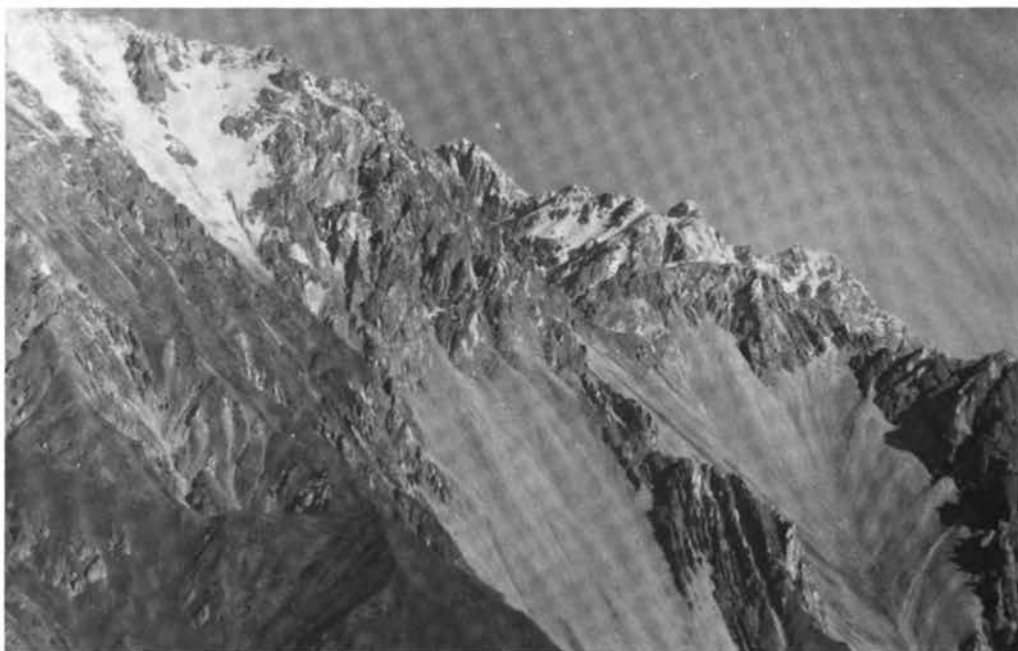
FIGURE 5.13 Slides and rockfalls in the mountainous terrain affected by the SP earthquakes.

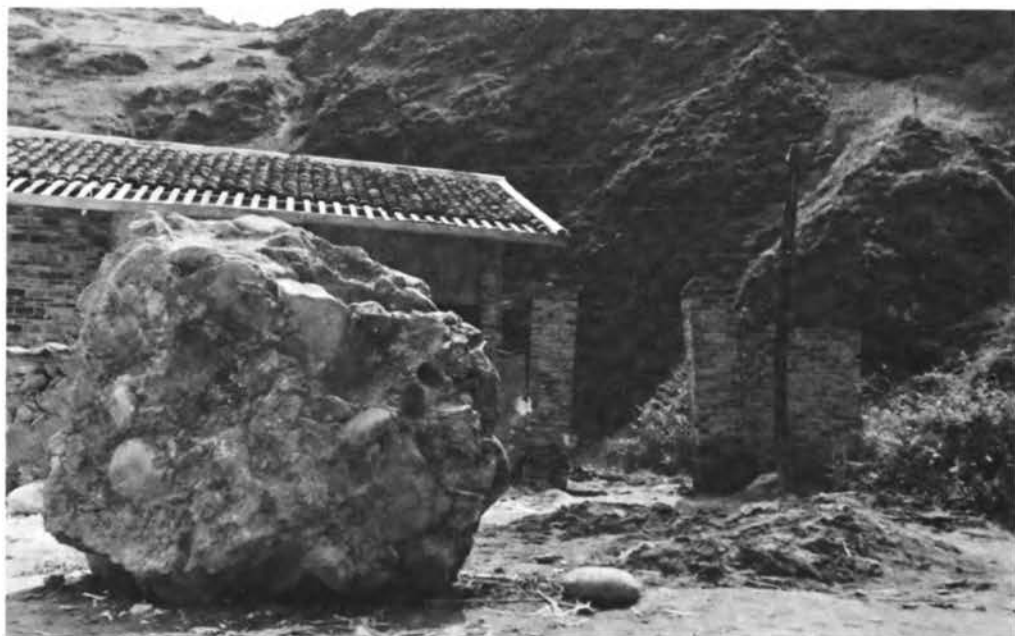
FIGURE 5.16 Large conglomerate boulder that fell during the SP earthquakes. Note also the structural damage to the building.

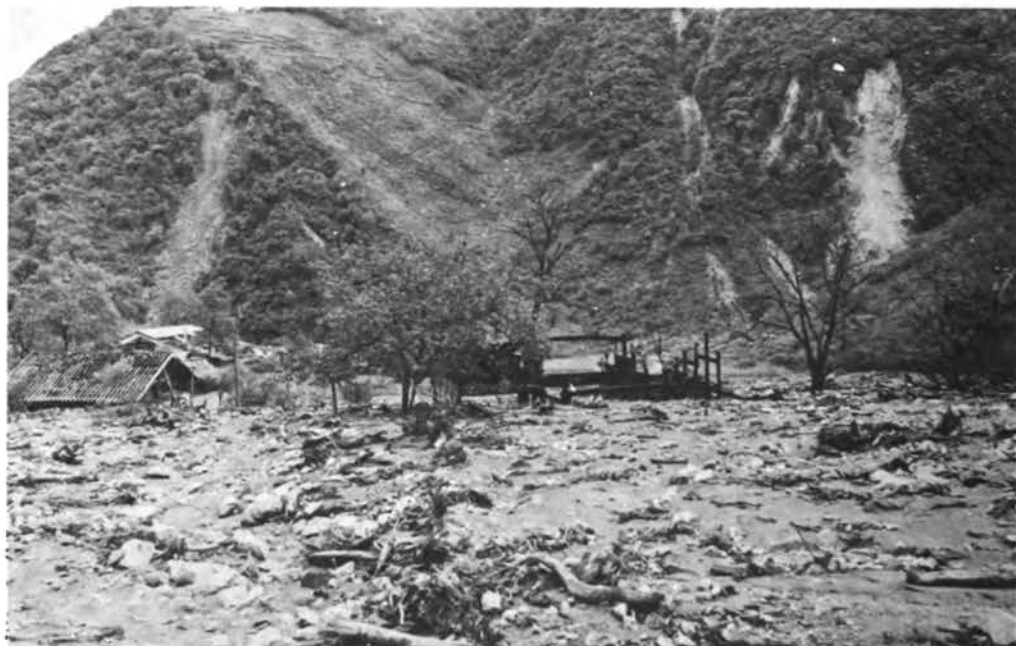
FIGURE 5.17 Mud flow damage from the SP earthquakes. Heavy rain occurred before the second and third shocks, and many mud flows occurred.

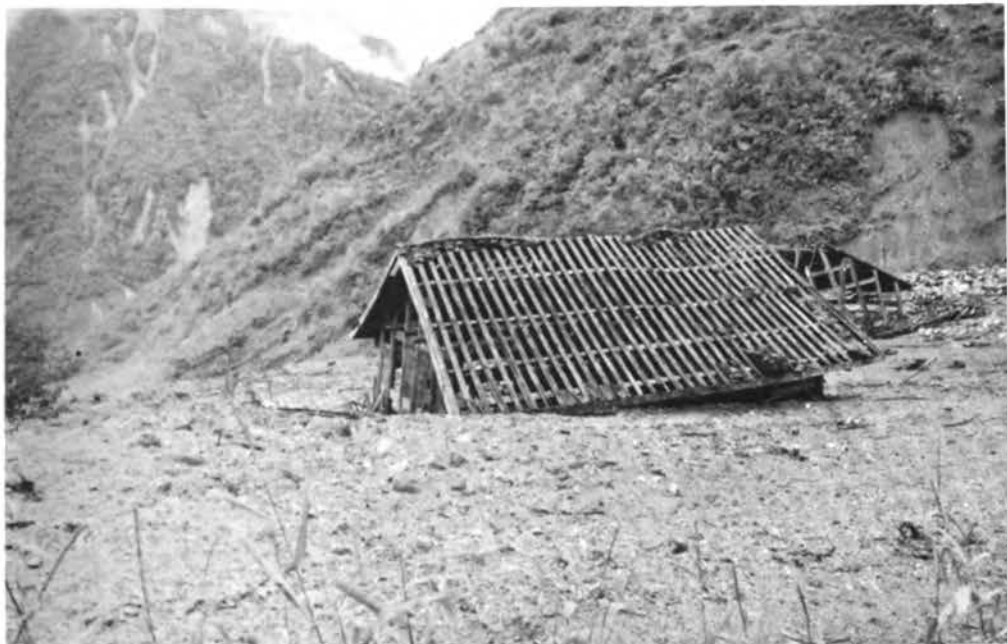
FIGURE 5.18 Mud flow damage from the SP earthquakes.

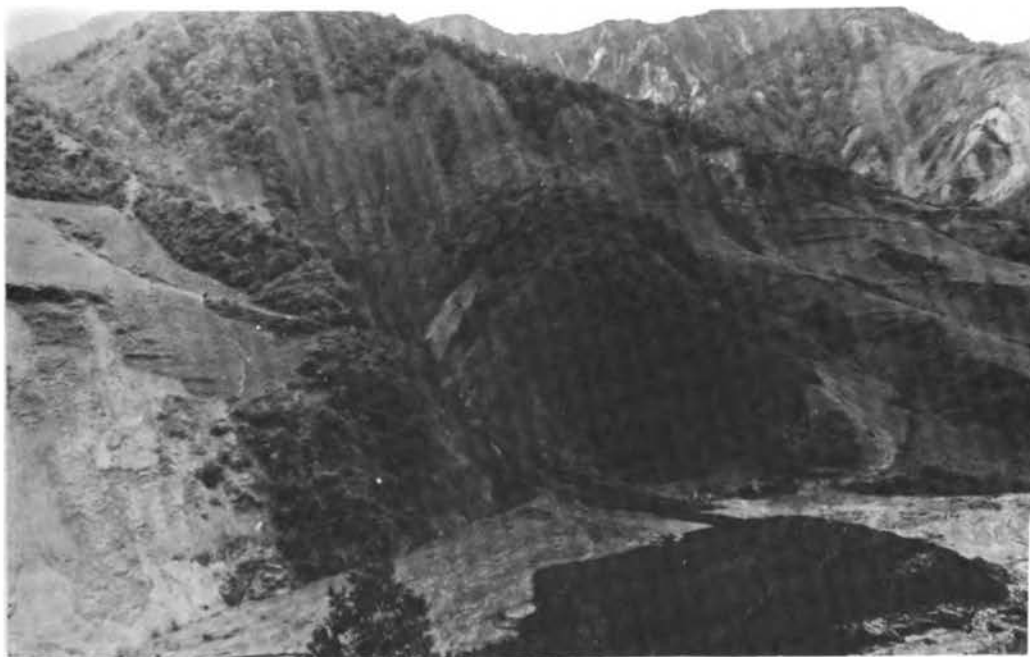
FIGURE 5.19 Fresh mud flow (light colored material) on a recent alluvial fan, SP earthquakes.

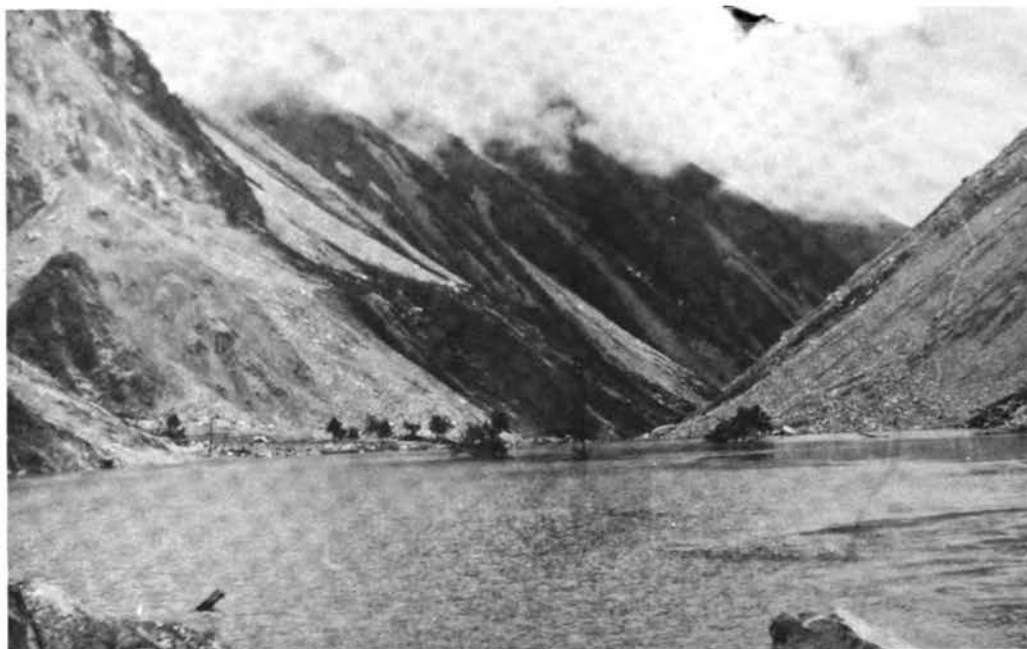
FIGURE 5.20 "Earthquake lake" formed during the SP earthquakes by a rockfall.
