THE LANDSLIDE AT TUVE, NEAR GÖTEBORG, SWEDEN,  
ON NOVEMBER 30, 1977

J. M. Duncan,  
University of California, Berkeley

for the  
Committee on Natural Disasters  
Commission on Sociotechnical Systems  
National Research Council

NATIONAL ACADEMY PRESS  
Washington, D.C.  
1980

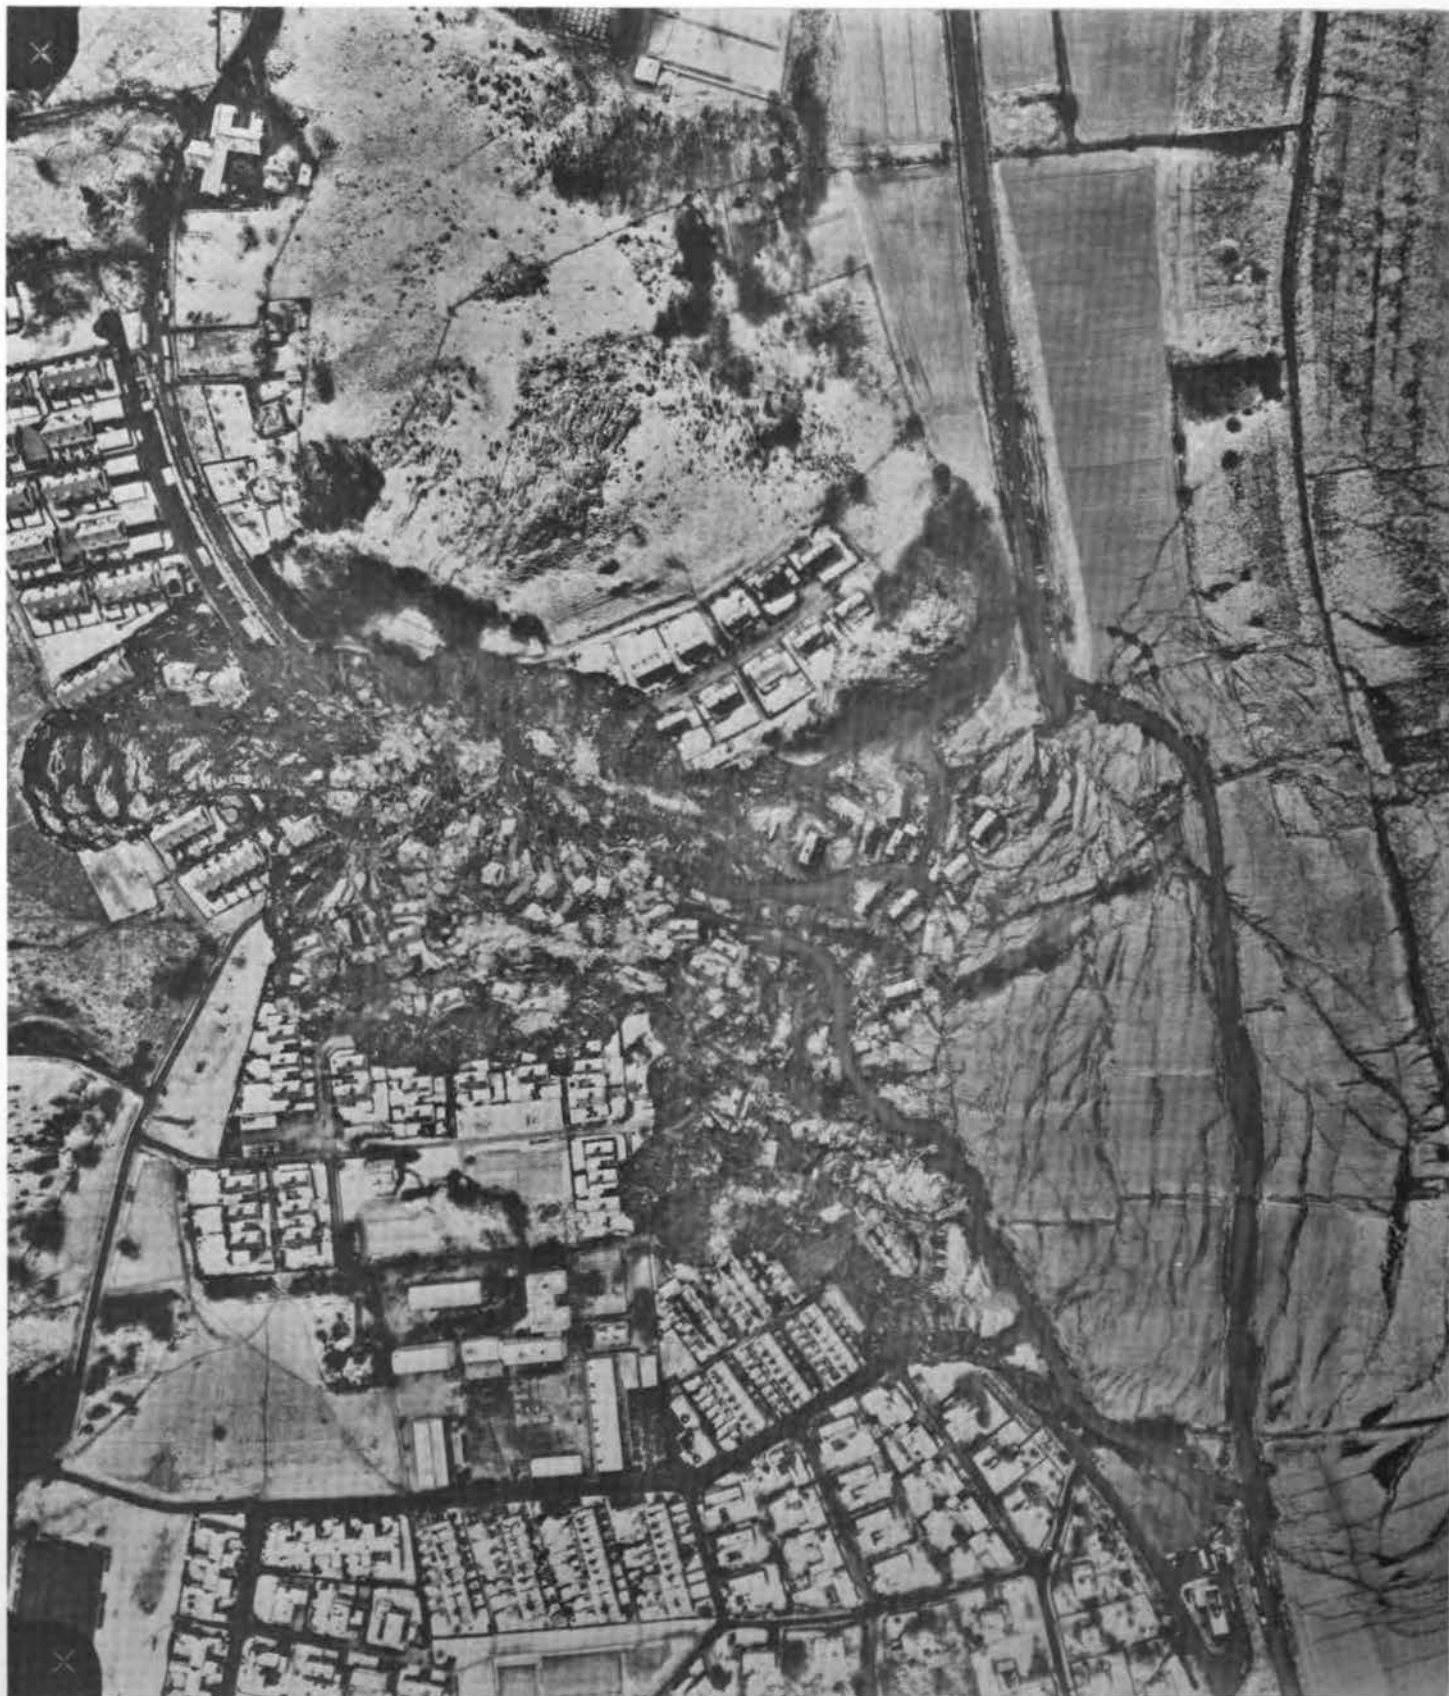
The area affected by the landslide is indicated on the topographic map (Figure 2) and may be seen in the photographs in Figures 4 and 5. The motion of the slide was from west to east, toward the main valley. The failure started with a small slide in the roadway embankment that traversed the area from southeast to northwest (Tuve Kyrkväg). From its point of beginning, it retrogressed across and up the hill; successive episodes of sliding continuing for a period of about 2 minutes. On December 3 and 4, a few minor slides occurred in the steep scarps that had been formed at the upper limits of the slide.

Fig. 4 Air photo of the Tuve region after the landslide of November 30, 1977.

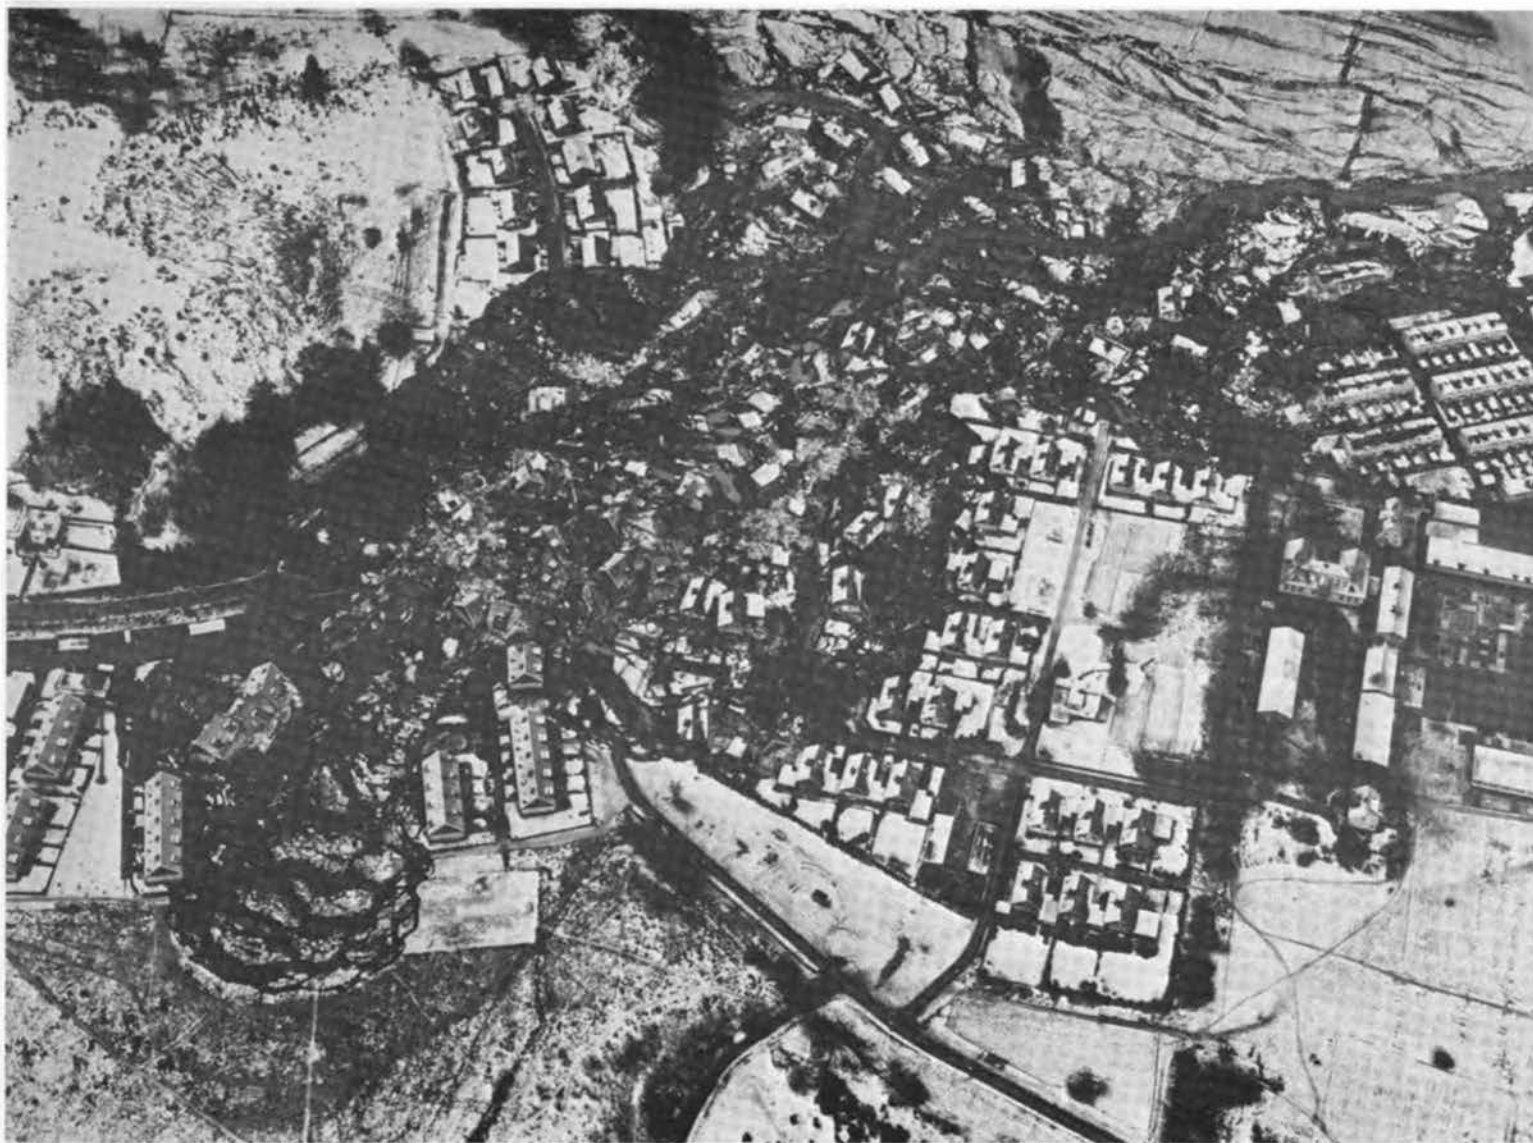
Fig. 5 Air photo of the Tuve slide area, looking northeast.

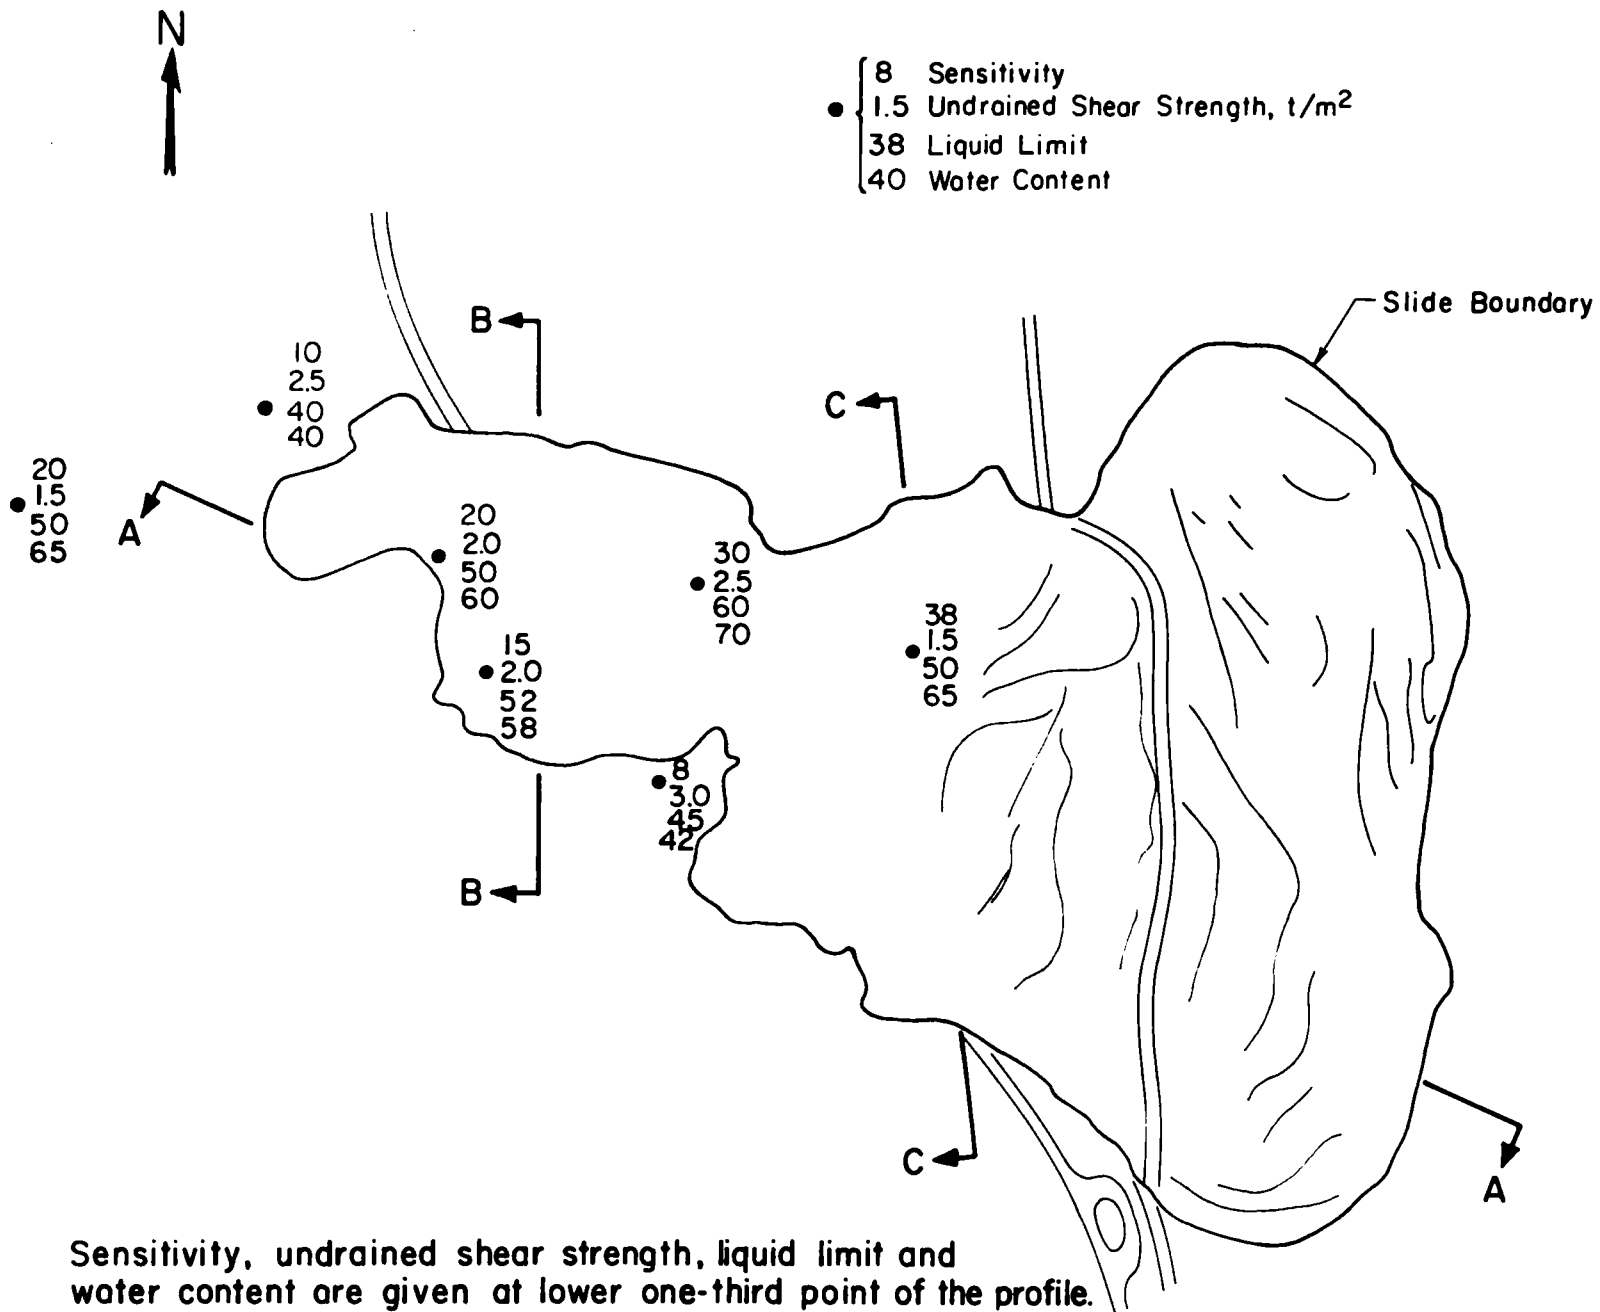
A plan of the slide area is shown in Figure 6. The numbers on the drawing indicate values of sensitivity (ratio of undrained strength before remolding/undrained strength after remolding), undrained shear strength (before remolding), liquid limit, and water content that were

Fig. 6 Plan of the landslide area with soil properties determined before the slide (see cross-sections on Figure 7).

obtained from geotechnical investigations in the area before the slide. It may be noted that the undrained strength of the clay is low throughout the slide area, varying from 1.5 to 2.5 t/m<sup>2</sup> (from 300 to 500 lb/ft<sup>2</sup>). The sensitivity increases toward the east, in the downhill direction. Throughout the area the natural water content is above the liquid limit, which is consistent with the fact that the clay has very low strength after remolding.

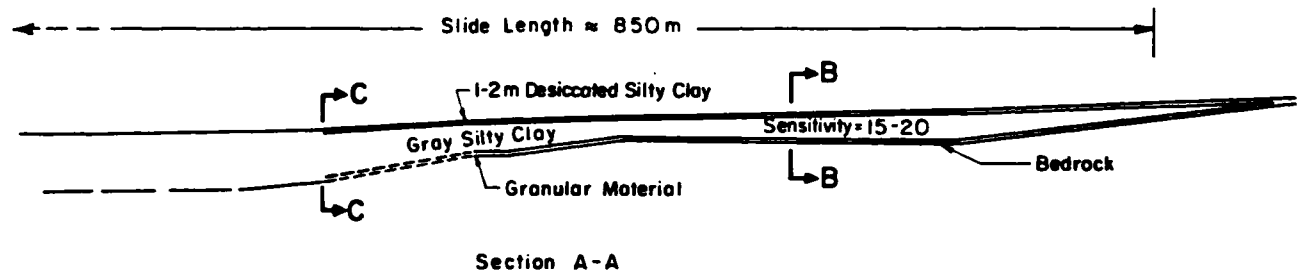
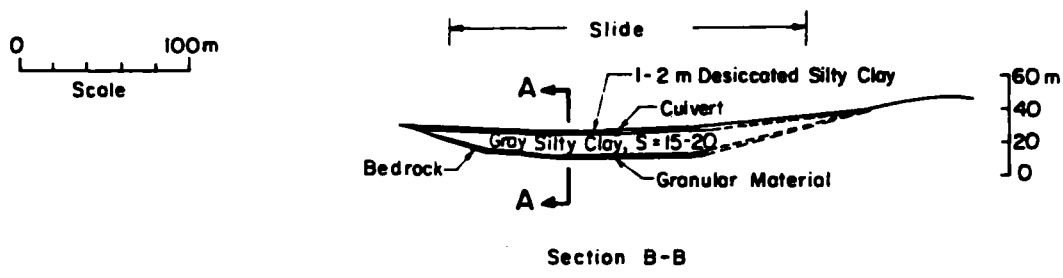
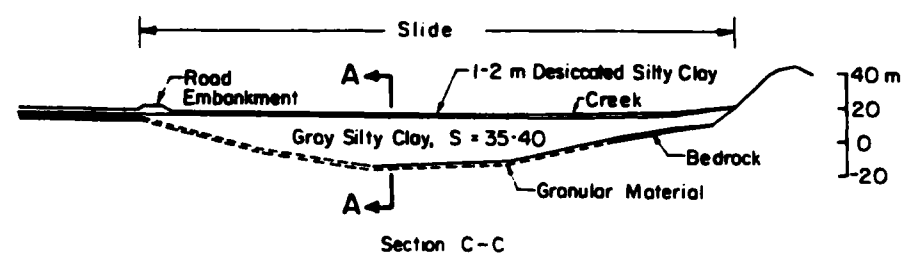
Three cross-sections illustrating conditions before the landslide are shown in Figure 7. The portion of the slide above section C-C was characterized by large displacements of the ground toward the main valley, with a consequent drop in the ground-surface elevation as the clay, flowing and sliding downhill, left a partly empty rock bowl with scattered pieces of the former landscape and houses resting at its bottom, as shown in Figure 8.

Fig. 7 Cross-sections through the slide area determined before the slide (see Figure 6).

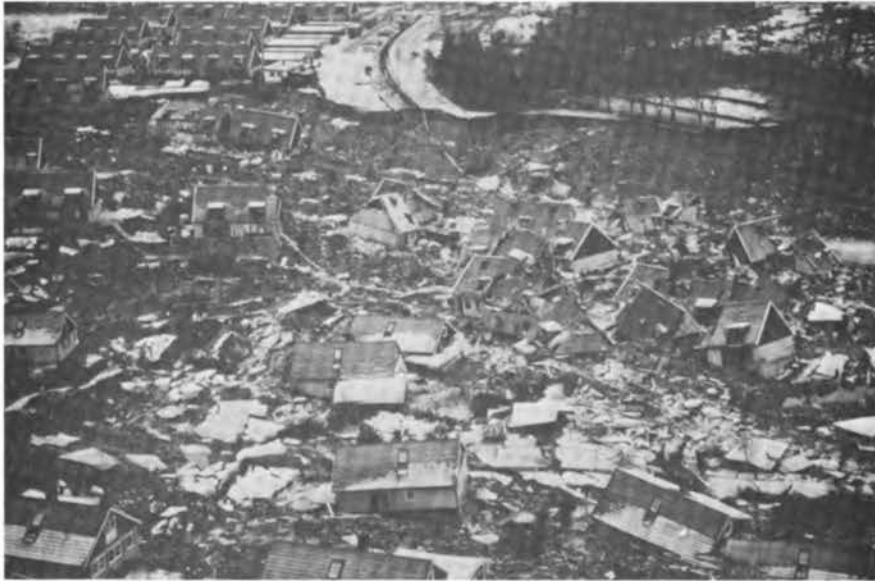
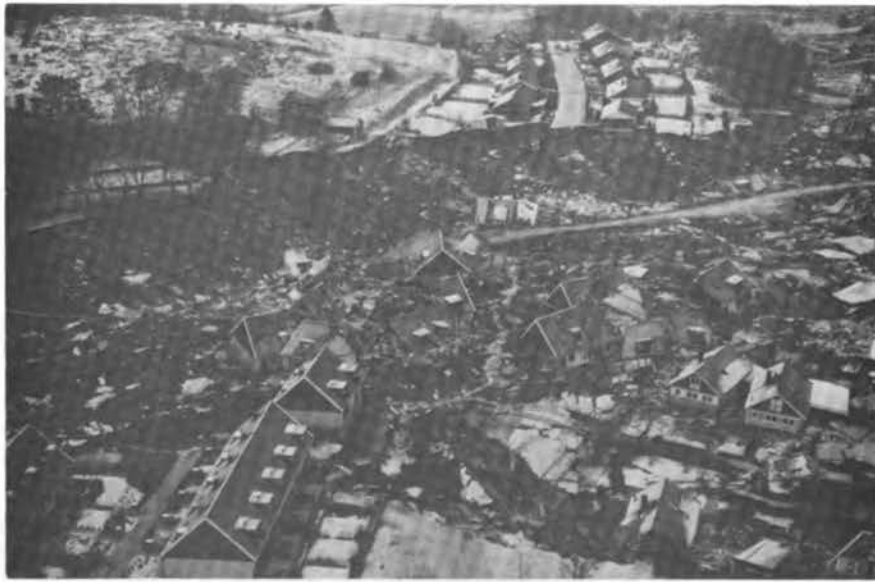
Fig. 8 Two views of the bowl formed at the upper part of the slide.

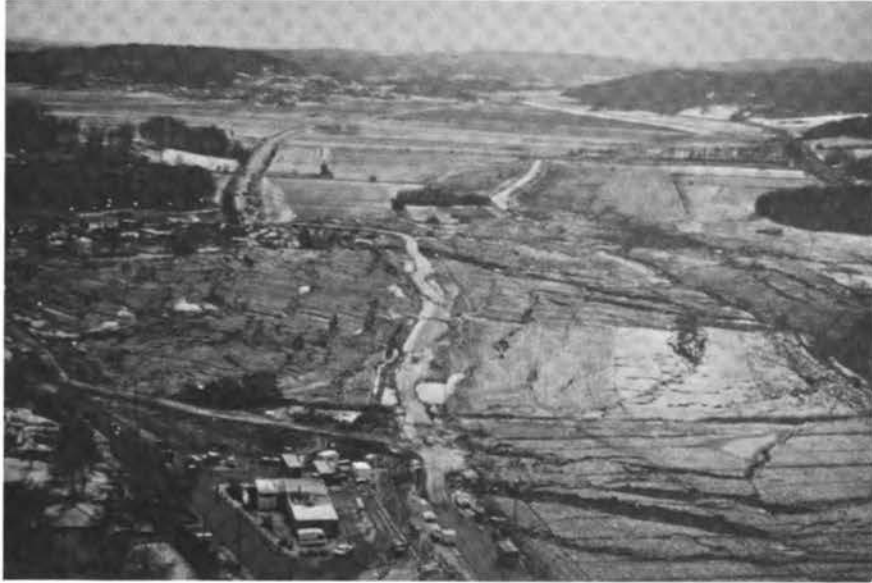
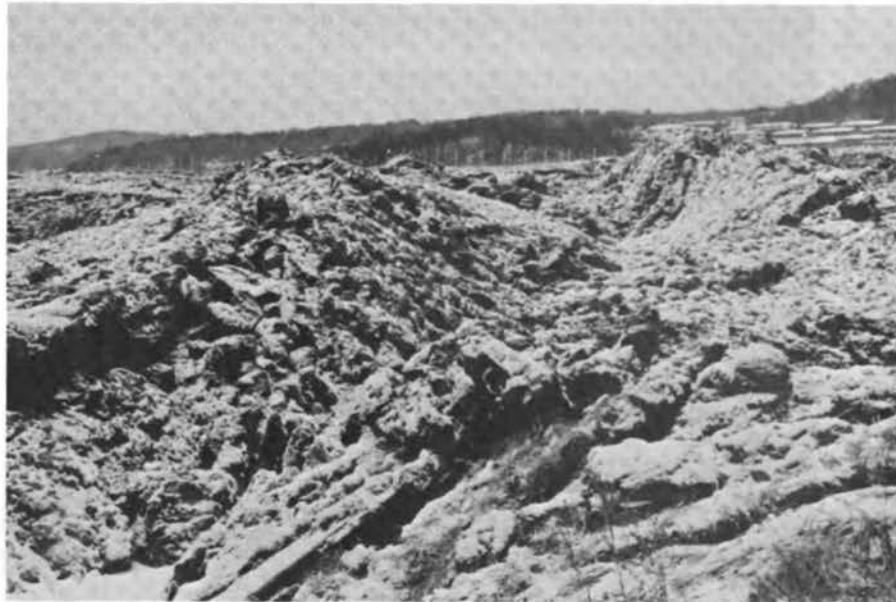
The portion of the area below section C-C also suffered large lateral movements that resulted in displacement of the road in this area about 40 m to the east, toward the main valley, as shown in Figure 9. The ground in this lower area was heaved upward and the surface was compressed, as soft clay from uphill forced itself against and beneath the stiff crust that blanketed the lower part of the slope. The bulging and compression of the ground surface in this area are shown in Figure 9.

Fig. 9 Displacement of the road and heave and compression of the ground surface in the lower part of the slide.

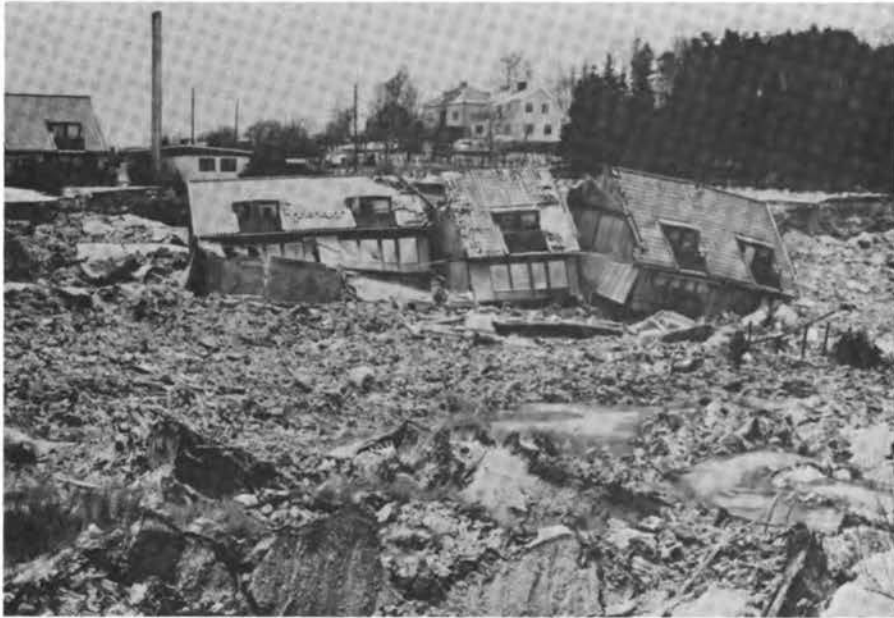
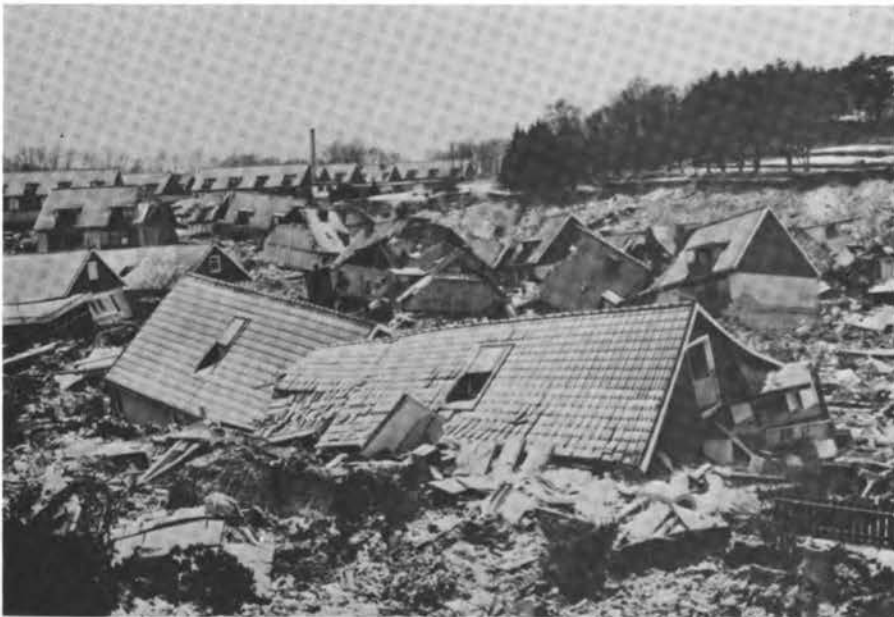
All of the houses involved in the slide were severely damaged and rendered unusable. Larger houses and row houses were frequently broken apart by the movement, and in some cases their walls crumbled and collapsed completely, leaving only the more securely braced roof structure in a recognizable condition, as shown in Figures 10 and 11.

Fig. 10 Houses in the center of the slide area.

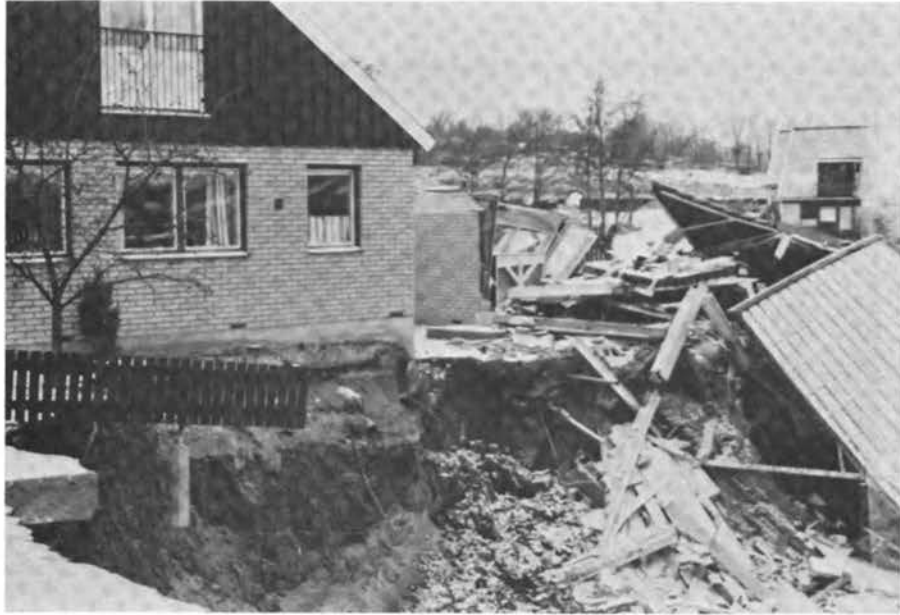
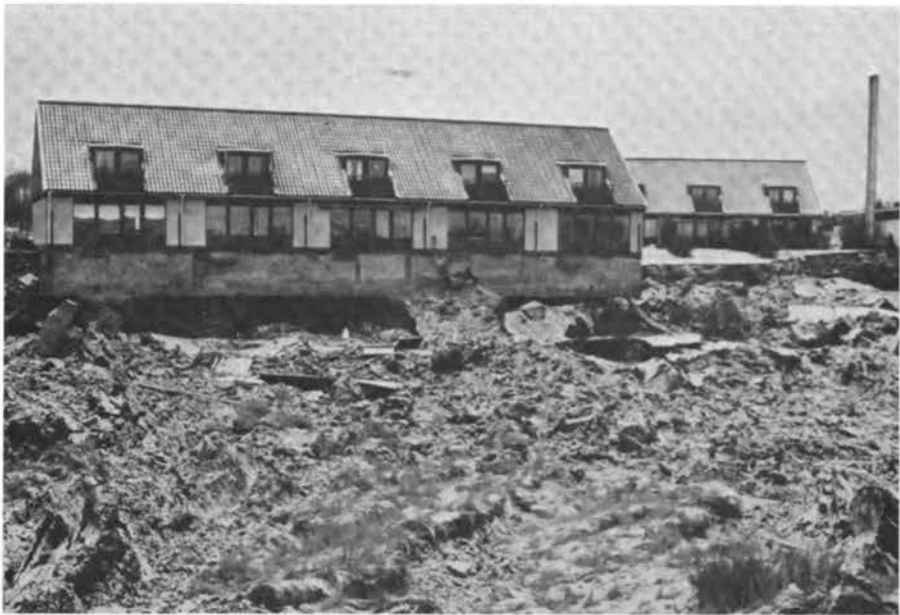
In a number of cases the slide scarp coincided nearly exactly with the wall of a house, leaving the house perched precariously at the brink of a newly formed vertical drop-off several meters high. Two such houses are shown in Figures 11a and 11b. This situation occurred with sufficient frequency to make it appear highly unlikely that it was due entirely to chance. Possible explanations are that the clay beneath the houses had been strengthened by consolidation under the added load of the houses and that the frames of the houses themselves offered additional strength or resistance to development of tension cracks around the margins of the slide.

Fig. 11 Houses near the margins of the slide.

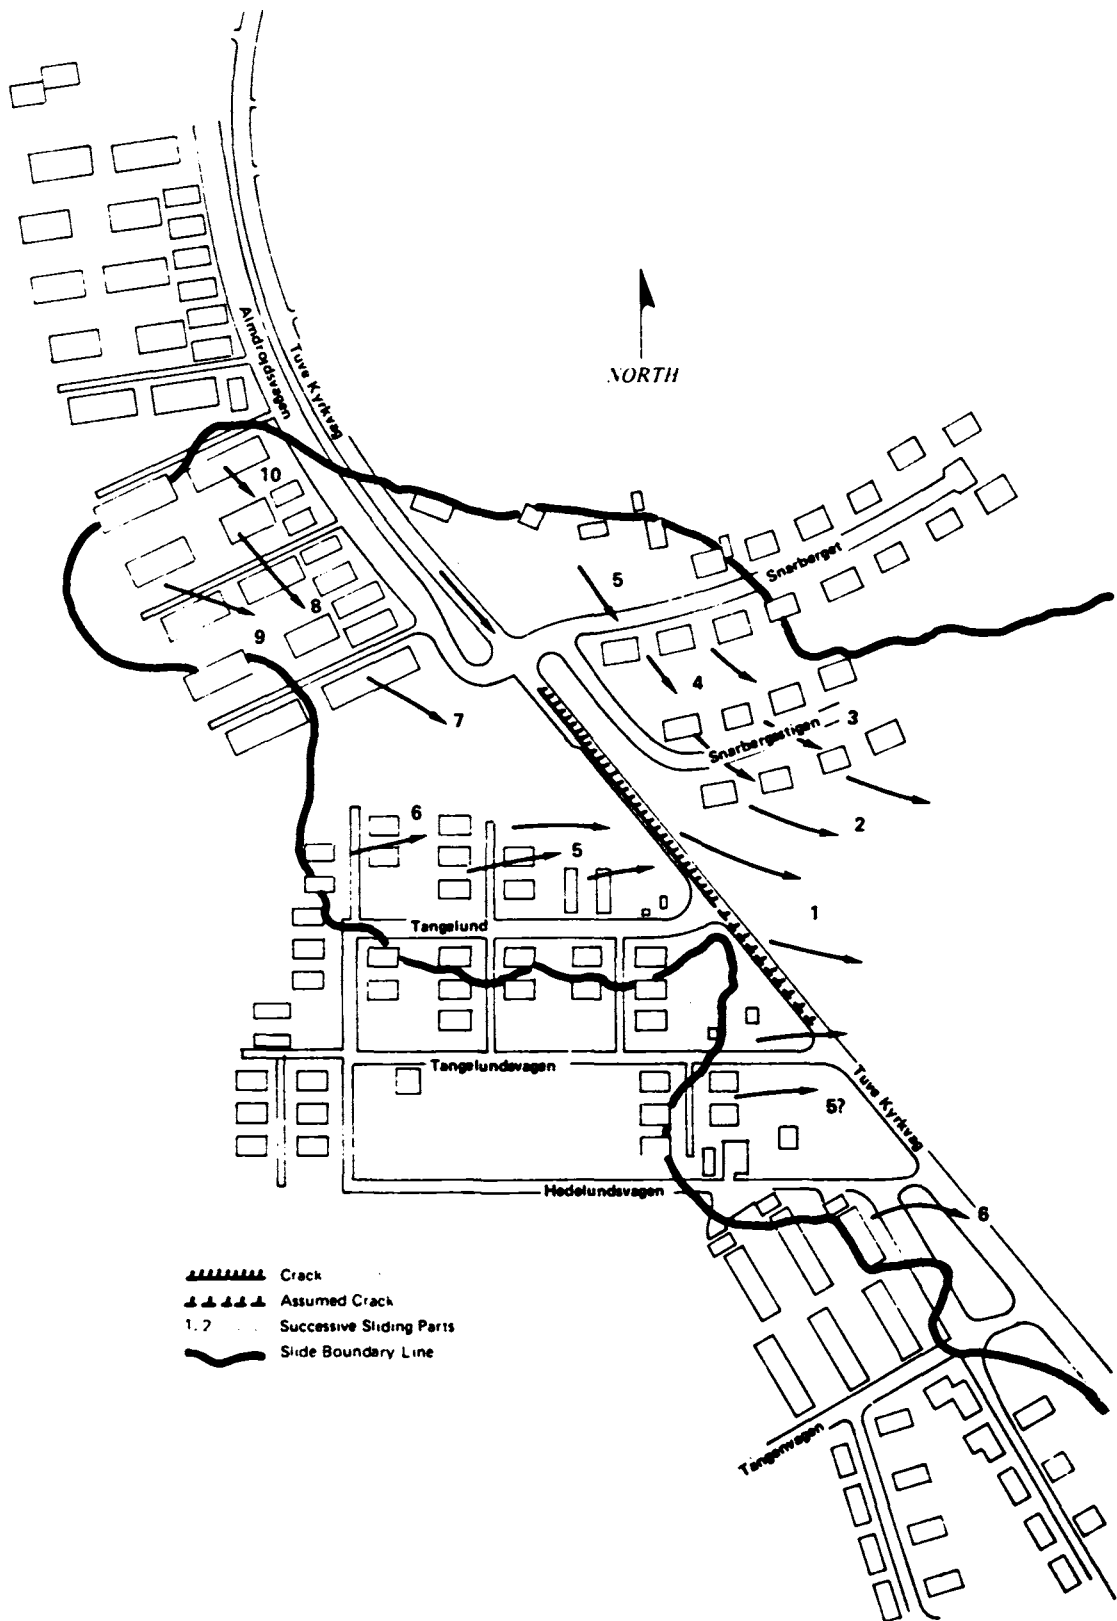
1. The stream flowing down the secondary valley in which the slide occurred emerged from a conduit under the Tuve Kyrkväg embankment (see Figures 2 and 12). Where it emerged from the conduit, the stream ran parallel to the embankment for about 50 m. On the morning of the slide, a resident of the area noticed unusually heavy flow in the stream, which might have resulted in erosion of the toe of the embankment or the stream slopes further downstream, thus triggering the initial slide.

Fig. 12 Sequence of events in the Tuve landslide.

sequence of events involved in development of the slide. The order of the events, as shown by the numbers on Figure 12, was as follows:

1. Shortly after 4:00 p.m., a crack developed in the pavement of Tuve Kyrkväg. It ran from Snarberget to Tångelundsvagen. The crack propagated approximately at walking speed, about 2 m/second. When the crack formed, a small portion of the Tuve Kyrkväg embankment, with a surface area of 10 to 20 m<sup>2</sup>, slid away toward the southeast.

2. The lower row of houses on Snarbergsstigen then slid out, approximately at walking speed, about 10 or 20 seconds after the crack developed in Tuve Kyrkväg.

3. The second row of houses on Snarbergsstigen slid out a few seconds later as the slide retrogressed to the north.

4. The row of houses on the lower side of Snarberget slid out a few more seconds later, following those from Snarbergsstigen down the hill.

5. Within about 20 seconds after development of the crack in Tuve Kyrkväg, the houses on the upper side of Snarberget, those north of Tångelund, and those north of Hedelundsvagen began to slide. By this time, the houses from Snarbergsstigen had moved about 50 m downhill.

6. Within a very short time, the houses further up Tångelund and those on Tangenvagen began to slide.

7-10. Subsequently, in a succession of slides, the houses to the west of Almdrojdsvagen slid away. From the development of the crack in Tuve Kyrkväg to the last of the slides, the total duration of the slides was estimated as 1-2 minutes.

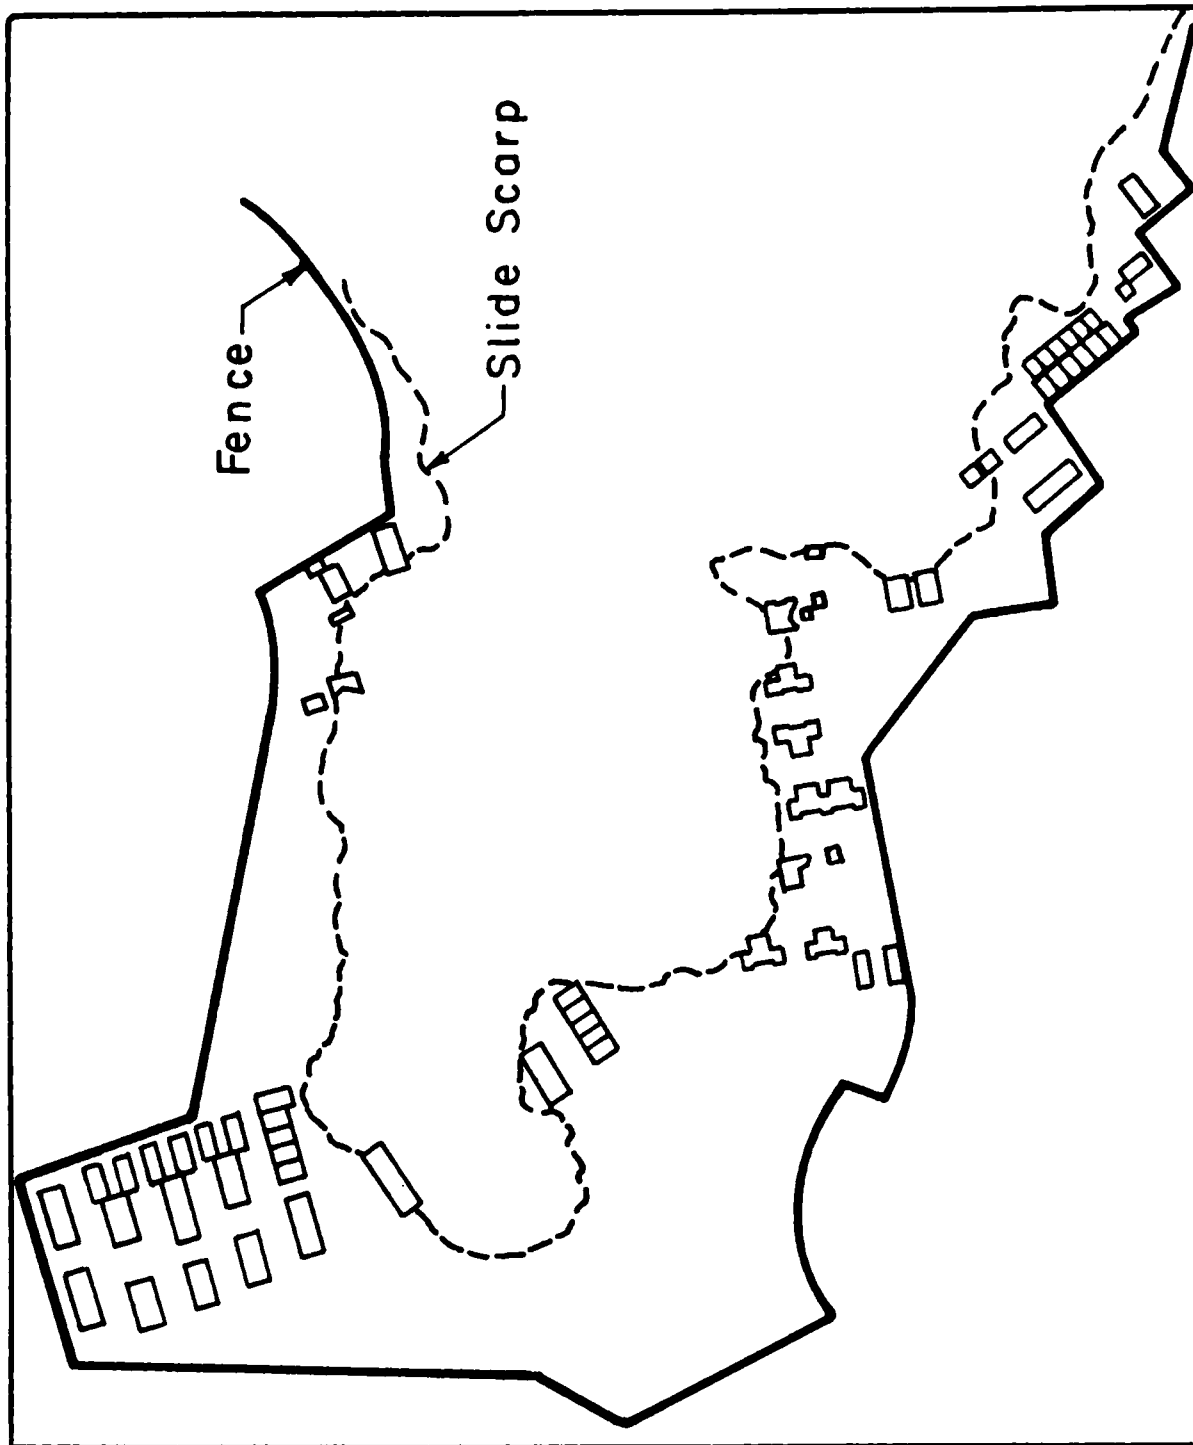
Immediately after the slide, a fence was erected around the destroyed area and the undamaged houses believed threatened by possible further sliding, as shown in Figure 13. All of the houses within the fenced zone were evacuated. On Friday, December 2, a crack was discovered outside the fence, and 34 additional houses were evacuated. A total of 65 houses were destroyed and about 100 were evacuated.

Fig. 13 Security fence around the evacuated houses.
