California Coastal Erosion and Storm Damage During the Winter of 1982-83

A Reconnaissance Report Prepared by:

Committee on Natural Disasters
Commission on Engineering and Technical Systems
National Research Council

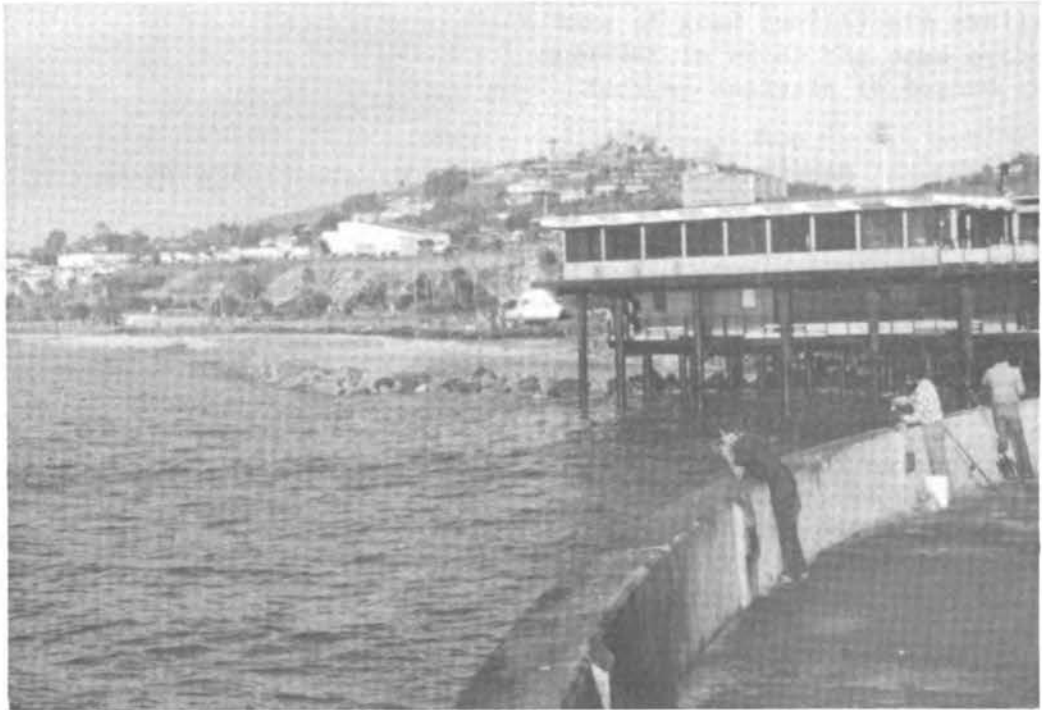
The condition of this revetment during the study team's visit is shown in Figure 9. The storms of 1982-83 removed a considerable amount of sand from behind the breakwater, "stranding" the revetment. It also appears, although it is not certain, that the larger revetment units settled substantially.

FIGURE 9 Revetment adjacent to the Santa Barbara Yacht Clubhouse at the base of the Santa Barbara breakwater. Note the complete loss of sand from behind the revetment.

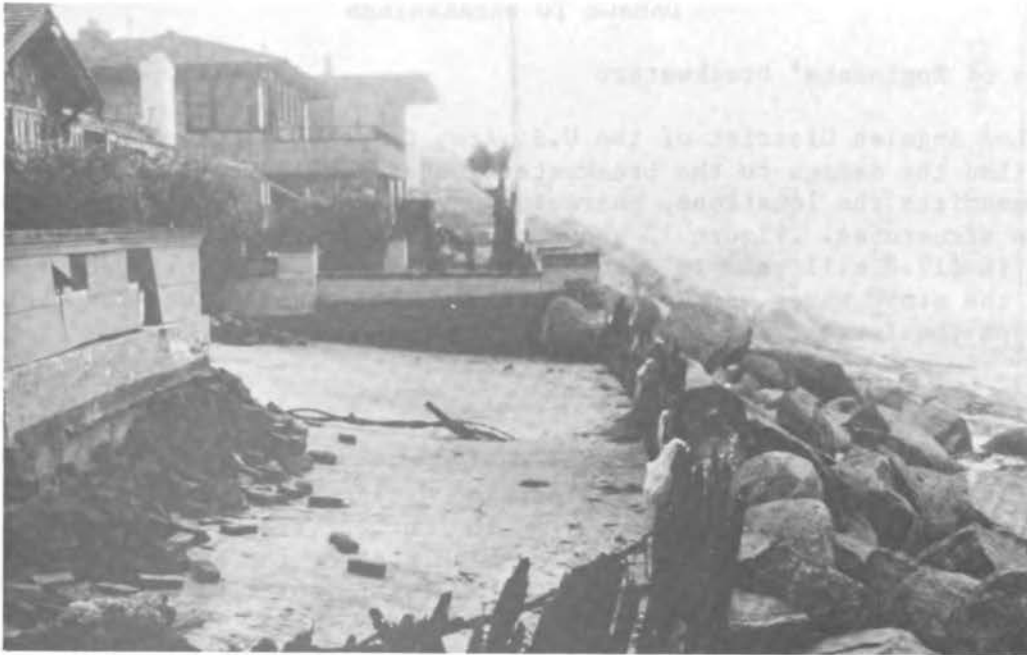
The revetment rock appeared to the study team to be in relatively good condition. However, the Longard tube had been ruptured and contained little sand (see Figures 10 and 11). Moreover, although the revetment had not failed structurally, it had been severely overtopped. The structures behind the revetment had suffered damage from overtopping water and flying debris.

FIGURE 10 A view of Delmar Beach showing the light ineffective seawall, revetment, and damaged Longard tube. Note the small Caterpillar in the background moving sand to the upper portions of the beach.

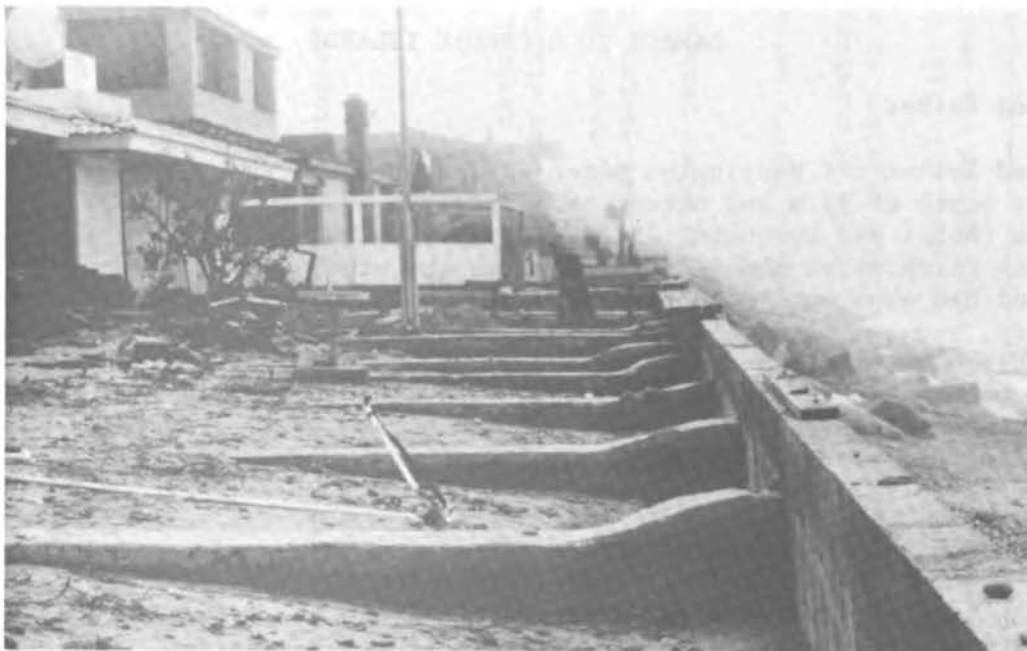
FIGURE 11 Delmar Beach showing the seawall with the damaged Longard tube in the background. Note the effect of the waves overtopping the seawall and causing erosion on the lee side.

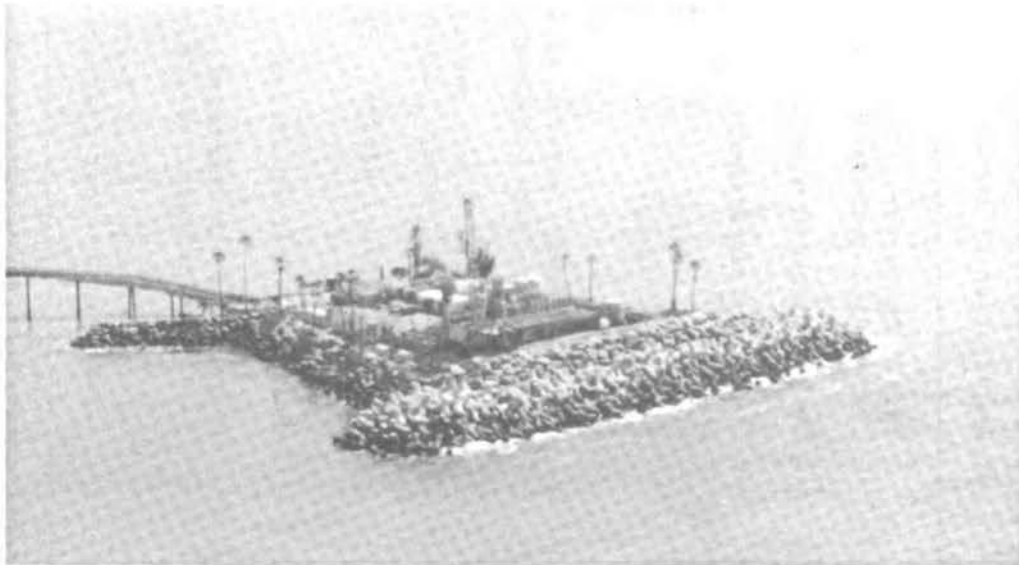
Rincon Island is located in water approximately 15 m deep and is armored by tribar units weighing 31 tons each on the seaward side. Construction of the island was completed in August 1958 (Blume and Keith, 1959). Figure 13 shows an aerial view of Rincon Island taken during the reconnaissance trip. No damage is evident.

FIGURE 13 Rincon Island showing no apparent damage.

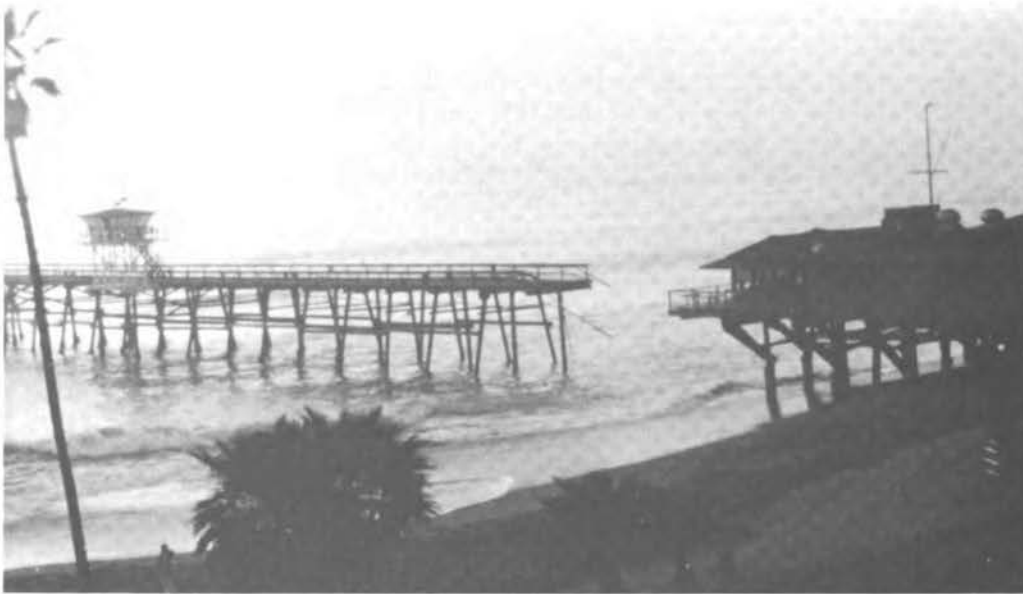
FIGURE 14 Nearshore section of the San Clemente Pier removed by storm.

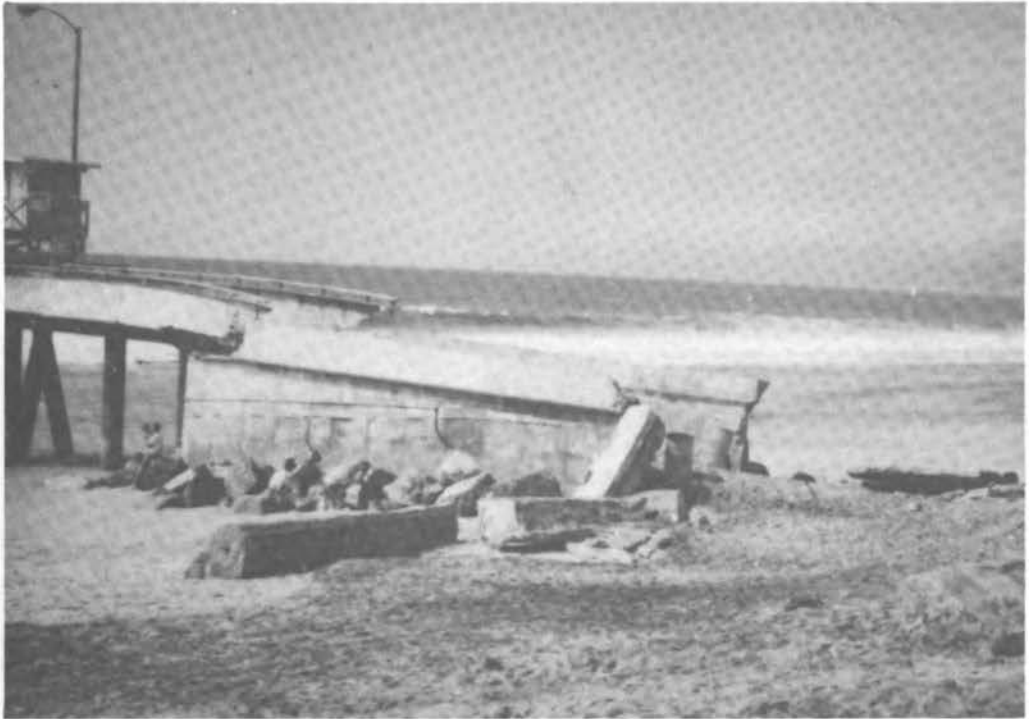
This failure underscores the importance of taking into account the potential depth of wave erosion when designing the foundations of coastal installations. To illustrate this point, Figure 16 shows a small building housing restrooms and changing rooms adjacent to the Venice Pier. This structure escaped destruction because it was founded on piles, even though spread footings would have been enough to carry the foundation's loads.

FIGURE 15 The Venice Pier was damaged due to undermining and settlement of the approach ramp.

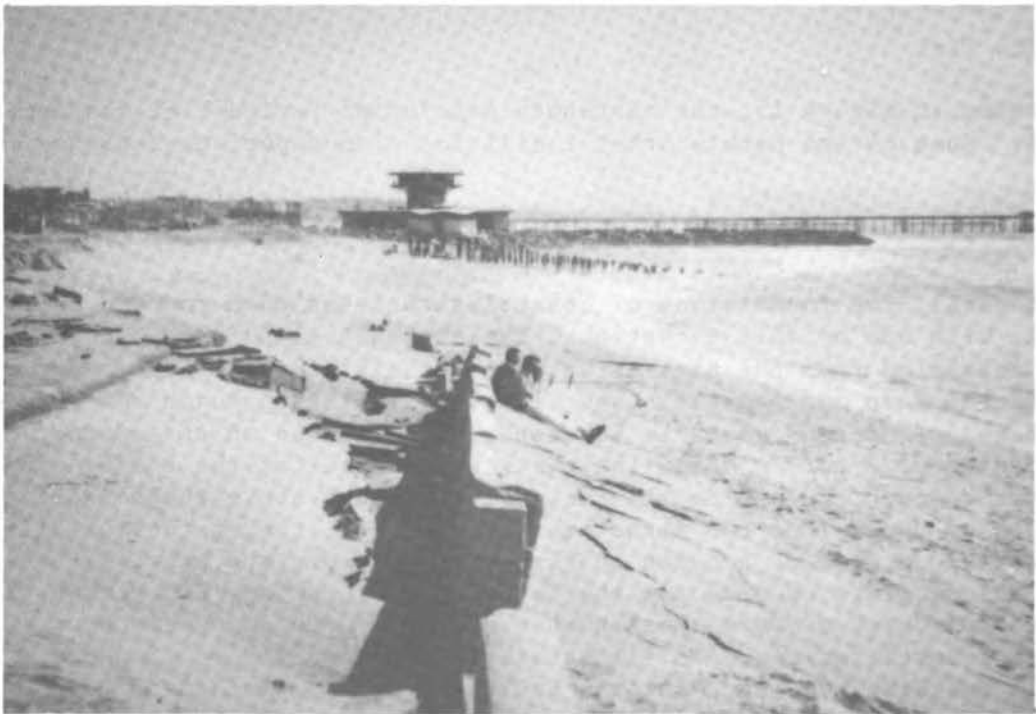
FIGURE 16 This structure supported by light piles escaped direct wave damage. The Venice Pier is in the background.

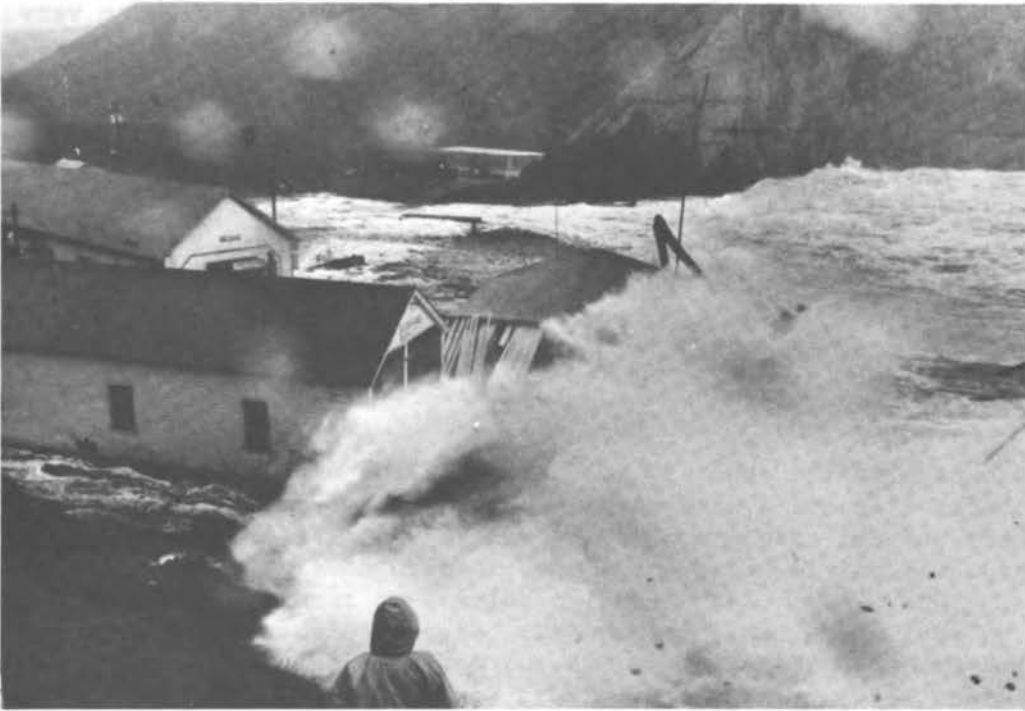
FIGURE 18C The boathouse and fishhouse being attacked by waves.
Photograph copyright © Nicholas King.

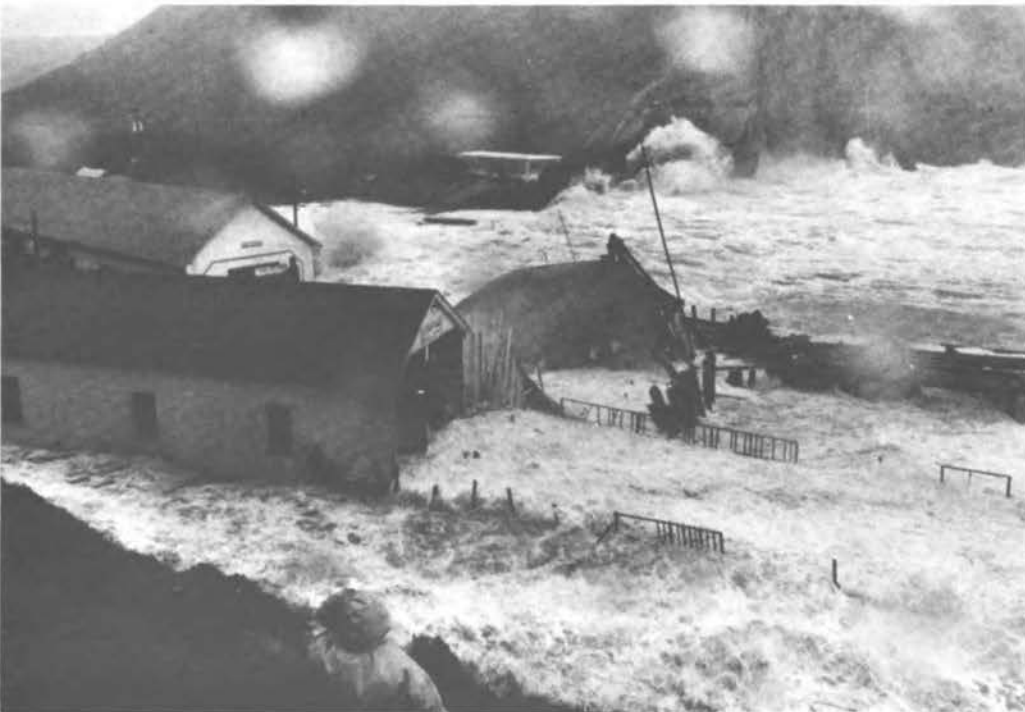
FIGURE 18D The boathouse and fishhouse being attacked by waves.
Photograph copyright © Nicholas King.

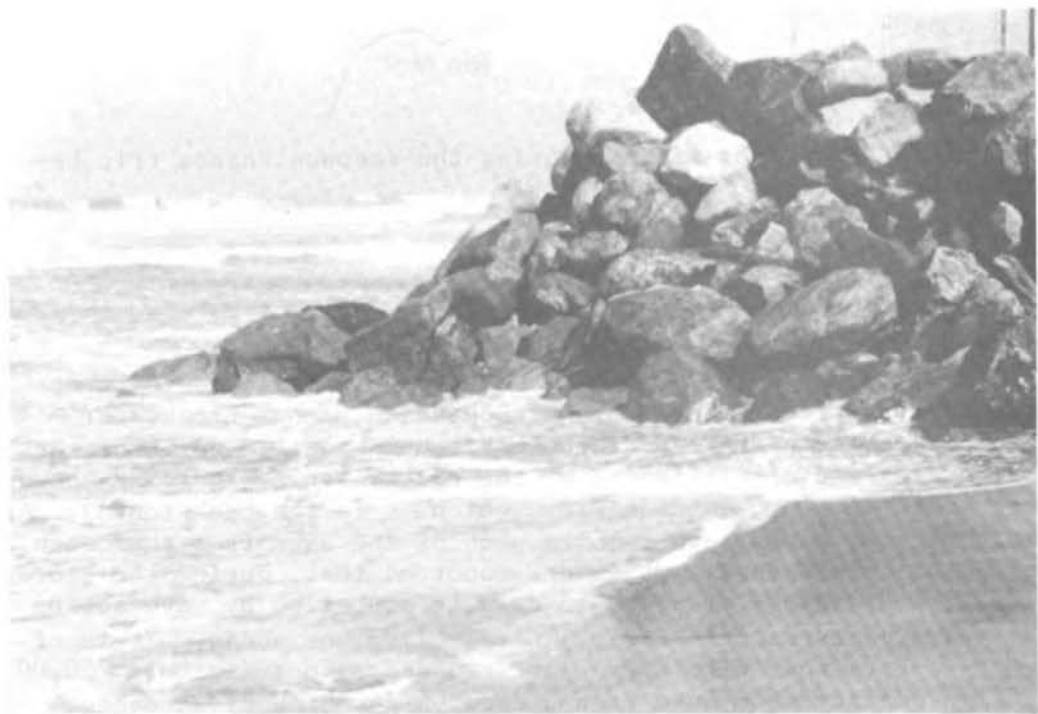
FIGURE 26 Closeup of revetment shown in Figure 25.

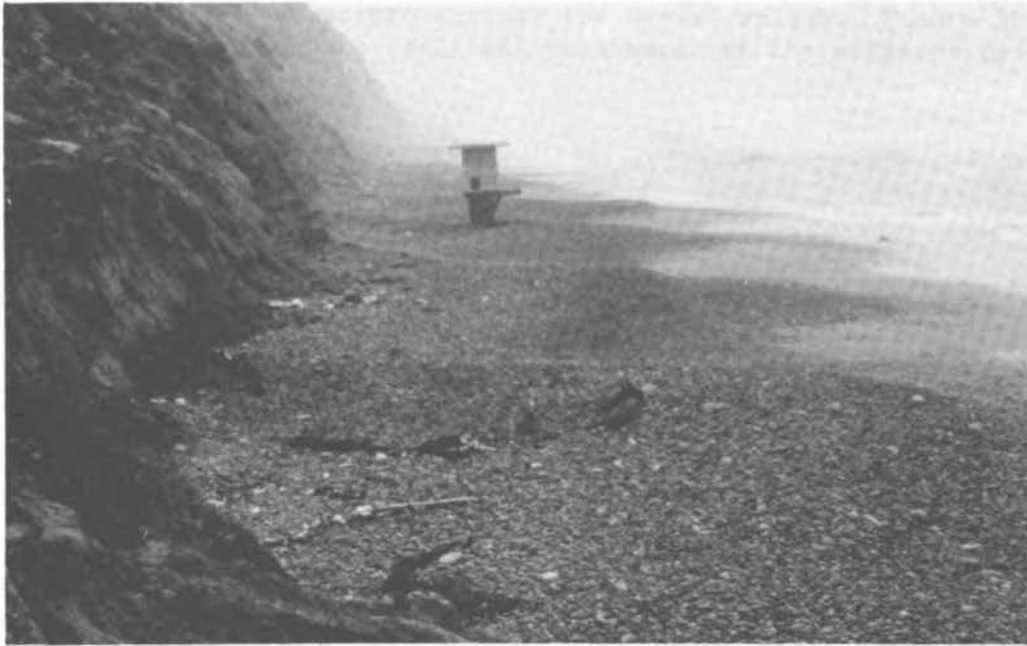
FIGURE 27 Torrey Pines Beach. Note the cobble berm and steep cusp formations.

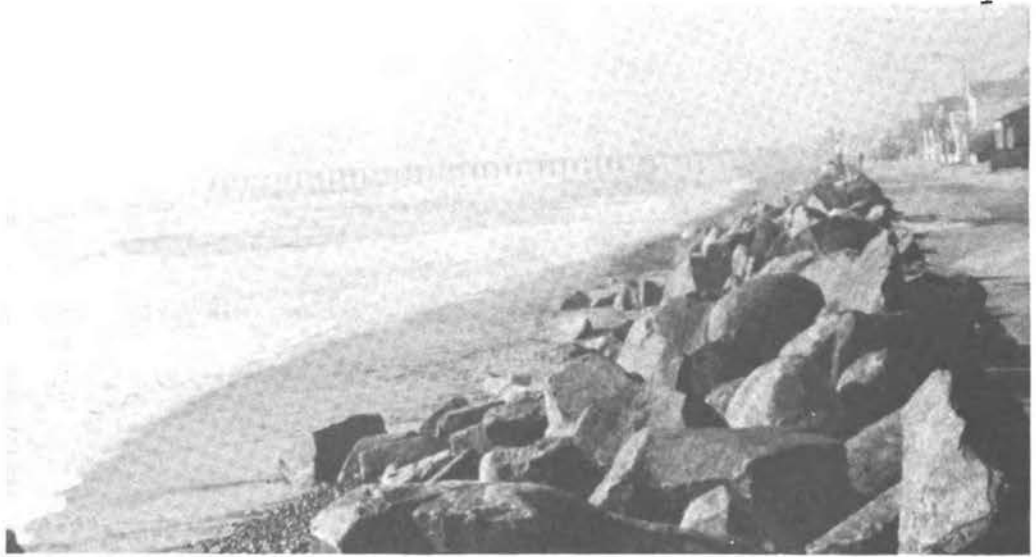
FIGURE 29 Oceanside Beach with Oceanside Pier in the background. Note the narrow beach, revetment, and evidence of overtopping.

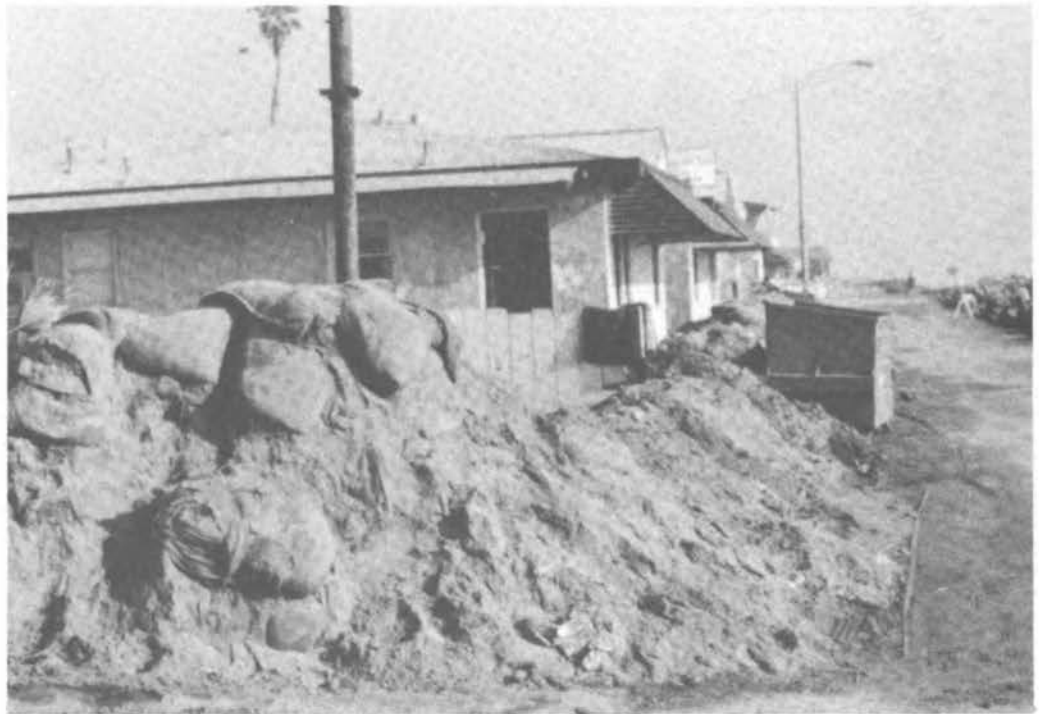
FIGURE 30 Oceanside Beach showing efforts to protect oceanfront cottages against water and debris damage.

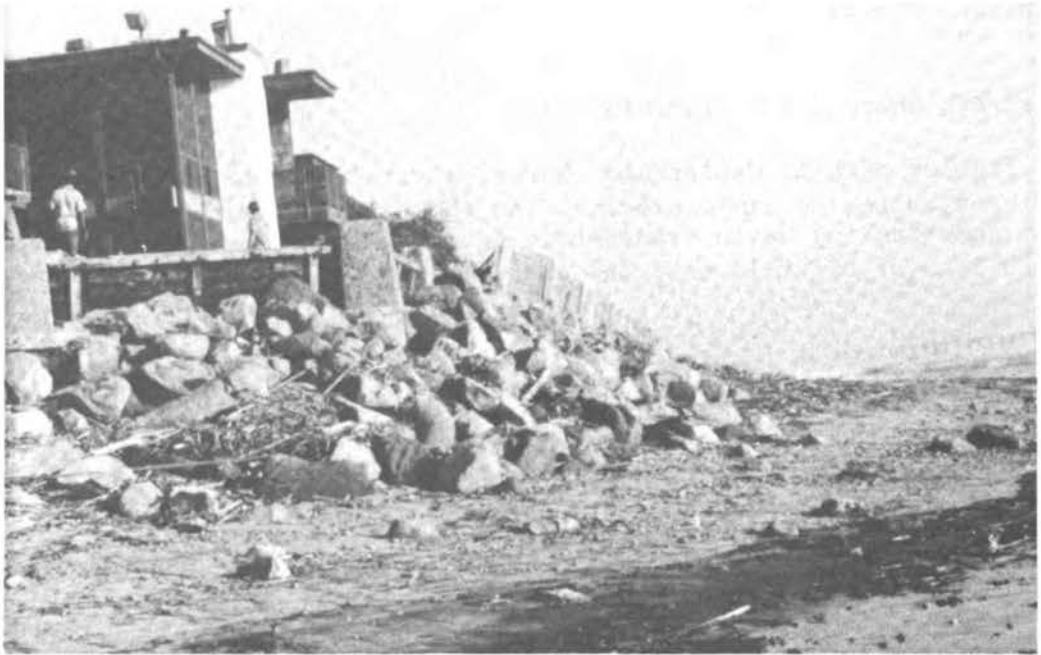
FIGURE 31 Oceanside Beach just south of the mouth of the San Luis Rey River. Heavy revetment and wooden splash guards can be seen. Oceanside Pier is in the background.

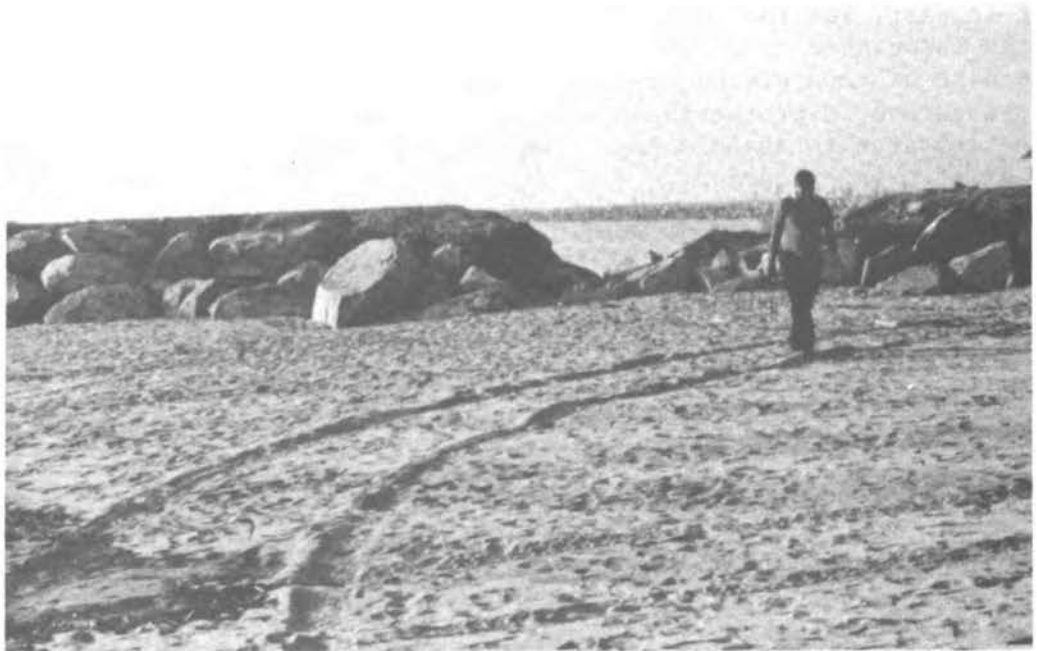
FIGURE 32 Small breach in the south breakwater at Oceanside Harbor.

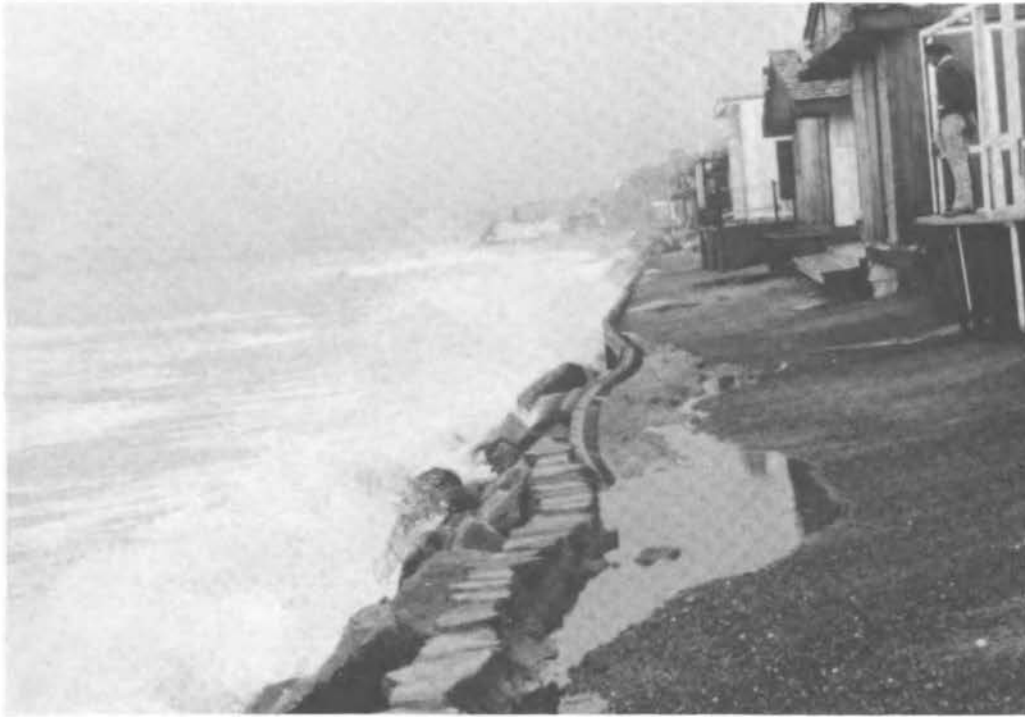
FIGURE 33 Capistrano Shores. A light timber seawall is fronting the trailer park. Note the evidence of overtopping.

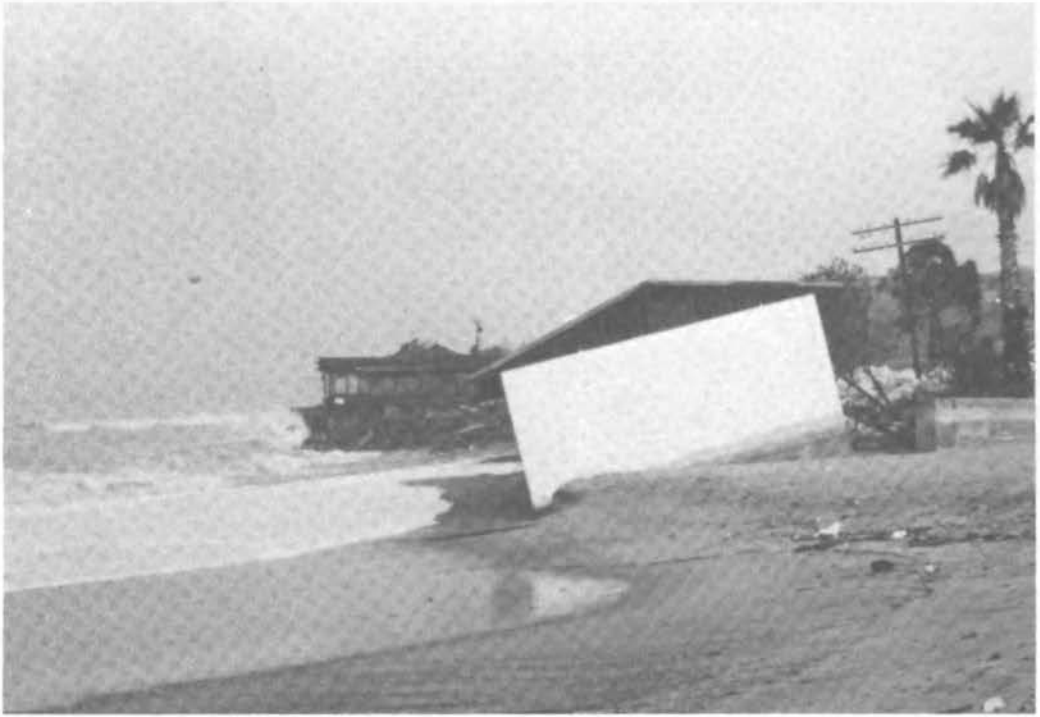
FIGURE 35 This foundation on North San Clemente Beach failed due to undermining of the slab.

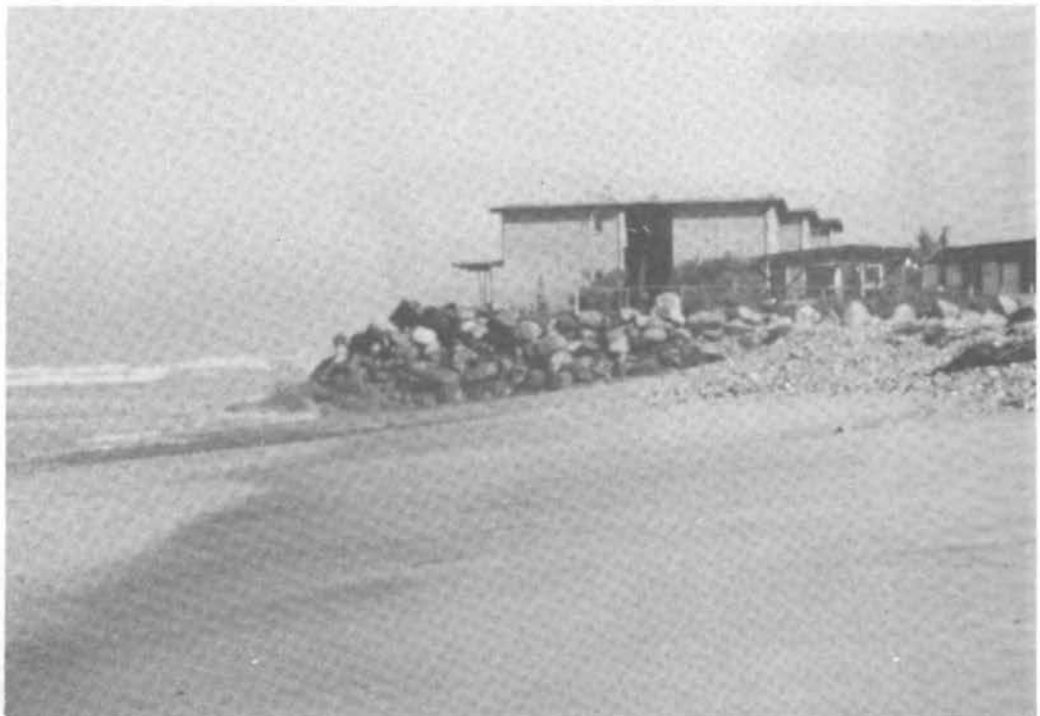
FIGURE 36 Revetment protects this North San Clemente Beach dwelling.

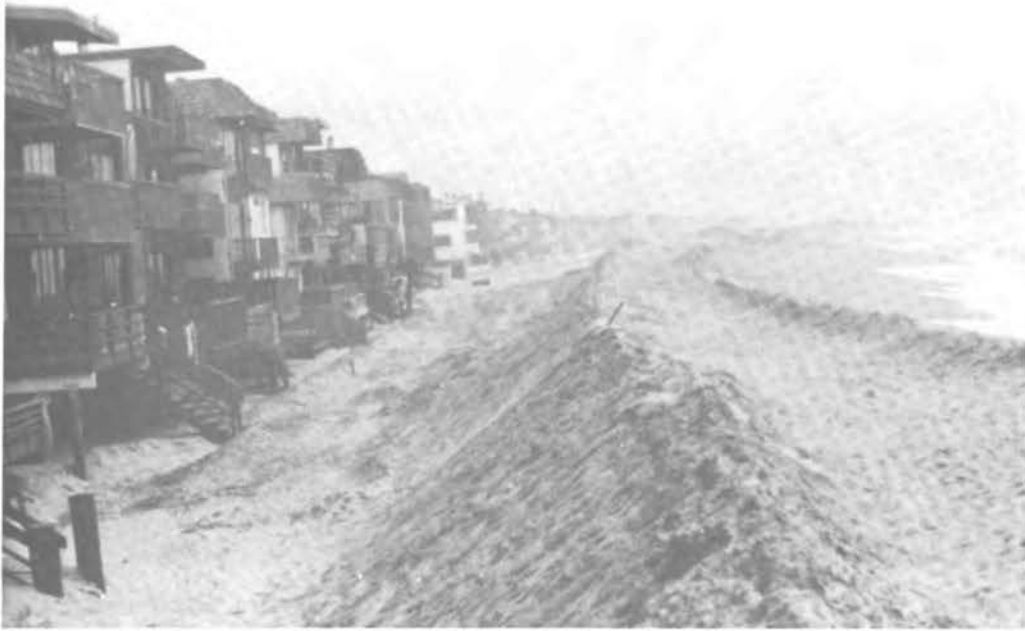
FIGURE 37 A sand berm overlies revetment as protection against flooding at Surfside Colony.

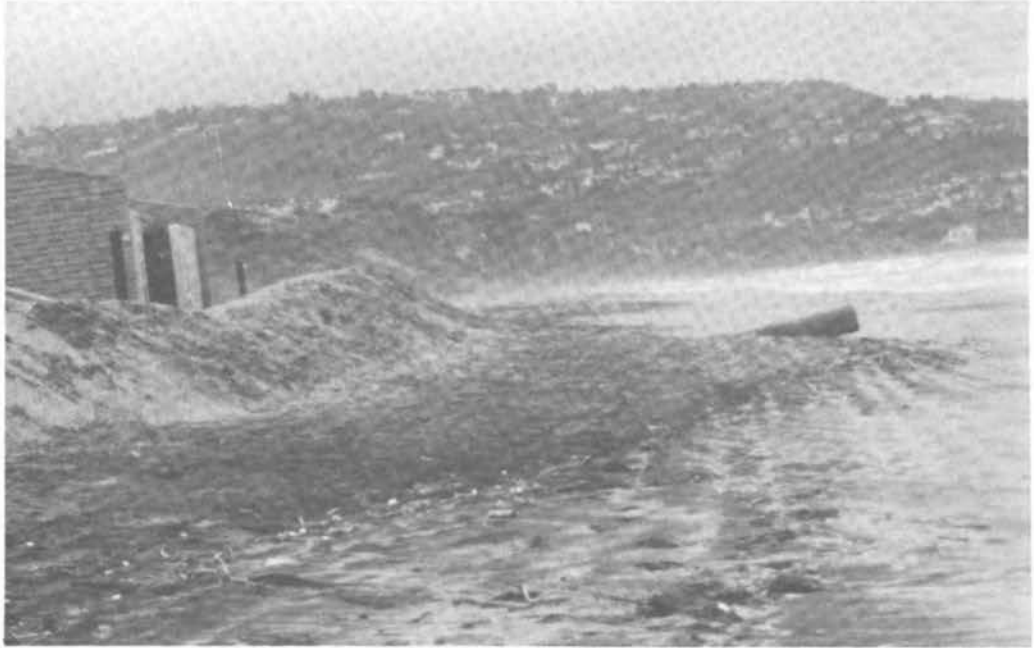
FIGURE 39 Torrance County Beach. Severe erosion is threatening the restroom facilities. Heavy minerals (black sand) were left as "lag" deposits on the beach. The Palos Verdes Hills are in the background.

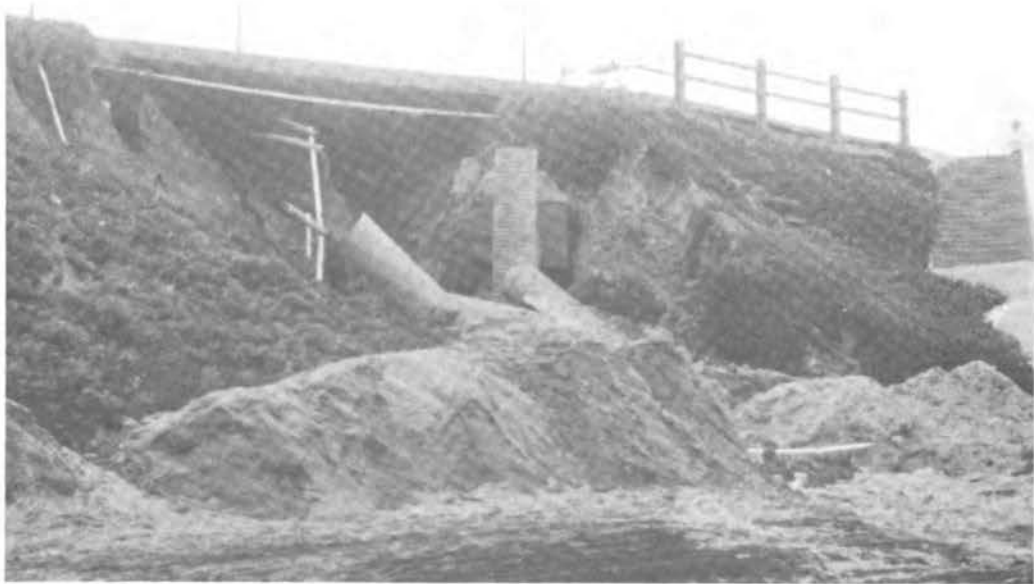
FIGURE 40 Torrance County Park. This view toward land shows damage to drainage conduits and water lines. The erosion was probably due to a combination of waves and runoff.

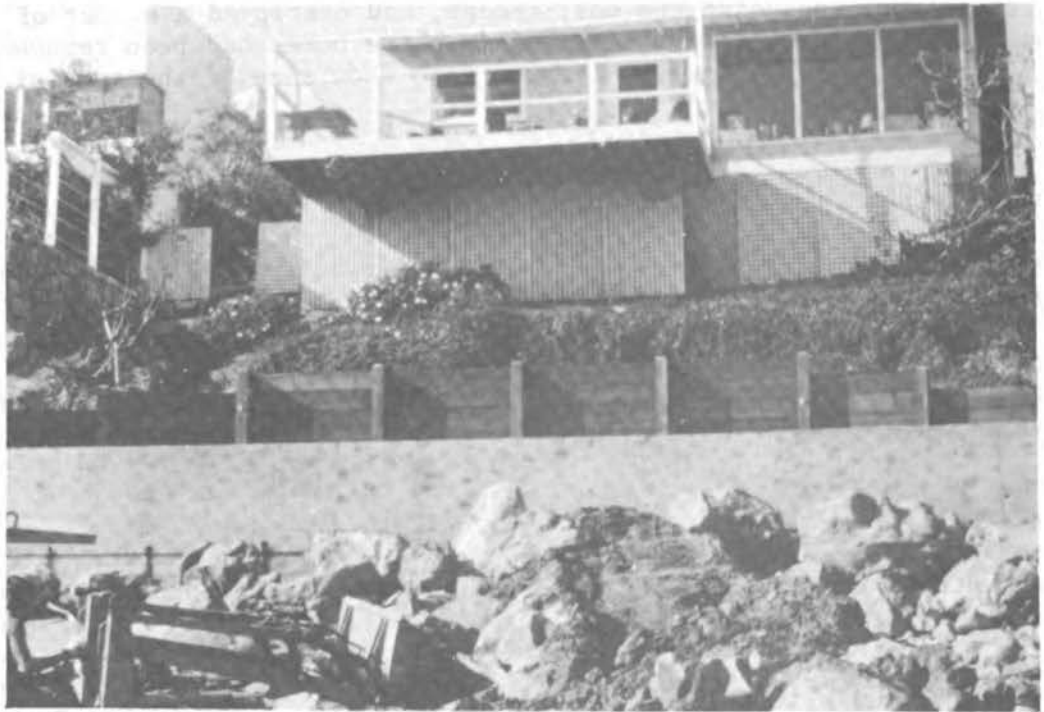
FIGURE 41 Construction during low tide of protective revetment fronting a newly installed seawall.

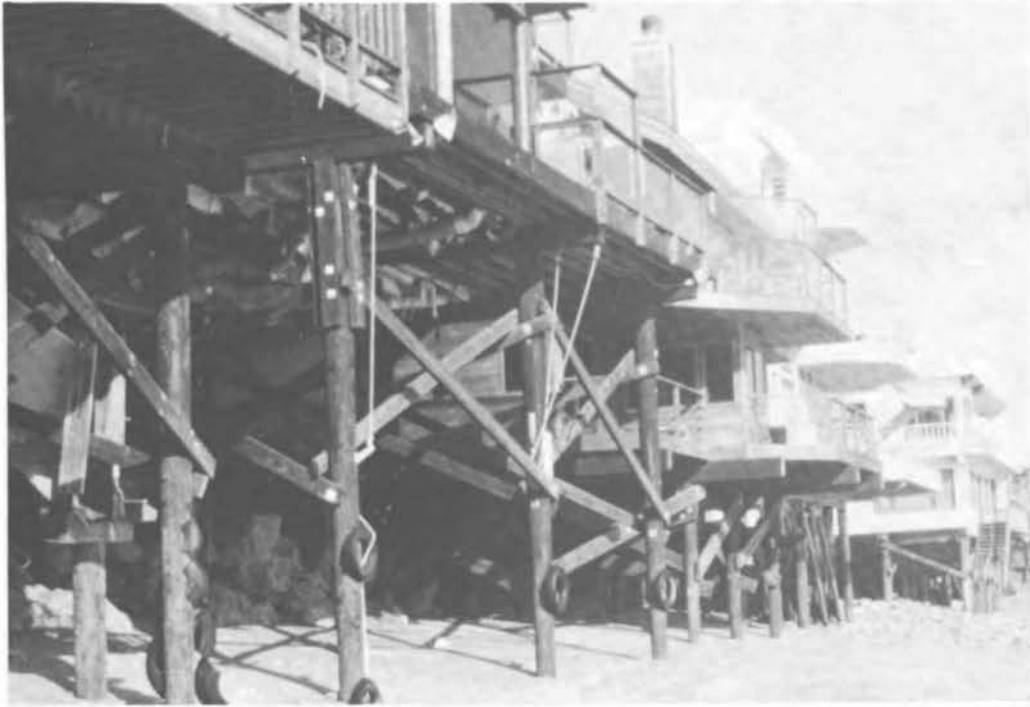
FIGURE 43 Pile-supported structures in Malibu Beach are located near a zone of high wave energy.

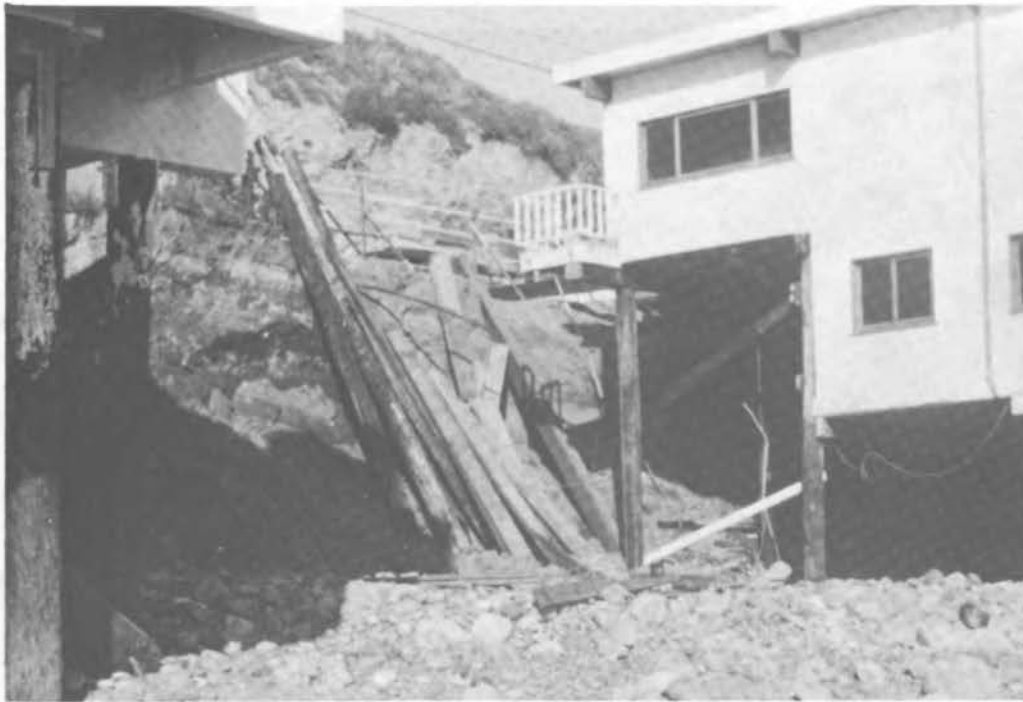
FIGURE 44 Location where a dwelling in Malibu Beach was destroyed by waves. Most of the debris had been removed at the time of this photograph.

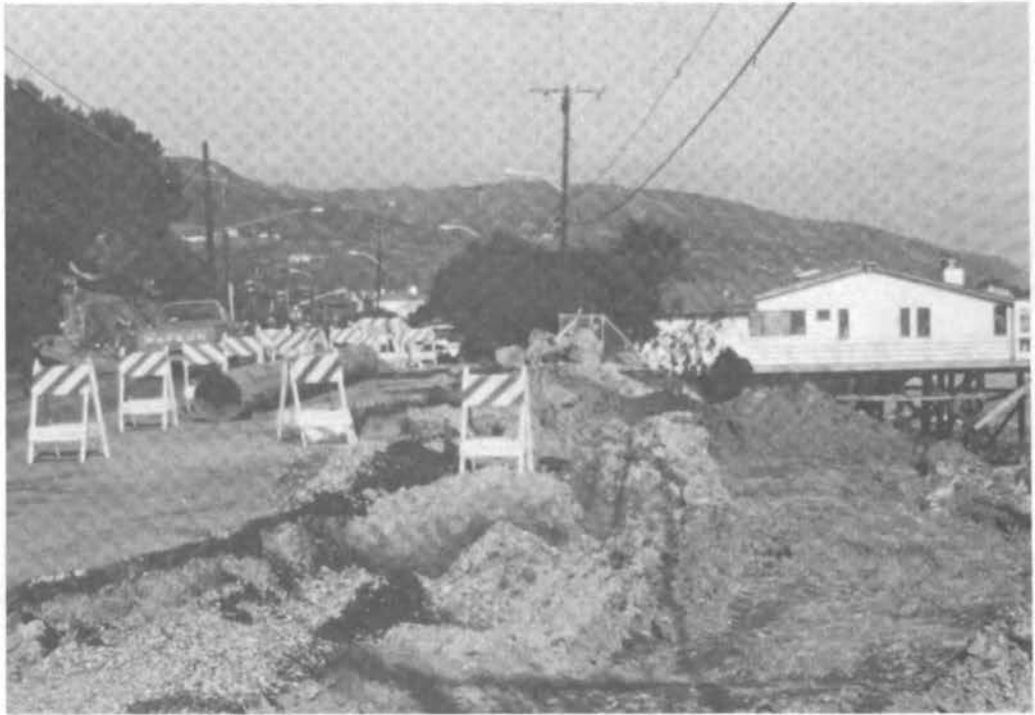
FIGURE 45 Road damage in Malibu Beach due to wave or runoff erosion.

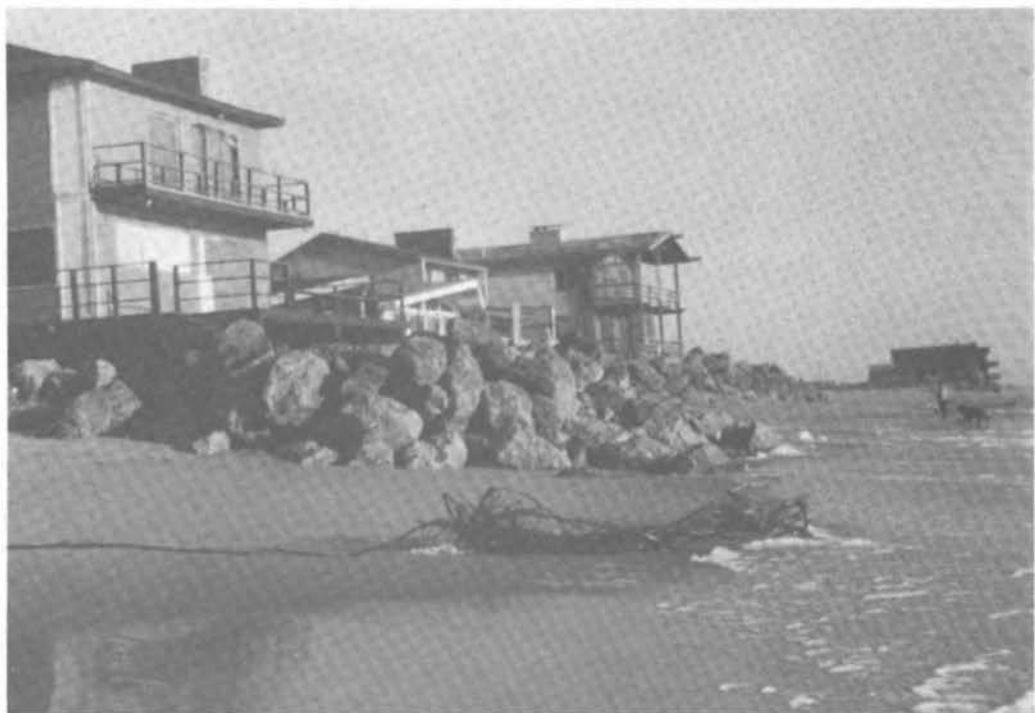
FIGURE 46 Dwellings in Oxnard Shores located on unstable shoreline.

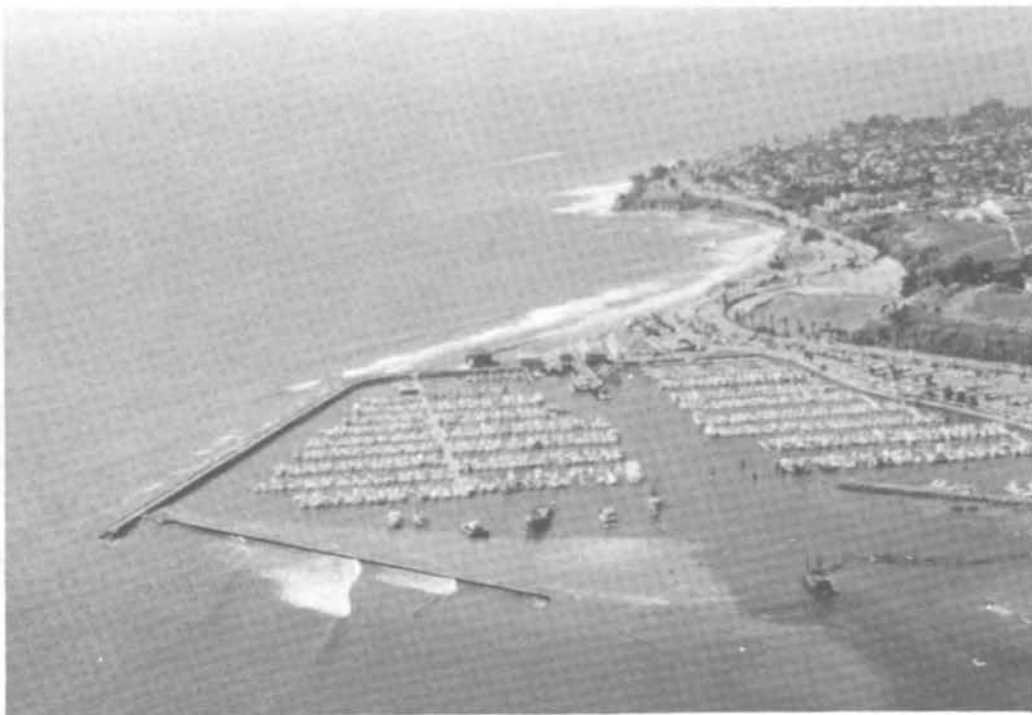
FIGURE 48 The Santa Barbara area. Note the degraded spit and beach areas compared with Figure 47.

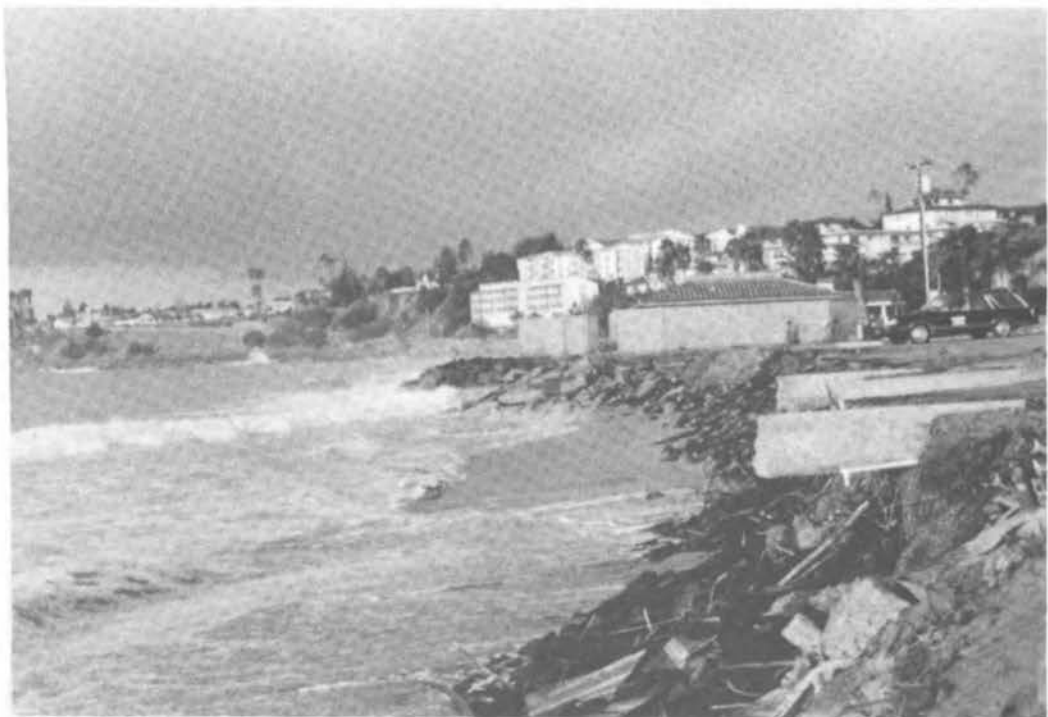
FIGURE 50 View west along eroded Leadbetter Beach.

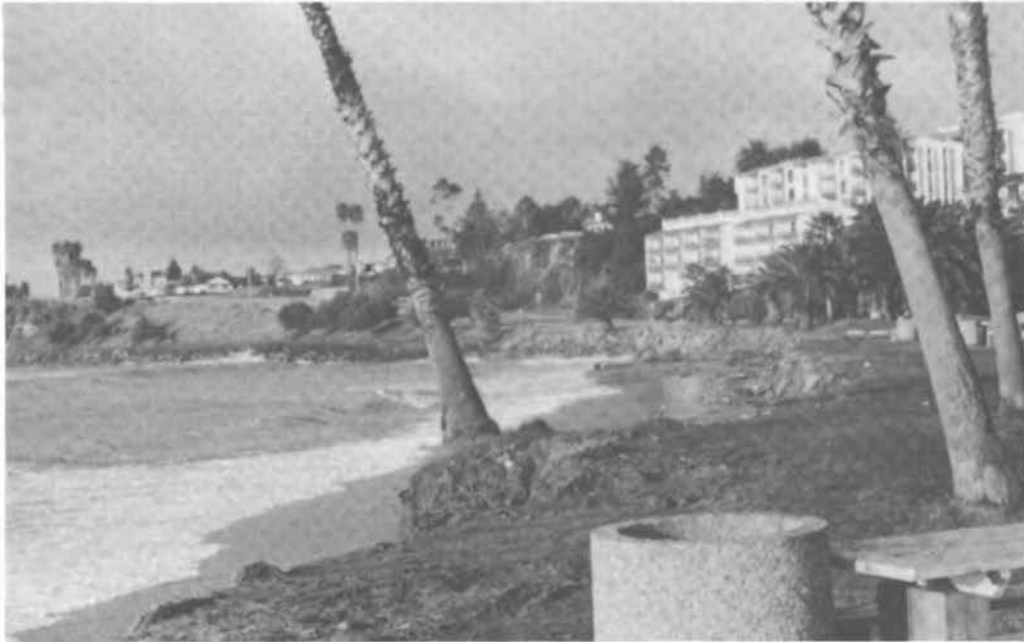
FIGURE 51 View west from west end of Leadbetter Beach. The beach and upland were substantially eroded, with the loss of a number of palm trees.

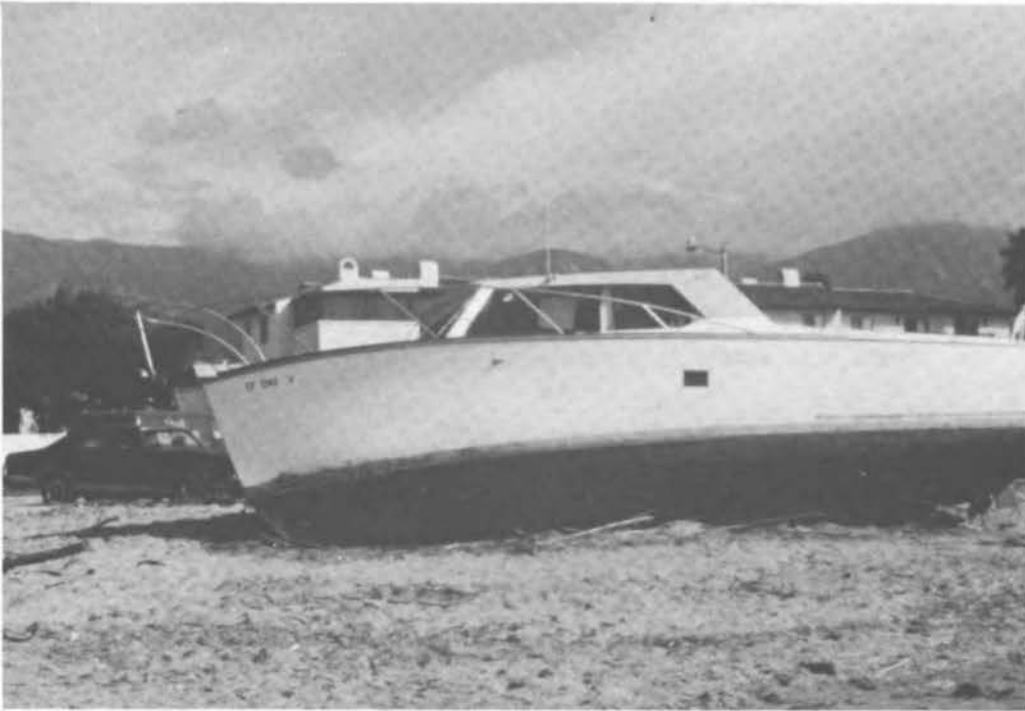
East Beach also experienced substantial erosion and undermining of vegetation. In addition, a number of small boats were beached by the storm, an example of which is shown in Figure 53.

FIGURE 53 Beached boat on East Beach.

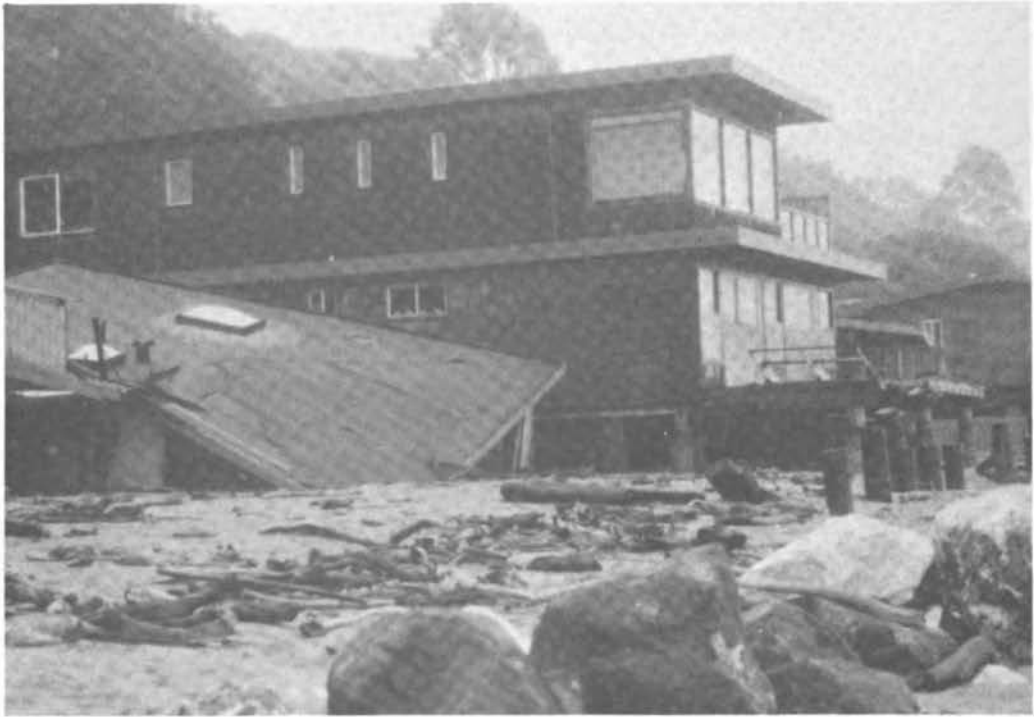
FIGURE 55 Destroyed home in Rio Del Mar Beach. Note the ineffective revetment fronting the structure.
