California Coastal Erosion and Storm Damage During the Winter of 1982-83

A Reconnaissance Report Prepared by:

Committee on Natural Disasters
Commission on Engineering and Technical Systems
National Research Council

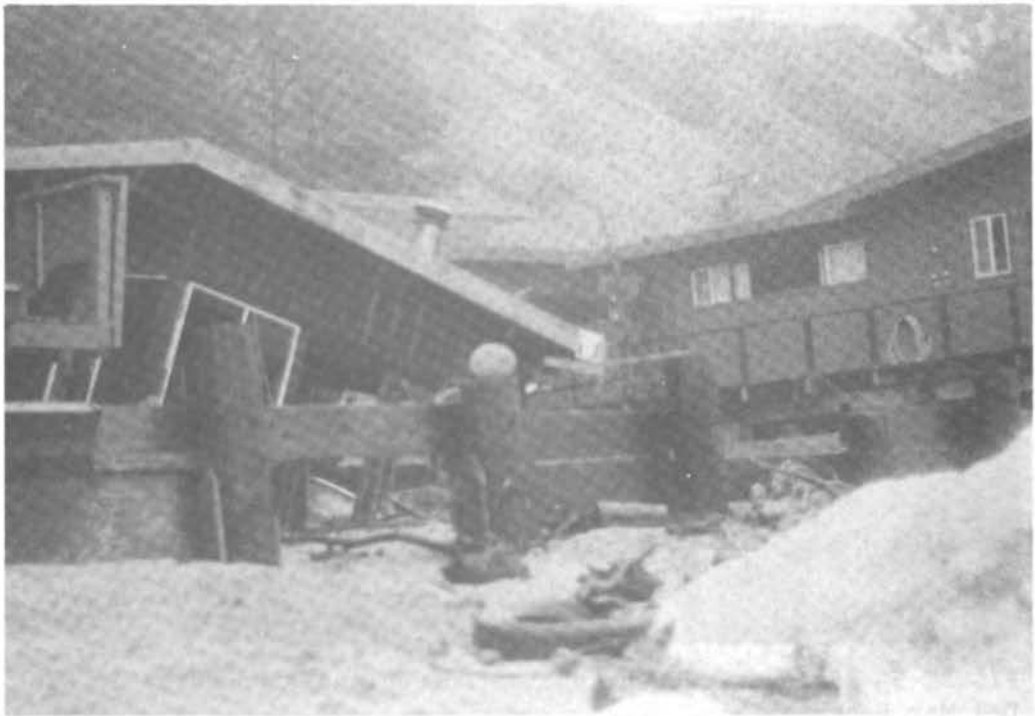
FIGURE 56 Destroyed home in Rio Del Mar Beach fronted by damaged wooden seawall.

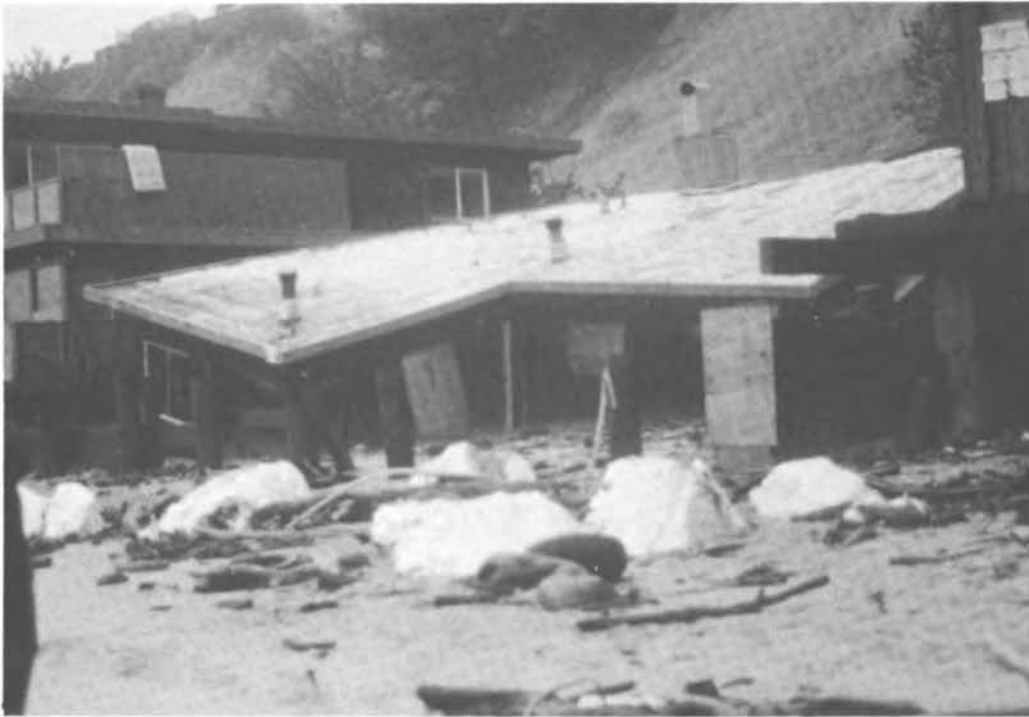
FIGURE 57 Destroyed home in Rio Del Mar Beach with remnants of a poorly designed revetment.

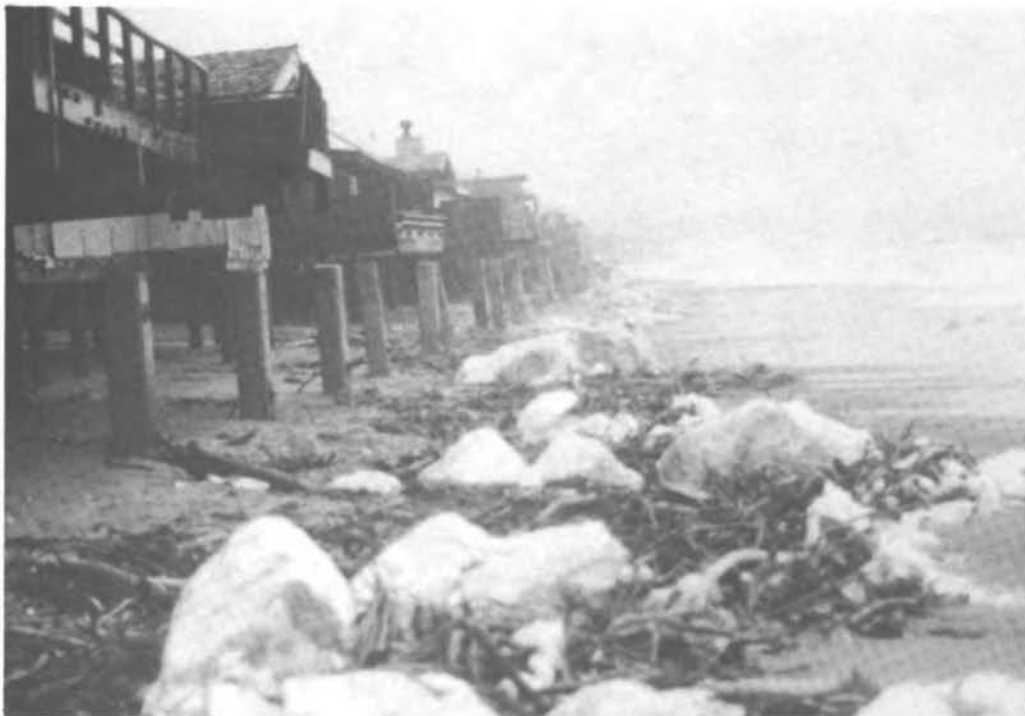
FIGURE 58 Fairly ineffective revetment in Rio Del Mar Beach lowered as a result of scour. The vertical erosion was approximately 2 m.

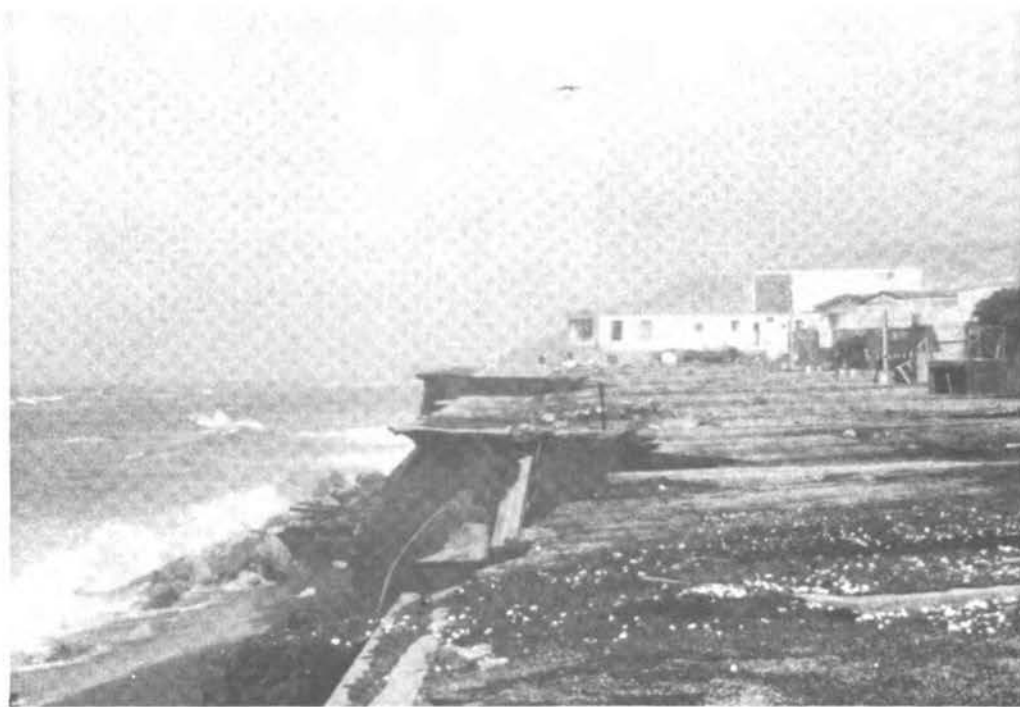
FIGURE 59 Severe erosion in Pacifica adjacent to trailer park.

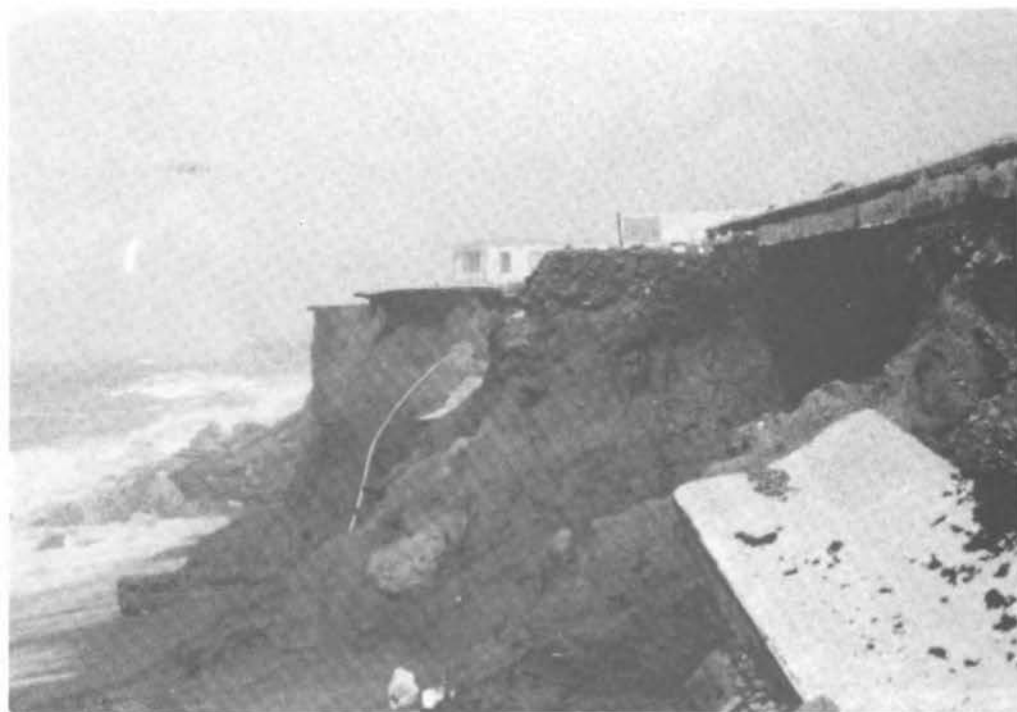
FIGURE 60 Vertical scarp of approximately 5 m in Pacifica.

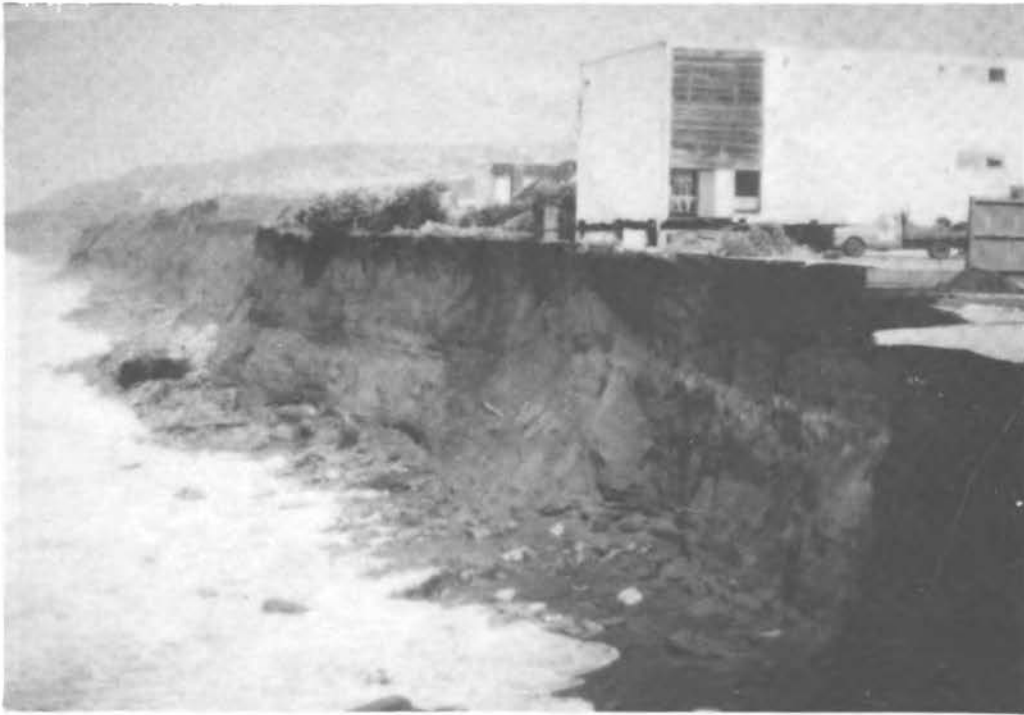
FIGURE 61 Masonic Lodge in Pacifica undercut by wave erosion. The scarp is approximately 10 m high.

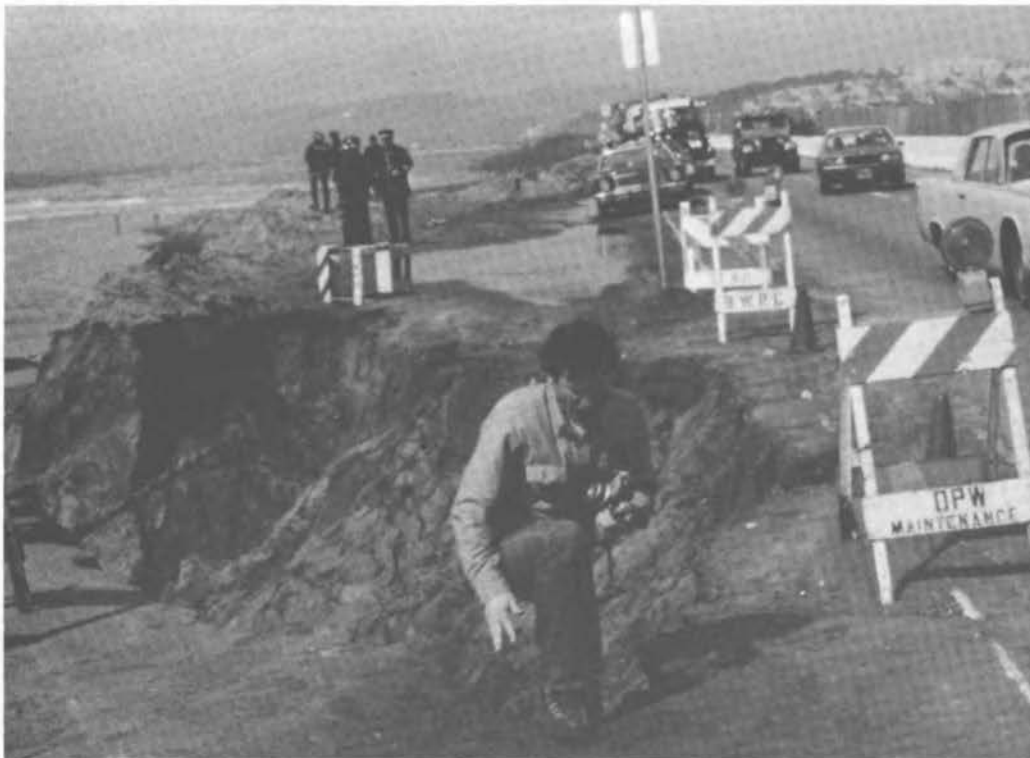
FIGURE 62 Beach erosion and road damage at Ocean Beach south of the entrance to San Francisco Bay.

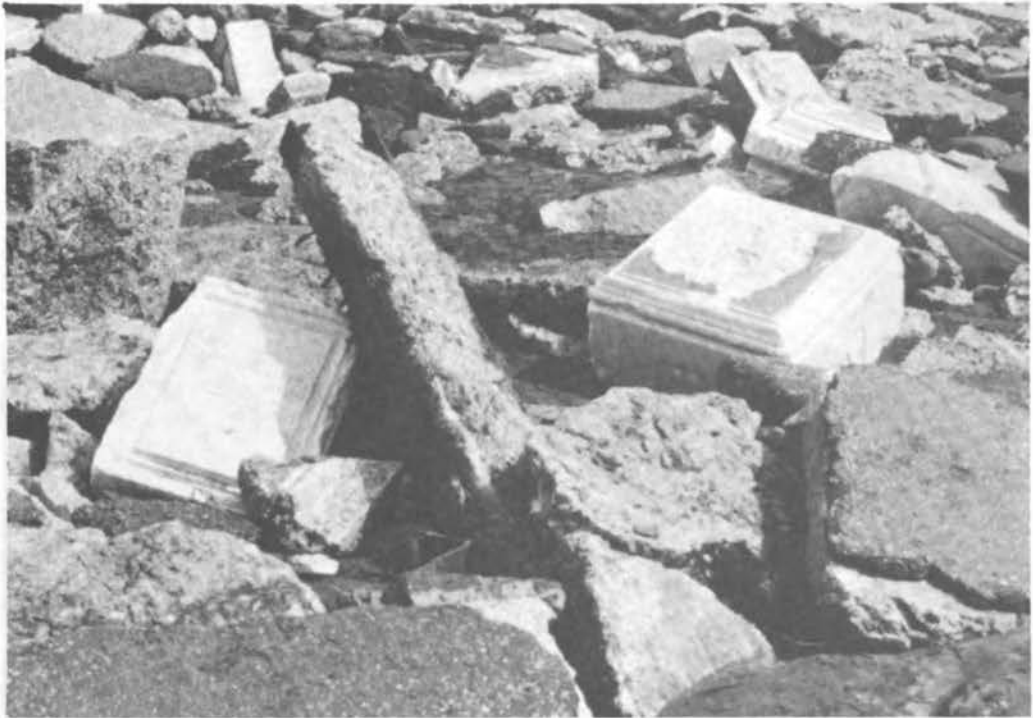
FIGURE 63 Makeshift revetment for road protection at Ocean Beach including headstones from cemetery.

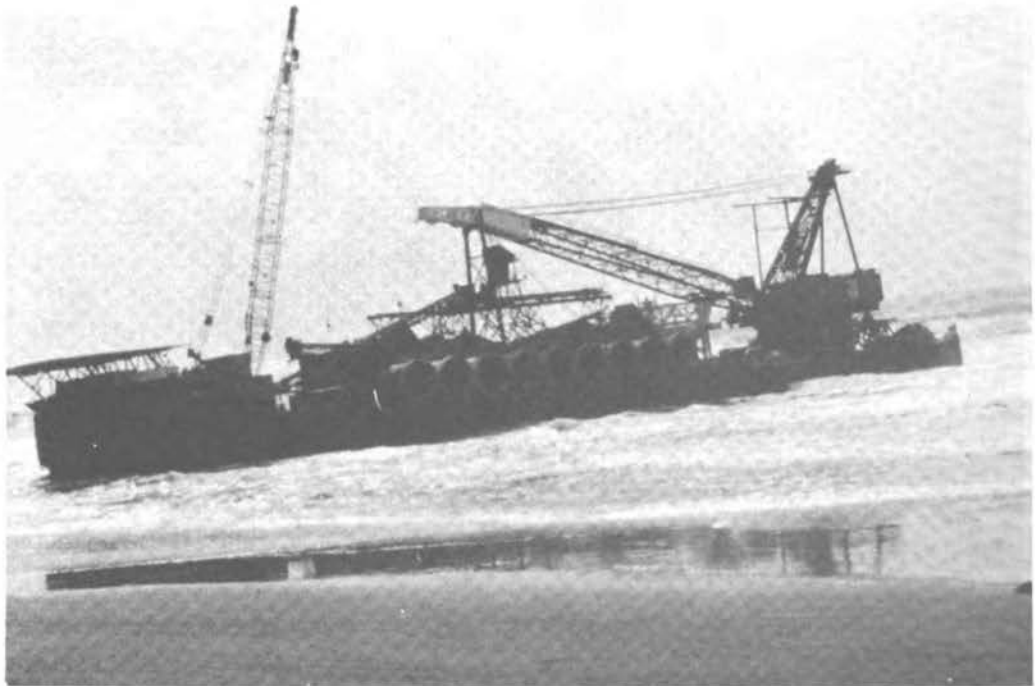
FIGURE 64 The stranded construction barge Betty L at Ocean Beach with efforts under way to free this casualty of the storm.

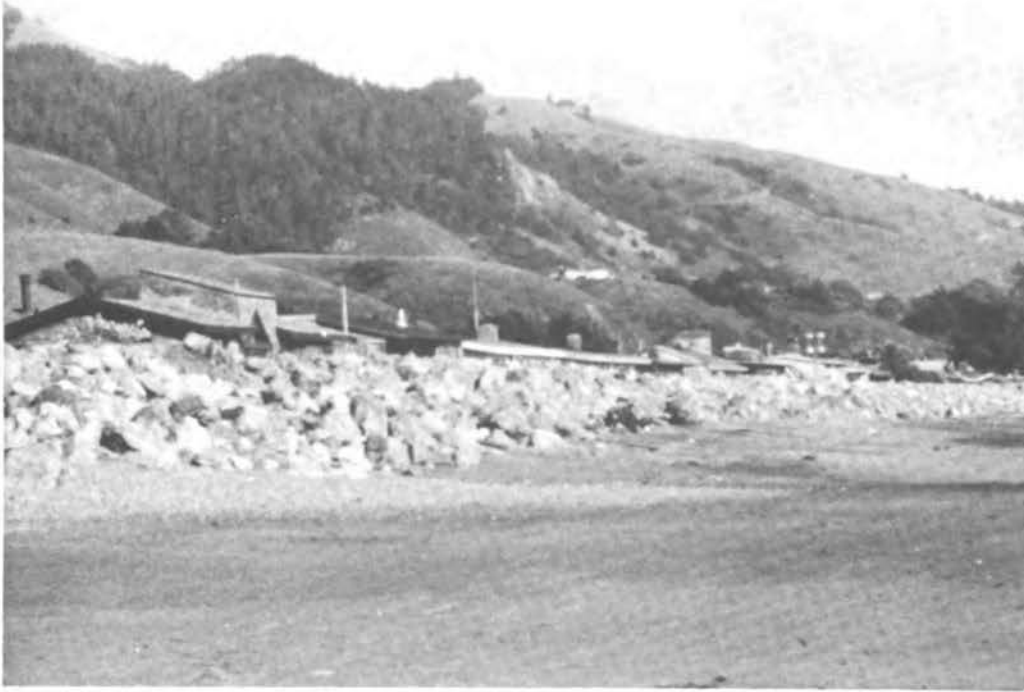
FIGURE 65 Substantial revetment in Stinson Beach to protect dwellings from erosion and waves.

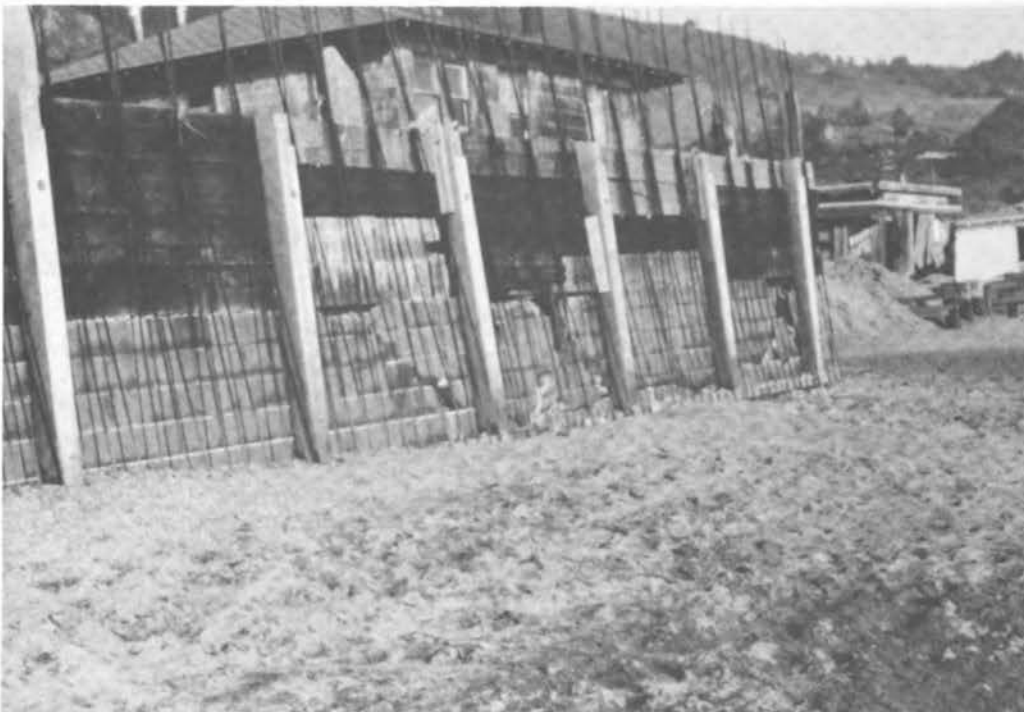
FIGURE 66 Reinforced concrete seawall in Stinson Beach being constructed.

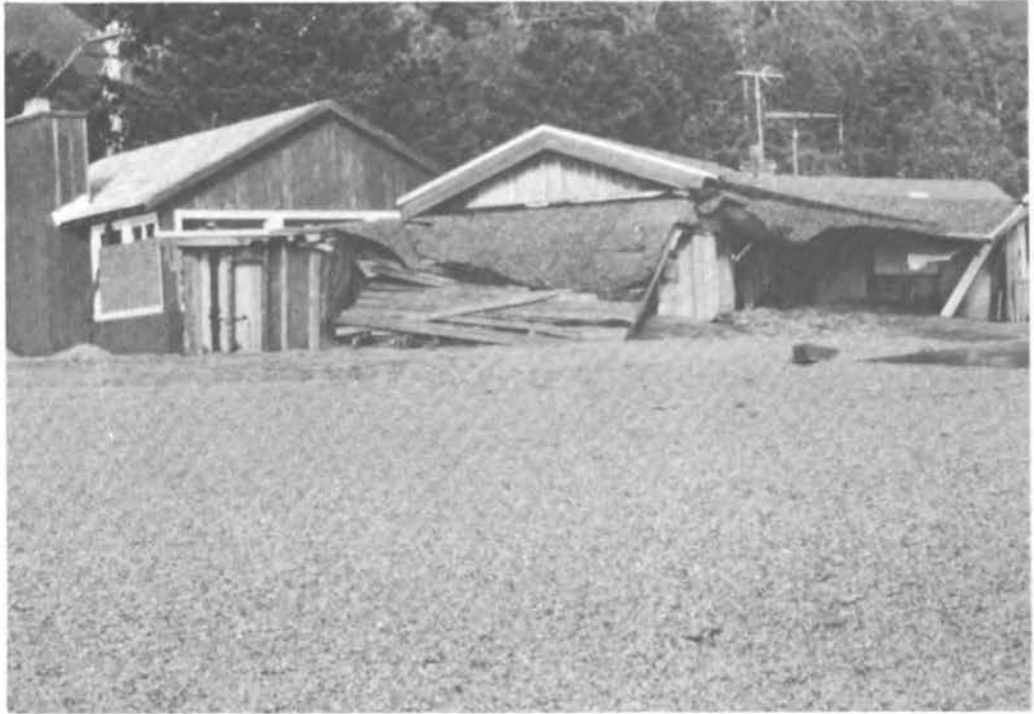
FIGURE 67 Structures in Stinson Beach damaged and destroyed from erosion undermining and direct action of waves.

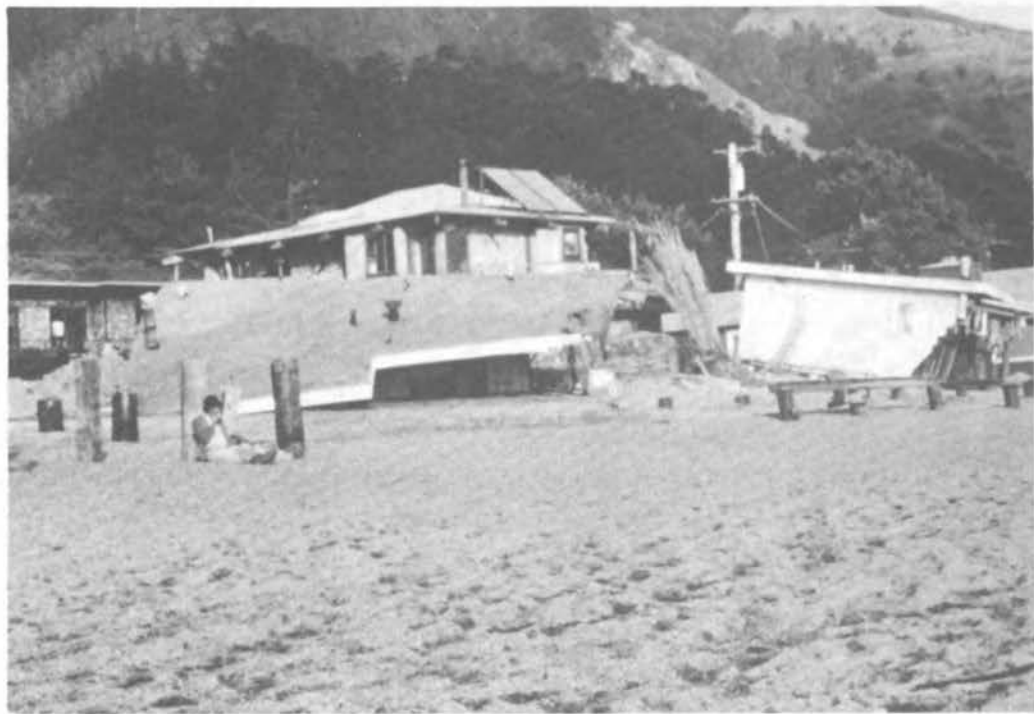
FIGURE 68 Dwellings damaged in Stinson Beach due to erosion undermining and direct action of waves.

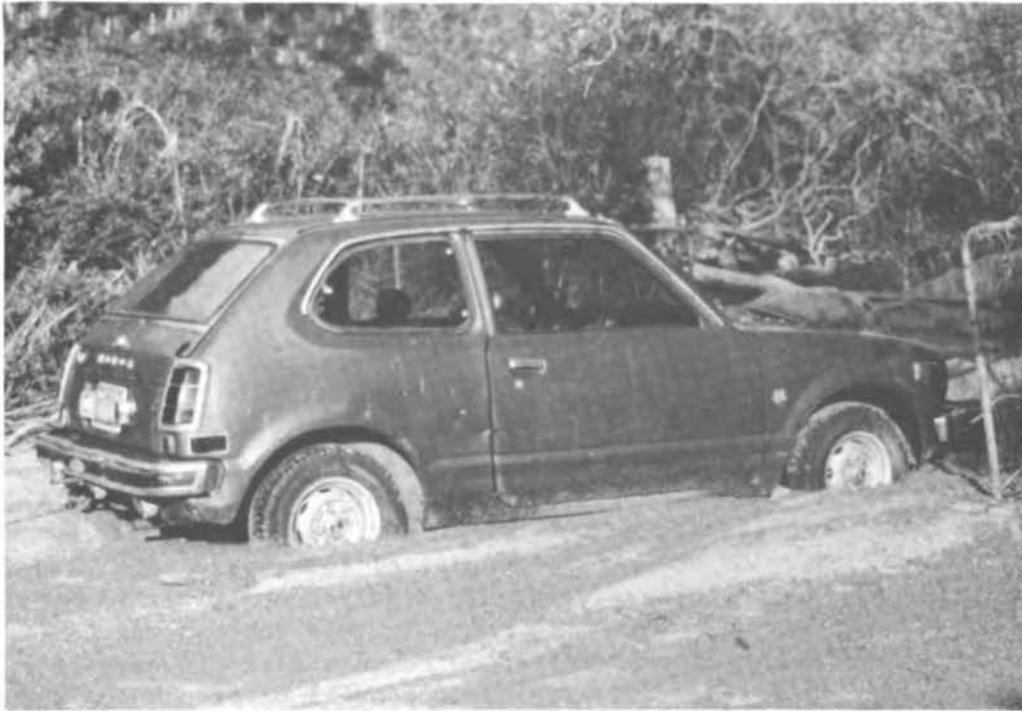
FIGURE 69 Overwash deposits of sand deposited approximately one block inland at Stinson Beach.

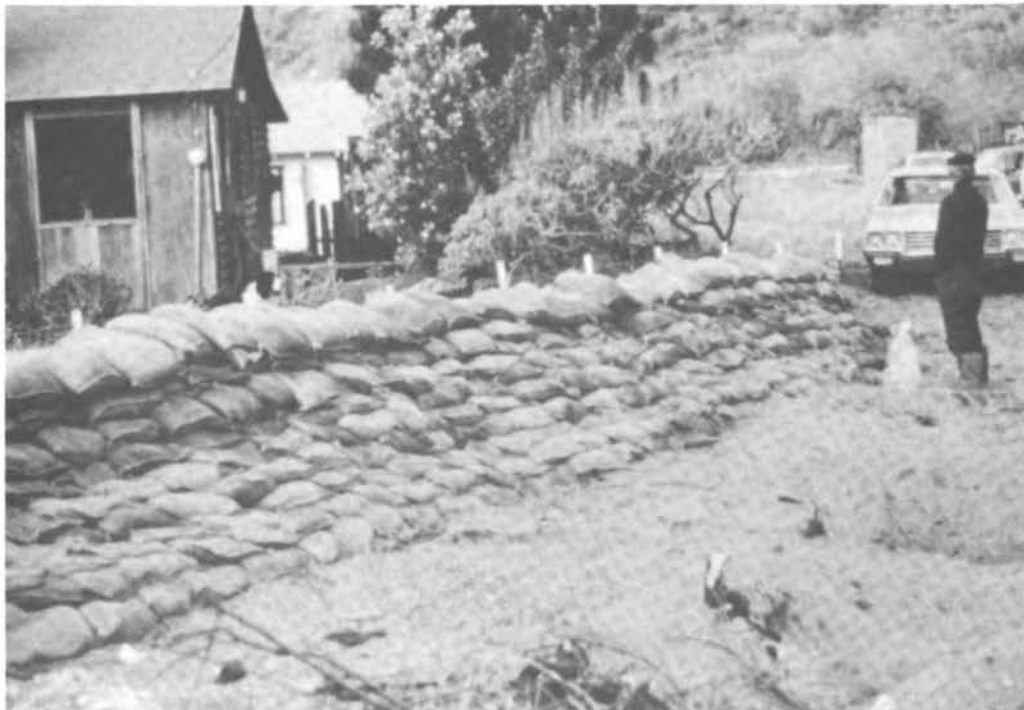
FIGURE 70 Sandbag barrier at Stinson Beach to prevent flooding from waves and sand deposition from overwash.

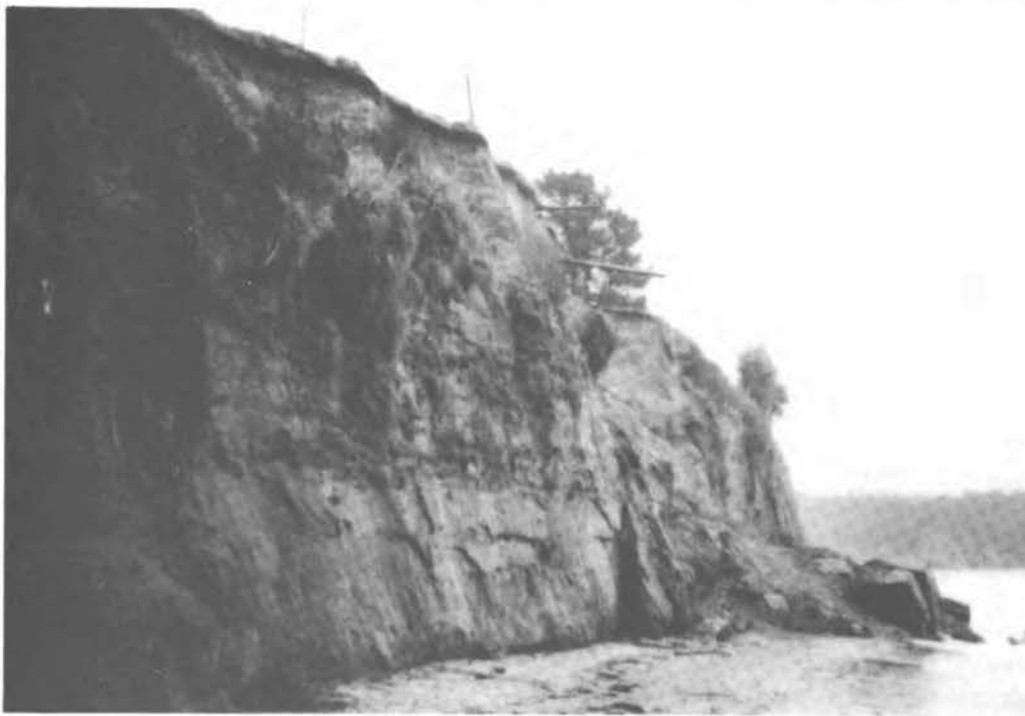
FIGURE 72 Failure of coastal cliff at Capitola.
