Building Damage in South Carolina Caused by the Tornadoes of March 28, 1984 (1985)

Building Damage in South Carolina Caused by the Tornadoes of March 28, 1984

**Peter R. Sparks, Department of Civil Engineering, Clemson University,
Clemson, South Carolina**

**Committee on Natural Disasters
Commission on Engineering and Technical Systems
National Research Council**

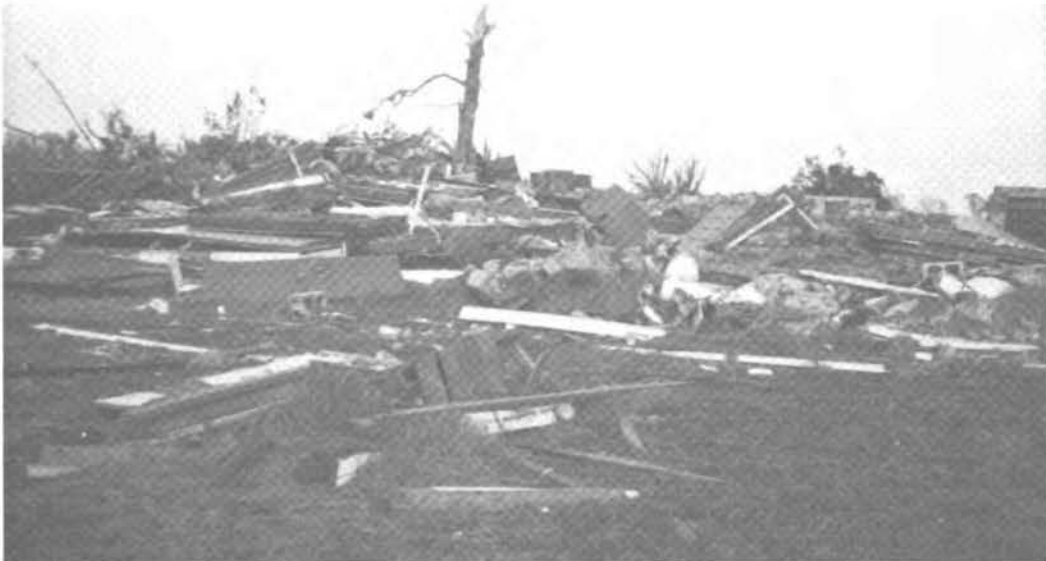
Examples were found of both masonry and framed construction in which the buildings had been completely destroyed, reduced either to a pile of rubble or widely scattered pieces of wood (Figures 2, 3, and 4).

FIGURE 2 Modern frame house in Winnsboro.

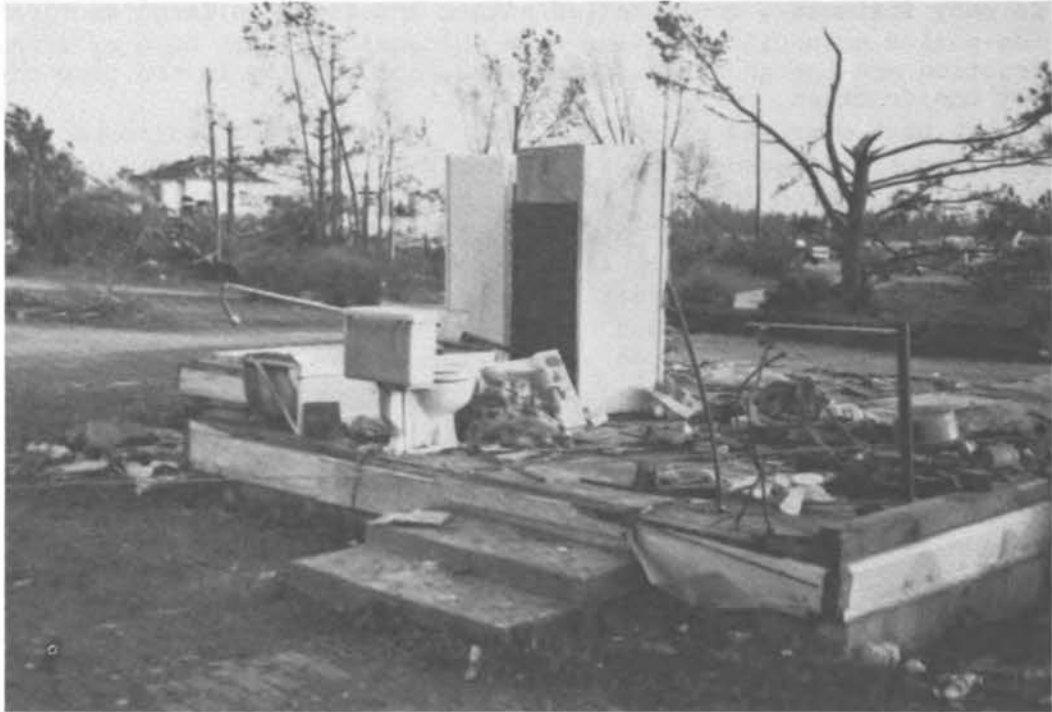
FIGURE 3 Older frame house in Winnsboro.

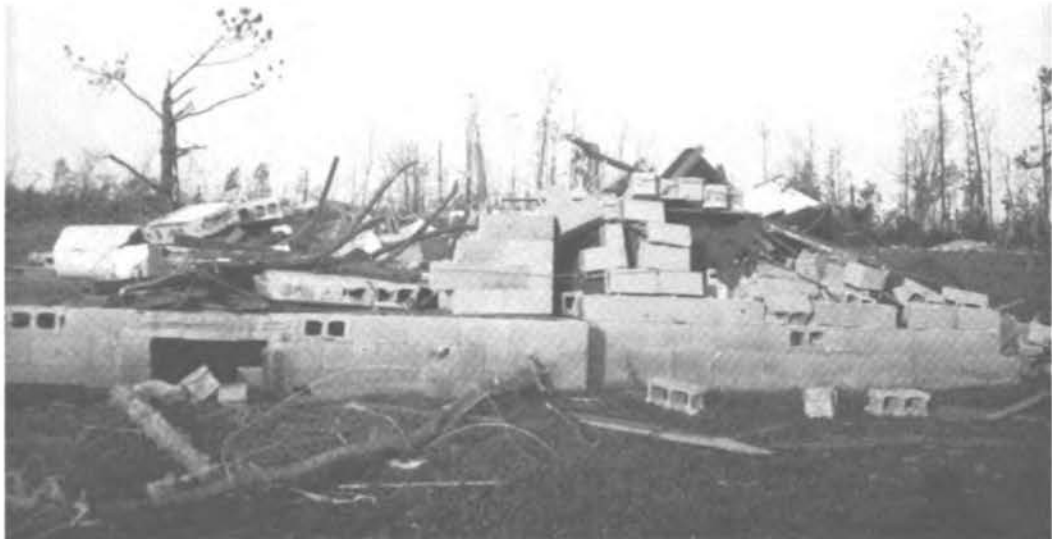
FIGURE 4 Masonry house in Winnsboro.

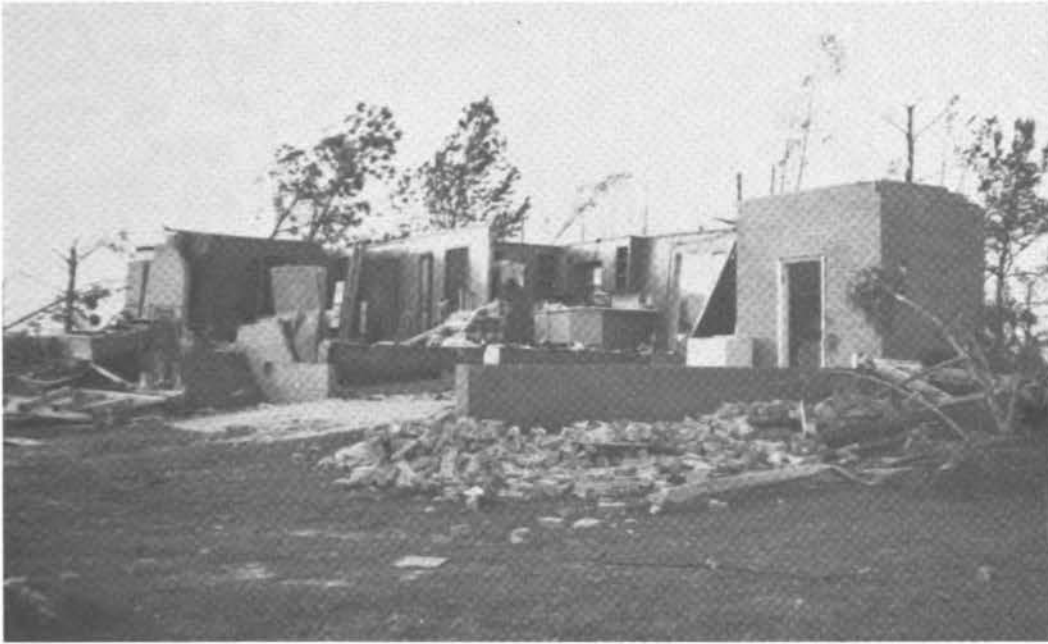
In better constructed single-story buildings of frame construction, the damage was often restricted to the loss of roofs, windows, and portions of exterior walls (Figure 5). Internal corridors often remained sufficiently intact to provide shelter for the occupants (Figure 6). In other instances, basements provided a safe refuge even though the house above was completely destroyed. In Winnsboro, one fatality occurred when an unreinforced masonry wall of a house collapsed on an occupant. The shelter of a bed was sufficient to ensure the survival of others in the building.

FIGURE 5 Modern frame house with brick siding in Winnsboro.

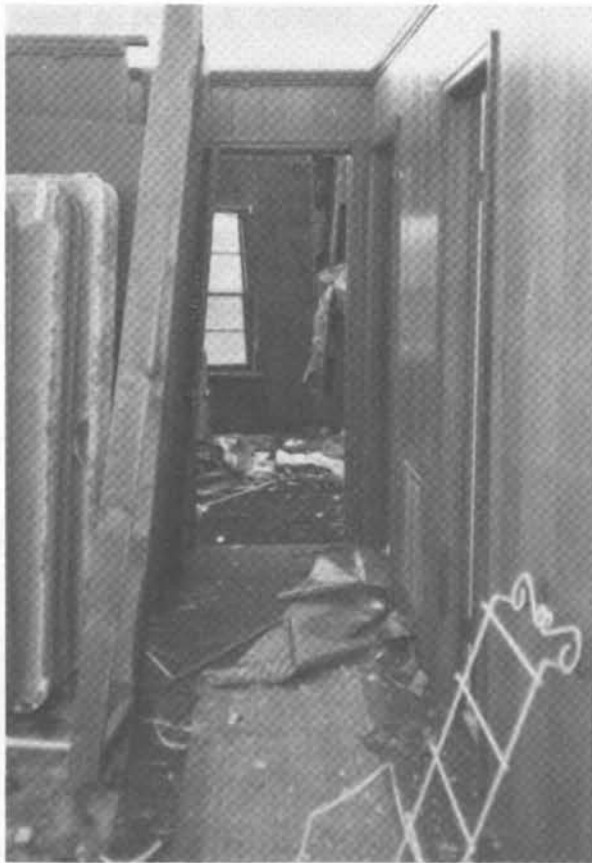
FIGURE 6 Detail of interior corridor.

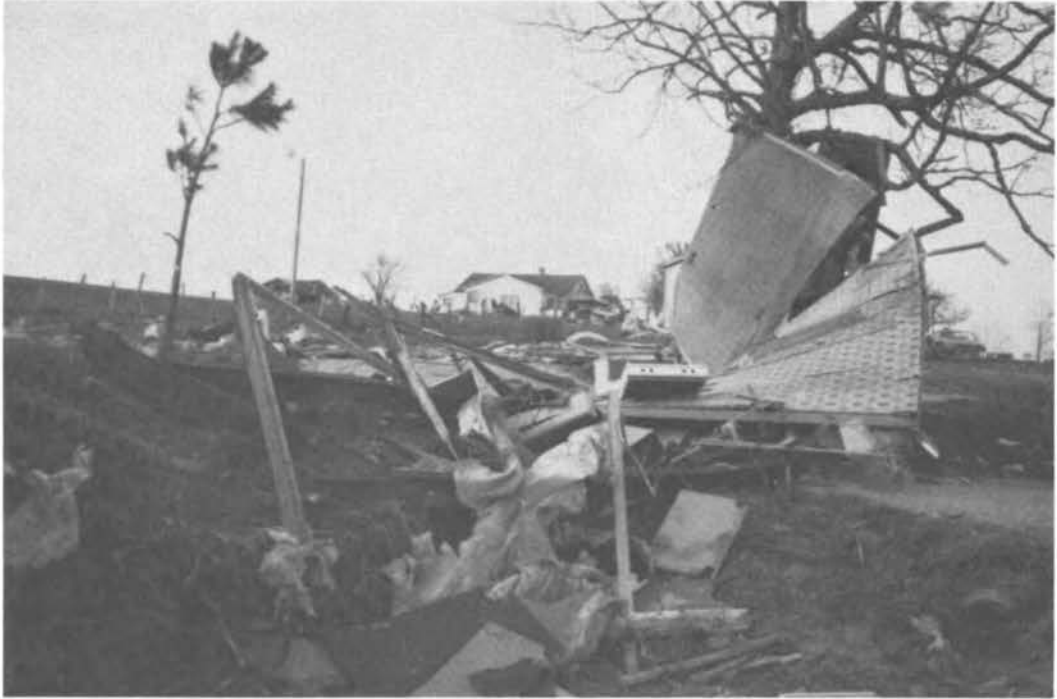
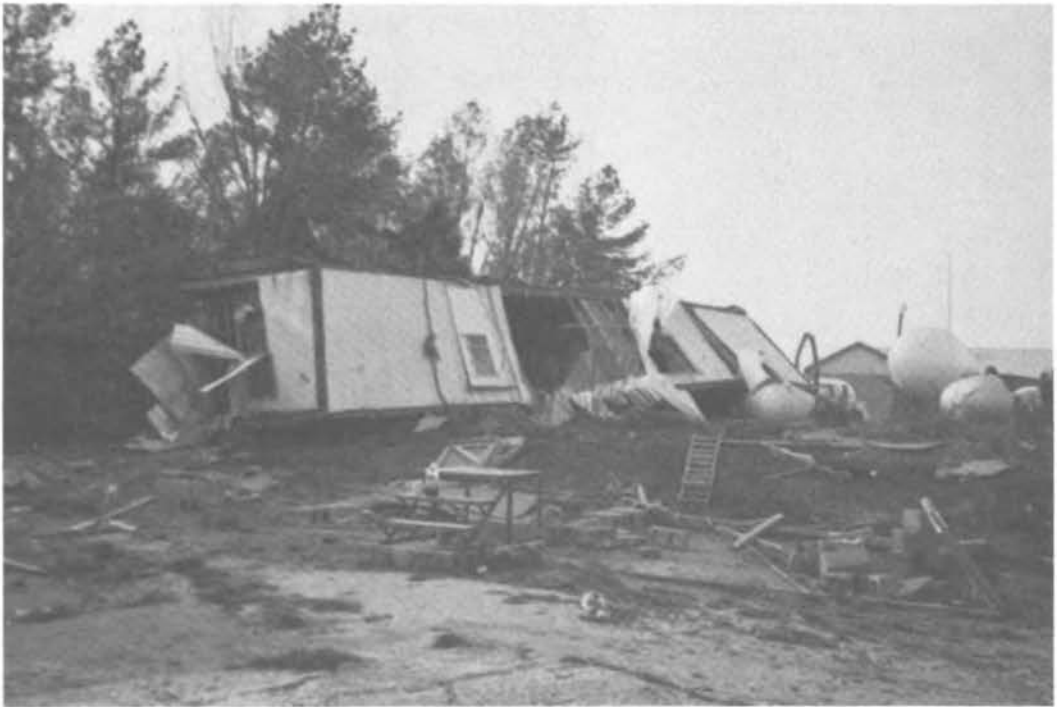
As has been observed many times before, mobile homes performed extremely poorly (Figures 7 and 8). Nearly 40 percent of all the deaths in the storm occurred in mobile homes. Most of the mobile homes damaged were not fitted with tie down straps. In some instances they were completely destroyed while adjacent buildings of conventional construction, albeit rather poor, were virtually undamaged.

FIGURE 7 Mobile home in Winnsboro.

FIGURE 8 Mobile home in Winnsboro.

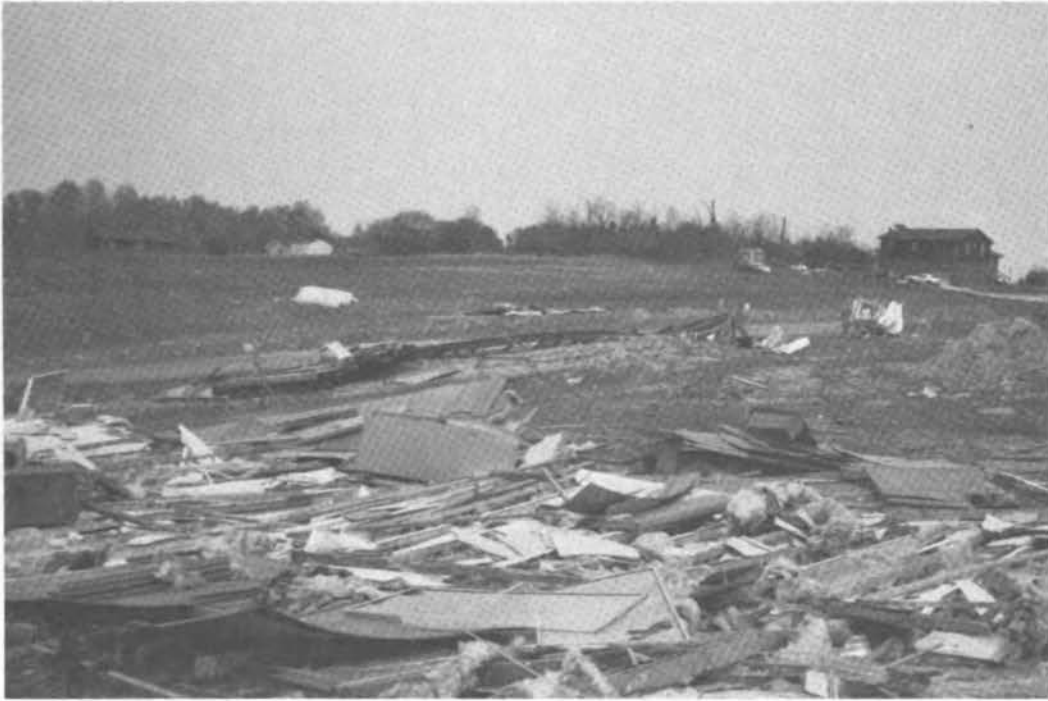
An isolated tornado touched down in Anderson County near the Georgia border and completely destroyed a mobile home that had been well tied down. In some places the ground anchors pulled out, but in other places the tie-down straps failed (Figures 9 and 10).

FIGURE 9 Mobile home in Anderson County.

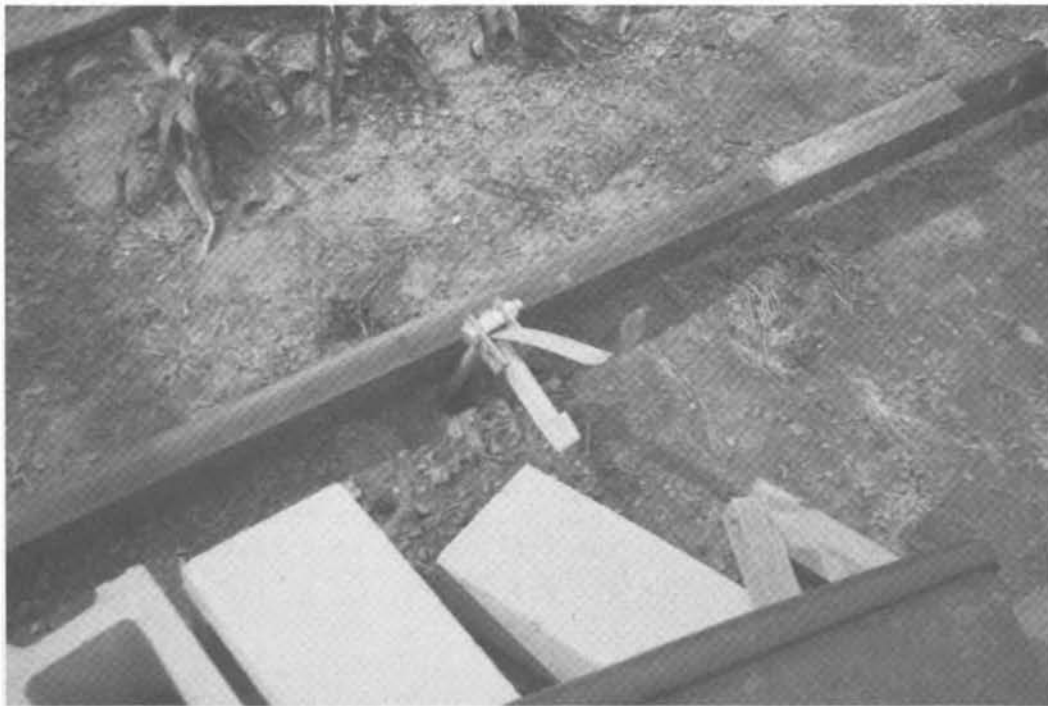
FIGURE 10 Failed tie-down strap.

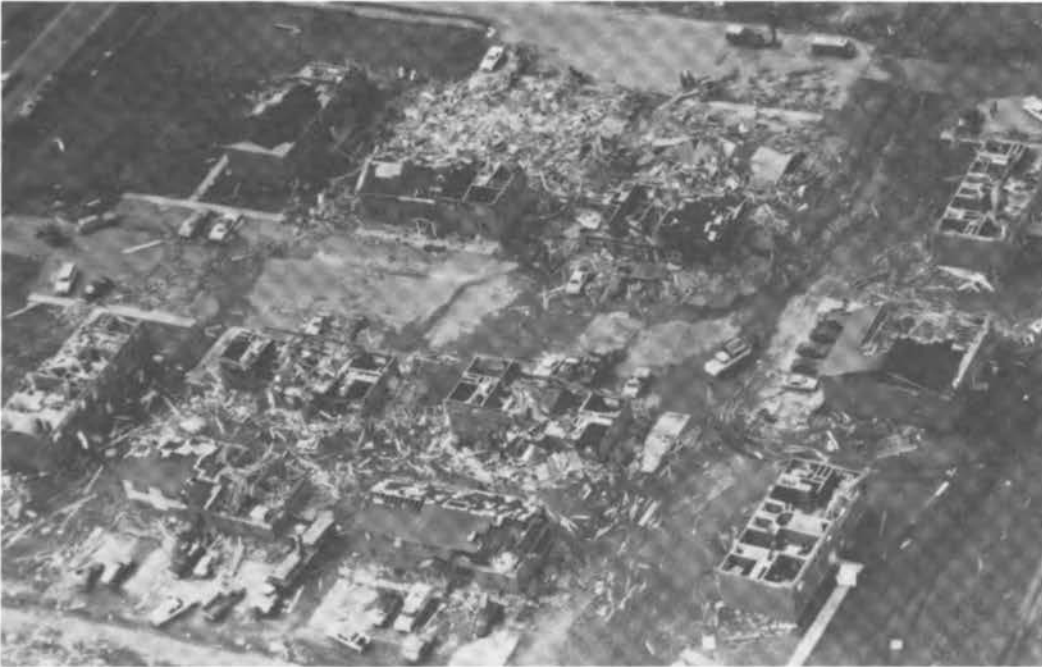
Two apartment complexes were hit by the Bennettsville tornado. Neither was more than two stories high, and their form of construction was essentially the same as that of a framed single-family dwelling. Damage ranged from almost complete collapse of a structure to localized roof damage. Figure 11 shows the more heavily damaged complex. Figures 12 and 13 show typical damage in an adjacent complex.

**FIGURE 11 Hillcrest apartments in Bennettsville.
(Photograph courtesy The State.)**

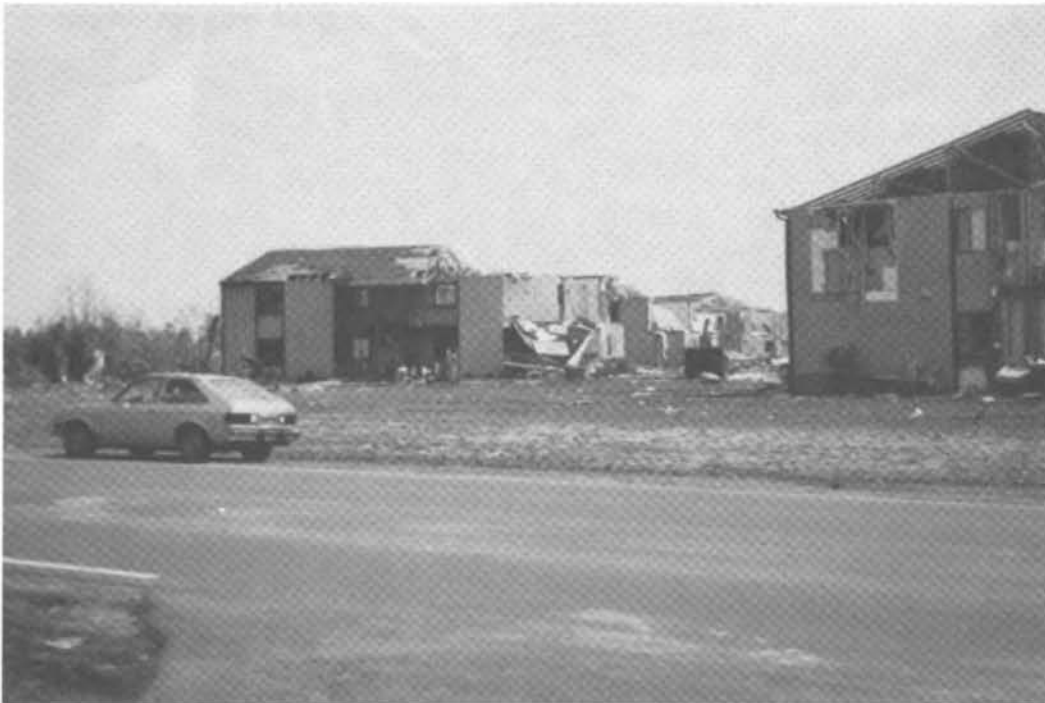
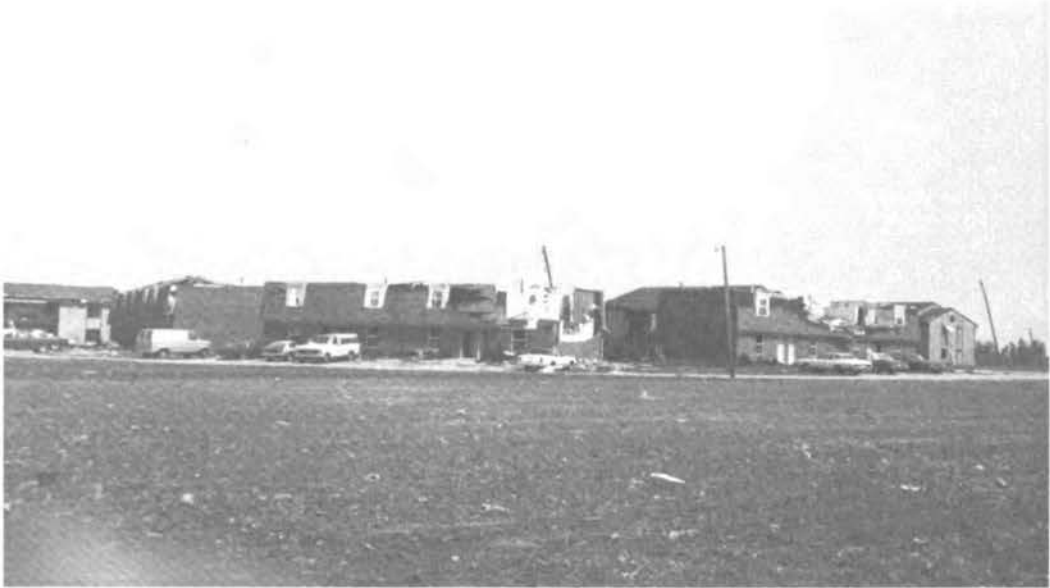
FIGURE 12 Marlboro Court Apartments in Bennettsville.

FIGURE 13 Marlboro Court Apartments in Bennettsville.

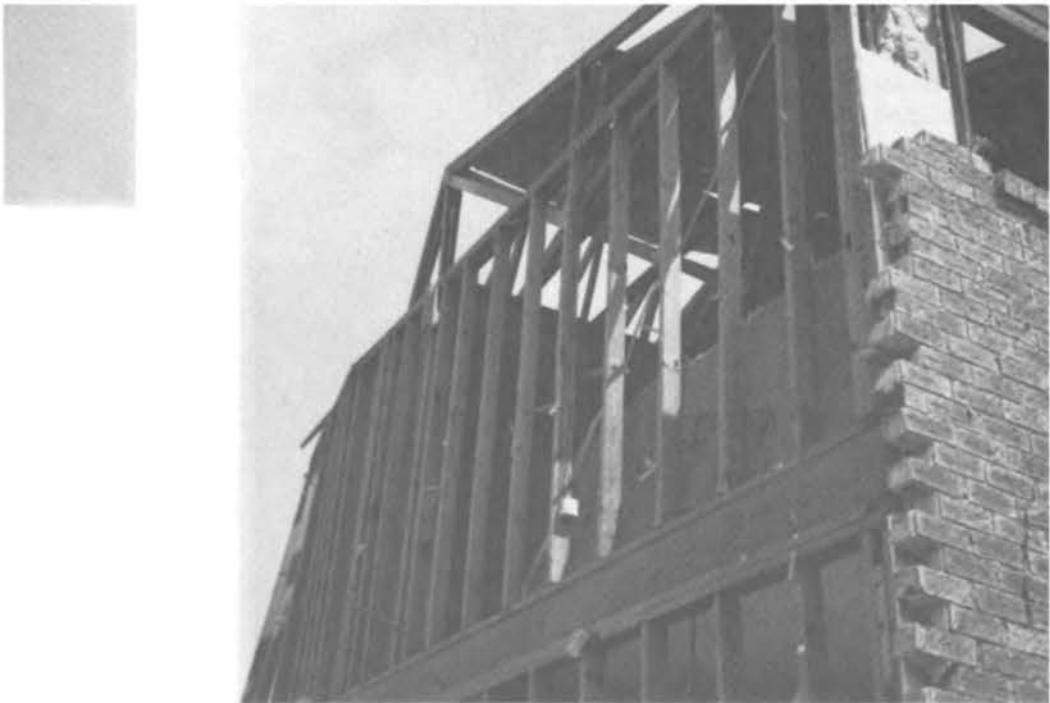
The more heavily damaged complex had brick veneer siding, which in some instances appeared to have been poorly tied to the framing (Figure 14). Corner bracing of plywood sheeting was provided in some buildings but was not continuous from floor to floor (Figure 15). In other buildings, diagonal ties were provided, with only styrofoam between the brick and the framing (Figure 16). Under the action of extreme winds, the brick veneer on the sides appeared to have been stripped from these buildings. Once that occurred, apart from the weight of the building, only the nails used to locate the framing, acting in withdrawal, were available to resist the overturning moment of the wind. In many instances this proved inadequate.

FIGURE 14 Detail of Hillcrest Apartments showing unused masonry ties.

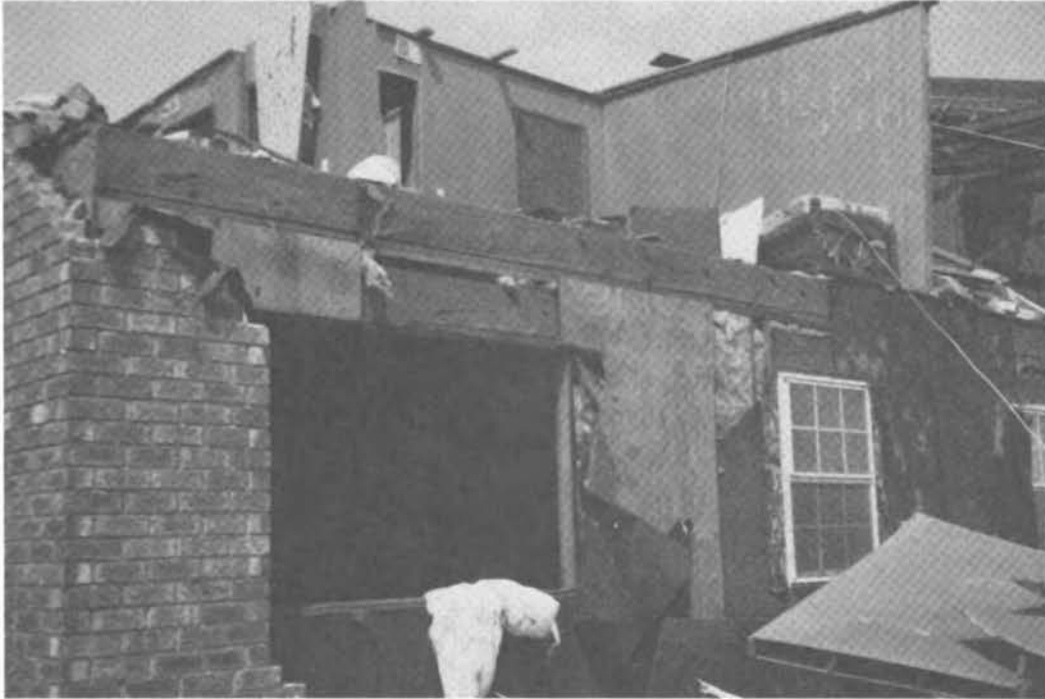
FIGURE 15 Detail of Hillcrest Apartments showing lack of continuity of plywood sheathing.

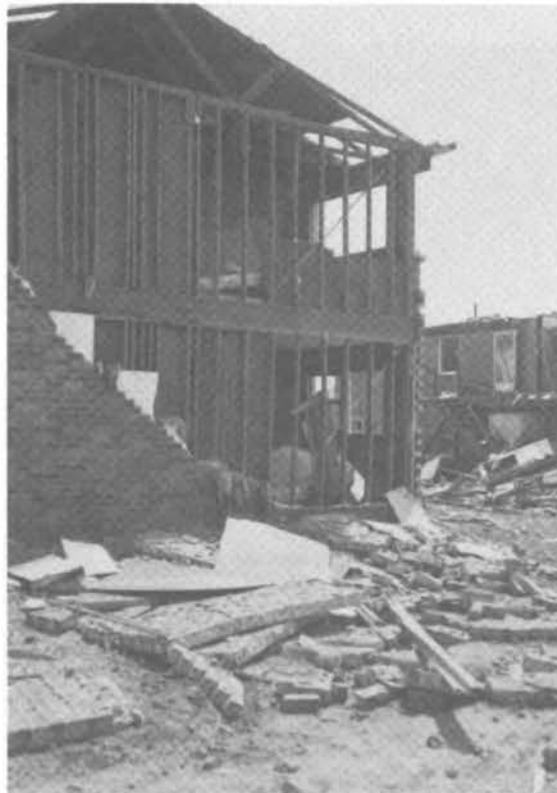
FIGURE 16 Detail of Hillcrest Apartments showing poor diagonal bracing.

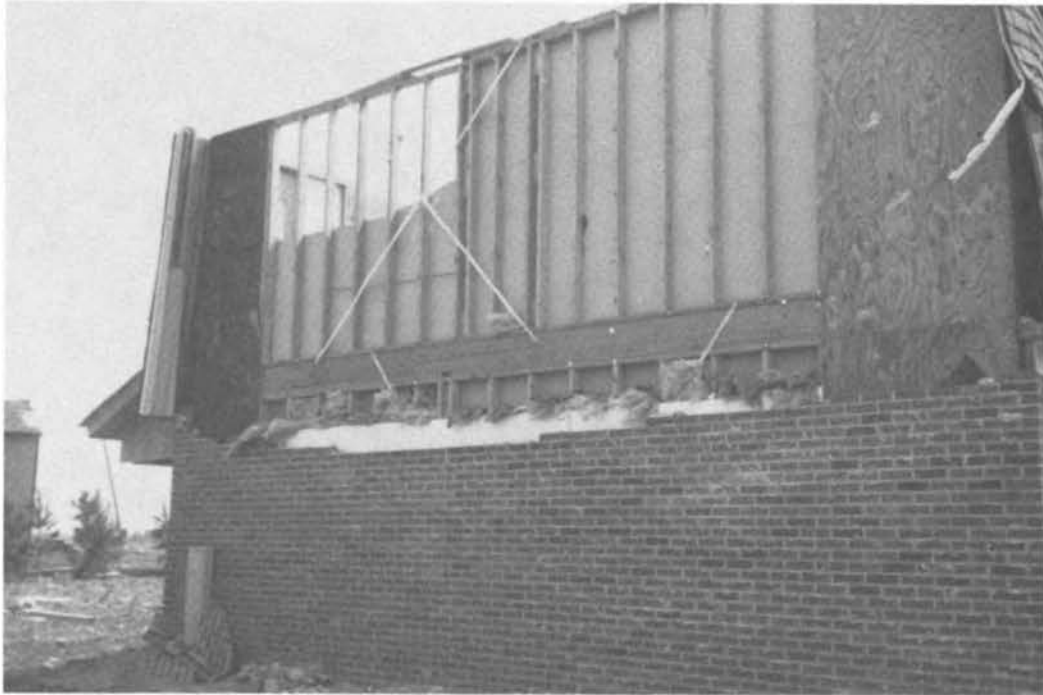
In the adjacent apartment complex, where damage was not as severe but where wind speeds may have been lower due to the path of the tornado, an example of better bracing was discovered. Here the metal ties and plywood overlapped at the corners (Figure 17). Exterior wood siding also appeared to have provided some continuity (Figure 18). The single-story rental office of the complex revealed, however, that, although the bottom plate of the frame had been bolted to the foundation, the rest of the framing had been inadequately attached to that plate (Figure 19). This building was carried away by the wind.

FIGURE 17 Detail of Marlboro Court Apartments showing better bracing.

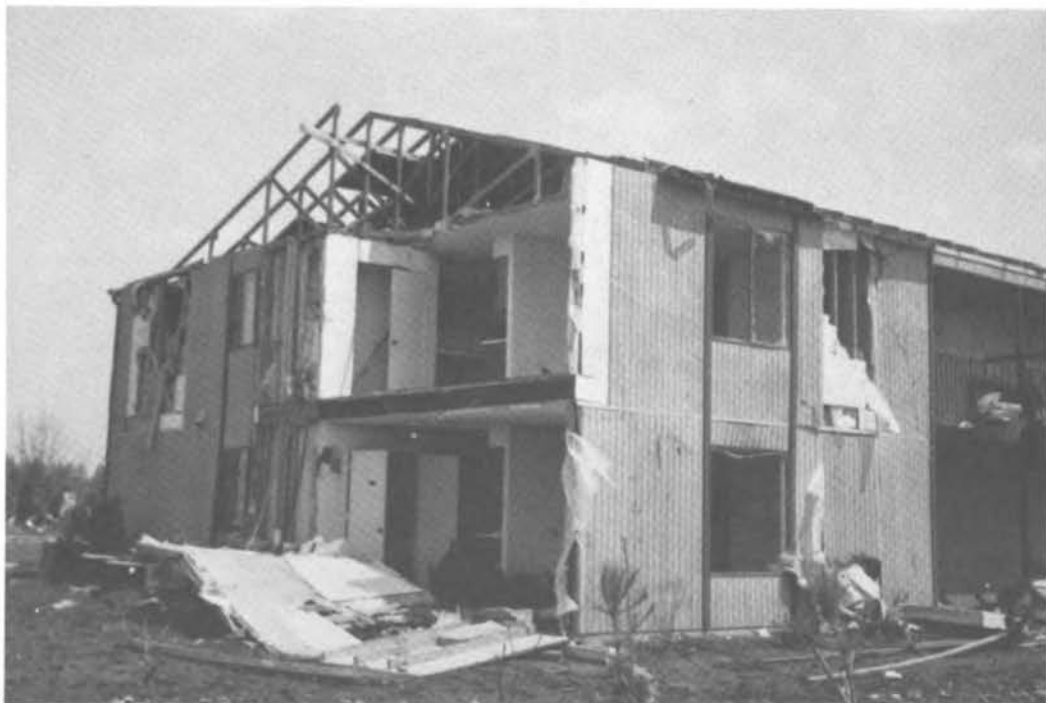
FIGURE 18 Detail of Marlboro Court Apartments showing continuity provided by wood siding.

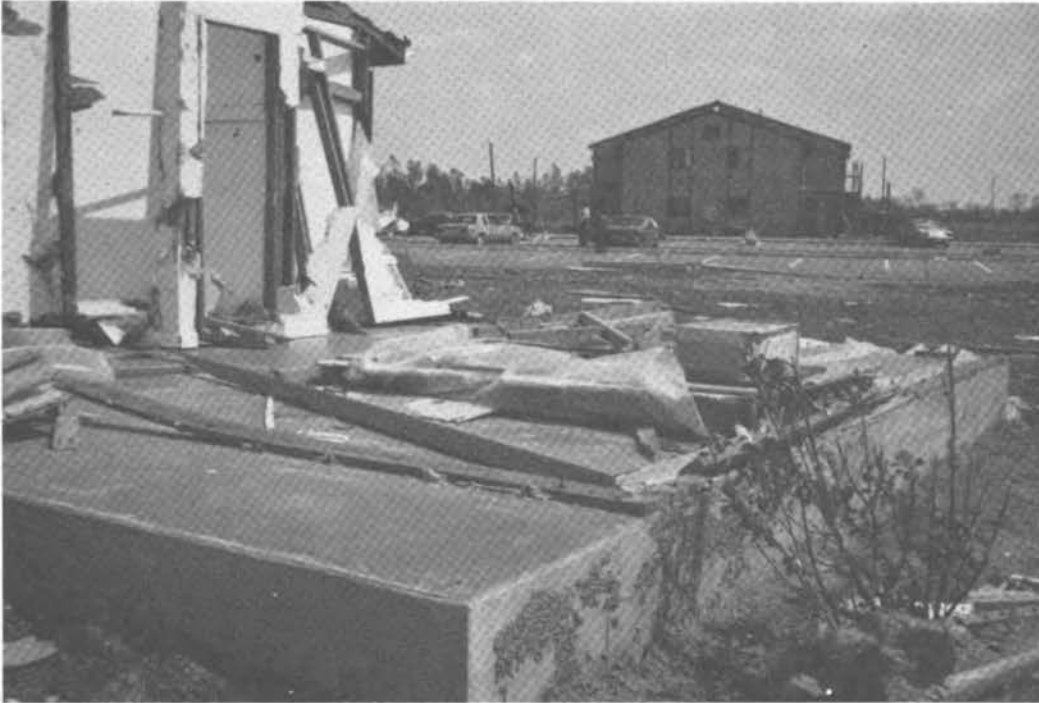
FIGURE 19 Rental office of Marlboro Court Apartments.

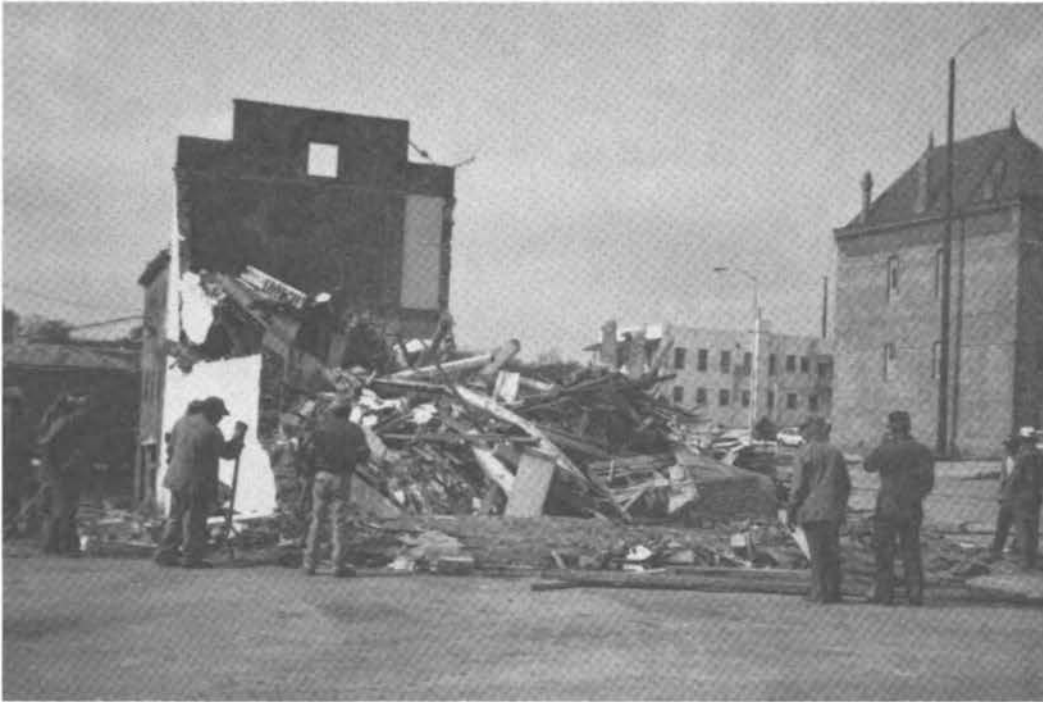
A dance academy housed in an old brick building in Newberry collapsed entirely (Figure 20). Fortunately, the occupants sought shelter under a stairway and survived with minor injuries. A short distance away an auto parts store consisting of 18-ft-high hollow masonry walls faced with brick and supporting heavy steel roof trusses collapsed, killing the manager. Figure 21 shows the structural arrangement after the debris had been cleared. Also in Newberry, St. Luke's Episcopal Church, which is listed in the register of historic monuments, suffered severe roof damage and the collapse of one load-bearing masonry wall.

FIGURE 20 Dance academy in Newberry.

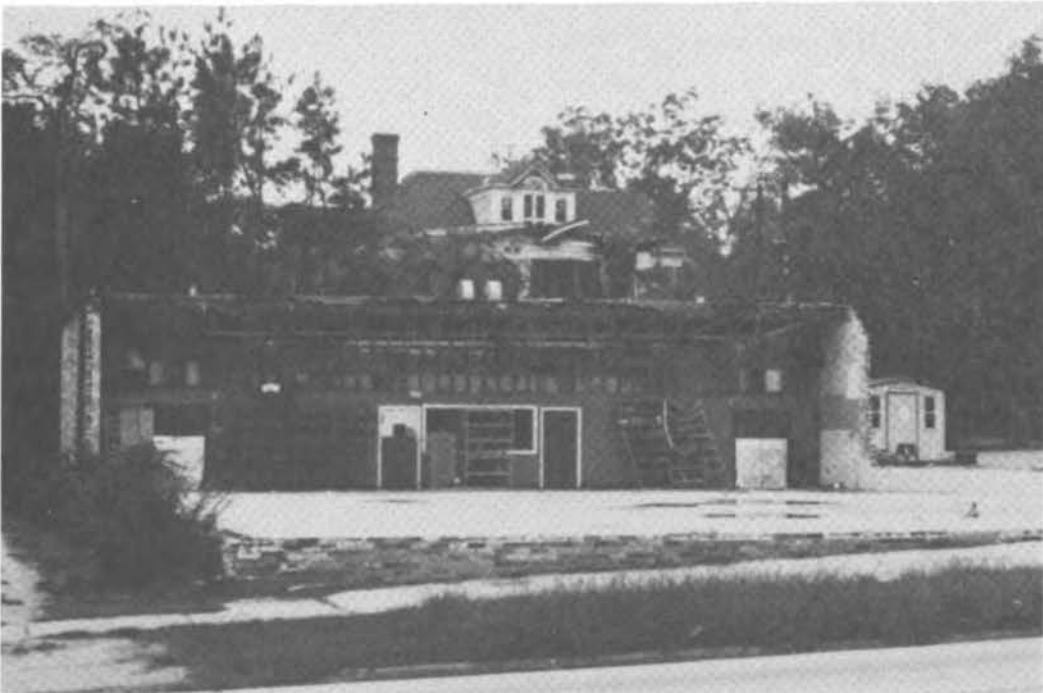
FIGURE 21 Auto parts store in Newberry.

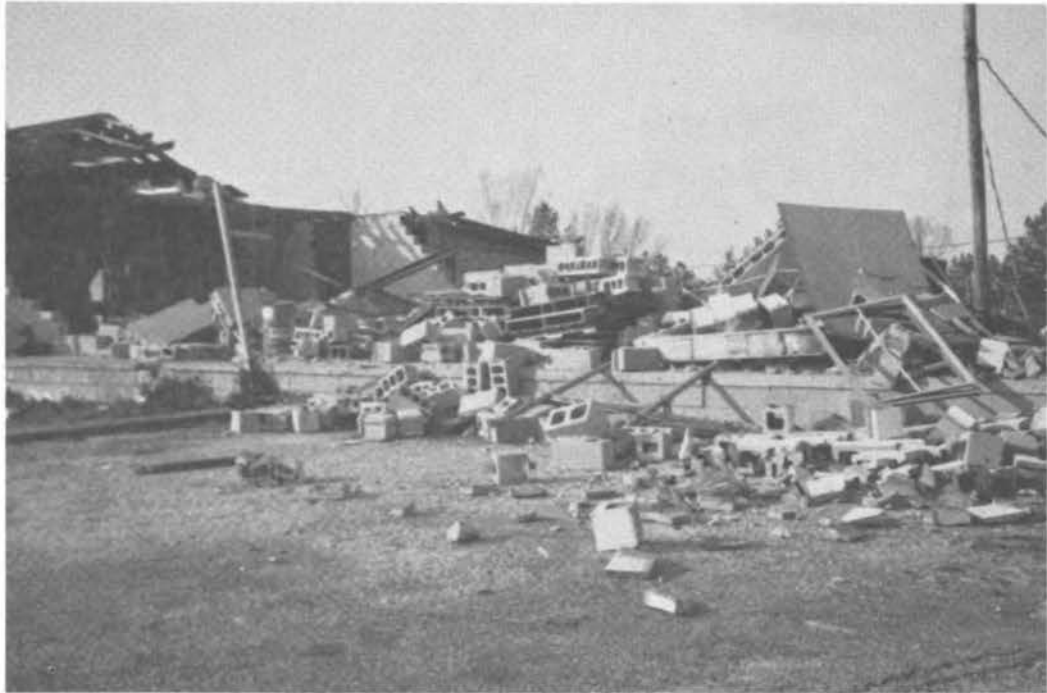
In Winnsboro a number of retail stores and workshops made of unreinforced load-bearing concrete masonry units either collapsed entirely or suffered severe damage. An example is shown in Figure 22. One wing of a private school, the Richard Winn Academy, of similar construction also suffered severe damage, mostly from the wind but possibly also from school buses reportedly seen flying through the air during the tornado. The construction of this part of the school followed the normal practice of using unreinforced walls and short roof anchors. Had the tornado struck earlier, or had after-school activities not been canceled due to the bad weather, serious injury and loss of life might have resulted. There was no safe refuge area in this section of the school, and a lightweight annex building was completely carried away (Figures 23, 24, and 25).

FIGURE 22 Masonry retail store in Winnsboro.

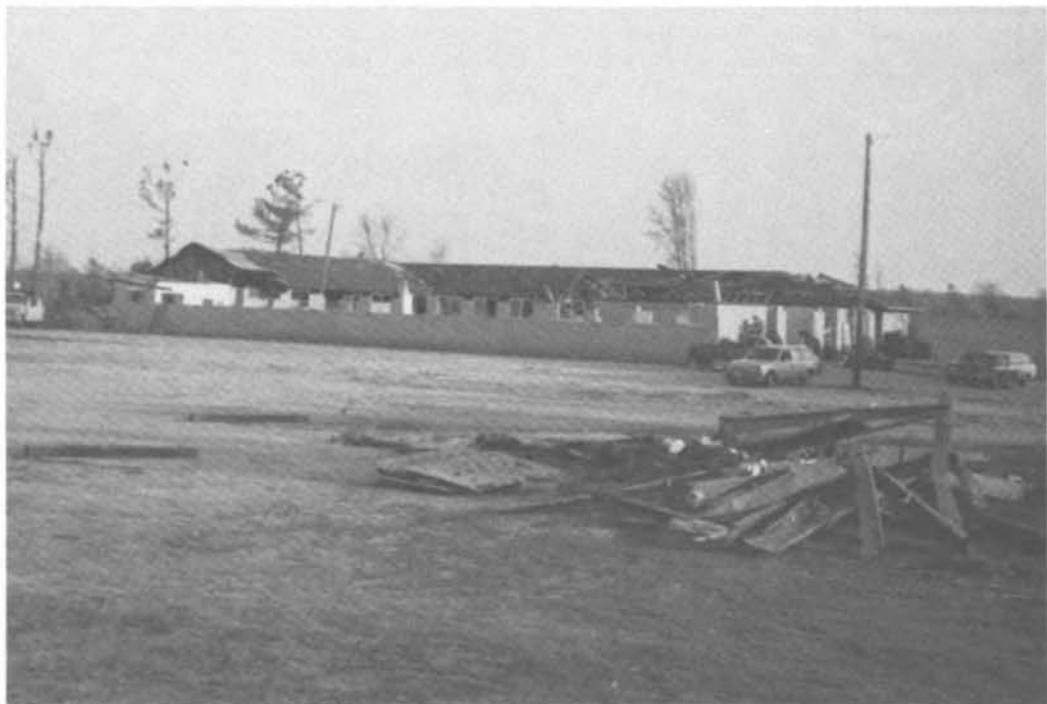
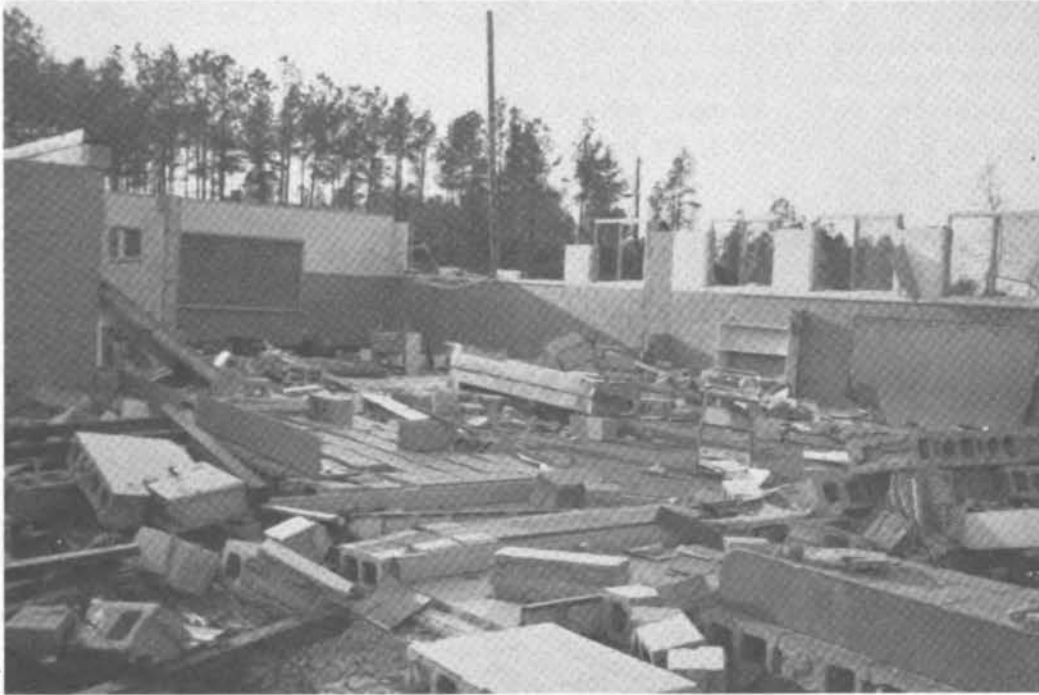
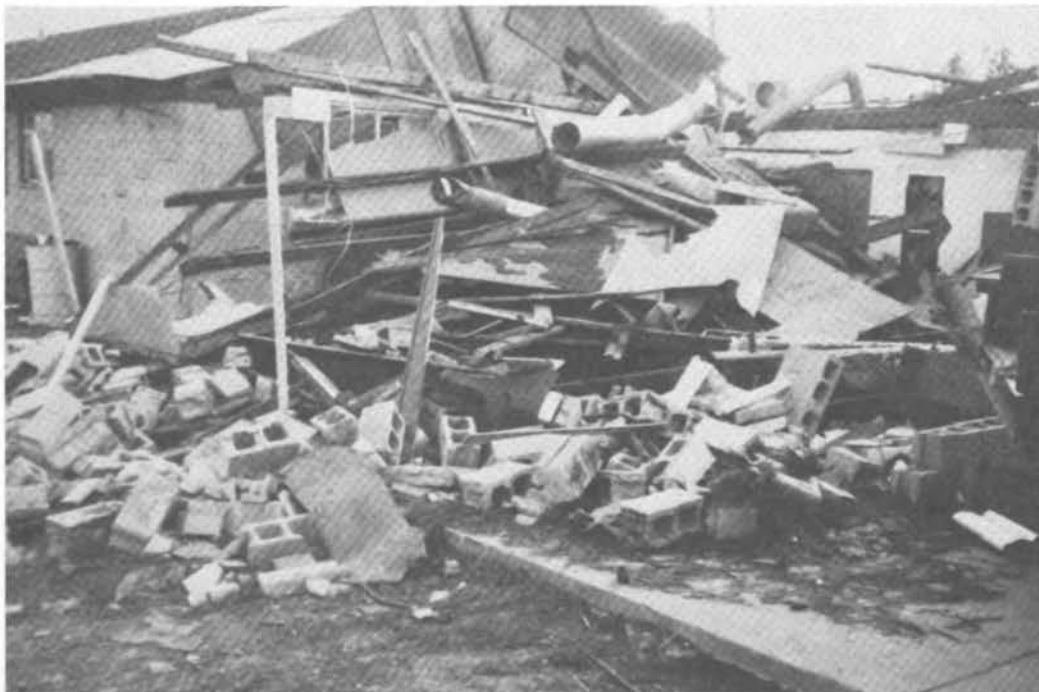
FIGURE 23 Richard Winn Academy in Winnsboro.

FIGURE 24 Classroom at Richard Winn Academy.

FIGURE 25 Classroom at Richard Winn Academy.

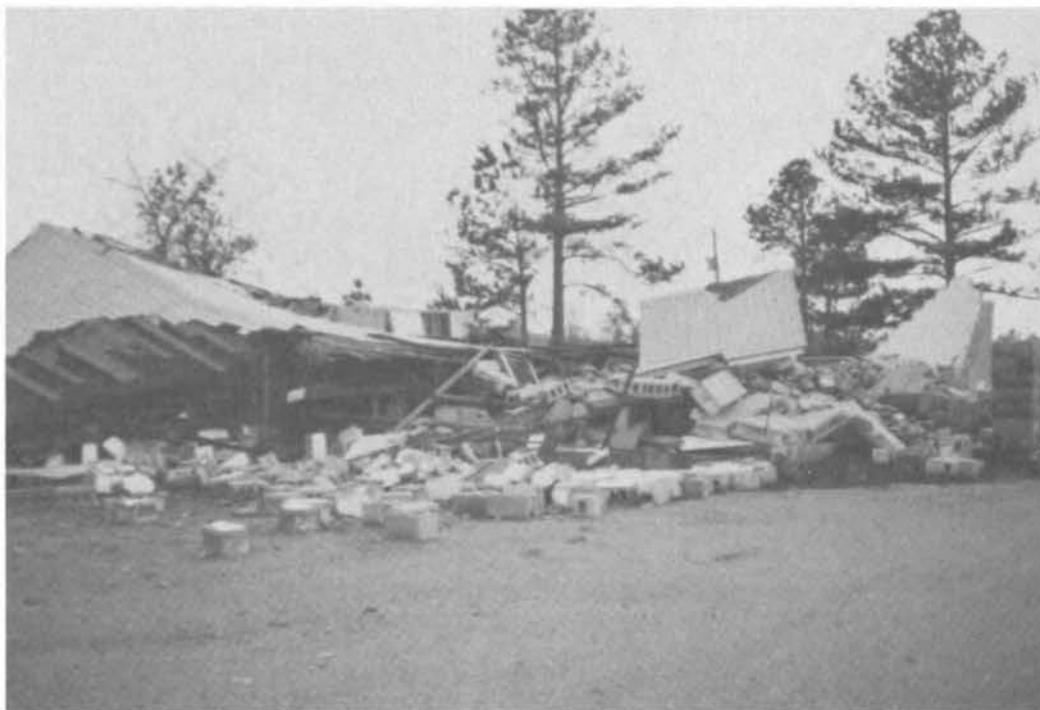
A church also collapsed in Winnsboro (Figure 26). The method of construction again followed the common local practice regarding slenderness of the walls, the positioning of pilasters, and the connection of the roof to the walls. The complete inadequacy of such roof-wall connections in resisting uplift forces is clearly shown in Figure 27. The plane of weakness is simply transferred from the roof-wall connection to

FIGURE 26 Church in Winnsboro.

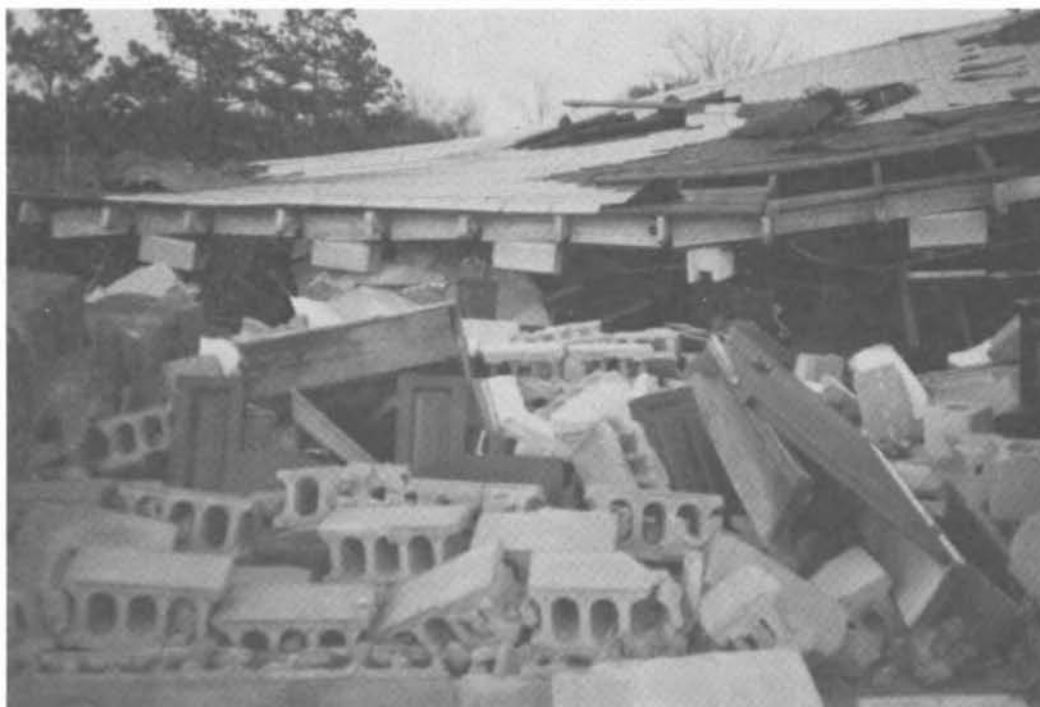
FIGURE 27 Detail of church showing roof-wall connection.

the block-block connection in the row below. The uplift forces not balanced by the weight of the roof must be resisted by the tensile strength of the mortar. The walls of the church also collapsed easily when the resisting diaphragm of the roof was removed. The building was unoccupied at the time, but the consequences of a tornado striking this church during a service are obvious.

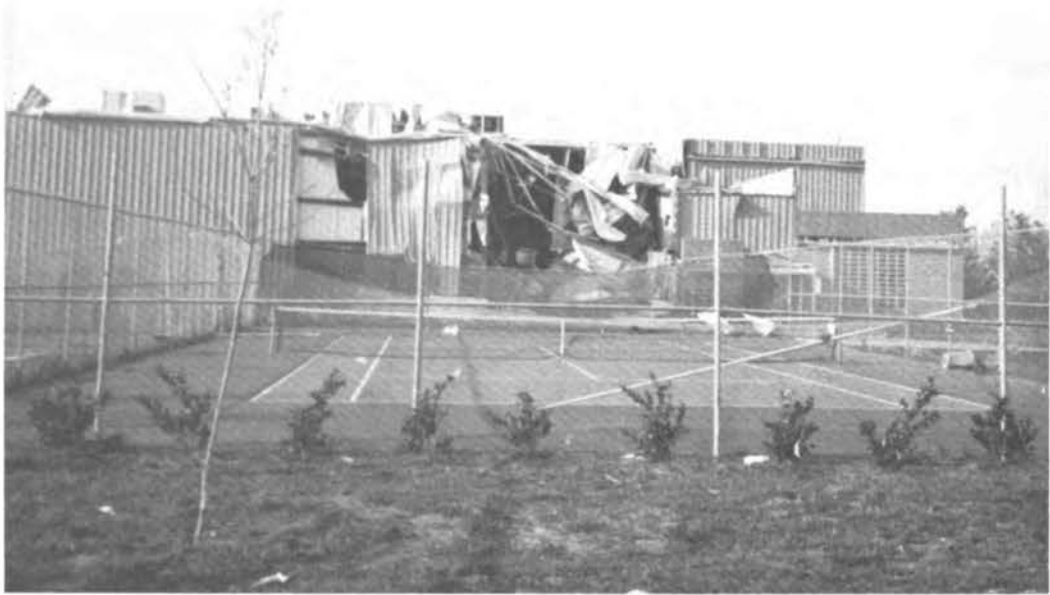
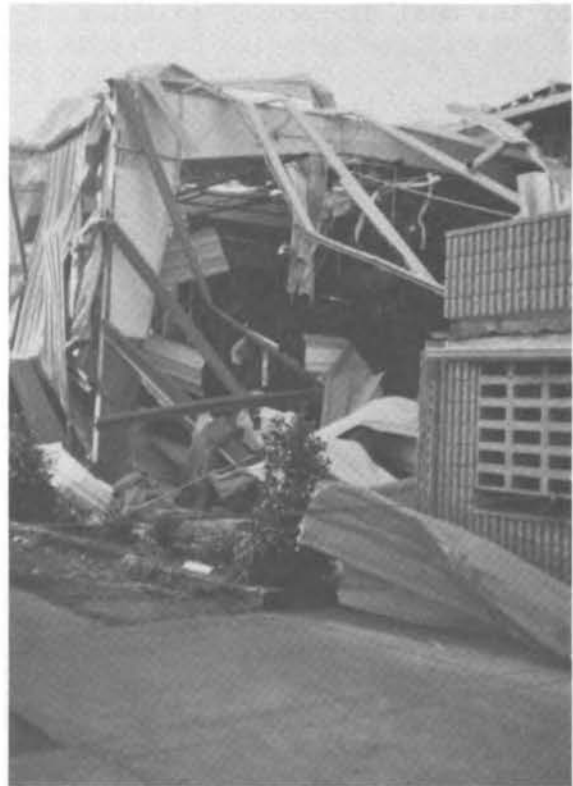
Buildings consisting of moment-resisting steel frames appear to have performed well. Although the cladding and secondary members such as purlins were often severely damaged, the buildings maintained their structural forms and would have provided safe refuge during the storm. Figures 28 and 29 show the Fairfield County Community Center in Winnsboro. Contrast the damage to this structure with the severe damage to the masonry building next to the center shown in Figure 22. Nearby, the gymnasium of the Richard Winn Academy also suffered damage only to its cladding (Figure 30).

FIGURE 28 Fairfield County Community Center in Winnsboro.

FIGURE 29 Detail of Fairfield County Community Center.

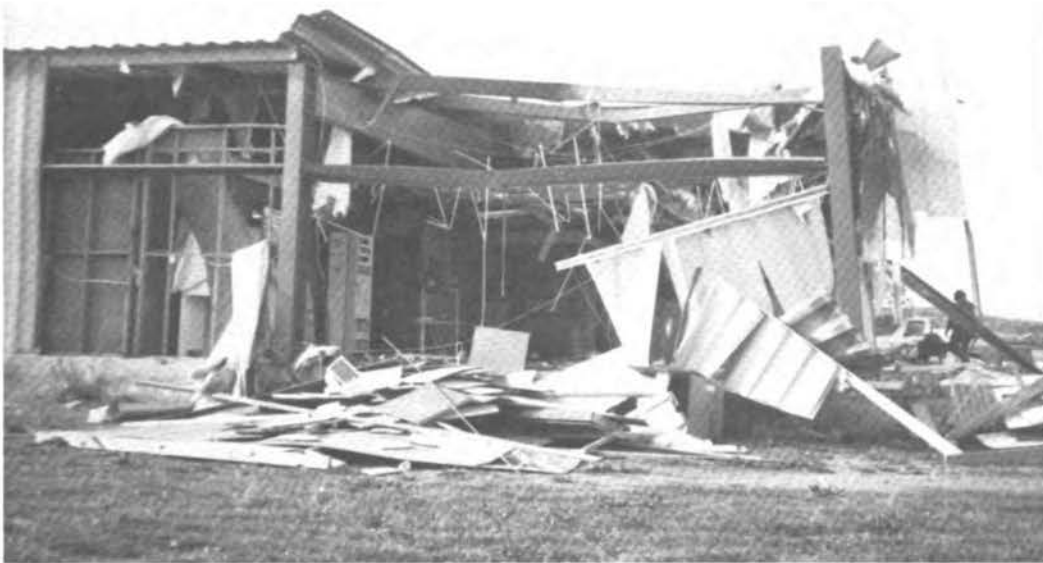
FIGURE 30 Gymnasium of Richard Winn Academy.
