Building Damage in South Carolina Caused by the Tornadoes of March 28, 1984 (1985)

Building Damage in South Carolina Caused by the Tornadoes of March 28, 1984

**Peter R. Sparks, Department of Civil Engineering, Clemson University,
Clemson, South Carolina**

**Committee on Natural Disasters
Commission on Engineering and Technical Systems
National Research Council**

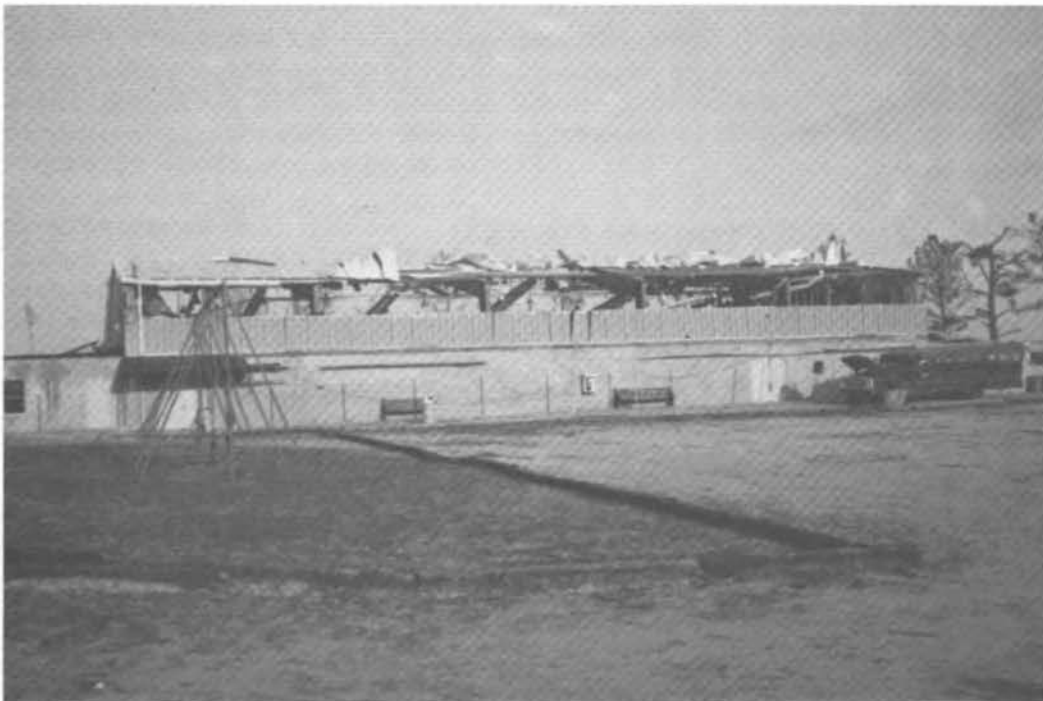
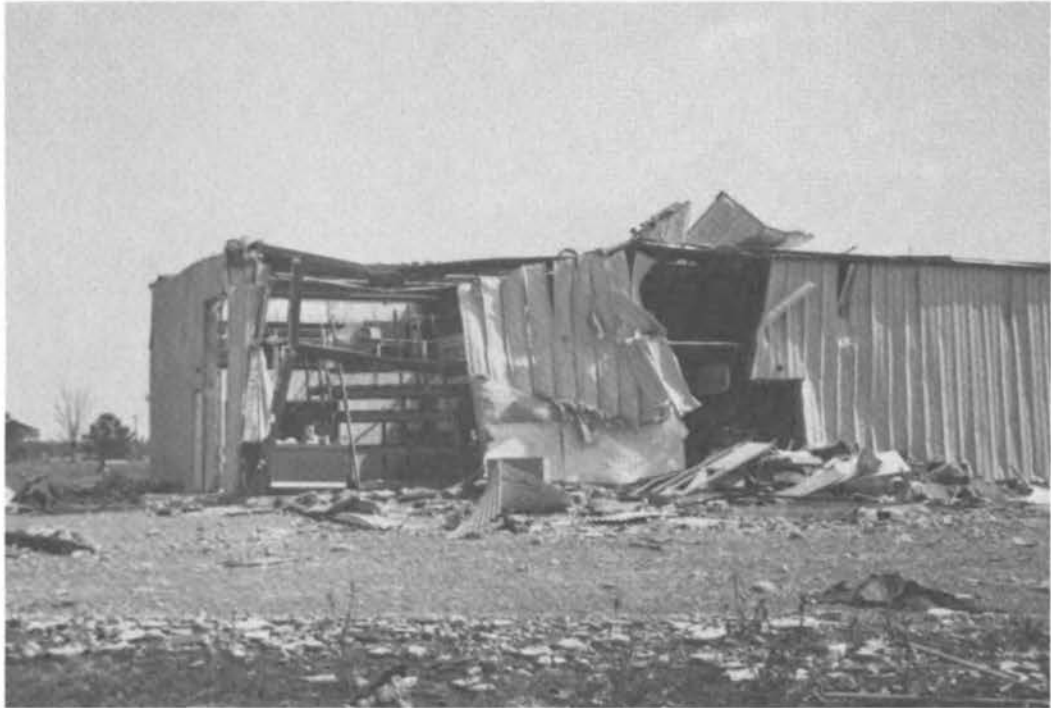
Figures 31 and 32 show typical damage suffered by retail stores of metal construction, the first in Winnsboro, the second in Bennettsville.

FIGURE 31 Steel-framed retail store in Winnsboro.

FIGURE 32 Steel-framed retail store in Bennettsville.

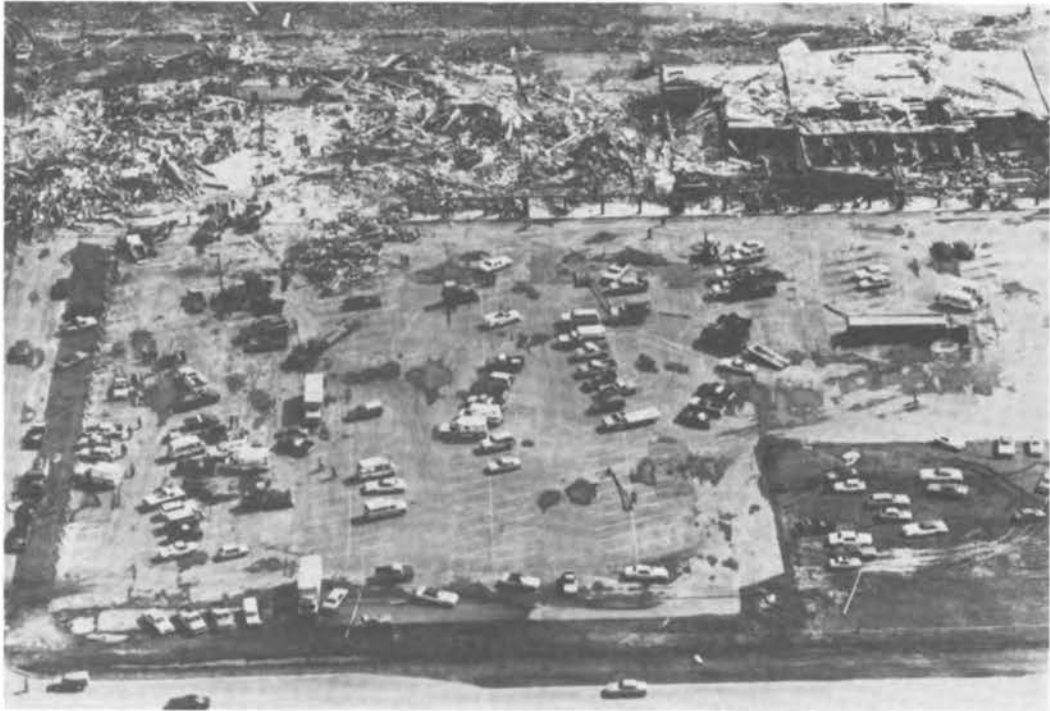
Figure 35 shows the general extent of the damage. The department store at the west end was reduced to a pile of twisted steel and masonry. The front wall had been blown in, the side and back walls had been blown out, and the roof framing system had collapsed.

FIGURE 35 Aerial view of damage to Northwood Village Shopping Center. (Photograph courtesy The State.)

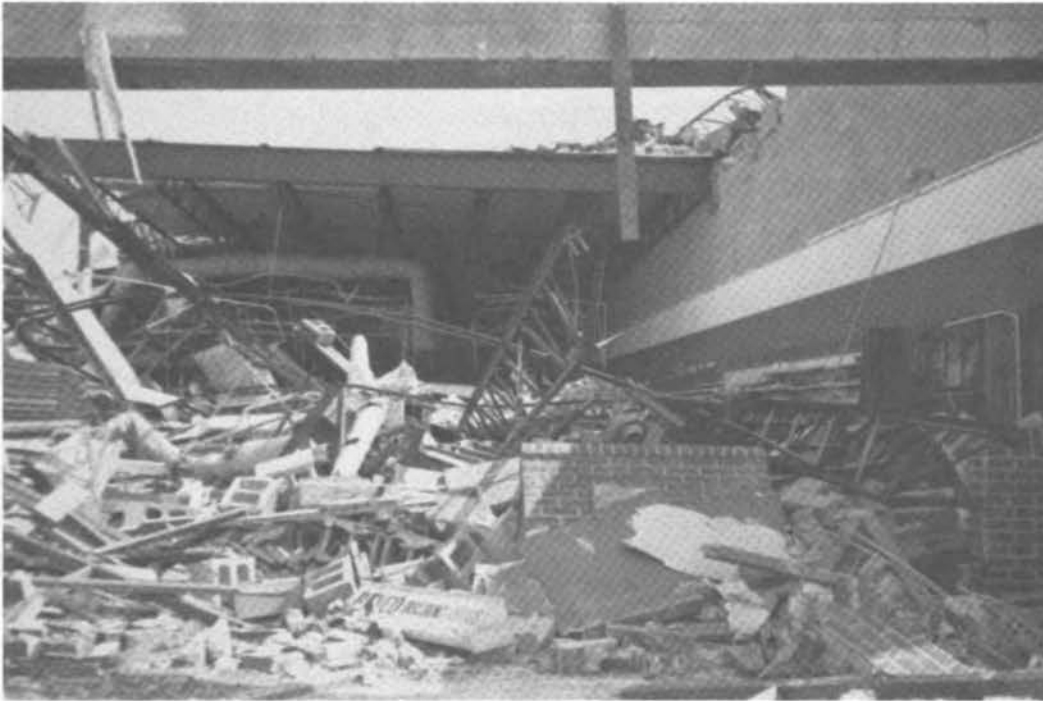
In the drug store the front and side walls collapsed, as did the front half of the roof (Figure 37). The girders had been joined at a point that would normally carry little moment. With the collapse of the side wall, this became a highly stressed area and the joint failed (Figure 38).

FIGURE 37 Roof collapse in drug store.

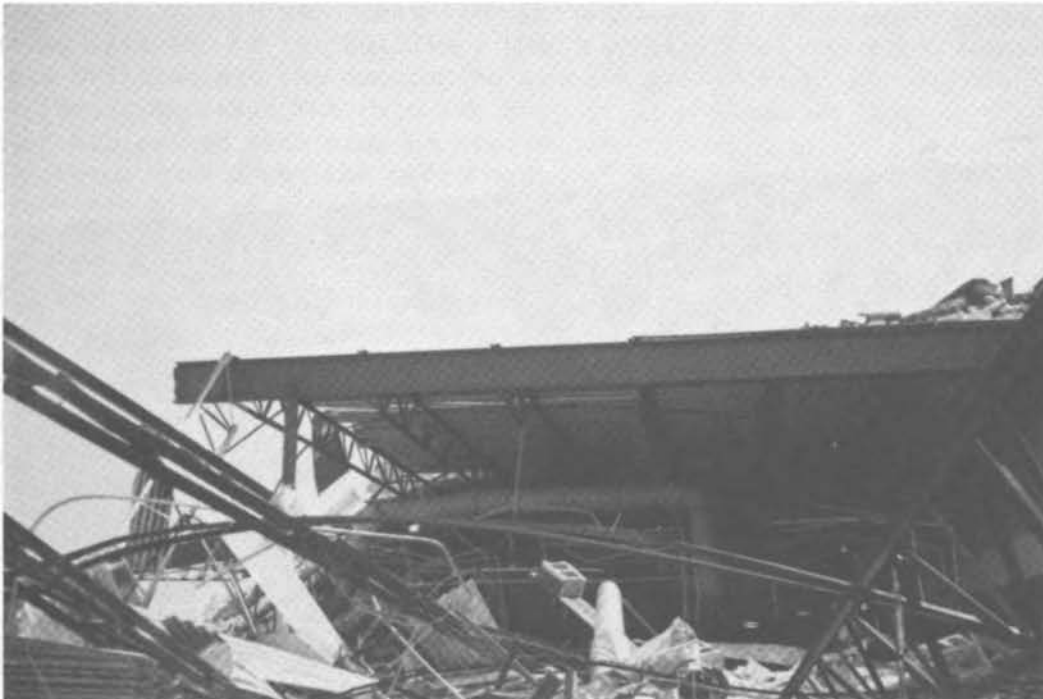
FIGURE 38 Failure of beam joint.

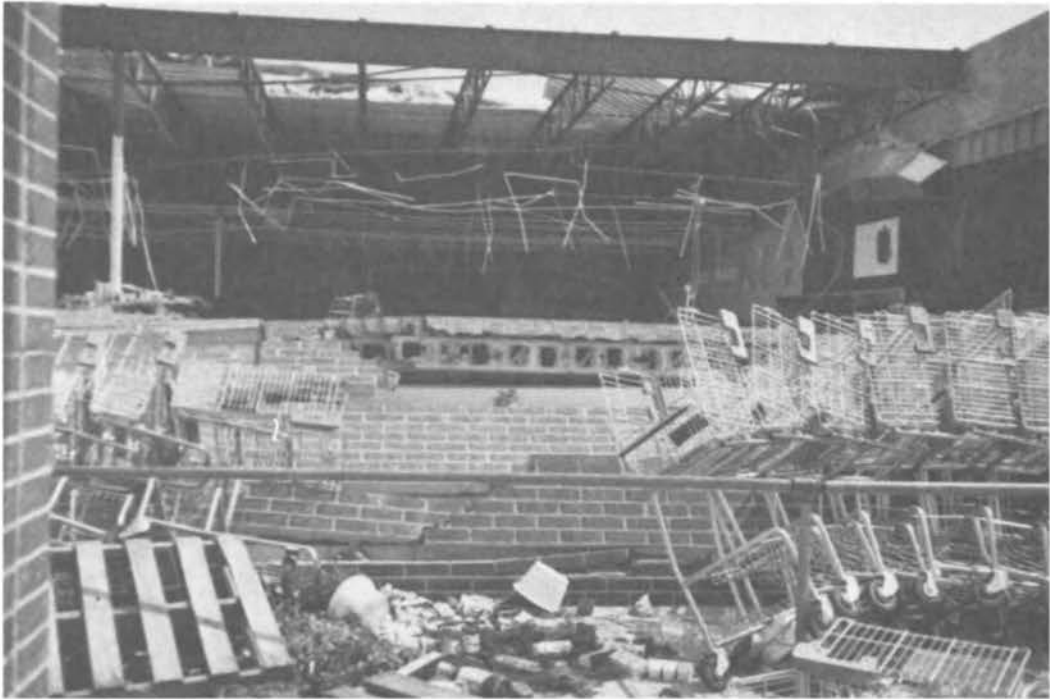
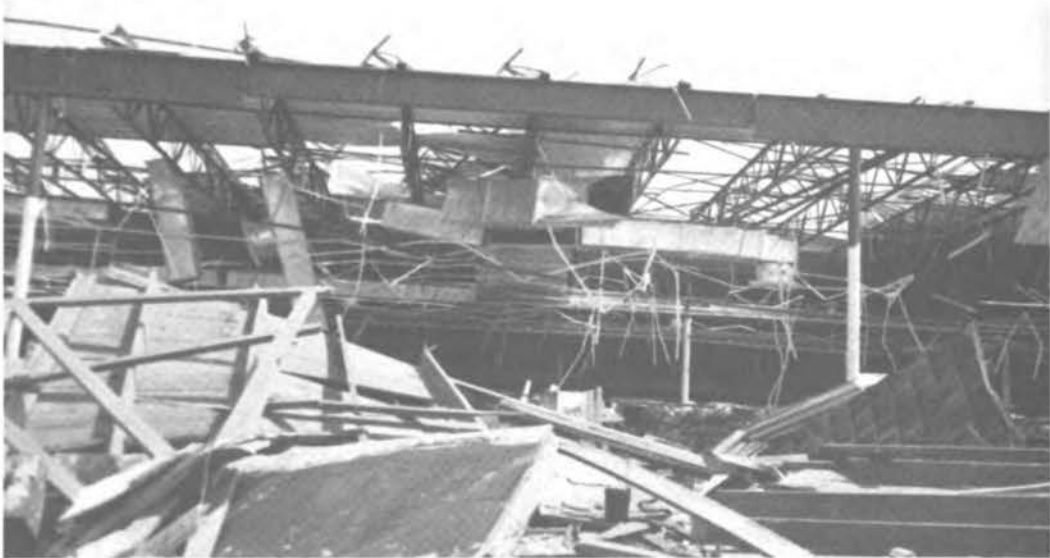
In the adjacent supermarket the front wall failed, and the resulting pressurization of the interior and the suction on the roof appeared to have lifted the first row of bar joists and wrapped them around the first line of girders (Figures 39 and 40).

FIGURE 39 Failure of front wall in supermarket.

FIGURE 40 Failure of roof in supermarket.

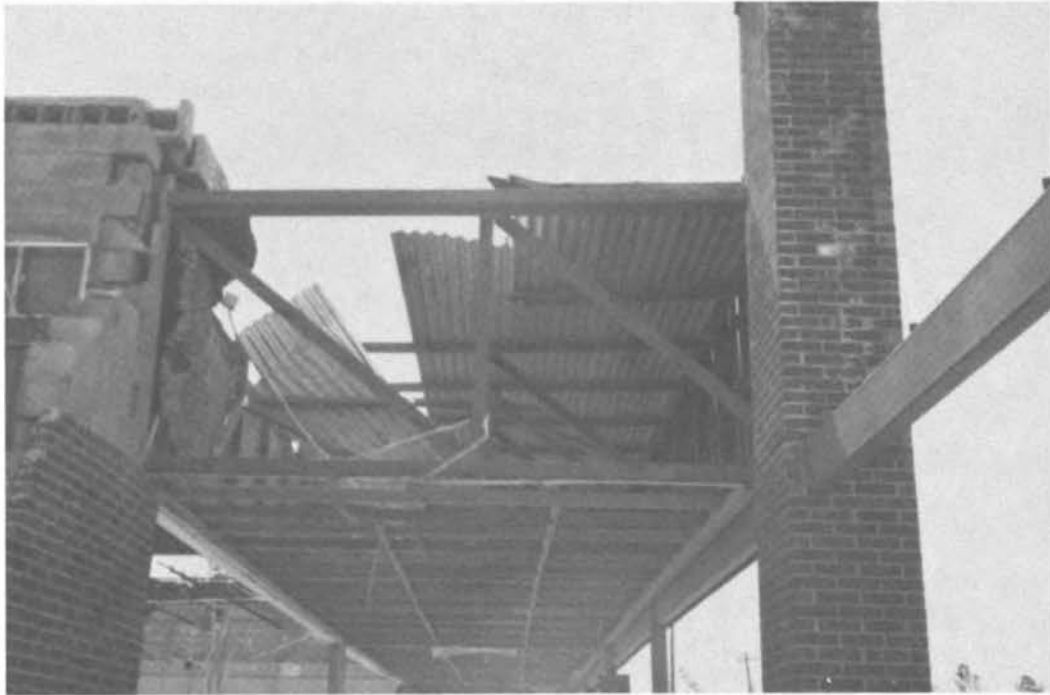
front canopy (Figure 42). Although the wind speeds were undoubtedly lower at this end of the building, the orientation of the roof members in this building and the unoccupied store differed from that of the three larger stores. The main girders ran from front to back in the smaller stores and from side to side in the larger ones.

FIGURE 42 Surviving canopy at east end of the shopping center.

Another factor that may have contributed to the failure was the fact that the canopy had not been built as shown in Figure 44, but had been replaced by inferior wood framing as shown in Figure 42. Without the restraint and shelter provided by this canopy, the front wall of the department store possessed very little wind resistance.

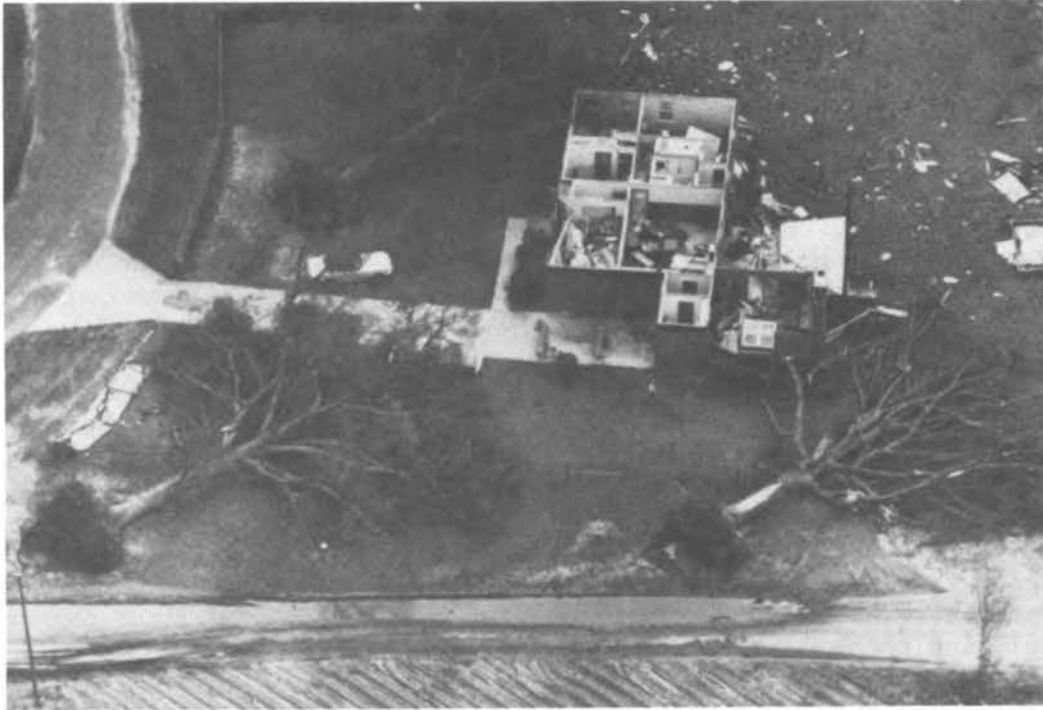
FIGURE 47 Typical roof failure caused by the South Carolina tornadoes. (Photograph courtesy The State.)
