## **Hurricane Elena, Gulf Coast: August 29 - September 2, 1985**

Committee on Natural Disasters, National Research Council

Volume Two  
HURRICANE ELENA, GULF COAST  
AUGUST 29-SEPTEMBER 2, 1985

Peter Sparks (Team Leader),  
Department of Civil Engineering, Clemson University, South  
Carolina  
Earl J. Baker,  
Department of Geography, Florida State University, Tallahassee  
James Belville,  
Forecast Office, National Weather Service, Sterling, Virginia  
Dale C. Perry,  
Department of Construction Science, Texas A&M University,  
College Station

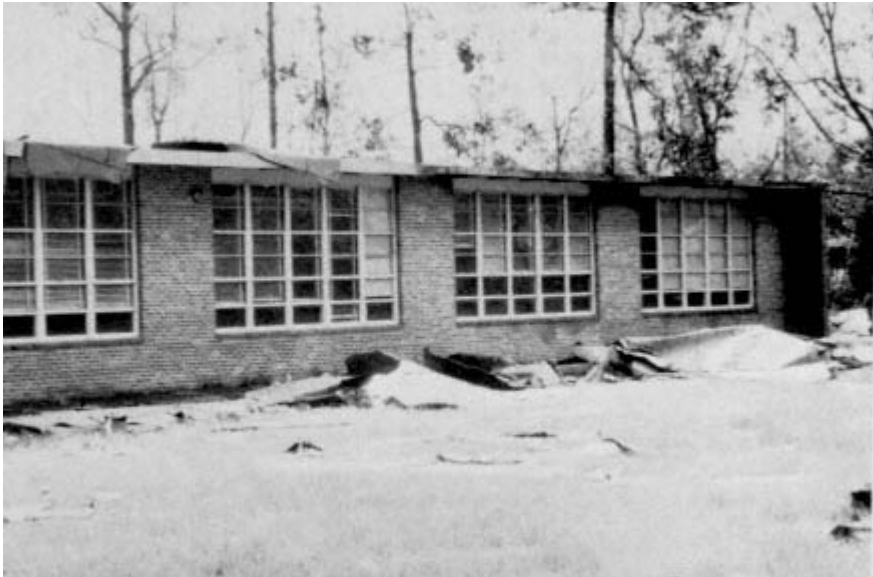
*Failure of Roof Decking* As indicated earlier, while the loads on these roofs may have exceeded the design level as a result of a window failure, a properly designed and installed system should have accommodated this overload.

Figure 4-1  
Loss of roof covering—West Elementary School.

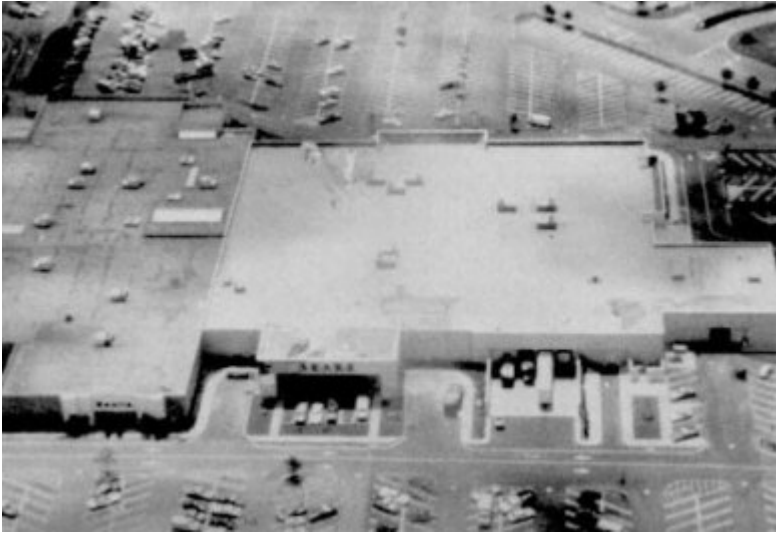
Figure 4-2  
Roof membrane damage to a shopping mall, Gautier.

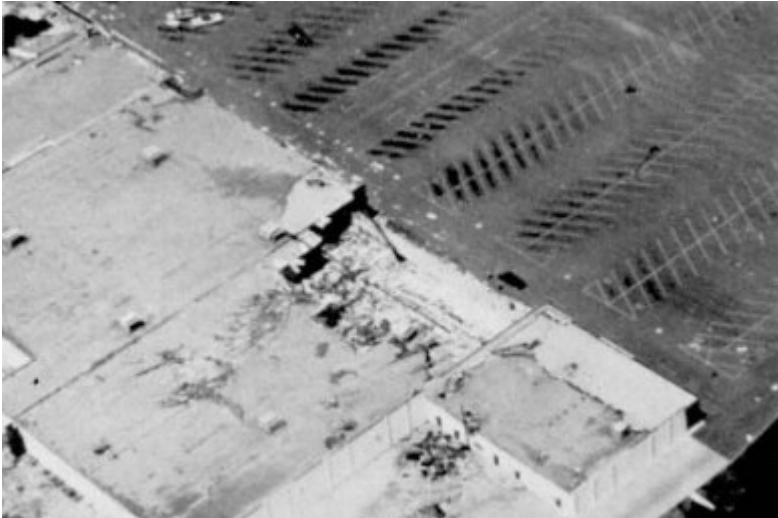
Figure 4-3  
Collapse of a section of the Jackson Square Shopping Center, Gautier.

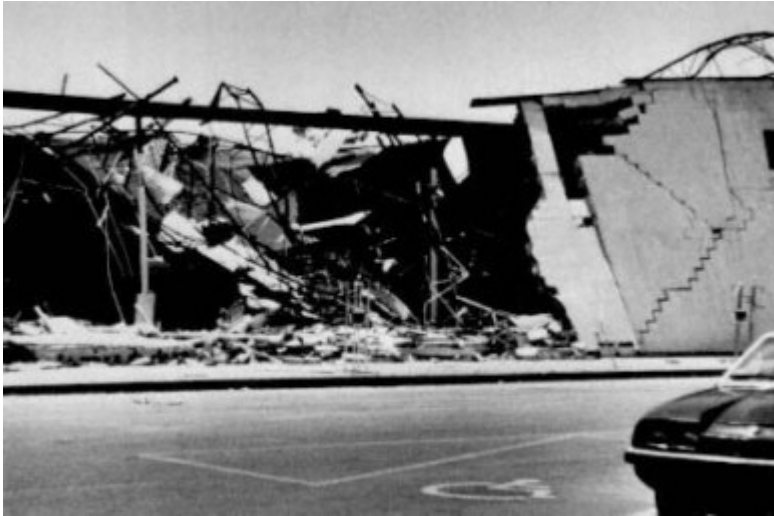
Figure 4-4  
Detail of roof and wall damage in Figure 4-3.

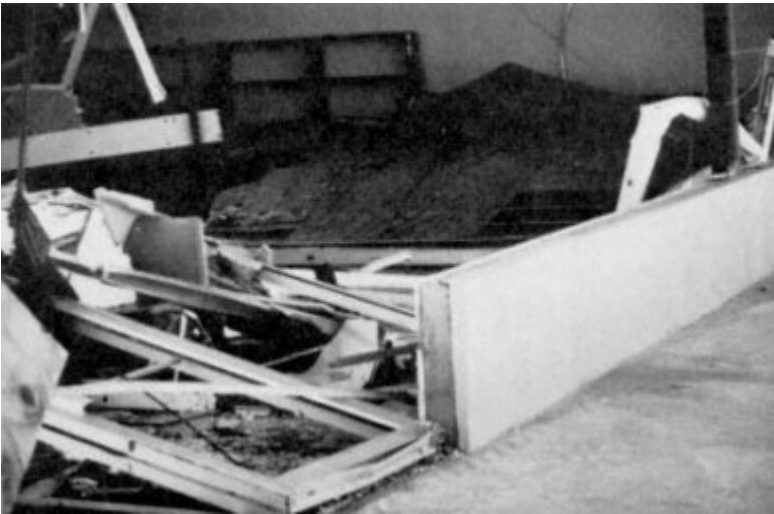
This serious damage was probably due to some very minor details. The high internal pressure probably resulted not from glass breakage but from failure of the wall-to-window-frame connection ([Figure 4-5](#)). The bar joists

Figure 4-5  
Wall-to-window-frame connection failure, Jackson Square Shopping Center,  
Gautier.

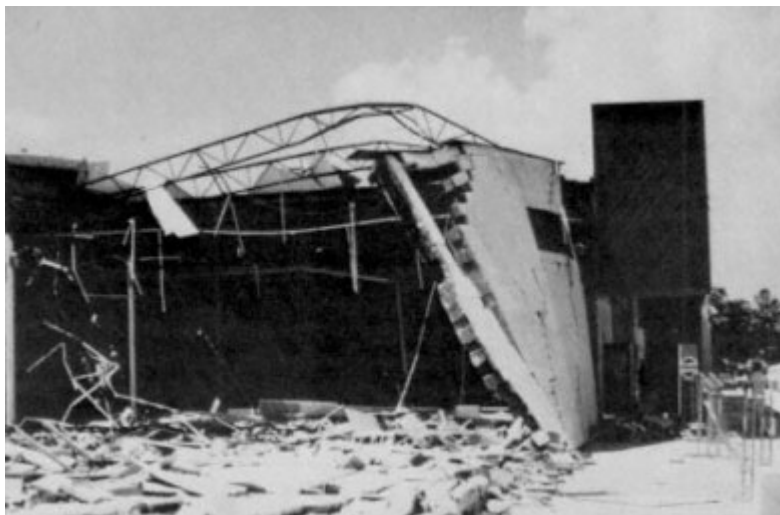
Figure 4-6  
Buckling of bar joists due to roof uplift, Jackson Square Shopping Center, Gautier.

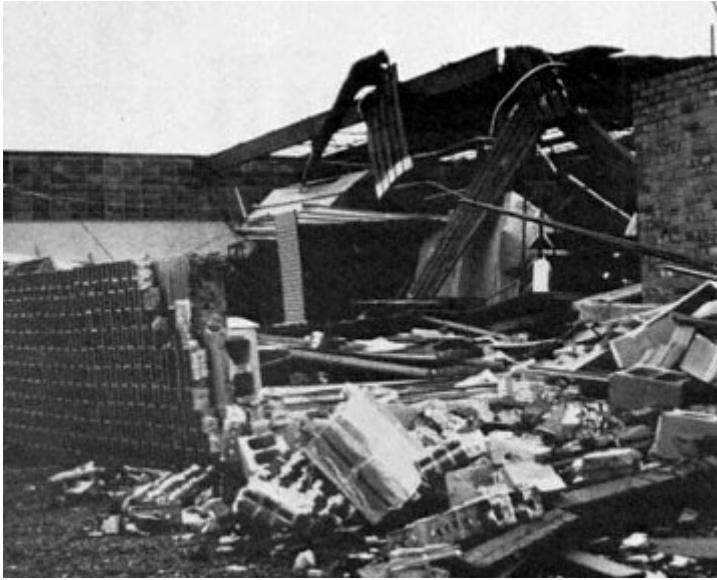
Figure 4-7  
Collapse of Payless Shoe Store, Pascagoula.

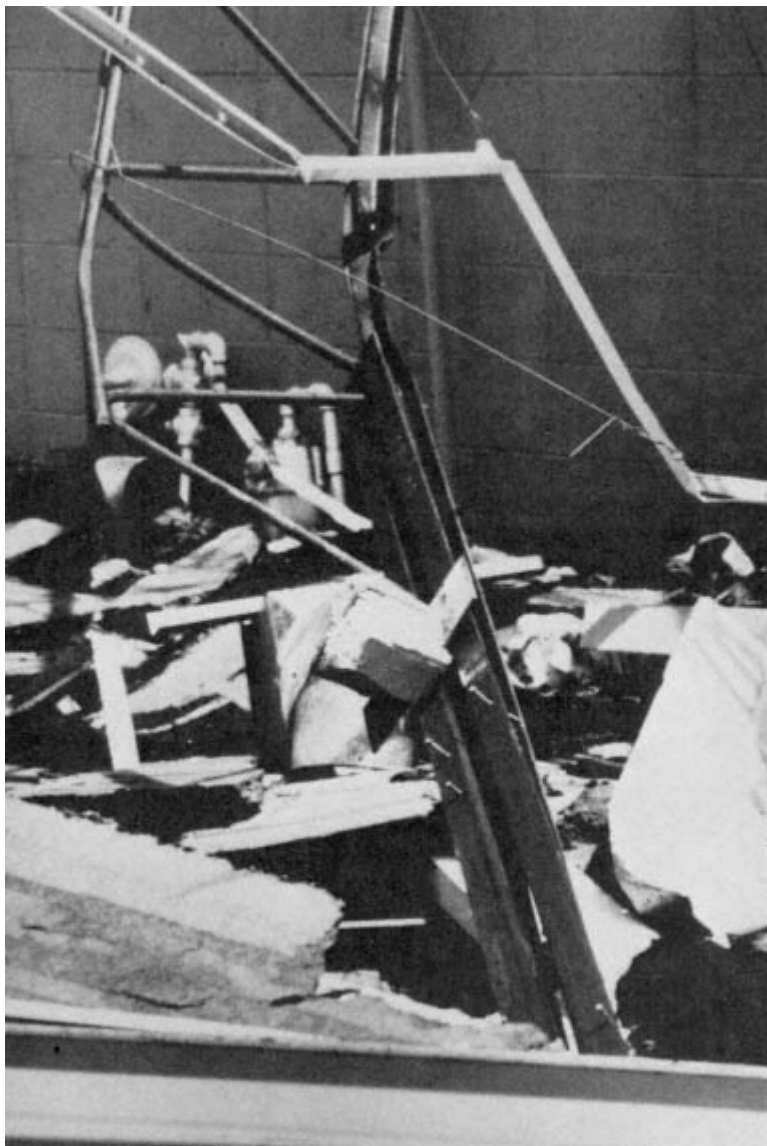
Figure 4-9  
Mortar failure at roof anchor, Payless Shoe Source, Pascagoula.

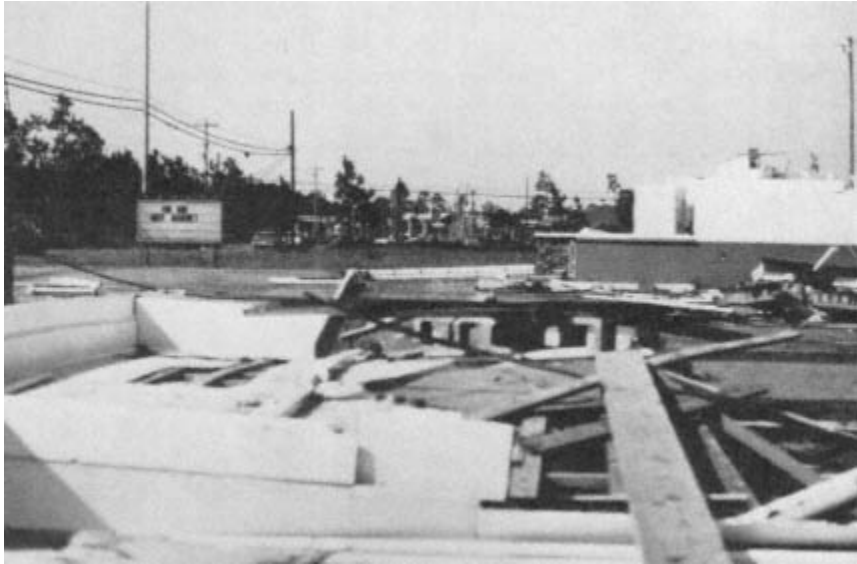
Figure 4-10  
Loss of wood roof from masonry-walled building (note sign), Gautier.

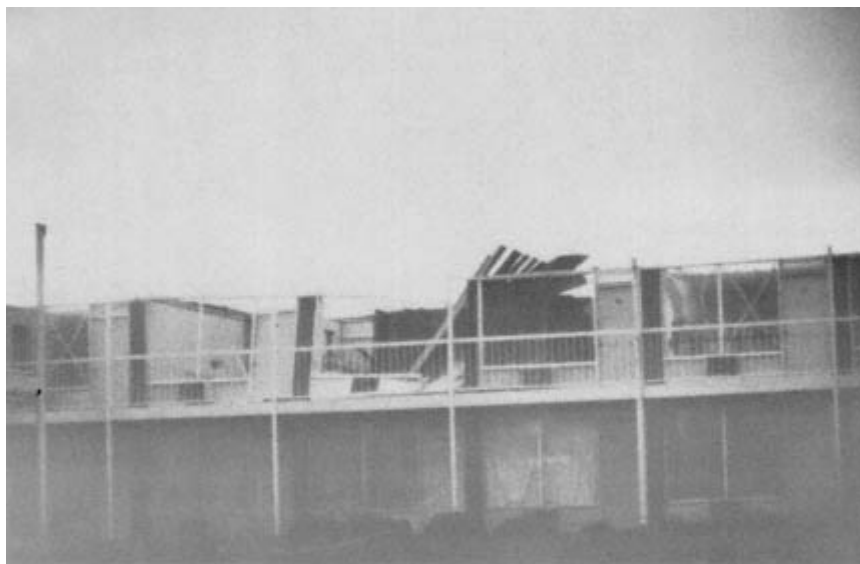
A number of motels sustained roof damage of the type shown in [Figure 4-12](#). These buildings were probably not designed professionally. The connections between the walls and roof were inadequate to resist the wind forces on the roof overhangs. While the high internal pressure resulting from broken windows might not have been anticipated, the high forces on overhangs were clearly specified in the building code. These buildings probably did not meet the code requirements at the time they were built. However, at that time, there may not have been a means of checking compliance.

Figure 4-12  
Motel damage, Pascagoula.

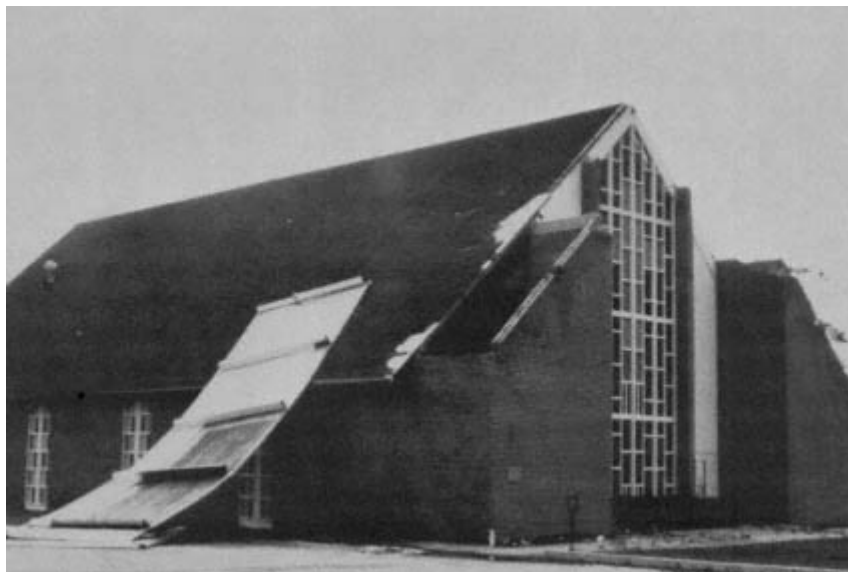
Figure 4-13  
Roof damage to church, Gautier.

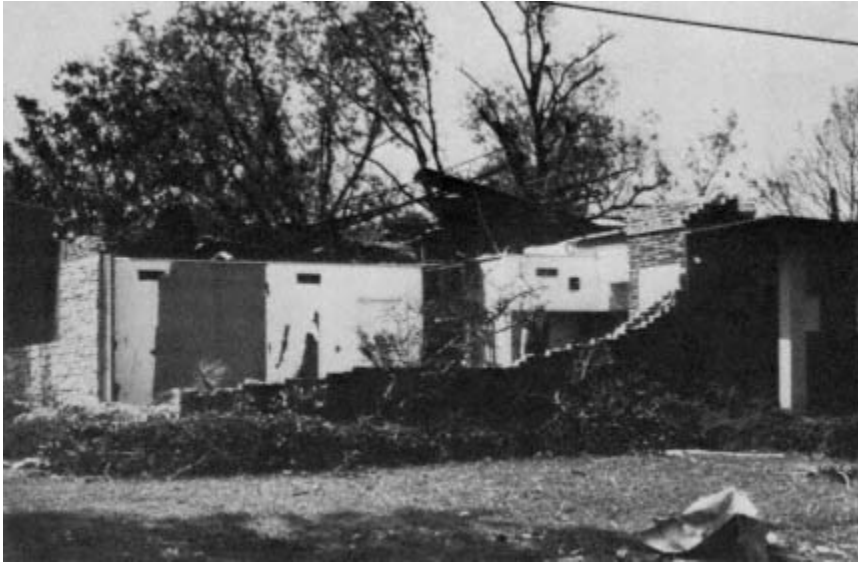
Figure 4-14  
Damaged house using metal deck roof, Pascagoula.

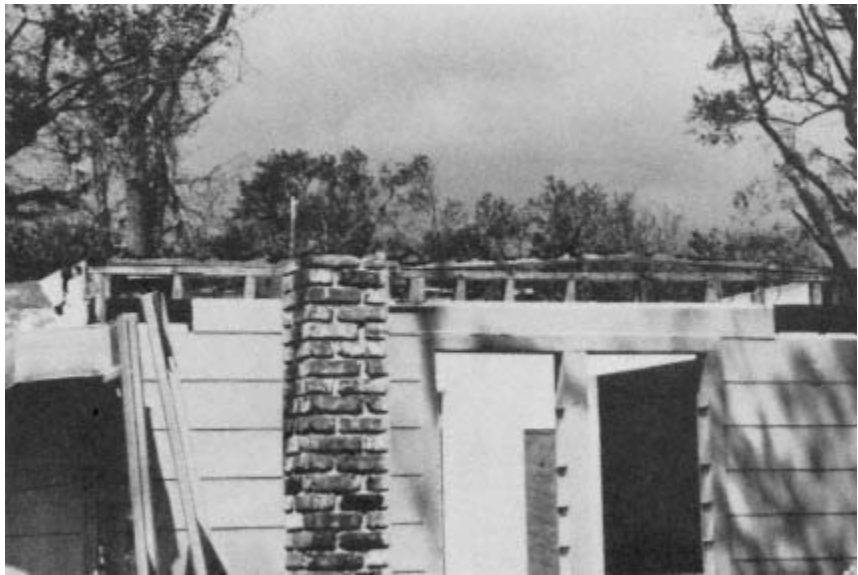
Figure 4-15  
Loss of roof due to improperly secured overhang, Pascagoula.

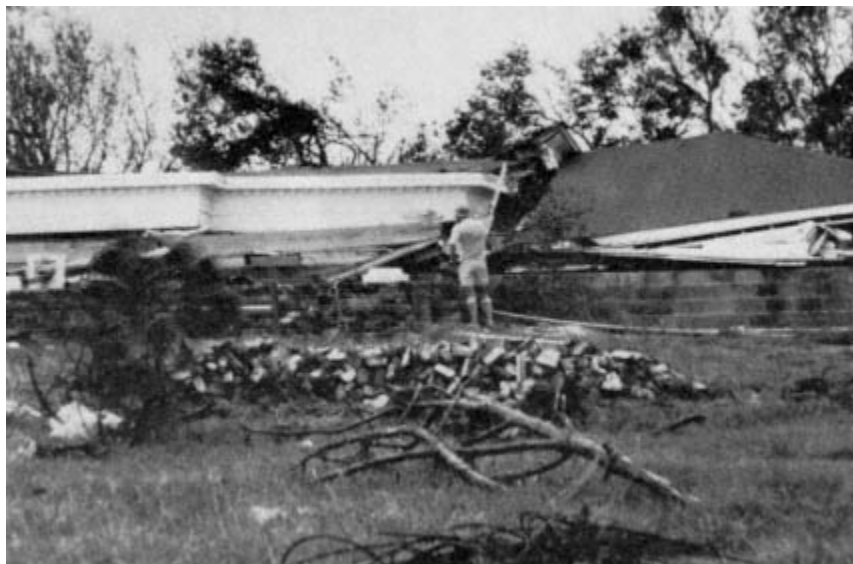
Figure 4-16  
Shear failure of house, Pascagoula.

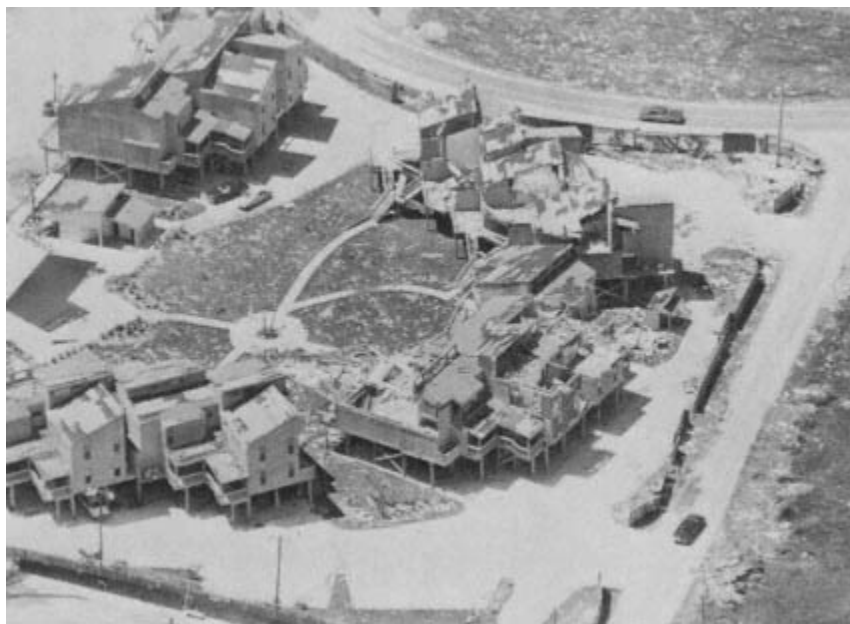
Figure 4-17  
Extensive damage to Spinnaker Point Condominiums, Pascagoula. (Courtesy of *The Sun/The Daily Herald*, Biloxi.)

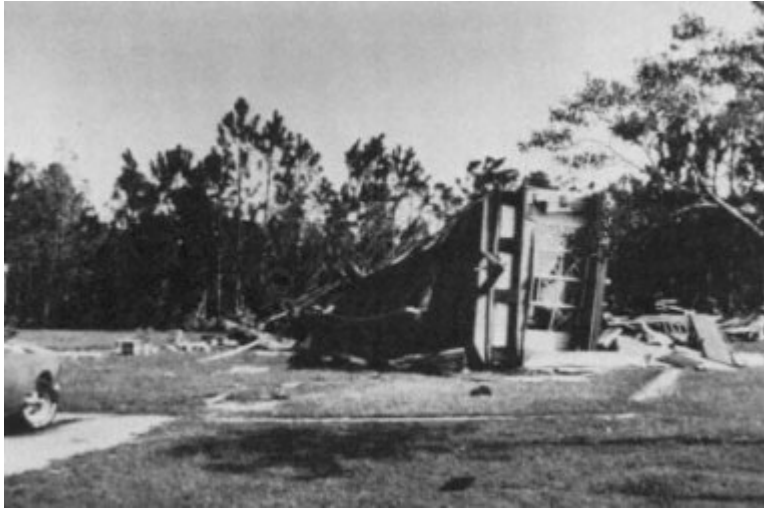
Figure 4-18  
Anchor failure in mobile home, Gautier.

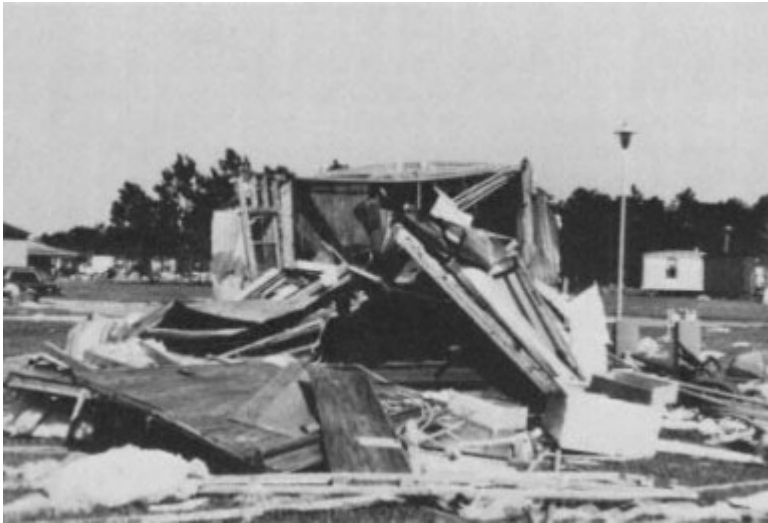
Figure 4-19  
Structural damage to well-anchored mobile home, Gautier.

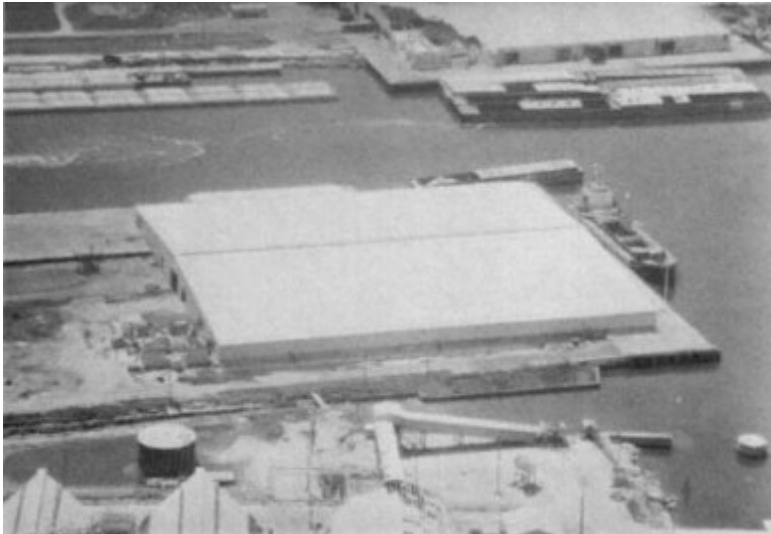
Figure 4-22  
Preengineered warehouse buildings at Ingalls Shipyard. Wind damage limited to older building (top).

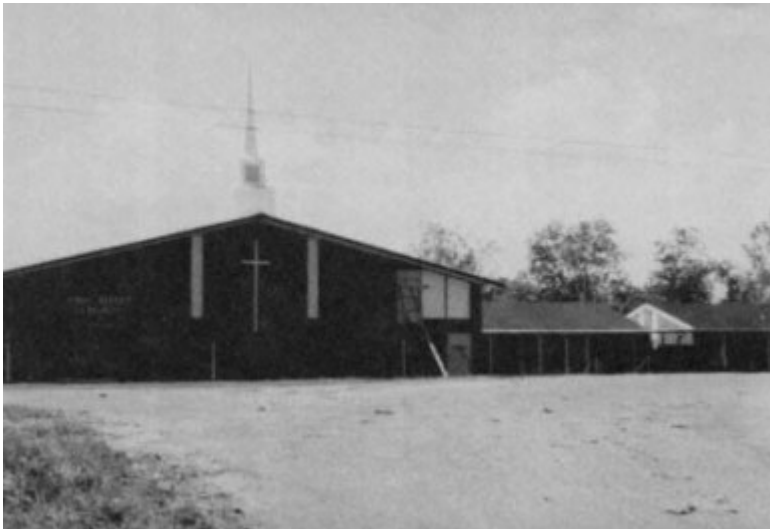
Figure 4-25  
First Baptist Church of Lyman. Wind damage to complex of metal buildings limited to glass breakage due to windborne debris.

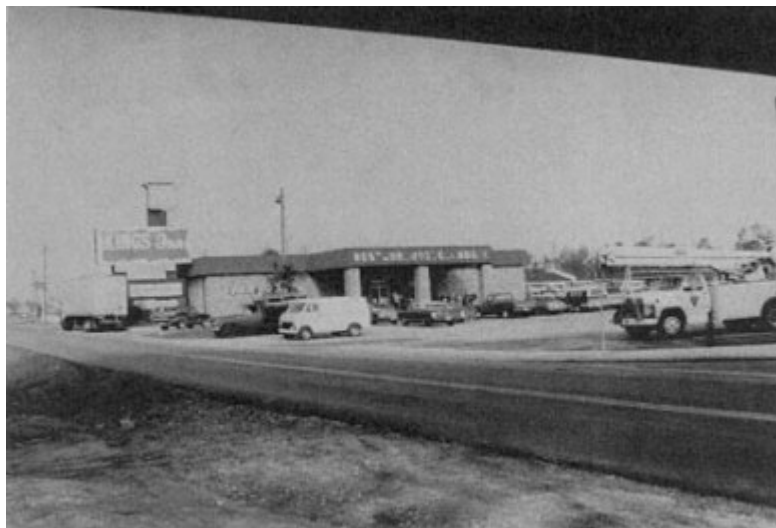
Figure 4-26  
Preengineered metal building in Pascagoula. Wind damage limited to logo.

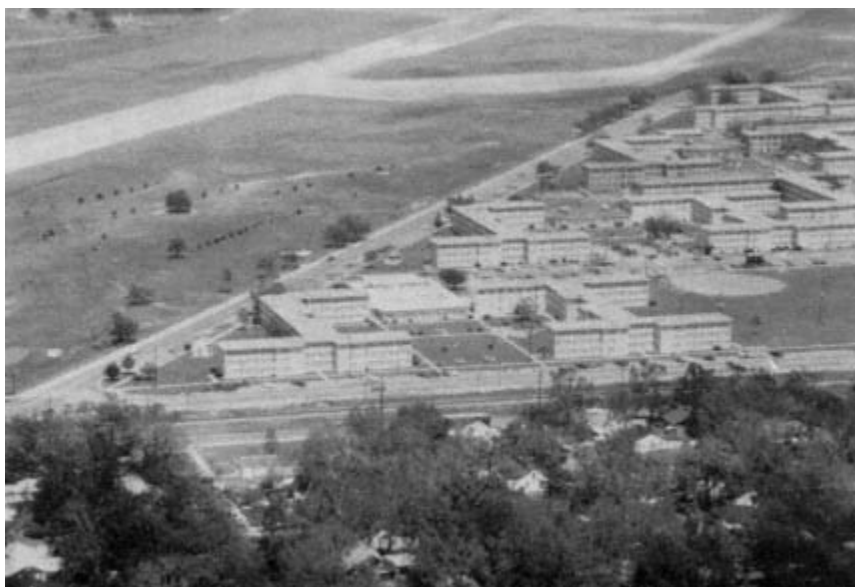
Figure 4-27  
Reinforced masonry buildings at Keesler Air Force Base; roof damage caused leakage.

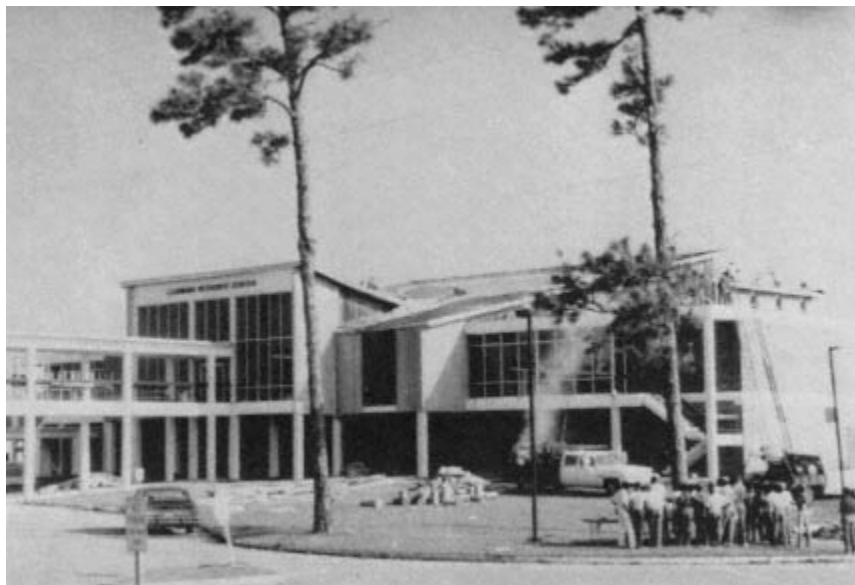
Figure 4-28  
Learning Resource Center, Mississippi Gulf Coast Junior College; roof damage.

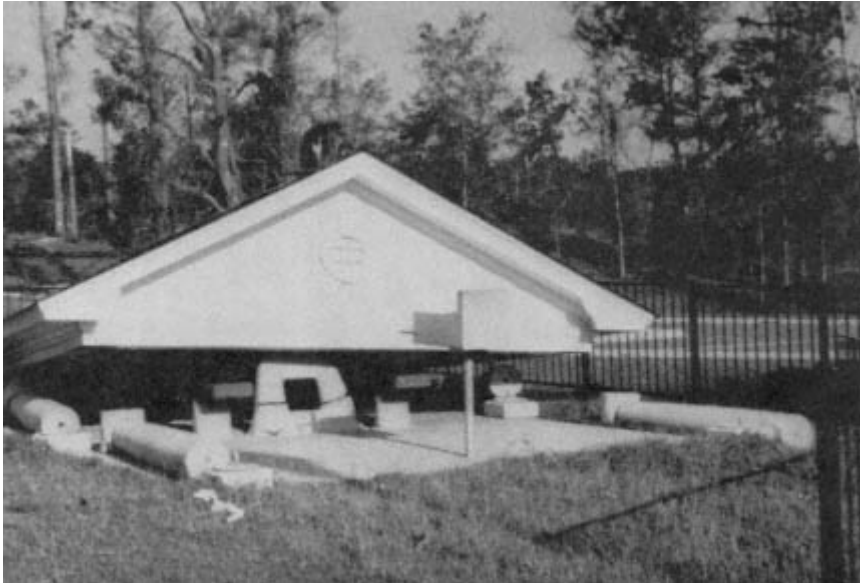
Figure 4-31  
Collapsed roadside shelter at rest area on Interstate Highway 10 All units failed.

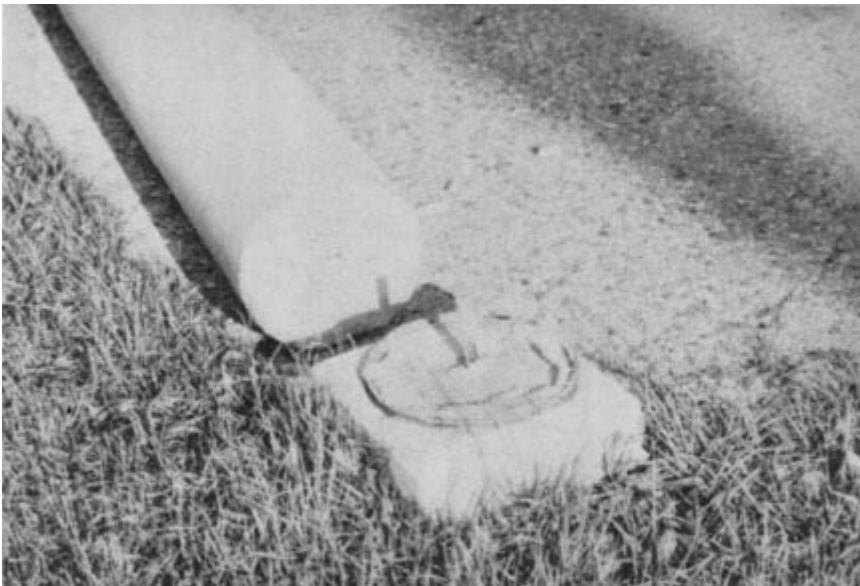
Figure 4-32  
Base-to-column connection of shelter of [Figure 4-31](#).

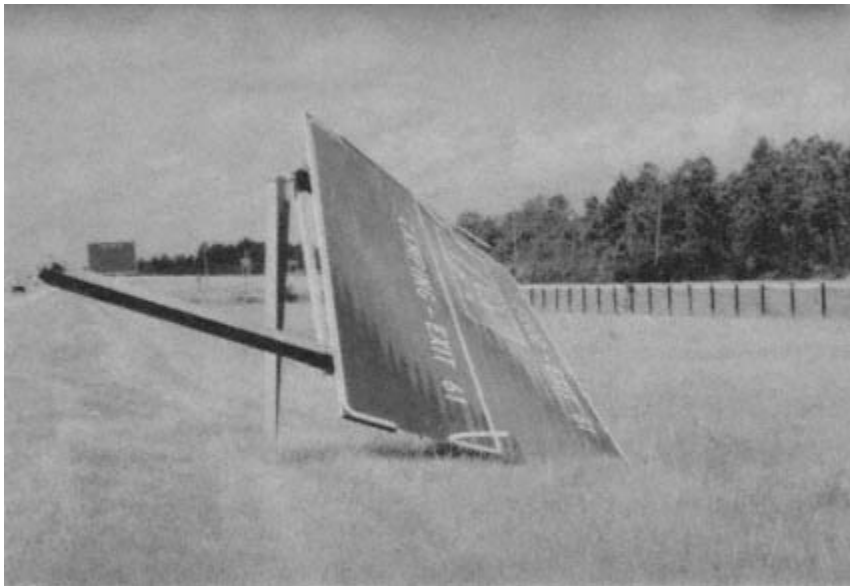
Figure 4-34  
Failure of highway sign on Interstate 10.

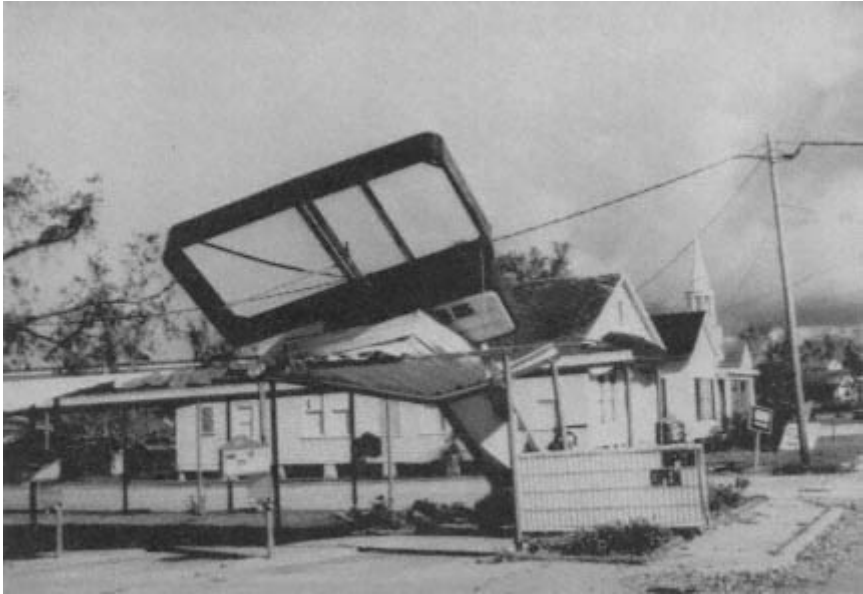
Figure 4-35  
Failure of sign in Moss Point.

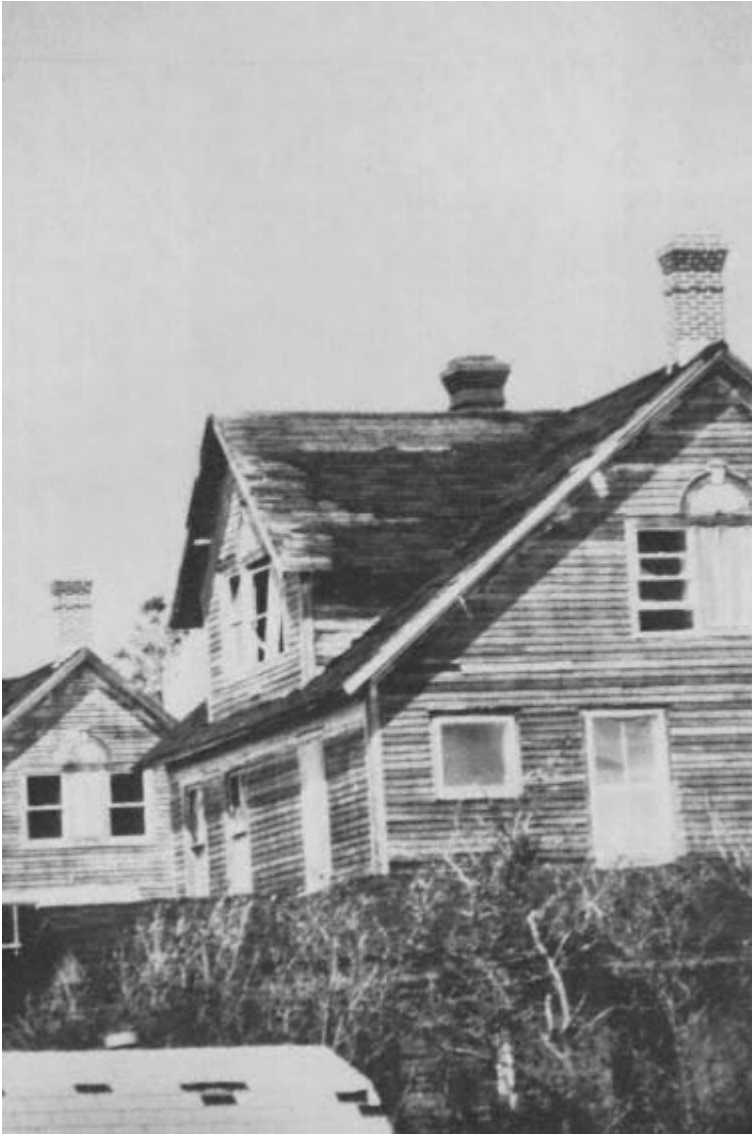
Figure 4-38  
Minor damage to old military building, near Fort Gaines, Dauphin Island.

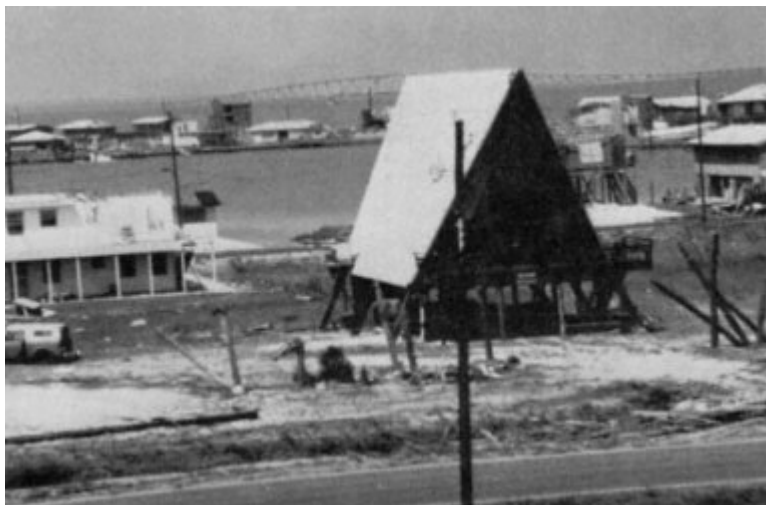
Figure 4-41  
Damaged building with low-pitched roof (left) and undamaged A-frame house (right), Dauphin Island.

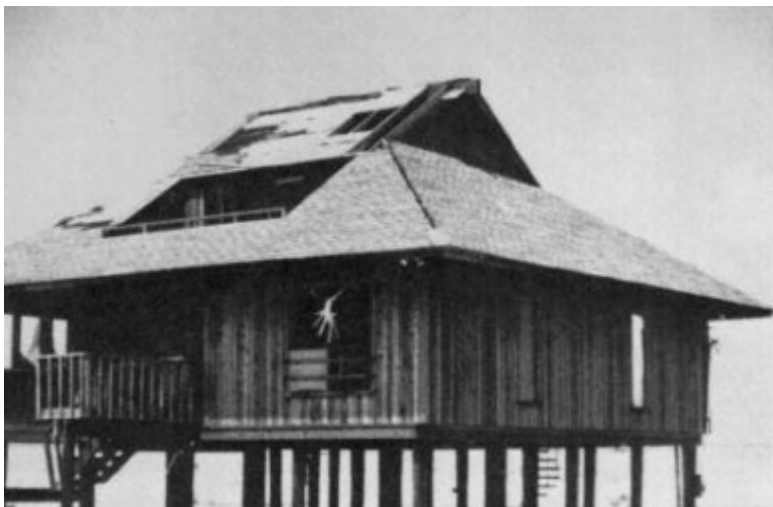
Figure 4-42  
Roof damage showing the influence of roof shape, Dauphin Island.

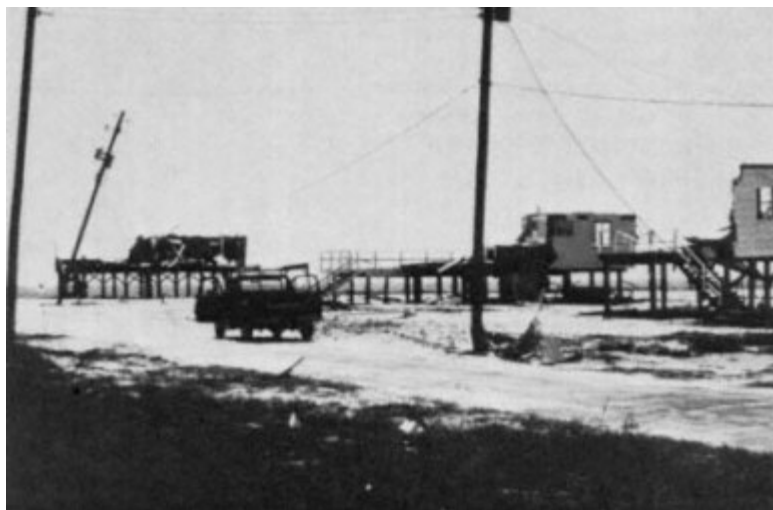
Figure 4-43  
Repeated damage patterns in similarly constructed buildings, Dauphin Island.

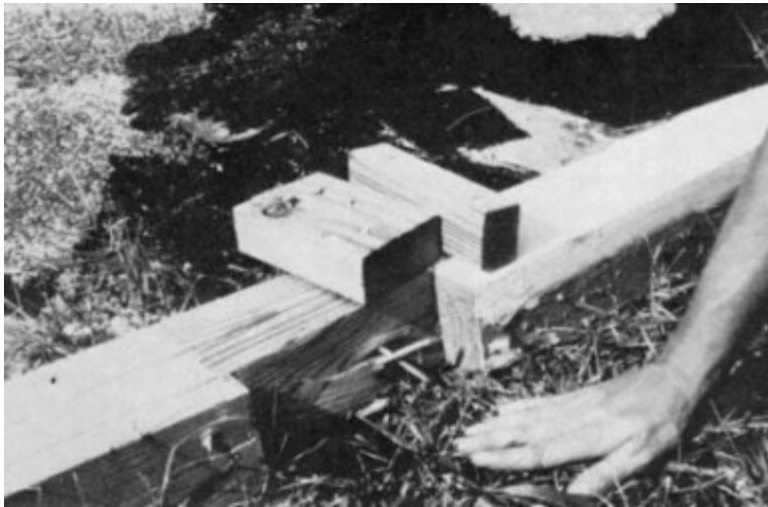
Figure 4-45  
Detail of toenailed roof-to-wall connection associated with damaged roof in [Figure 4-44](#).

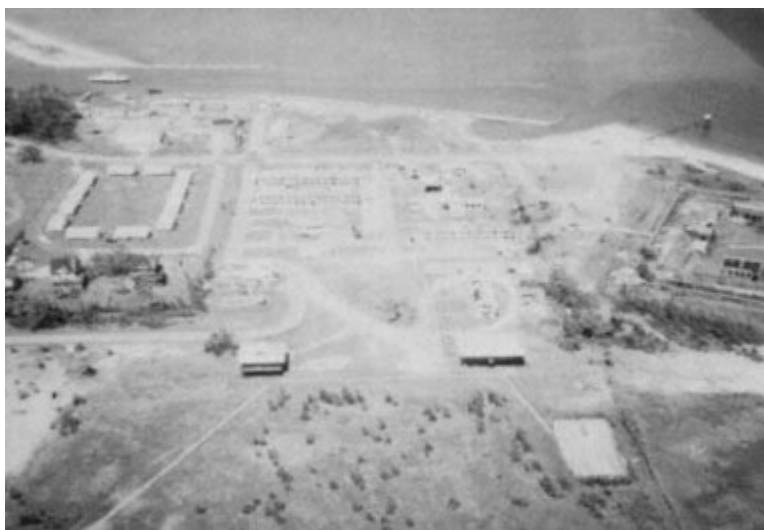
Figure 4-47  
Fort Gaines area showing damage to flat-roofed buildings, Dauphin Island.

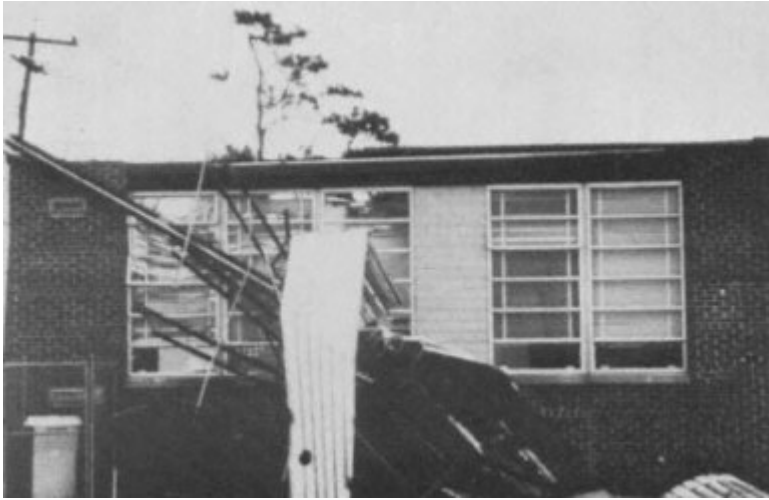
Figure A-1  
Loss of metal roof deck—Pascagoula Vocational High School.

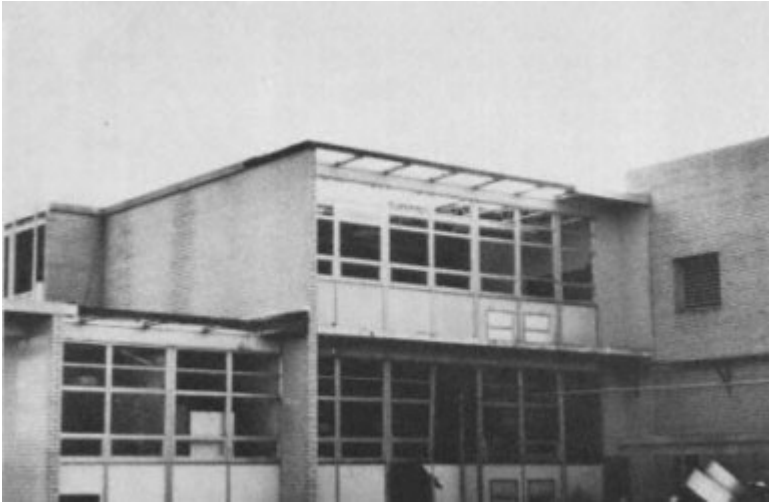
Figure A-3  
Window and roof damage at Dukate Elementary School, Biloxi.

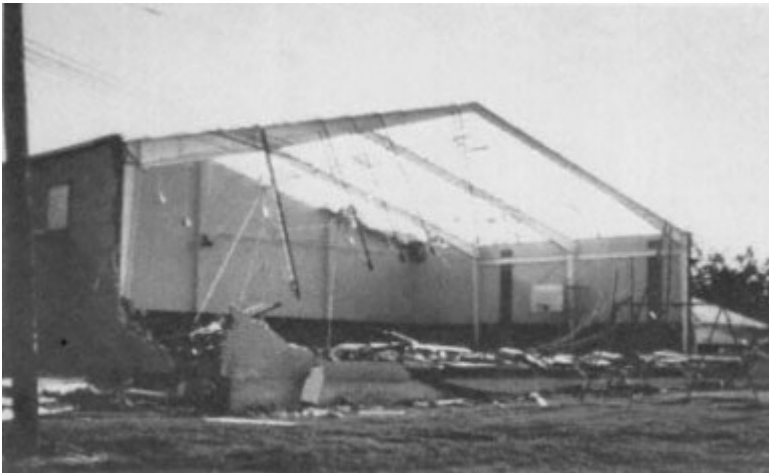
Figure A-4  
Collapse of gymnasium at Dukate Elementary School, Biloxi.

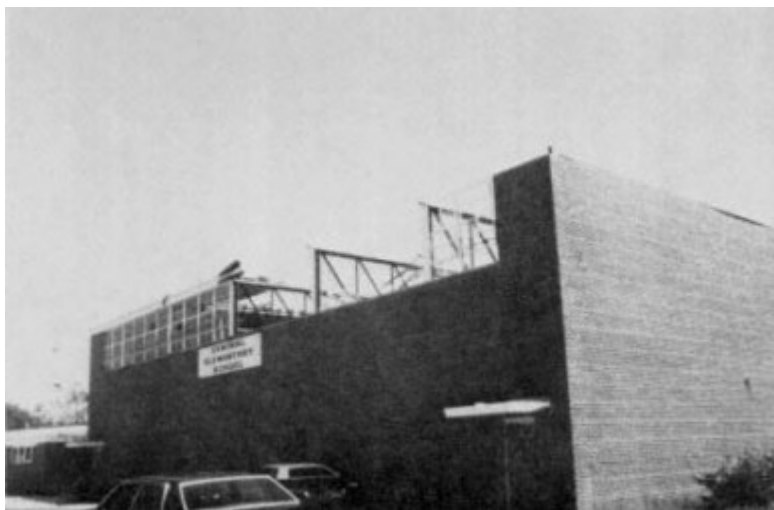
Figure A-5  
Gymnasium damage, Central Elementary School, Gulfport.

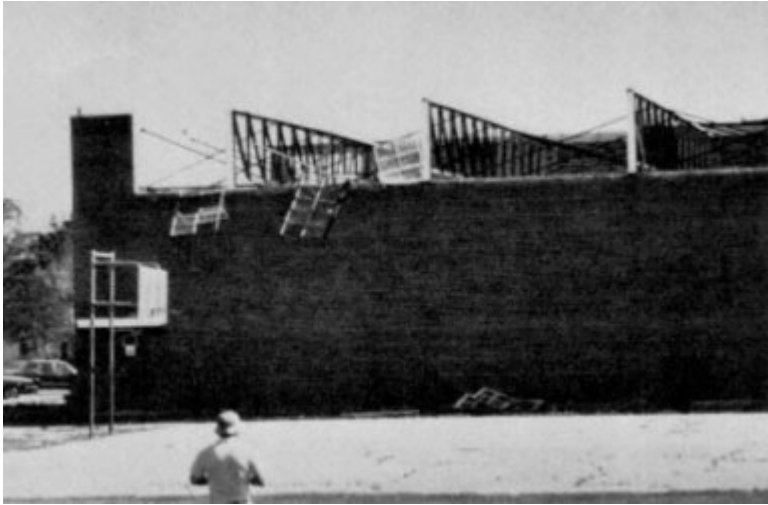
Figure A-6  
Gymnasium damage, West Elementary School, Gulfport.

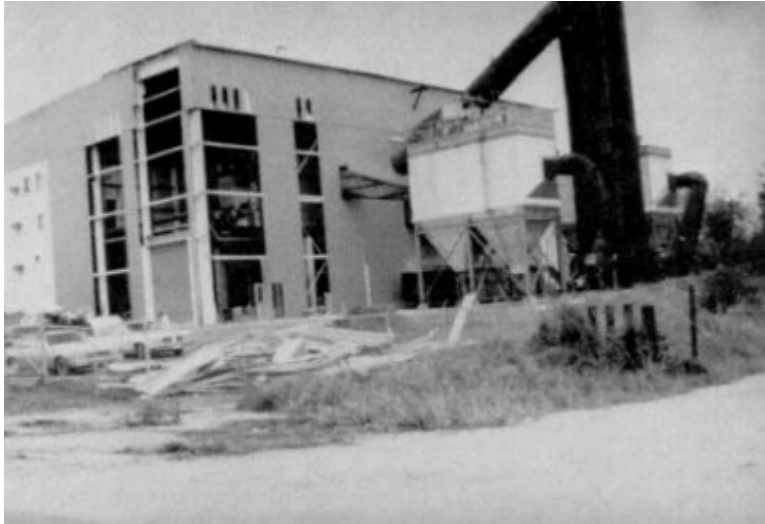
Figure C-1  
Damage to cladding (side and leeward walls) of the Pascagoula Energy Recovery Facility resulting from overhead door failure.

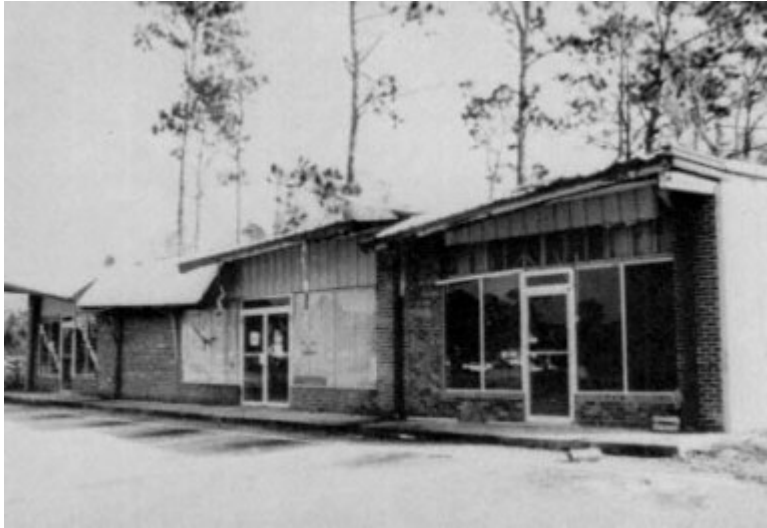
Figure C-2  
Wind damage of canopy of metal building in Gautier. Note that overhang has been provided by extending roof sheeting beyond eave, a poor but common practice.

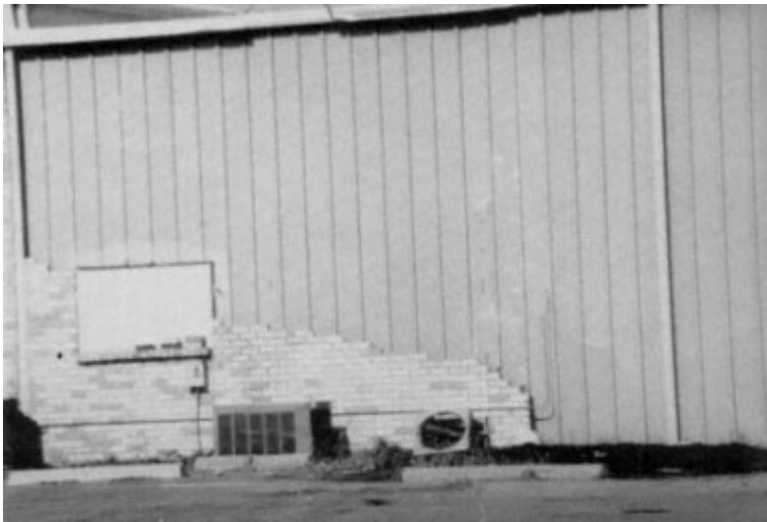
Figure C-3  
Brick veneer stripped from metal building by high suction pressures.

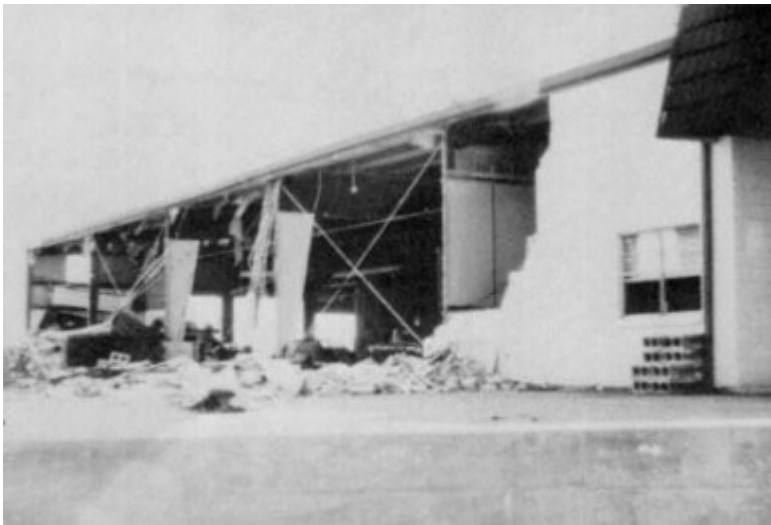
Figure C-4  
Damage to unreinforced masonry wall enclosing metal building in Biloxi. Failure may have been precipitated by loss of large overhead doors. Steel framing was undamaged.

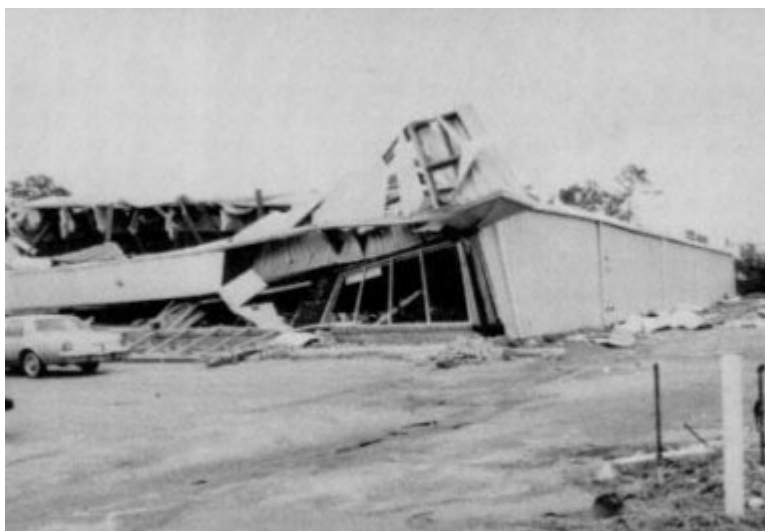
Figure C-7  
 Metal building system in Pascagoula. Failure due to buckling of strut purlins under combined bending and axial loading. Damage limited to first bay.

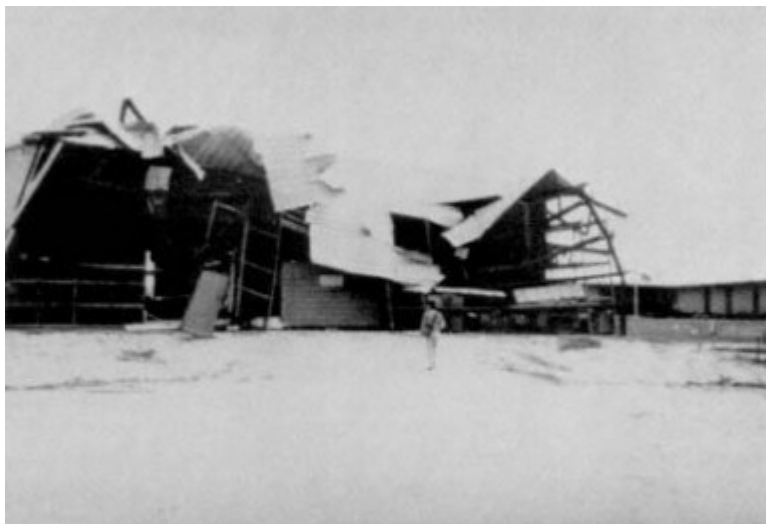
Figure C-8  
End bay damage to preengineered building in Pascagoula.  
Note new, undamaged metal building on right.

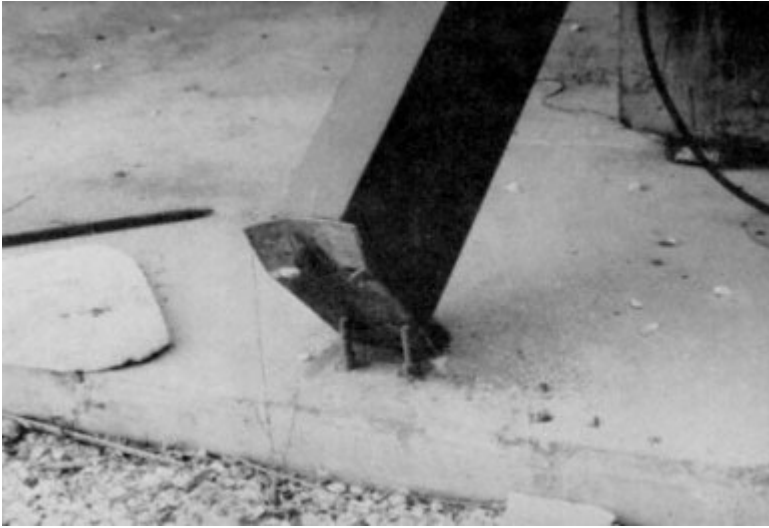
Figure C-9  
Failure of column base plates of building in [Figure C-8](#).
