Hurricane Hugo, Puerto Rico, the Virgin Islands, and Charleston, South Carolina, September 17-22, 1989

Committee on Natural Disasters, Board on Natural Disasters, National Research Council

NATURAL DISASTER STUDIES

Volume Six

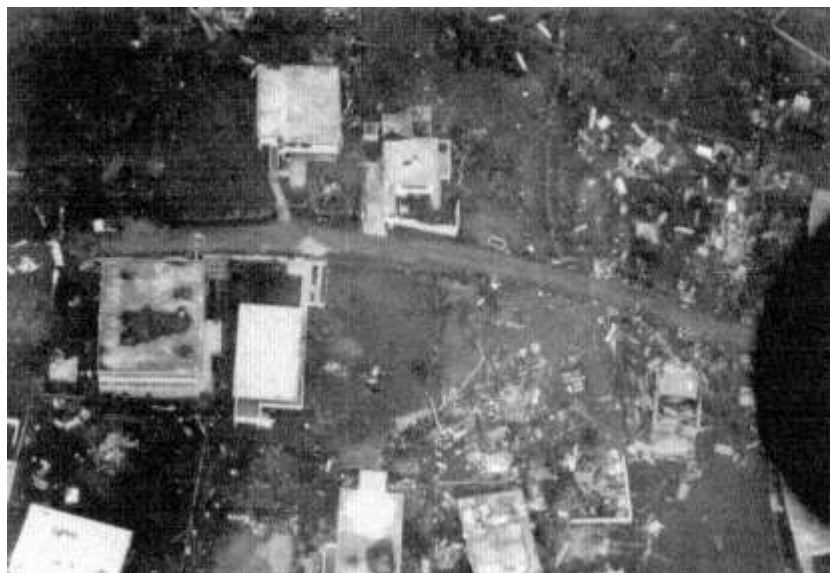
Figure 1-21a
Microburst damage as seen from the low-flying aircraft over Vieques (first photo).

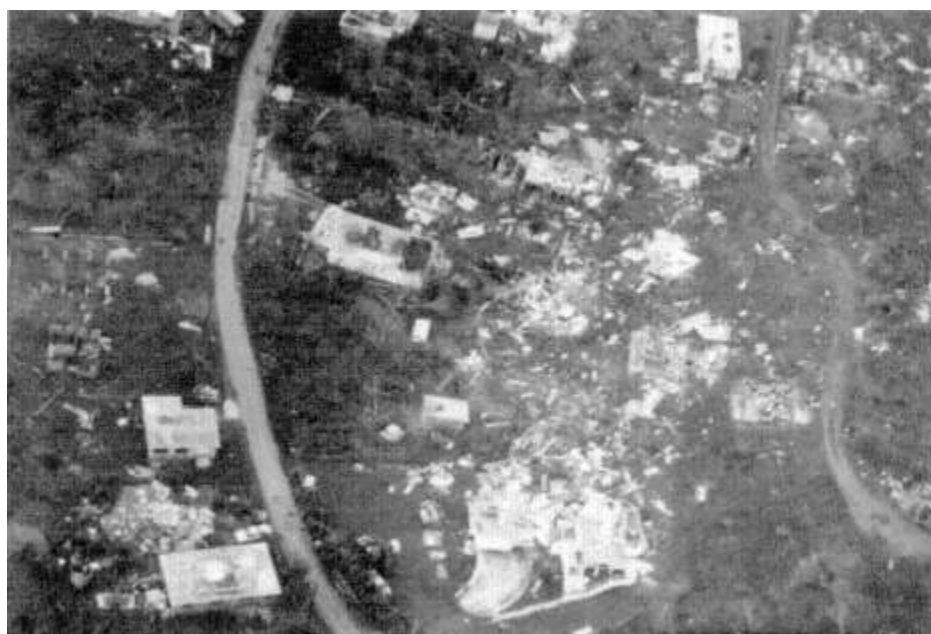
Figure 1-21b
Microburst damage as seen from the low-flying aircraft over Vieques (second photo).

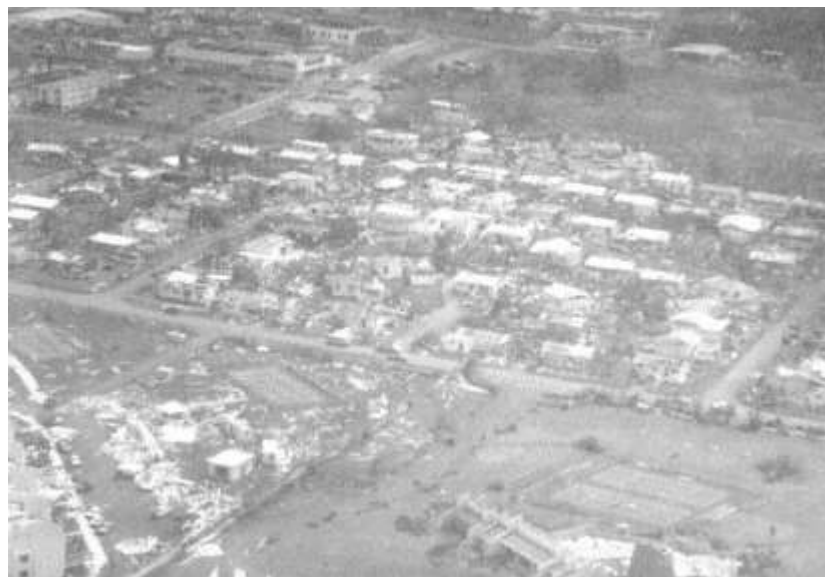
Figure 1-21c
Microburst damage as seen from the low-flying aircraft over the north coast of St. Croix (first photo).

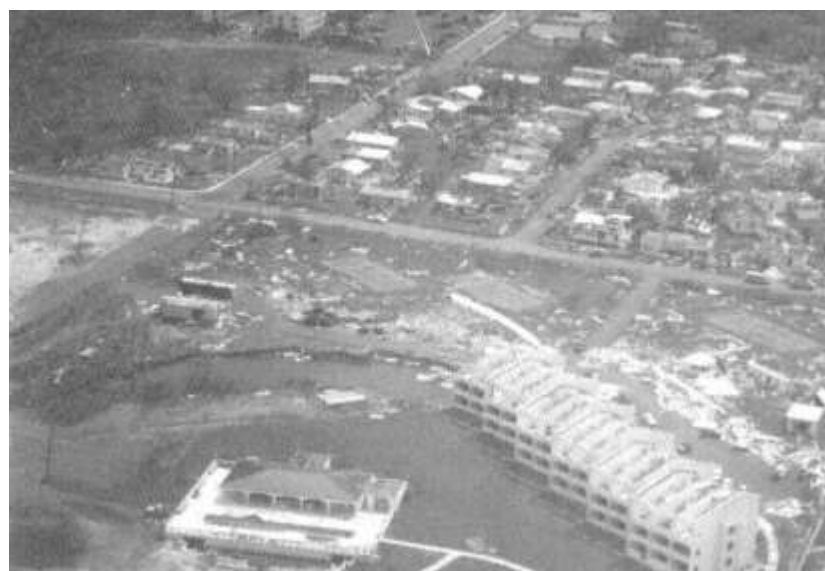
Figure 1-21d
Microburst damage as seen from the low-flying aircraft over the north coast of St. Croix (second photo).

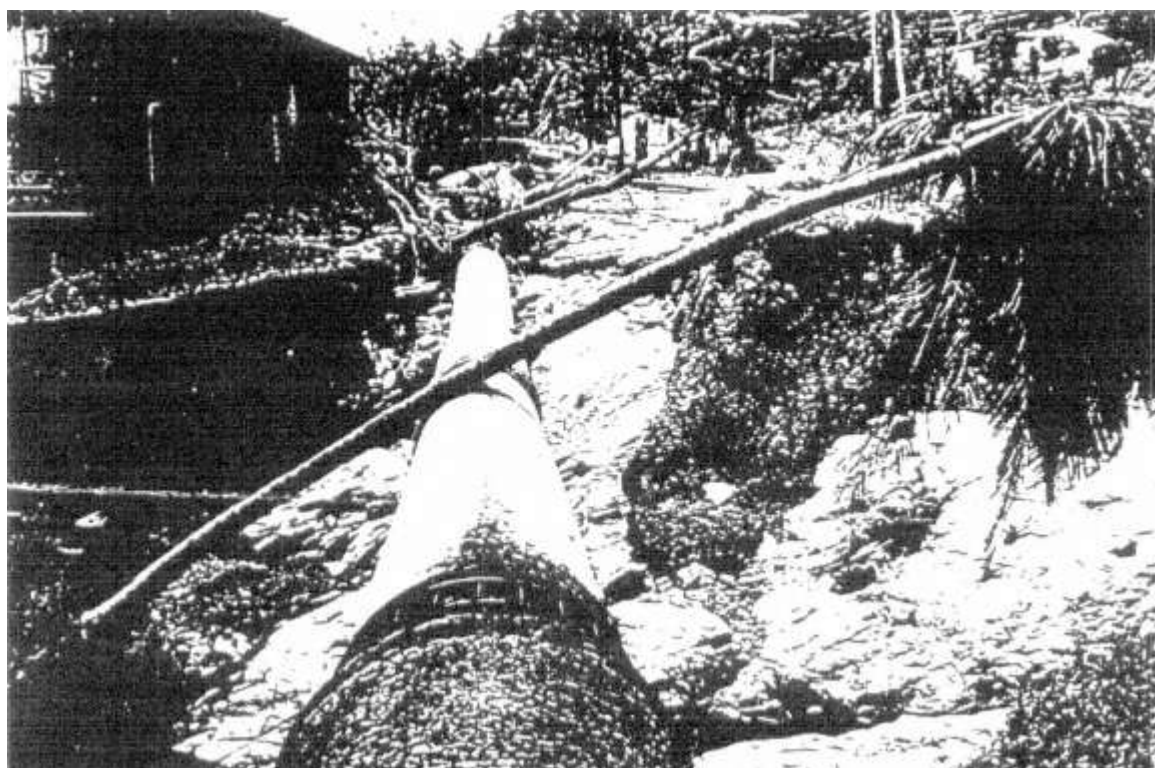
Figure 2-7 Damage at El Carraizo Dam.

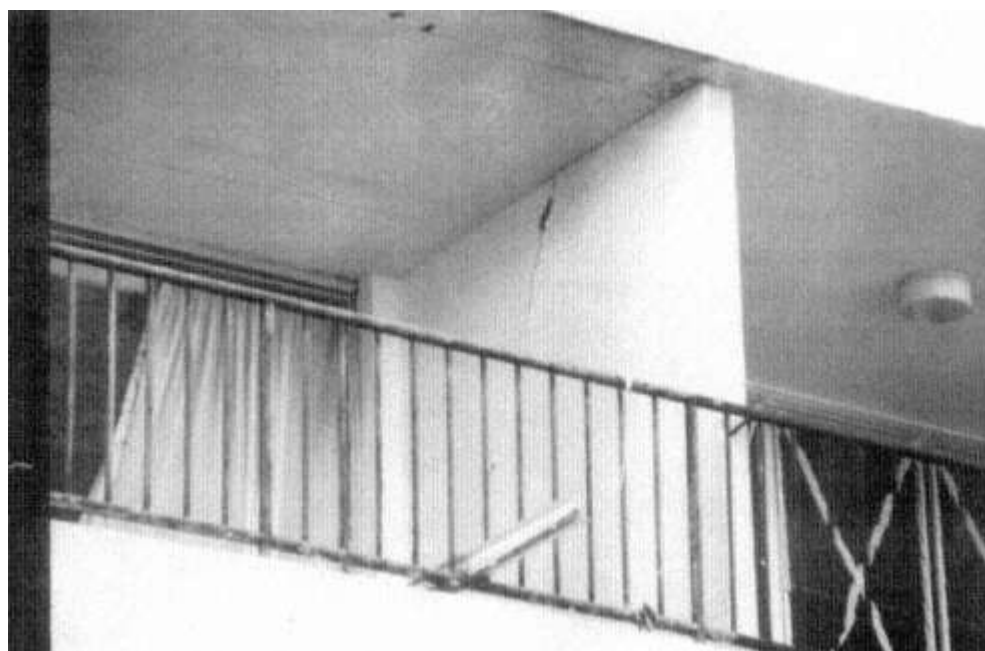
Figure 4-25 Diagonal tension crack in partition wall, Dos Marinas.

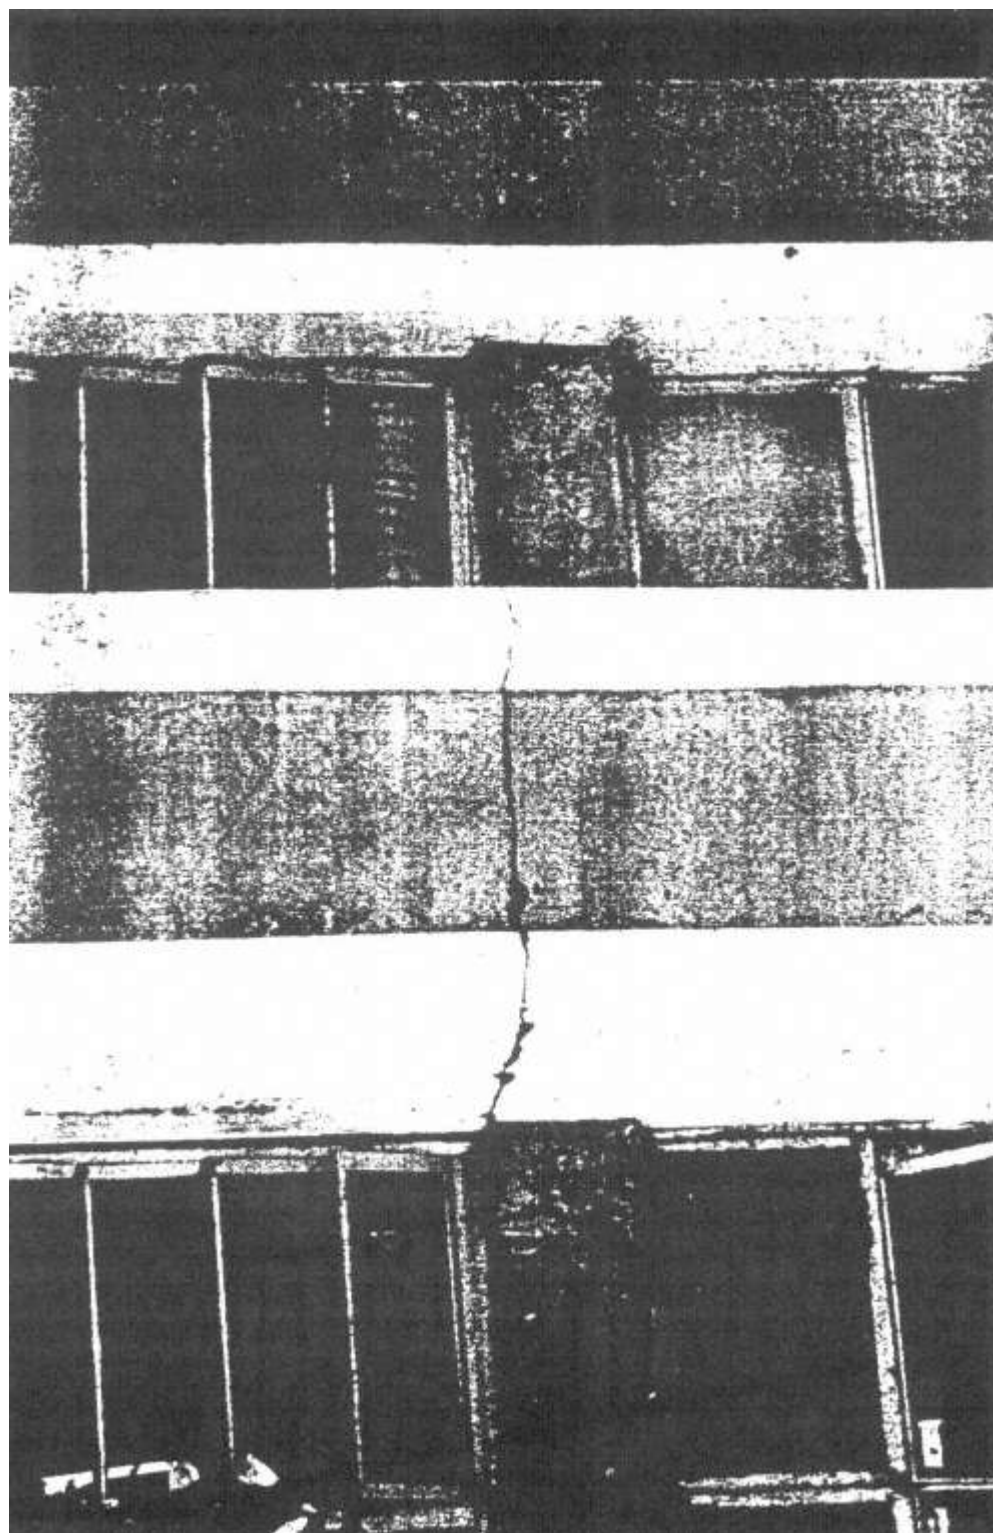
Figure 4-26 Horizontal construction joint in shearwall, Dos Marinas.

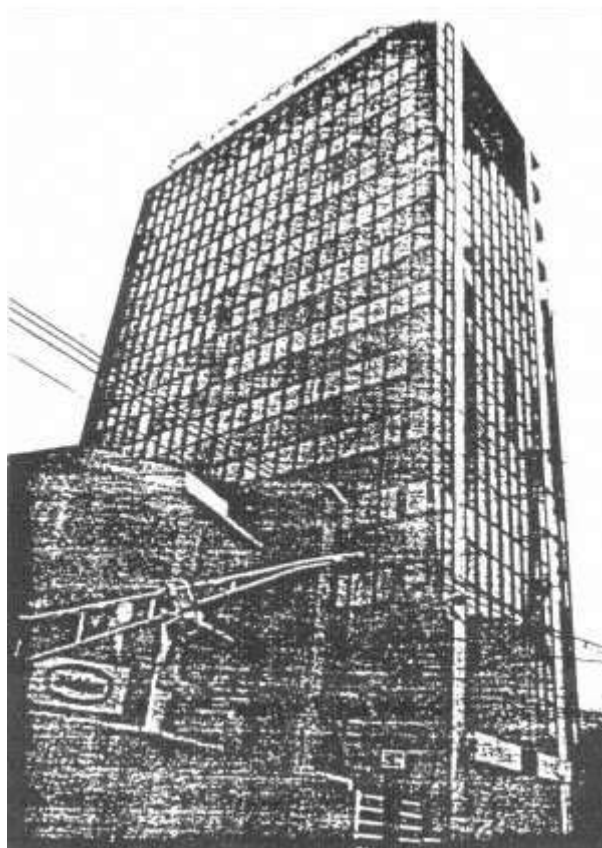
Figure 4-31
Damage to curtain wall, San Juan.

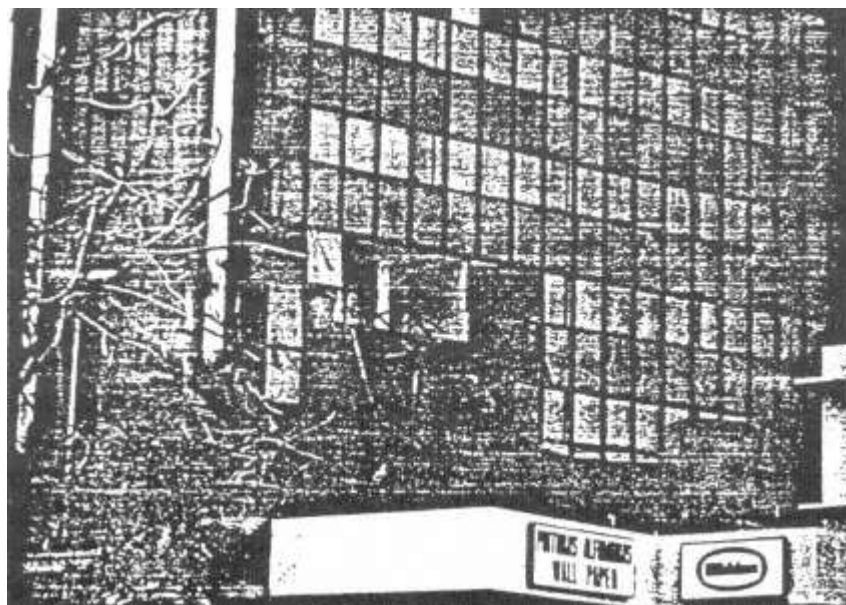
Figure 4-32
Damage to curtain wall near street level, San Juan.

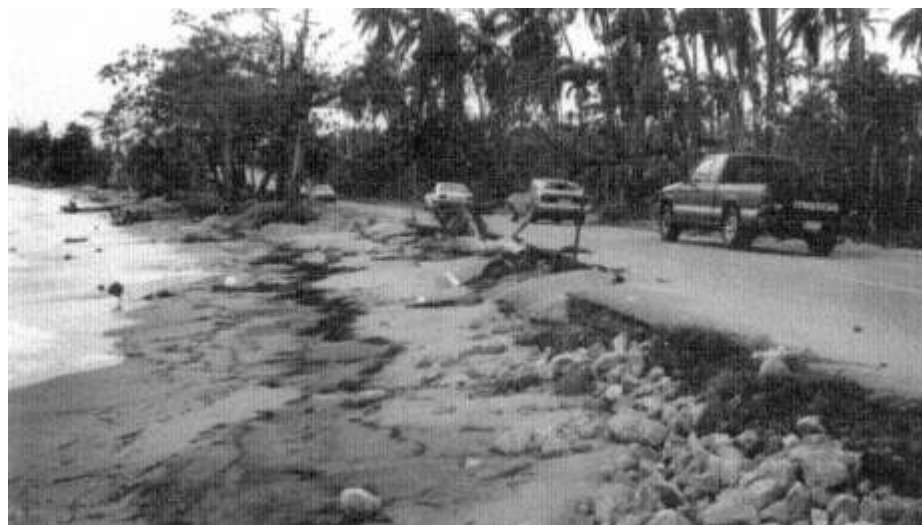
Figure 5-11 Undercutting of pavement by wave action on Route 3, north of Humacao, Puerto Rico.

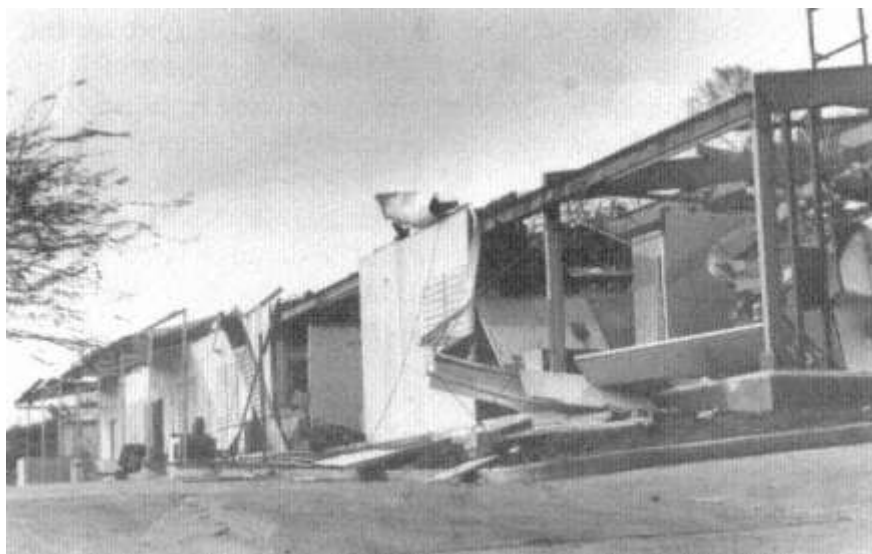
Figure 5-13 Damaged hospital at Culebra.

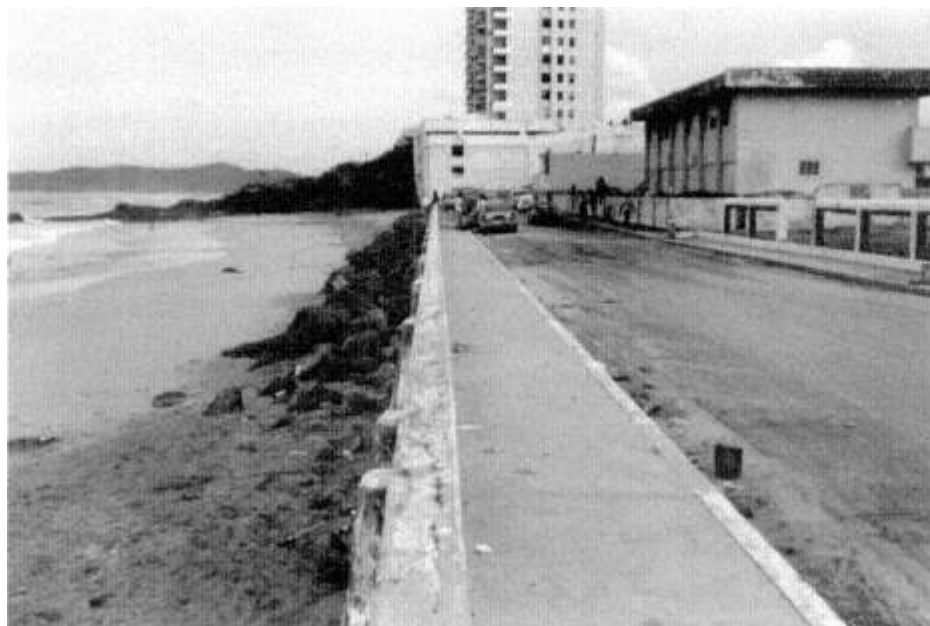
Figure 6-3 Luquillo shorefront showing seawall that had reportedly fallen during Hugo. Storm surge and wave heights near the time of passage of the eye were determined by observing water levels on the distinctive rock formations.

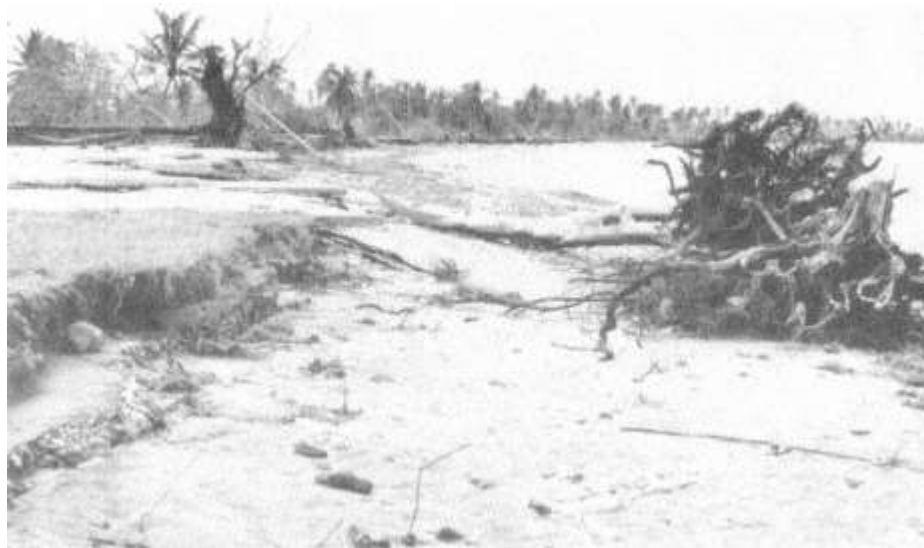
Figure 6-17 Balneario Isla Verde shoreline showing tree stumps on beach and toppled light poles.

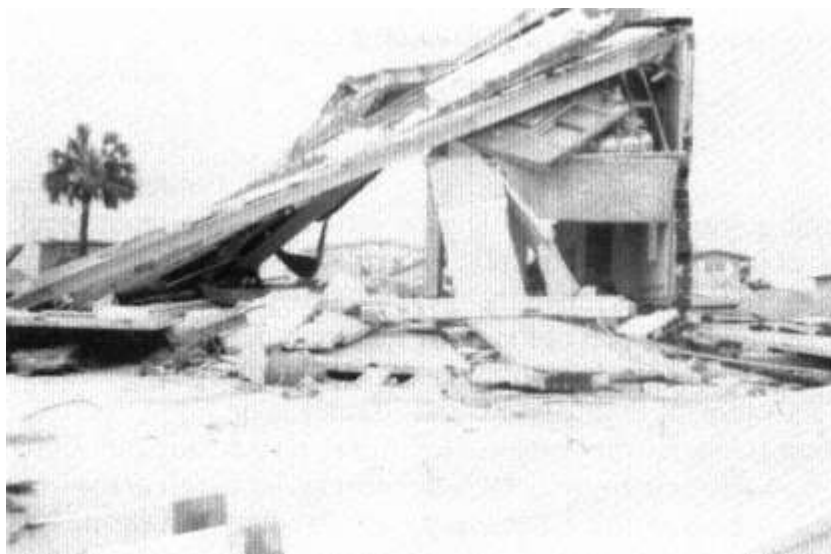
Figure 12-5 A two-story concrete residential structure collapsed under its own weight because of weak foundation (Garden City).

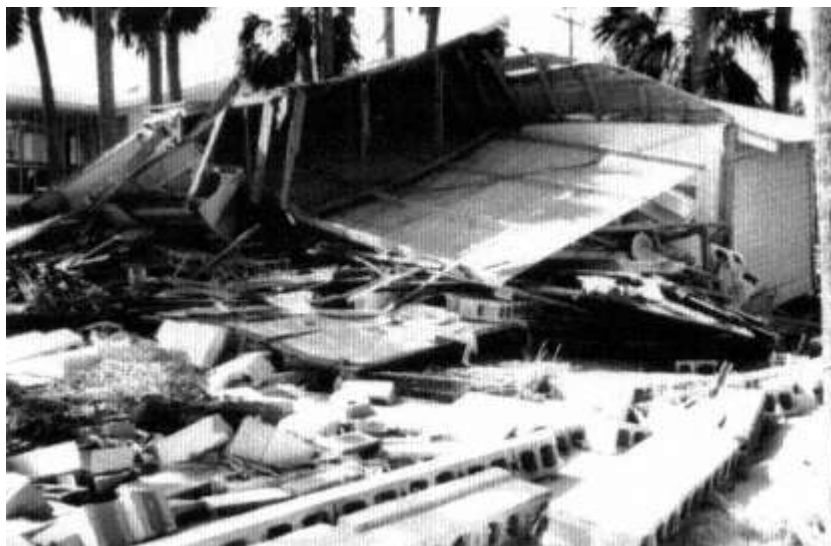
Figure 12-6 Structure with foundation on grade totally demolished by wave force.

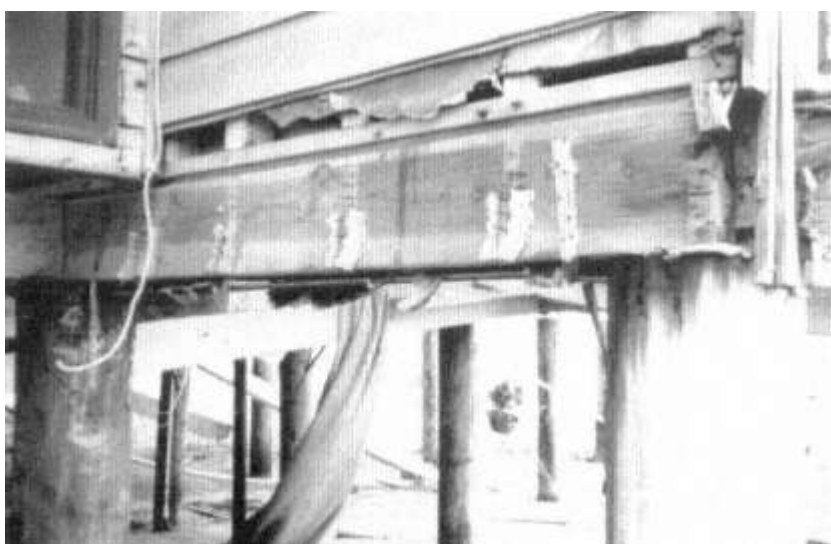
Figure 12-15 Inadequate and improper nailing caused the floor joist to separate from floor beams.

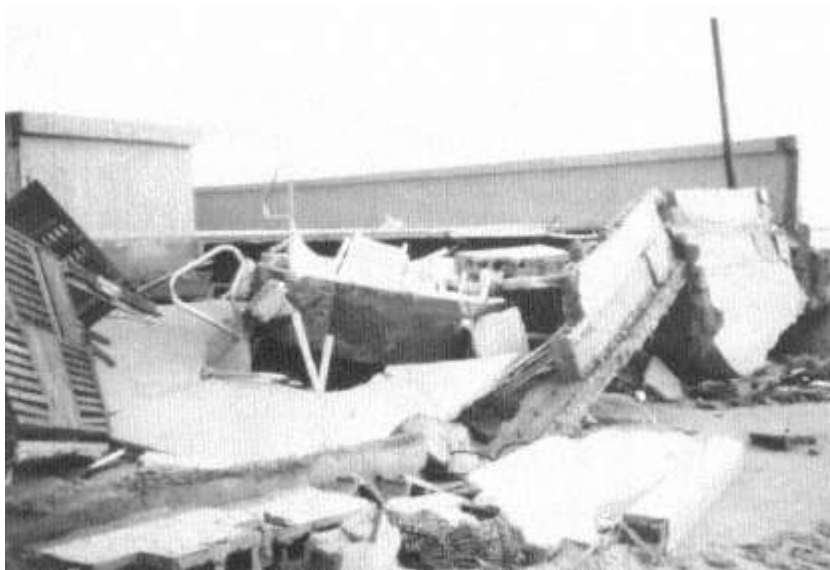
Figure 12-17 Underdesigned return wall was common.

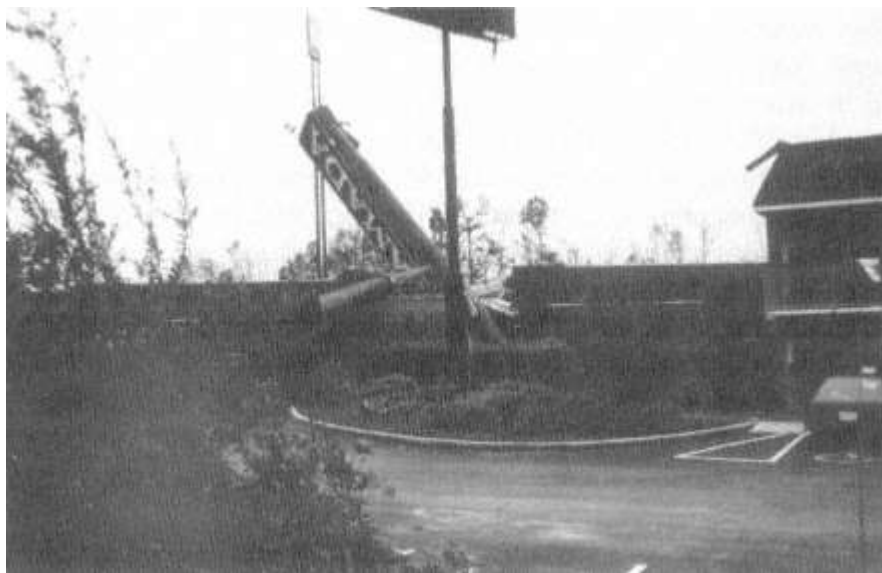
Figure 13-1 Typical damage associated with signs.

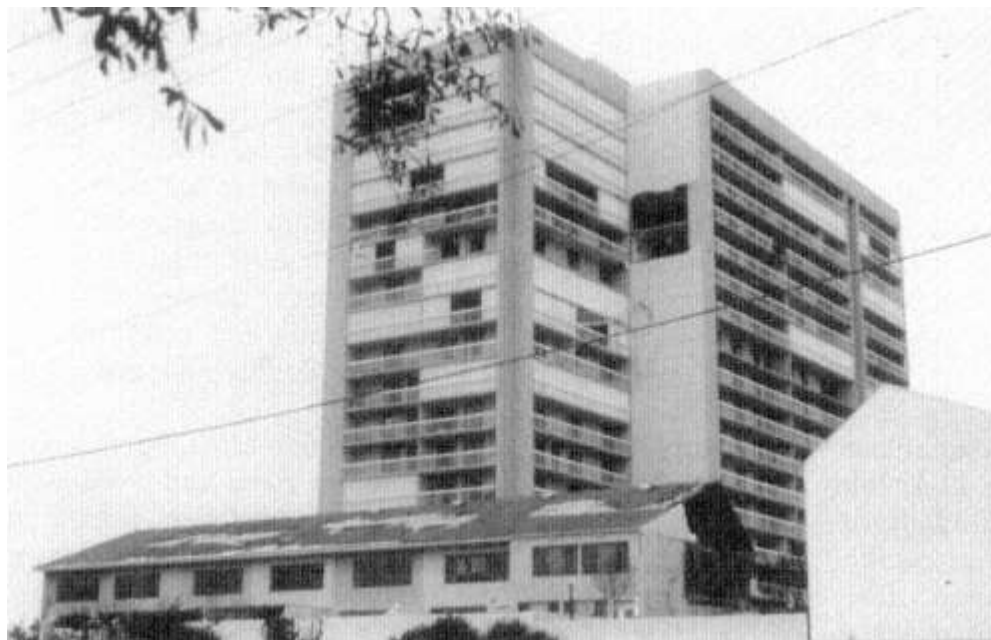
Figure 13-2 Typical damage to roofs.

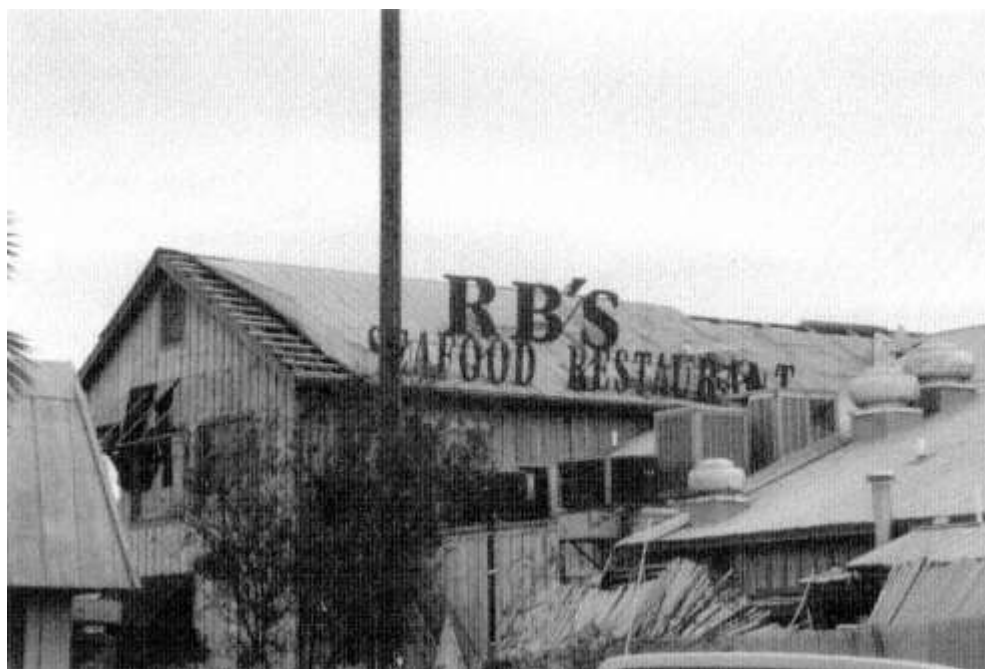
Figure 13-3 Typical damage to metal roof coverings.

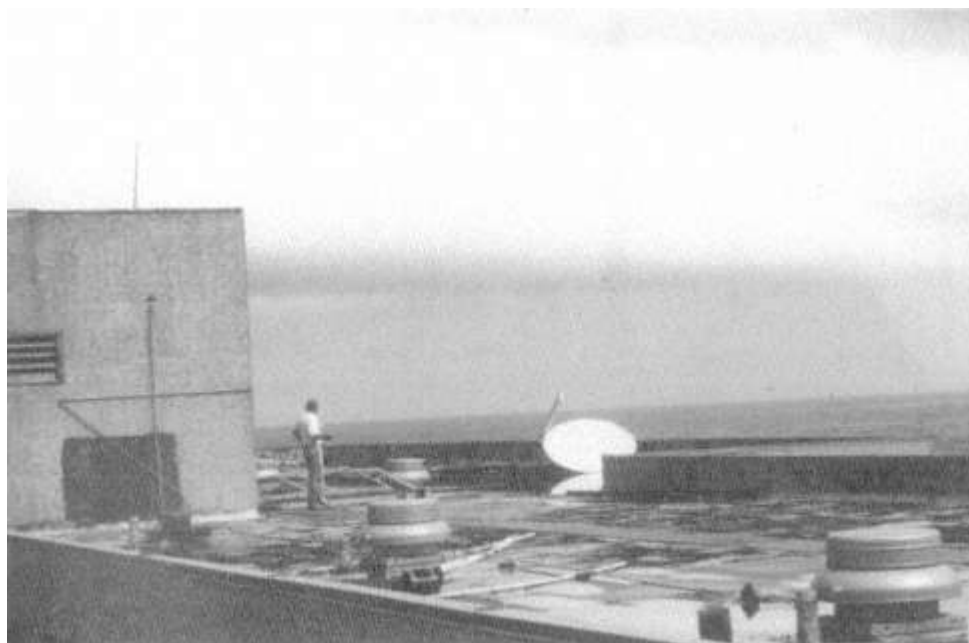
Figure 13-4 Damaged satellite dish is typical of damage associated with roof-mounted mechanical equipment.

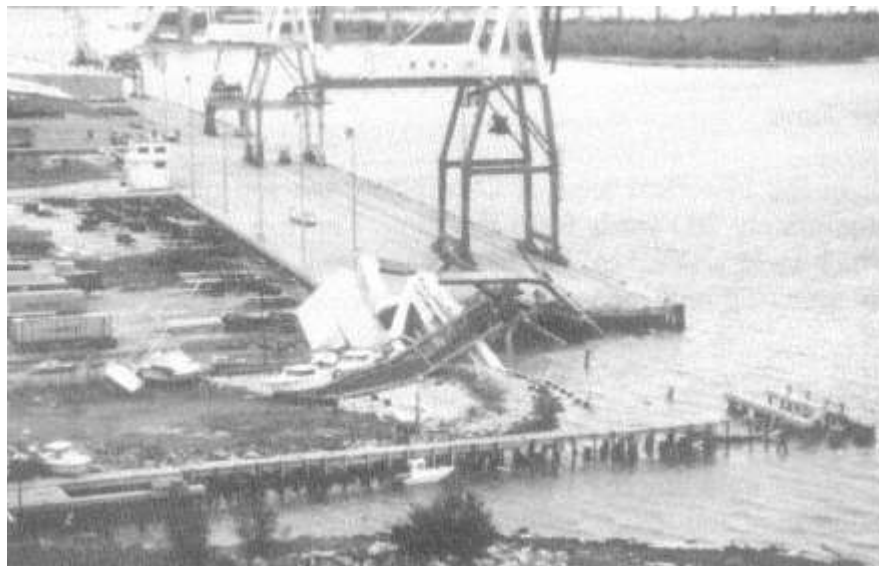
Figure 13-5 Damage to track-mounted cranes in industrial complex.

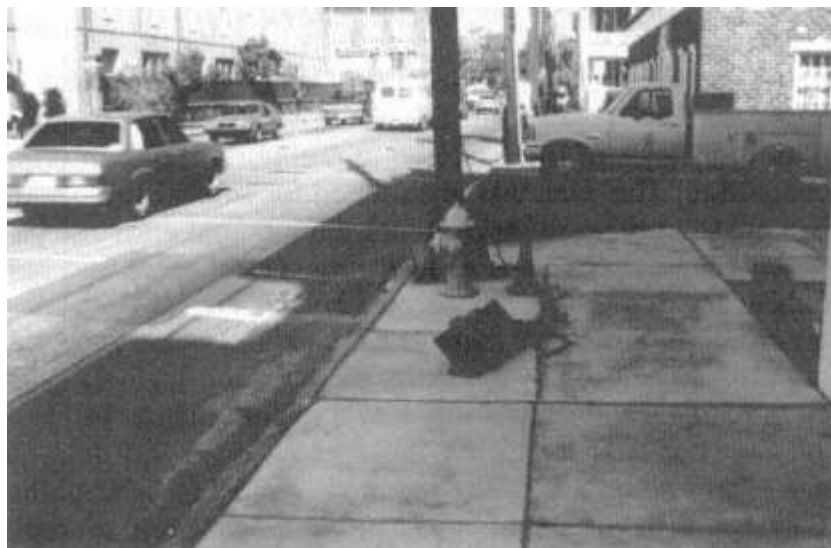
Figure 14-7 Traffic signal downed by wind.
