Macondo Well Deepwater Horizon Blowout: Lessons for Improving Offshore Drilling Safety

LESSONS FOR IMPROVING
OFFSHORE DRILLING SAFETY

Committee on the Analysis of Causes of the
Deepwater Horizon Explosion, Fire, and Oil Spill to
Identify Measures to Prevent Similar Accidents in the Future

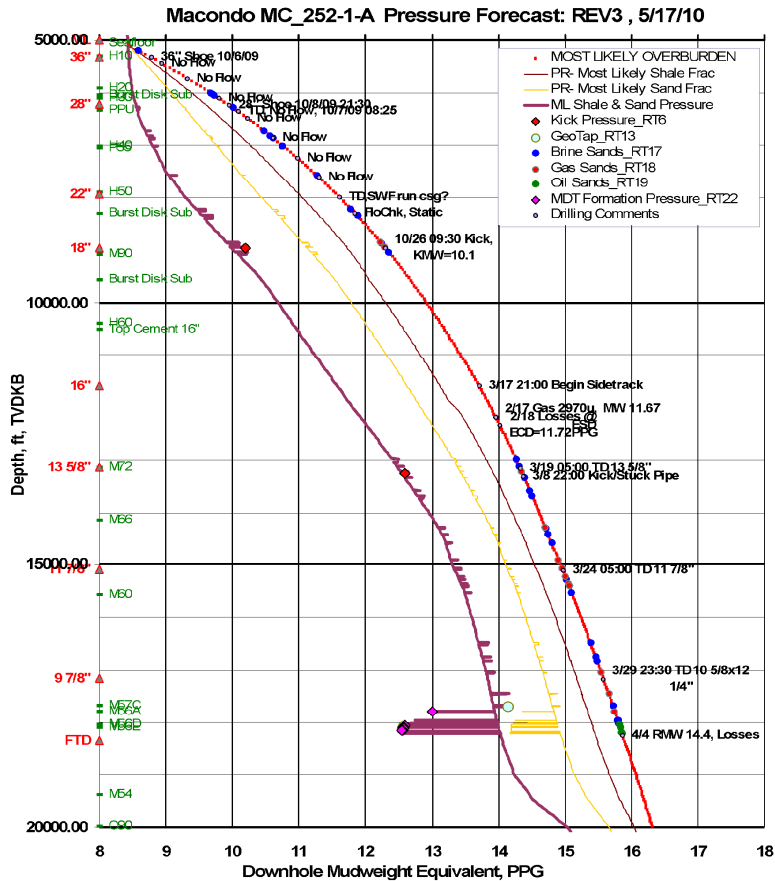
2. In the course of drilling at 13,250 feet, a kick occurred, and the lower annular blowout preventer (BOP) was closed in response. During well control operations, the drill string became stuck and was severed at 12,147 feet. The drill string and hole below 12,147 feet were abandoned, and subsequent well drilling deviated slightly to go around the abandoned materials left in the original hole. The $13\frac{5}{8}$ -inch liner was run at 13,145 feet, which was shallower than planned, to allow the well to be drilled safely past the higher-pressure reservoir that had been encountered. The $11\frac{7}{8}$ -inch liner was used at 15,103 feet to seal the reservoir and allow for the use of higher mud weights than had been anticipated. Mud weight was to be kept between the curves for pore pressure and fracture pressure, as shown in Figure 2-3.

FIGURE 2-3 The four curves (moving from right to left) represent overburden stress, fracture gradients in the shale and sands, and pore pressure in the Macondo well. Depth and diameter values on the y-axis correspond to the final well bore architecture shown in Figure 2-2. The equivalent mud weight (EMW), expressed in pounds per gallon (ppg), must be higher than the pore pressure to avoid flow from the well and lower than the fracture gradient to prevent accidental hydraulic fracturing. Note the small separation between the values at depths below 18,000 feet. Source: BP unpublished report, July 26, 2010.³ Reprinted with permission, BP.

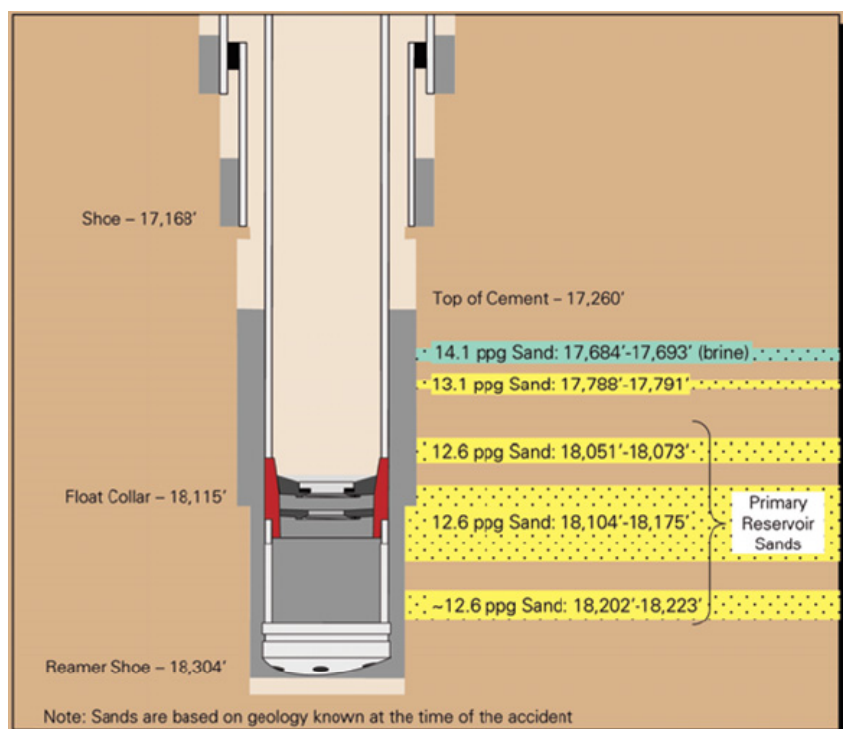
tion report, the well analysis indicated that there were in fact several reservoirs open in the wellbore with decreasing pore pressure with depth, as shown in Figure 2-4. The hydrocarbon reservoirs had pore pressures equivalent to a range of 12.6 to 13.1 ppg. A reservoir containing salt water that had a pore pressure equivalent to 14.1 ppg was also exposed in the wellbore. As discussed below, the difference between the mud weight needed to prevent flow of salt water and the mud weight above which reservoir fracture could occur was only 0.2 ppg. Recent reports in the press have indicated that a thin gas sand was present above the salt water bearing zone shown in Figure 2-4 and have questioned the possible contribution of this sand to the blowout. The committee has seen no evidence indicating that flow occurred upwards in the annulus between the production casing and the reservoirs (see discussion below). Also, the presence of the high-pressure salt water sand created the same completion problem referenced above as would have been created by the presence of a high-pressure gas sand. Therefore, the presence or absence of the gas sand is expected to have had no material effect on the cause of the blowout.

FIGURE 2-4 Variation of pore pressure in the open hole section of the Macondo well expressed in pounds per gallon. Source: BP 2010, p. 54. Reprinted with permission; copyright 2010, BP.

To continue drilling to the planned final depth of 19,650 feet, the reservoirs that had been discovered with decreasing pore and fracture pressures with depth (Figure 2-4) were to be sealed with the $9\frac{7}{8}$ - × 7-inch combination casing string and cement. However, because the hole diameter that could be drilled below the 7-inch casing was considered too small to be practical, the well was terminated at 18,360 feet.

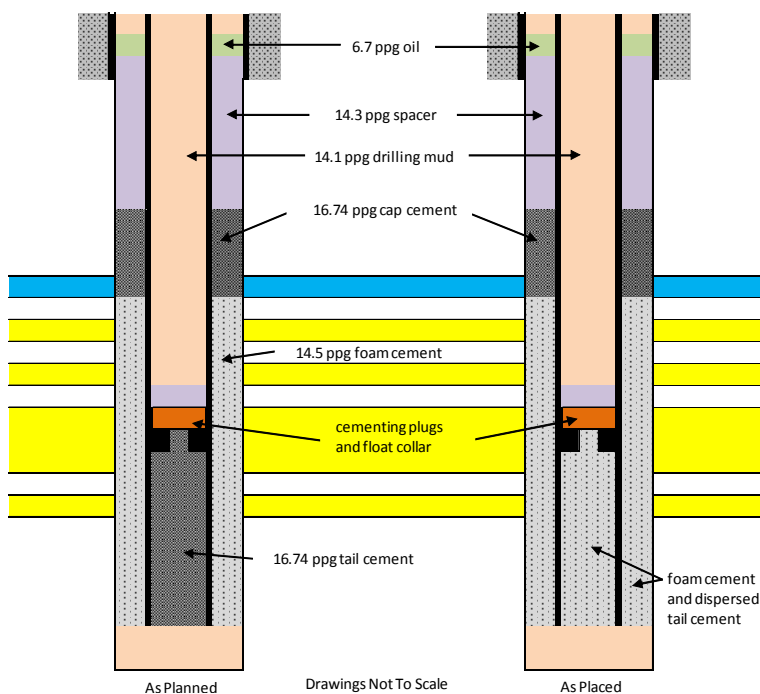
FIGURE 2-5 Planned cement location and likely cement location after pumping. Source: Committee.

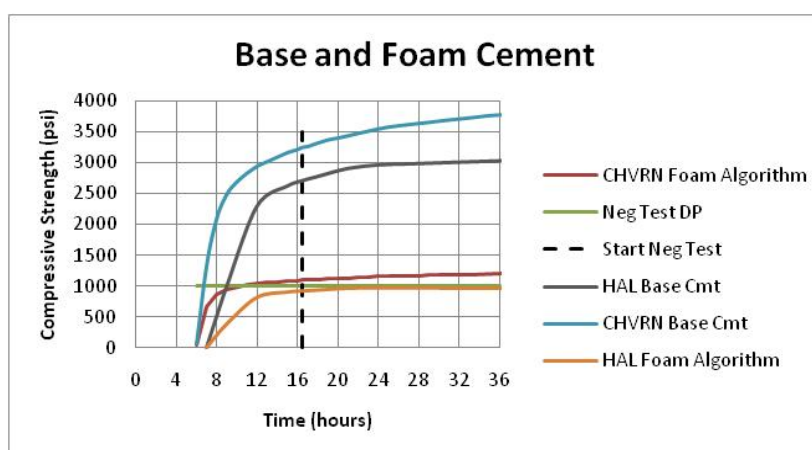
FIGURE 2-7 Uncontaminated cement compressive strength tests (DP = differential pressure). Source: Committee.

The curves for the two foamed cements are not from direct measurement but assume that the foamed cement compressive strength is reduced according to the foam protocol used in the Chevron test software (by a factor of approximately 35 percent).

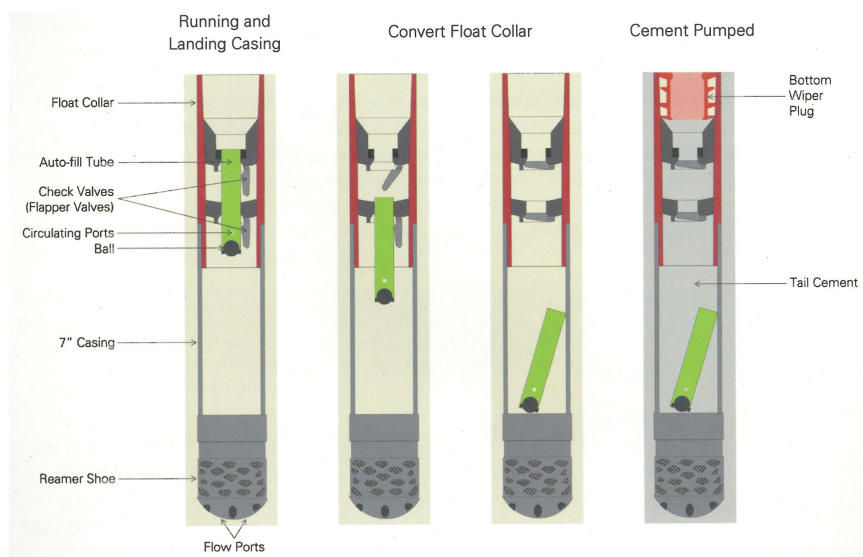
FIGURE 2-8 Float collar with flapper valves and differential fill tube. Source: BP 2010, p. 71. Reprinted with permission; copyright 2010, BP.

Once the casing was in place in the Macondo well, initial circulation could not be established until 3,142 psi of pump pressure was applied. This suggests that the shoe track was plugged with foreign material when it was run into the well. The practice of allowing mud to fill the casing by flowing up through the differential fill tube is a time-saving step that would not be needed if the casing were filled with mud from the top as it is run, a much slower process but one that reduces the possibility of debris entering the casing.

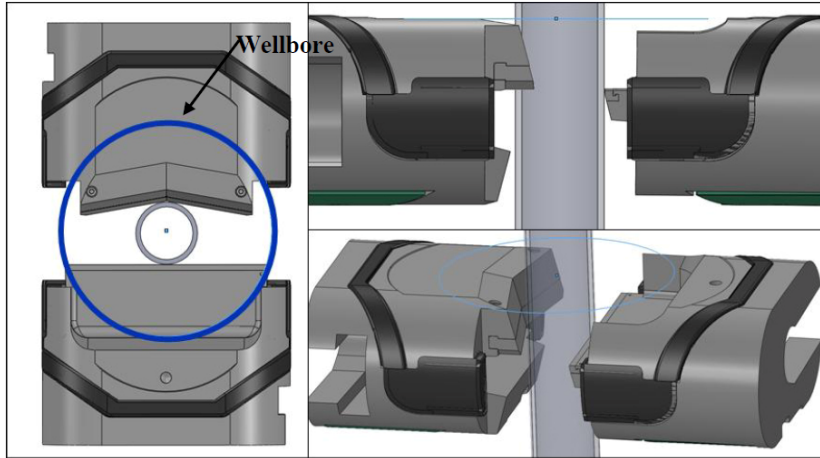
The BSR was the uppermost of the five rams of the BOP stack and is shown for nominal operation in Figure 3-2. A BSR is like a massive metal scissors with two opposing blades that are designed to slice through the drill pipe as the blades pass by each other, as shown in Figure 3-3, and seal the well. The design intent was that, when the two blades of the “scissors” passed by each other and fully penetrated into the “side packers” on the other side, the seal

FIGURE 3-2 Sketch of intended nominal operation of BSR in the Macondo well. Source: DNV 2011a, I, p. 155. Reprinted with permission; copyright 2011, DNV.

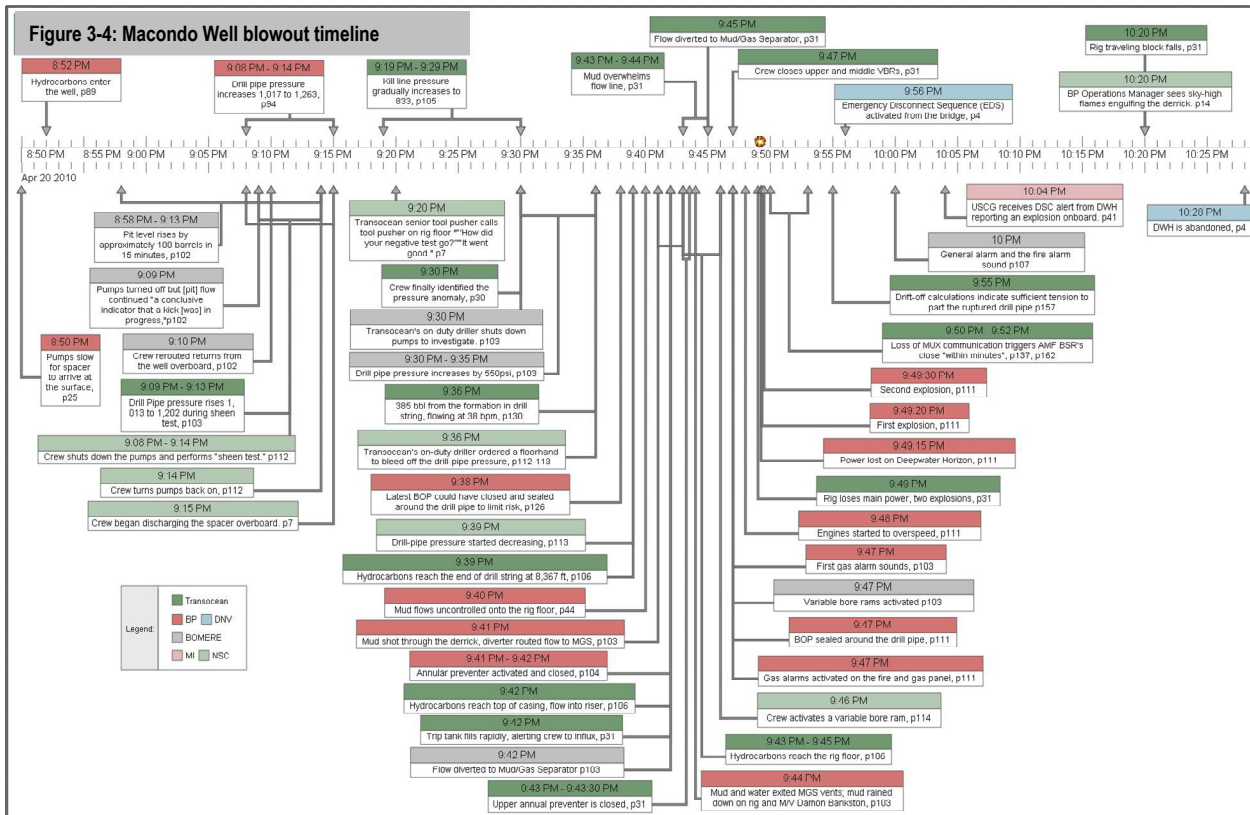
FIGURE 3-4 Macondo well blowout timeline. Source: Committee.

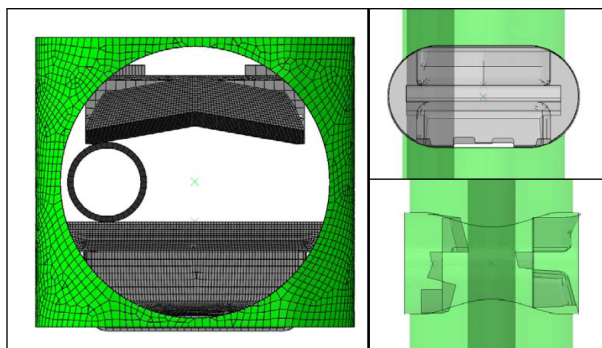
FIGURE 3-5 Finite element analysis model of BSR blade surfaces and off-center drill pipe. Source: DNV 2011b, p. 15. Reprinted with permission; copyright 2011, DNV.

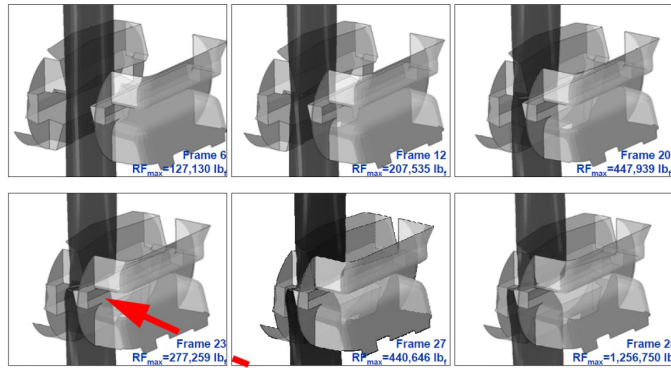
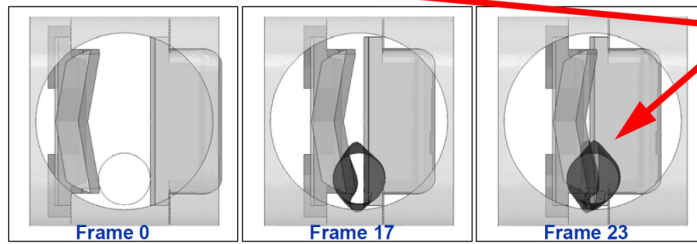
Revised Figure 140 Progression of Off-Center BSR Shear Model - Isometric View

Total flow area available from the well with VBRs sealed until the drill pipe erodes with only ~1/3 the ultimate ram closing load applied.

FIGURE 3-6 Progression of off-center BSR shear model, isometric view (*top*) and top view showing deformation of drill pipe outside of shearing blade surfaces (*bottom*). Source: DNV 2011b, p. 17. Reprinted with permission; copyright 2011, DNV.
