**The New Year's Eve Flood on Oahu, Hawaii:
December 31, 1987 - January 1, 1988**

Committee on Natural Disasters, National Research Council

NATURAL DISASTER STUDIES

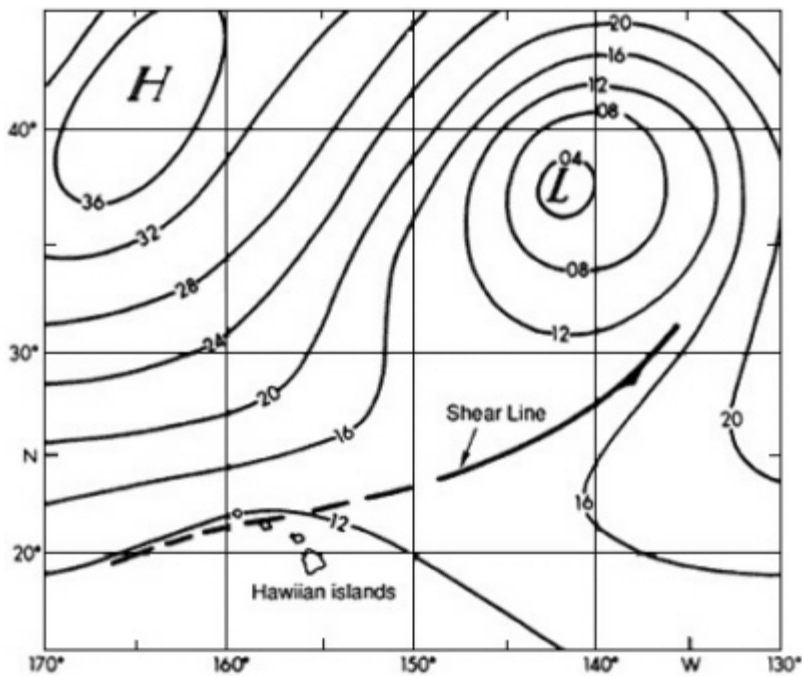
Figure 2 Honolulu surface analysis for 0000 GMT January 1, 1988 (2:00 p.m. December 31, Hawaiian Standard Time). Pressure values are given in millibars with 1,000 millibars = 00. The dashed line over the Hawaiian Islands represents the shear line emanating from the cold front NE of Oahu. 1° latitude = 60 nautical miles.

The surface weather conditions on the afternoon prior to the floods are shown in Figure 2. A cold front extending from a low-pressure center at 37°N, 142°W, weakened into a shear line in the vicinity of the islands. A shear line has few of the classical characteristics of a front but is a center of strong low-level convergence between weak east winds or, in this instance, east-southeasterly winds to the south and fresh north or northeast winds to the north. A shear line is a significant cloud

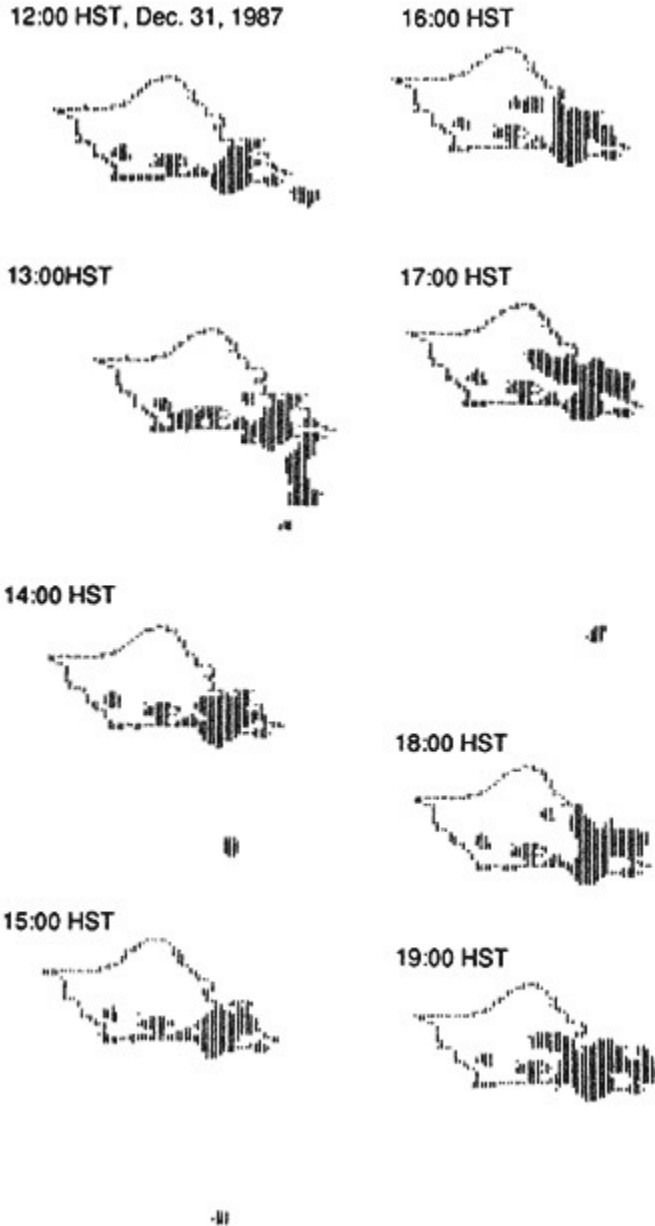
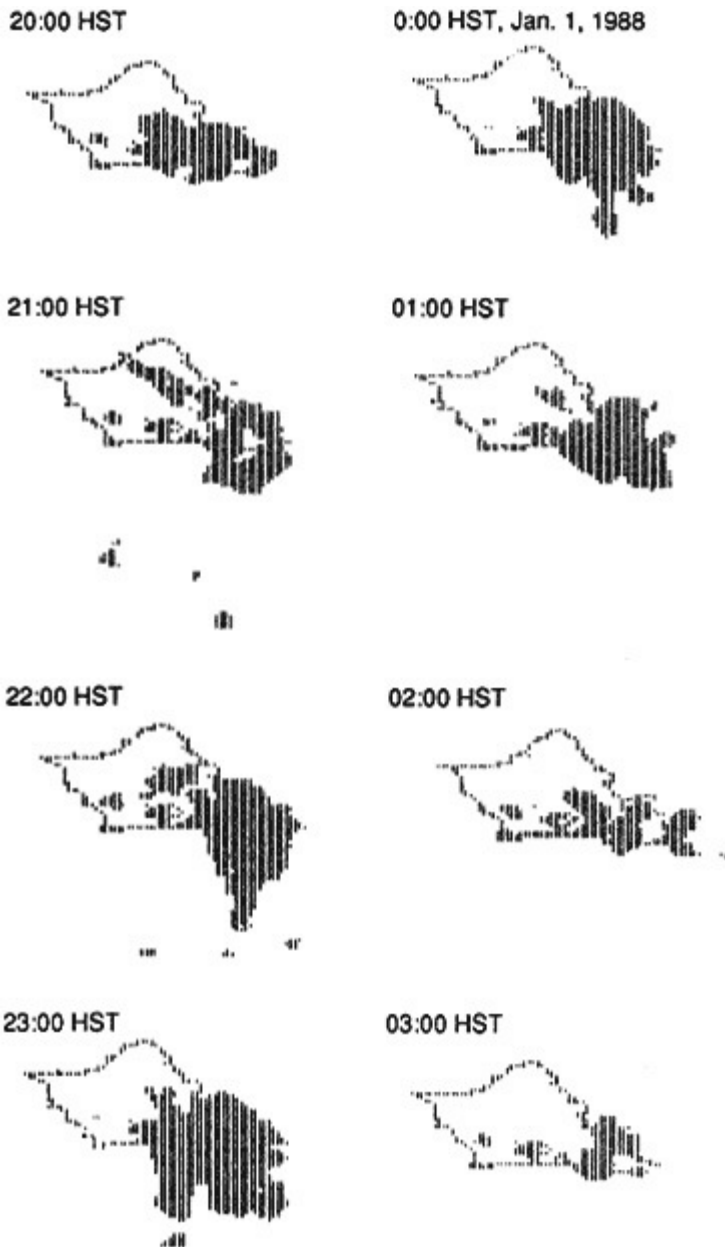
Figure 3a
Figures 3a and 3b Reproduced radar images from the University of Hawaii 3-centimeter radar for the period between 1200 (Hawaiian Standard Time) December 31, 1987 and 0300 January 1, 1988. The radar

Figure 3b cannot detect shallow clouds at azimuths between 300 and 360 degrees due to blockage by mountains. The return from 270 degrees at 1200 is a reflection off the southern ridge of the Waianae mountain range.

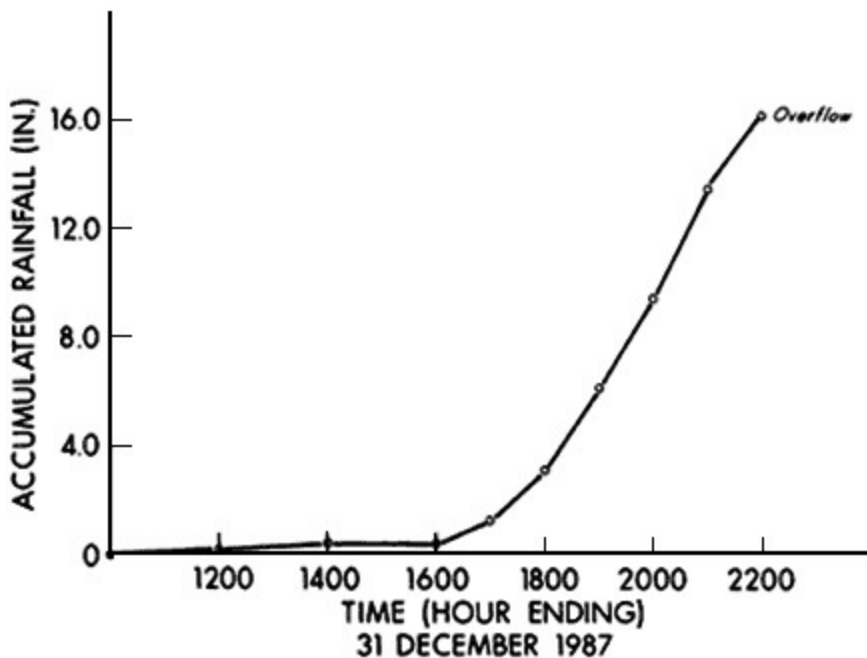
Figure 6
Rainfall accumulation for recording raingauge at Maunawili (state raingauge no. 787.1).

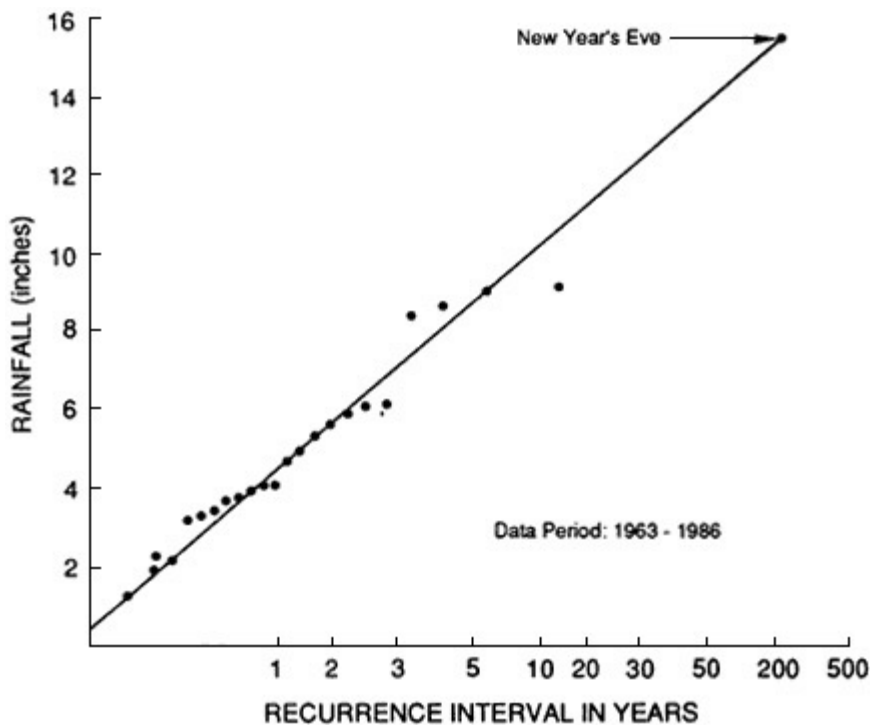
Figure 8 Type-I Gumbel frequency distribution for 1965–1986 annual maximum 6-hour rainfall at Maunawili (state raingauge no. 787.1). Rainfall totals such as that from the New Year's Eve storm are expected to recur only every 100–200 years.

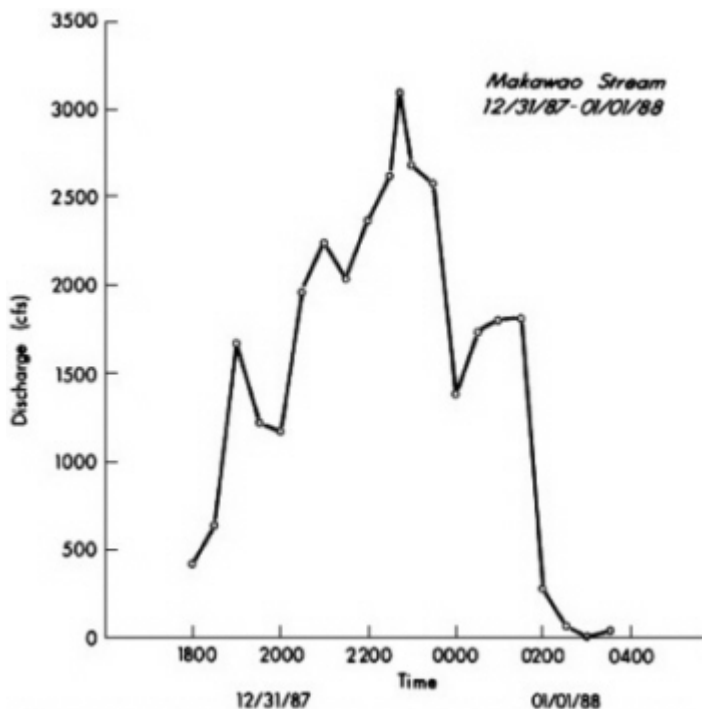
Figure 11 Hydrograph of the New Year's flood recorded at Makawao Stream (station no. 2540).

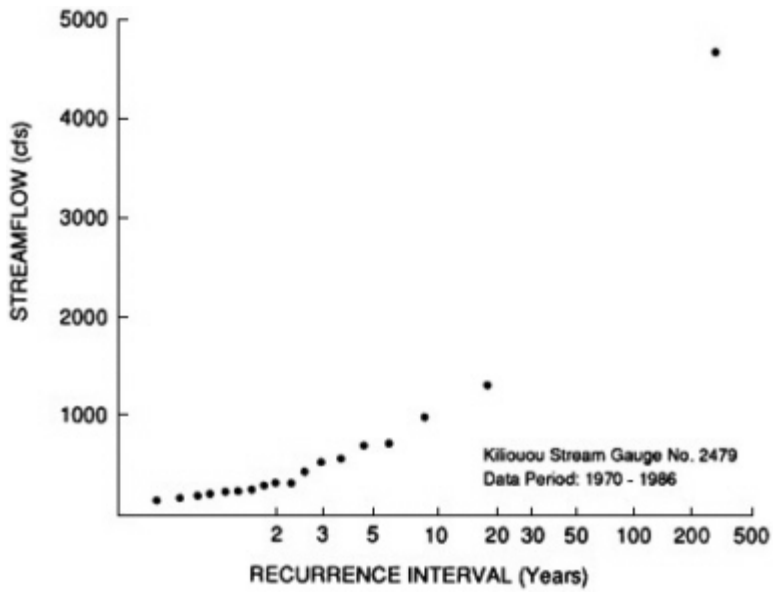
Figure 12
Gumbel Type I frequency distribution of an annual maximum instantaneous streamflow for Kuliouou Stream (station no. 2479). Period of record is 1970 through 1986.

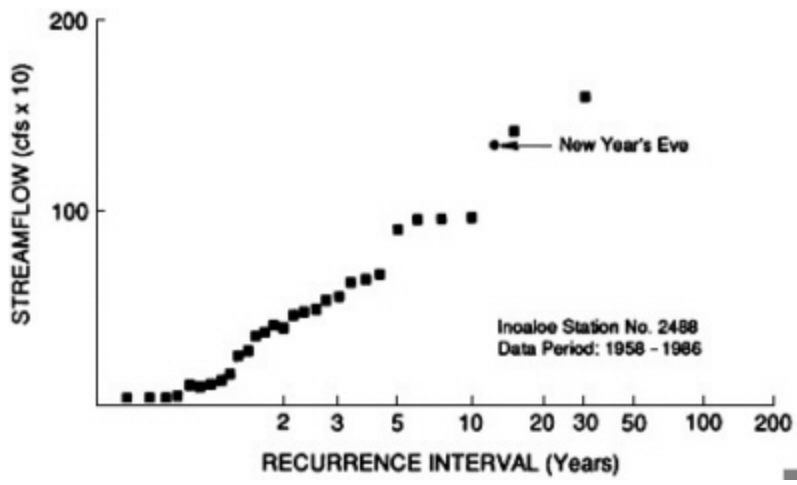
Figure 13
Gumbel Type I frequency distribution of an annual maximum instantaneous streamflow for Inoaole Stream (station no. 2488) for period of record 1958 through 1986.

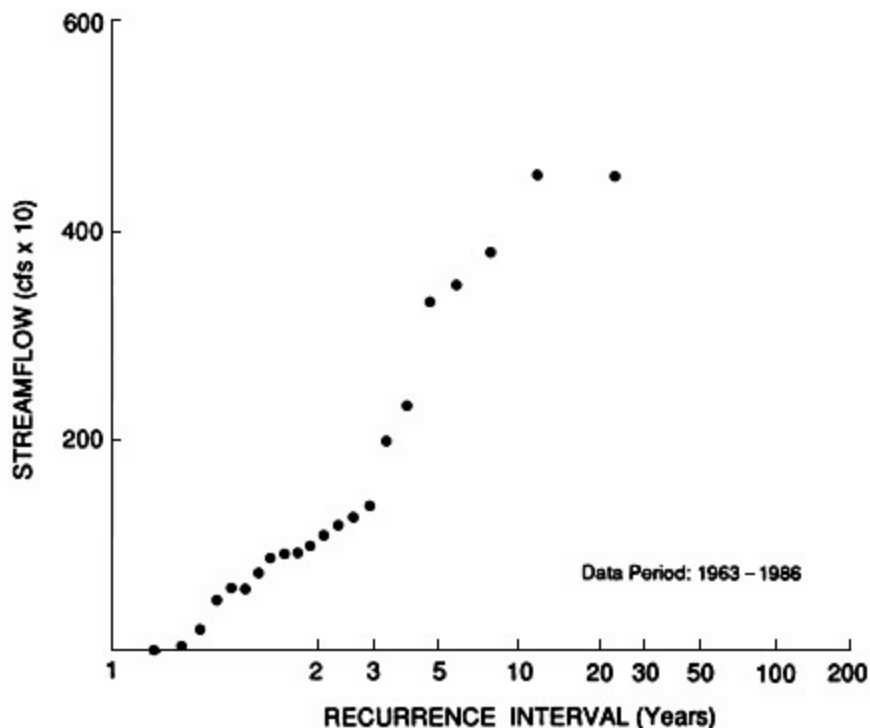
Figure 14
Gumbel Type I frequency distribution of an annual maximum instantaneous streamflow for Waimanalo Stream (station no. 2490) for period of record 1963 through 1986.

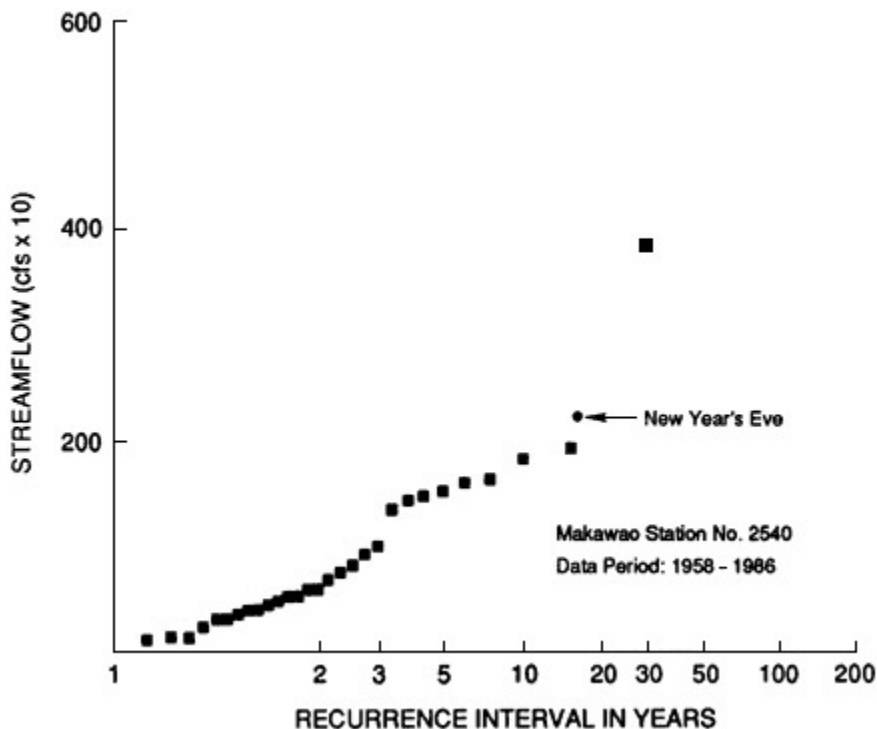
Figure 15
Gumbel Type I frequency distribution of an annual maximum instantaneous streamflow for Makawao Stream (station no. 2540) for period of record 1958 through 1986.

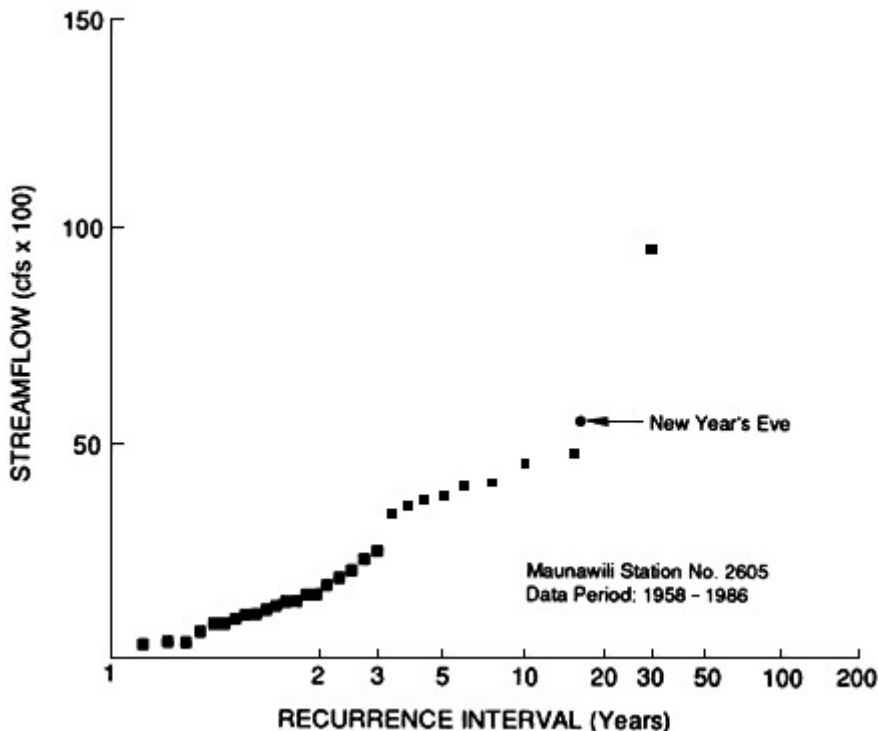
Figure 16
Gumbel Type I frequency distribution of an annual maximum instantaneous streamflow for Maunawili Stream (station no. 2065) for period of record 1958 through 1986.

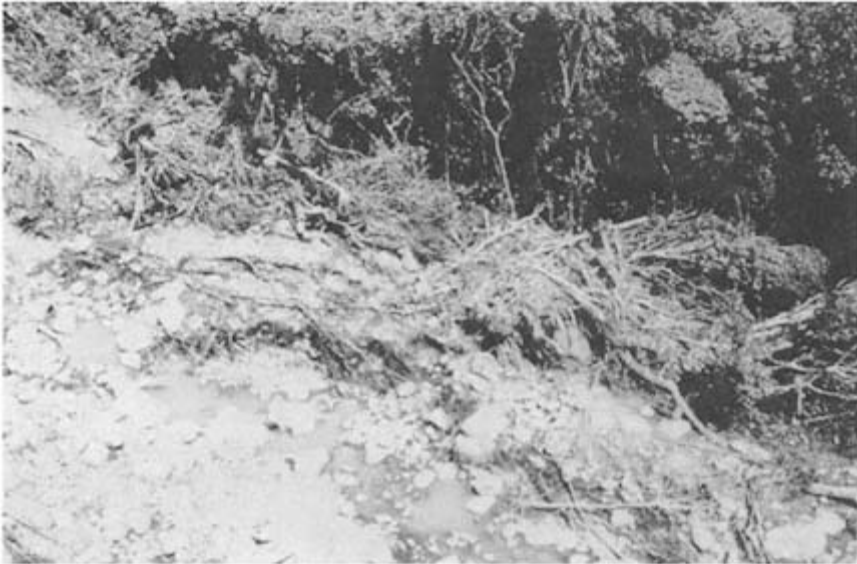
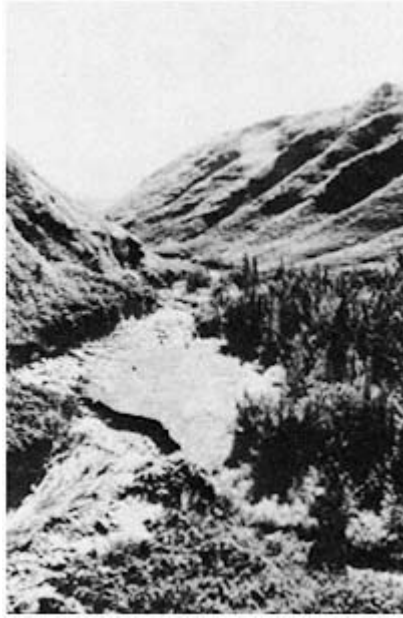
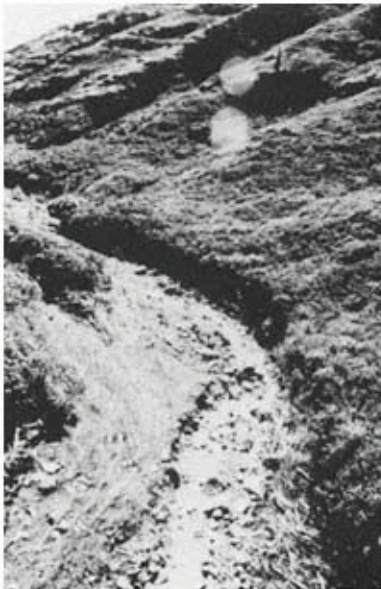
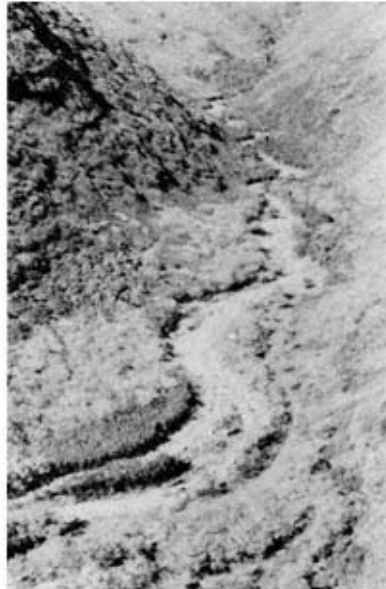
Figure 17a-e Floodways in upper Niu Valley.

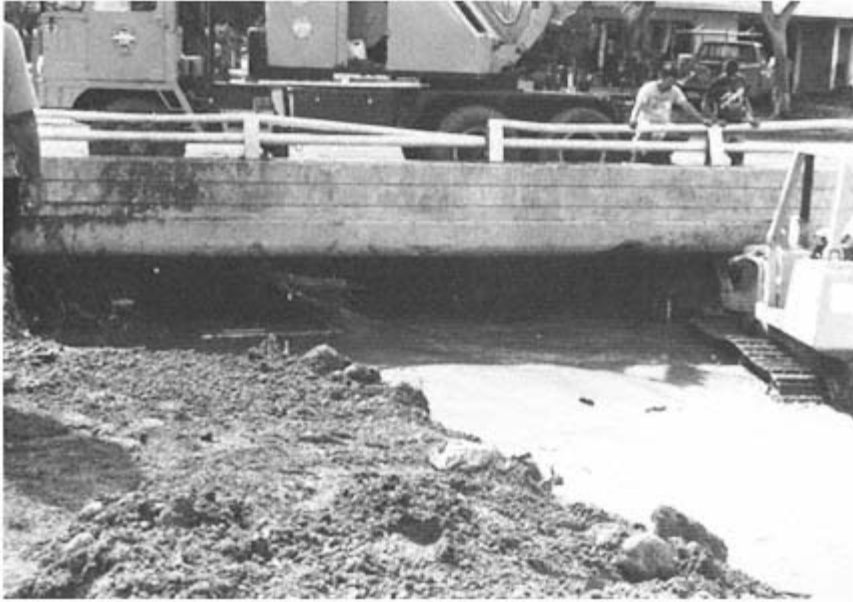
Figure 18a Bridge over east fork of Niu stream at Halemaumau Street.

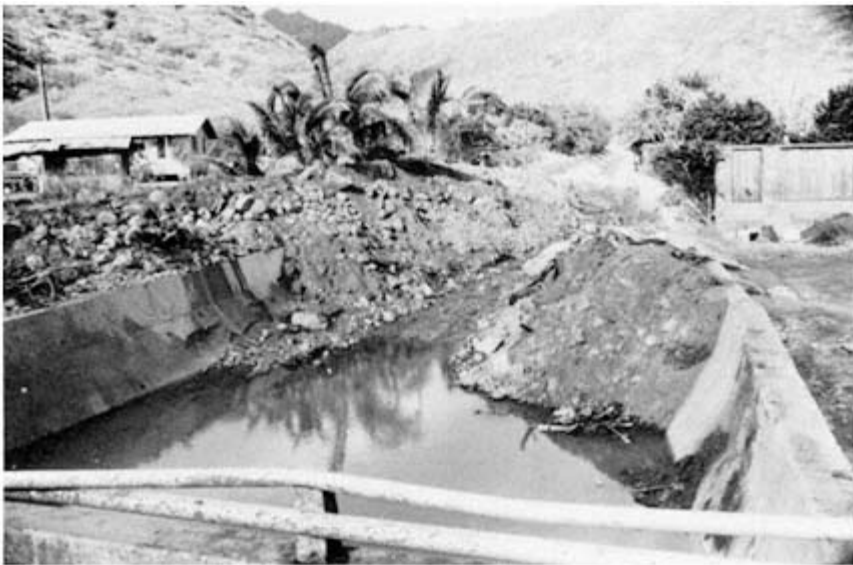
Figure 18b View of east fork of Niu stream above Halemaumau street.

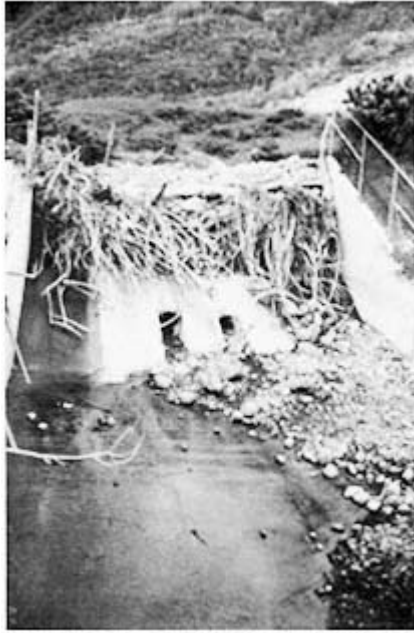
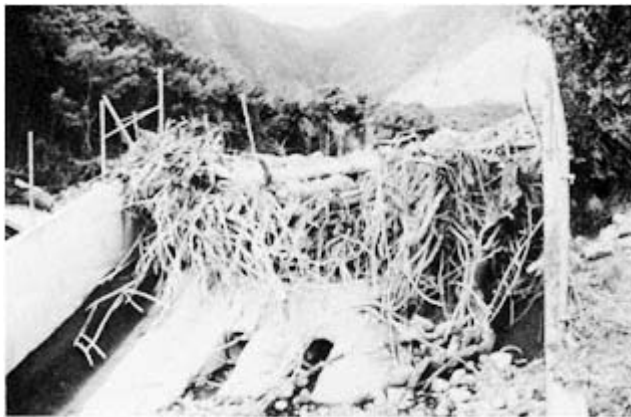
Figures 19a and b

This debris basin on Kuliouou Stream (photo taken 1/8/88) was completely sealed off by storm debris.

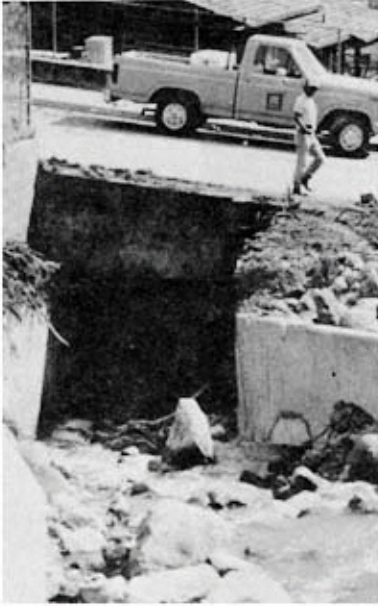
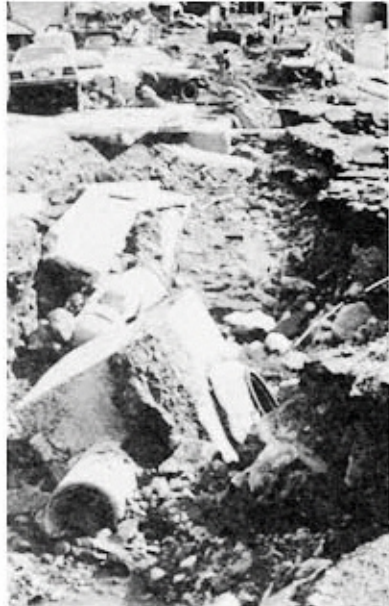
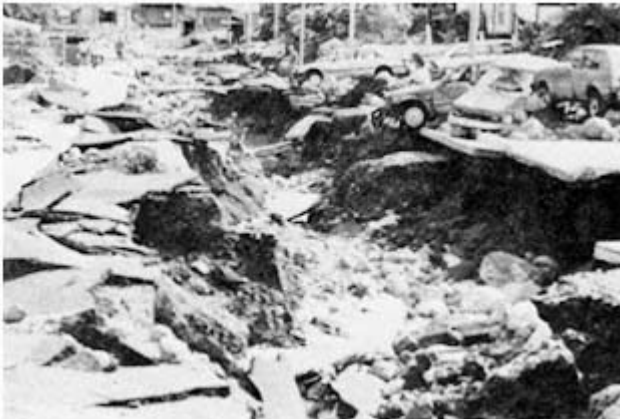
Figures 20c
[Figures20a-c](#)

Kahena Street, Hahaione Valley on January 2, 1988. Flood waters gouged a 10–20 ft channel in the roadway. (Photo courtesy of T. Giambelluca).

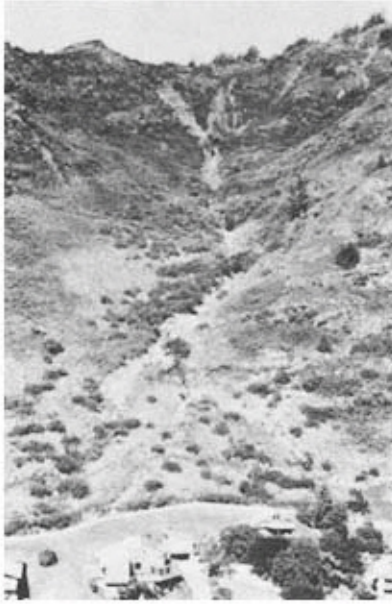
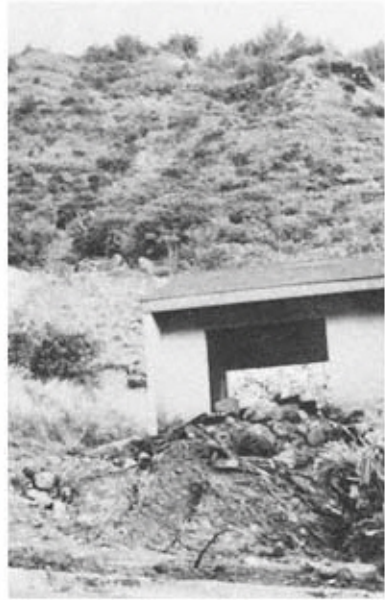
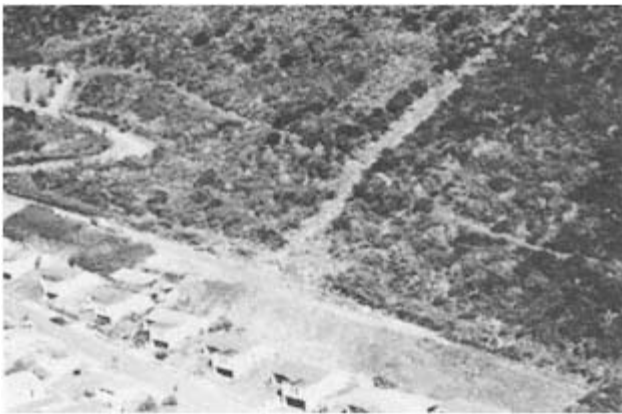
[Figures 21a-c](#) Landslides in Hahaione Valley and the Kuliouou Valley.

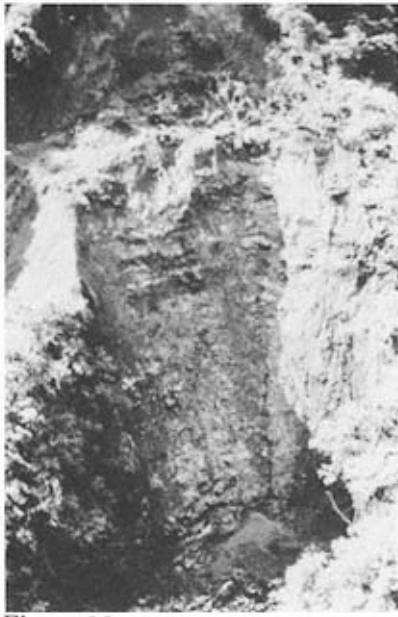
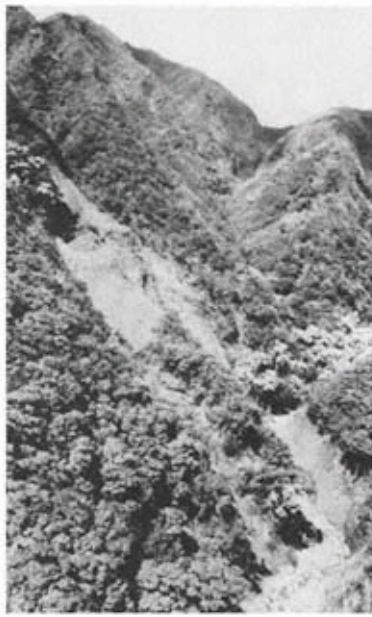
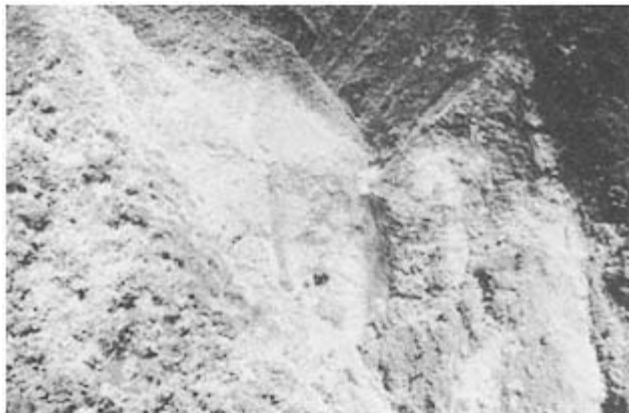
Figures 22a–c Landslides in the Niu Valley.
