The Eruption of Nevado Del Ruiz Volcano Colombia, South America, November 13, 1985

Committee on Natural Disasters, Division of Natural Hazard Mitigation, National Research Council

**Natural Disaster Studies
Volume Four**

The Eruption of Nevado Del Ruiz Volcano Colombia, South America November 13, 1985

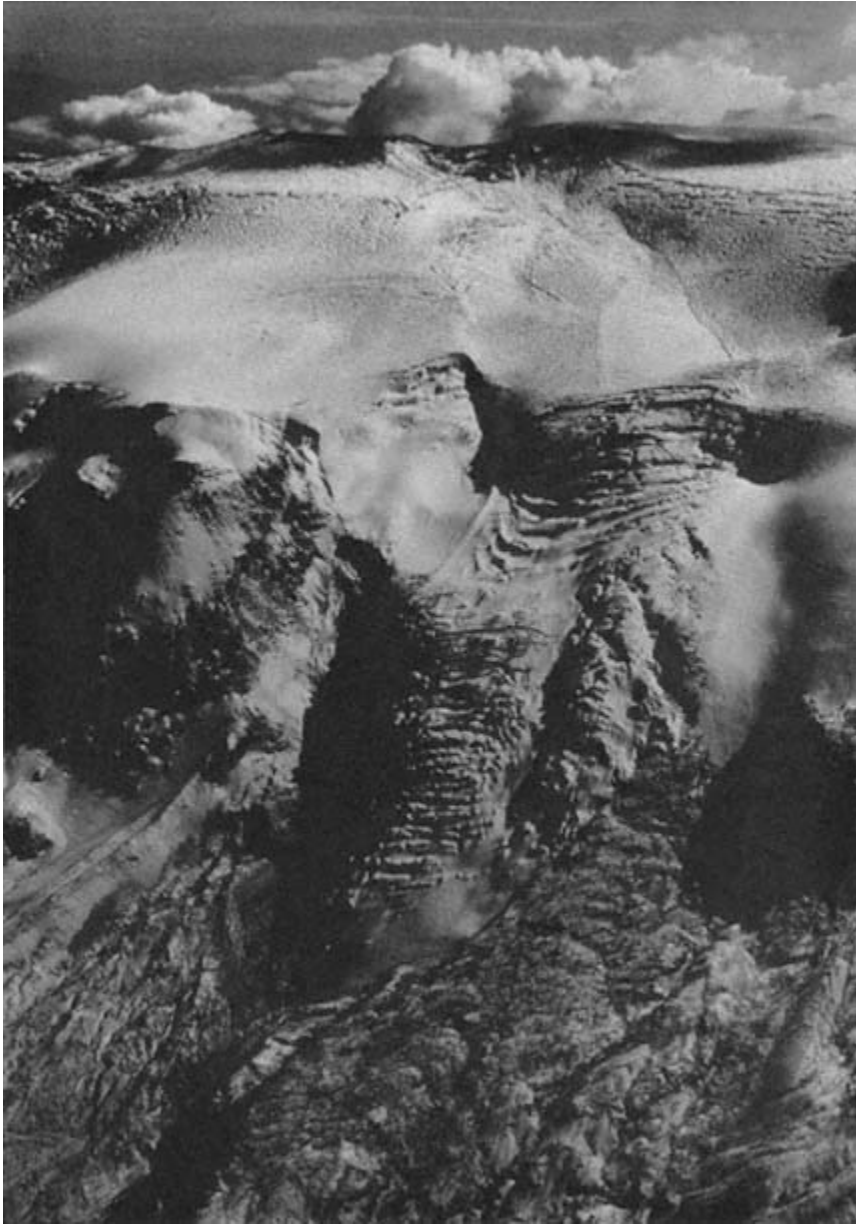
Figure 1.1
The summit region of Nevado del Ruiz volcano subsequent to the November 13, 1985 eruption. Note vapor cloud issuing from the summit crater and the tephra blanket overlying the glacial ice cap. (Photograph by D. Herd, USGS.)

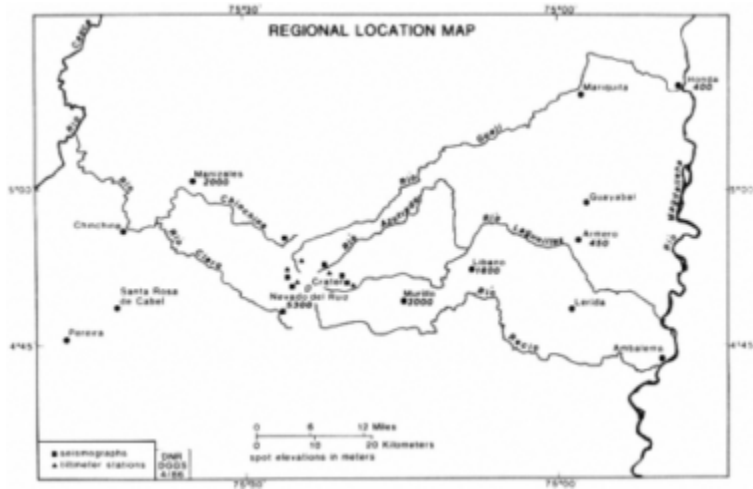
Figure 1.2
Regional map showing the location of towns and rivers referenced in this report. Numbers below physical locations indicate approximate elevations in meters. North is at the top of map.

The upper part of the volcano, above an average elevation of 4,000 m, exhibits relatively steep slopes with inclinations ranging from 20 to 30 degrees. This part of the volcano consists of recent volcanic deposits. The break in slope at about 4,000 m elevation marks the contact between the recent volcanic units and the older basal volcano. Below this elevation the slope becomes flatter (approximately 10 degrees) and extends almost symmetrically to the floodplains of the north-bound Magdalena River on the east and the Cauca River on the west (Figure 1.2).

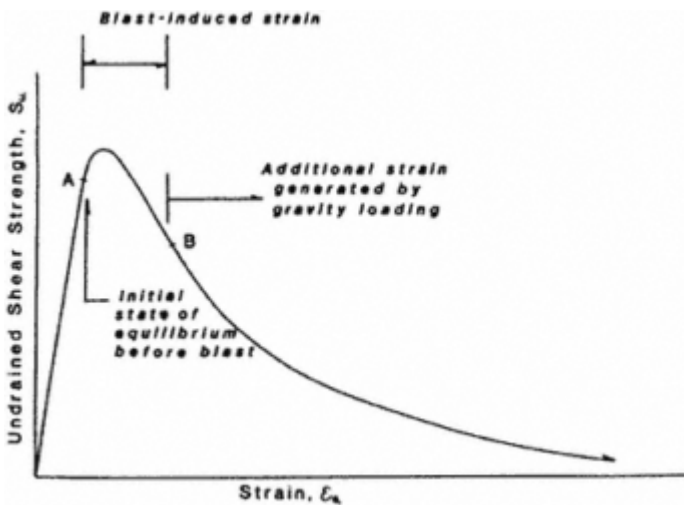
Figure 2.1

A schematic representation of the behavior of loose, saturated granular materials under rapid seismo-volcanic loading.

A schematic representation of the relationship between undrained shear strength and strain of loose, saturated, fine-grained deposits is shown in Figure 2.1. As depicted, strength initially increases with onset of strain, but once a given level of strain is reached, this gradual increase in strength ceases. With additional strain, soil strength begins to decrease and eventually, at large strain levels, the strength becomes almost negligible. This strength reduction is due to the excess pore water pressure buildup that develops in loose granular soils during the shearing process and which ultimately can become so large that the effective stress between grains approaches zero.

Before the eruption, a large percentage of the available shear strength of the soil was required to maintain stability of the sediments on the steep 10° – 12° slopes (Point A in Figure 2.1). The continuous introduction of large quantities of water due to precipitation and ice cap melting induced the

Further, the eruption-induced ground motions caused an additional shear stress large enough to rapidly increase pore water pressure, which decreased the static shear strength of the soil (Point B, [Figure 2.1](#)). The magnitude of the vibration-induced strain is directly proportional to the peak particle velocity generated by the vibrations and inversely proportional to the speed at which the shear waves travel within the sediment.

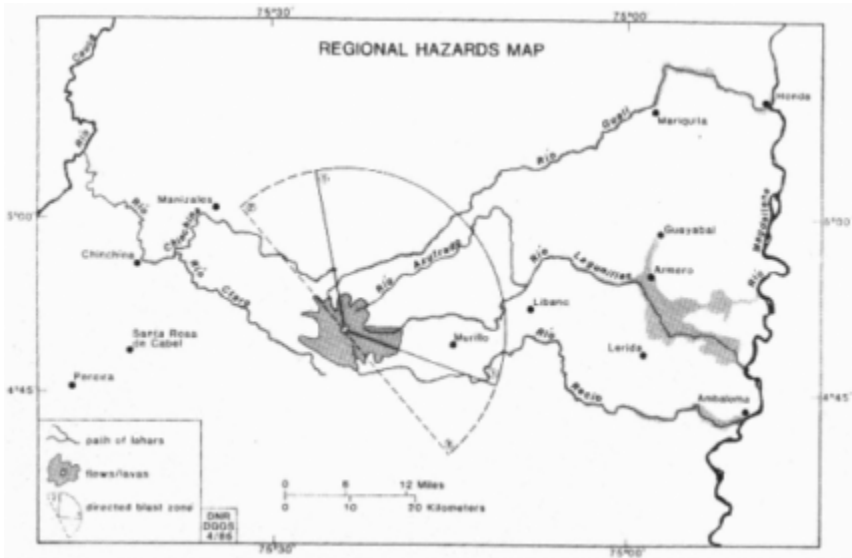
Figure 2.2

Sketch map showing volcanic hazards to the region surrounding Nevado del Ruiz. This map is derived from a map prepared by INGEOMINAS (1985) immediately prior to the November 13 eruption. The map accurately predicted the paths of the November 13 lahars.

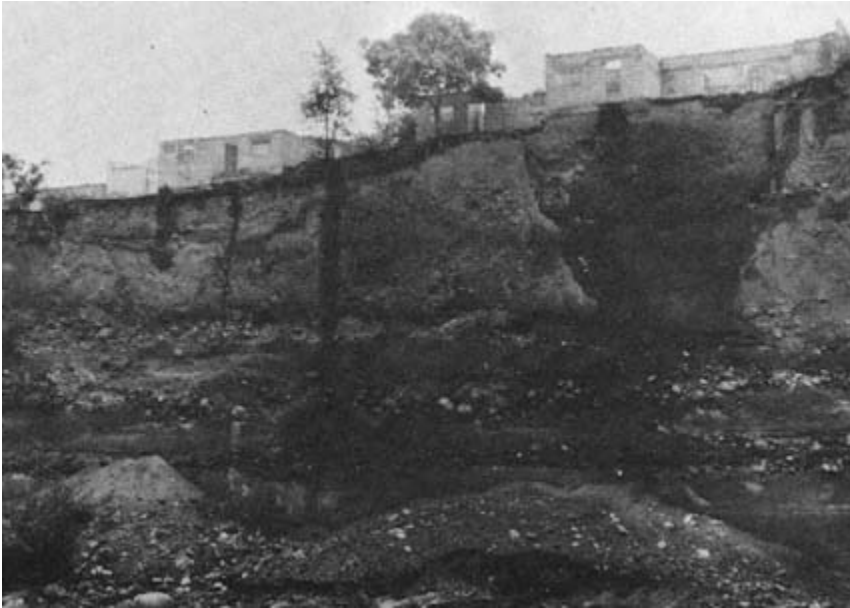
Figure 2.3

Erosion of bluffs along a sweeping curve of the Gualí River at Honda, just before entering the Magdalena River. Houses on bluffs above the river have been condemned and are mostly abandoned. (Photo by R. Updike, USGS.)

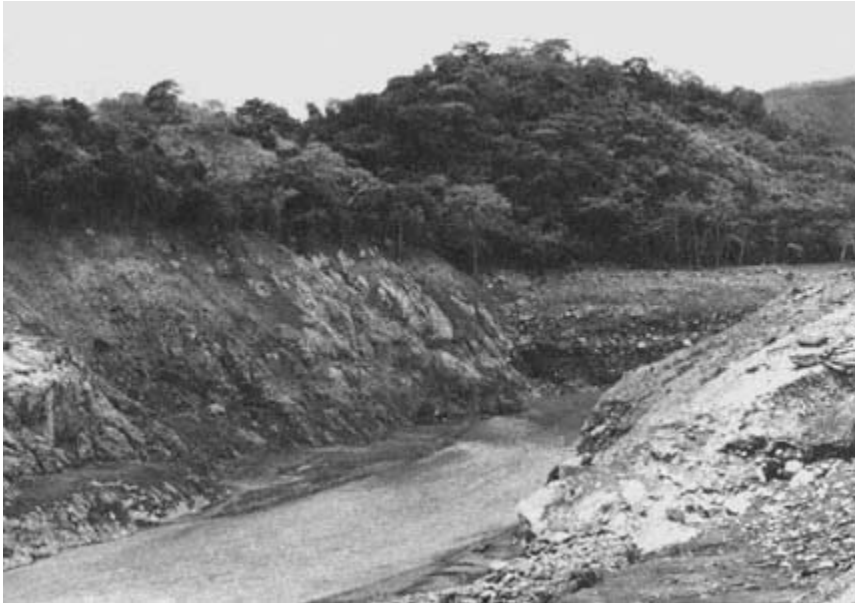
Figure 2.4

The mouth of the Lagunillas River canyon. Vegetation and soil were entirely removed from the floor and walls of the canyon to a point approximately 75 ft (25 m) above the river level, resulting in extensive exposure of bedrock. (Photo by R. Updike, USGS.)

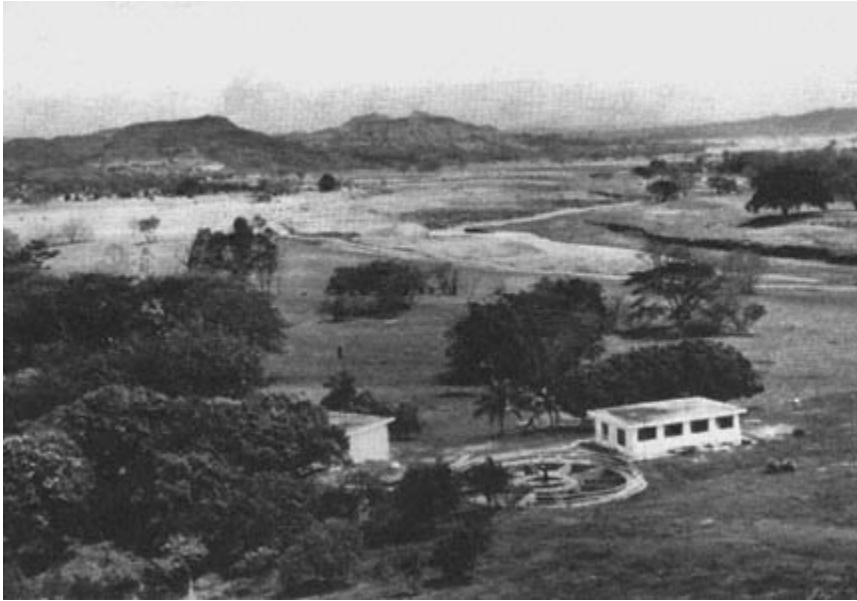
Figure 2.5

A view from near the mouth of the Lagunillas River canyon, looking down the fan toward the site of Armero (middle distance). Most of the panorama was covered by the lahars, the edge passing through the trees immediately beyond the water treatment plant in the foreground.

Once the mudflow reached the Magdalena plain, it spread radially into two main lobes ([Figure 2.5](#)) separated by slightly higher ground. The central part of Armero, built on higher deposits from previous lahars, was not swept away by the 1985 mudflows ([Figure 2.6](#)). The hills of Tertiary sedimentary rocks immediately east of Armero, with elevations up to 500 m above sea level, further prevented the lahars from flowing directly east into the Magdalena River. A detailed map of the mudflows in the immediate vicinity of Armero is shown in [Figure 2.7](#).

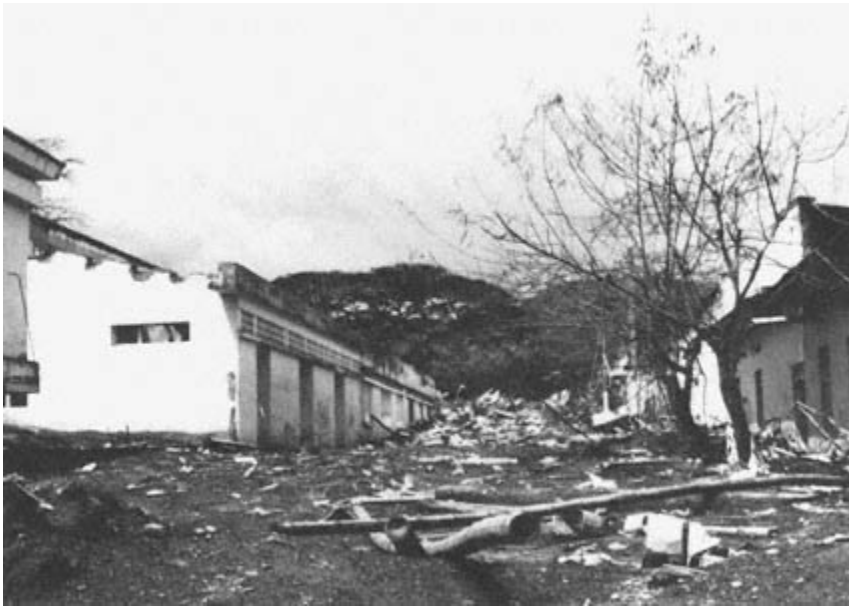
Figure 2.6

A business district in Armero on gently sloping terrain a few meters higher than most of the city. Buildings are erect, but the street is filled with mud and debris. Note that at the far end of the street (upstream direction), the mud level increases in height relative to doorways. The main force of the lahars was directed north and south of this area, due to topography. (Photo by R. Updike, USGS.)

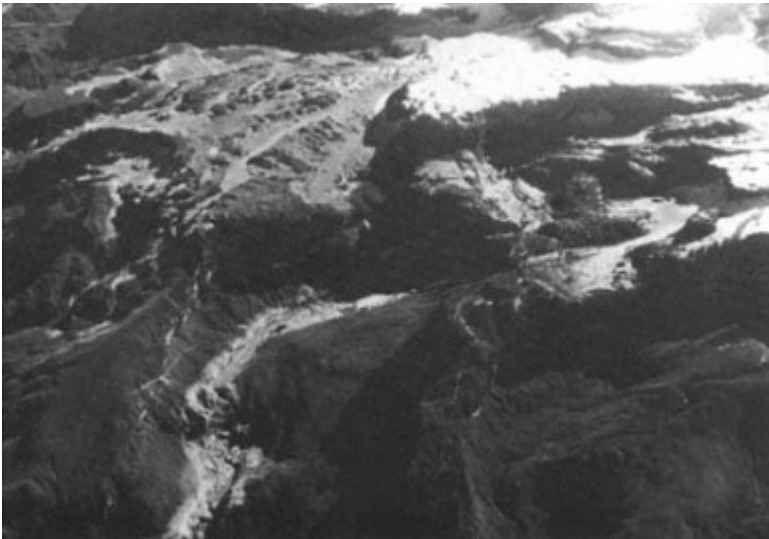
Figure 2.8

Oblique aerial photograph showing the distributary pattern of laharic deposits on the intermediate slopes below Nevado del Ruiz. Note the channelized debris flow in the canyon in lower center. (Photo by D. Herd, USGS.)

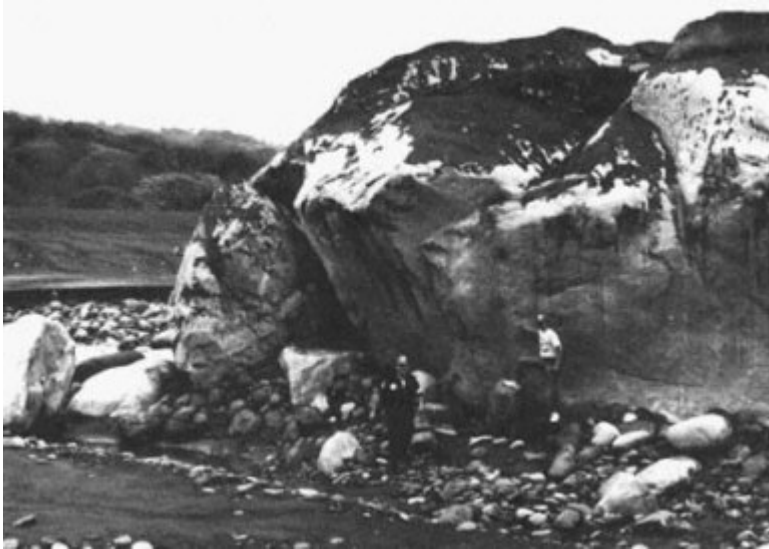
Figure 2.9

Two Colombian Red Cross workers stand in front of a monzonitic boulder in the floodplain of the Gualí River near Mariquita. The boulder, a local landmark, was transported approximately 400 m by the lahar. Note lahar sediment on top of the boulder and across the floodplain in the background. (Photo by R. Updike, USGS.)

few centimeters to a few meters in diameter, were deposited around the large block in a matrix-supported fabric. Such a heterogeneous distribution of unsorted particle sizes—from sands to cobbles, with no apparent stratification—is typical of high-energy, turbulent-flow transport.

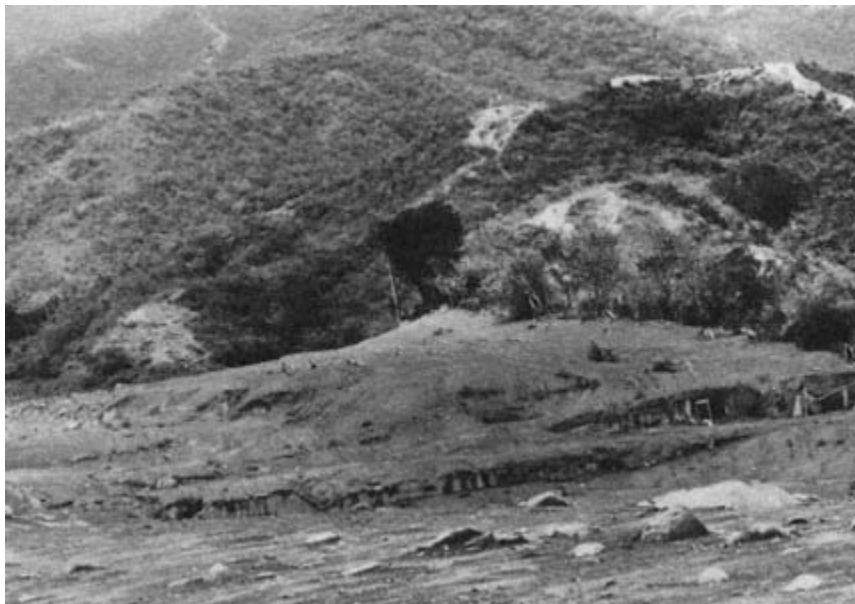
Figure 2.10

"The margin of safety" is the mudline drawn against this hillside north of Armero. Hundreds of survivors were found on these low hills. In the middle foreground, segments of building walls are exposed beneath the blanket of mud. (Photo by R. Updike, USGS.)

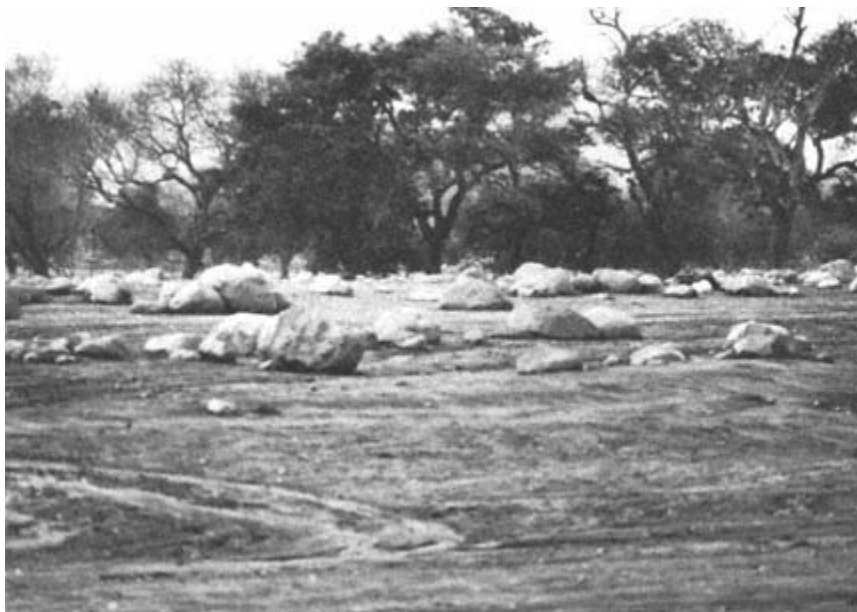
Figure 2.11

Large boulders (commonly more than 2 m diameter) littering former agricultural fields along the southern lobe of the Lagunillas lahar, approximately 3 km southeast of Armero. (Photo by R. Updike, USGS.)

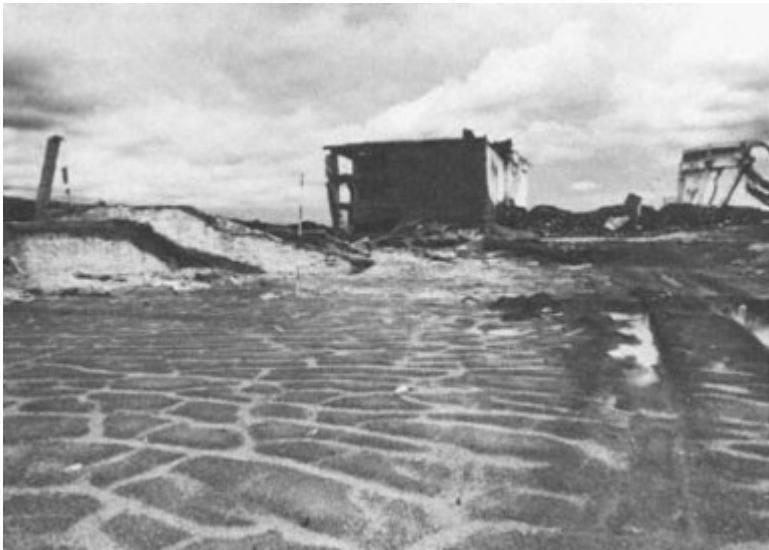
Figure 2.12

A granary complex located within Armero. Note the polygonal jointing of laharic mud in foreground. At peak discharge, the flow reached the top of the building in the background. (Photo by R. Updike, USGS.)

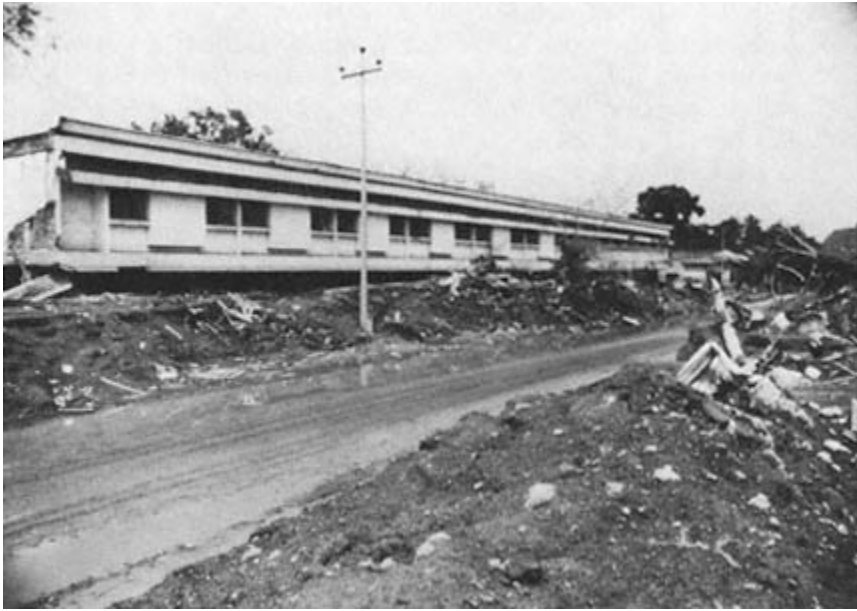
Figure 2.13

The public hospital in Armero. Two stories were constructed above grade and one below grade. Only the topmost story remained above mud level, sustaining minor damages. (Photo by R. Updike, USGS.)

Farther east, in central Armero, at an approximate distance of 2.5 km from the canyon mouth, the accounts of survivors who spent the night on top of the hospital indicate that the mudflow almost reached the roof of the building. The study team observed that the lahar deposits at this location completely filled the first floor of the hospital building and partially filled

the second floor (Figure 2.13). The height of the first floor was measured to be approximately 2.75–3.0 m and the estimated total thickness at this location is about 4.0 m.

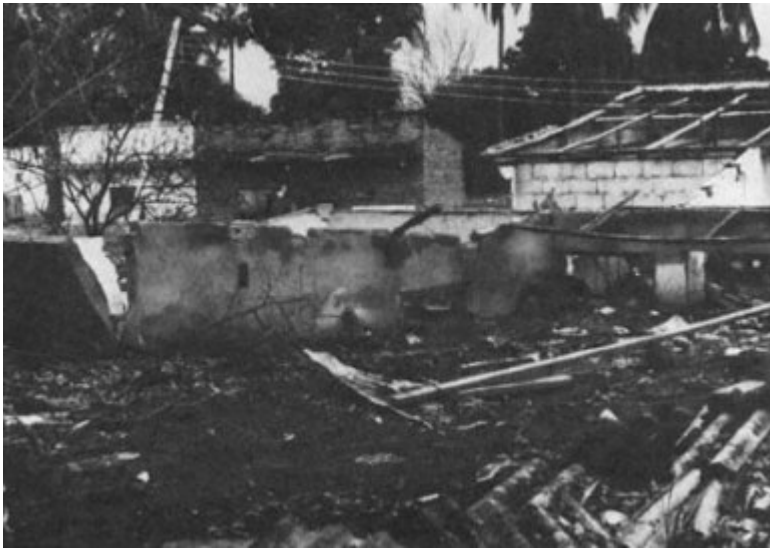
Figure 2.14

A residential area of Armero situated near the margin of the mudflows. Although the buildings remained intact, mudflows nearly reached the top of the doorways. Roofs and wall members partially collapsed due to torsional stresses caused by the impacting mud. Most buildings seen here were constructed of nonreinforced concrete or adobe block. (Photo by R. Updike, USGS.)

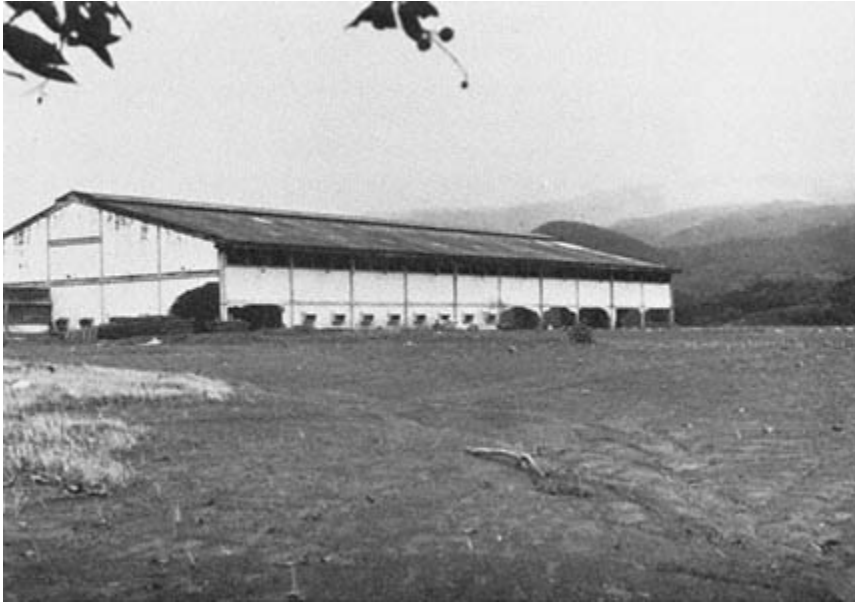
Figure 2.15

An engineered granary structure 4 km north of Armero. Construction consisted of steel rebar-reinforced concrete pillars and beams with nonreinforced concrete block fill-in between pillars. This view is of the downstream side of the building where pillars remain but concrete block has been carried away. (Photo by R. Updike, USGS.)

About 1 km farther downstream from the tree described above (approximately 3.75 km from the canyon), mudflow elevations were measured in another warehouse (Figure 2.15). This structure, identified as warehouse II in this report (Site 3, Table 2.2), is a 45-m-long structure located near the main Mariquita-Armero highway. A view toward the downstream side of the warehouse (Figure 2.16) shows that the long axis of the warehouse is in an east-west direction perpendicular to the course of the Santo Domingo Creek, which runs between the warehouse and the hills shown in the background. The far corner of the warehouse is thus nearest to the creek, at a distance of approximately 50–75 m. Traces of mud left on the warehouse walls indicate that in sections of the warehouse nearer to the creek the lahar reached an approximate height of 2.5 m above the present ground surface, breaking the masonry wall panels between columns. Approximately 1.5 m

of consolidated sediment covers the warehouse floor, so that total lahar thickness during peak flow was about 4.0 m.

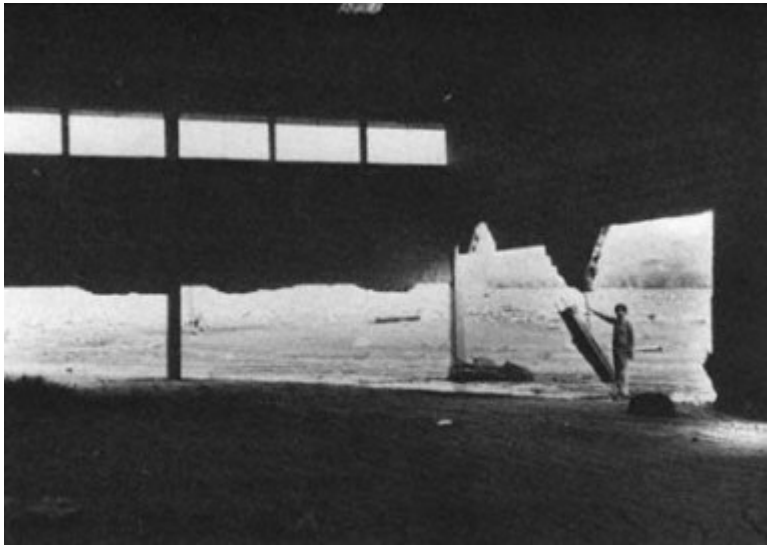
Figure 2.16

Upstream corner of building in [Figure 2.14](#). G. Fernandez stands by pillar dangling by rebar. Approximately 1.3 m of mudflow debris covers the interior floors of the building. (Photo by R. Updike, USGS.)

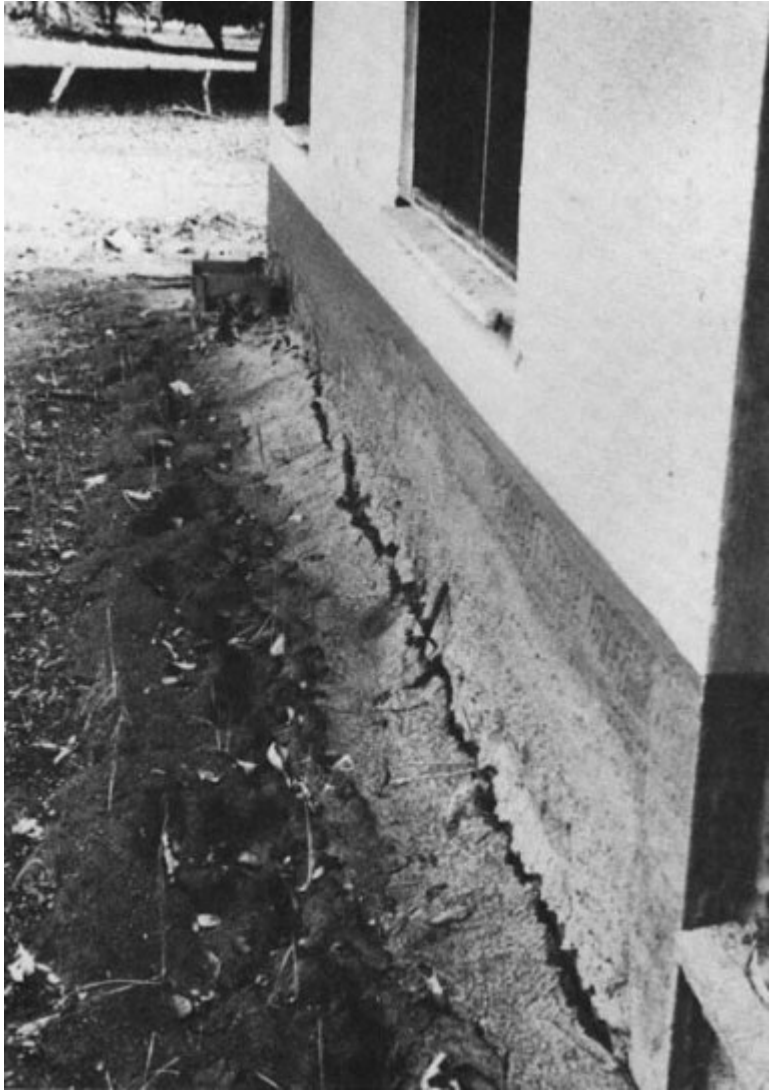
Figure 2.18
The administration building at a serpentarium 5.5 km north (downstream) from Armero. Note the high mud line on the building wall. According to trapped survivors, the mud gradually lowered to the present surface in about three days. (Photo by R. Updike, USGS.)

The thickness of the northern branch of the Lagunillas lahar was measured near its terminus at the National Serpentarium Administration Building, located approximately 5.5 km north of Armero (Site 1A, [Table 2.2](#)). A

clear trace of the flow line elevation was left on the walls of this building (Figure 2.18). The flow line reached an elevation of approximately 0.9 m above the consolidated lahar surface, which was about 0.3 m thick over the original land surface. A summary of the measured depths of the Lagunillas River lahar at the various locations described above is given in Table 2.3.

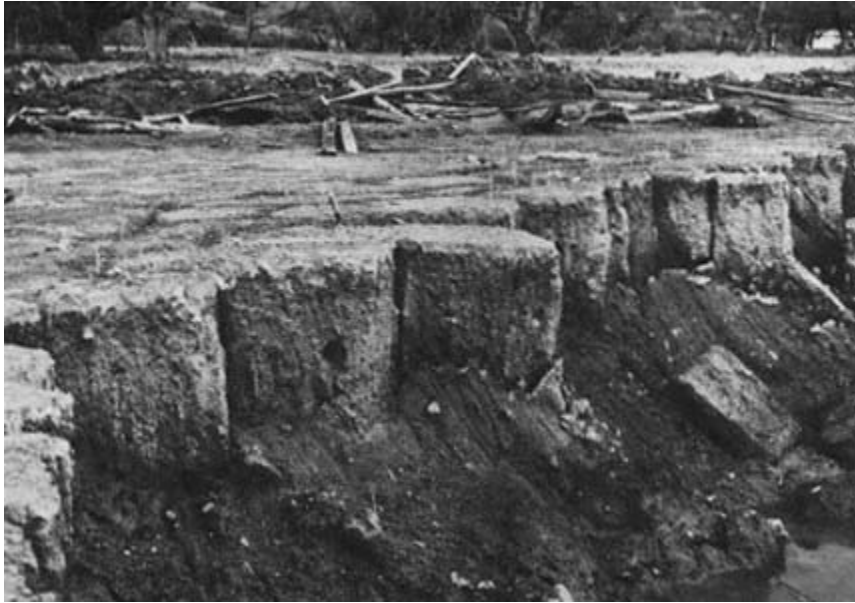
Figure 2.19

Vertical exposure of the upper fine-grained zone of the lahar downstream from Armero. This zone is believed to have behaved as a quasiviscous suspended flow. Note the rudimentary columnar jointing extending nearly 1 m into the sediment from a polygonal fracture pattern on the surface. Penetrometer values consistently exceeded the 3.0 tsf limit of the instrument, used on both the surface and exposed face. (Photo by R. Updike, USGS.)

At the time of the field inspection, the primary consolidation was nearly complete, and shrinkage and desiccation of the lahar deposits were well under way. A pronounced pattern of polygonal jointing of the fine-grained lahar deposits was observed at several locations, for example, in the immediate vicinity of warehouse I (Site 6, [Table 2.2](#)). An identical polygonal joint pattern was observed at the Serpentarium (Site 1A, [Table 2.2](#)). At an excavated pit in the southeast sector of Armero, these desiccation polygons were found to be columnar joints extending nearly 1 m into the upper, fine-grained phase ([Figure 2.19](#)). The unconfined compressive strength of the silty fine sands in this upper 1-m-thick zone, as measured on both the flow surface and the exposed face, consistently yielded pocket penetrometer values that exceeded the 3.0 tsf limit of the instrument. Penetrometer resistance

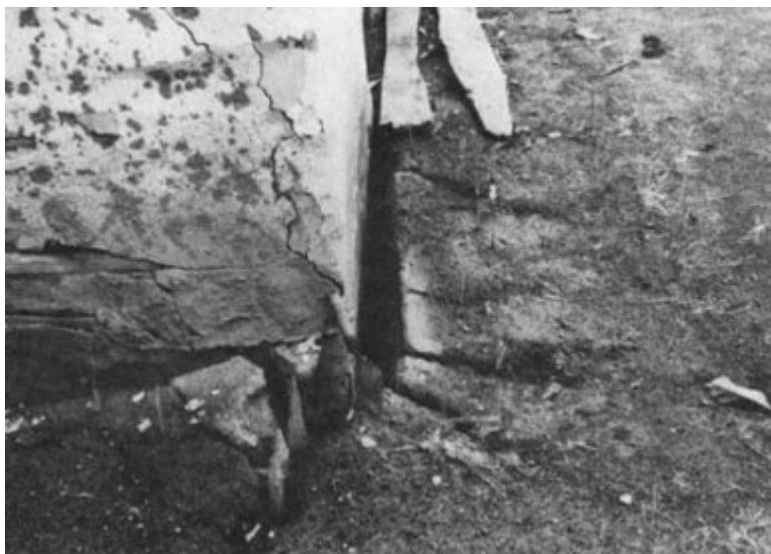
Figure 2.20

Foundation corner of building in Figure 2.18. The desiccation has drawn the silty sand away from the foundation as consolidation continues. (Photo by R. Updike, USGS.)

Shrinkage and desiccation of the lahar deposits were observed in the mudflow materials along exterior walls of the Administration Building in the Serpentarium complex (Figure 2.20). This observation, in conjunction with the mud traces left on the wall of the building, provided an indication of the process of sedimentation, primary consolidation, partial desiccation, and shrinkage that have occurred since November 13, 1985. A caretaker who survived the disaster at the Serpentarium and remained there for several weeks after the event was able to confirm these conclusions through his own observations.

A quantitative evaluation of the reduction in the thickness of the initial mudflow was carried out based on measurement of the uniformly horizontal mudflow tracks left on the wall of the Administration Building. The surface of the mudflow reached a height of approximately 90 cm above the initial ground surface. The velocity of the mudflow at this location (approximately 5.5 km north of Armero) was apparently very low, presumably

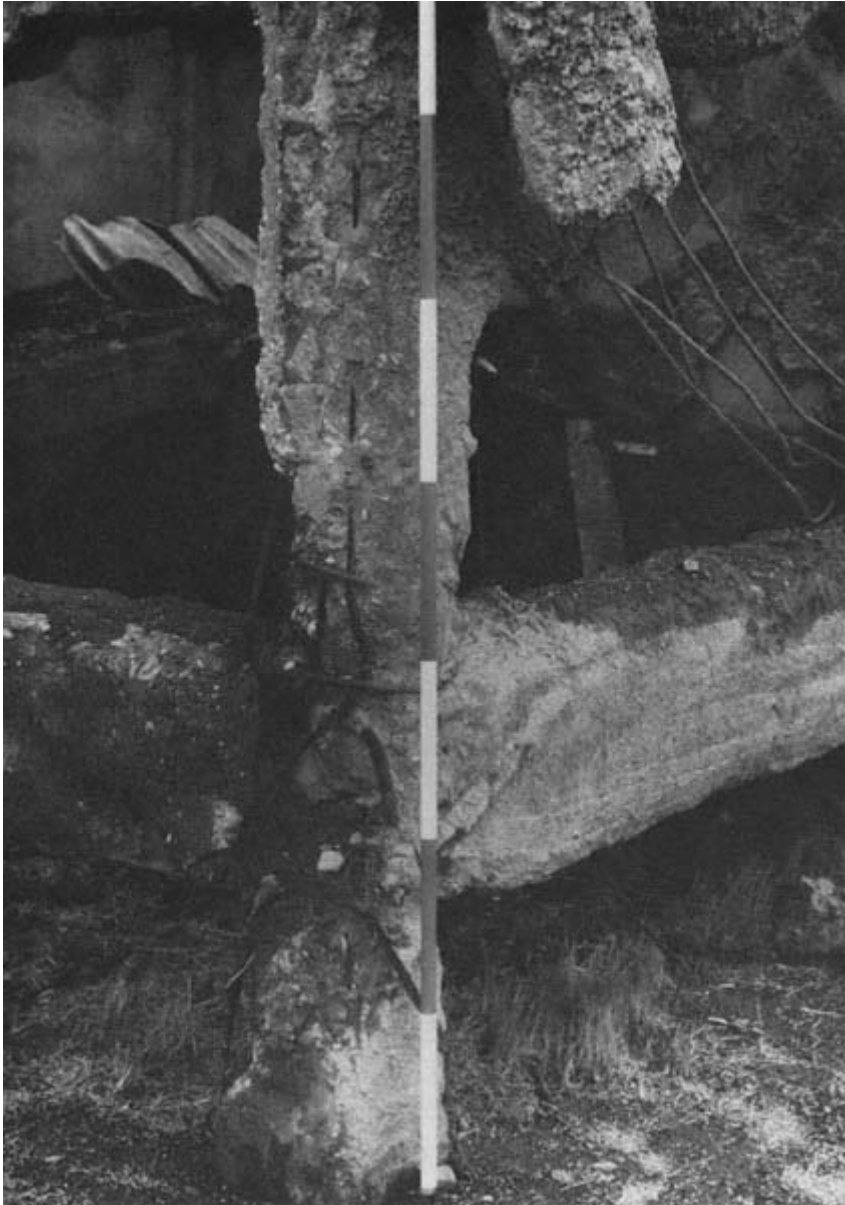
Figure 3.1

A corner pillar of the building shown in [Figure 2.12](#), showing concrete abraded to expose rebar. This degree of abrasion is particularly noteworthy given the short duration of the event. (Photo by R. Updike, USGS.)

A close-up of one of the front columns of the granary building is shown in [Figure 3.1](#). Complete removal of the concrete from the face of the column on the front of the building, exposing the steel bar reinforcement within the column, demonstrates the high abrasive effect of the lahar. Two steel hoppers installed in a front room inside the building were buckled by the force transferred through the wall.

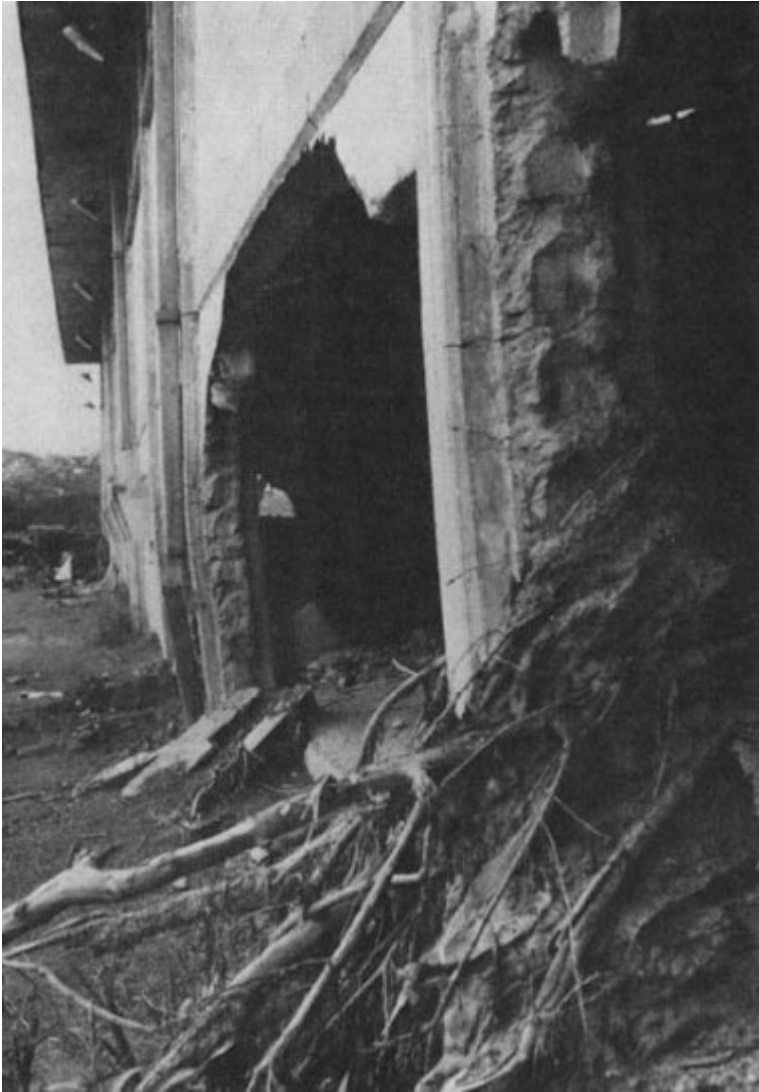
Figure 3.2
Reinforced pillars on downstream wall of the building in [Figure 2.15](#). The concrete block fill-in has been nearly entirely removed. Pillars are cracked and bent in the downstream direction. (Photo by R. Updike, USGS.)

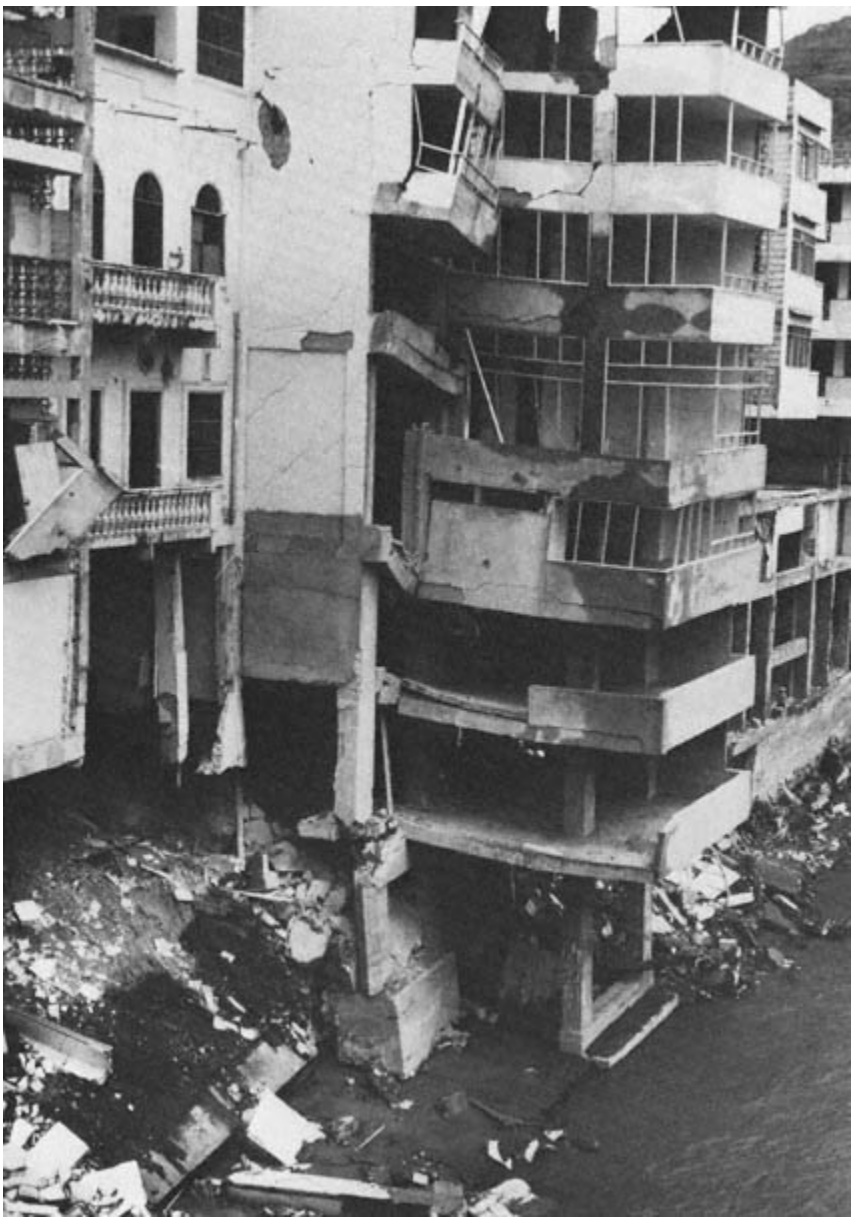
Figure 3.3
Foundation damage to apartment buildings in Honda along the channel of the Gualí River. (Photo by R. Updike, USGS.)

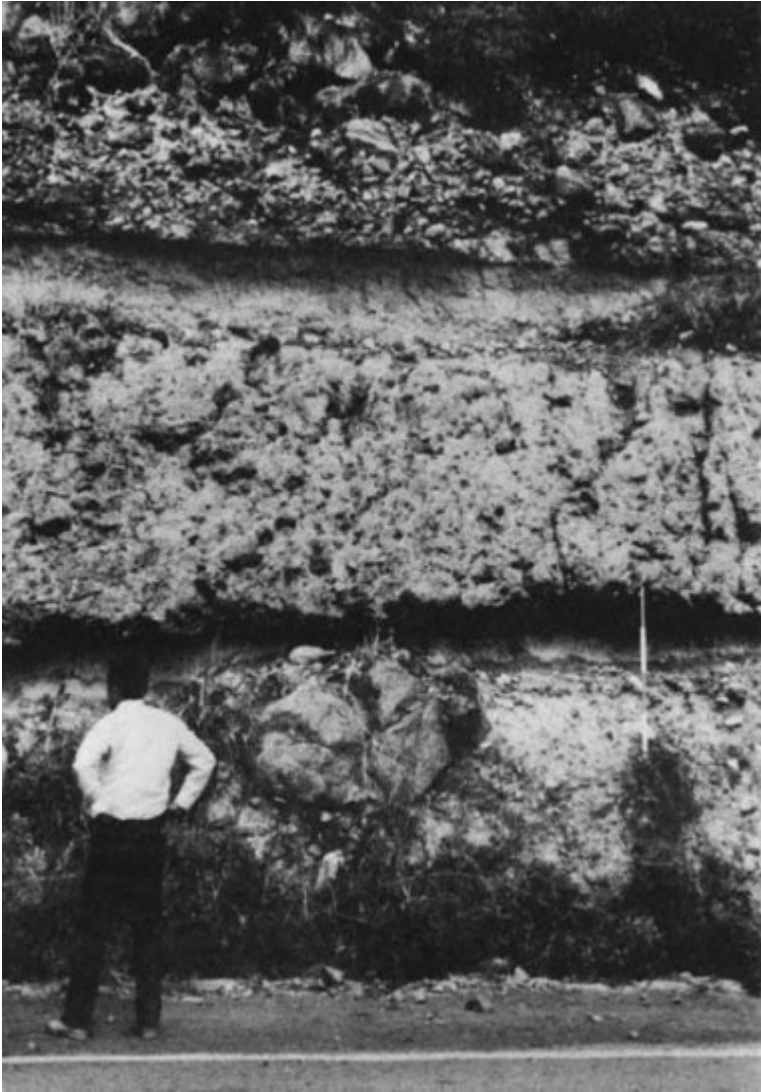
Figure A.2

A roadcut near Lérída showing two Quaternary lahars, each composed of an upper, fine-grained zone and a lower, poorly sorted, coarse clast zone. The upper portion of the picture shows the slope colluvium. However, farther up the roadcut, three additional lahar units similar to those shown are exposed. (Photo by R. Updike, USGS.)

The Nevado del Ruiz complex has undergone a phase of explosive volcanism during Holocene times. A number of lahars and pyroclastic flows exposed in the Ruiz area (Figure A.2) provide a record of the various explosive eruptions of the volcano. Almost all of these deposits are postglacial in origin. Radiocarbon dating indicates that the earliest flow occurred between 13,000 and 8,600 B.P. (before the present) (Herd, 1982). Several additional eruptions have occurred between 6300 B.P. and the present. The most recent Ruiz tephra examined in 1985 is believed to be related to the historically recorded eruption of March 12, 1595.
