Scour at Contracted Bridges

National Cooperative Highway Research Program

U.S. Geological Survey and University of Louisville

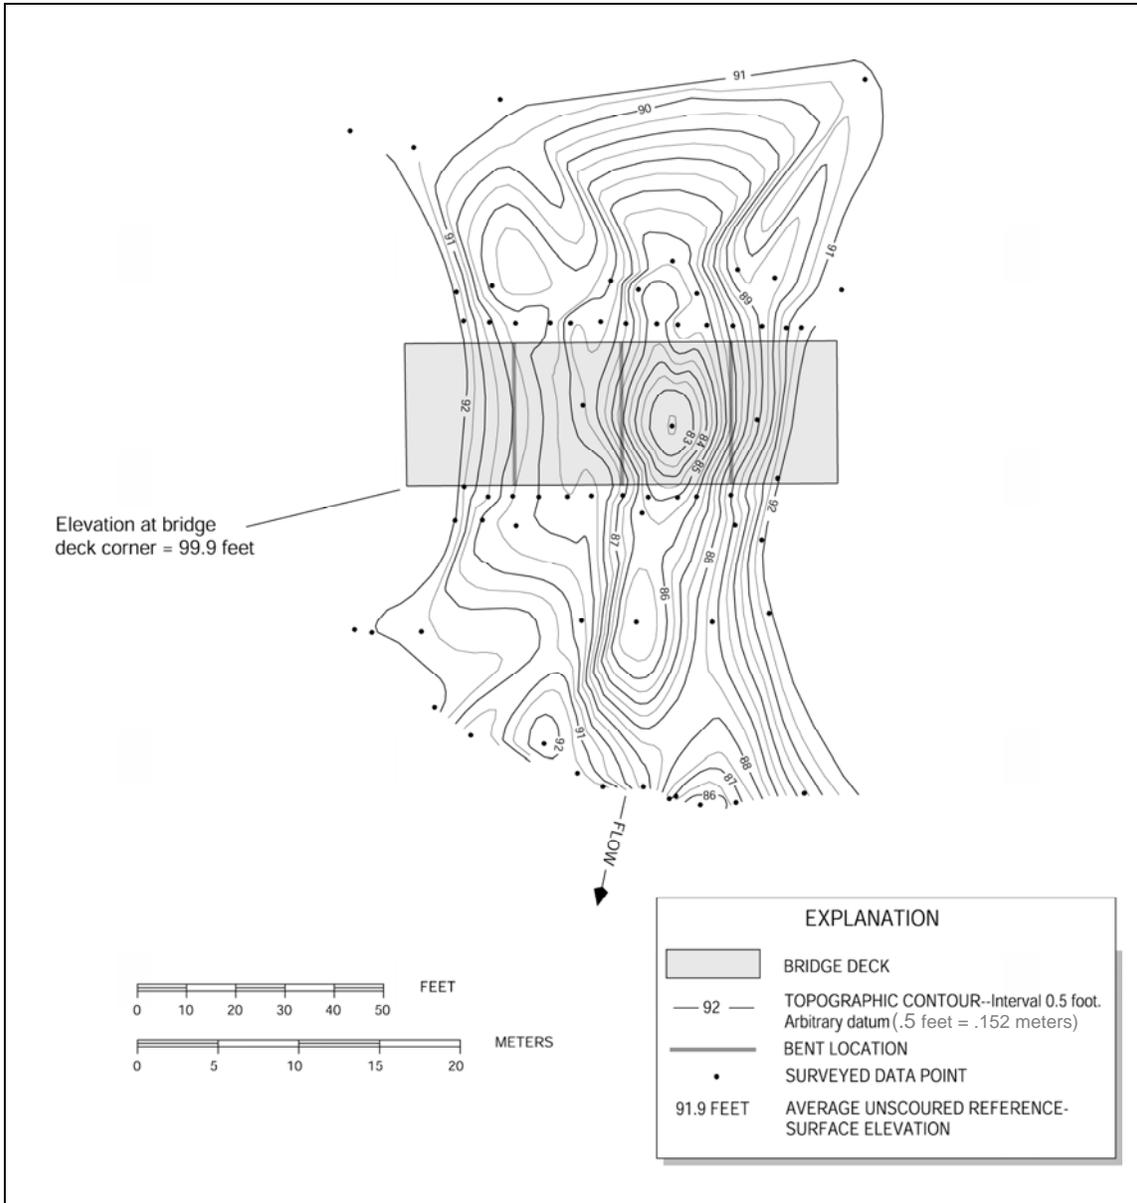
Figure 1. Example of single scour hole at shorter bridges, as shown at U.S. Route 301, crossing Douglas Swamp in Florence County, South Carolina, July 31, 1996.

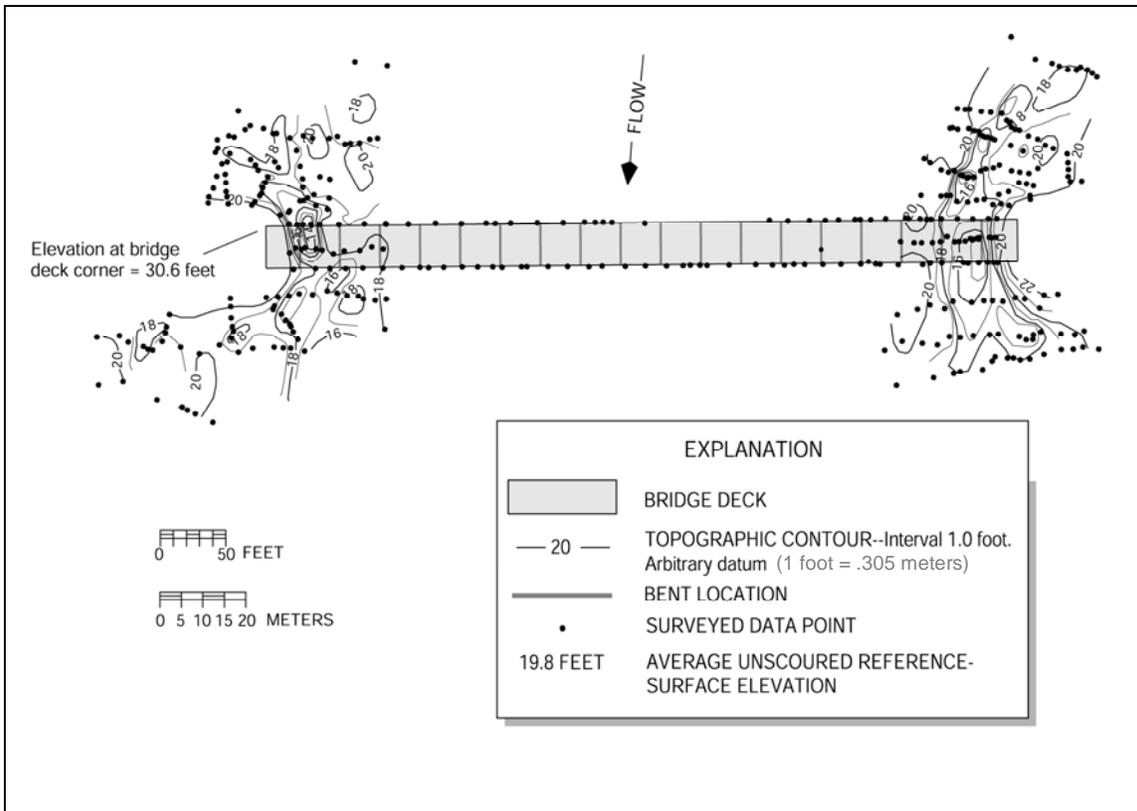
Figure 2. Example of separate left and right abutment-scour holes at longer bridges, as shown at Road S-87 bridge, crossing the Coosawhatchie River in Jasper County, South Carolina, November 12, 1997.

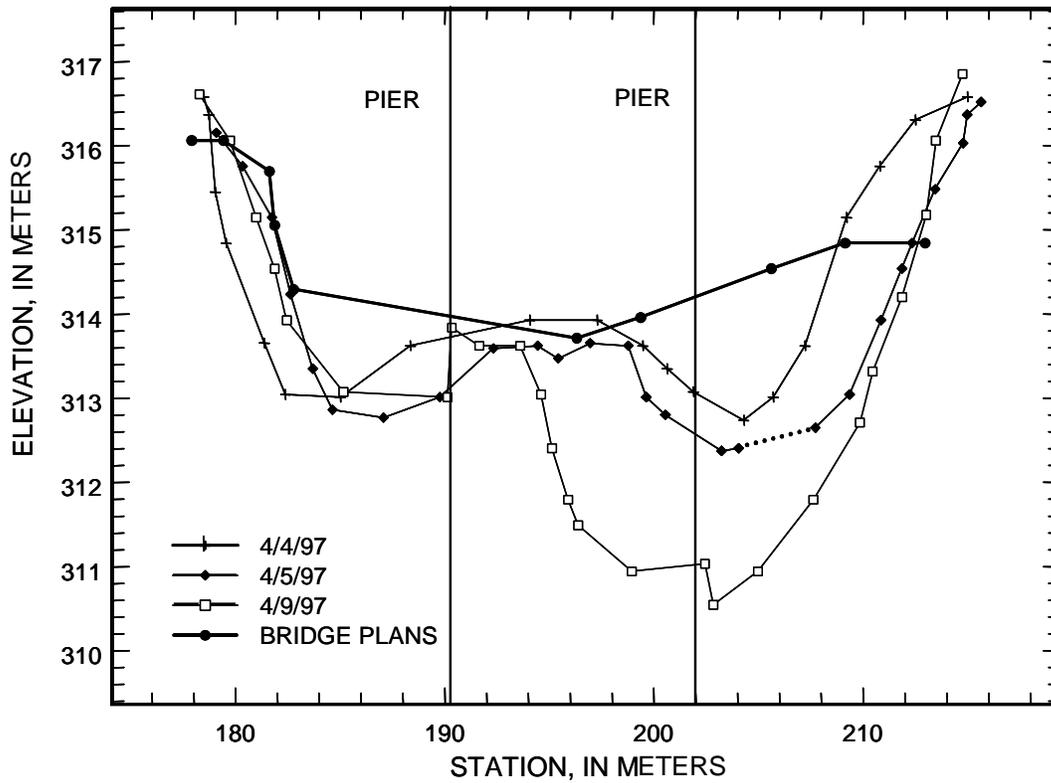
Figure 3. Plot of abutment scour measurements at the C.R. 22 bridge over the Pomme De Terre River near Fairfield, Minnesota in April 1997.

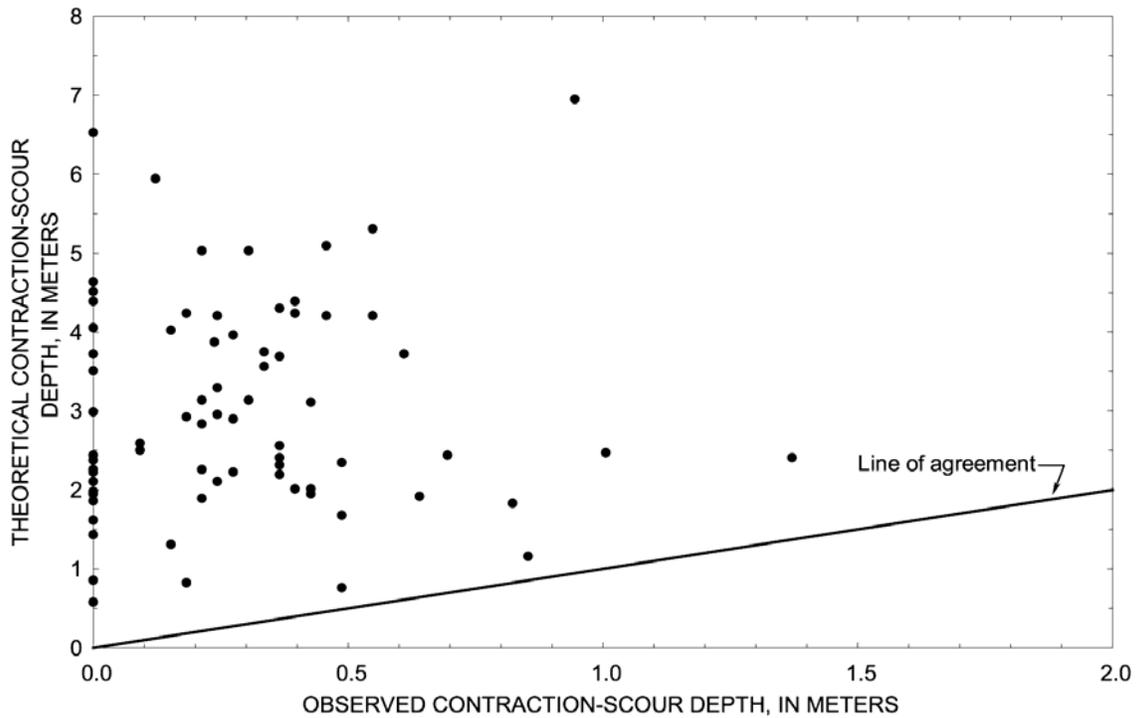
Figure 5. Relation of observed and theoretical clear-water contraction-scour depth for the 100-year flow, in the Piedmont of South Carolina. (Theoretical contraction scour calculated with the Laursen (1963) equation.)

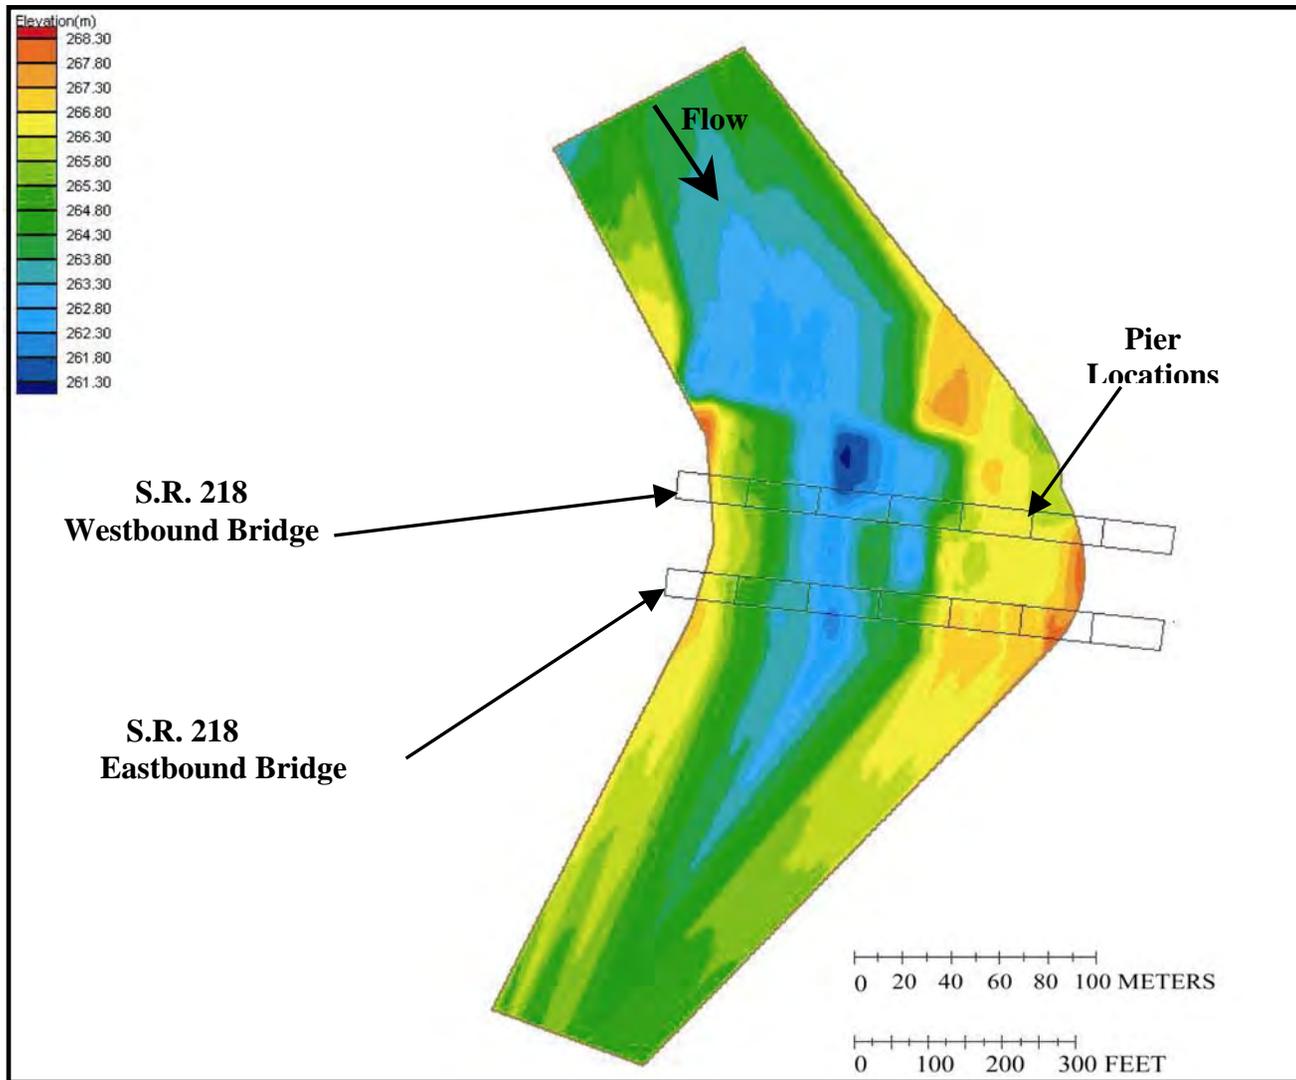
Figure 6. Example of scour-hole low point located upstream of S.R. 218 over the Cedar River near Janesville, Iowa.

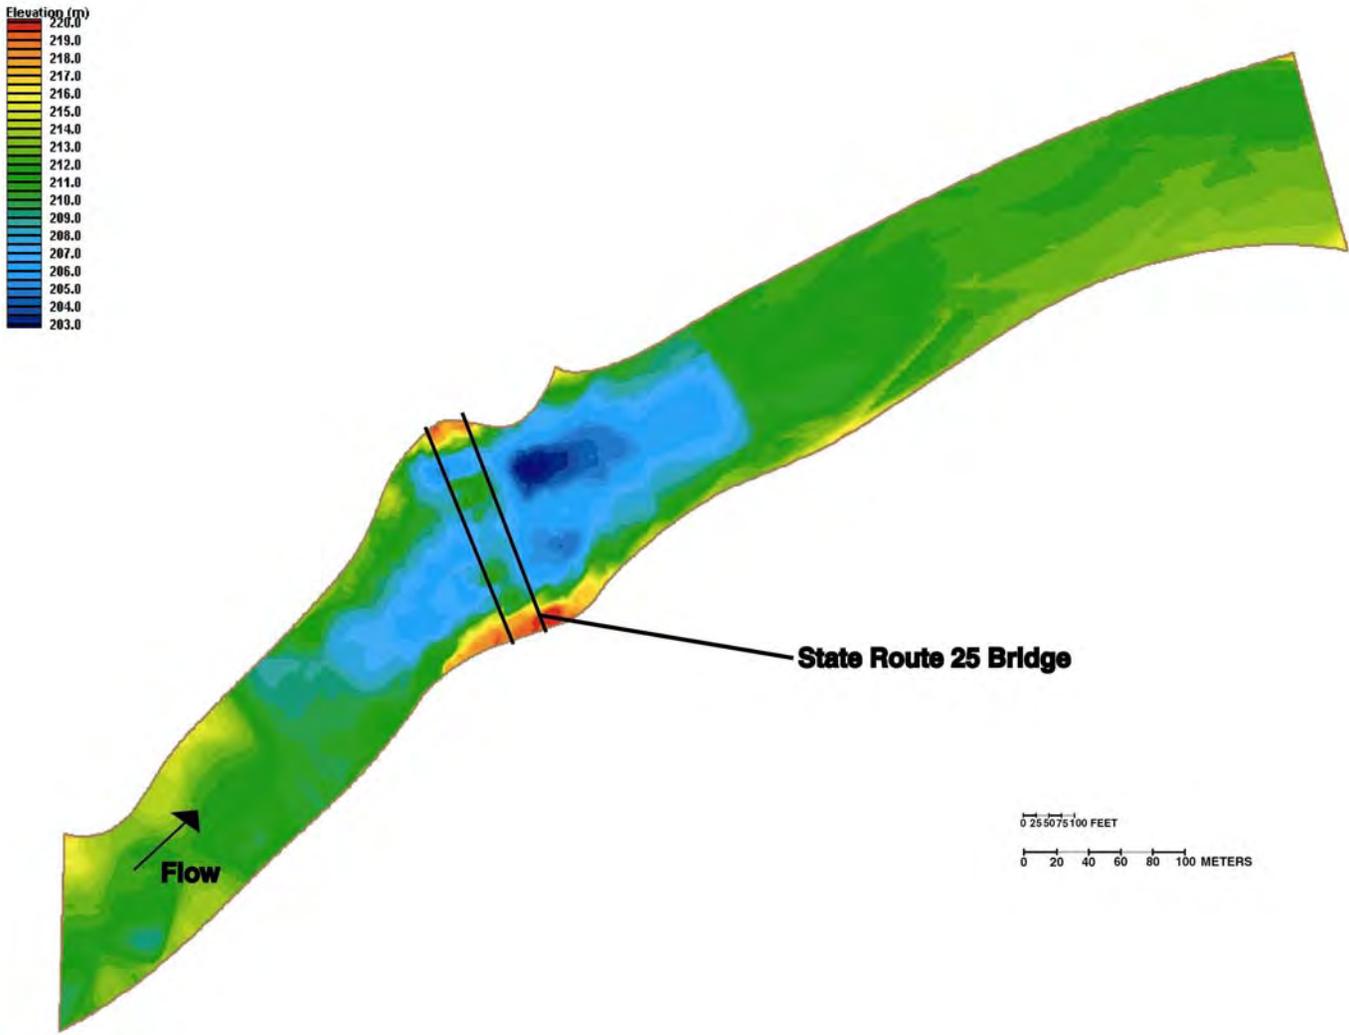
Figure 7. Example of scour-hole low point located downstream of S.R. 25 over the Minnesota River near Belle Plaine, Minnesota.

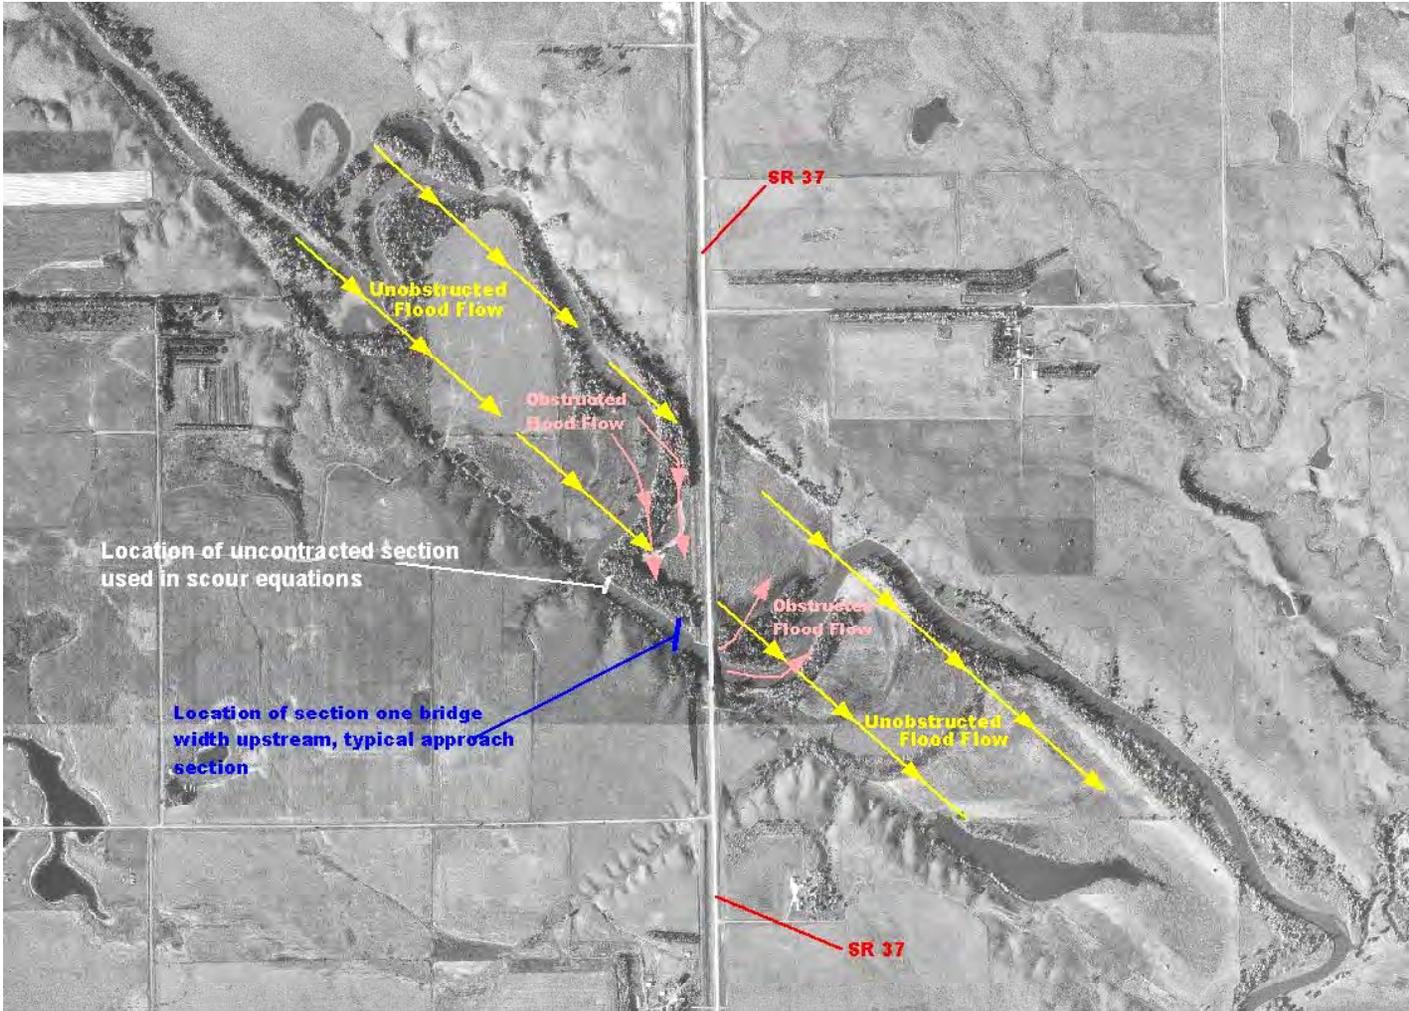
Figure 8. Site configuration, flow patterns and approach section location for S.R. 37 over the James River near Mitchell, SD

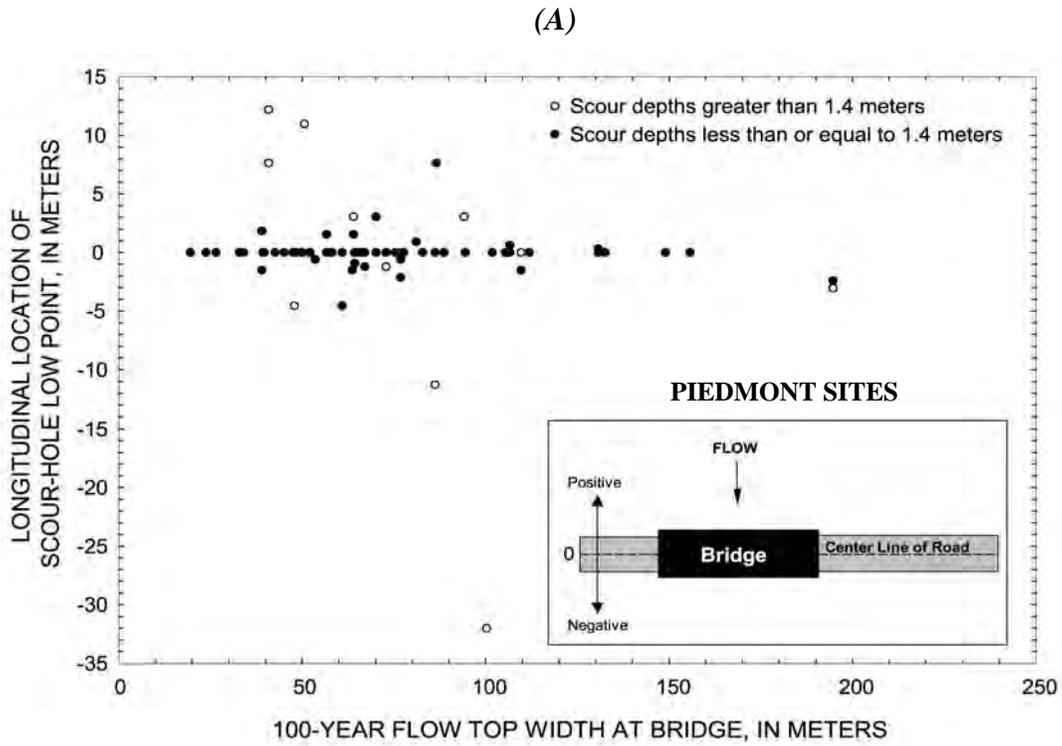
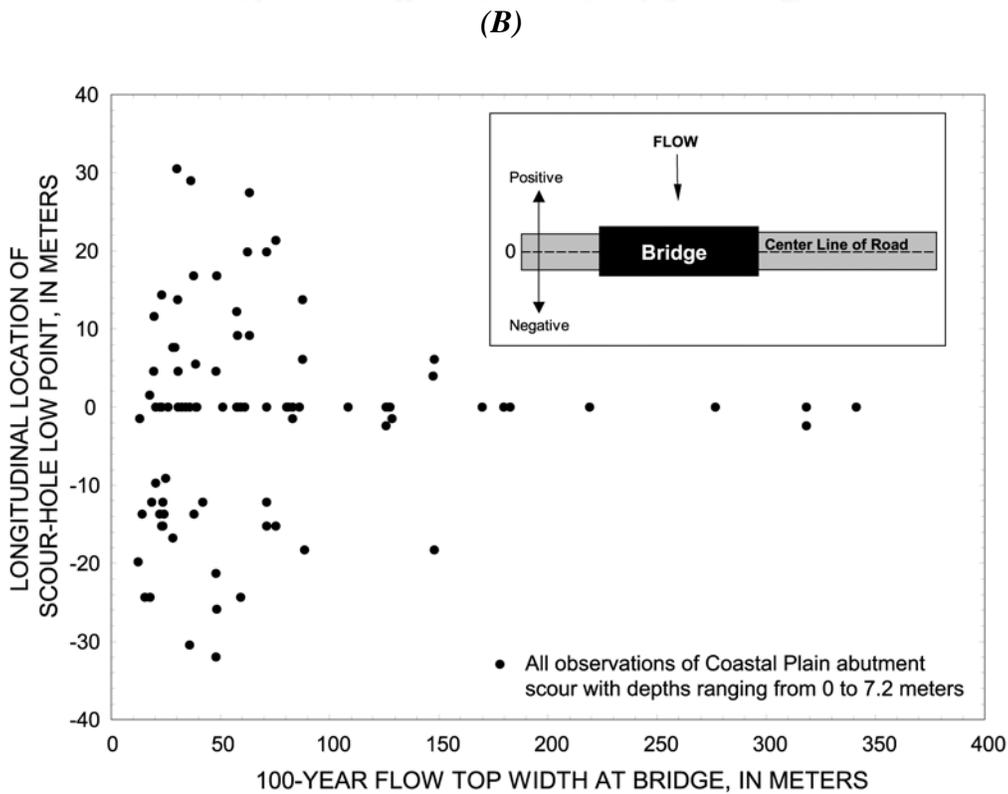
Figure 9. Relation of longitudinal location for the low point of the abutment-scour hole and the 100-year-flow top width at the bridge for (A) shallow and deep scour holes in the Piedmont of South Carolina, and (B) sites in the Coastal Plain of South Carolina.

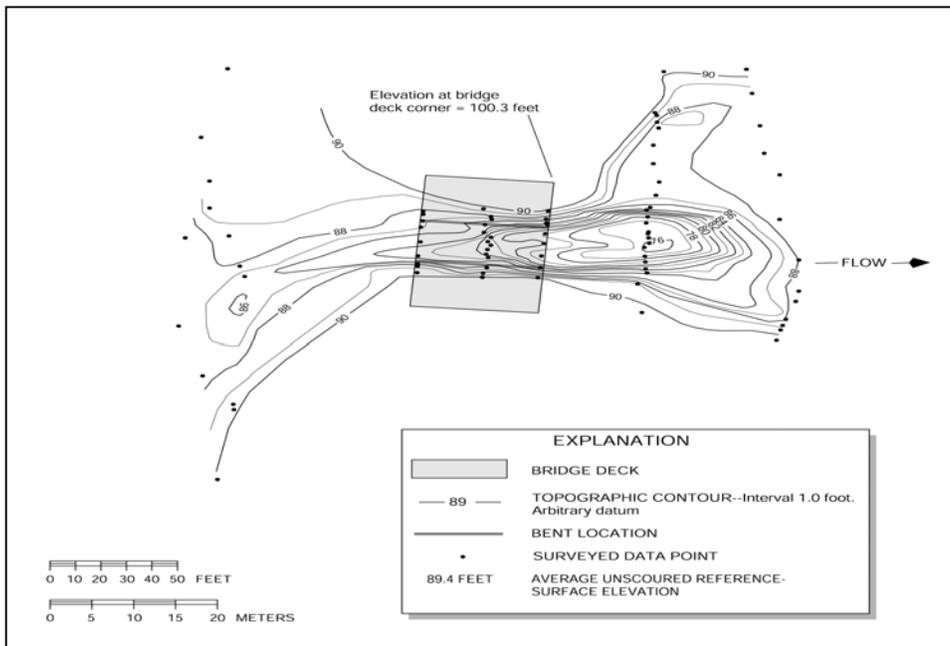
Figure 11. Example of scour-hole low point located downstream of S.C. Route 41, crossing Maiden Down Swamp in Marion County, South Carolina, December 3, 1996.

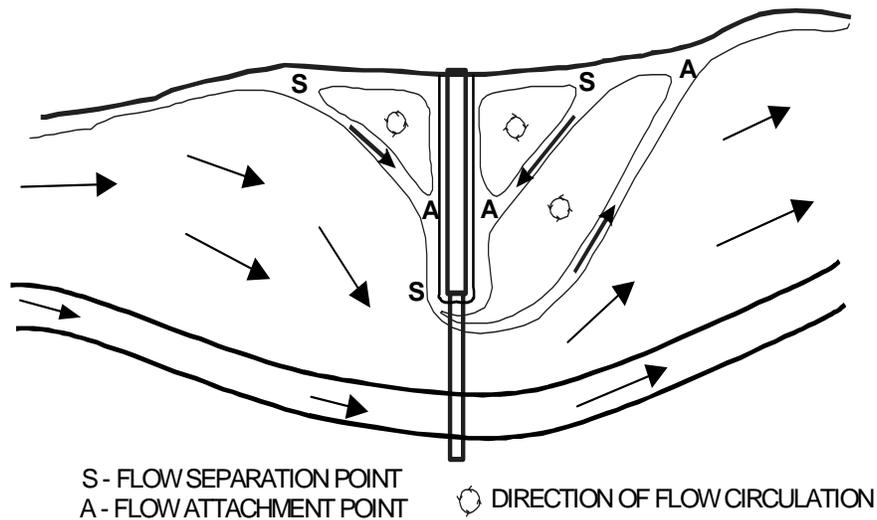
Figure 12. *Illustration of flow contracted by an embankment constructed in a floodplain.*

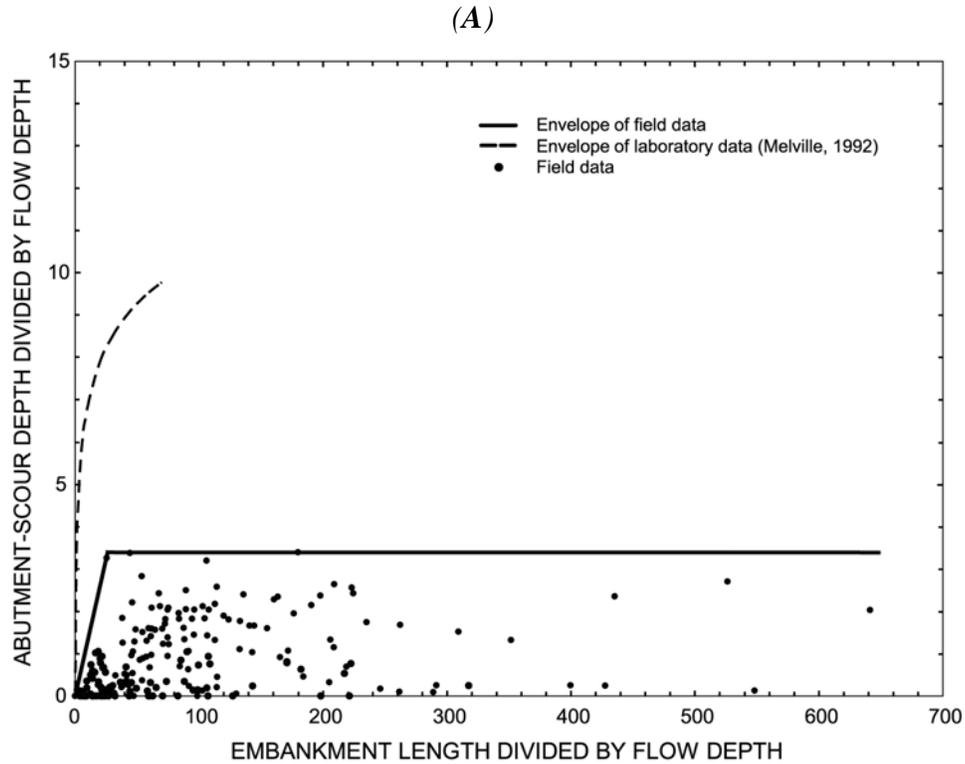
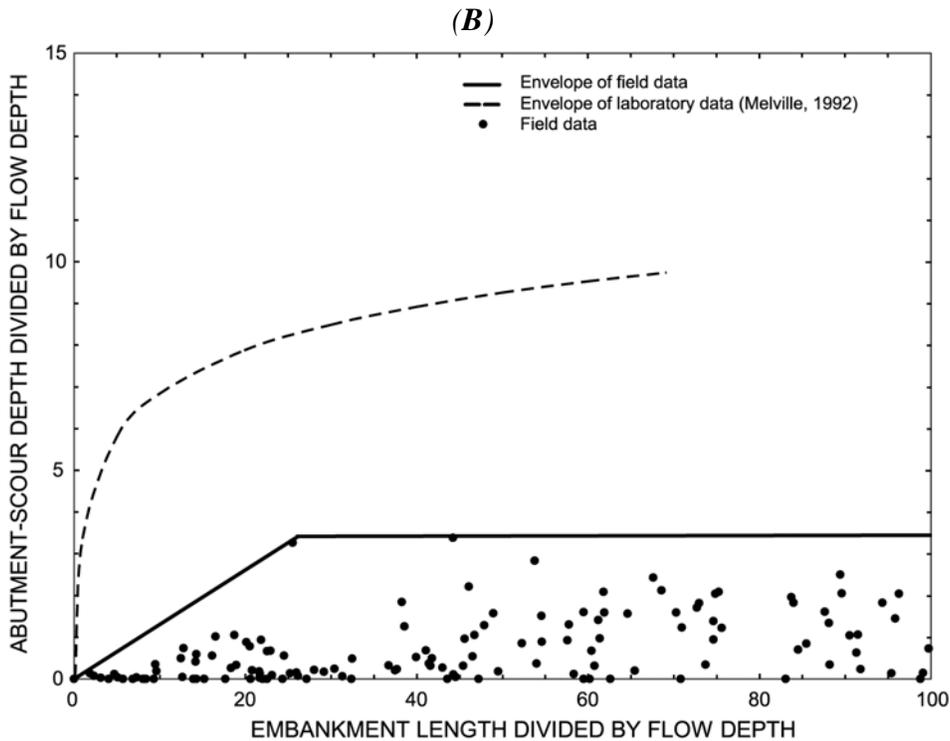
Figure 13. Relation of observed clear-water abutment-scour depth and the 100-year-flow embankment length, normalized by the 100-year-flow depth near the abutment toe, for the Piedmont and Coastal Plain of South Carolina with (A) a complete horizontal axis, and (B) a truncated horizontal axis.

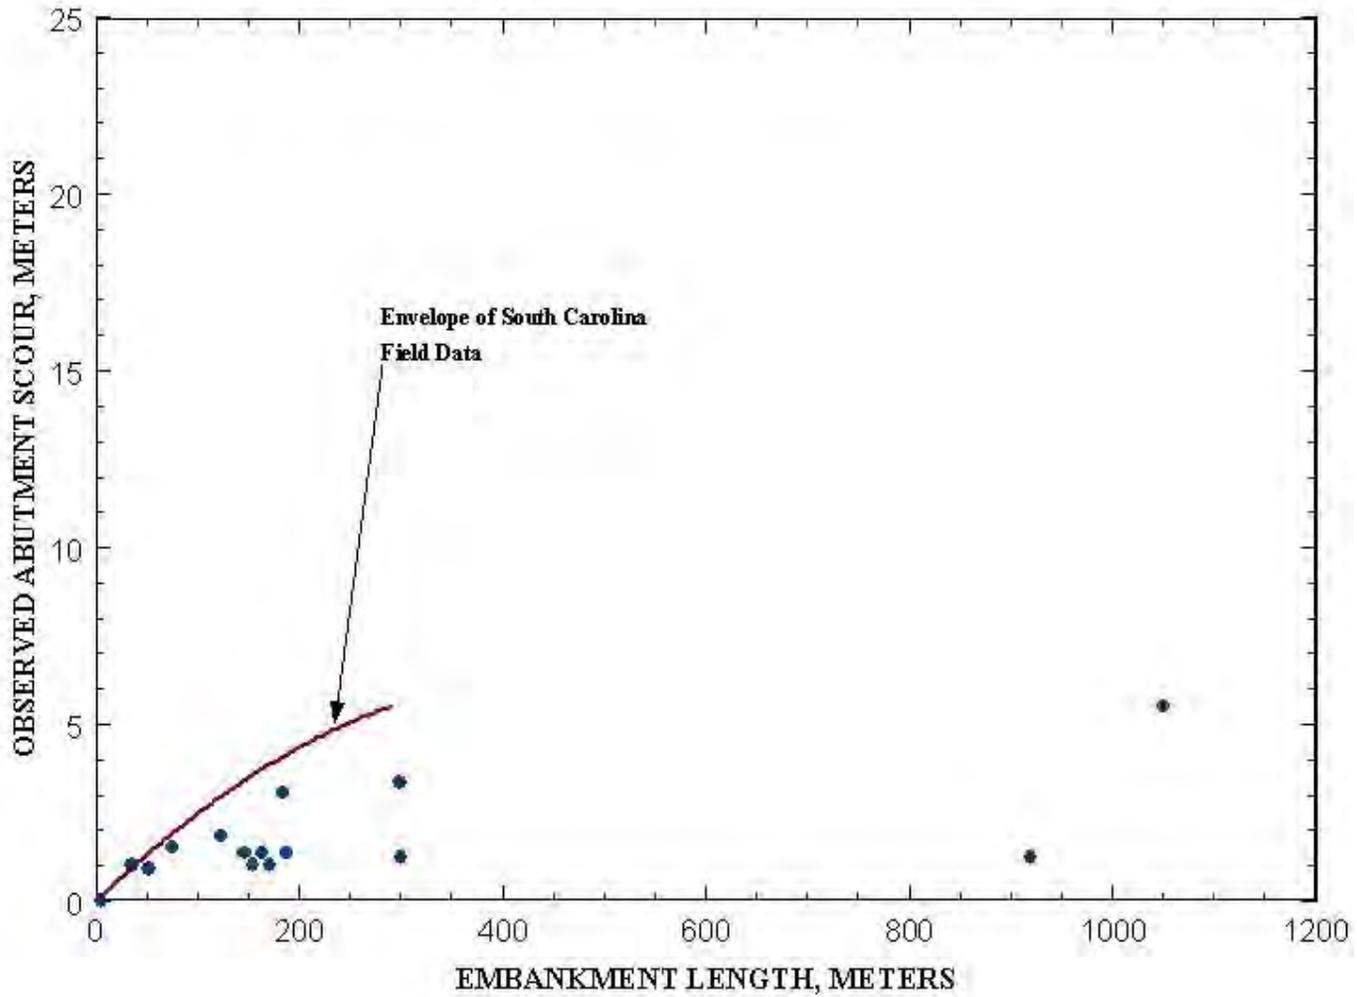
Figure 14. Comparison of the embankment-length envelope for field observations of abutment-scour depth in South Carolina with the observed abutment scour for selected sites from the National Bridge Scour Database (BSDMS).

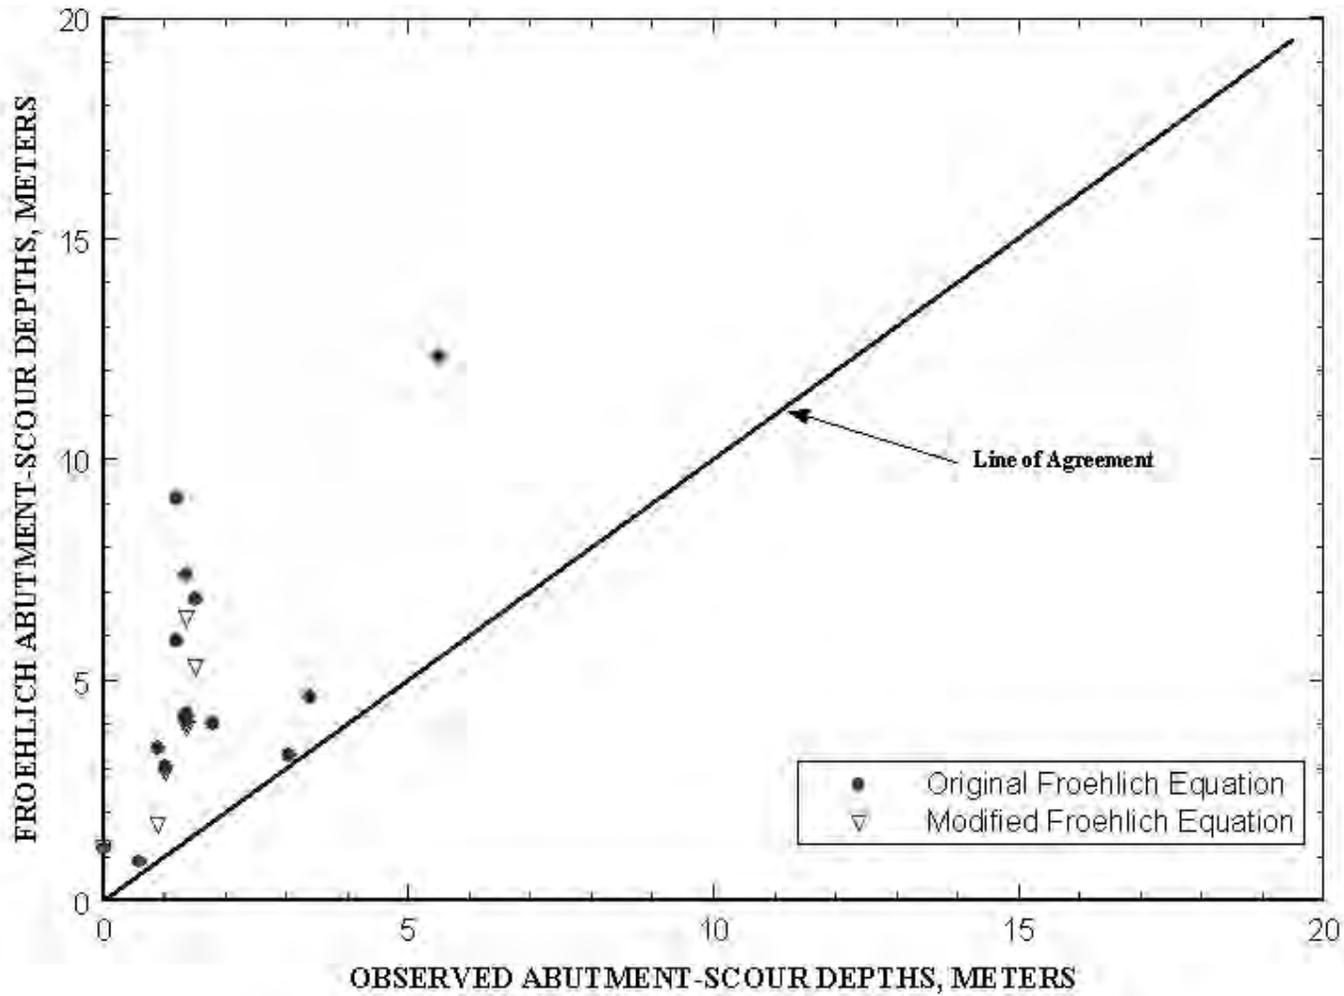
Figure 15. Comparison of field observations of abutment-scour depth with the theoretical abutment-scour depth computed with the original Froehlich (1989) and modified Froehlich (2001) equations for selected sites from the National Bridge Scour Database (BSDMS).

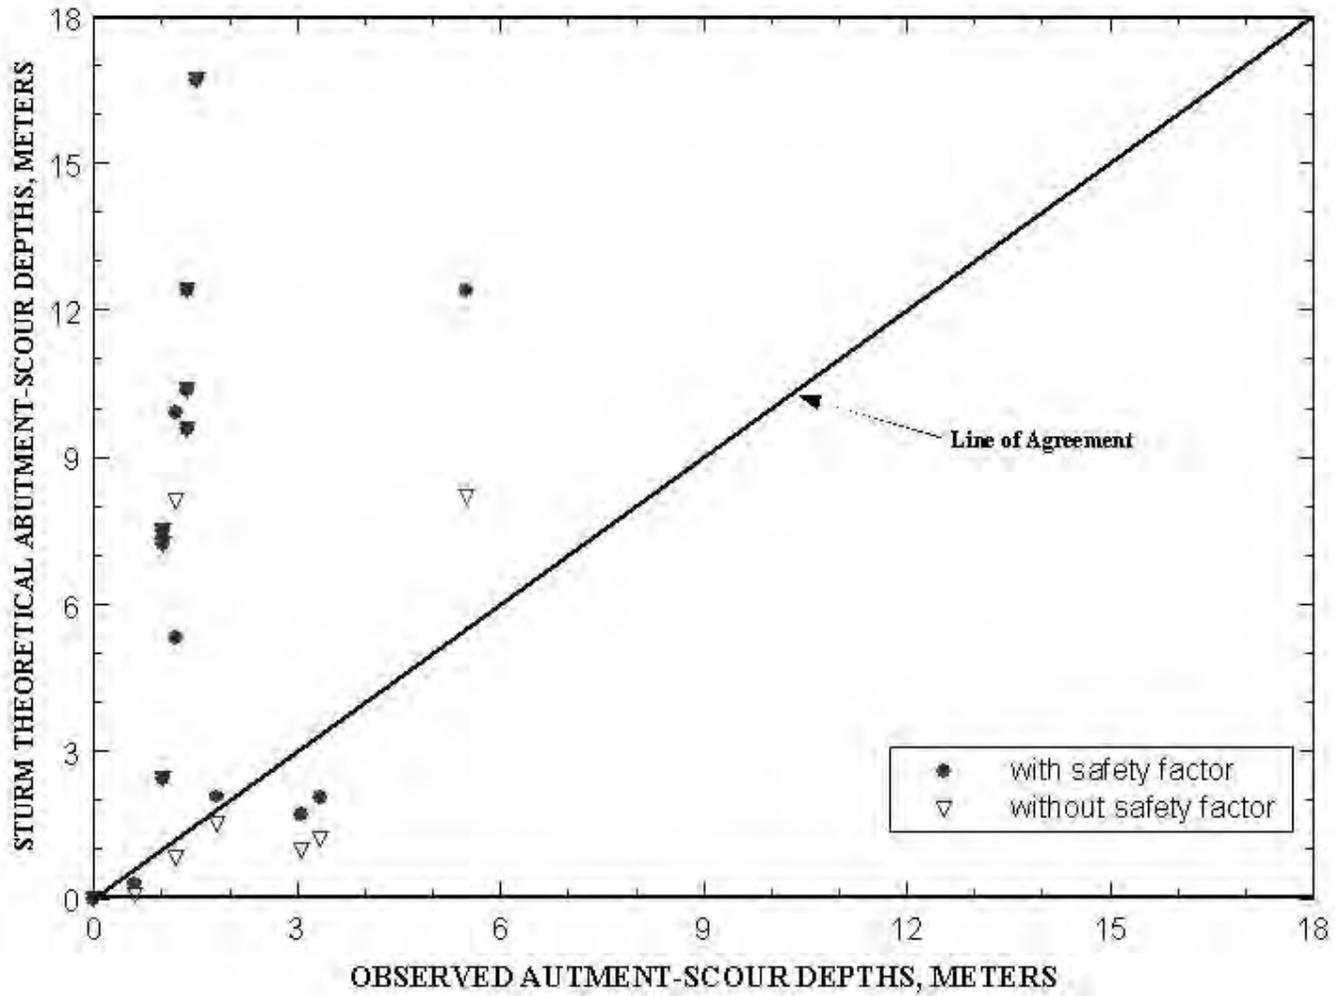
Figure 16. Comparison of field observations of abutment-scour depth with theoretical abutment-scour depth computed with the HEC-18 (2001) Sturm equation (with and without the safety factor) for selected sites from the National Bridge Scour Database (BSDMS).

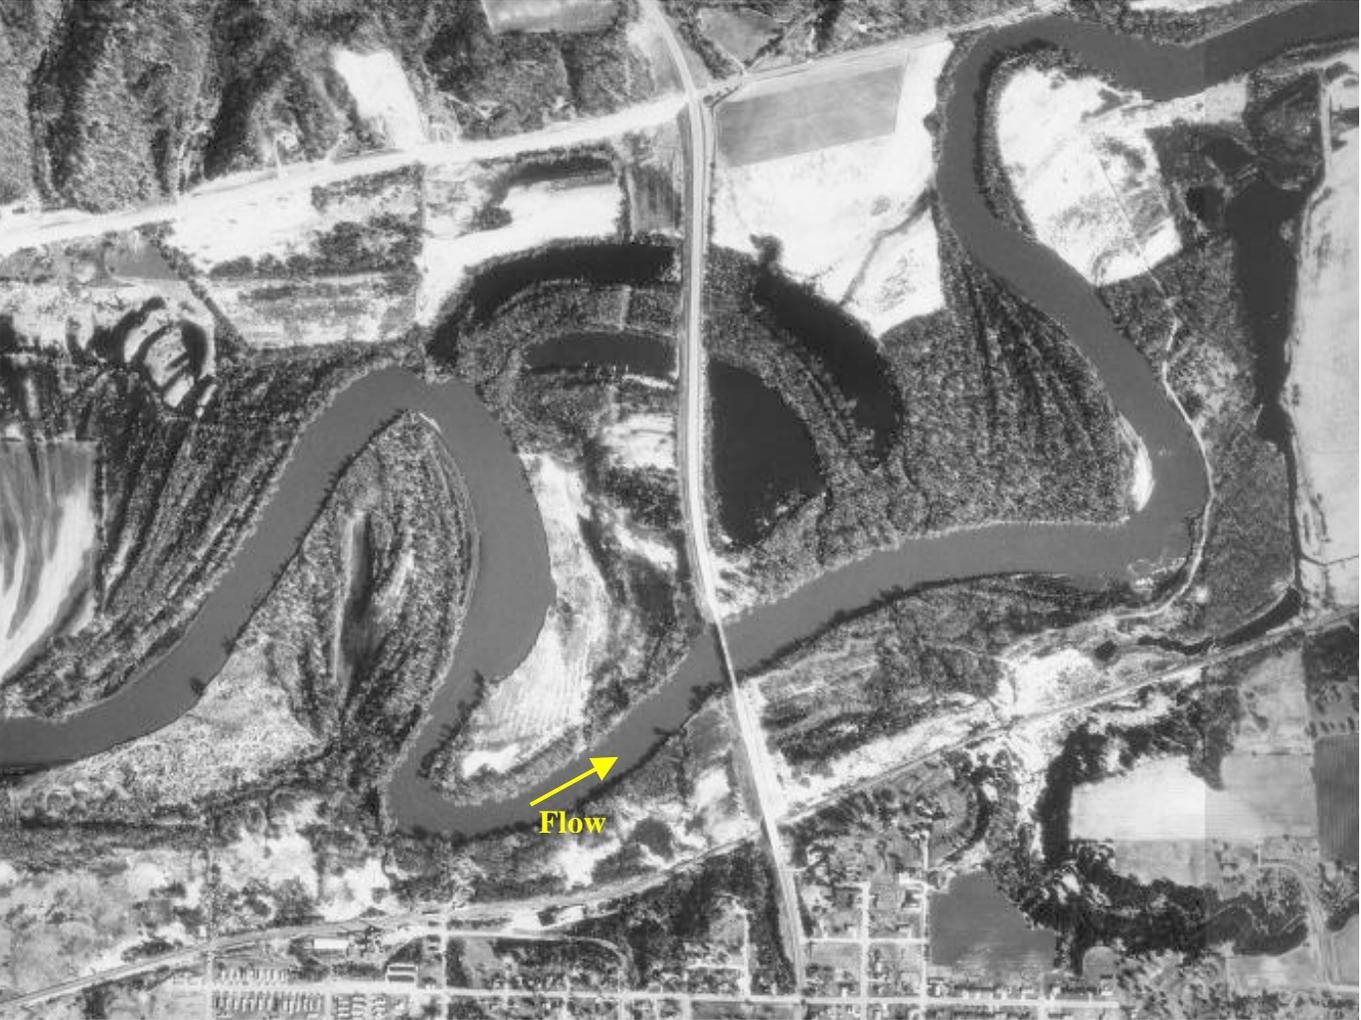
Figure 17. Aerial photograph of State Route 25 over the Minnesota River near Belle Plaine, Minnesota

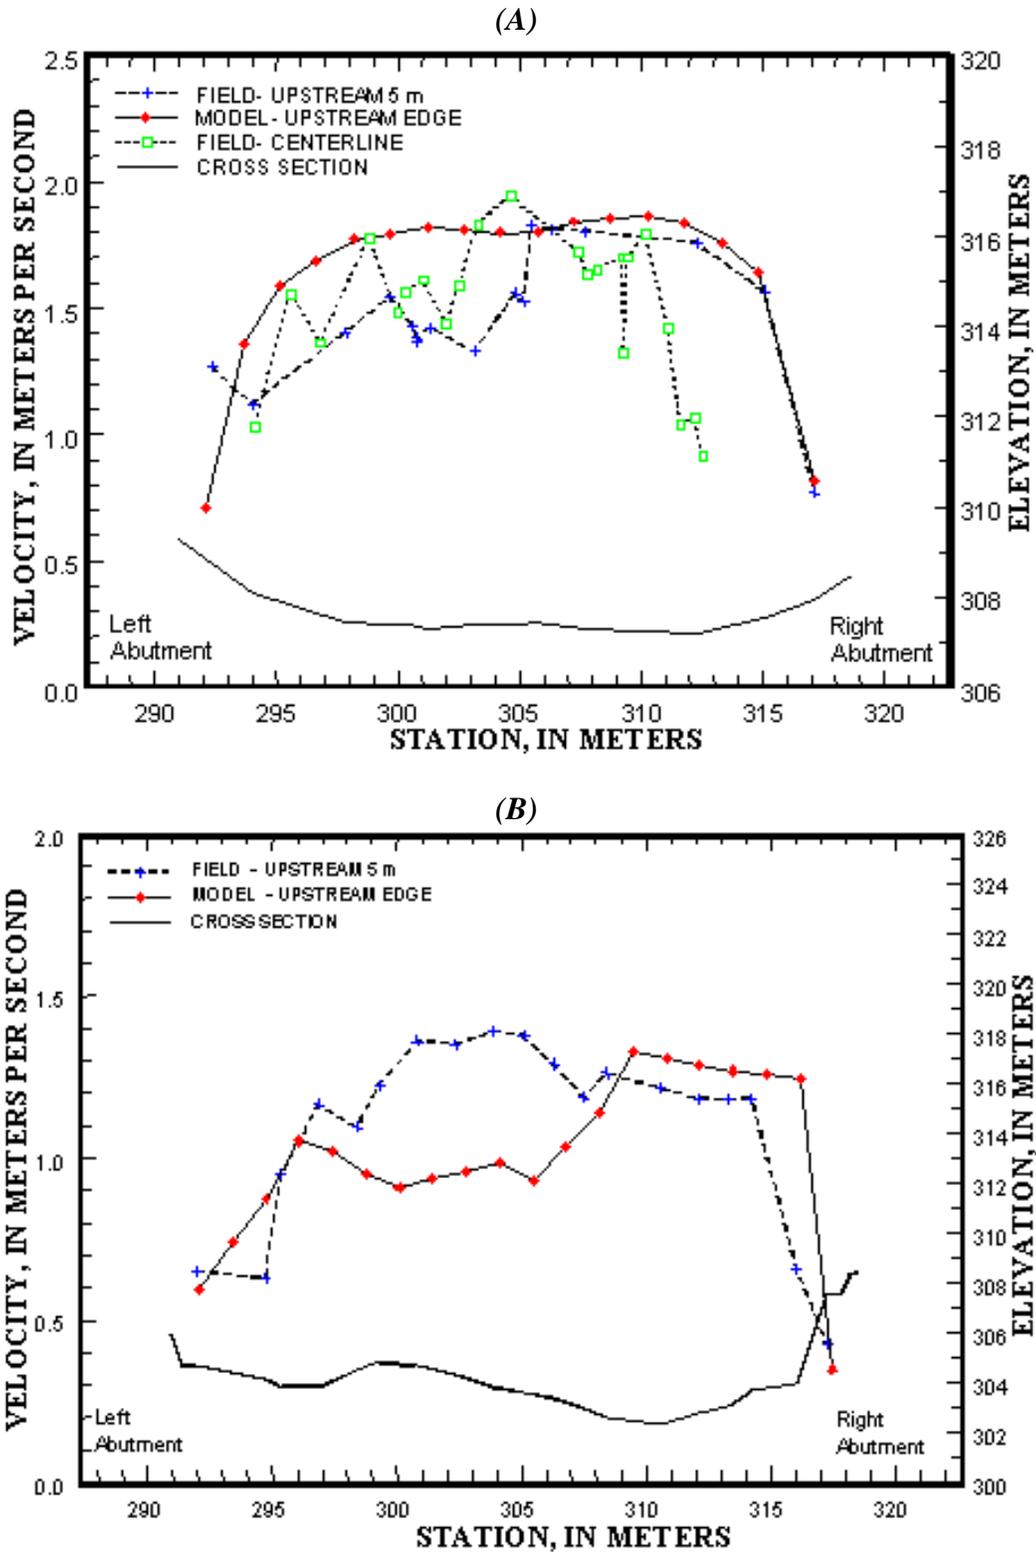
Figure 18. Comparison of observed- and model-velocity distributions at U.S. Route 12 over the Pomme de Terre River, Minnesota, for (A) April 5, 1997 and (B) April 9, 1997.

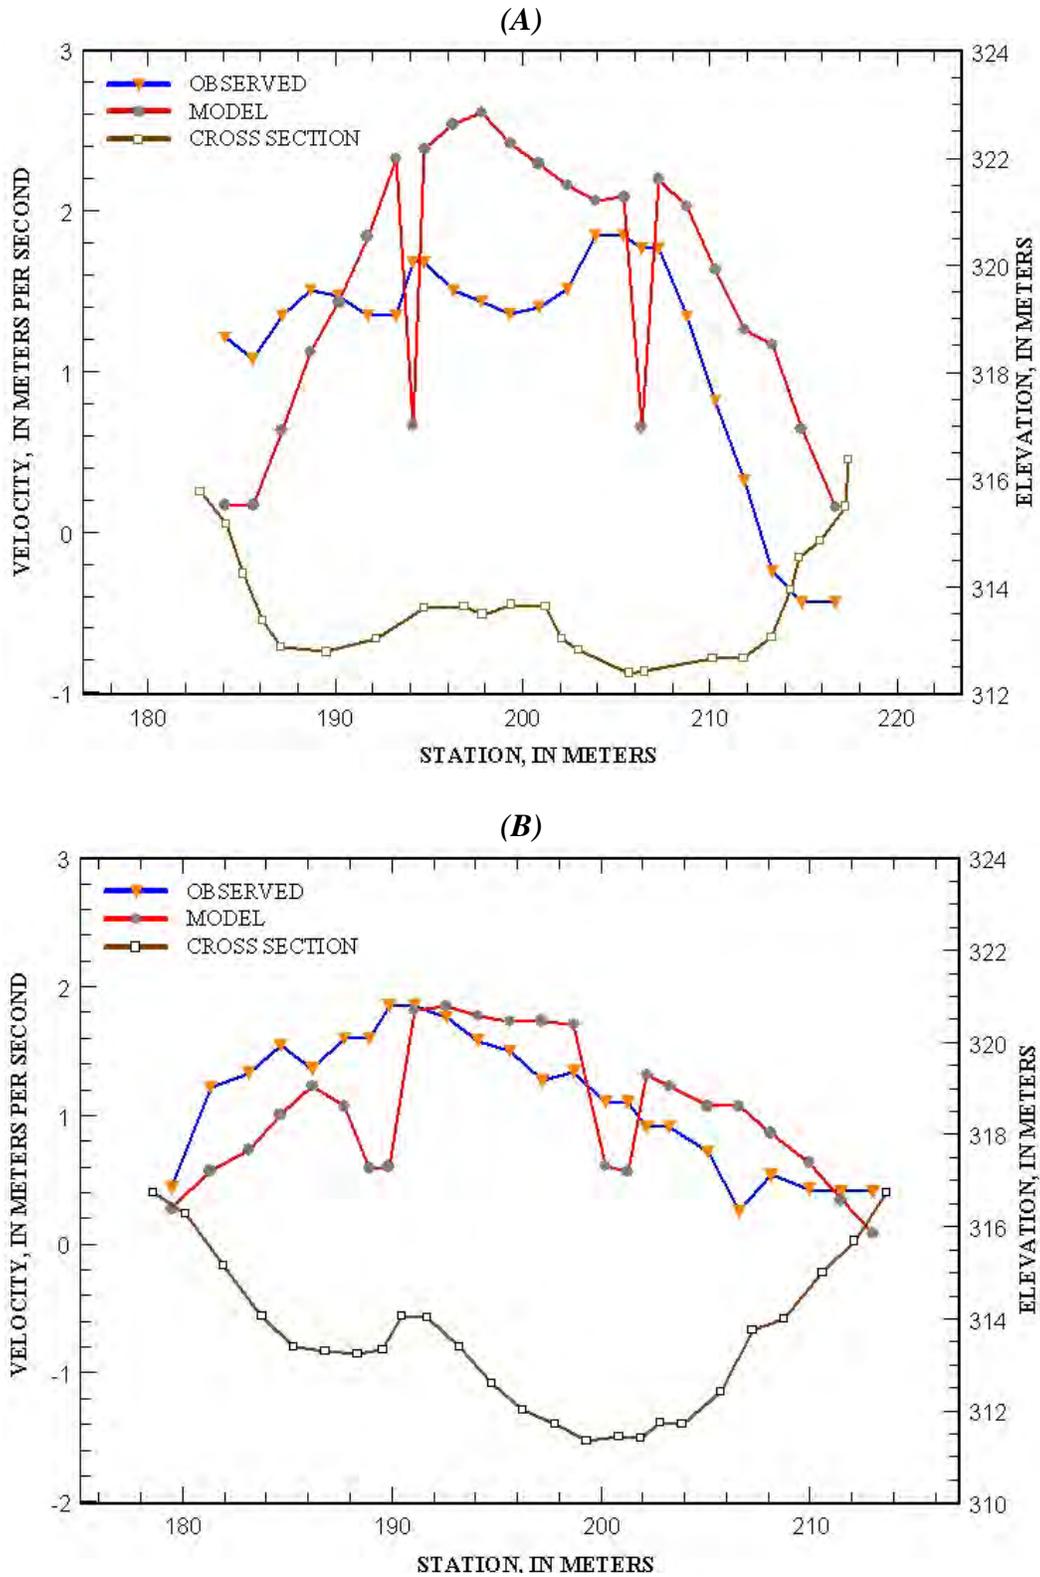
Figure 19. Comparison of observed- and model-velocity distributions at County Route 22 over the Pomme de Terre River, Minnesota, for (A) April 5, 1997 and (B) April 9, 1997.

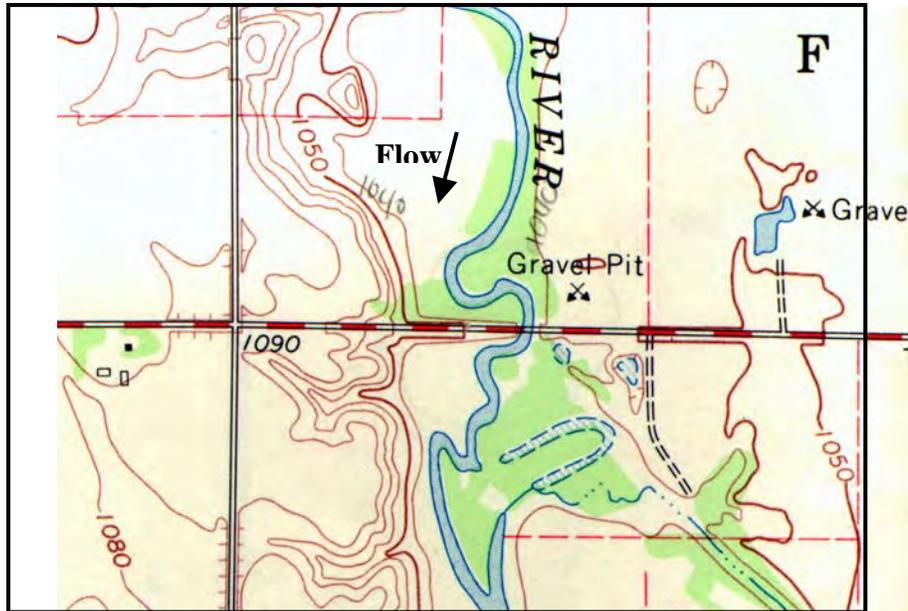
Figure 20. Plan view of topography and channel alignment for County Route 22 over the Pomme De Terre River near Fairfield, Minnesota (elevation referenced in feet above seal level; 1 ft = 3.2808 m).

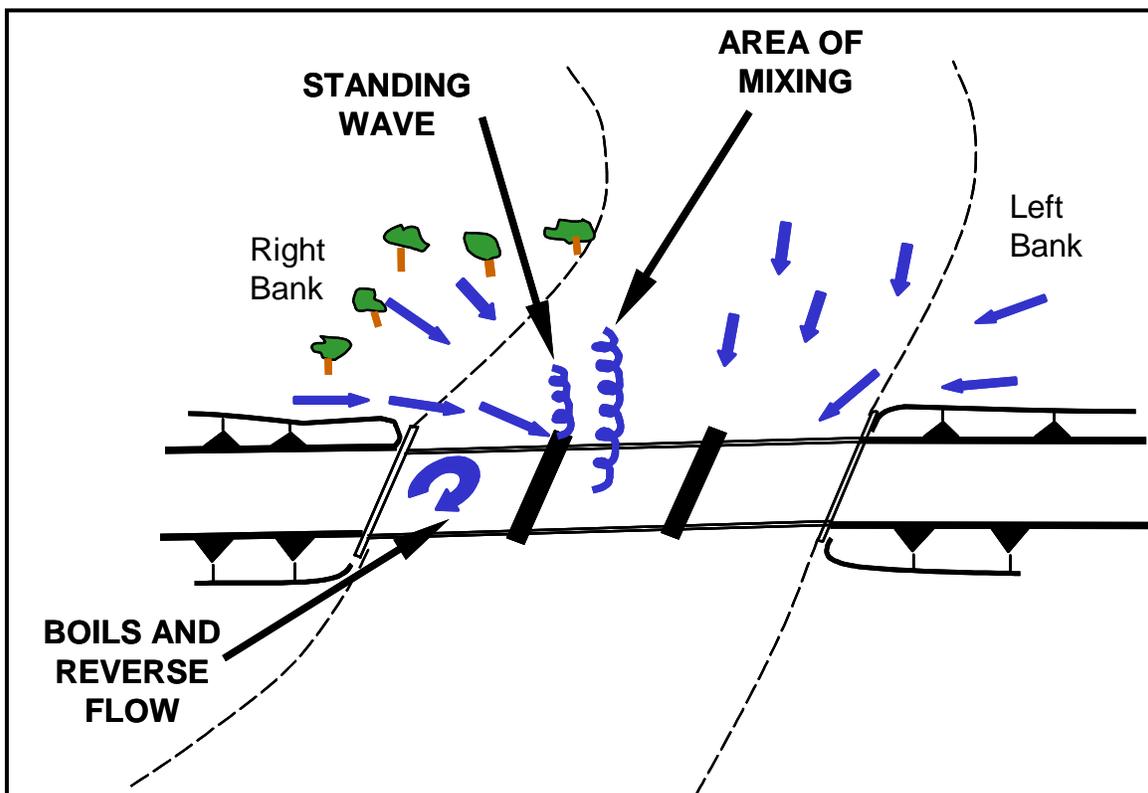
Figure 21. Sketch of the hydrodynamics observed during bridge scour measurements at County Route 22 over the Pomme de Terre River on April 5, 1997.
