Scour at Contracted Bridges

National Cooperative Highway Research Program

U.S. Geological Survey and University of Louisville

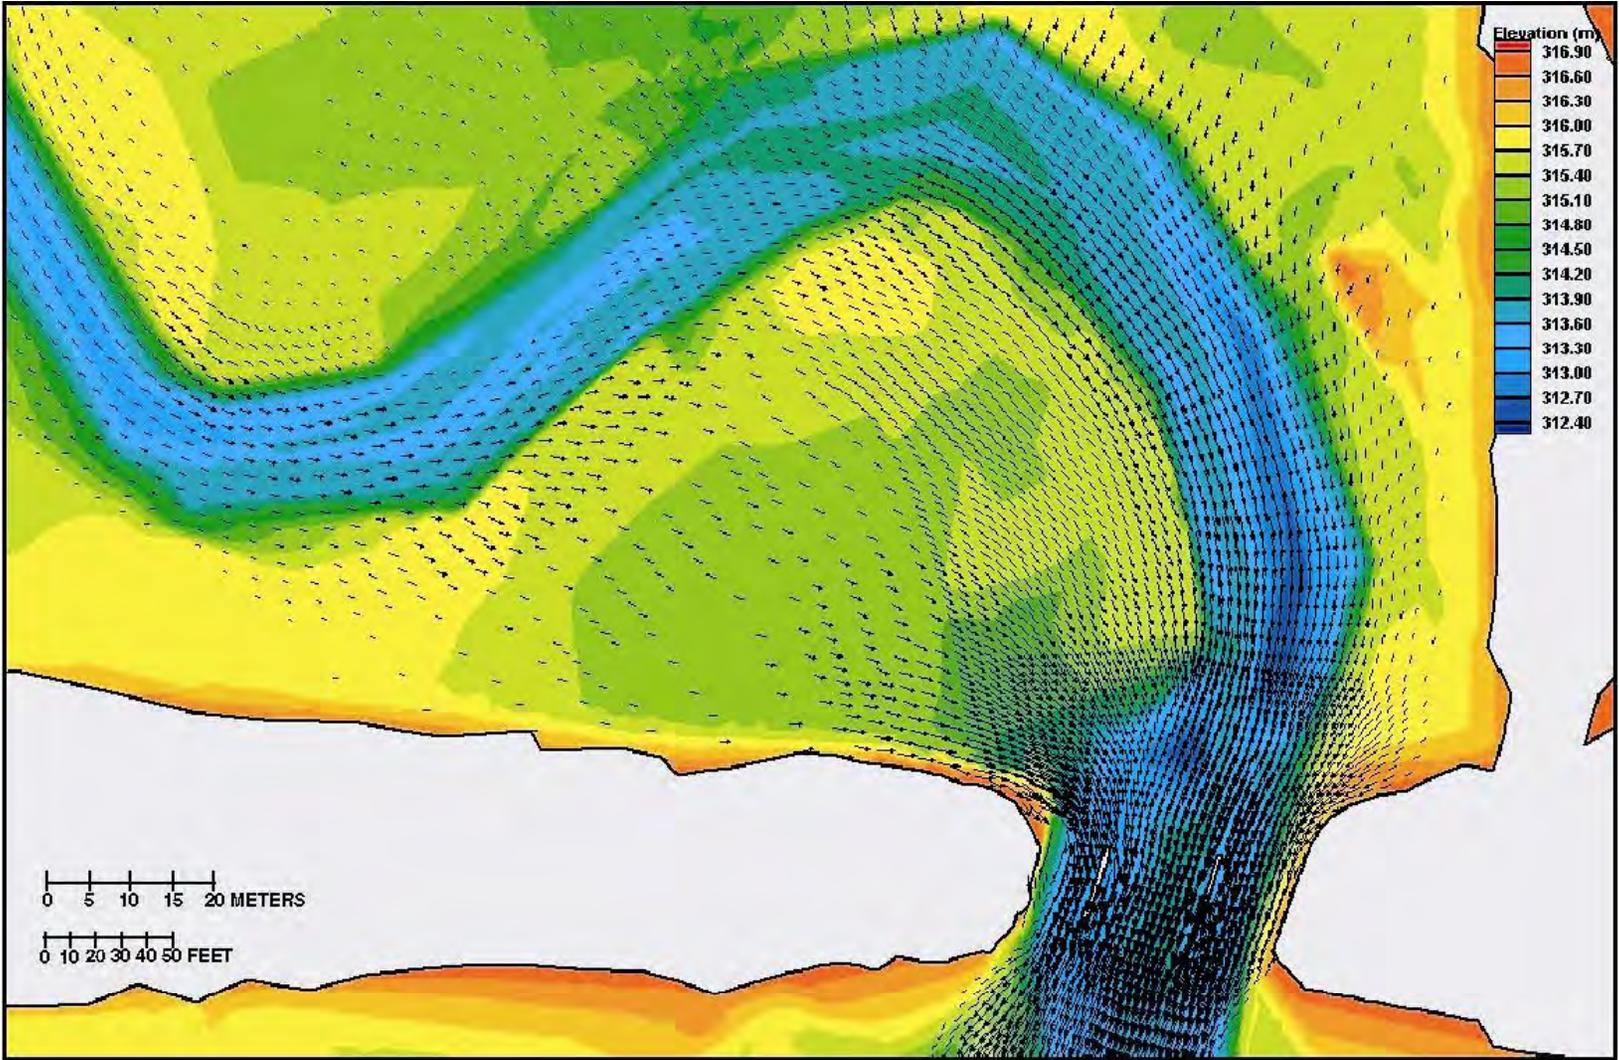
Figure 22. Modeled flow field for County Route 22 over the Pomme de Terre River for conditions on April 5, 1997.

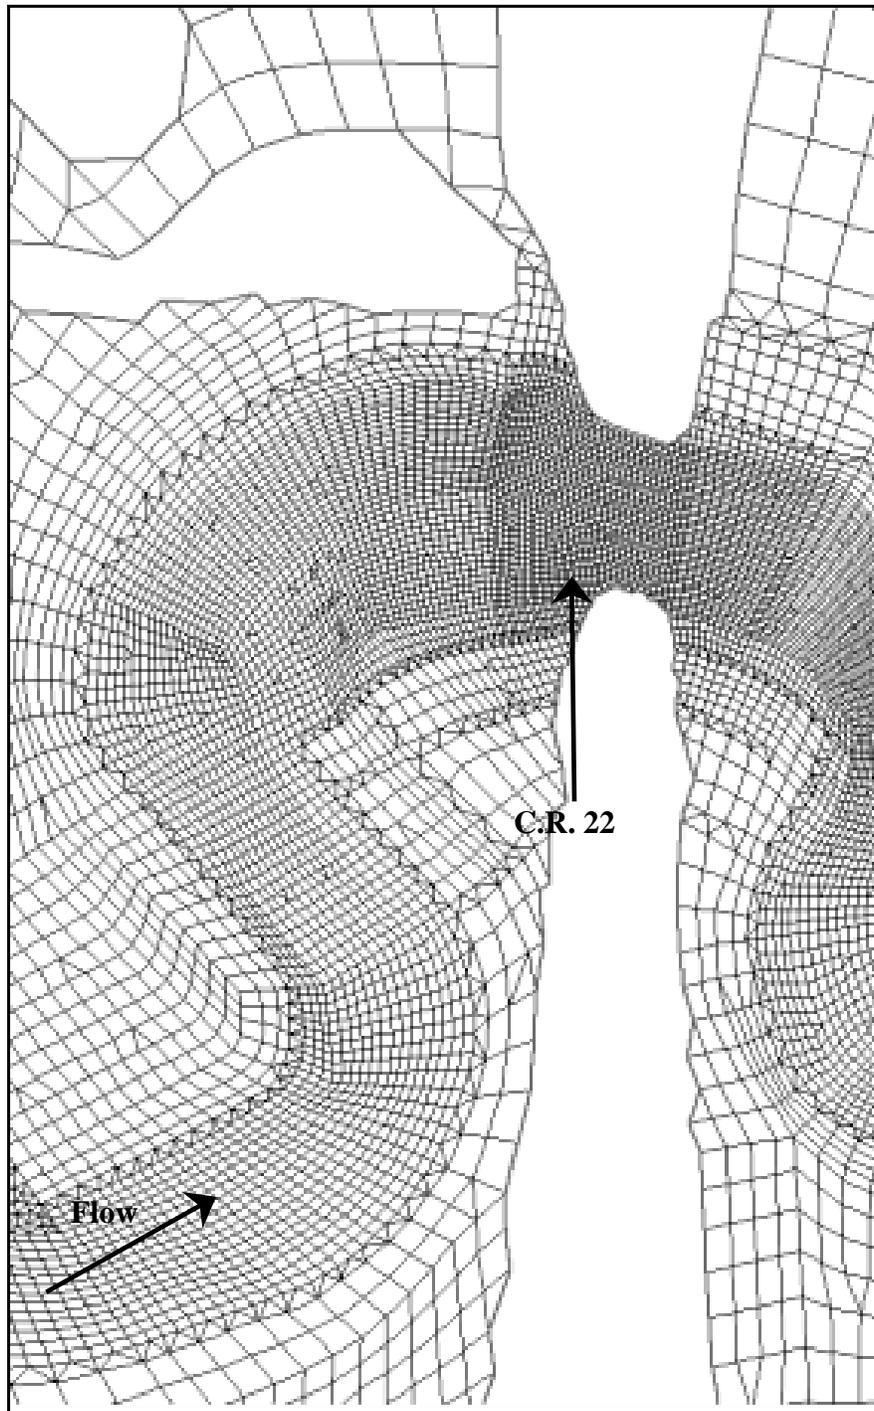
Figure 23. Computational mesh for the two-dimensional model of County Route 22 over the Pomme de Terre River.

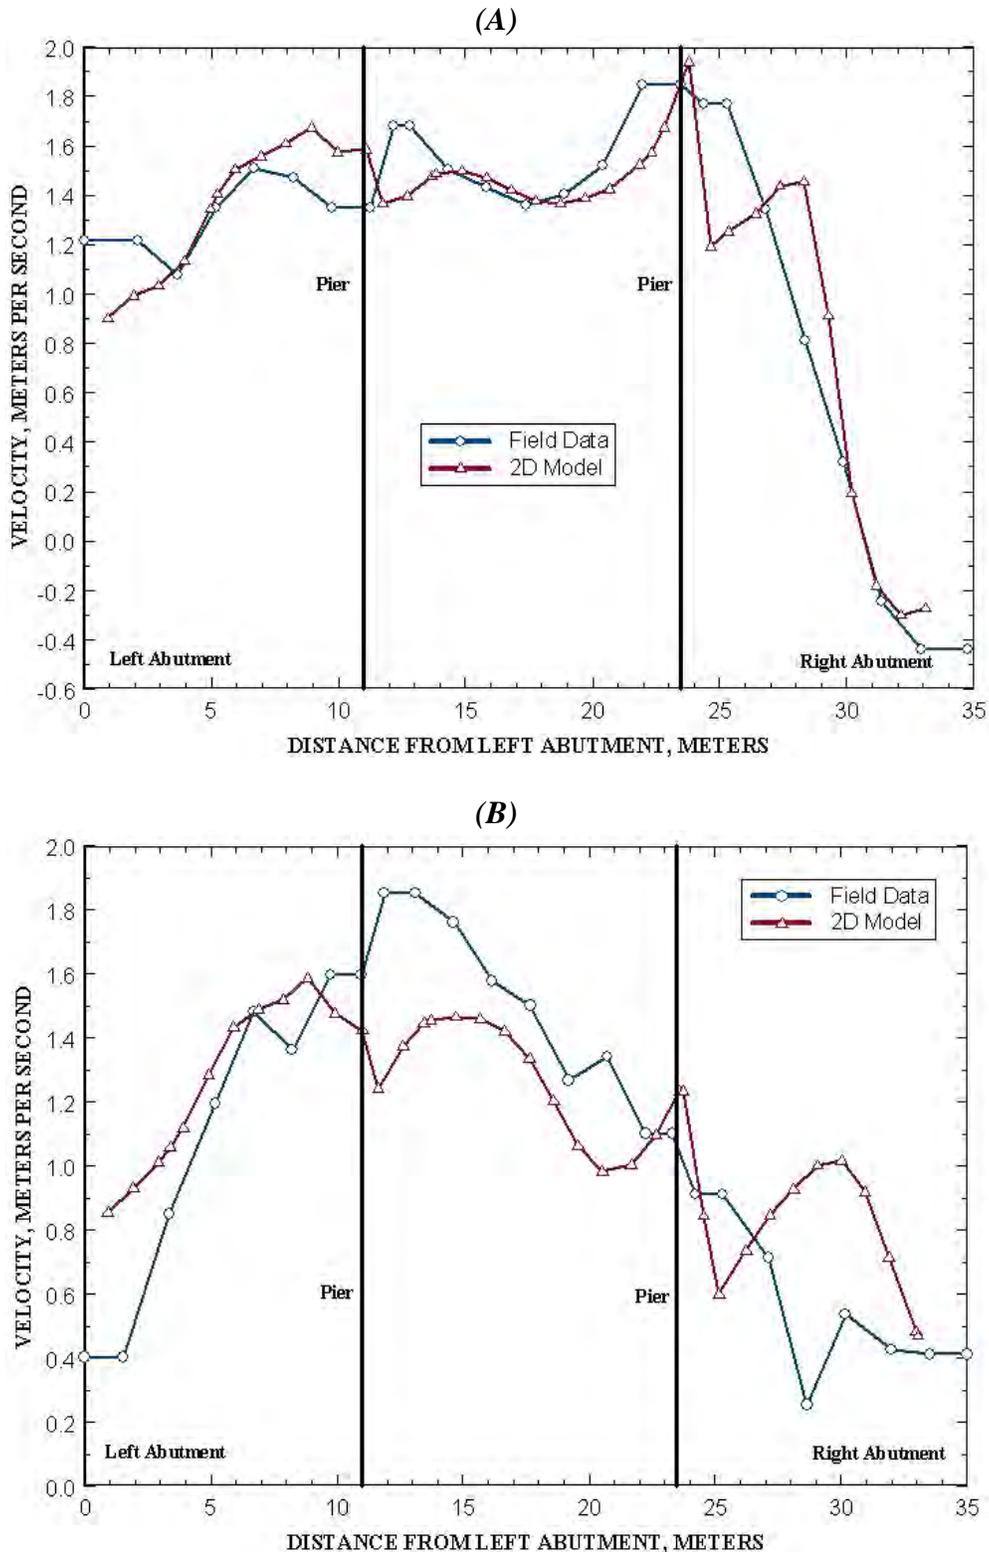
Figure 24. Comparison of the velocity distribution for the two-dimensional model and field measurements at the upstream bridge face of County Route 22 over the Pomme de Terre River on (A) 4/5/1997 and (B) 4/9/1997.

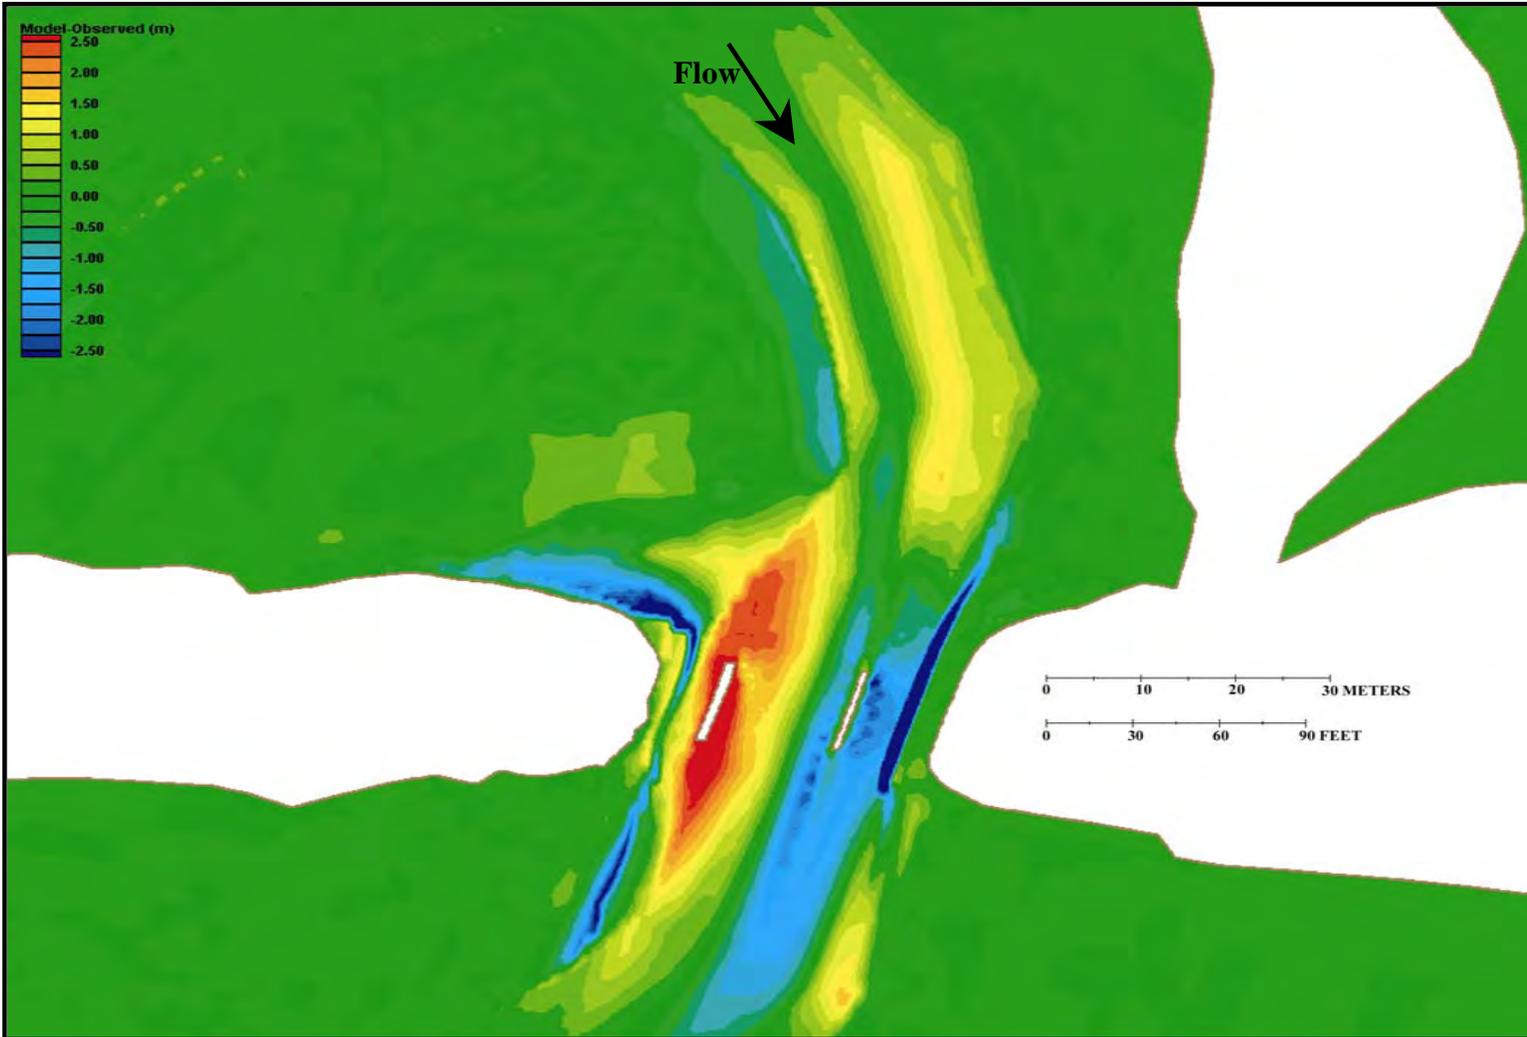
Figure 25. Difference in bed elevation (in meters) between two-dimensional sediment-transport model output and field data collected during flood conditions on the Pomme de Terre River at County Route 22, April 4-9, 1997.

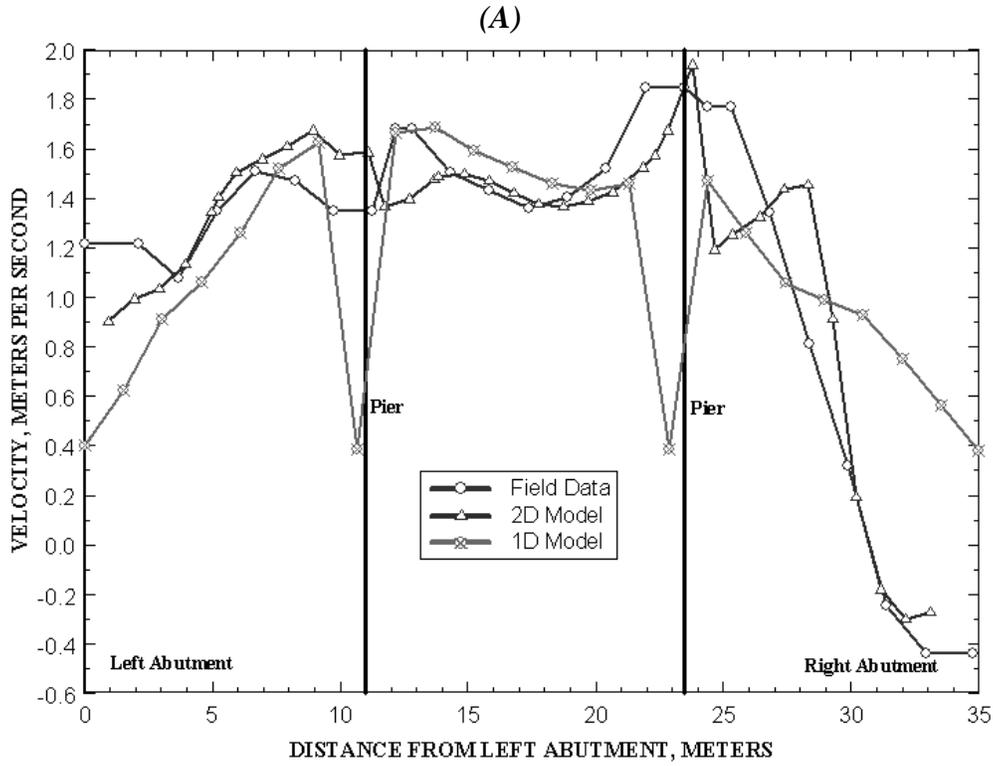
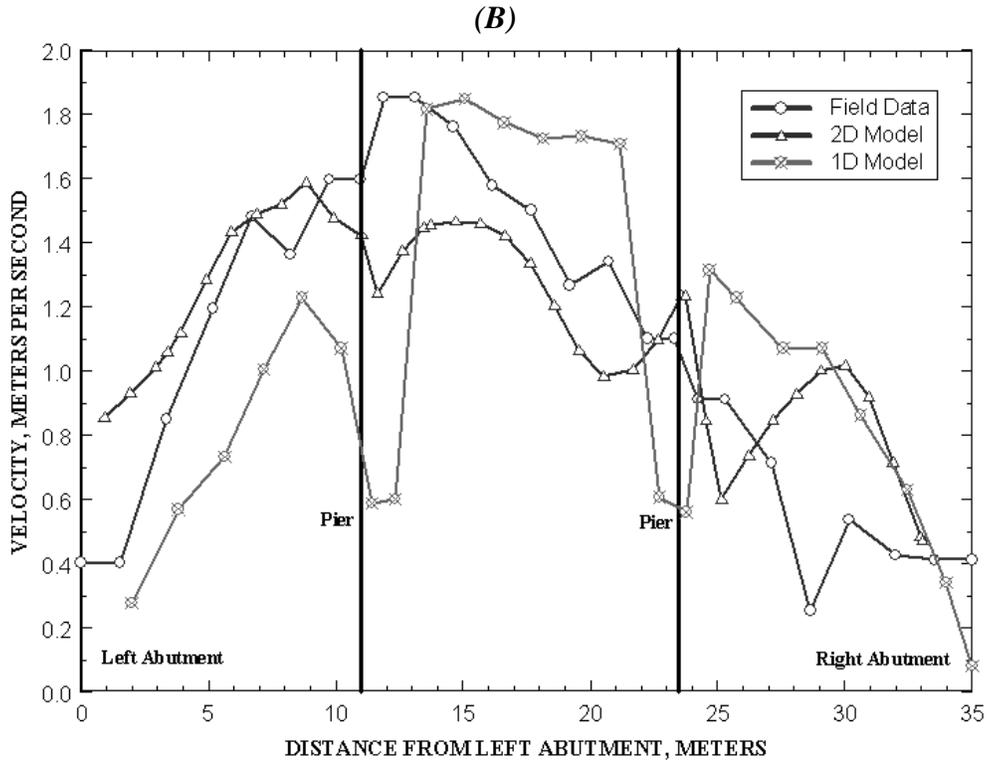
Figure 26. Comparison of the velocity distribution for the two-dimensional model, one-dimensional models and field measurements at the upstream bridge face of County Route 22 over the Pomme de Terre River on (A) 4/5/1997 and (B) 4/9/1997.

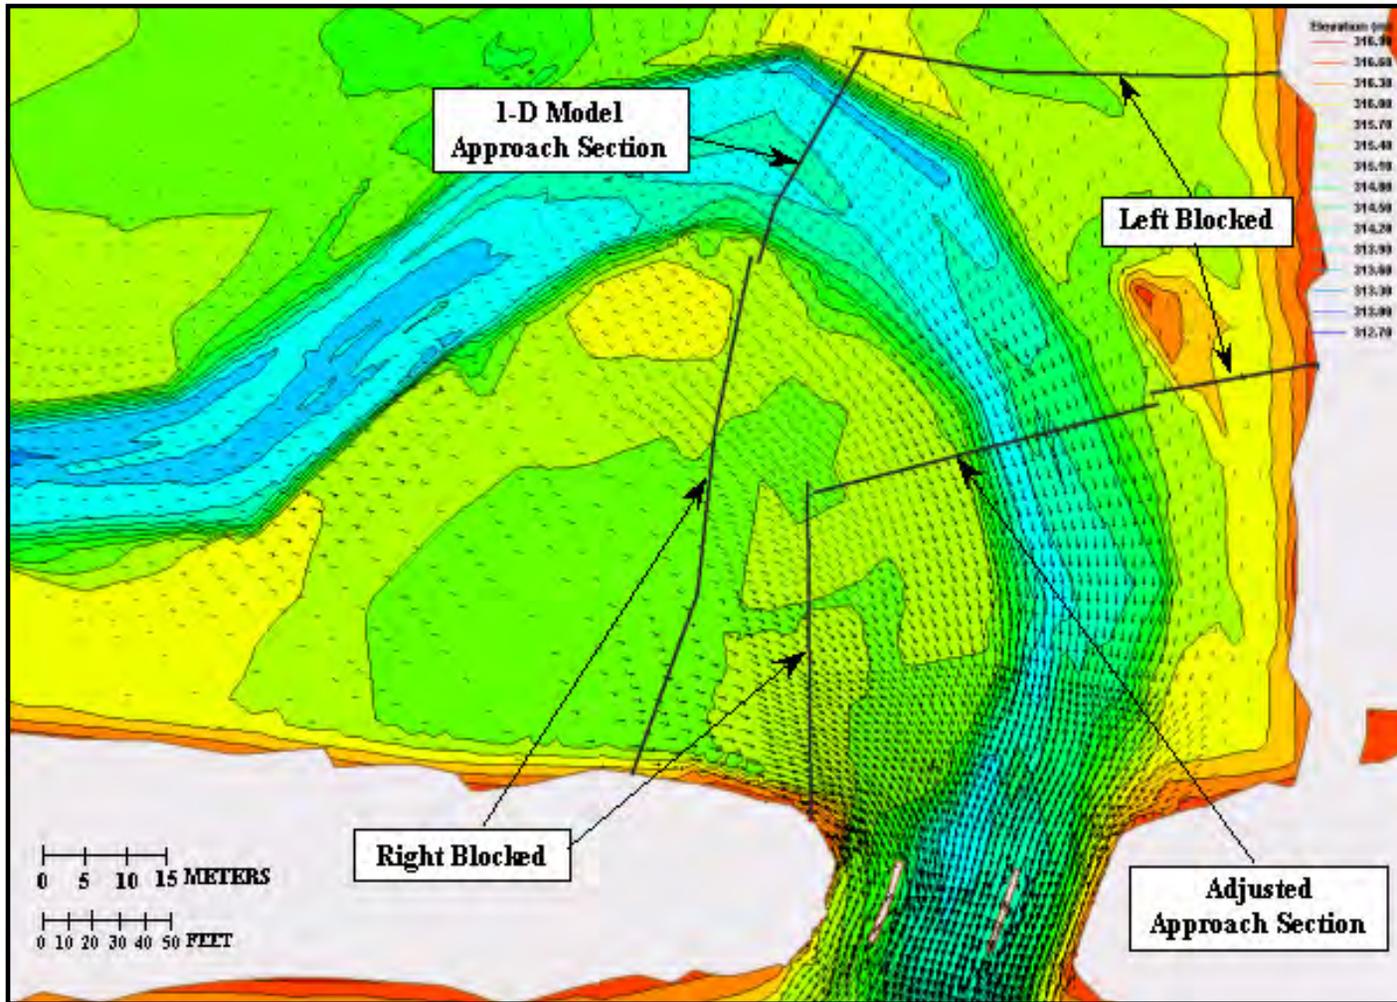
Figure 27. Comparison of the original one-dimensional and two-dimensional model approach section location with an approach section in a location more representative of the actual blocked and main channel hydraulics at County Route 22 over the Pomme de Terre River. (Velocity vectors are overlain to illustrate flow patterns through the bridge contraction for conditions on April 9, 1997).

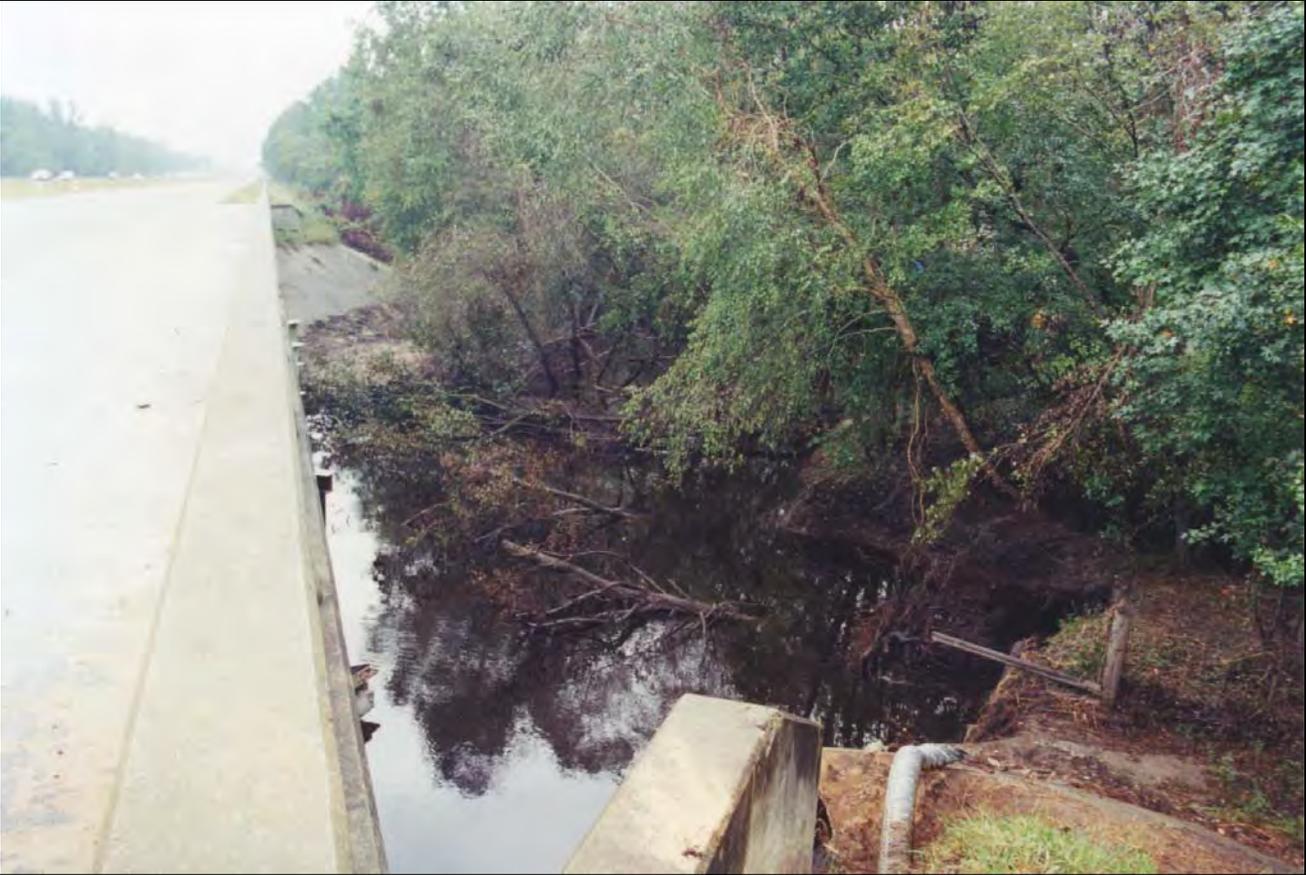
Figure 28. Looking upstream from the east bound bridge deck of highway 70 over Bear Creek near LAGRANGE, North Carolina during low-flow.

The upstream edge of a scour hole formed during Hurricane Floyd at the U.S. 70 Bridge over Bear Creek in North Carolina (Appendix A, Case Study No. 6) is illustrated in Figure 28. The scour hole appeared to be initiated in the main channel and propagated across the stream and upstream. The fine-grained surface soils reinforced by the roots of woody vegetation did not appear to have been scoured; however, the toe of the bank appeared to have been scoured and the undermined soil block containing the fine-grained surface material failed (toppled) into the scour hole. The orientations and positions of trees in Figure 28 indicate the mechanism of mass failure. Complex flow patterns caused by the rapid vertical expansion of flow over the vegetated floodplain surface at the upstream end of the scour hole and into the scour hole may be responsible for erosion of the more vulnerable basal soils that typically containing higher components of coarse-grained sediments. Erosion of the basal soils at the edge of the scour hole caused mass instability of the upper layers eventually leading to their collapse and the upstream propagation of the scour hole.

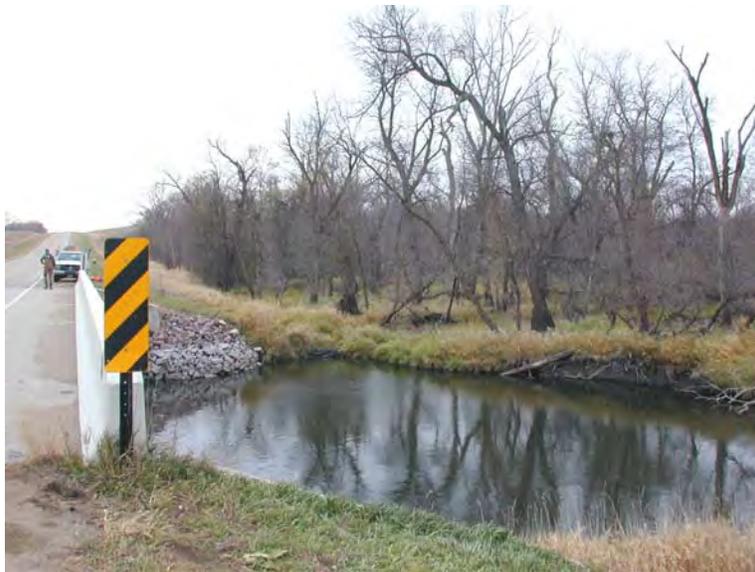
Figure 6. Looking at scoured area on right upstream bank of County Route 22, during low flow.

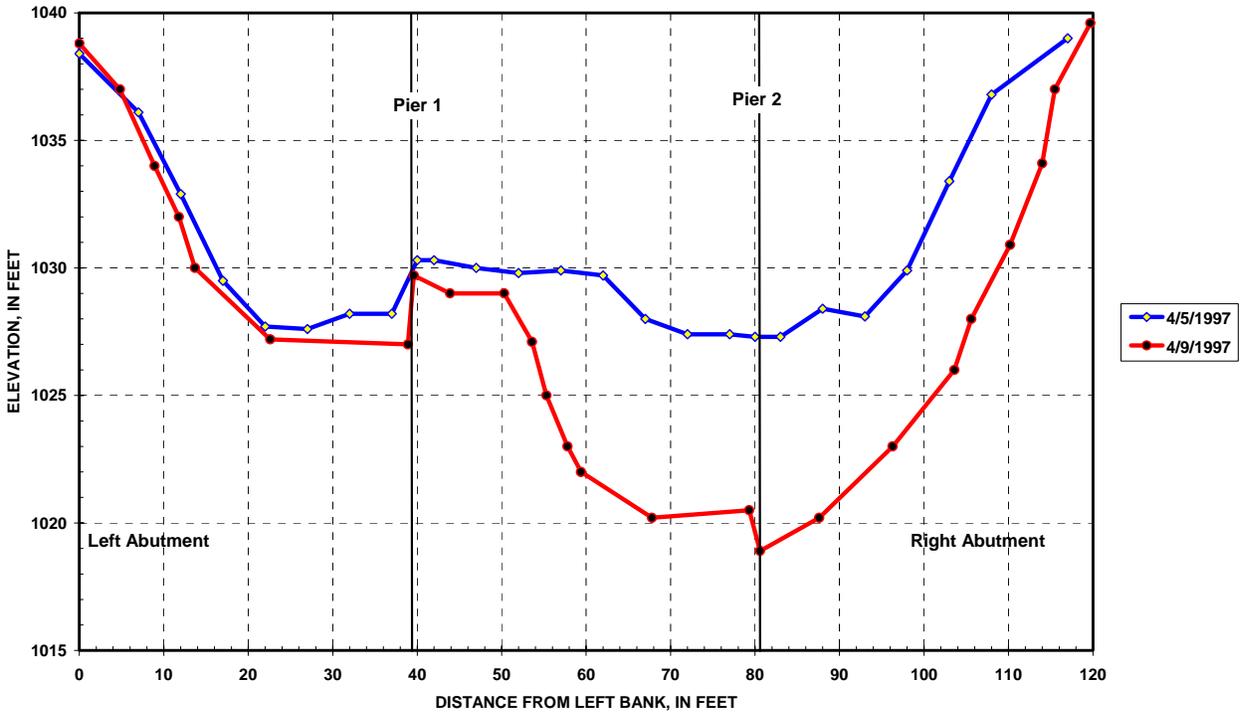
Figure 7. Cross-section data collected from the County Route 22 upstream bridge face during the April 1997 flood.

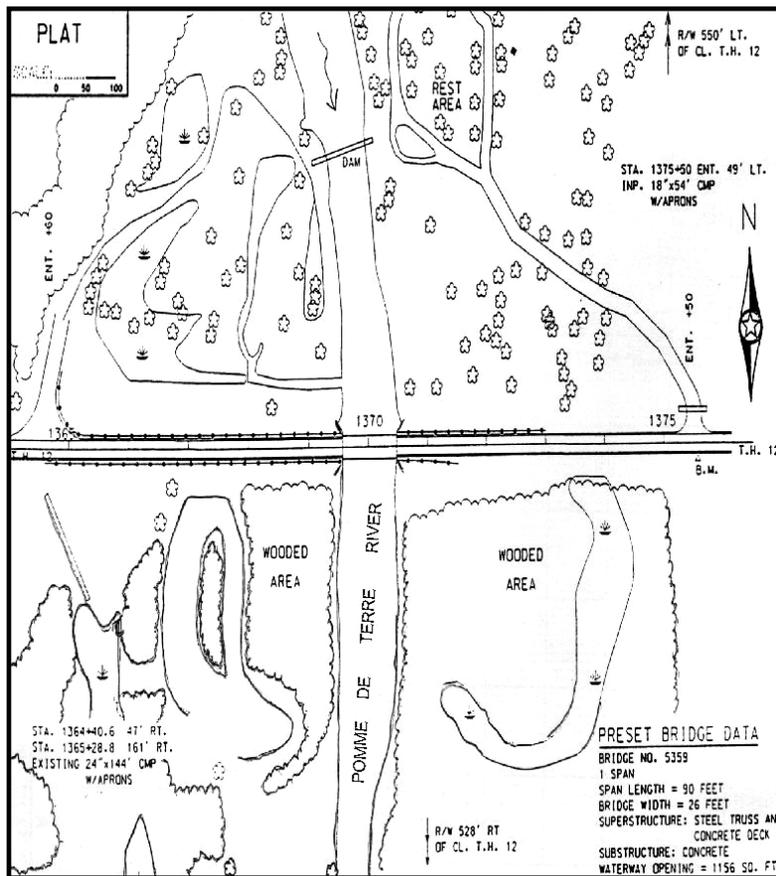
Figure 2. Plan view of U.S. 12 bridge site over the Pomme De Terre River.

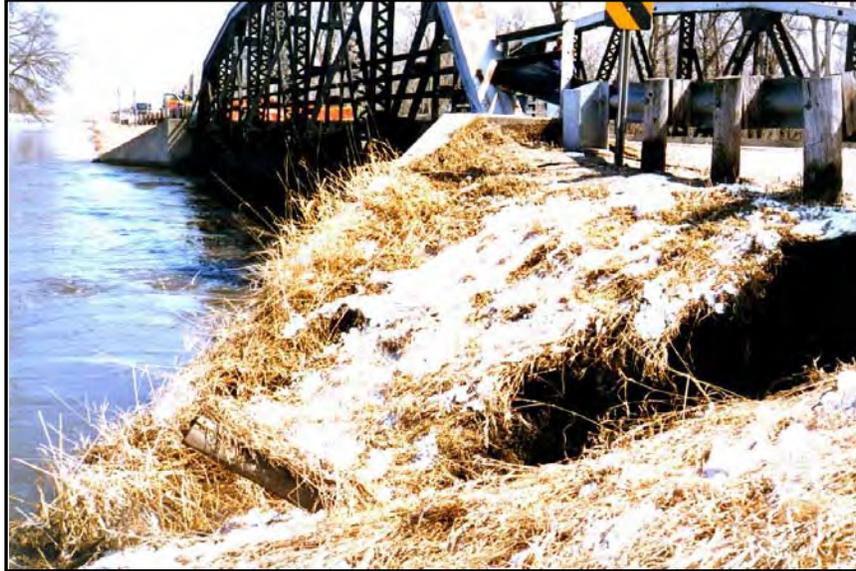
Figure 5. Looking at the upstream U.S. 12 bridge face from right bank during the April, 1997 flood.

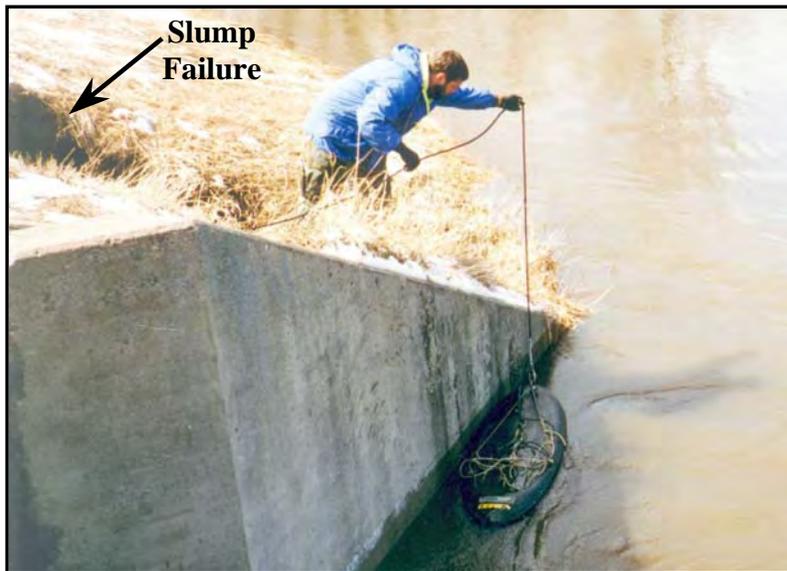
Figure 6. Scour measurement at upstream right wingwall of U.S. 12 bridge over the Pomme De Terre River; notice slump failure of embankment.

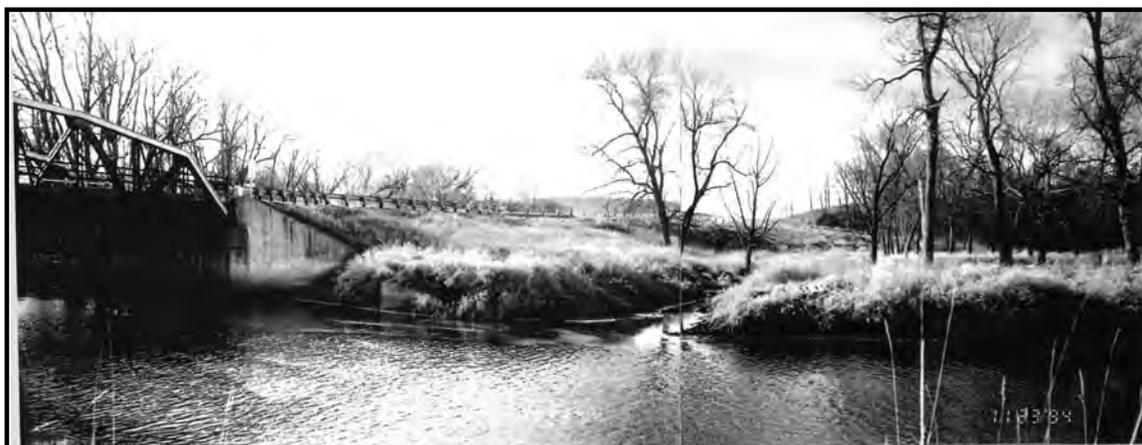
Figure 9. Looking at upstream right abutment and embankment of U.S. 12 bridge during low-flow prior to April, 1997 flood.

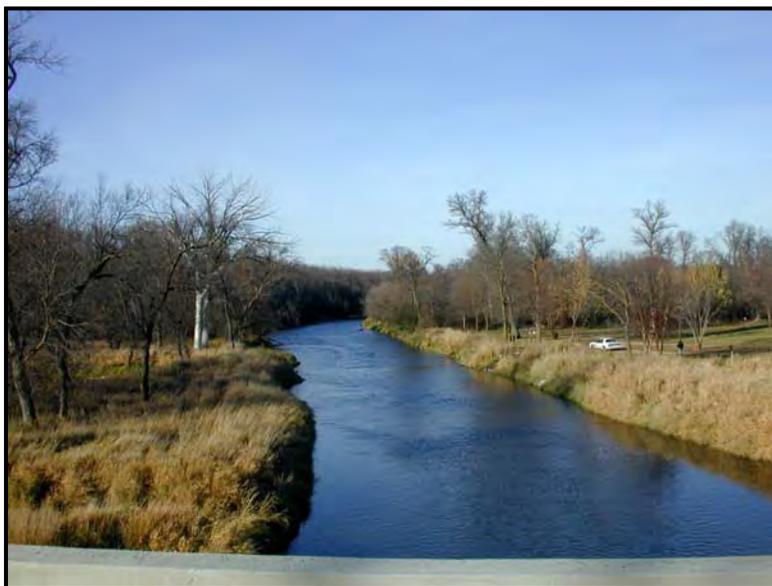
Figure 11. Looking upstream from replaced U.S. 12 bridge deck during low-flow following the April, 1997 flood; notice the absence of the small upstream dam.

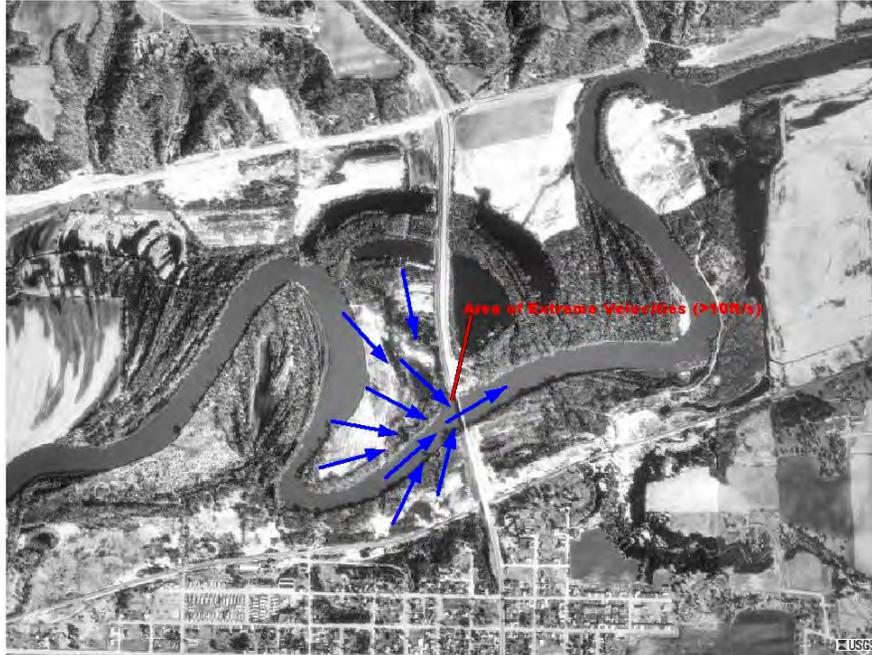
Figure 1. Sketch of site hydraulics during April, 2001 flood.

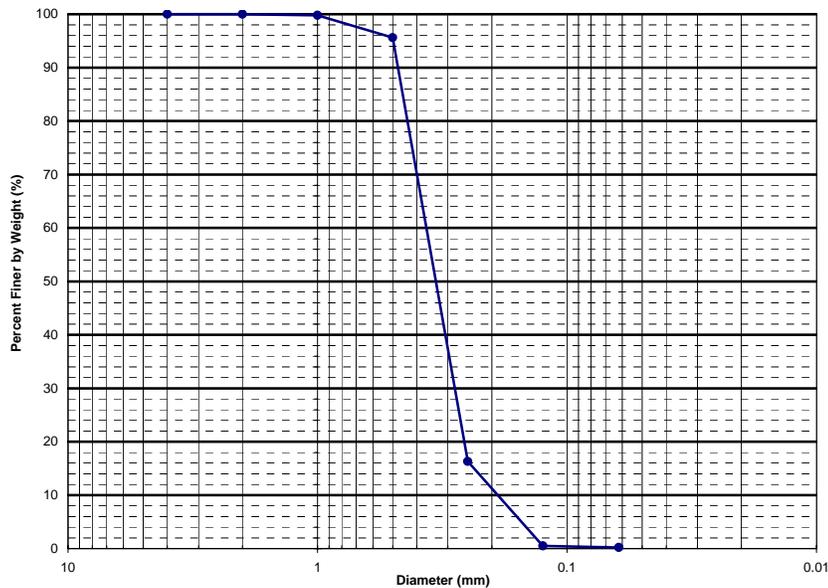
Figure 3. Grain size distribution for CR 22 bed material samples

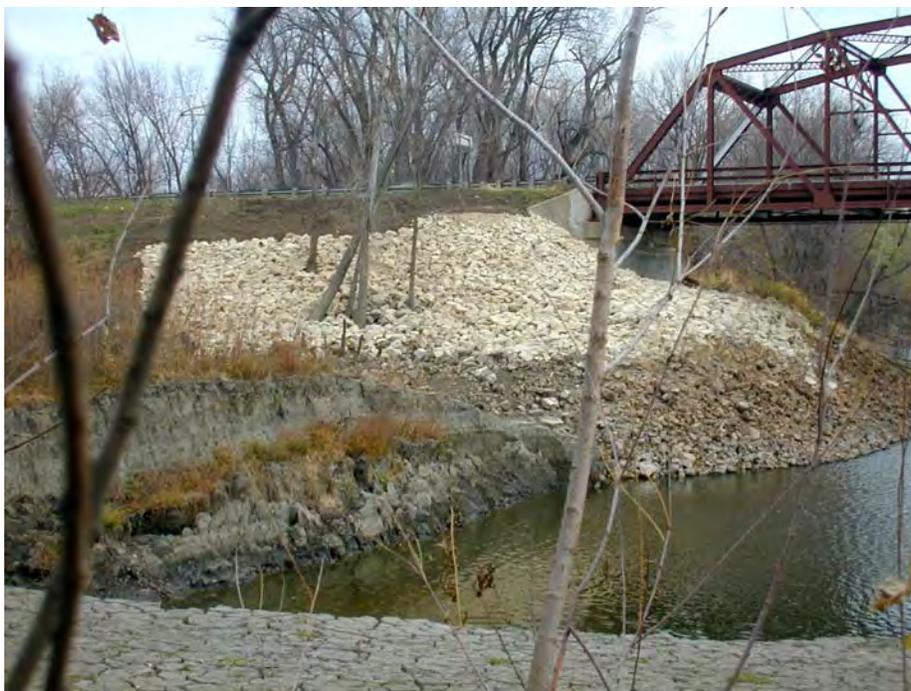
Figure 4. Picture of the re-stabilization done to the left abutment of the S.R 25 bridge over the Minnesota River near Belle Plaine, MN following April, 2001 flood.

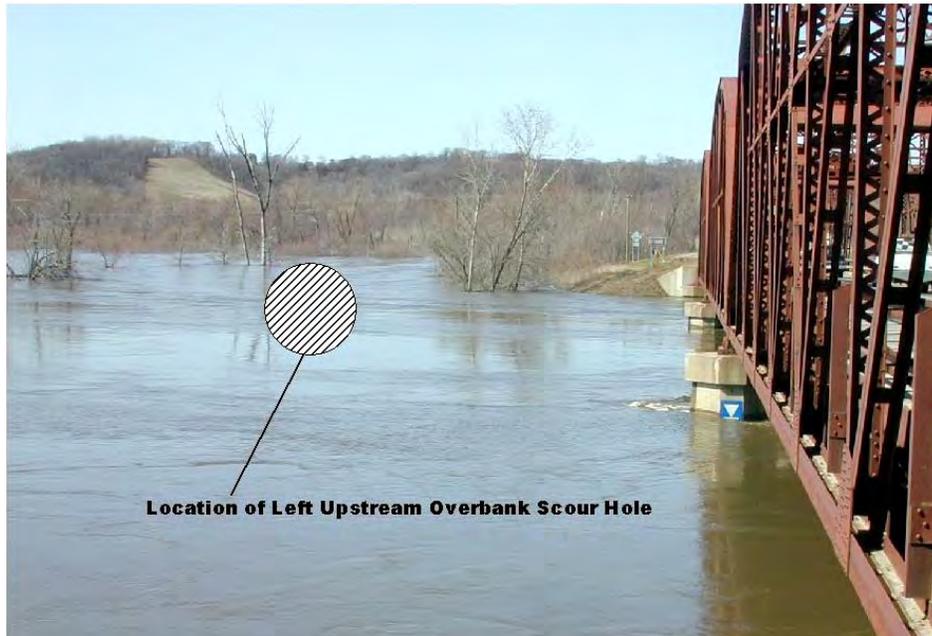
Figure 5. Looking at flow contraction from left floodplain and location of upstream left overbank scour hole from right upstream abutment of S.R. 25 bridge during April, 2001 flood.

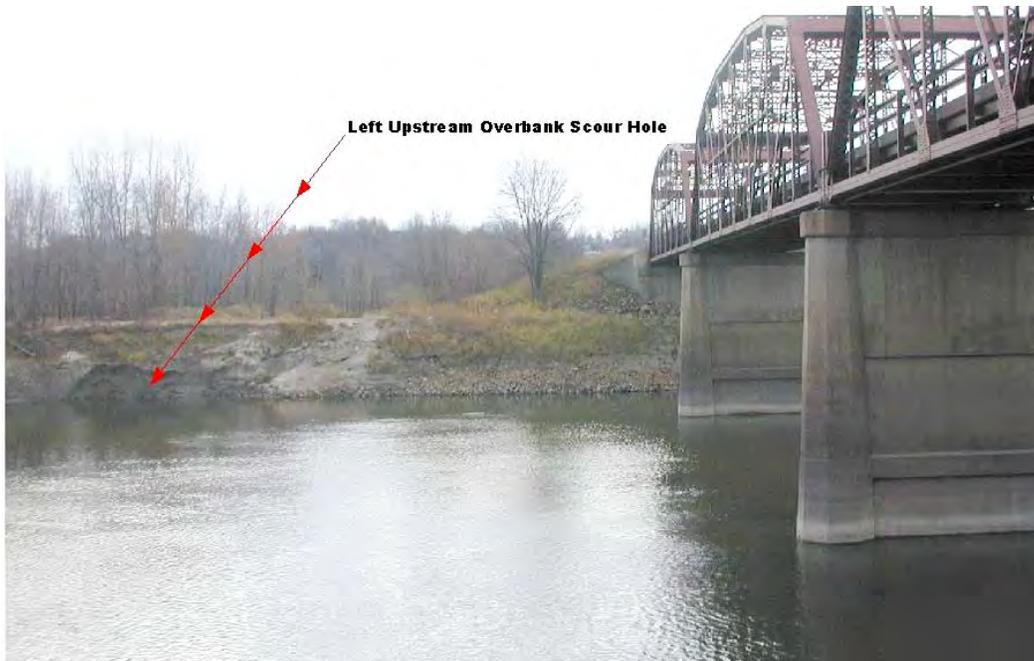
Figure 6. Looking at left upstream overbank scour hole (inside what appears to have been a much larger scour hole) from right bank along the upstream bridge face of S.R. 25 over the Minnesota River during low-flow.

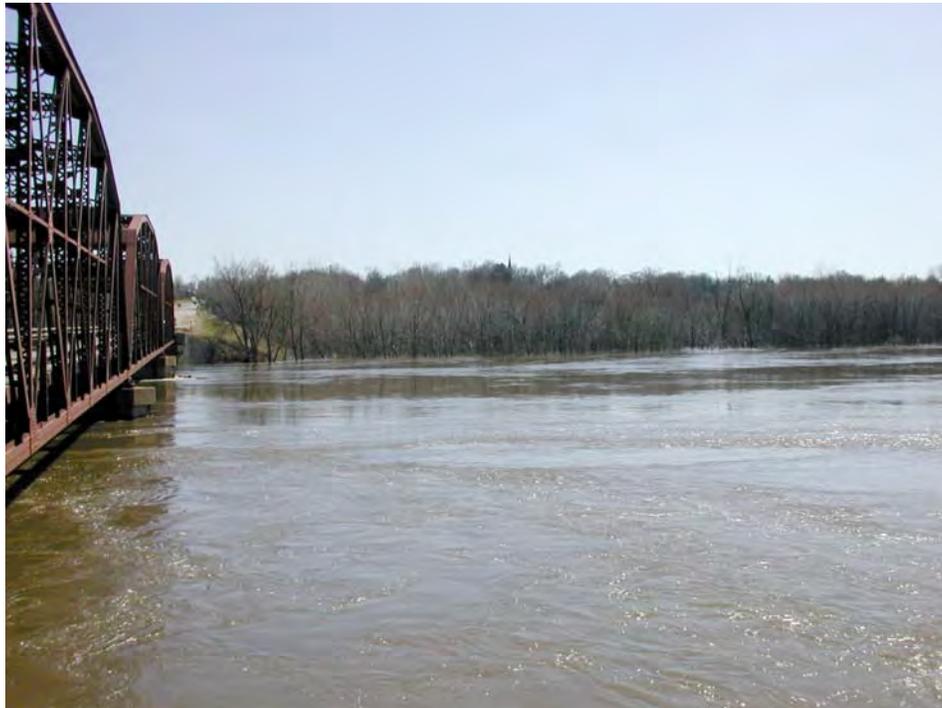
Figure 7. Looking at turbulent flow and eddy fence attributed to severe contraction along the upstream left abutment of the S.R. 25 bridge during the April, 2001 flood.

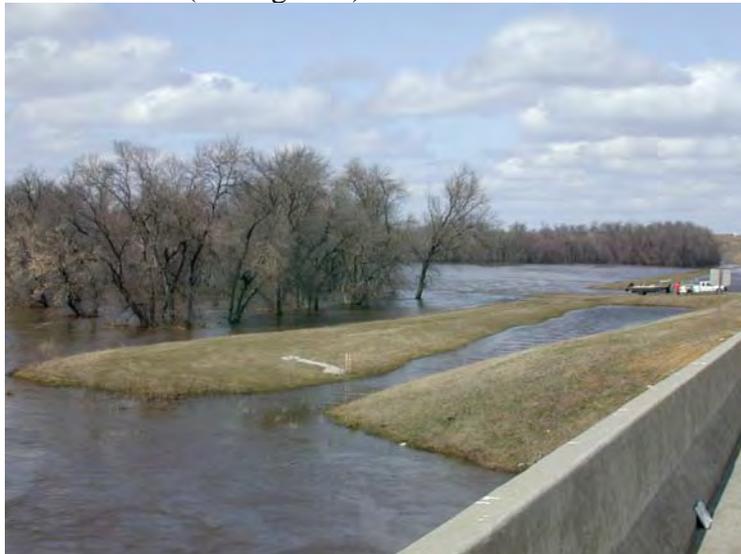
Figure 1. Looking upstream at left floodplain and berm, from S.R. 37 bridge deck during April, 2001 flood.

The bridge had a geometric contraction ratio of around 0.48, with a large majority of the contracted flow coming from the left floodplain. A berm located approximately 100 feet upstream of the bridge on the left overbank directed the contracting flow into the channel upstream of the left abutment (see Figure 1).

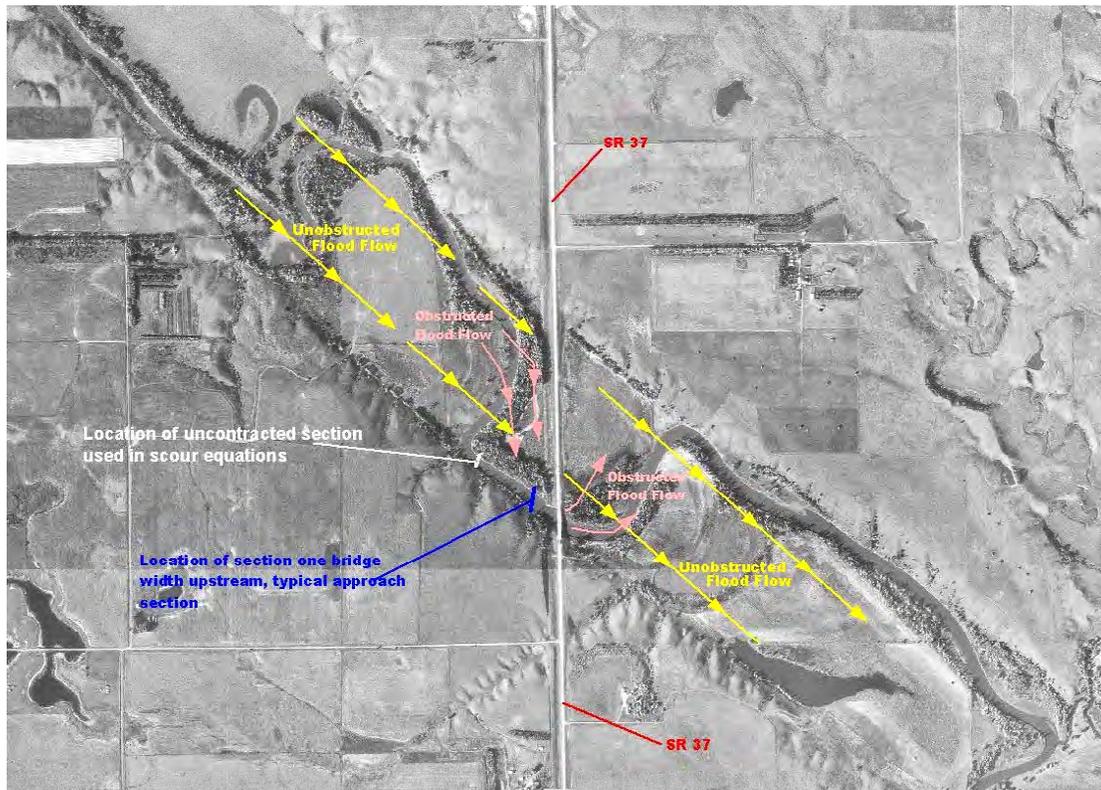
Figure 2. Geomorphic setting and channel alignment for the James River at SR 37 bridge near Mitchell, SD

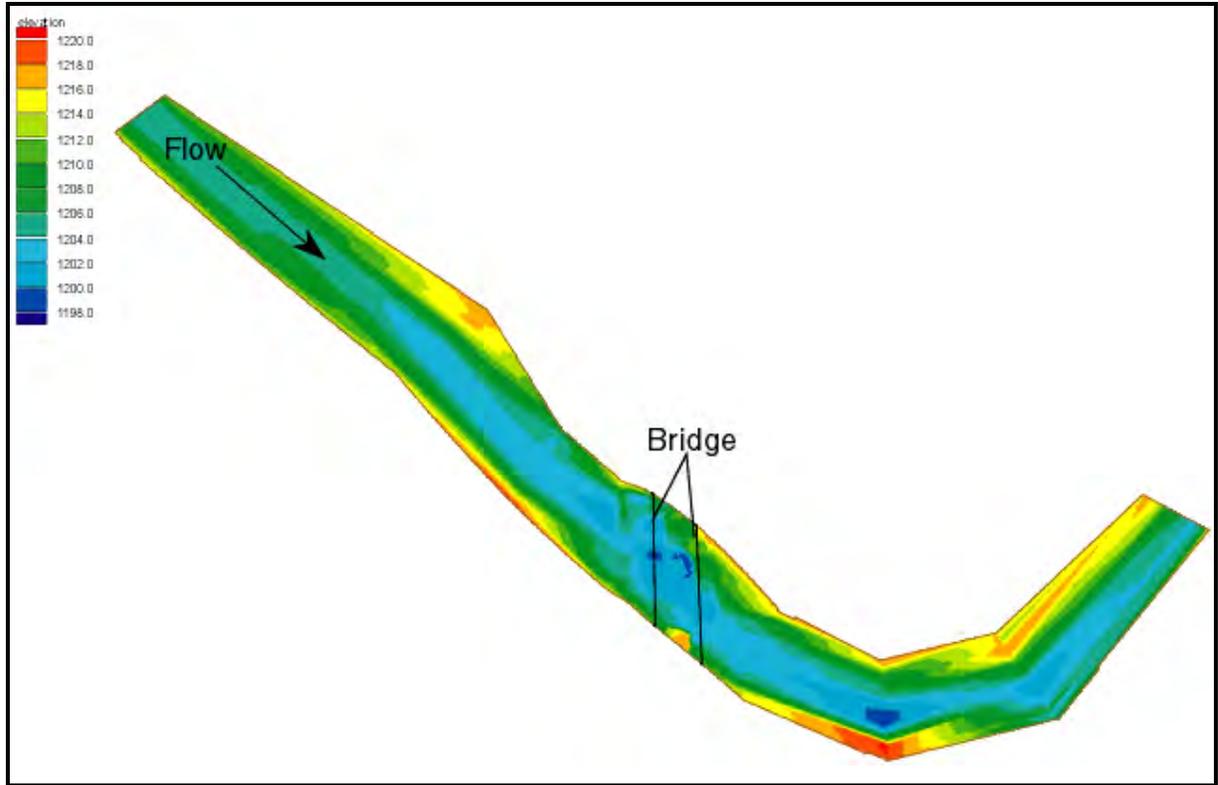
Figure 3. Bathymetric contour plot of James River in the vicinity of S.R. 37 bridge, collected during April, 2001 flood.

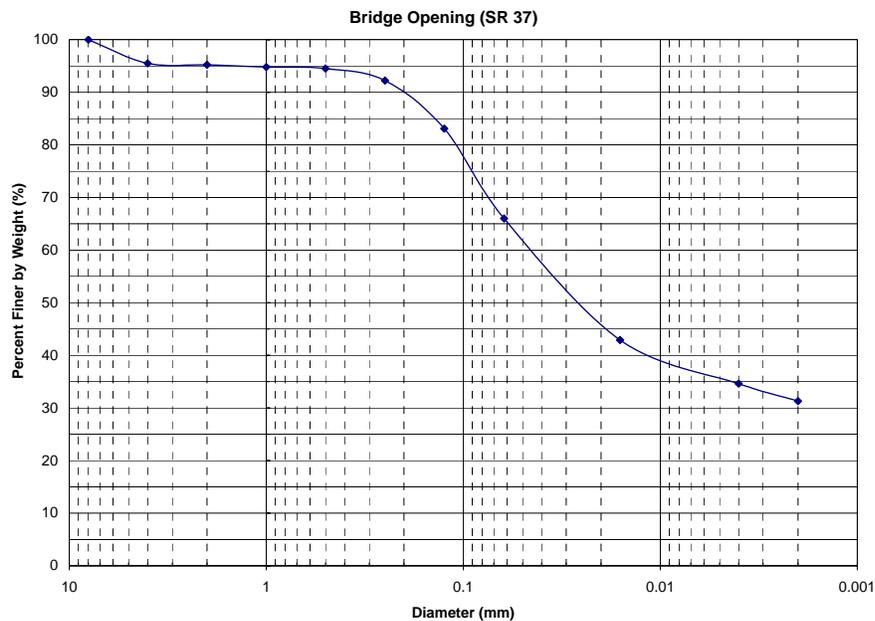
Figure 5. Grain size distribution for the bed material sample collected in the SR 37 bridge opening

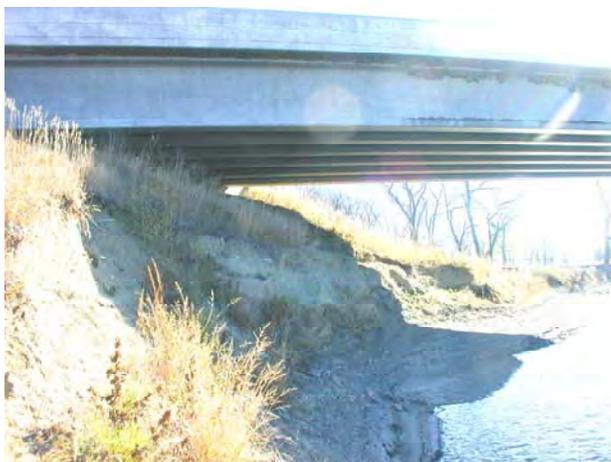
Figure 8. Picture of the bank failure at the left abutment of the S.R 37 bridge over the James River near Mitchell, SD taken during low-flow survey following April, 2001 flood.

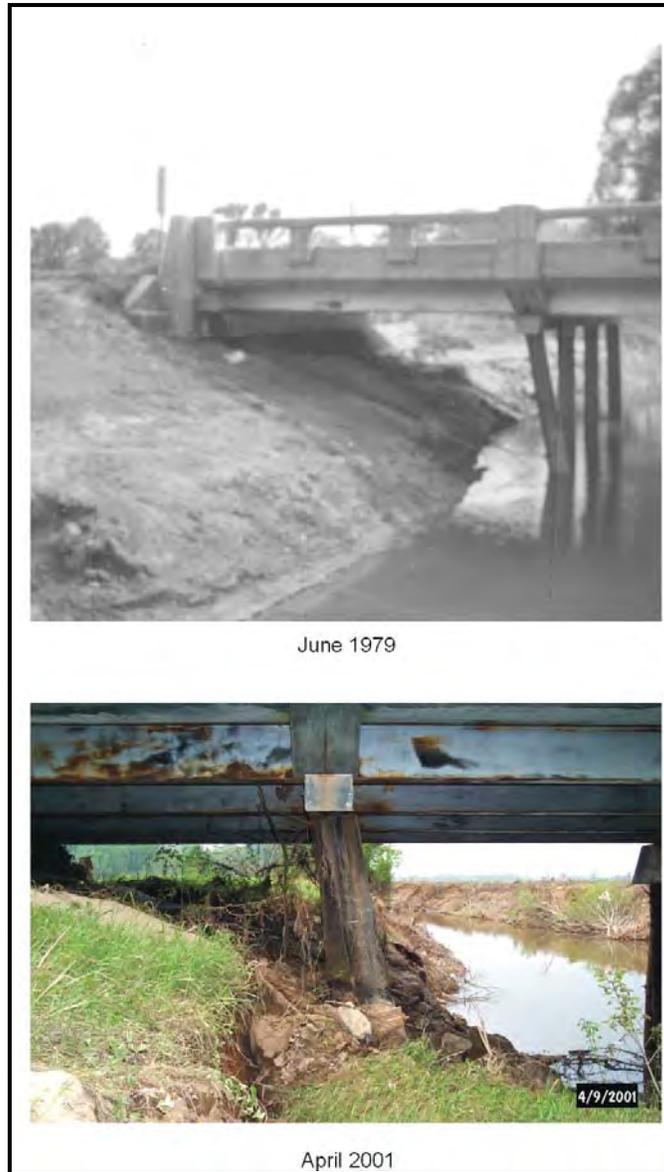
Figure 7. Looking downstream through the S.R. 35 bridge opening at left abutment and pile bent no. 2 following the 1979 and 2001 floods on Conehoma Creek.
