Scour at Contracted Bridges

National Cooperative Highway Research Program

U.S. Geological Survey and University of Louisville

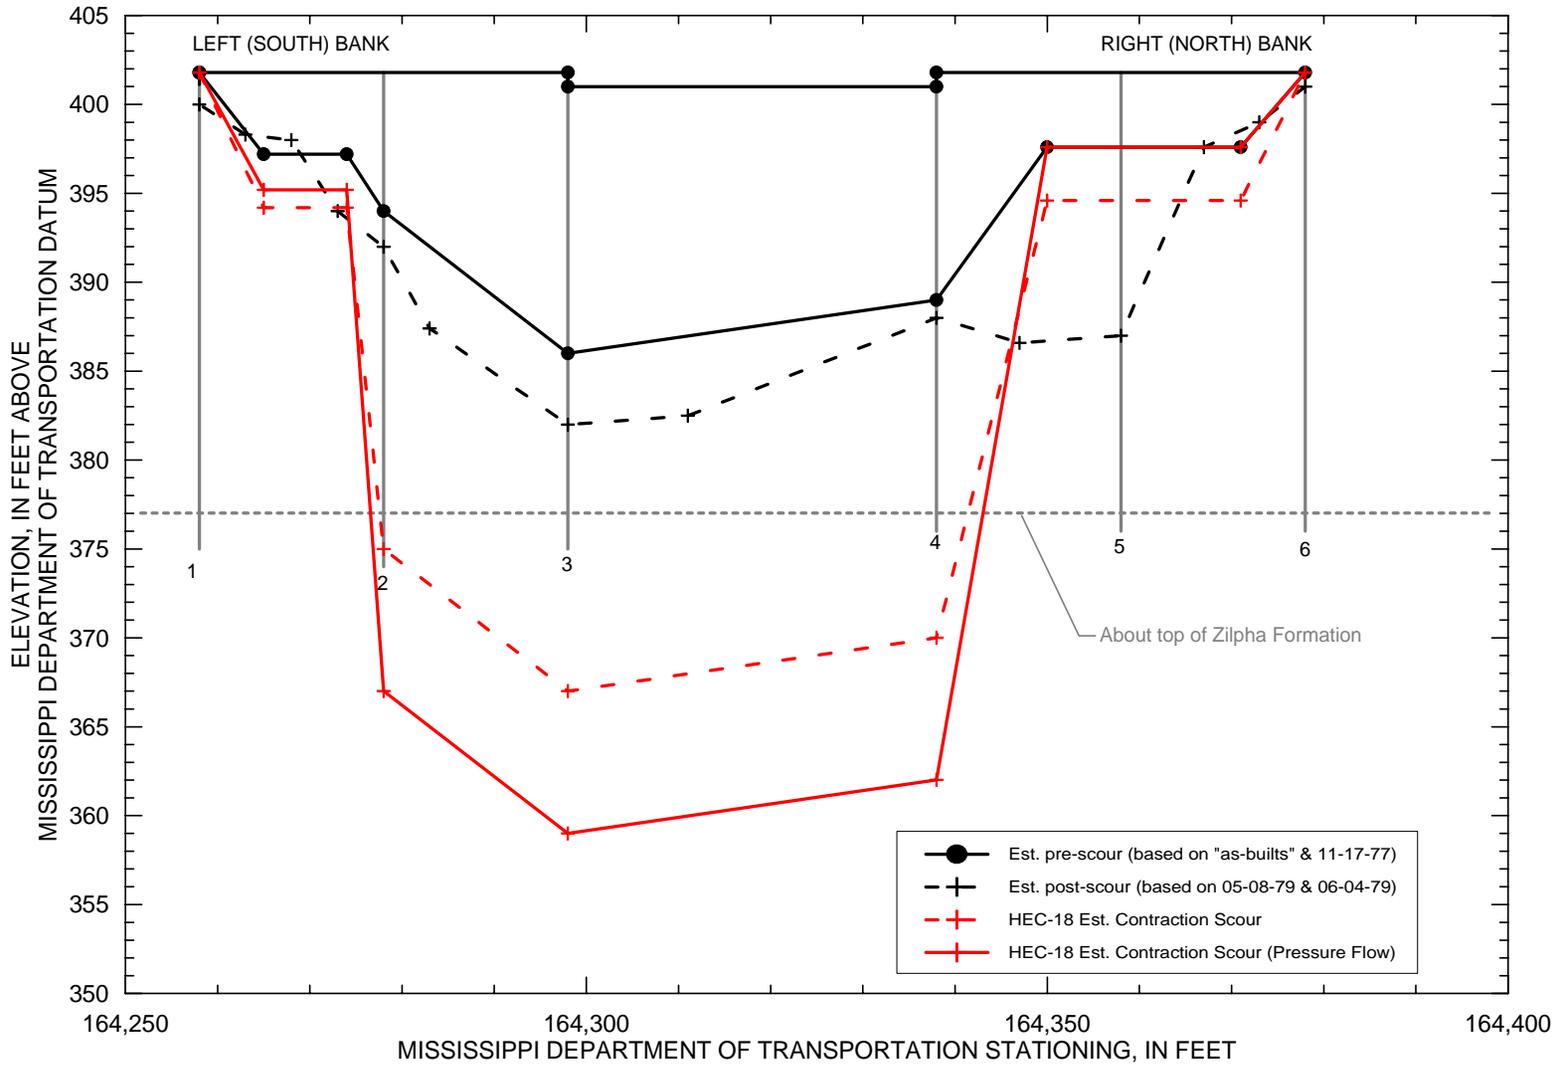
Figure 8. Comparison of the measured and computed scour on Conehoma Creek at S.R. 35 for the April 12, 1979 flood.

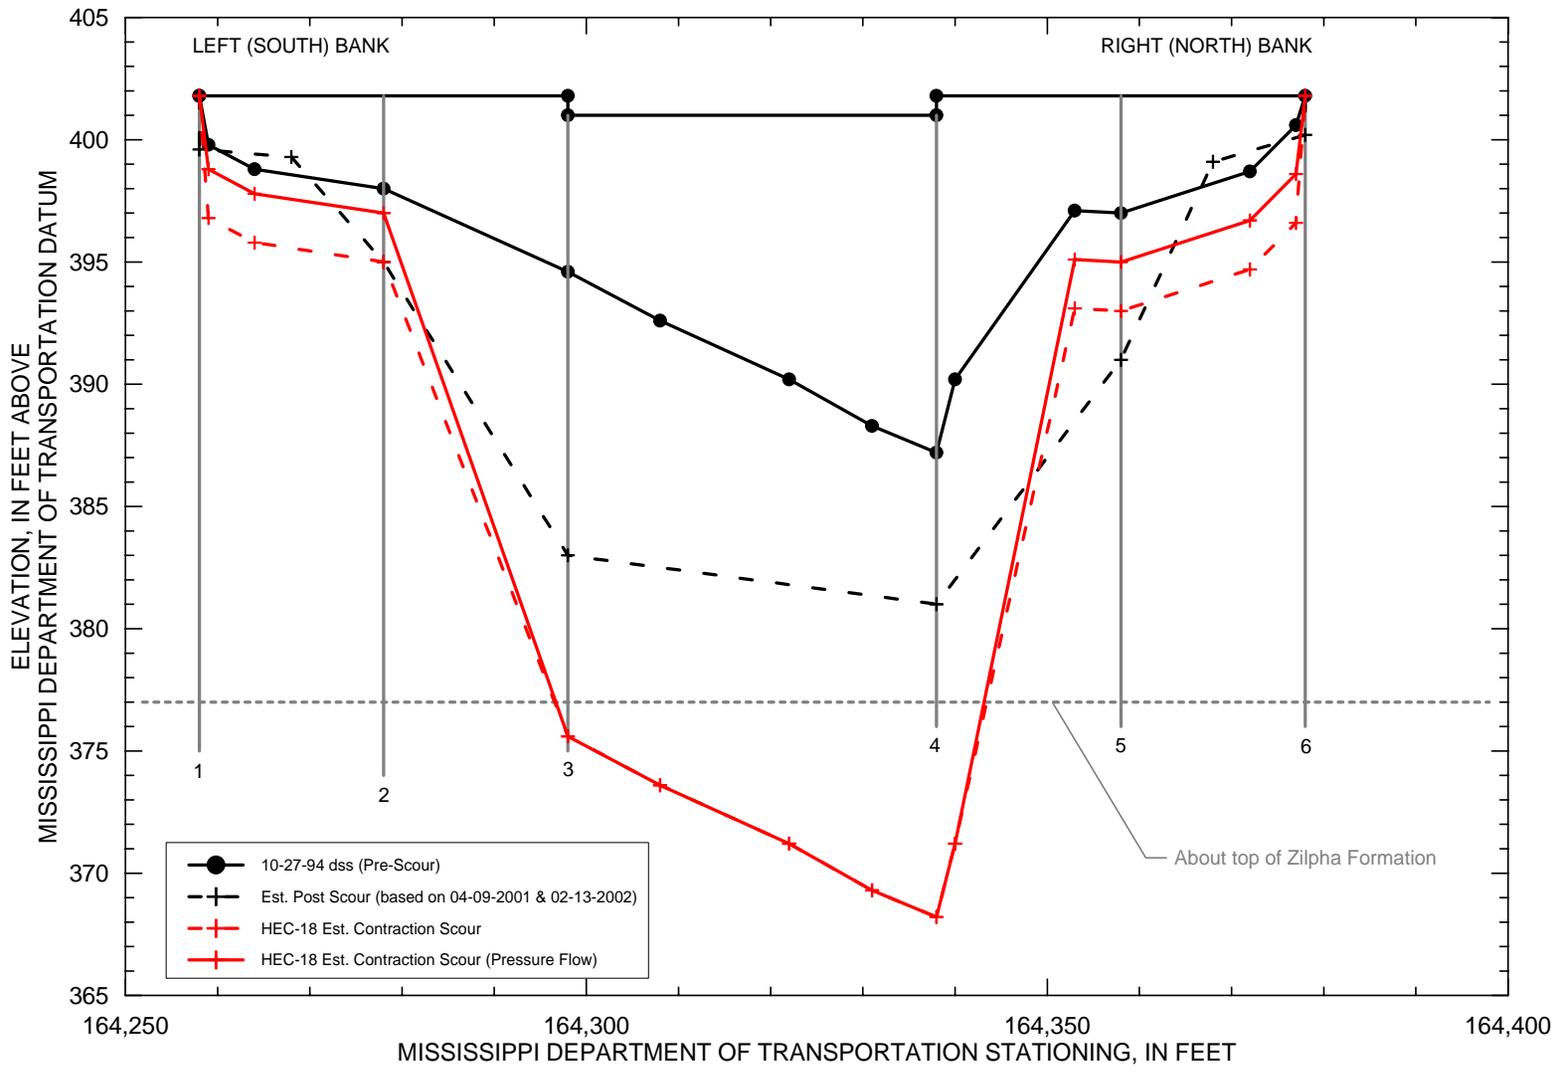
Figure 9. Comparison of the measured and computed scour on Conehoma Creek at S.R. 35 for the April 5, 2001 flood.

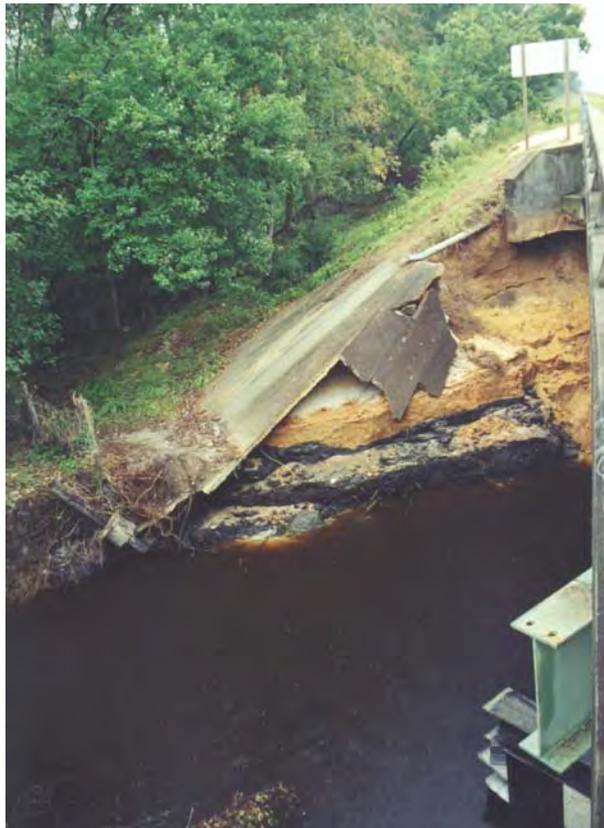
Figure 8. West bound bridge left abutment.

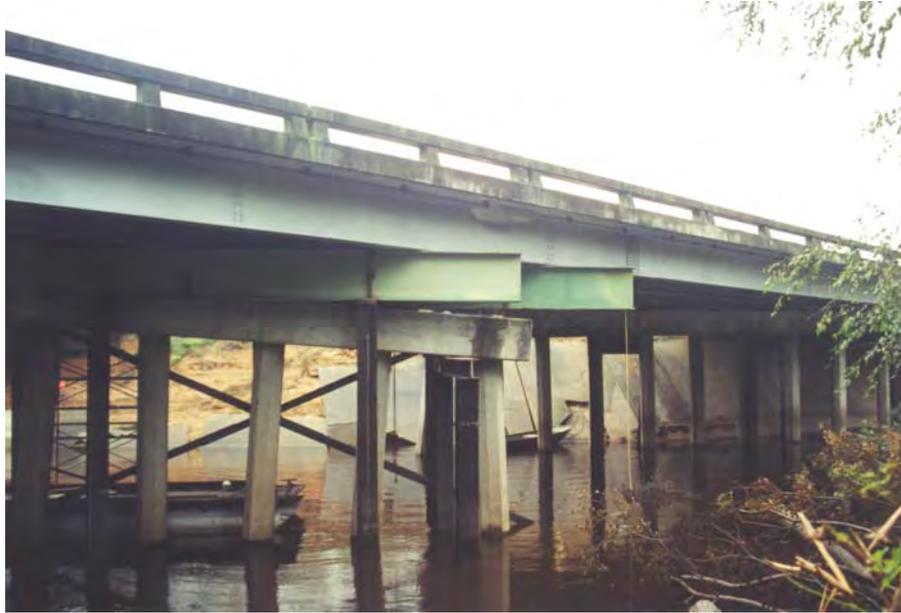
Figure 9. West bound left pile group with temporary steel soldier piles.

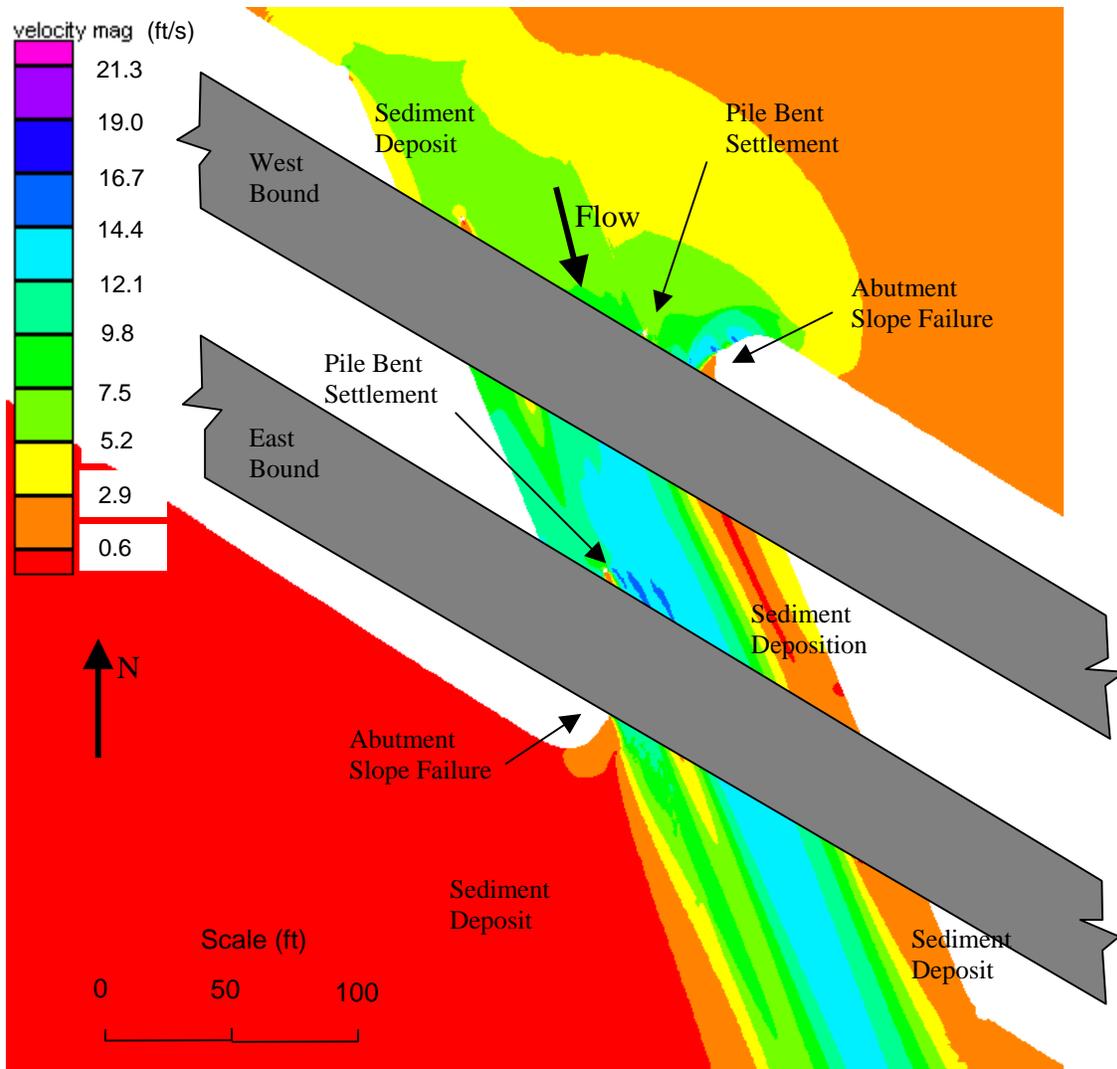
Figure 11. Velocity magnitudes from the 2-D model and significant features of post-flood assessment of the U.S. 70 crossing over Bear Creek.

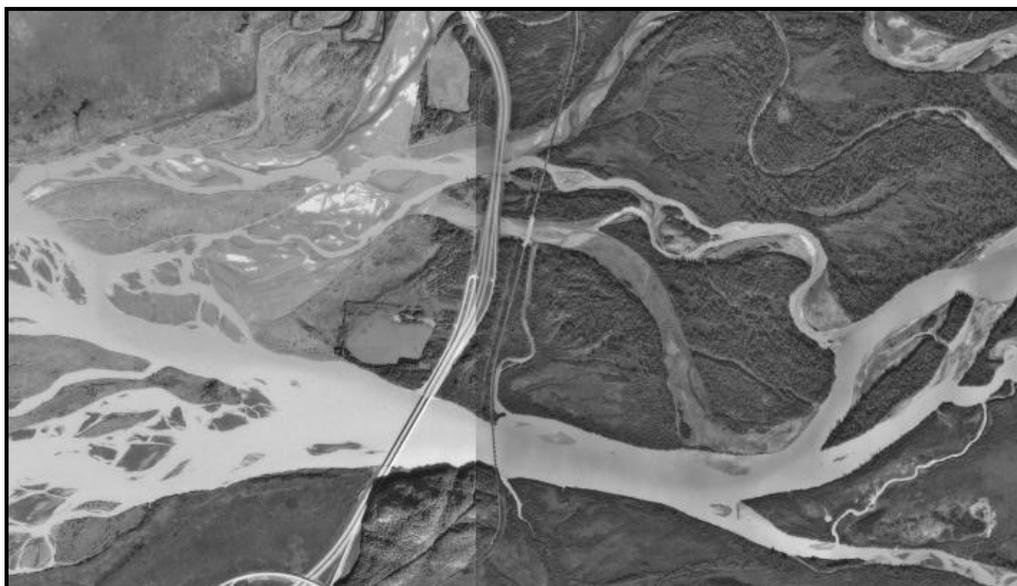
Figure 5. Aerial photo of the site taken in 1996 showing the geomorphic setting of the Knik River at the Old Glenn Highway (Route 1) bridge near Palmer, AK.

conveying flow. An aerial photo of the site taken in 1996 is shown in Figure 5. Data characterizing the geomorphic setting is summarized in Table 3.

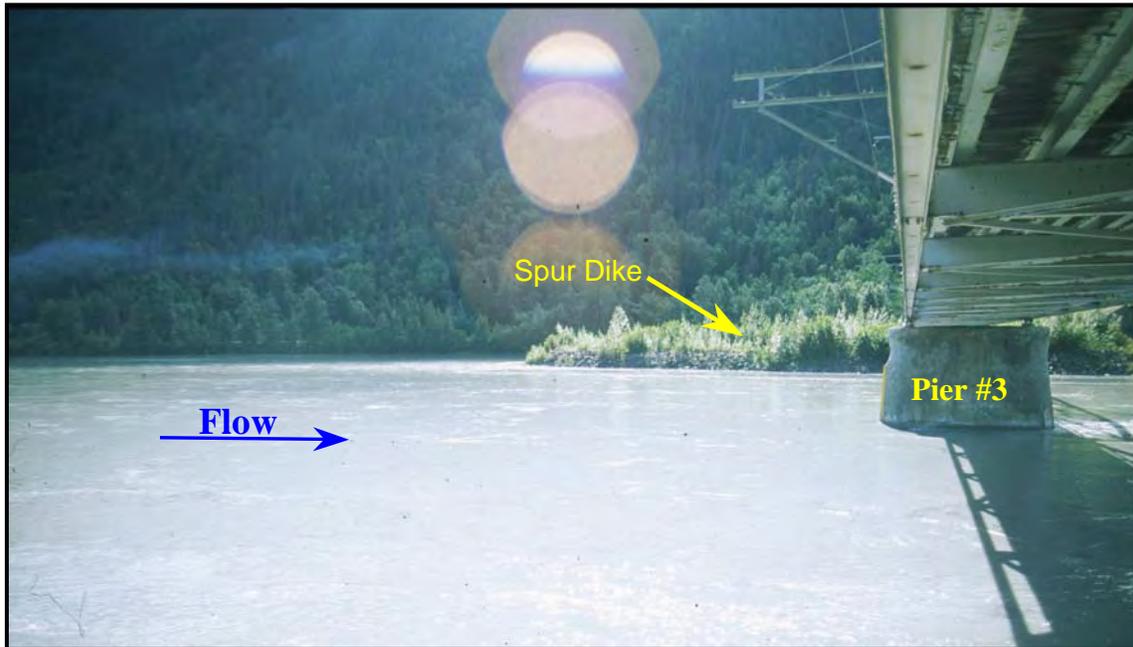
Figure 10. Looking along upstream face of the old Old Glen Highway bridge over the Knik River at the left bank and spur dike.

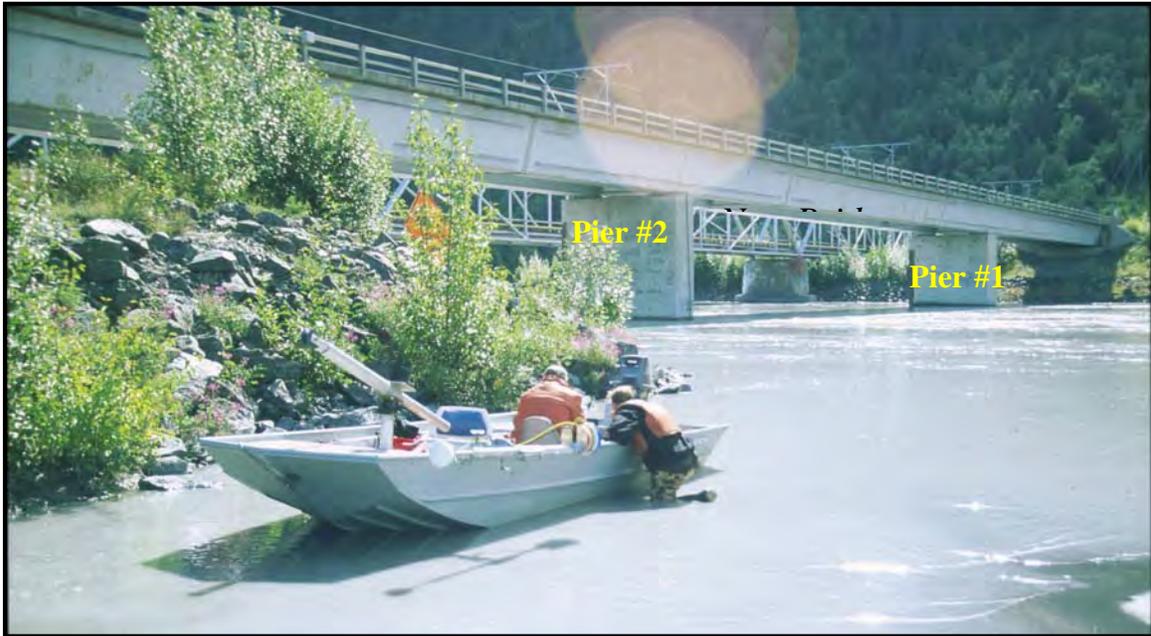
Figure 11. Looking along downstream face of the new Old Glen Highway bridge over the Knik River, field crew and survey boat are in shown in the foreground.

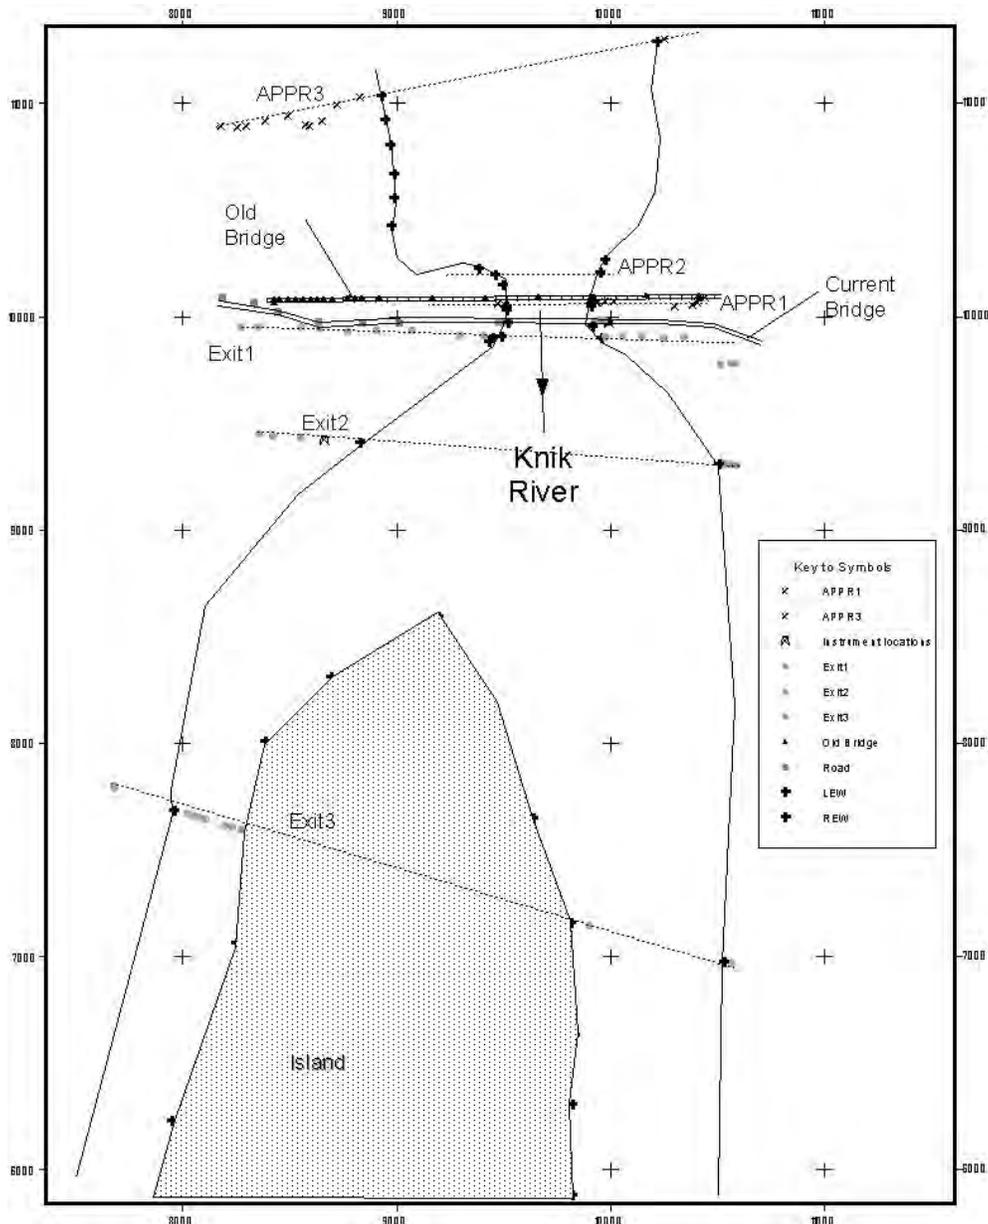
Figure 13. Schematic of survey data for bridge 539 at Knik River near Palmer, AK, collected during 1999-scour survey (Coordinate system is arbitrary).

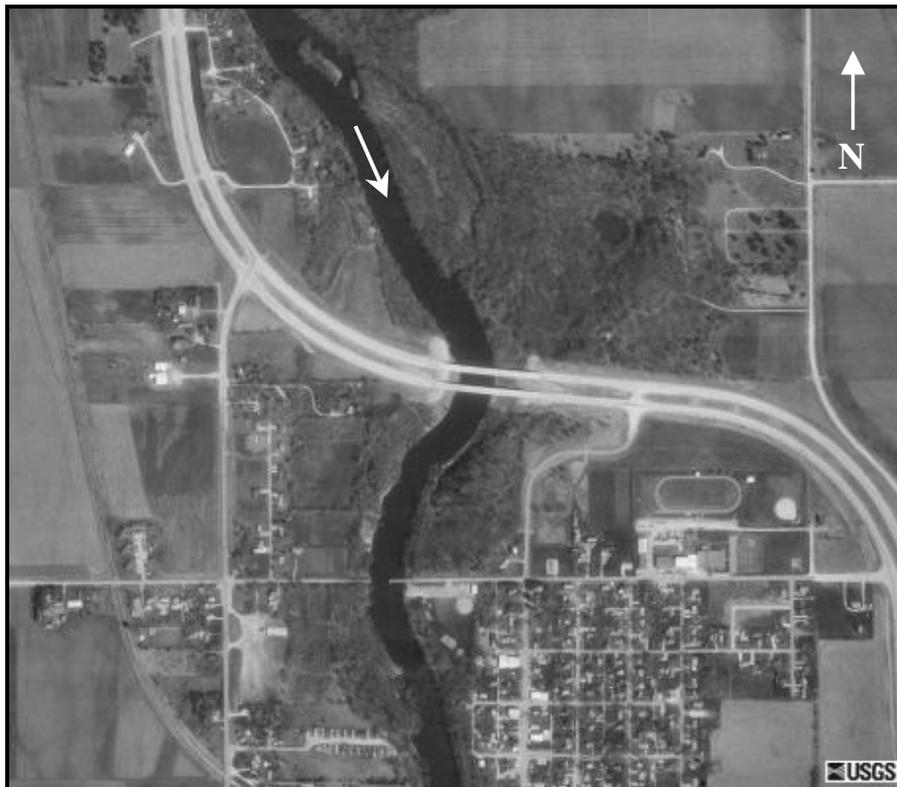
Figure 3. Aerial photo of the U.S. 218 bridge site over the Cedar River, taken in 1994.

A portion of the USGS 7.5 minute quadrangle topographic map of the site with the old bridge is shown in Figure 1 and an aerial photo of the site taken in 1994 with the new bridges is shown in Figure 3. Data characterizing the geomorphic setting is summarized in Table 3.

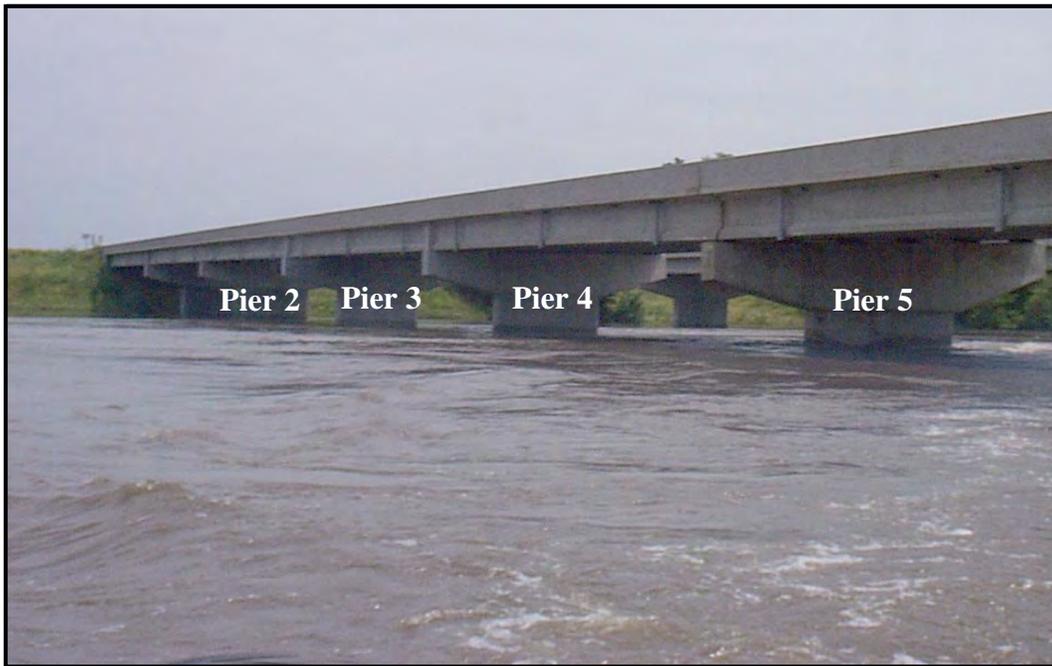
Figure 5. Looking west across upstream face of US 218 bridge over the Cedar River near Centralia, WA on 7/23/1999.

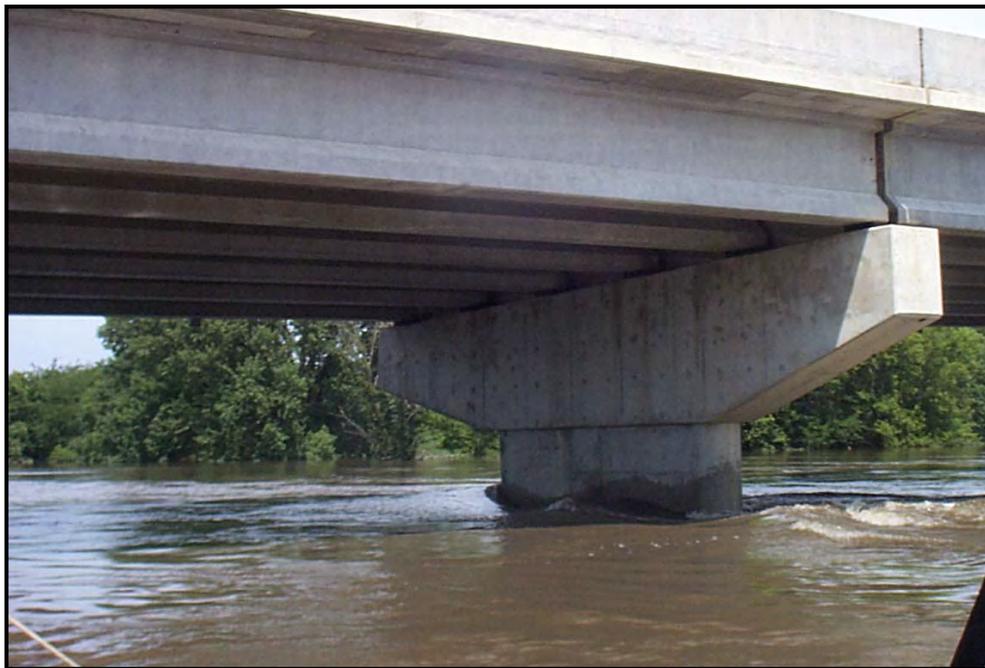
Figure 6. Looking upstream at wake around Pier 5 of upstream US 218 bridge over the Cedar River, 7/23/1999.

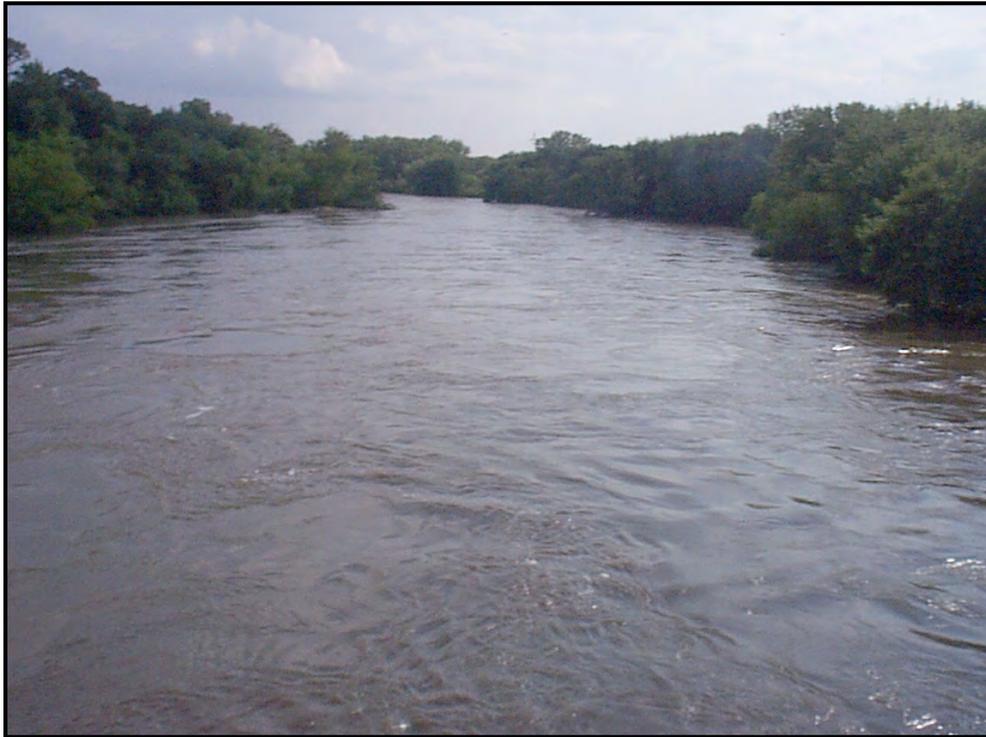
Figure 7. Looking downstream from downstream US 218 bridge deck, 7/23/1999.

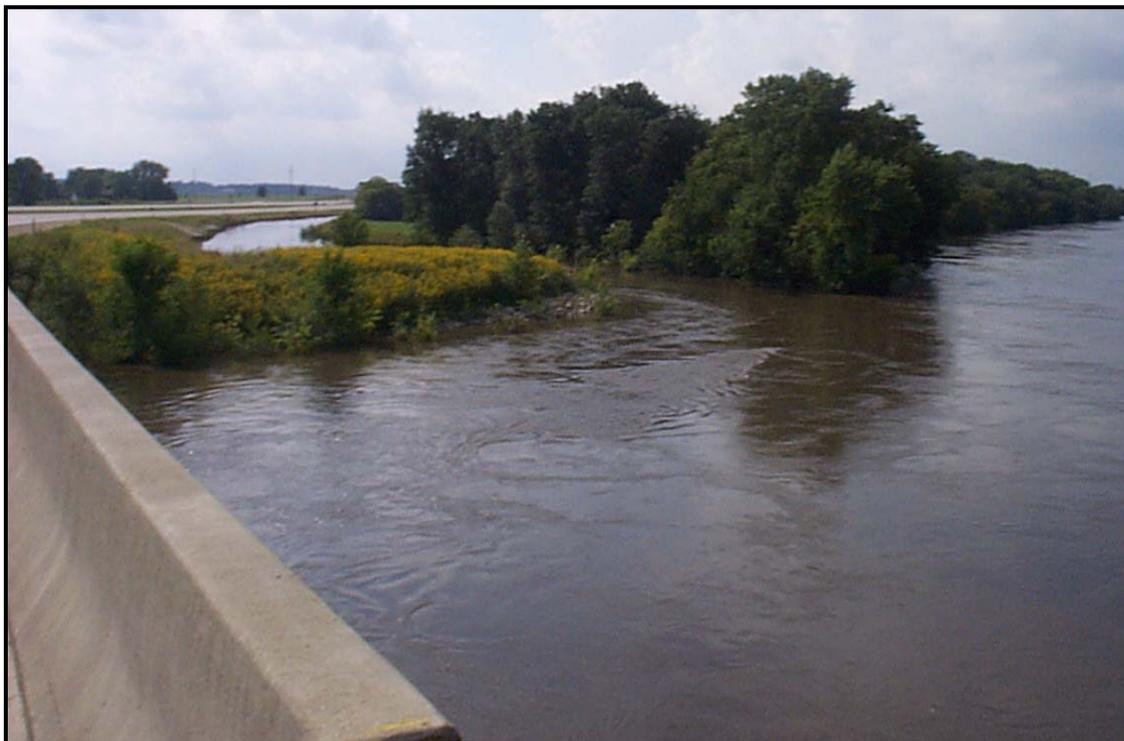
Figure 8. Looking upstream at right guide bank, floodplain and drainage ditch on 7/23/1999.

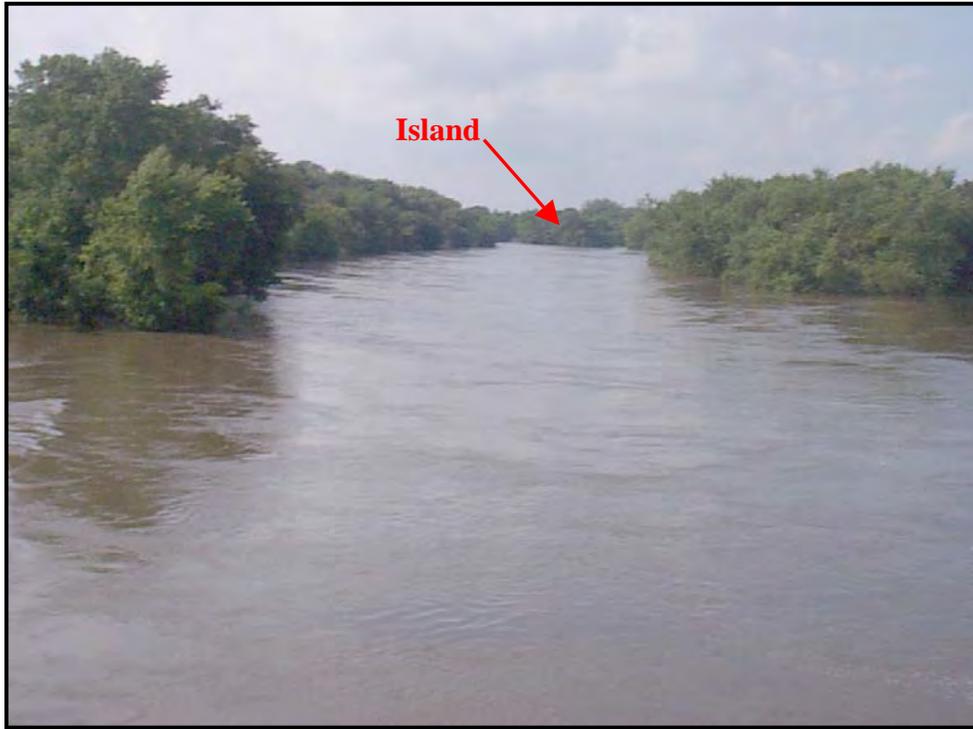
Figure 9. Looking upstream from upstream US 218 bridge over the Cedar River, 7/23/1999.

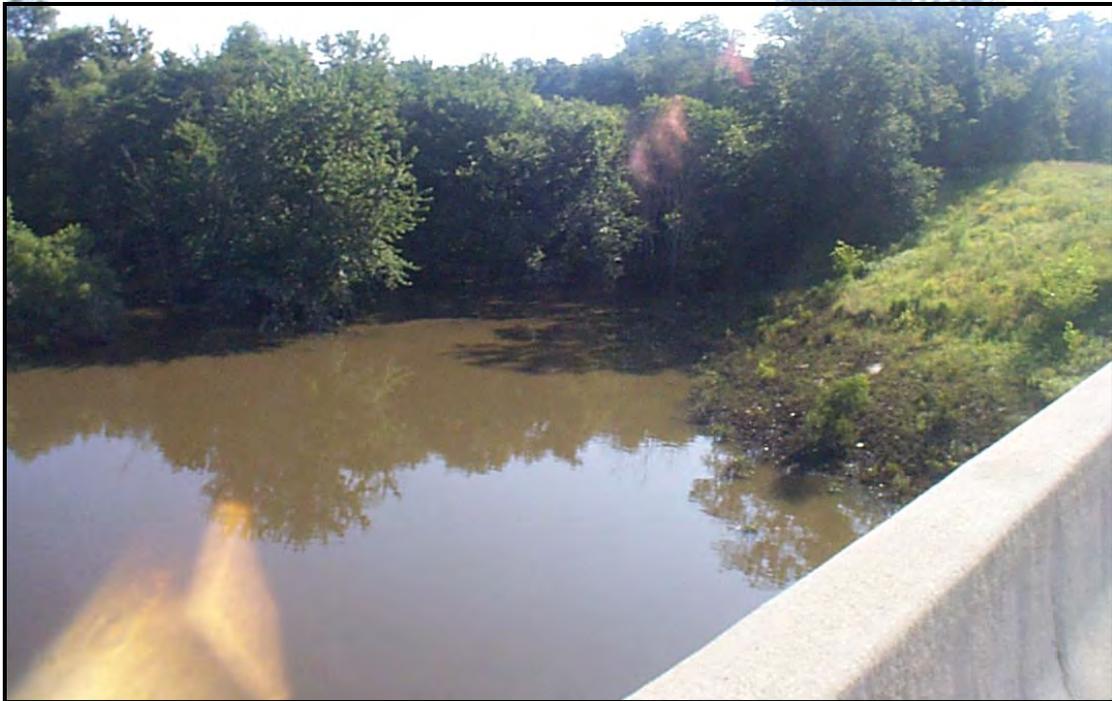
Figure 10. Looking at upstream left floodplain from upstream US 218 bridge over the Cedar River, 7/23/99.

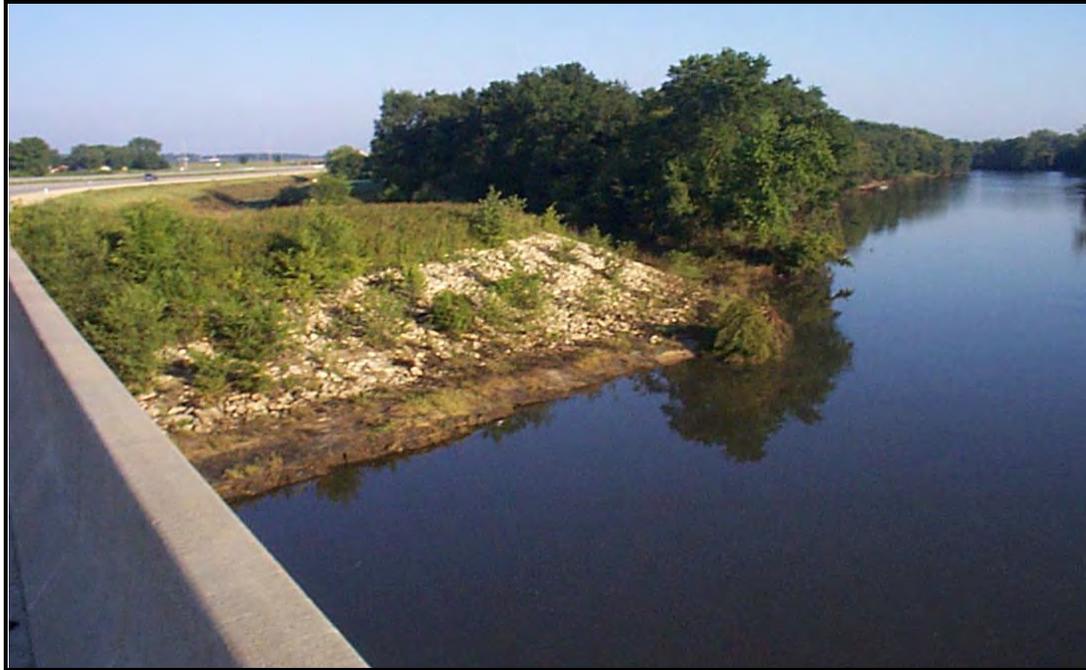
Figure 11. Looking upstream at right guide bank, floodplain and drainage ditch from upstream US 218 bridge over Cedar River during low flow, 8/10/99.

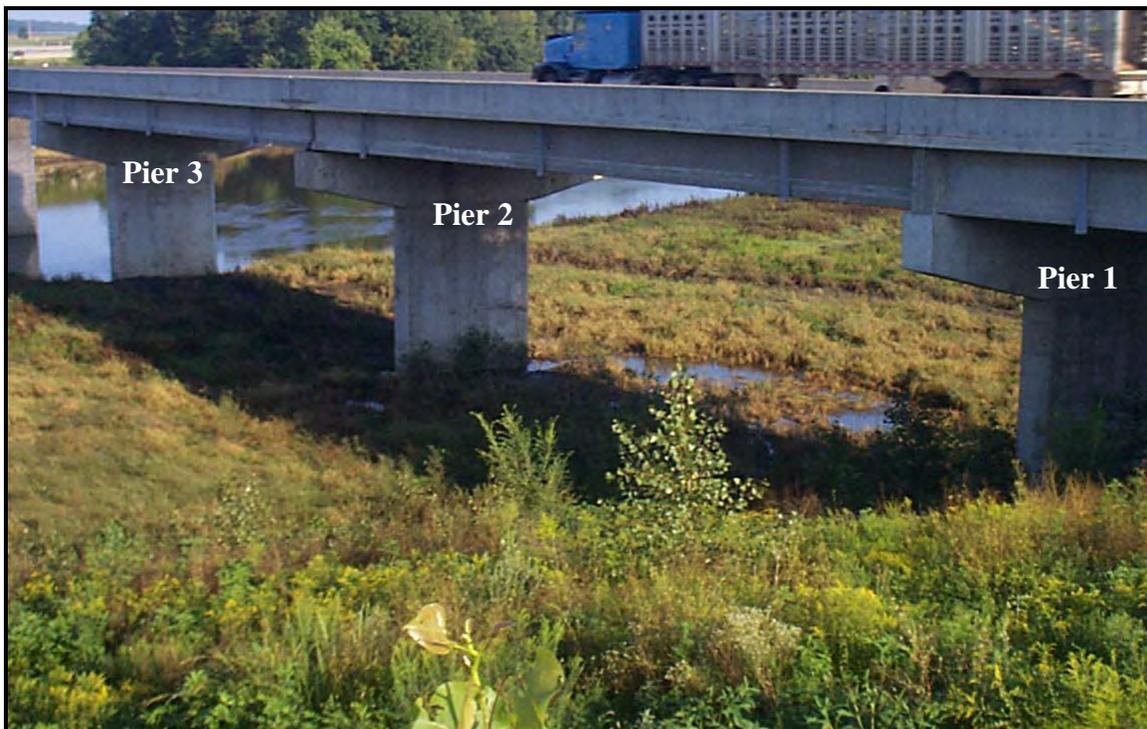
Figure 12. Looking upstream at left overbank and areas of clear-water scour from downstream US 218 bridge over Cedar River during low flow, 8/10/99.

The most substantial scour occurred in the main channel upstream of the bridges between piers 4 and 5 (Figure 2). The scour hole was approximately 100 feet long in the longitudinal direction of flow beginning near the upstream face of the westbound bridge and extending upstream. A minimal depression was observed around pier 5 on the right overbank for both the upstream and downstream bridges (Figure 12).

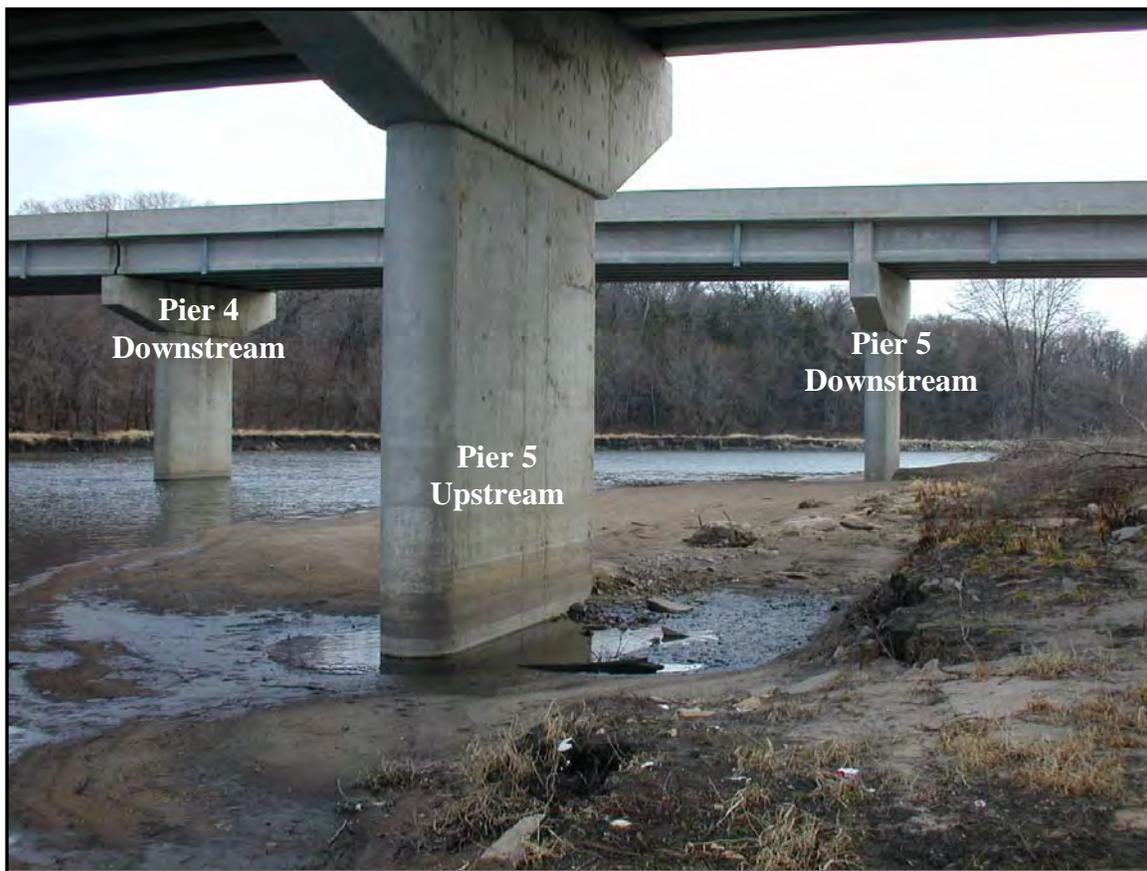
Figure 13. Looking downstream at right overbank and Pier 5 of US 218 bridge over Cedar River during low flow, 8/10/99.

No local pier scour was reported in the bridge scour database (BSDMS) although some minor depressions were observed around the base of pier 5 during the low-flow inspection.

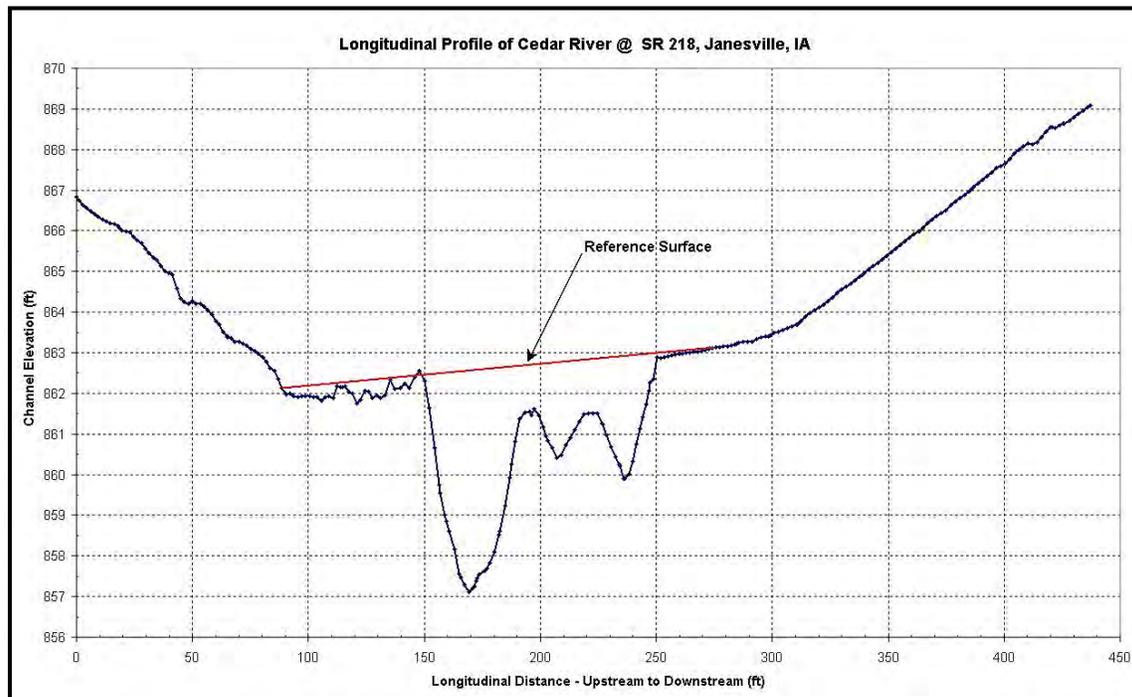
Figure 14. Surveyed longitudinal streambed profile of Cedar River at US 218 on 7/23/1999, used to estimate measured contraction scour.

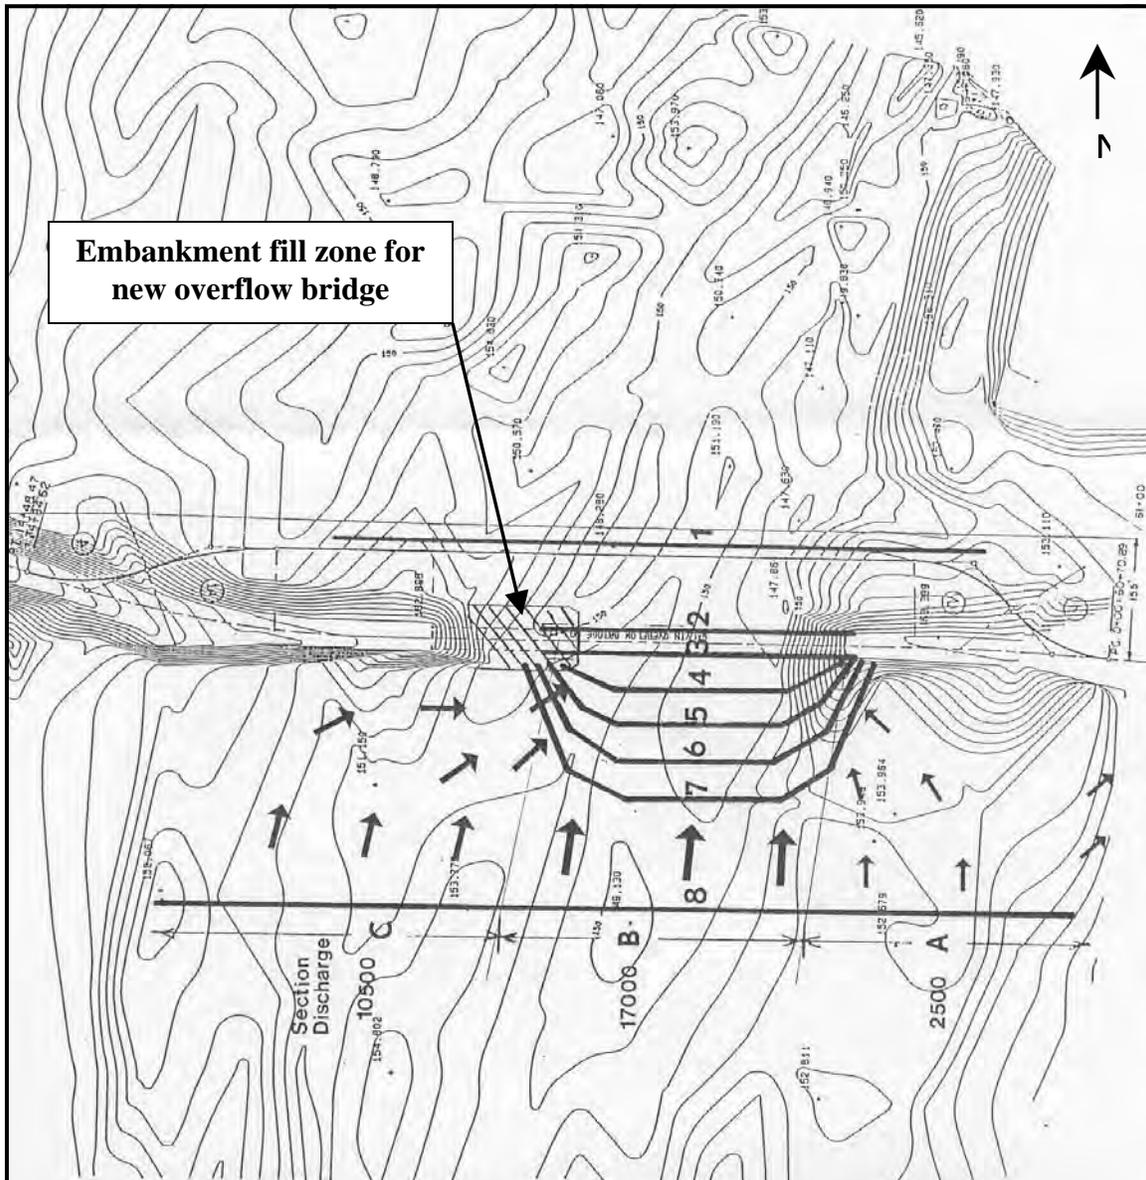
Figure 2. Sketch of flow patterns and HEC-2 model sections through Galvin Road overflow bridge during February 1996 flood.

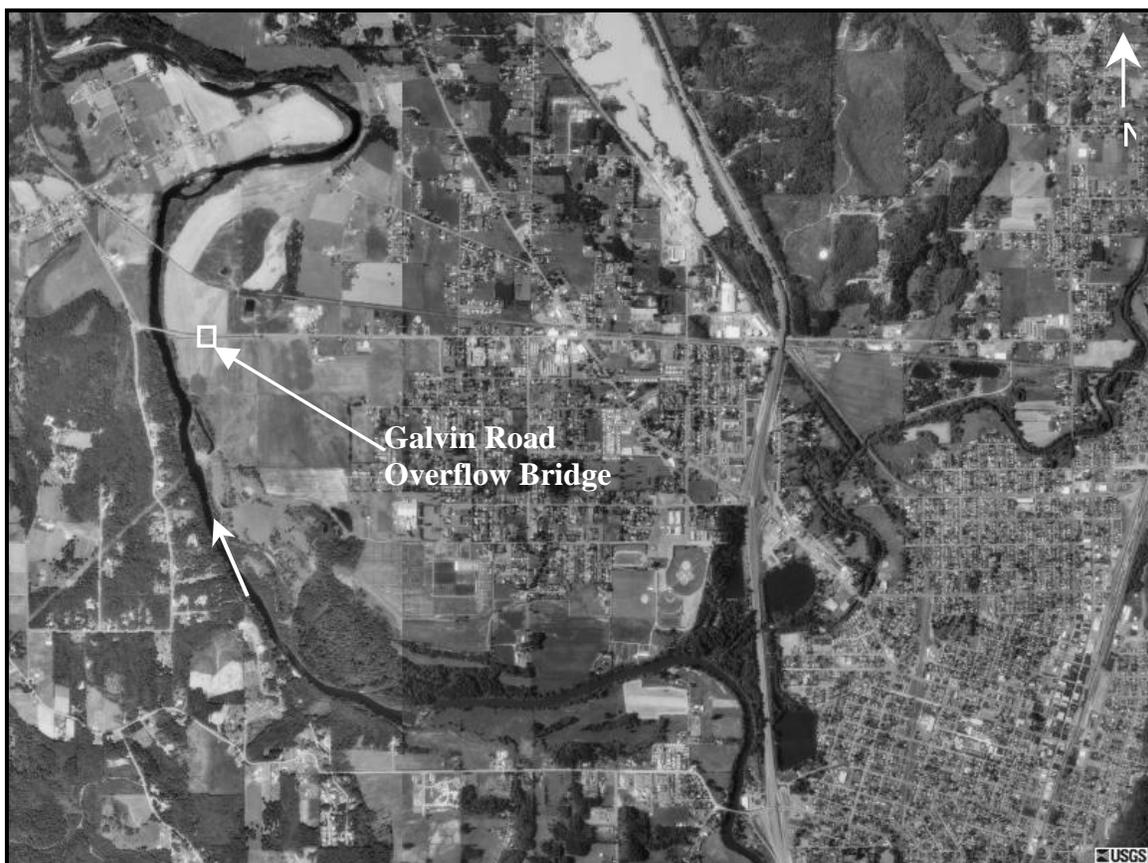
Figure 3. Aerial photo of the Galvin Road Overflow bridge site taken in 1990.

A portion of the USGS 7.5 minute quadrangle topographic map of the site is shown in Figure 1 and an aerial photo of the site taken in 1990 is shown in Figure 3. Data characterizing the geomorphic setting is summarized in Table 3.

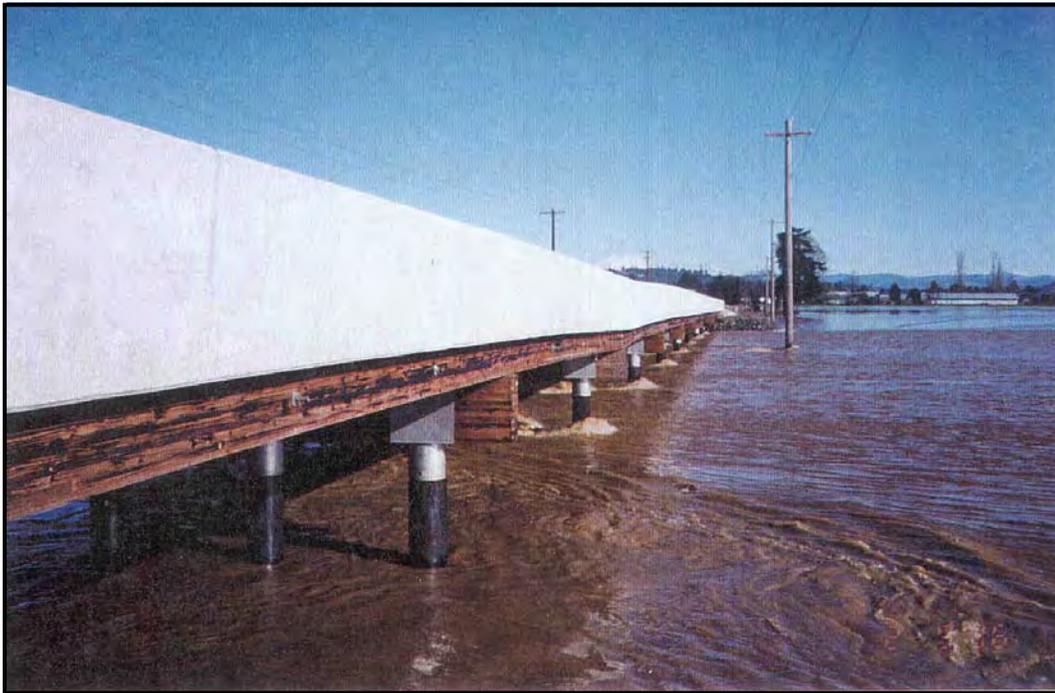
Figure 4. Looking east across upstream face of Galvin Road Overflow Bridge for Chehalis River near Centralia, WA on 2/9/1996.

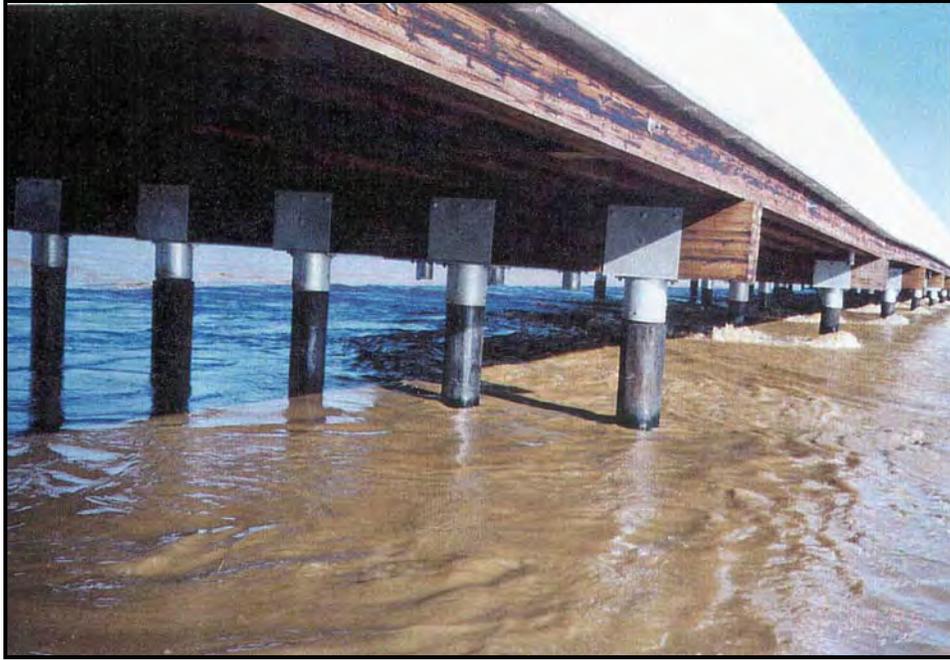
Figure 5. Looking east at Pier 10 (foreground) and Pier 9 (the pier that failed) of Galvin Road Overflow Bridge, 2/9/1996.

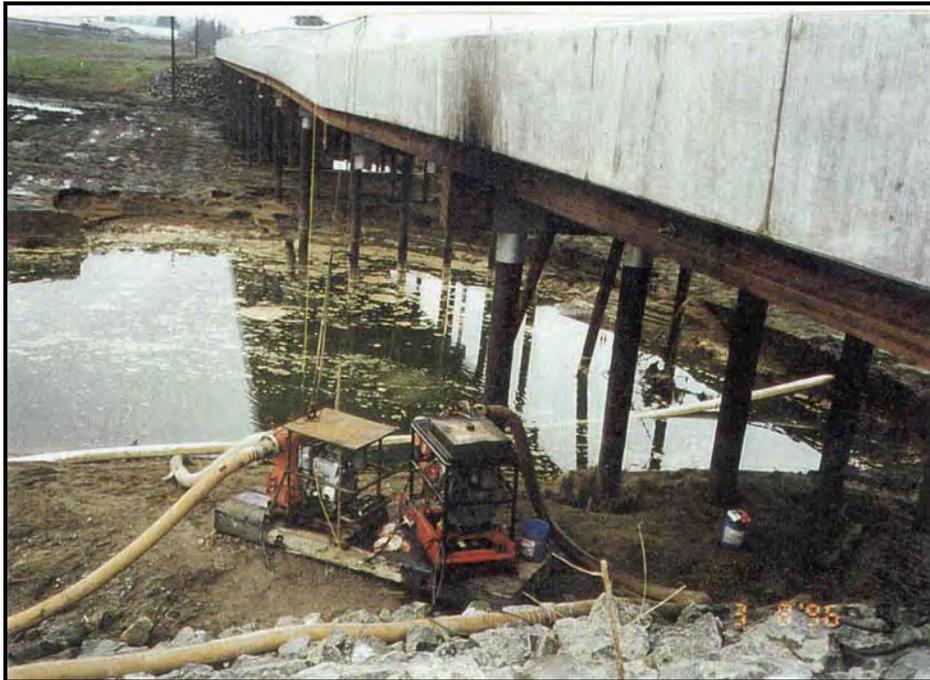
Figure 6. Looking east along downstream side of Galvin Road overflow bridge into scour hole during dewatering.
