Scour at Contracted Bridges

National Cooperative Highway Research Program

U.S. Geological Survey and University of Louisville

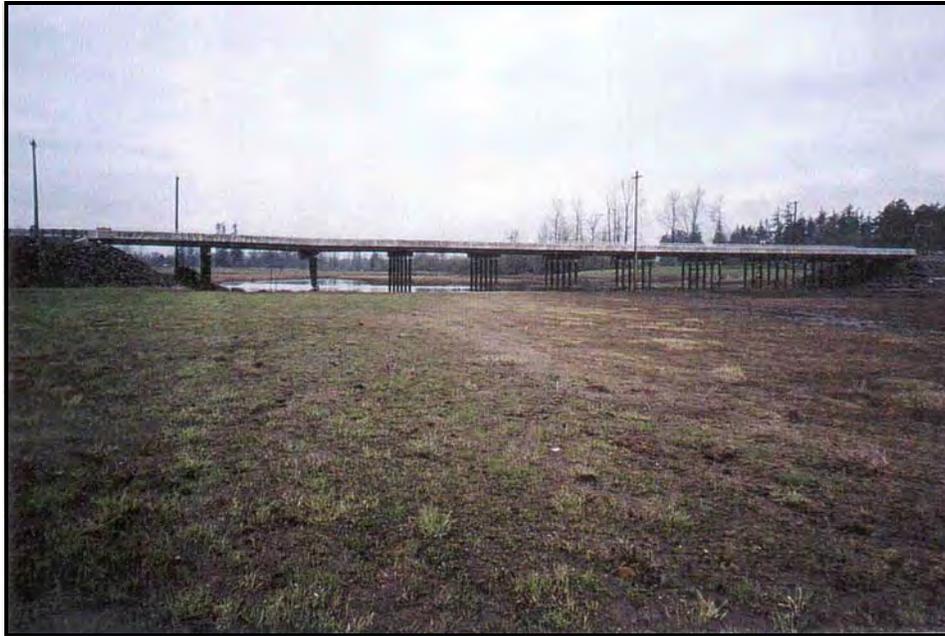
Figure 7. Looking downstream (north) to the Galvin Road overflow bridge.

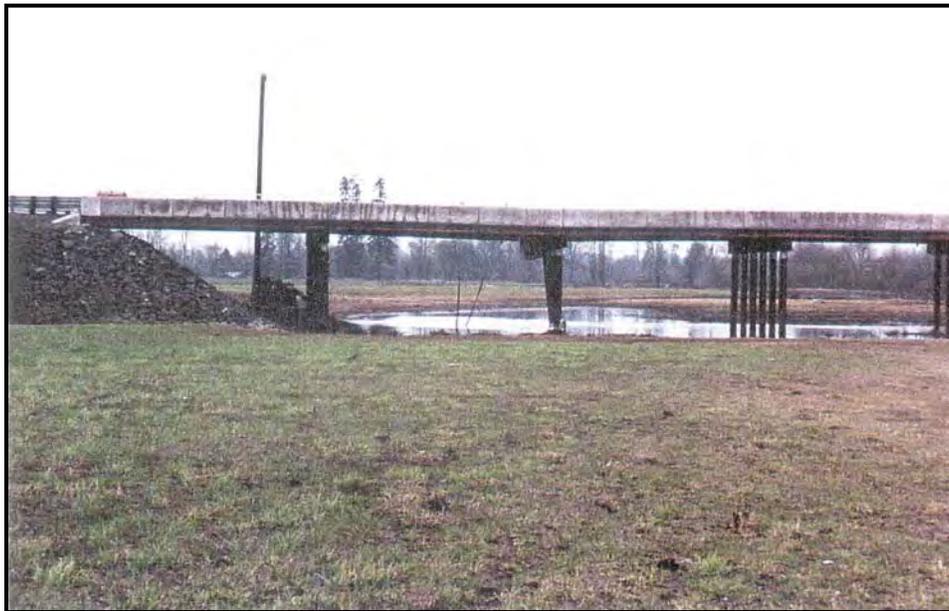
Figure 8. Looking downstream at piers 8, 9 (the pier that failed) and 10 following the February 1996 flood.

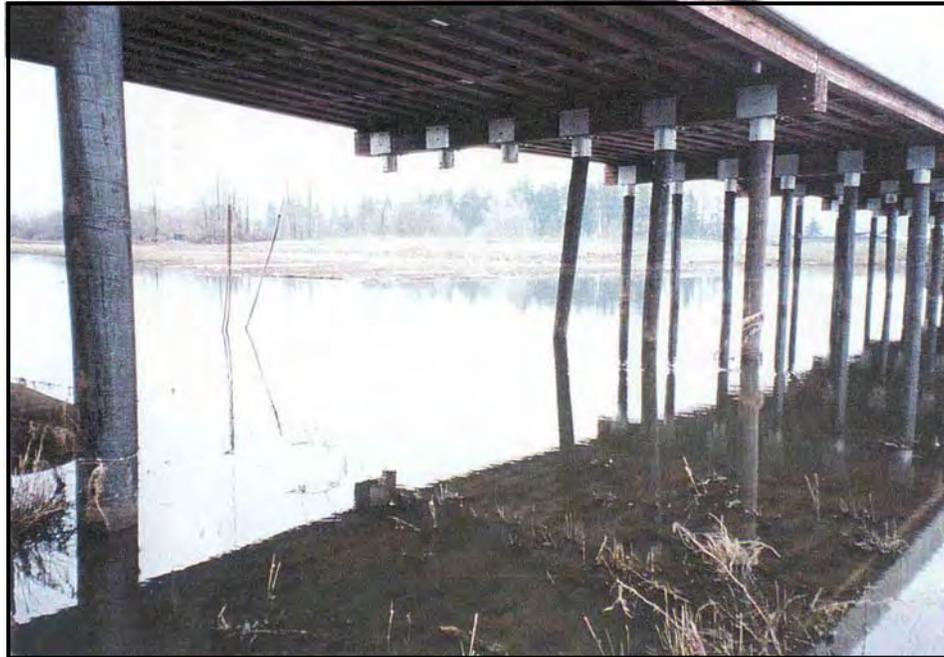
Figure 9. Looking east at failed pier #9 following the February 1996 flood.

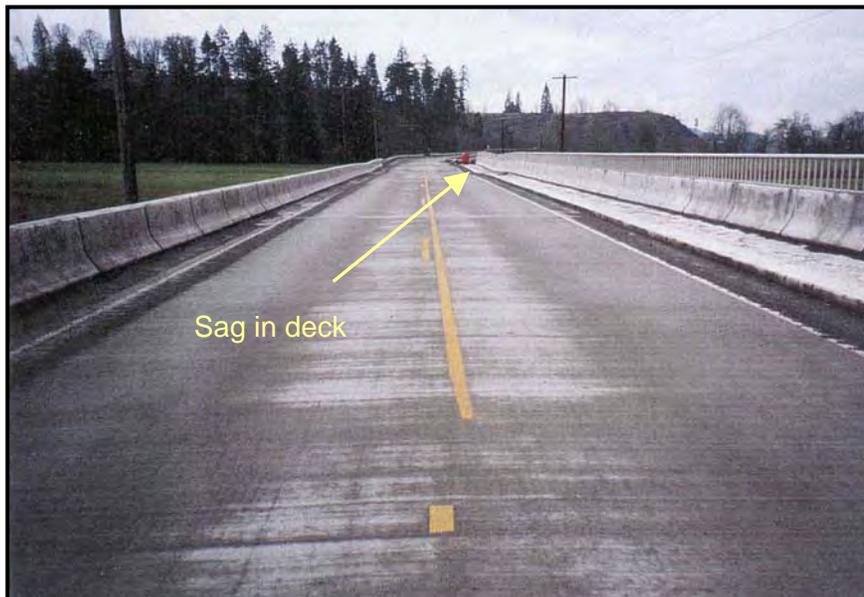
Figure 10. Looking west toward sag in bridge deck due to failure of pier #9 during the February 1996 flood.

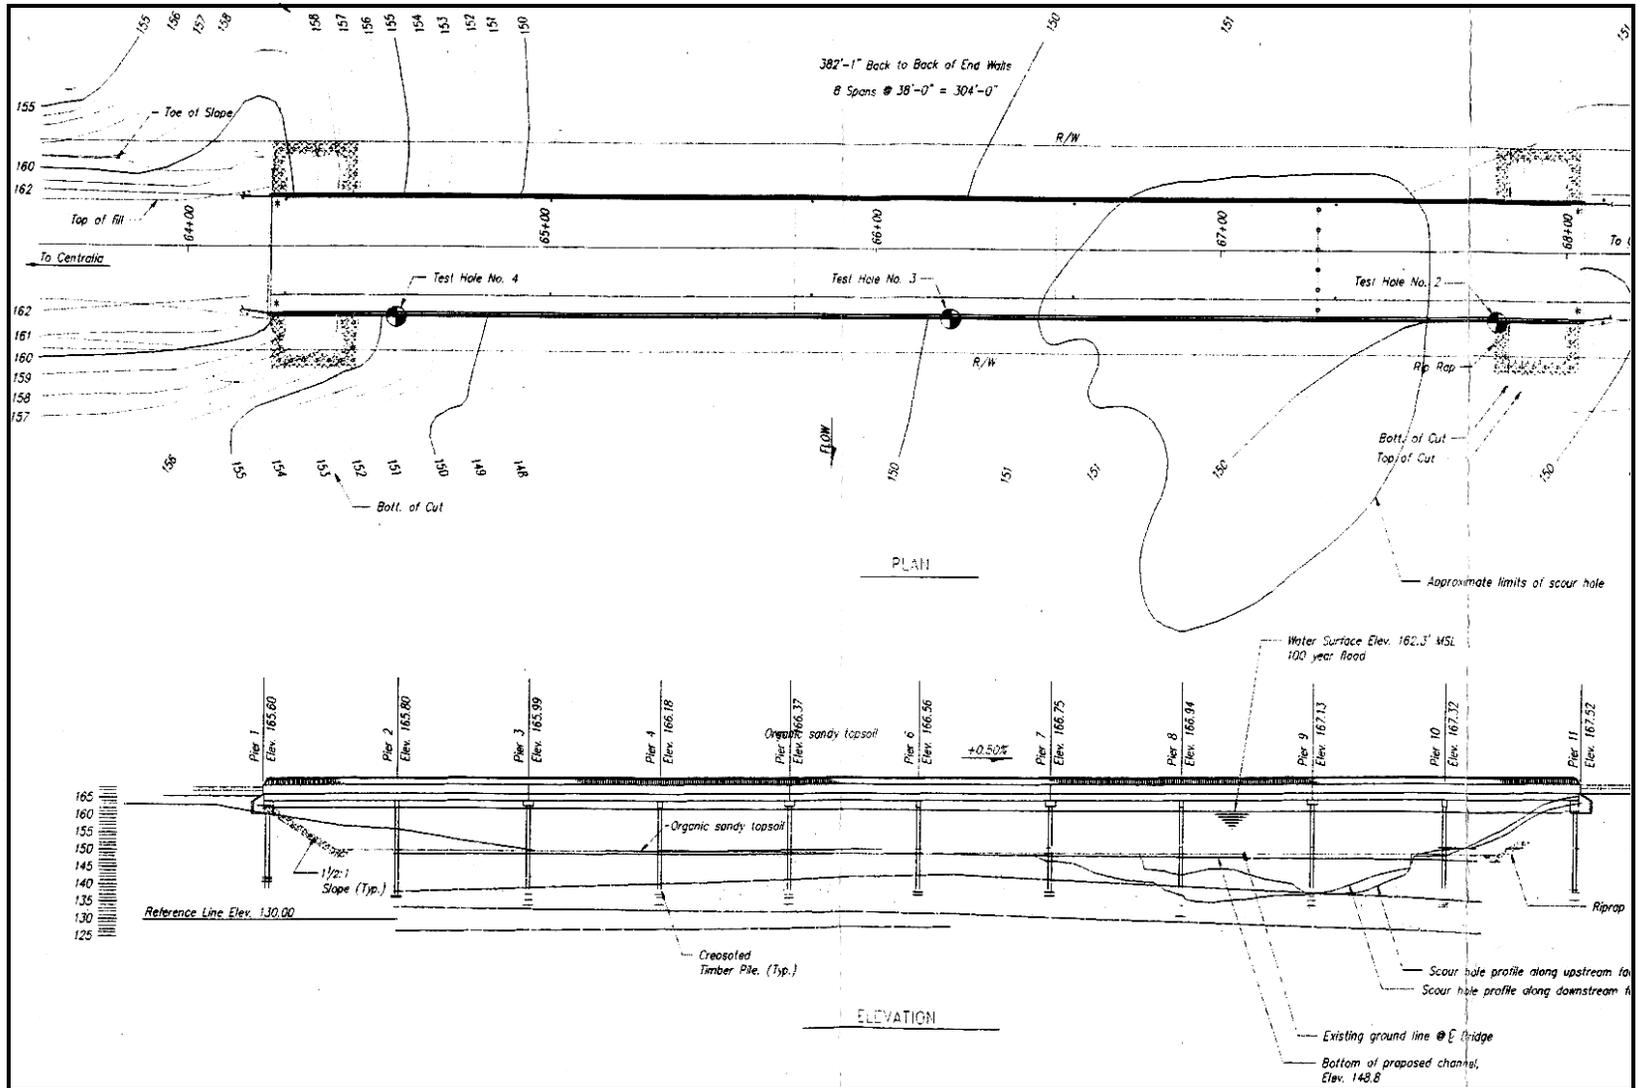
Figure 11. Plan and profile plots of scour hole location at Galvin Road overflow bridge for the Chehalis River, Centralia, WA.

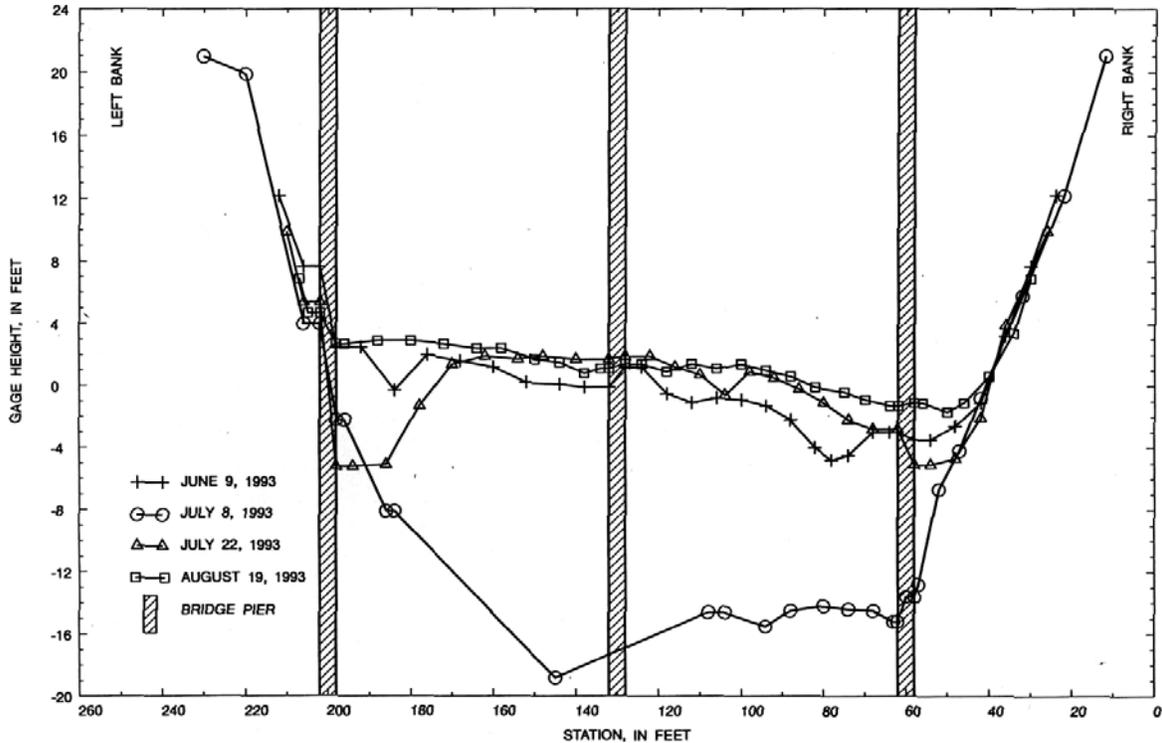
Figure 1. Streambed cross-sections at the downstream face of the SR 129 bridge over the Chariton River near Prairie Hill, MO.

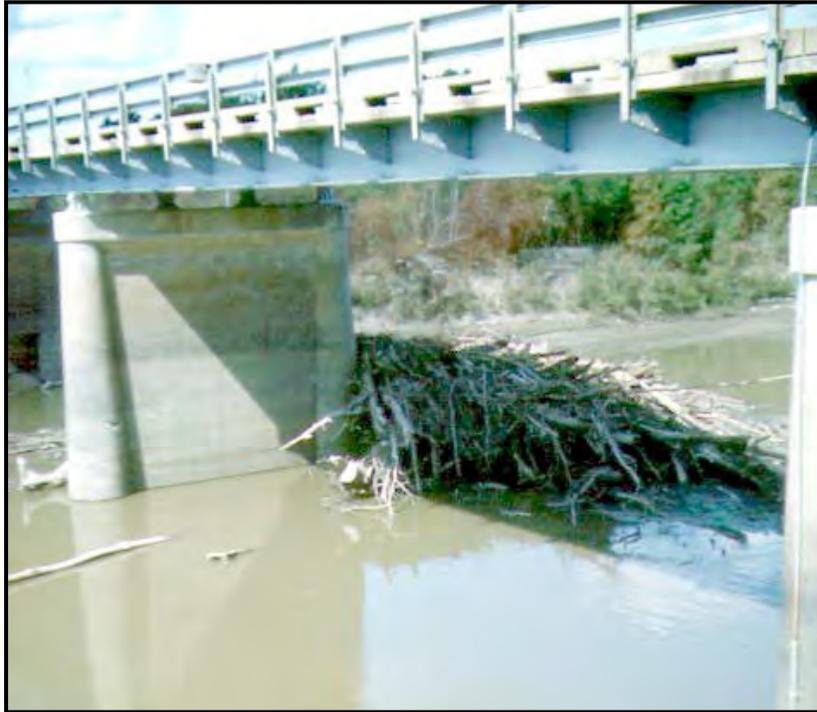
Figure 2. – Looking upstream at the remnants of the debris raft formed in front of the middle pier (#2) of the S.R. 129 bridge over the Chariton River during the May 24, 1995 flood.

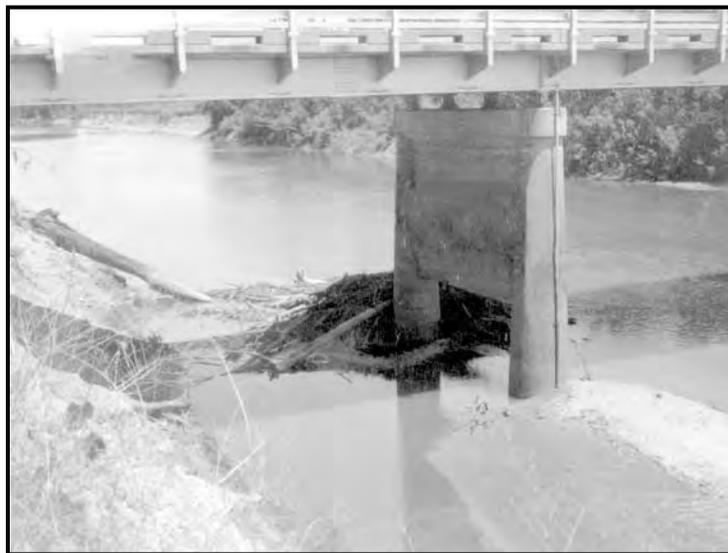
Figure 6. Looking upstream at debris raft formed in front of right pier (#3) in June, 1963.

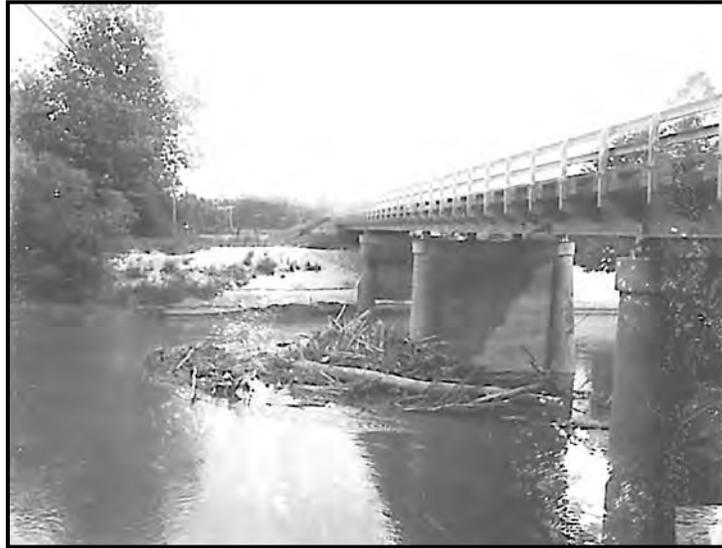
Figure 7. Looking at upstream S.R. 129 bridge face from right bank during low-flow on 5/26/1976.

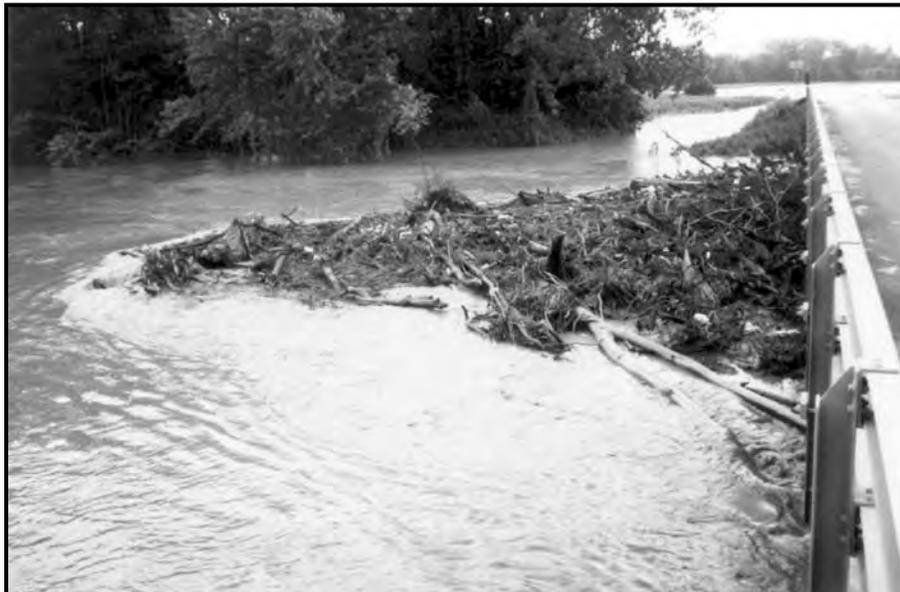
Figure 8. Looking along upstream S.R. 129 bridge face from right bank at debris raft in front of middle pier (#2) during July 1993 flood.

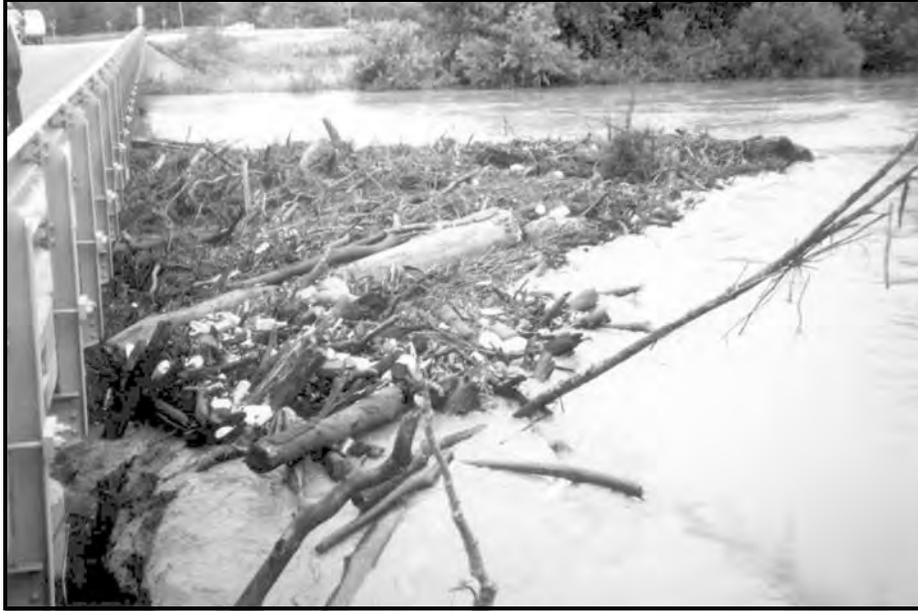
Figure 9. Looking along upstream S.R. 129 bridge face from left bank at debris raft in front of middle pier (#2) during July 1993 flood.
