NCHRP REPORT 553

**Crashworthy Work-Zone
Traffic Control Devices**

ROGER P. BLIGH
WANDA L. MENGES
REBECCA R. HAUG
Texas Transportation Institute
College Station, TX

WASHINGTON, D.C.
2006
www.TRB.org

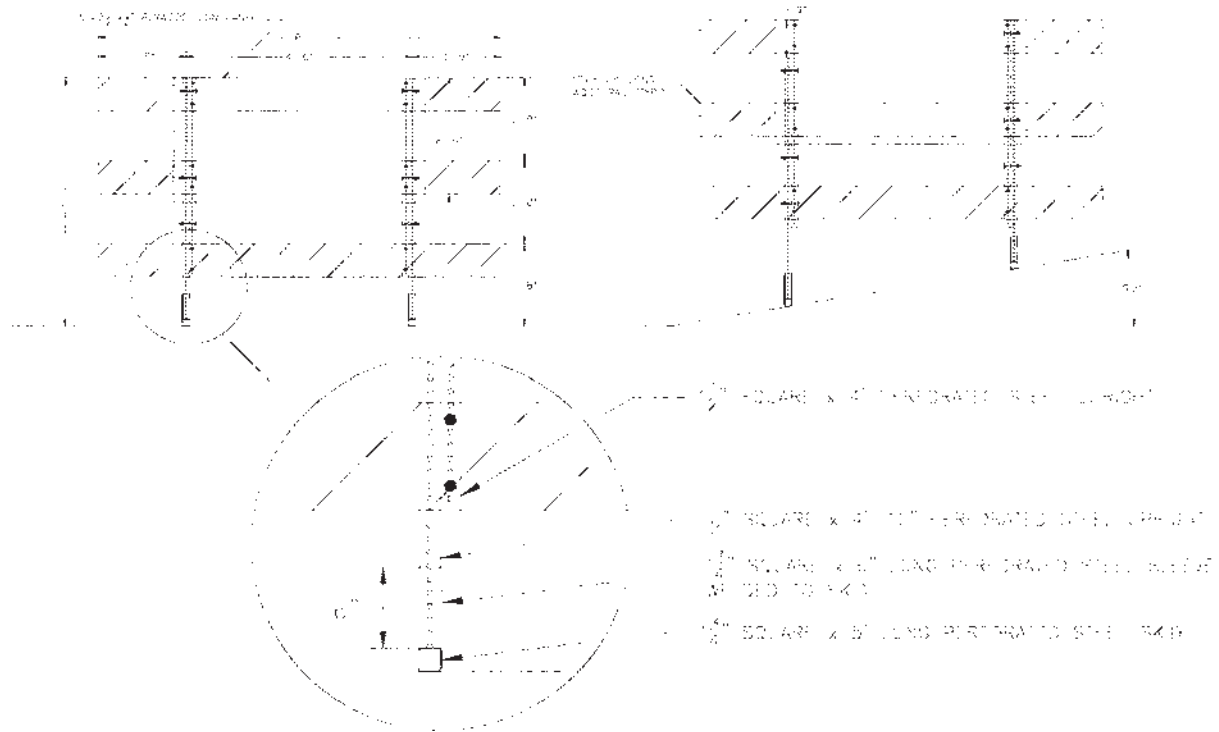
Figure 6.2. Perforated steel Type III barricade with wooden braces and telescoping base (sign mounted at 0.3 m [1 ft]).

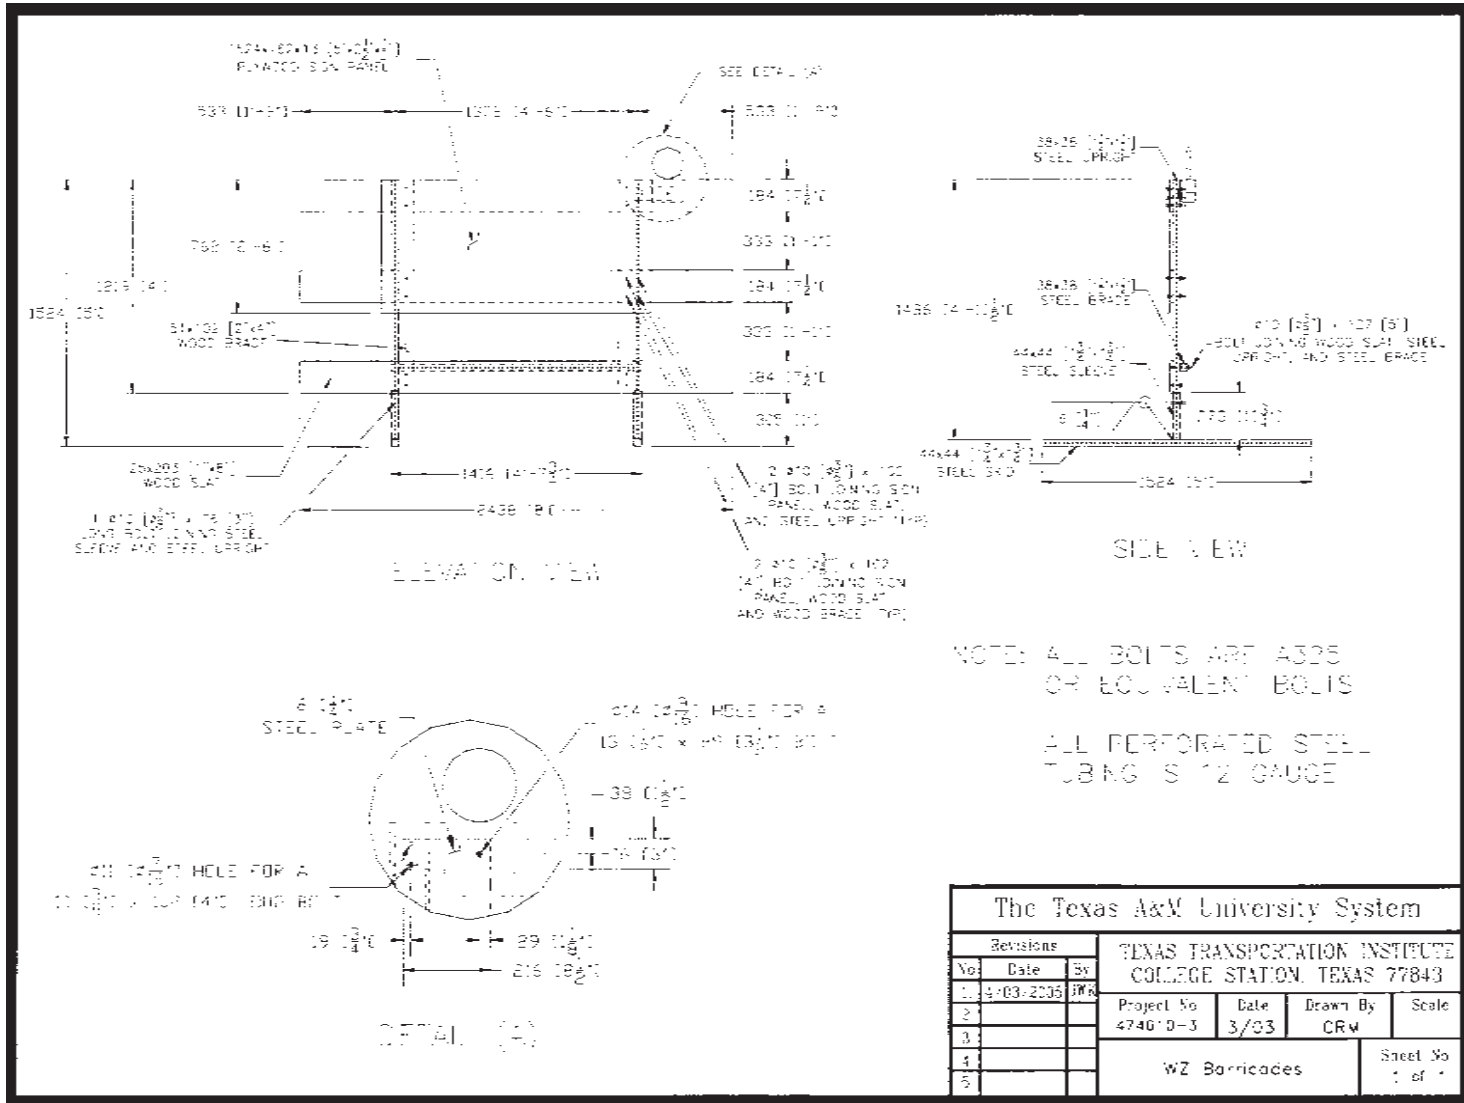
Figure 6.17. Details of the modified barricade with rectangular sign used in Test 3.

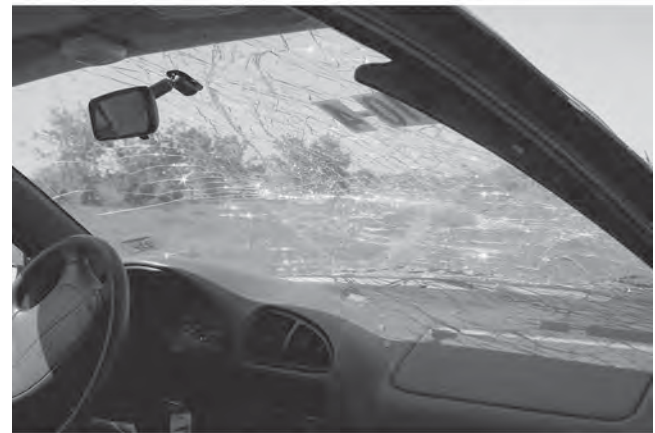
Figure 6.25. Damage to vehicle after Test 4.

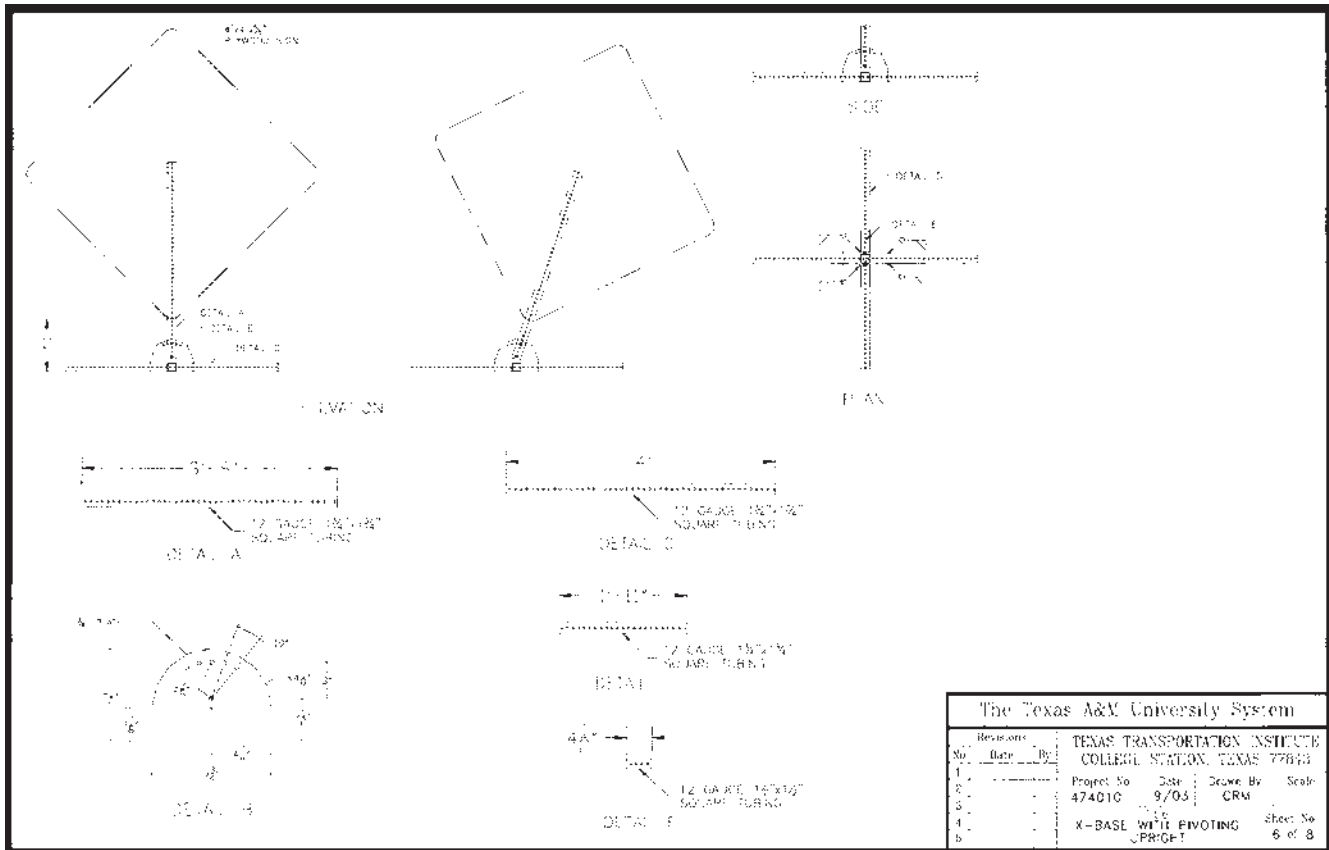
Figure 7.6. Design L6: X-base with pivoting upright.

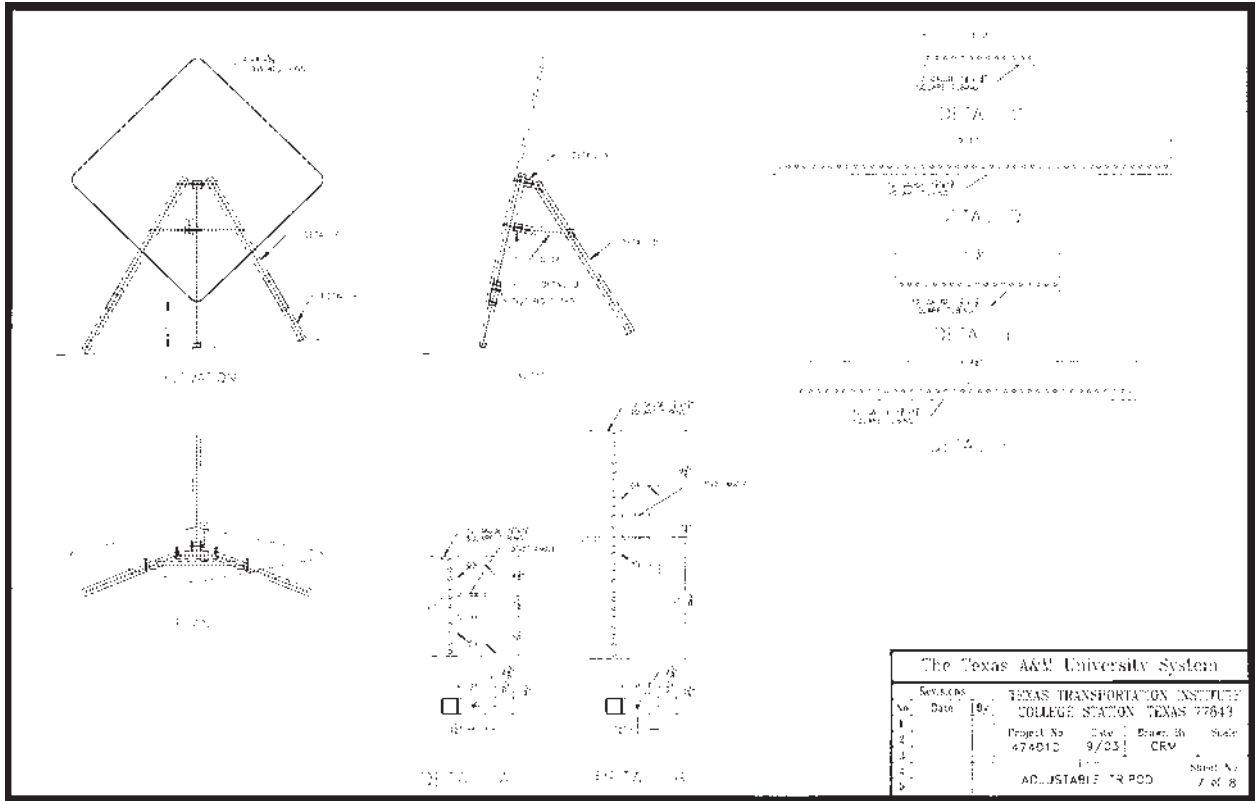
Figure 7.7. Design L7: adjustable tripod.

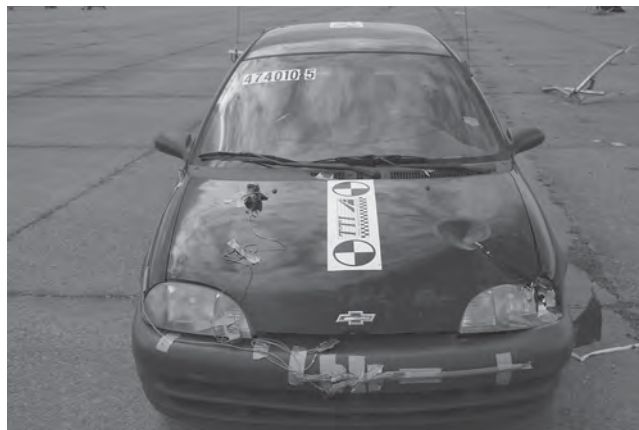
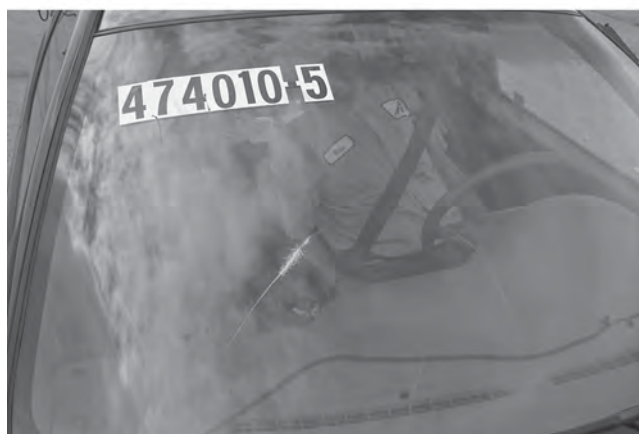
Figure 7.12. Vehicle after Test 5.

The vehicle remained upright during and after the collision event. Damage to the vehicle is shown in Figure 7.12. The front bumper, left headlight, hood, and roof were deformed. Maximum crush to the exterior of the vehicle was 30 mm (1.2 inches) at the left front at bumper height. The windshield

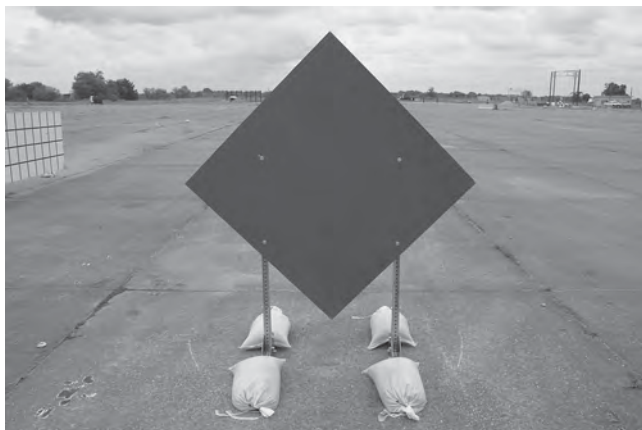
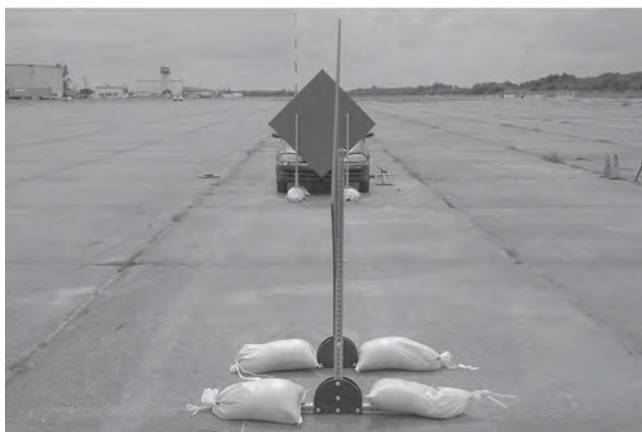
Figure 7.15. Pivoting dual-upright system used in Test 6.

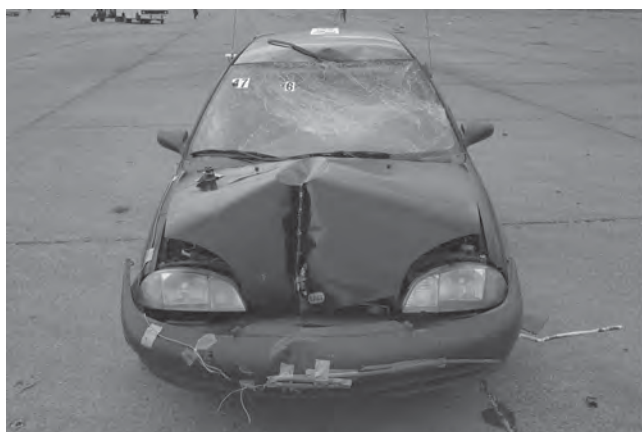
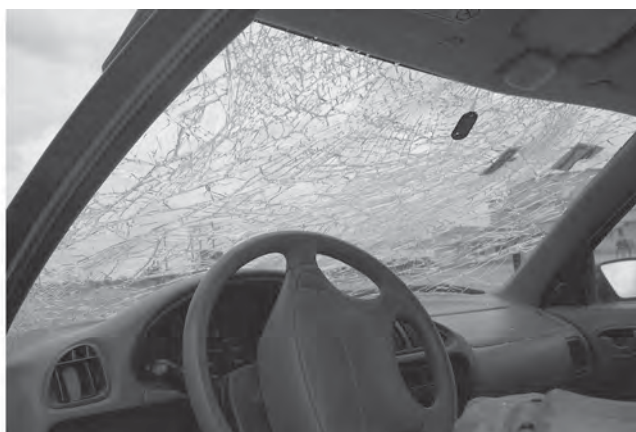
Figure 7.17. Vehicle after Test 6.
