Guidelines for Rail Base Inspection and Rail Condemnation Limits for Corrosion-Induced Material Loss

TCRP D-7/Task 17

Rail Base Corrosion Study

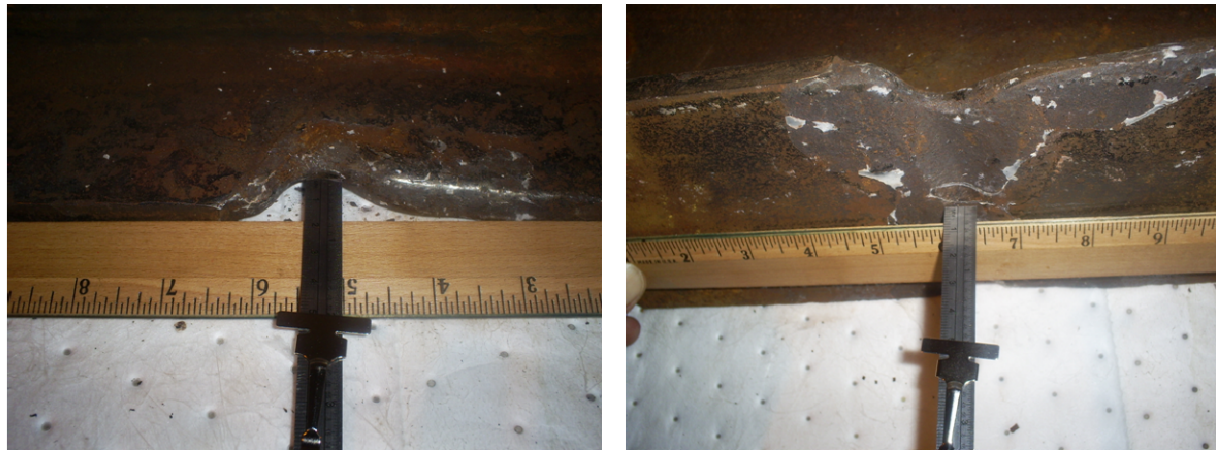
During inspections of condemned rail, 15 rail samples were selected for detailed study. A visual inspection showed that corrosion was generally at two places: at or around the fasteners on the rail base edges, and on the bottom of the rail base, where the tie plate and the bottom of rail base make contact. Material loss due to corrosion on the rail base bottom tends to be flat, and the maximum measured depth of corrosion was 0.4 in. No stress risers, such as sharp corners, were observed. Maximum material loss at the edge of rail base towards the rail web was measured up to 0.7 in., with 0.5 in. being the average. Figure 1 shows how the material loss was measured. Figure 2 shows the maximum vertical and horizontal measurements.

Figure 1. (Left) Rail Base Edge and (Right) Rail Base Bottom.

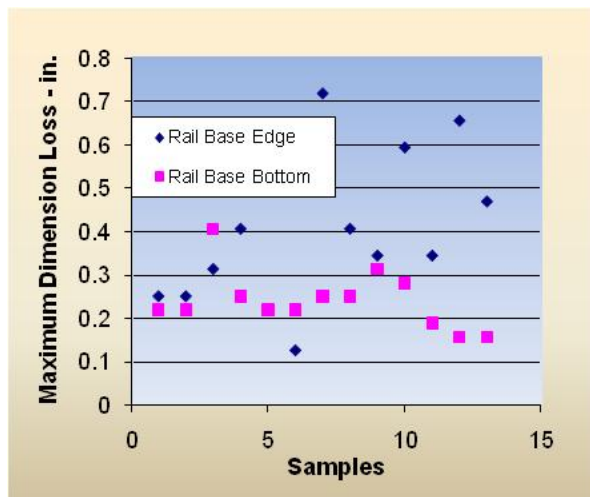
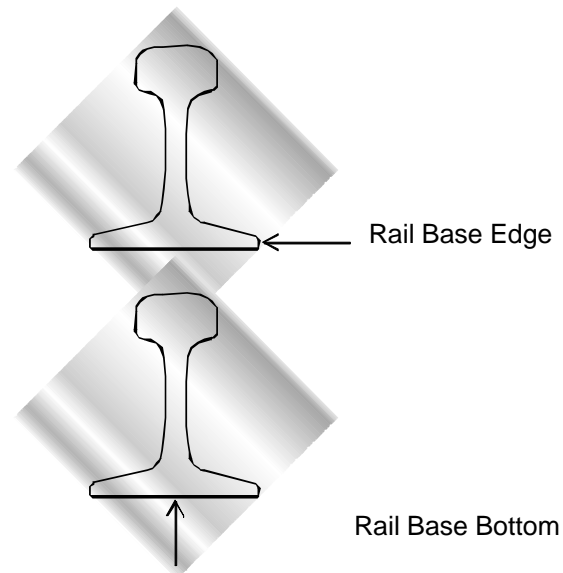
Figure 2. (Left) Material Loss Measurements, Maximum for Each Sample. (Right) Sketches Define Rail Base Edge and Rail Base Bottom.

As Figure 2 shows, a majority of the rail base edge measurements were significantly higher than the corresponding rail base bottom measurements. The average material loss at the rail base edge appeared to be under 0.25 in. for most of the rail base edge measurements. The rail-tie plate contact area is larger than fastener-rail contact area. Current flow density is higher through the rail base than the rail base edge. Although rail base edge measurements appear to be higher, total material volume loss (depth \times contact area) is higher at the rail base bottom than at the rail base edge.

Figure 2 shows that defects located in the rail base edge show more material loss than those located on the rail base bottom (in one dimension). Actually, the loss of material volume is lower for the rail base edge than for the rail base bottom. Because the rail base is mostly well seated on the ties, material loss may not be critical. However, the corrosion pits have sharp edges and corners and may act as stress risers. So corrosion pits may be more critical from a fatigue point of view, but may be less significant from a loss of strength point of view.

As mentioned before, the majority of the rail base edge measurements was significantly higher than the rail base bottom measurements. This observation may lead to the option that the corroded rail removal decision should be made based on the inspection and measurement of just the rail base edge. It will be more practical and convenient to measure material loss at the rail base edge than at the bottom of the rail base.

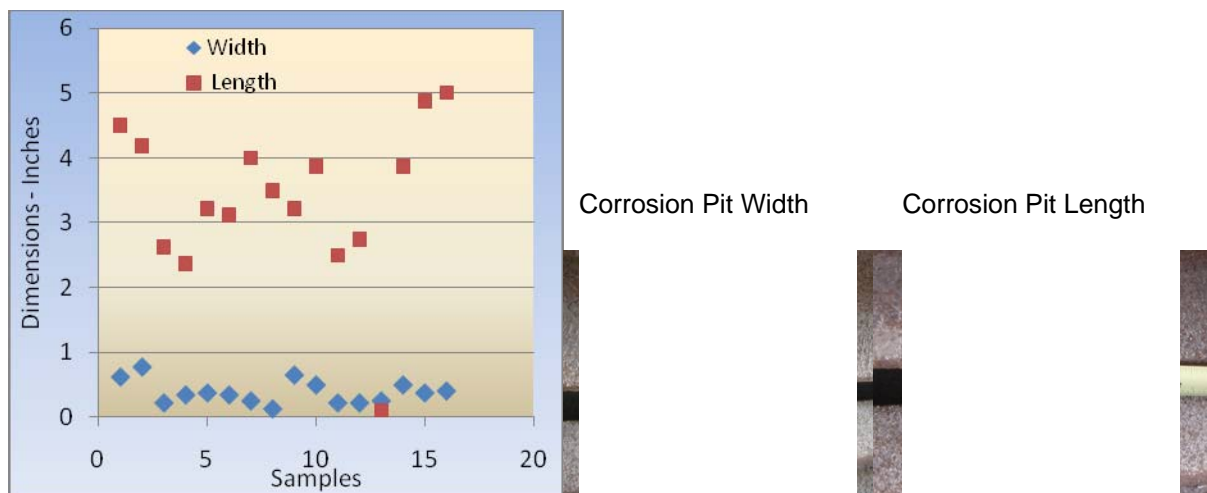
Figure 3 concentrates only on the maximum material loss under and around the fasteners. Corresponding widths and lengths of corrosion pits were measured for each sample as shown. Because the strength of rail depends on section properties, the length of a corrosion pit, although much higher than the width, is less important from a loss of strength point of view. The width of a corrosion pit directly affects the section properties; therefore, decisions to remove corroded rail from service should be made based on the width of the corrosion pit, not the length. Figure 3 also shows that material loss at condemned rail has width less than 1 in. at fastener locations.

Figure 3. Material Loss at the Rail Base Edge—Length and Width of Corrosion Pits.

The marking on one sample shows that the rail was rolled in 2002. The width of the corrosion pit is 0.34 in., and the rail was removed during 2007. Assuming a linear relationship, the corrosion rate appears to be 0.085 in./year. This rate of corrosion is by far the highest for the rails tested in a laboratory corrosive environment.¹ This rate might suggest that material parameters determined in the laboratory corrosive environment may not be applicable to rail corrosion due to stray current.

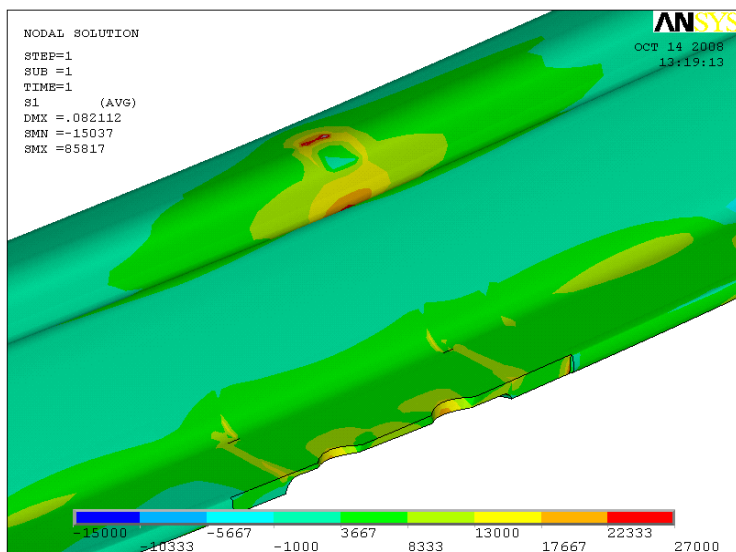
Figure 4a. Principle Stresses at a Corrosion Pit at a Fastener (Top) 0.3 in. Wide.

Next, finite element models were created for corroded rail. The dimensions of the corrosion pits were similar to what was found in the corroded rail samples (see Figures 4a and 4b). The width of material loss under and around fasteners varied from 0.3 in. to 1 in. in the simulations. The length of the defects was held constant since it has a negligible effect on the cross section of the rail. Also, the depth of material loss under the rail base was kept constant at 1/4 in. This is because for almost all corrosion pits with varying widths, the depth was uniform.

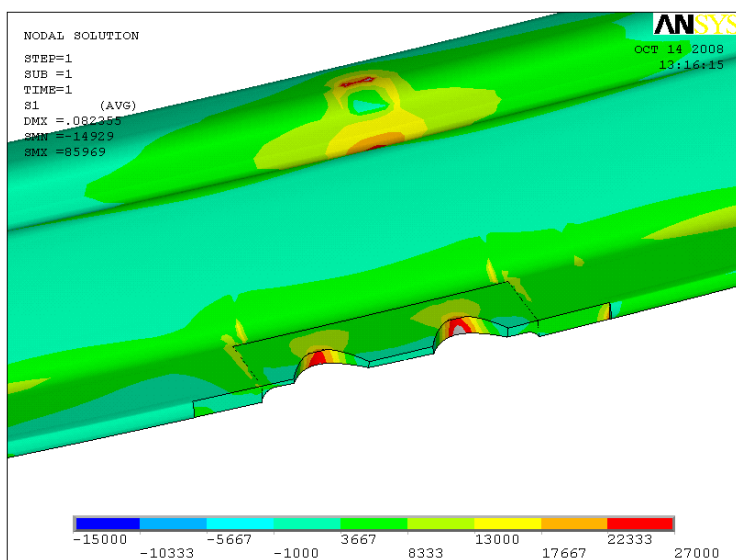
Figure 4b. Principle Stresses at Corrosion Pits (Bottom) 1 in. Wide

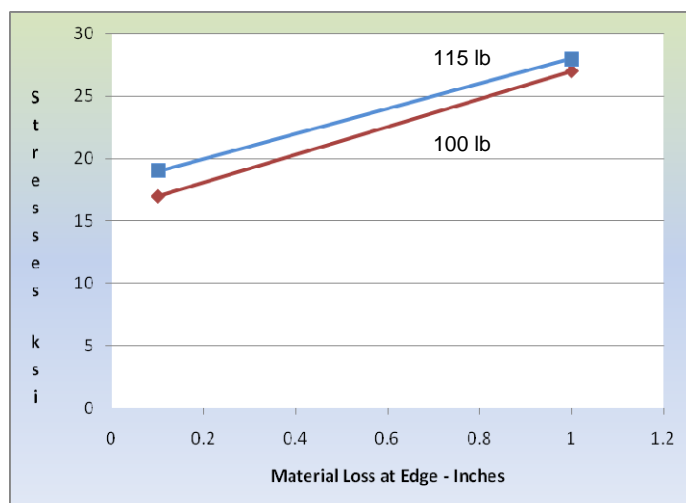
Figure 4c shows the principle stress in 115 lb/yd rail increased from 18,000 psi to 27,000 psi. The Factor of Safety (FOS) reduced from 5 ($=90,000/18,000$) to 3 ($=90,000/27,000$). The analysis suggests that corrosion pits beyond 1-in. width along the rail may compromise the strength of the rail and should be removed from service. The FOS for 100 lb/yd rail is similar. One-degree Fahrenheit changes thermal stress by 200 psi. Where rail temperatures vary significantly, this stress per degree change temperature should be added to the bending stress, and FOS should be recalculated accordingly.

Figure 4c. Material Loss and Principle Stress Relationship.

The material loss increases continuously over the service life of rail, and so does the level of stress concentrations. Assuming a linear relationship, as Figure 4c shows, fatigue life was calculated at 2 points. An average was determined as probable rail fatigue life under corrosive environment, which comes to 10-million cycles. Figure 7 shows the procedure graphically.

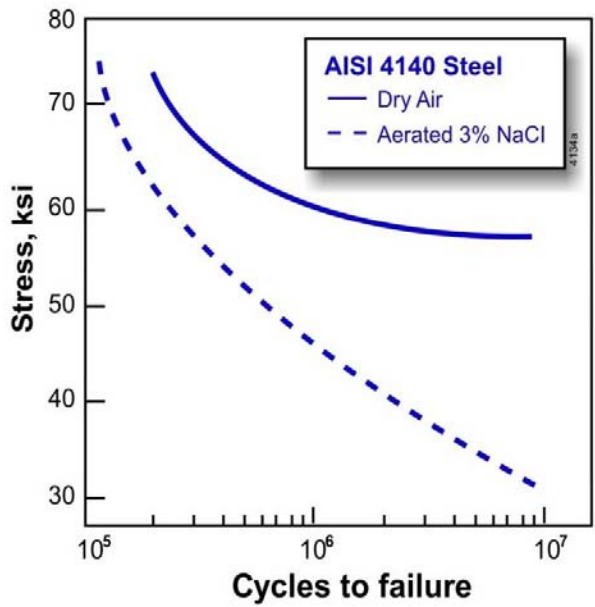
Figure 5. S-N Curves for Steel in Dry Air and a Corrosive Environment.⁴

A S-N curve for high carbon steel in a corrosive environment appears to be nonexistent. However, a generalized S-N curve for polished samples using mechanical strength parameters was developed. This curve was then modified using an approximate reduction factor to simulate the corrosive environment.⁷

Using tensile strength (σ_u) of high carbon steel of 120 ksi, an S-N curve for a polished sample can be developed by using $S_{100} = 0.9 \sigma_u$ and $S_e = 0.5 \sigma_u$. S_e is the fatigue threshold (or endurance limit) corresponding to 1-million cycles. This data was reduced by 43 percent to get an S-N curve for CF.⁸

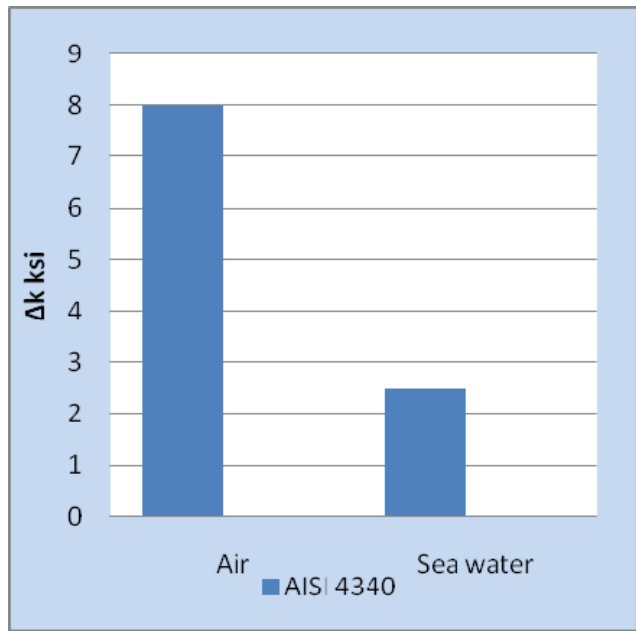
Once a crack has initiated, corrosion can significantly increase its growth rate. The stress intensity factor (ΔK) is a measure of crack growth. A lower stress intensity factor means higher crack growth. The stress intensity factor for AISI 4340 steel in sea water was measured as 1/3 of that in air, as Figure 6 shows.

Figure 6. Comparison of Stress Intensity Factor in Corrosive and Noncorrosive Environment.⁵

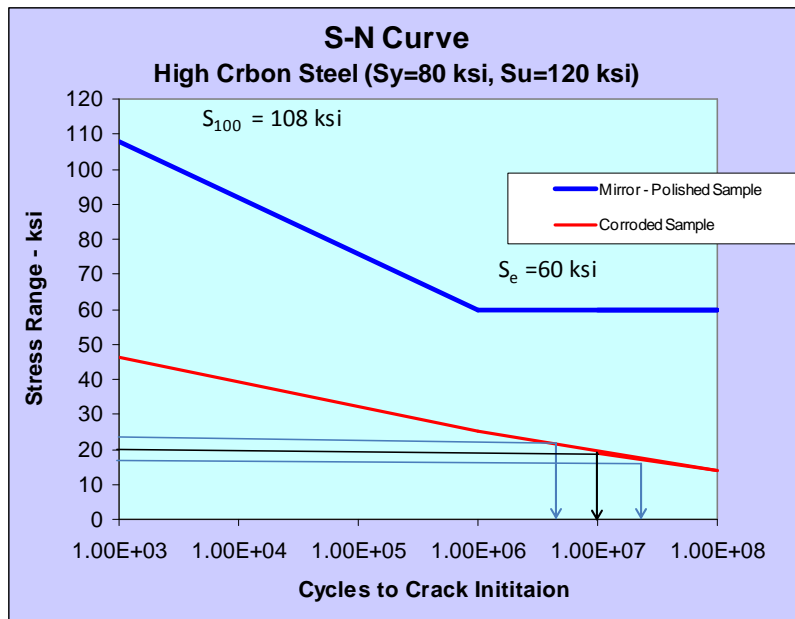
Figure 7. Likely Cycles Required for Crack Initiation at a 1-in. Wide Corrosion Pit.

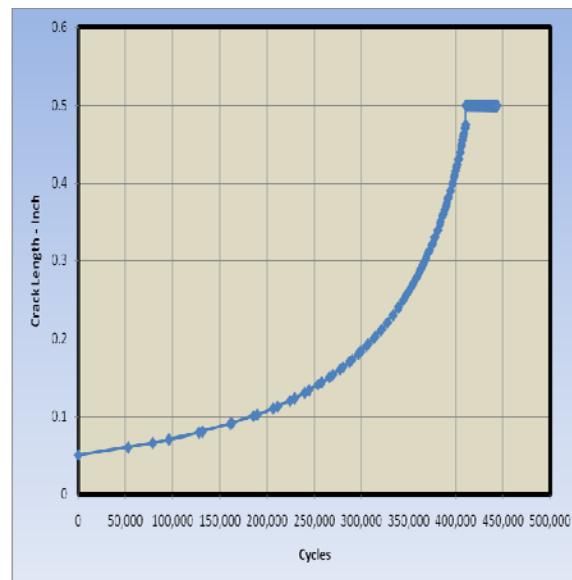
After all the inputs were provided, the program calculated that about half a million cycles may grow a flaw to critical size (see Figure 8). The stress at the tip of critical flaw has a stress level close to the yield strength of the material. This stress level can cause sudden failure.

Figure 8. Number of Cycles to Grow a 0.05-in Crack to Critical Crack.

This number can be useful when determining the inspection intervals per year. If the inspection intervals are smaller than 0.5-million cycles, there is high probability of detecting the crack before the rail breaks.

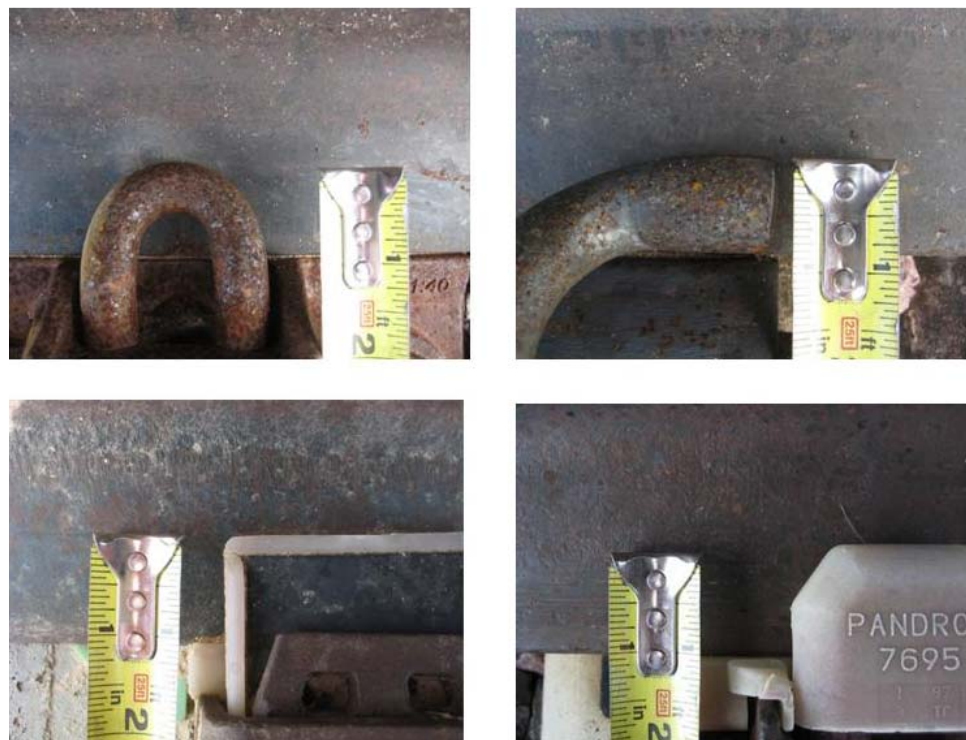
Figure 10 shows many different types of fasteners attached to a rail with a 6-in. base. The minimum width on the rail base edge necessary for good contact is about 3/4 in. However, this width may differ among the transit agencies depending on the type of fastener used. Most of the fastener requires at least 0.06-in. deflection to develop full toe load.

Figure 10. Rail Base Fasteners: Top Left, Norfast; Top Right, Pandrol e-clip; Bottom Left, Sonnevile; and Bottom Right, Pandrol-fast.
