NCHRP REPORT 654

**Evaluation and Repair Procedures
for Precast/Prestressed Concrete Girders
with Longitudinal Cracking in the Web**

Research sponsored by the American Association of State Highway and Transportation Officials
in cooperation with the Federal Highway Administration

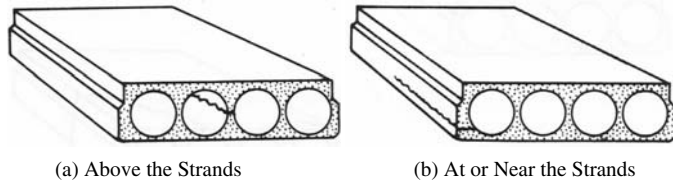
Figure 1.1. End-of-member cracks for hollow-core slabs.

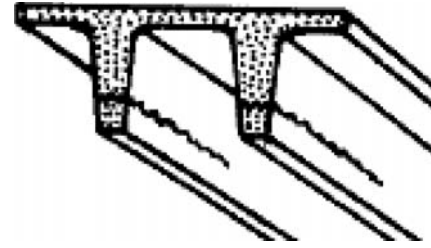
Figure 1.2. End-of-member cracks for double tees.

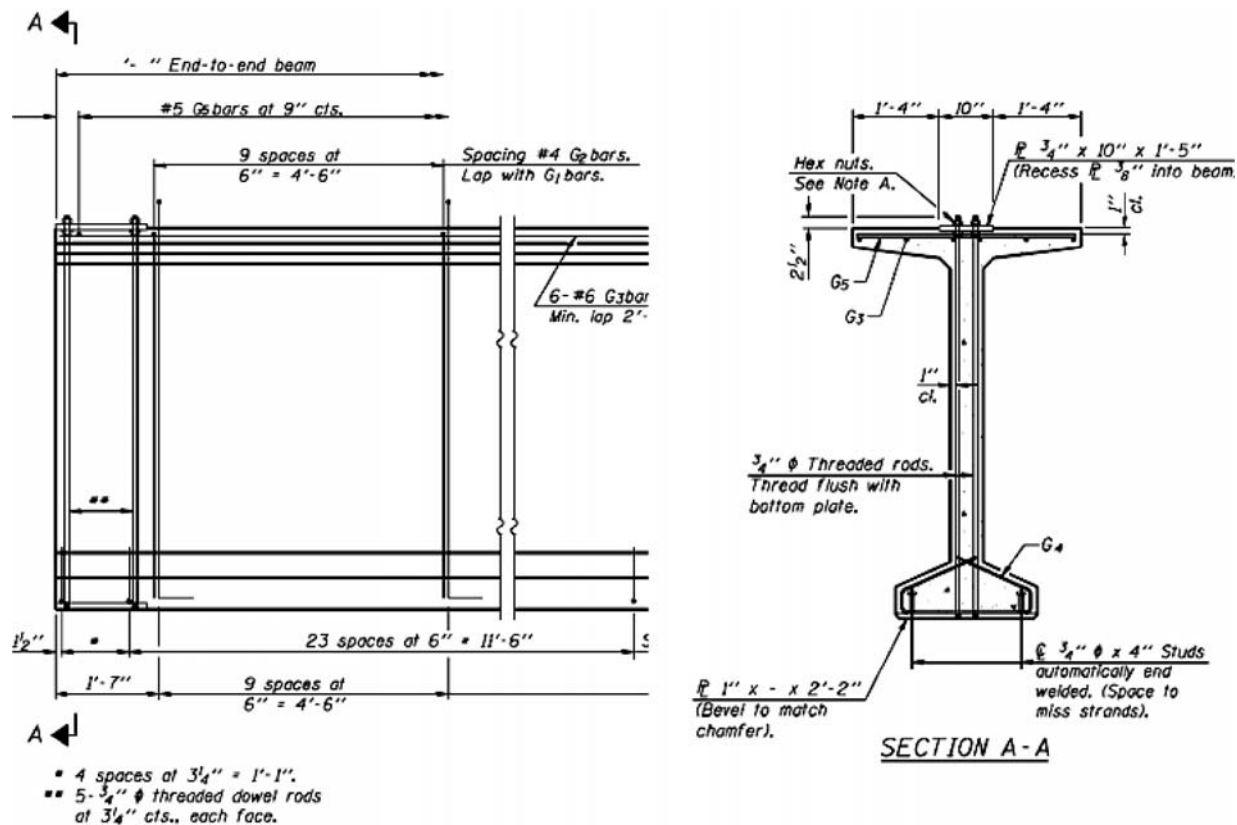
Figure 1.3. End zone reinforcement detail used by IDOT.

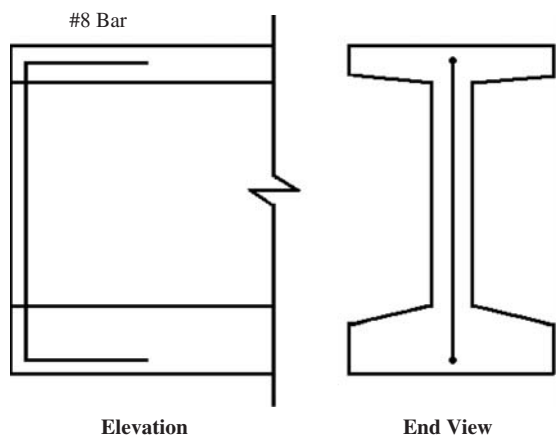
Figure 1.4. End zone detail used by Central Pre-Mix Prestress Co., Spokane, Washington.

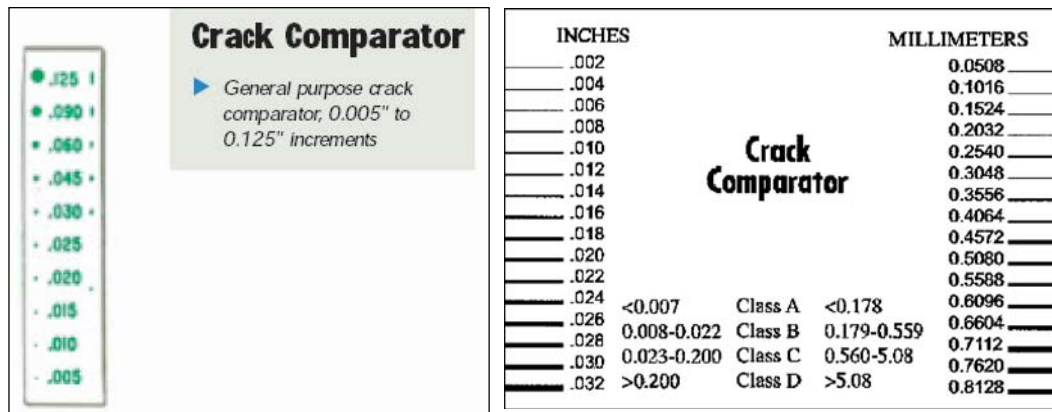
Figure 3.1. Crack comparator.

Most inspectors stated that routine inspection is used to determine the extent of cracking. However, 17 of the 36 who experienced end zone cracking used crack comparators, shown in Figure 3.1, and 5 used magnifying scopes.

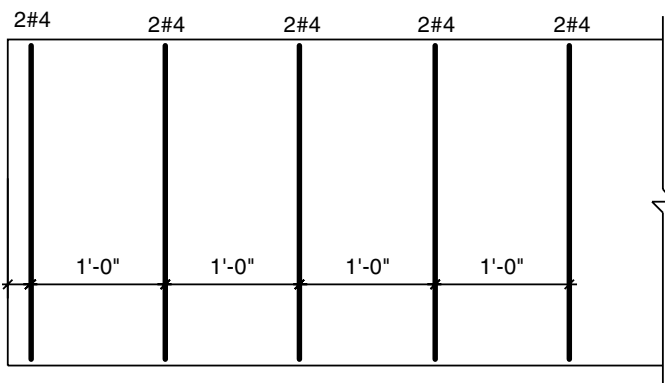
Figure 3.8. End zone reinforcement details of WA2L (no EZR) and WA2R (no EZR).

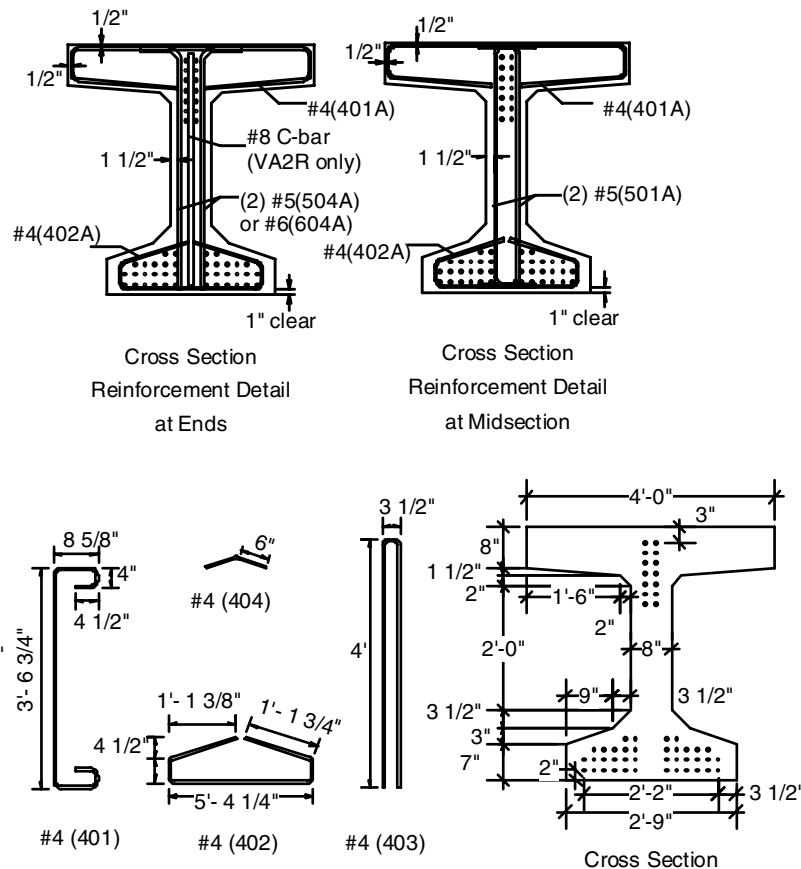
Figure 3.9. Cross section details of the Virginia specimens.

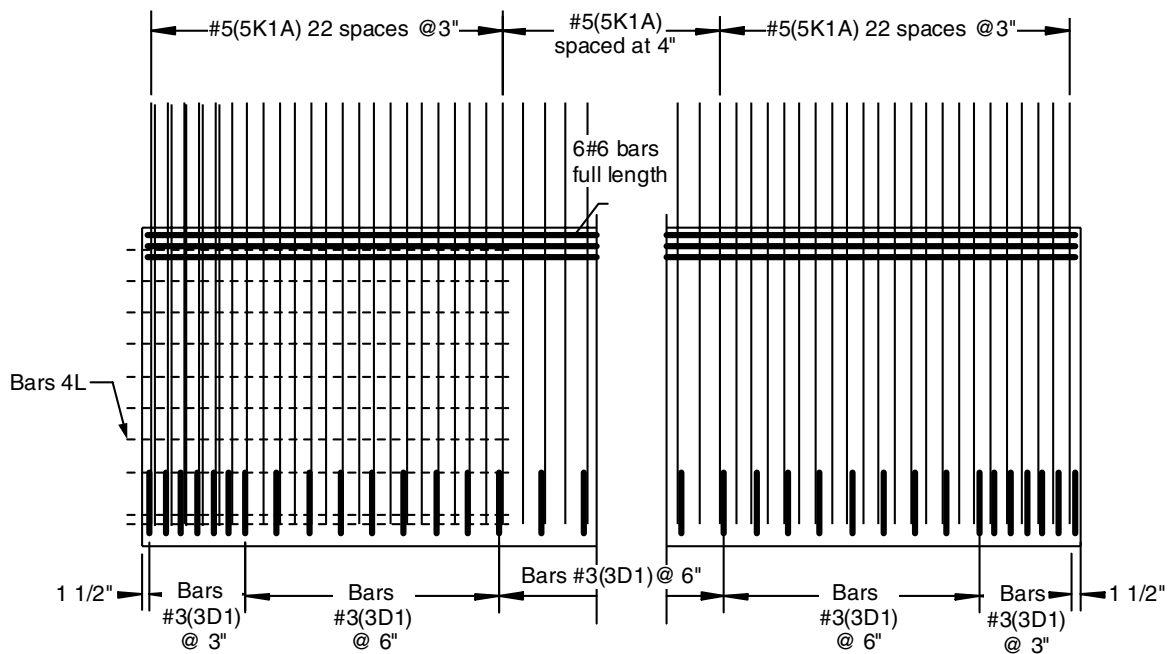
NOTE: PROVIDE A TOE PLATE 2'-2" BY 12" BY 1/2" WITH 6 STUDS AT EACH END

Figure 3.13. End zone reinforcement details of FL1L (FL) and FL1R (modified FL).

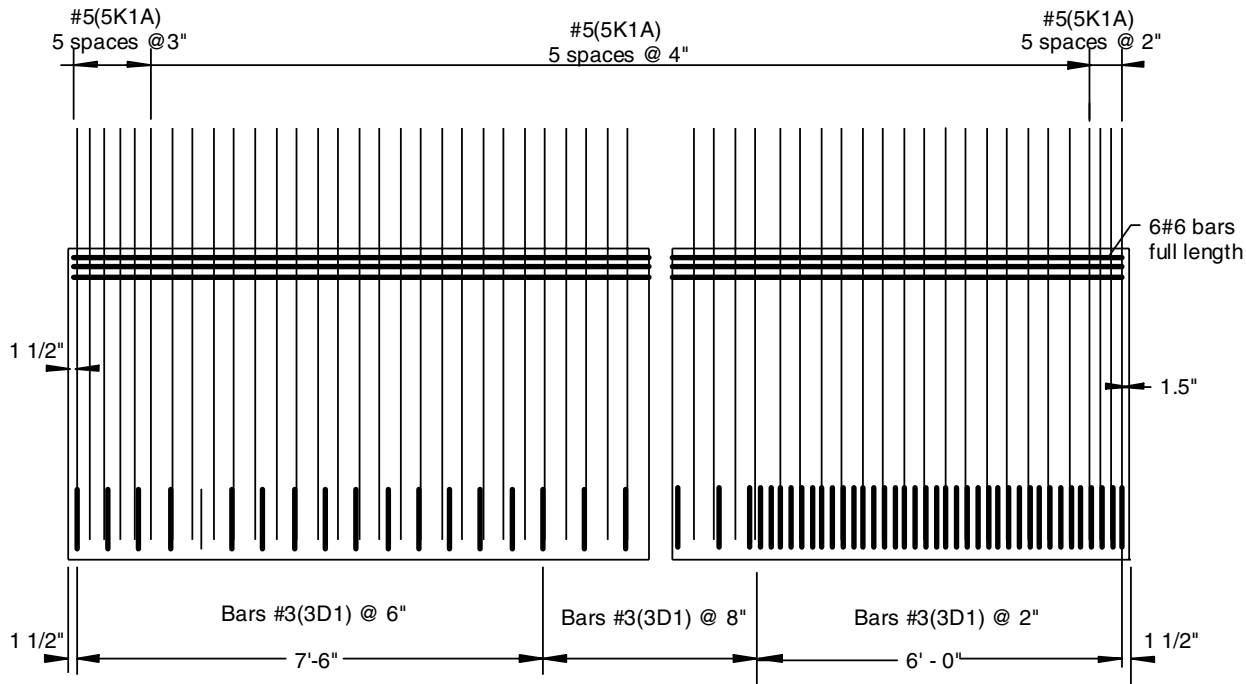
Figure 3.14. End zone reinforcement details of FL2L (LRFD) and FL2R (proposed).

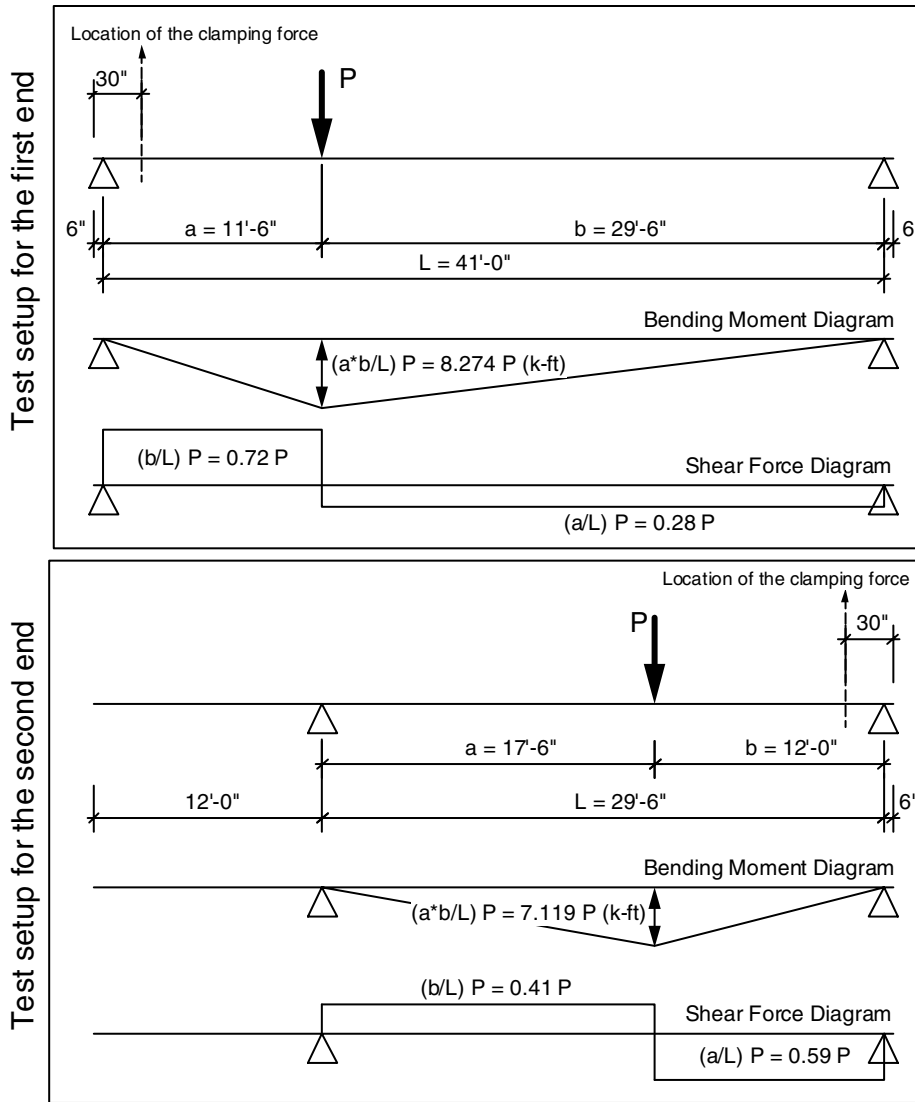
Figure 3.15. Support and loading arrangement of the full-scale specimens.

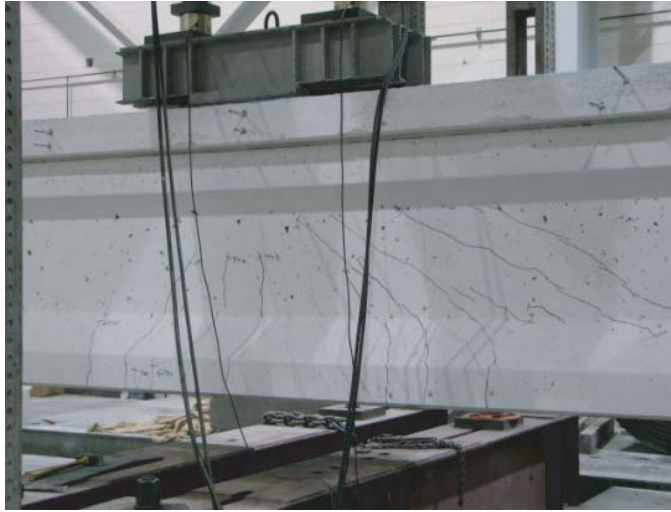
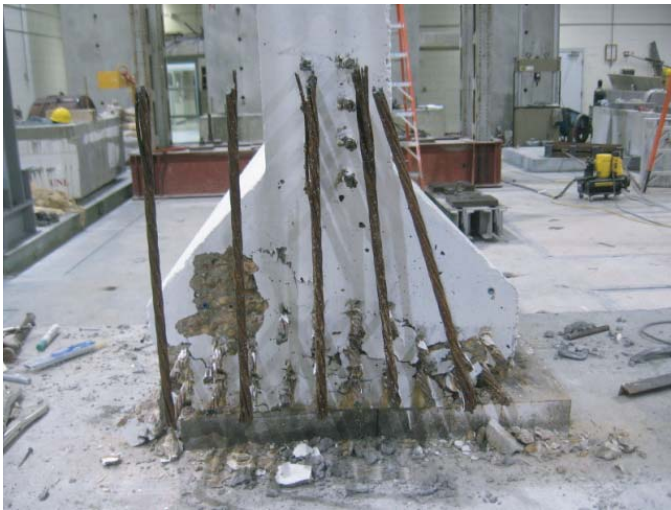
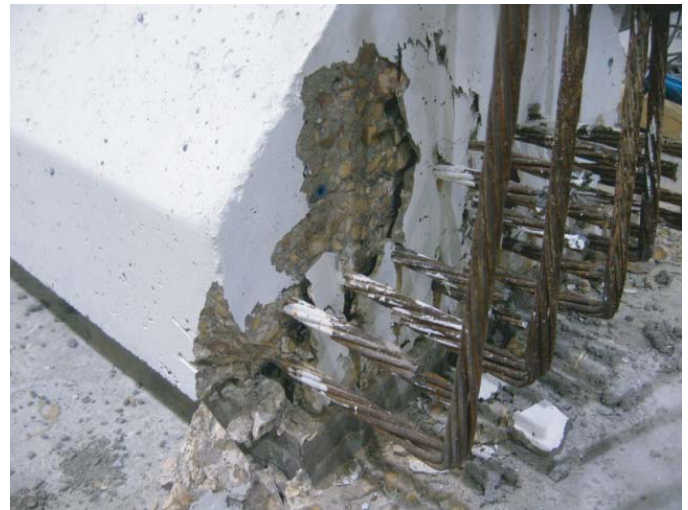
(a) Classical Flexural Cracking

(b) Strand Rotation

(c) Strand Slippage

Figure 3.18. Typical flexural failure and loss of bond in the Tennessee specimens.

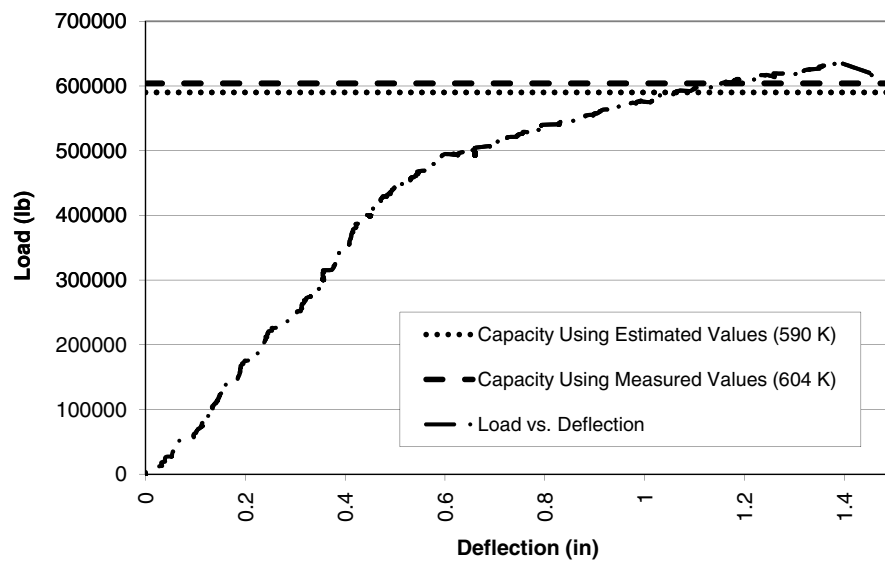
Figure 3.19. Load-deflection curve of TN1L.

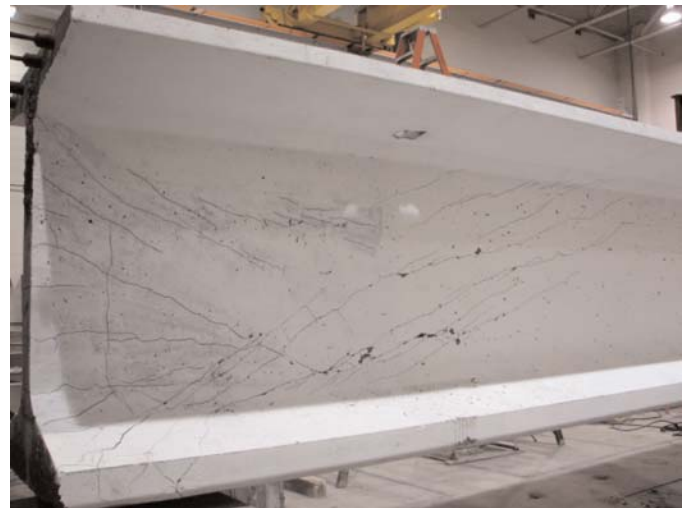
Figure 3.22. End WA1L after shear failure.

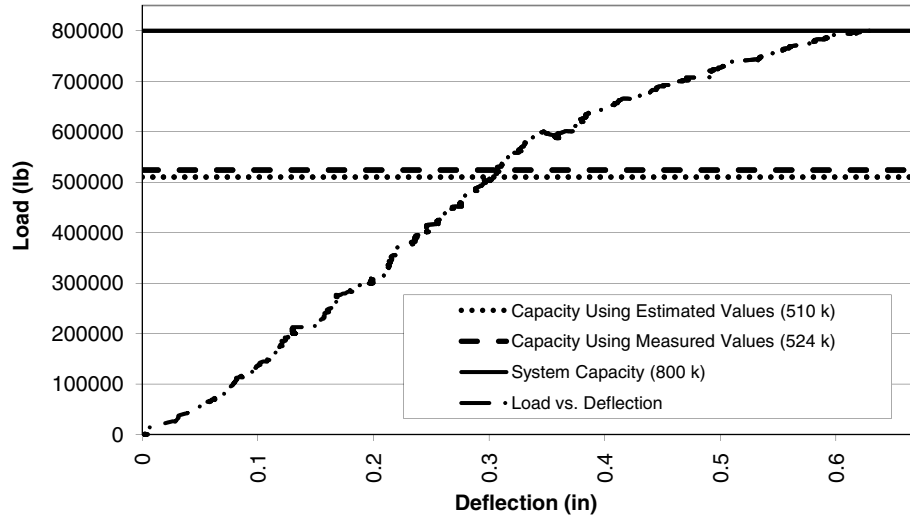
Figure 3.23. Load versus deflection curve for End WA1R.

An example of the load-deflection relationship is presented in Figure 3.23, which shows how the test data far exceeds the estimated capacities. The curve is for End WA1R that was designed using LRFD specifications. In this case, the load required to fail the girder in flexure was greater than the 800 kips capacity of the two hydraulic jacks in the test setup. The curve shows where loading was halted, but it can be

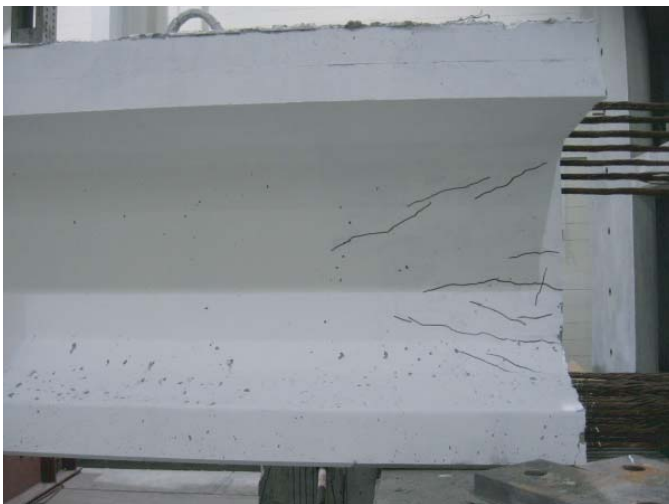
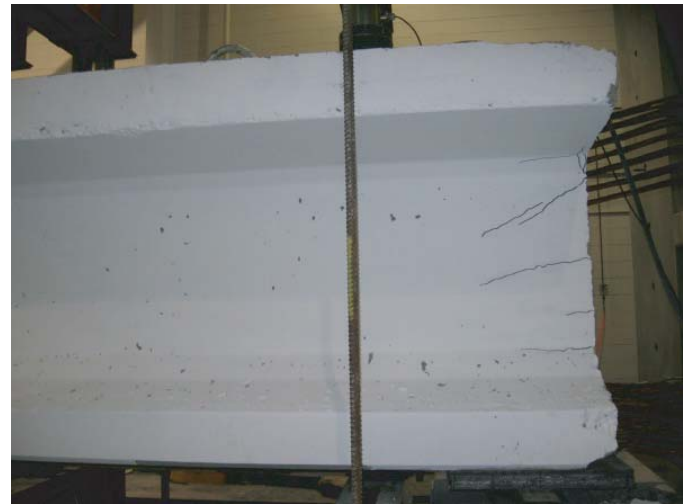
(a) VA1R (No EZR)

(b) VA2R (Proposed)

Figure 3.24. End zone cracking of VA1R and VA2R.

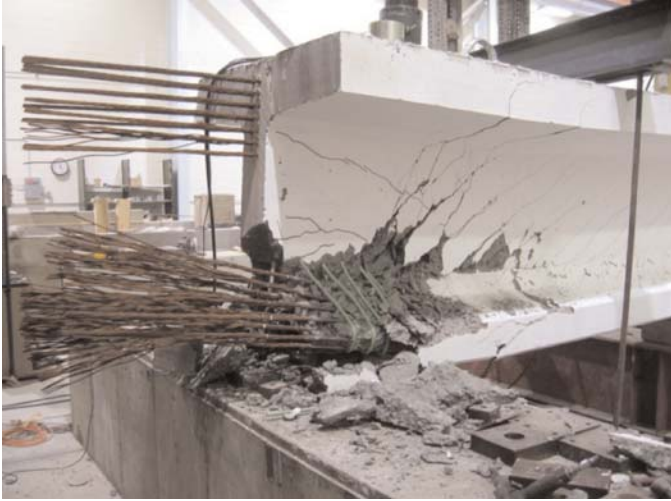
Figure 3.25. End VA1R after bearing failure.

End VA1R was the first Virginia end tested and it failed prematurely due to inadequate bearing area, as shown in

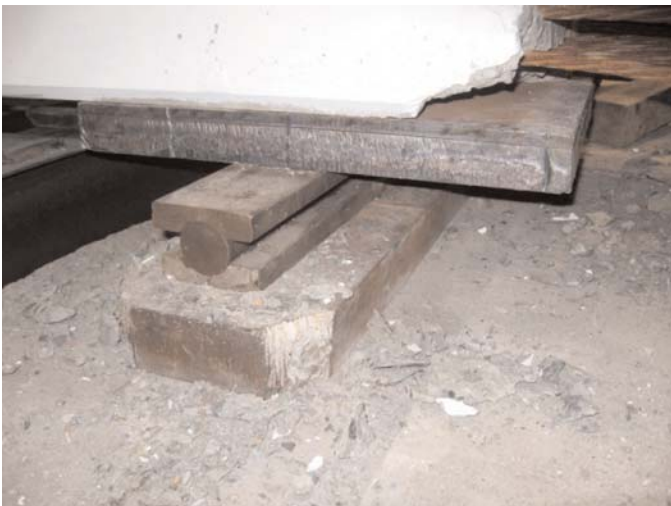
Figure 3.26. Support with roller.

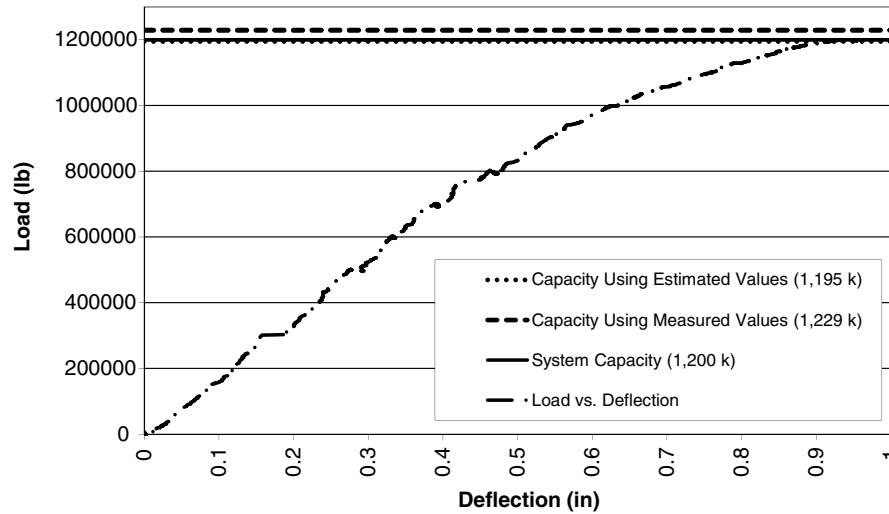
Figure 3.29. Load versus deflection curve for End FL2R.

Figure 3.29 shows the load-deflection curve for End FL2R. The loading of this end had to be stopped before failure because the three hydraulic jacks had reached capacity at 1,200 kips. However, it can be inferred that if more load had been applied, the test values would have risen above the experimental values.

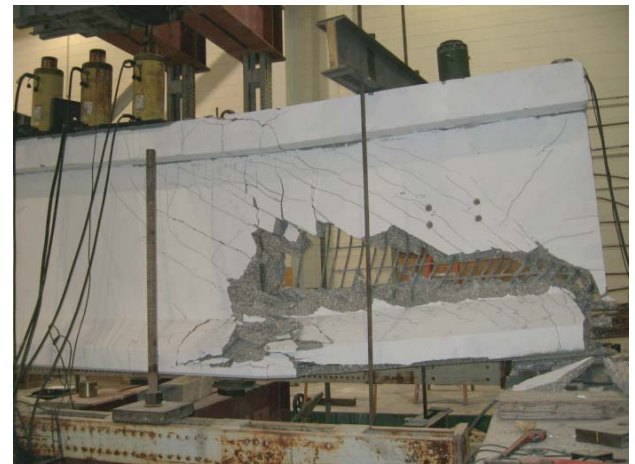
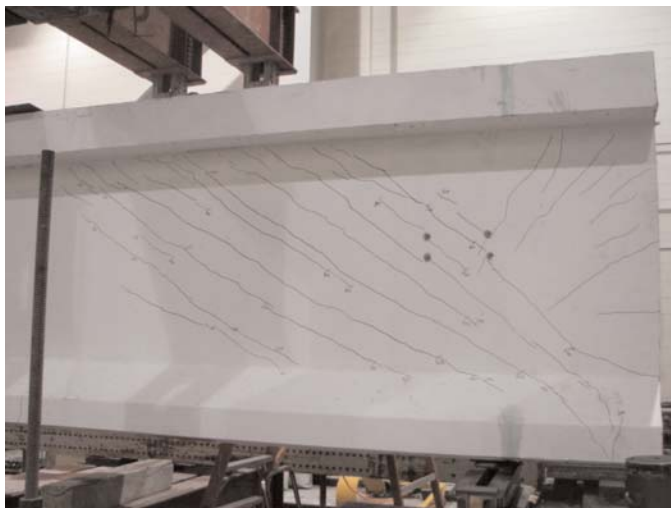
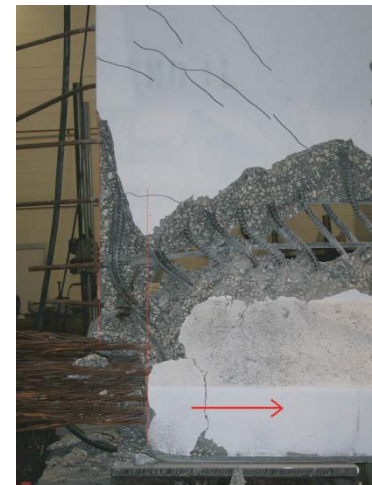
(a) General View

Figure 3.30. Shear cracks on End FL2R after loading was stopped.

(b) Close View Showing Relative Movement of the Bottom Flange

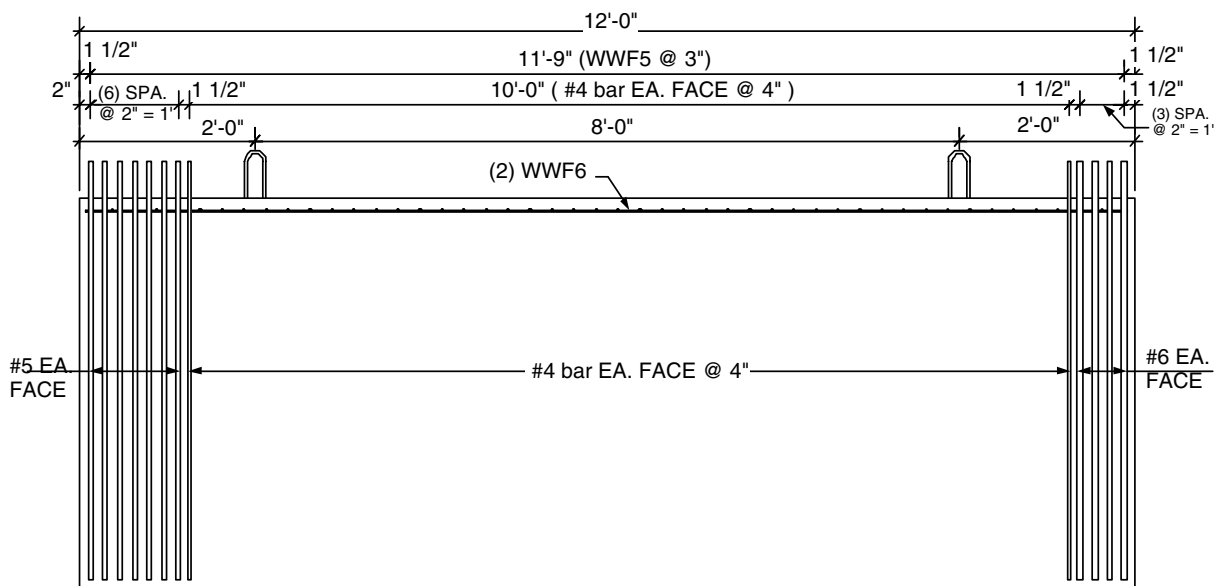
Figure 3.34. Specimen #2: S2L (LRFD), S2R (proposed).

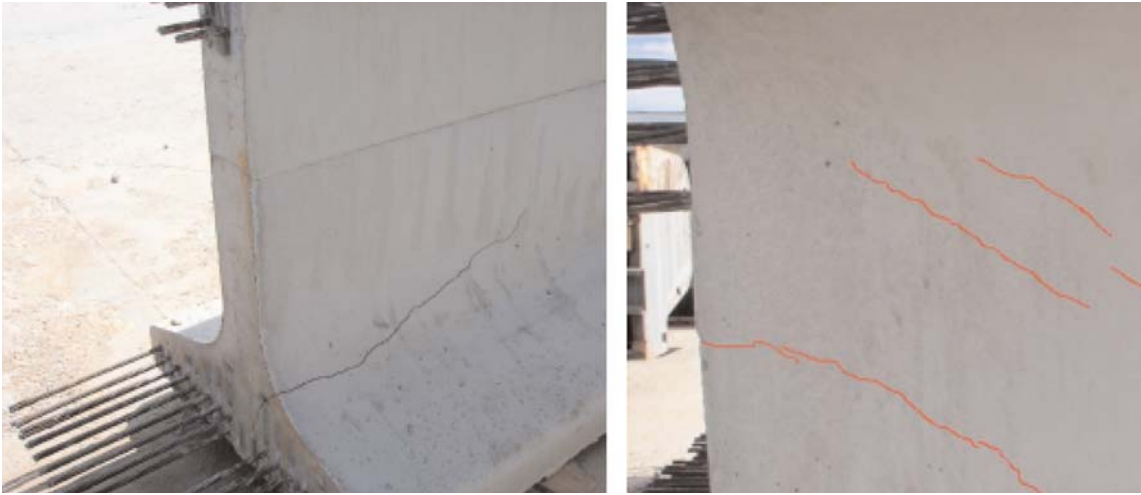
Figure 3.35. Specimen #1 with no special end zone reinforcement (cracks traced for clarity).

Both specimens, as well as the production girders, experienced end zone cracking. Figures 3.35 through 3.37 show the end zone cracks of the test girders. As expected, both ends of the first specimen, S1L and S2R, which had no special end zone

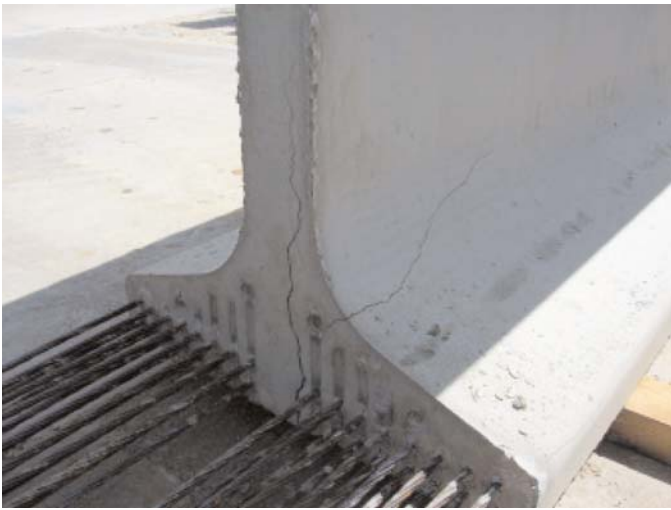
Figure 3.36. Specimen #2: S2L (LRFD).

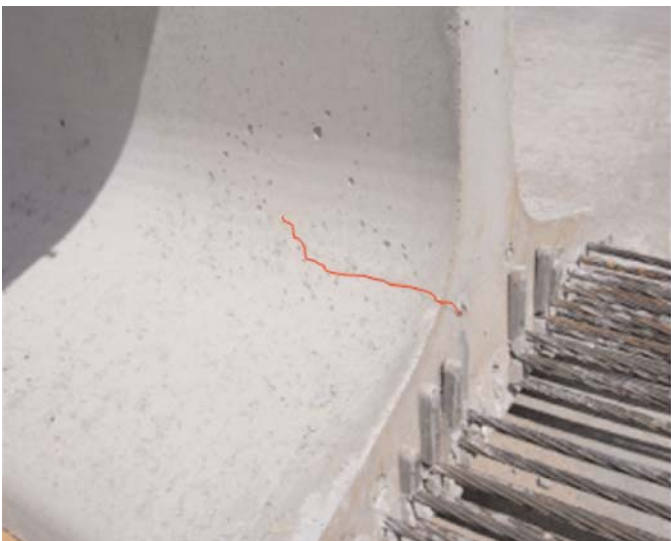
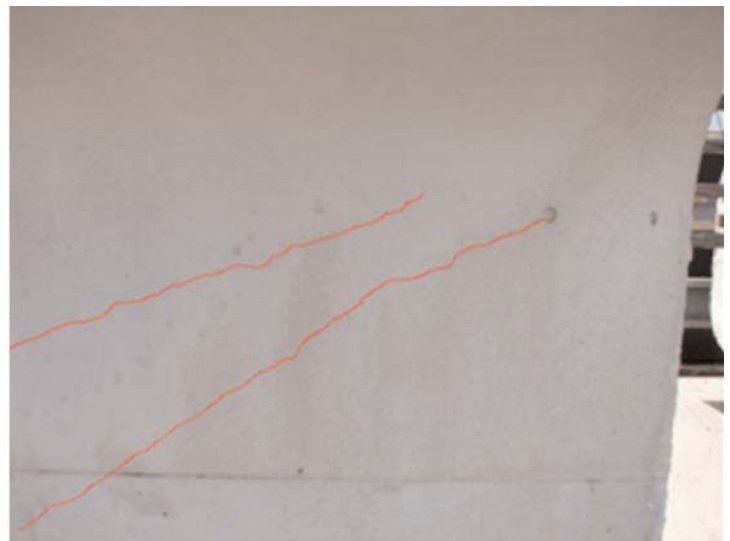
Figure 3.37. Specimen #2: S2R (proposed).

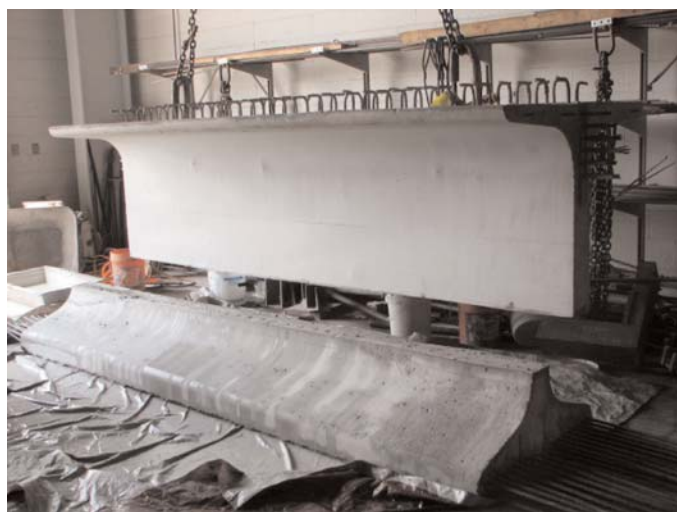
Figure 3.39. Bottom flange completely cut from the specimen.

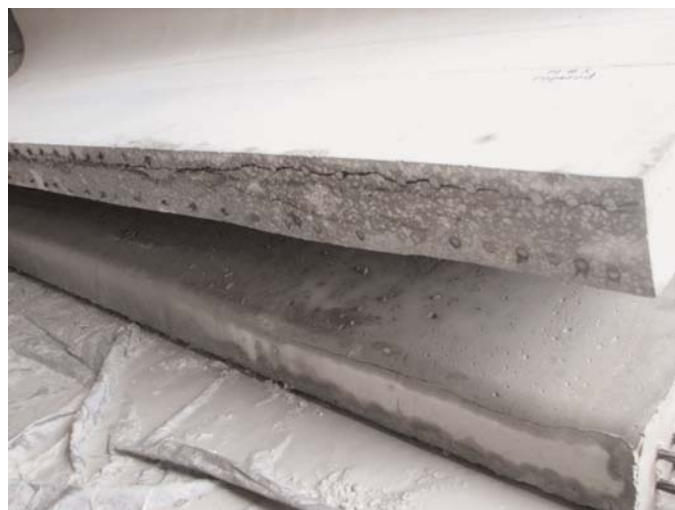
Figure 3.40. End zone cracking extending the full length of the web.

When the beam was cut, the full extent of the interior cracking became visible, as shown in Figure 3.40. Upon inspection, it was clear that the epoxy did not totally fill the cracks as anticipated. From the cut section, the epoxy could only be seen entering approximately 0.2 in. into the crack, as shown in Figures 3.41 and 3.42. Also, visual inspection revealed a lack of adhesion between the concrete and the epoxy.

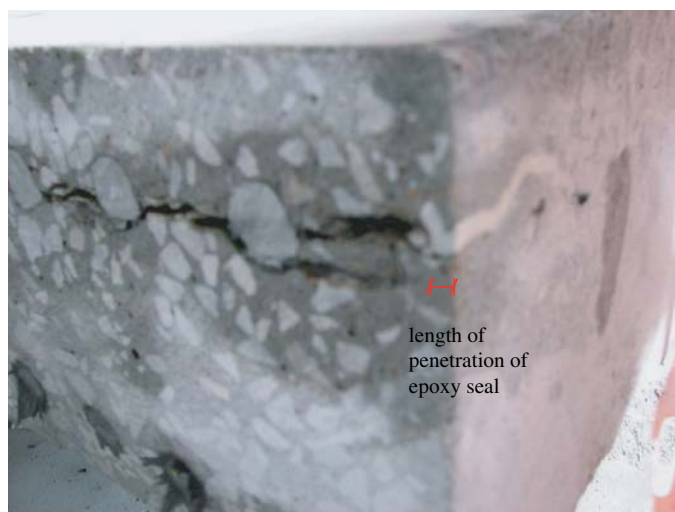
Figure 3.41. End zone cracking extends vertically and horizontally.

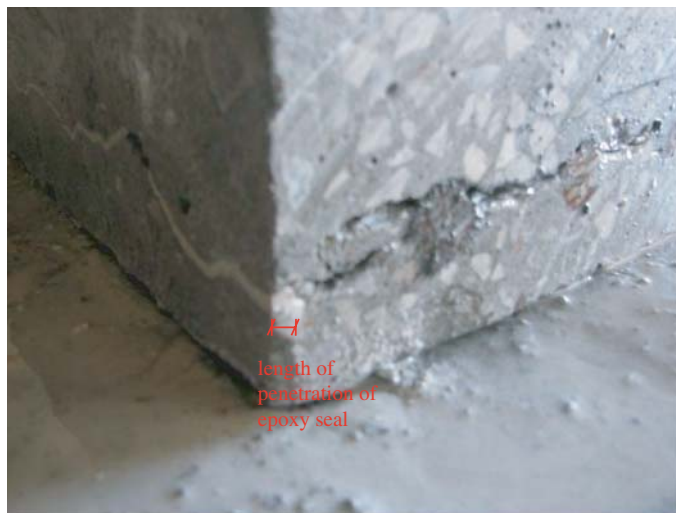
Figure 3.42. Very limited penetration of the epoxy repair.

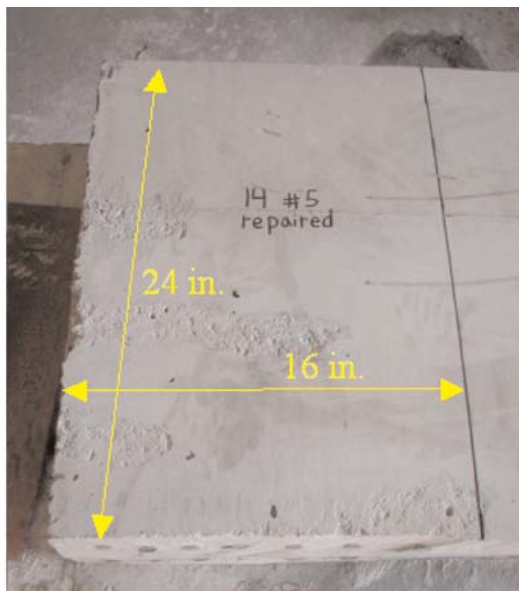
Figure 3.43. The 16-in.-wide strips and test setup.

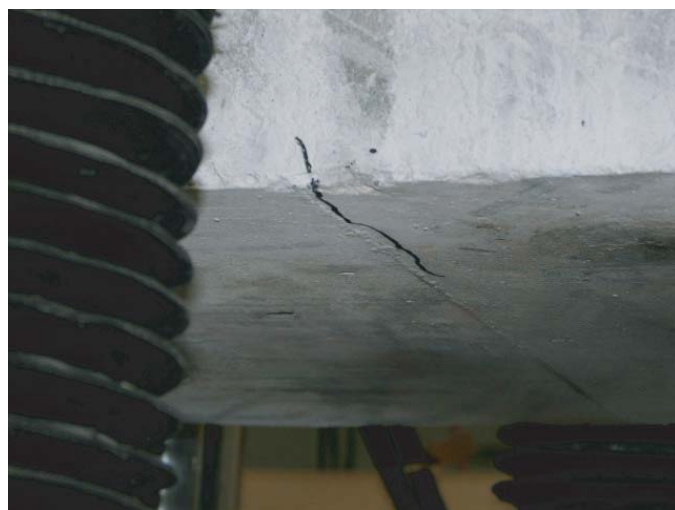
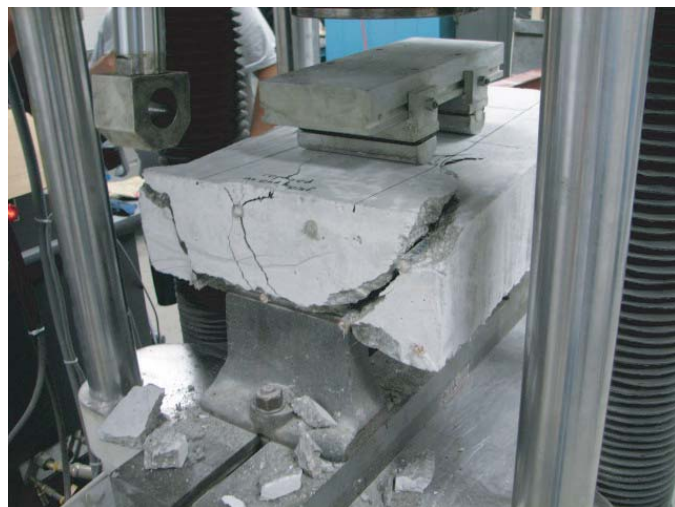
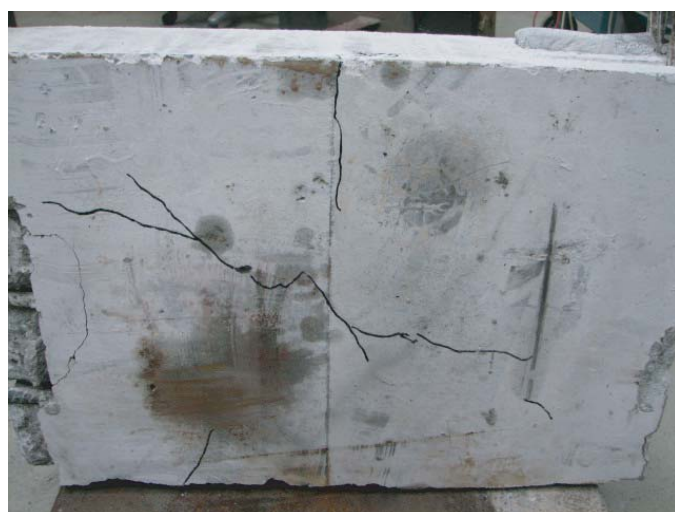
(a) Flexural Cracking

(b) Bearing Failure at the Support

(c) Bottom Surface at Failure

Figure 3.44. Test specimen S1L after failure.

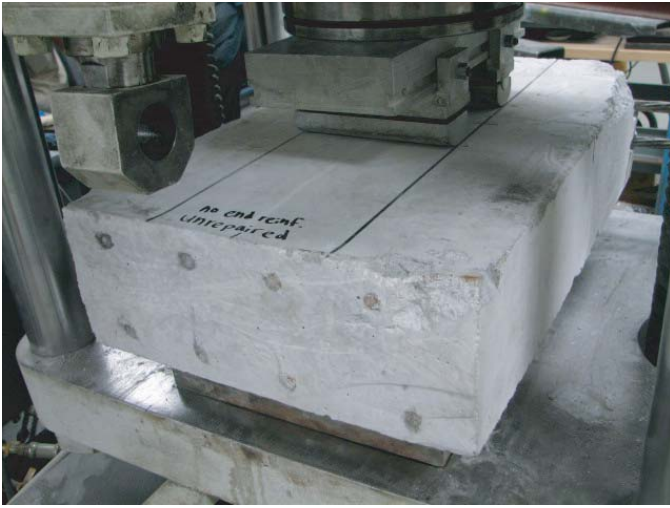
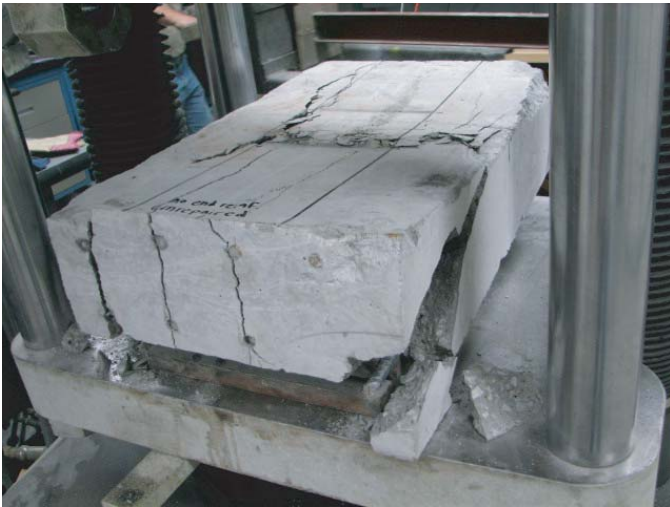
(a) Setup with Wider Bearing Plates

(b) At Failure

Figure 3.45. Specimen S1R before and after testing.

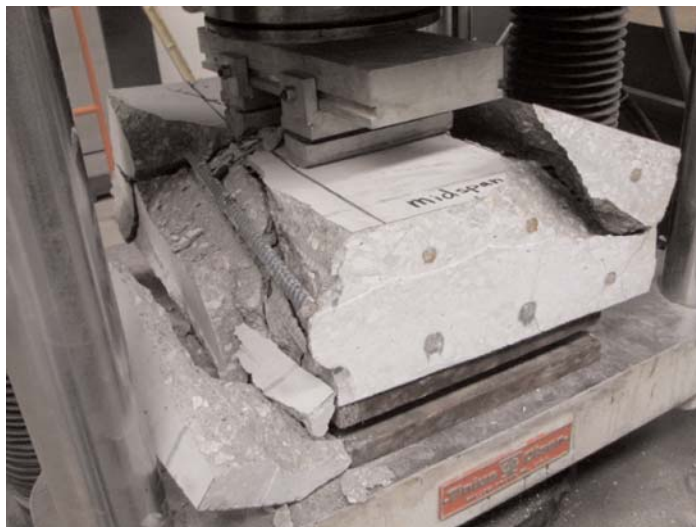
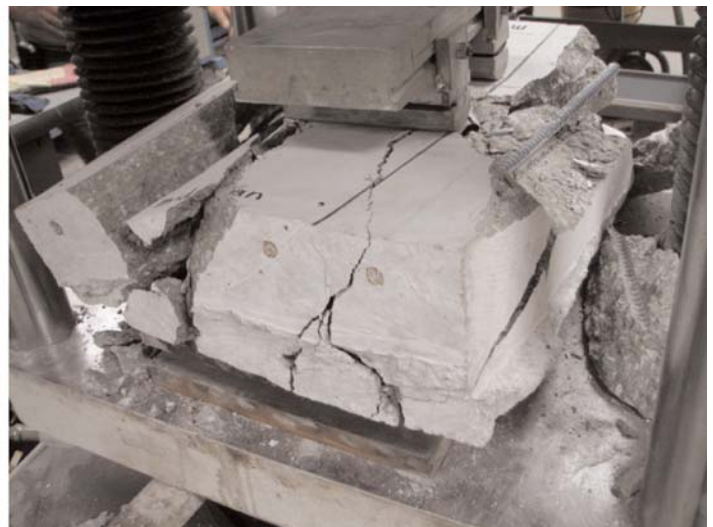
**Figure 3.46. Specimen S1MS after failure.**

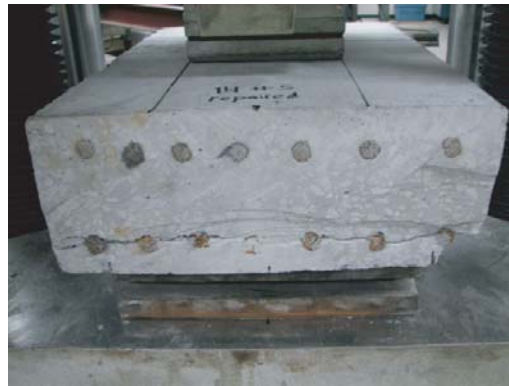
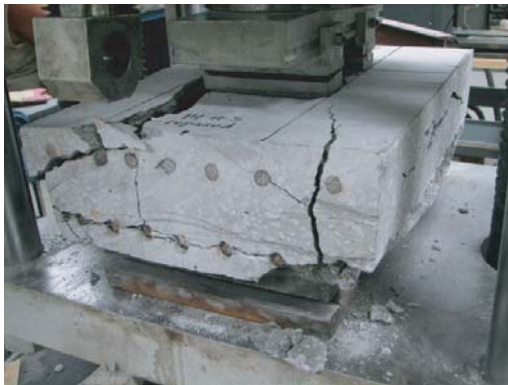
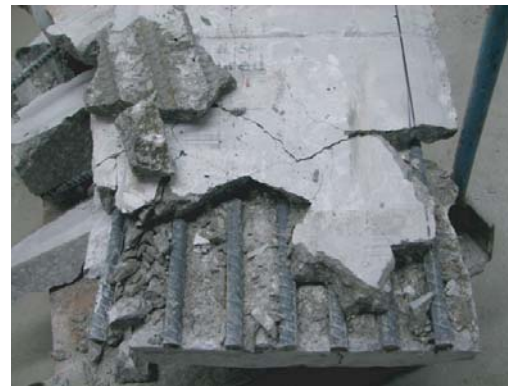
(a) Pre-Existing Crack across Bottom Layer of Reinforcement

(b) View at Bottom Flange Junction

(d) Splitting Occurred Right through Epoxy Injection

(e) Splitting Occurred Right through Pre-Existing Crack at Lower Layer of Reinforcement

Similar to Specimen S1L, this specimen contained a crack along the rebar before testing, as shown in Figure 3.47(a). The specimen failed at 103.4 kips and reached a maximum deflection of 0.260 in. Figures 3.47(b) and (c) show both ends of the specimen after failure. This specimen also split along the direction of the rebars at failure. Figure 3.47(d) shows how the splitting occurred through the epoxy injection. Instead of the concrete failing, the epoxy-crack separated. This shows that the epoxy repair of these specimens did not appear to be effective. The rest of the cracking occurred in the same planes as the pre-existing crack along the rebar, as shown in Figure 3.47(e).

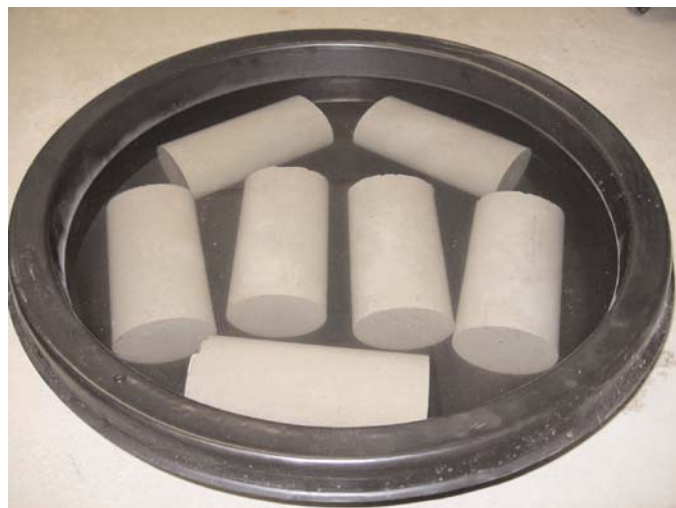
Figure 3.49. Specimens submerged in water.

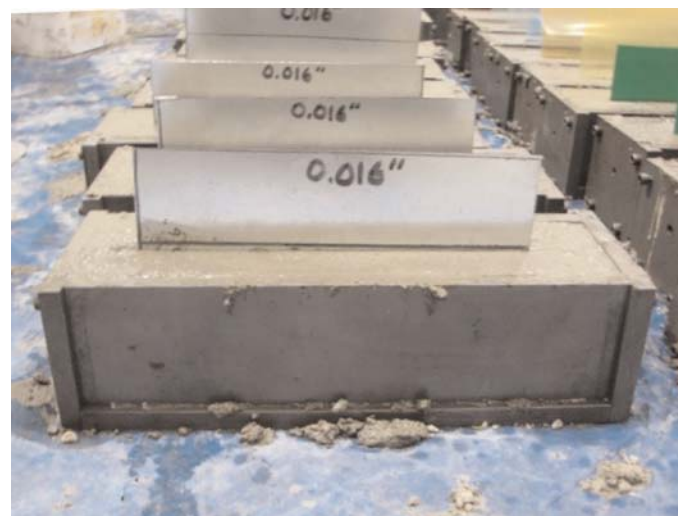
**Figure 3.51. Specimens with metal shims.**

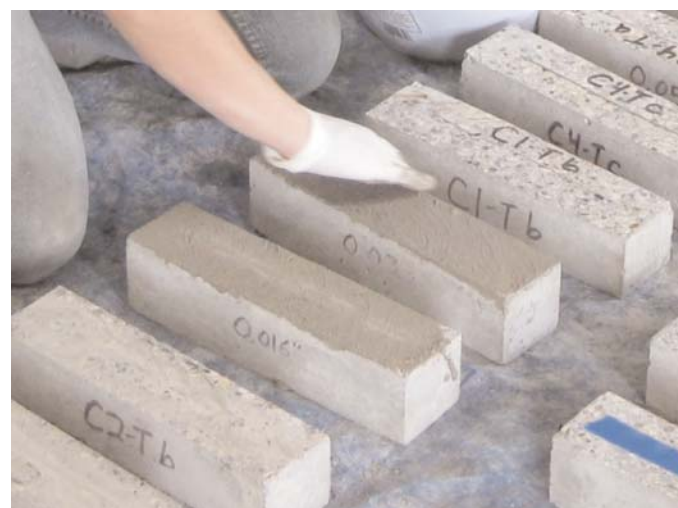
Figure 3.57. Hand application of REM 800.

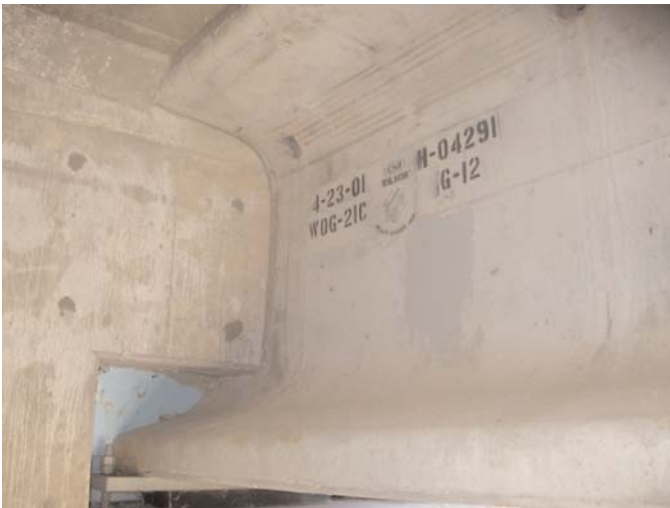
Figure 3.59. Girder showing end block.

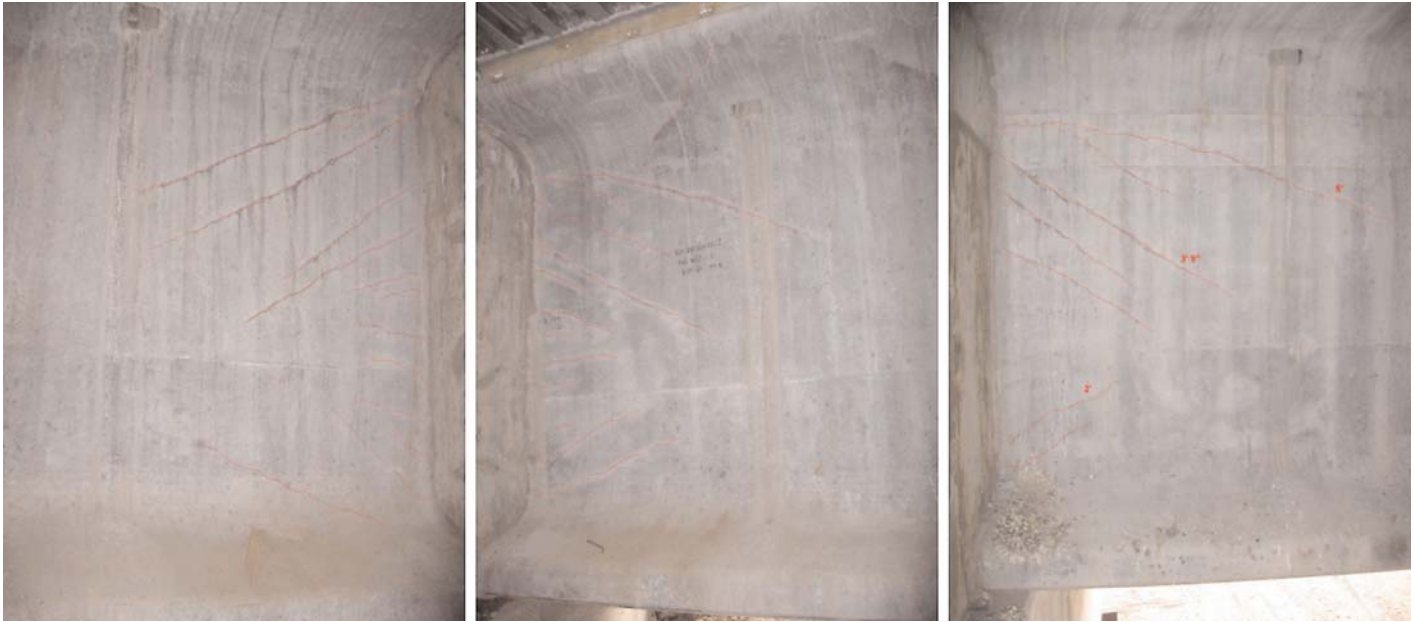
Figure 3.61. End zone cracks on the Platte River Bridge girders.

The cracks shown on the girders in Figure 3.61 are traveling in two distinct directions. Near the top portion of the web, the cracks are traveling diagonally downward. Near the bottom portion of the web, the cracks are traveling diagonally upward. The top section of cracks was caused by the prestressing force of strands in the bottom flange. Likewise, the collection of cracks on the bottom was caused by the prestressing strands

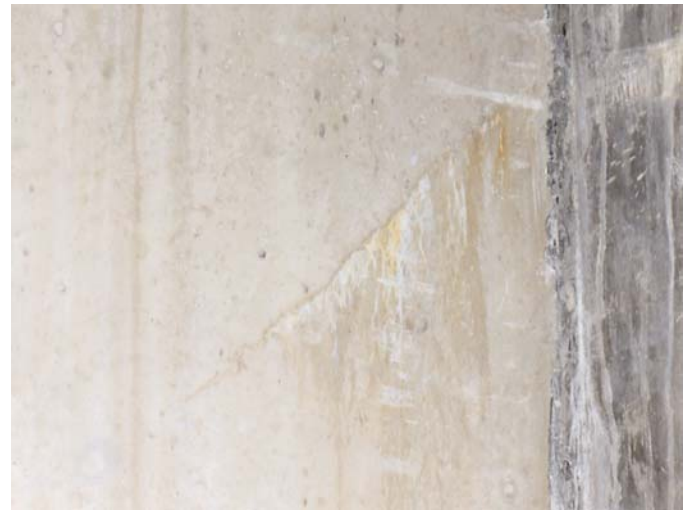
Figure 3.65. Web end zone cracking (0.009 in.) showing some efflorescence, no delamination, and some signs of corrosion.

Efflorescence could be seen around some of these cracks. The inspection engineer stated that the efflorescence was reported at the time when the bridge was opened to traffic in 2006 and, based on his experience, the amount of efflorescence did not increase with time. No signs of reinforcement corrosion were reported, except in one girder in one of the spans of the eastbound approach, as shown in Figure 3.65. No delamination was reported in the girders that were inspected.

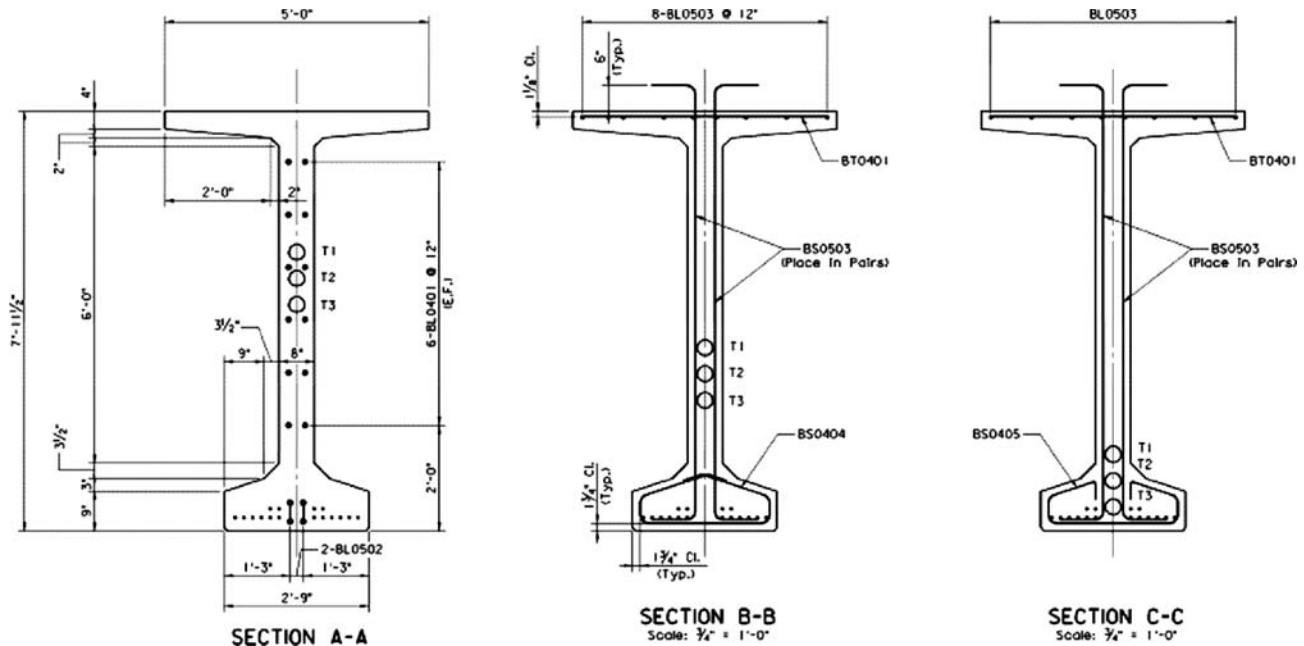
Figure 3.68. Girder details of the spans over the Pamunkey River.
