NCHRP REPORT 654

**Evaluation and Repair Procedures
for Precast/Prestressed Concrete Girders
with Longitudinal Cracking in the Web**

Research sponsored by the American Association of State Highway and Transportation Officials
in cooperation with the Federal Highway Administration

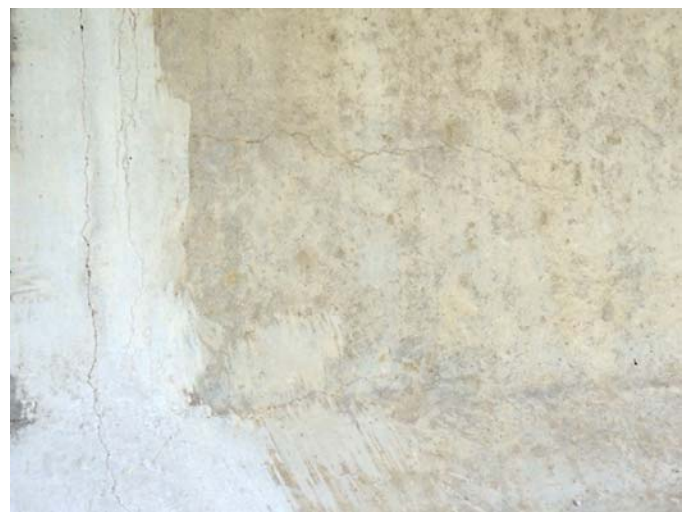
Figure 3.69. Web end zone cracking (0.008 in.) showing no efflorescence, no delamination, no signs of corrosion.

It was evident that efflorescence exists on about 75% of the cracks. Upon inspection, the concrete at the crack and in its vicinity looked very sound with no signs of delamination or reinforcement corrosion. The size of the crack ranges from 0.006 to about 0.009 in., with the majority of the cracks

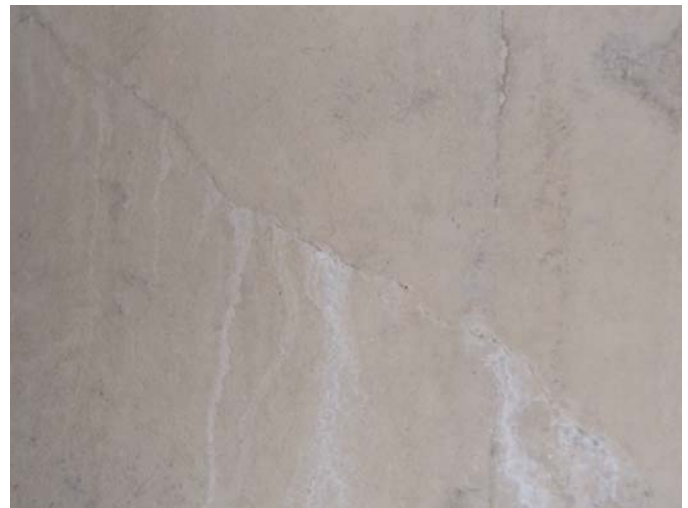
Figure 3.72. End zone crack, Span 5, left side, exterior girder, 0.006 to 0.008 in. wide, with efflorescence, no delamination, no reinforcement corrosion.
