## Real-Time Smoothness Measurements on Portland Cement Concrete Pavements During Construction

**SHRP 2 REPORT S2-R06E-RR-1**

# Real-Time Smoothness Measurements on Portland Cement Concrete Pavements During Construction

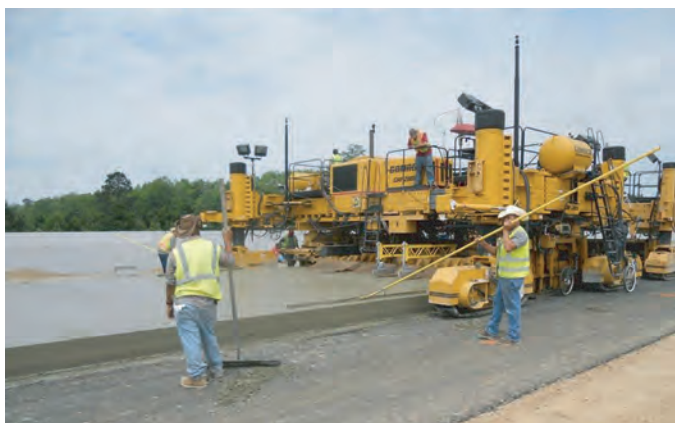
**Figure 2.13. Note-taking station: behind the paver.**

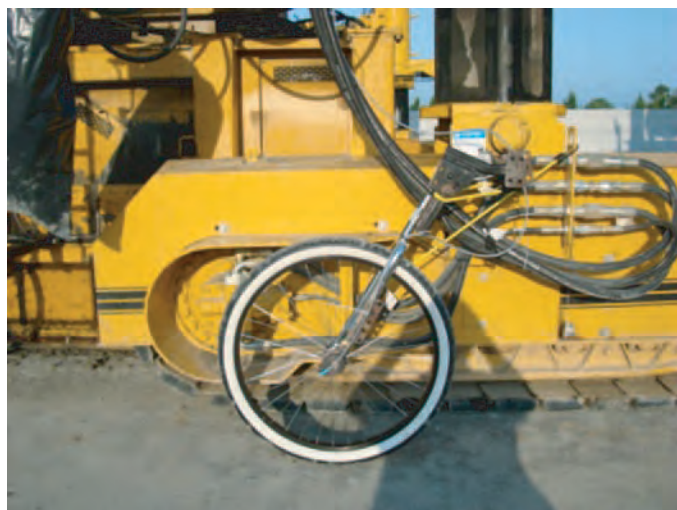
**Figure 2.23.** Fifth wheel mounted to the paver.

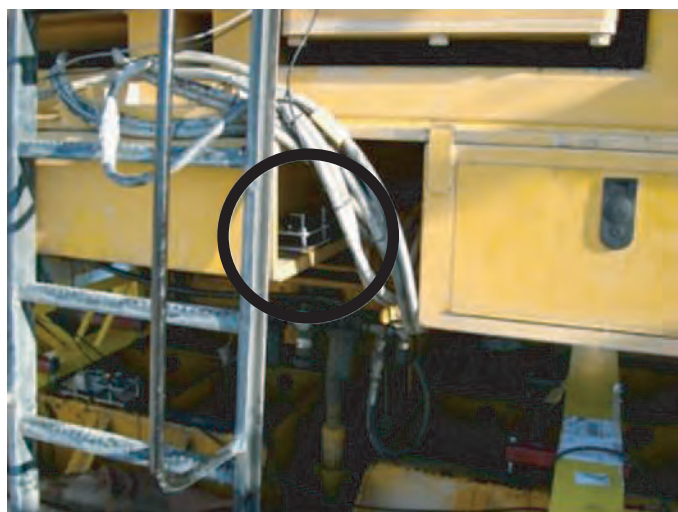
**Figure 2.26. IMU sensor above the finishing pan on the paver.**

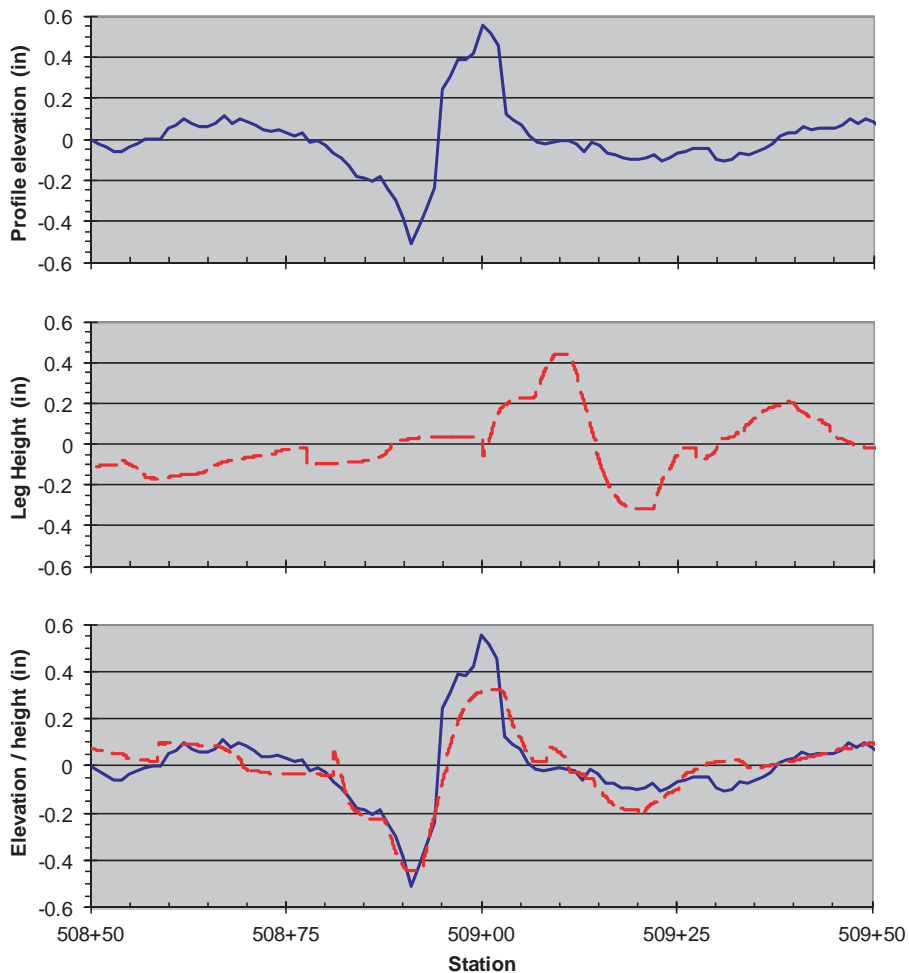
**Figure 2.28. Track line bump via the Dipstick profile, right rear leg height, and combined (after adjustments).**

The middle graph of Figure 2.28 shows the response of the right rear leg as measured by the draw wire sensor while the paver traverses the same bump. The graph shows the leg lifts up 0.45 in. by Station 509+10 and then retracts to -0.3 in. by Station 509+20. It must be noted, however, in this graph, that the  $x$ -axis is calibrated to the station corresponding to the location of the fifth wheel which, on Day 2, was mounted about 19 ft ahead of the rear leg.

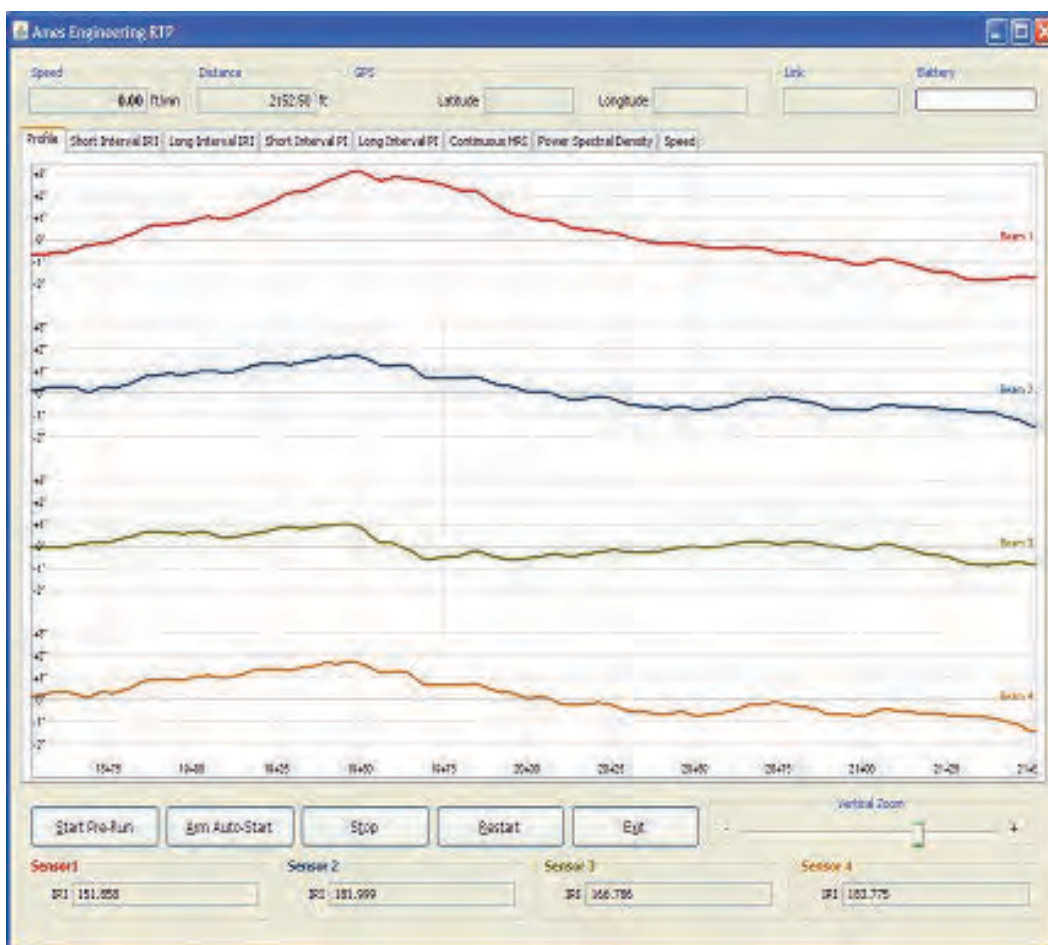
**Figure 2.37.** Ames Engineering RTP analysis software.

Figure 2.37 provides a screen capture of the Ames Engineering RTP operating in a postprocessing mode. (This screen

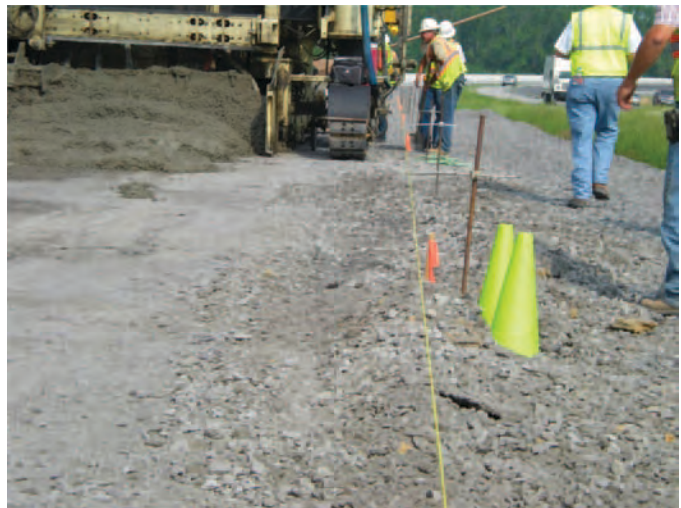
**Figure 2.42. Paver track line deviation resulting from unstable subgrade conditions.**

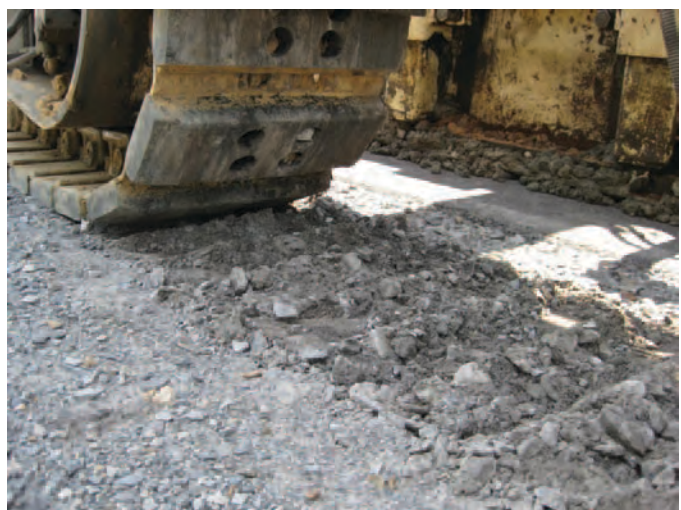
**Figure 2.43. Soft material in paver track line at location of localized roughness.**

One location of interest was indicated by localized roughness at Station 358+00. It was found that at this location, there was a splice in the string line, and it is possible that some survey error, or disturbance of the string line at this location, yielded

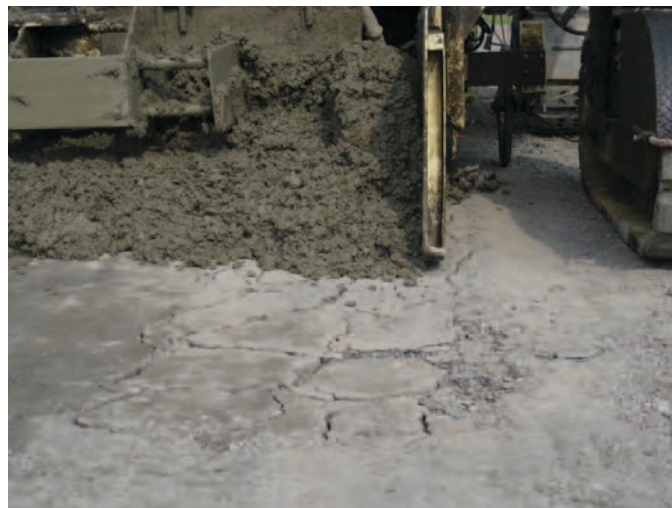
**Figure 2.45. Failure in HMA interlayer at location of localized roughness.**

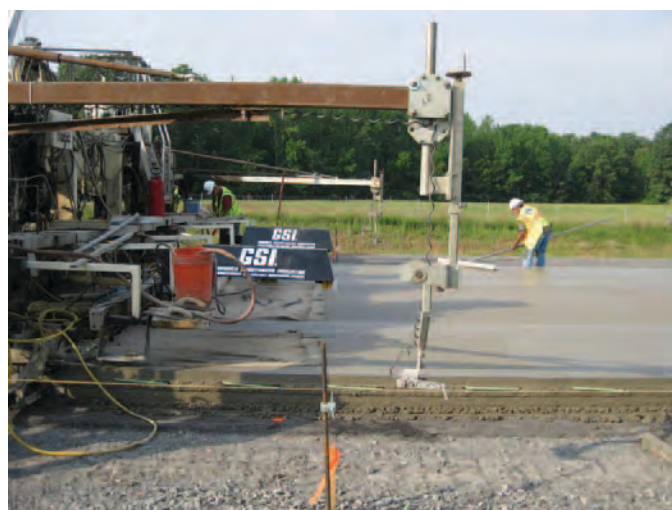
**Figure 2.46. Paver-mounted GSI setup.**

The dowel bar inserter on the paver used an OCB to finish the pavement after the dowels were inserted. The OCB caused significant movement of the real-time system measurement equipment when mounted to the paver (see Figure 2.46). In an effort to minimize the effect of the OCB, the GSI equipment was mounted to a work bridge towed by the paver as shown in Figure 2.47. Although not evaluated by the research team, observations by IHC led to the conclusion that this alternative mounting arrangement performed similarly to the original paver mount setup.

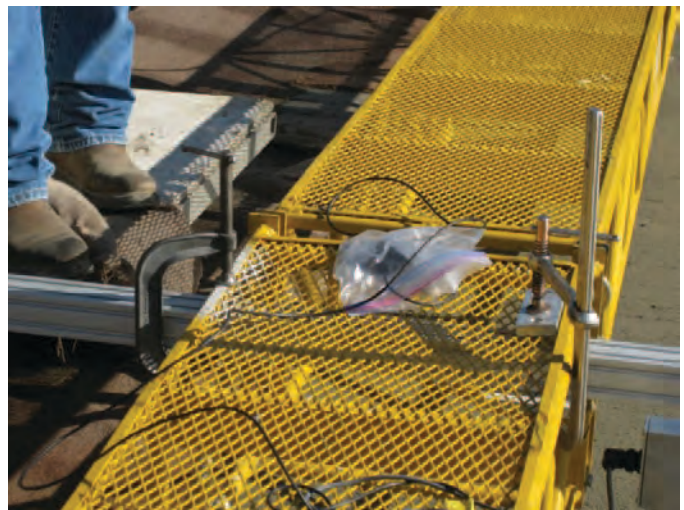
**Figure 2.56. Inertia-Link mounted to the profiler bridge.**

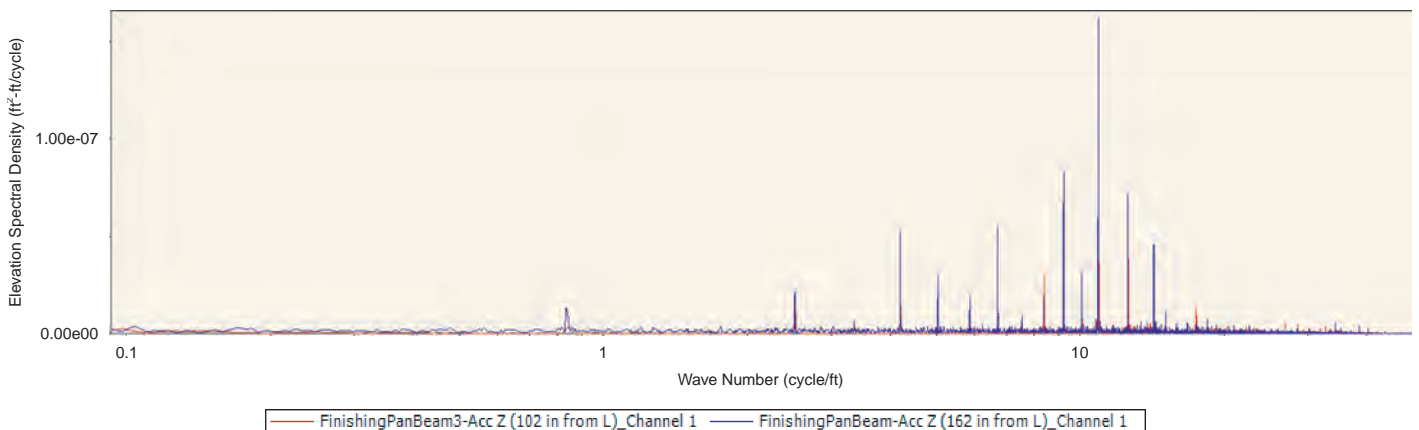
**Figure 2.60. Spectral analysis of vertical accelerometer data at two different locations along finishing pan beam (MI-1 and MI-2).**

Analyzing the frequency content of the signals is very straightforward using the ProVAL PSD analysis. Figure 2.60 illustrates the PSD of the two samples collected along the finishing beam, which are the same signals shown in Figure 2.57. As can be seen from the frequency analysis, there are distinct frequencies that are present in the signal. Most of these peaks fall within the 4- to 15-Hz range and are identical for the

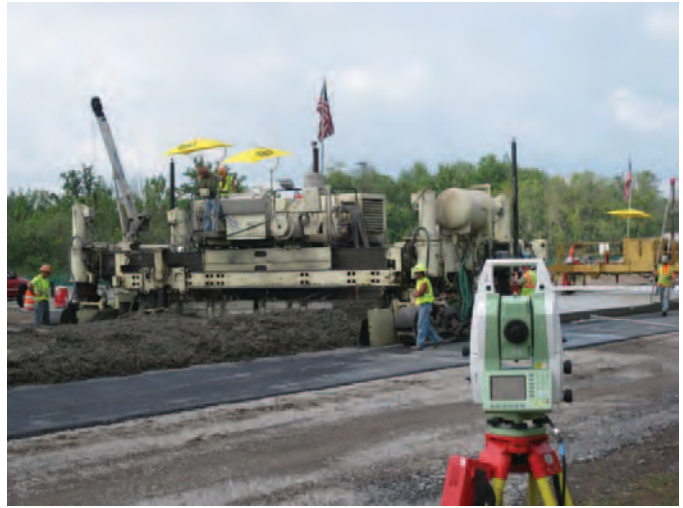
**Figure 2.68.** Stringless guidance system used on New York paving project.

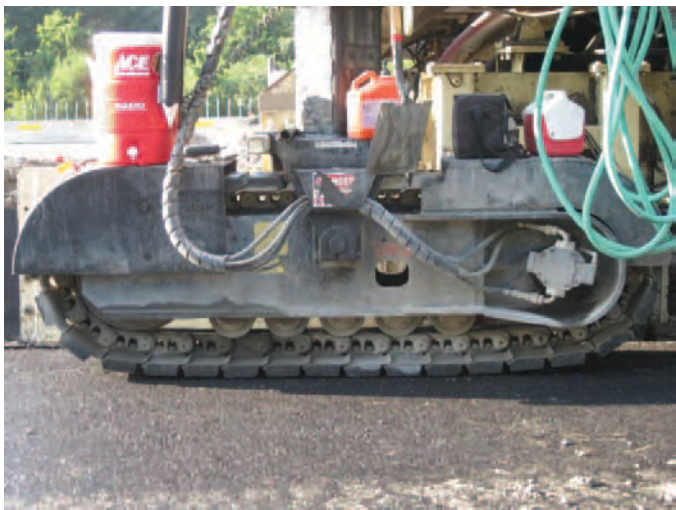
**Figure 2.67.** Length of paver track is a possible explanation of a repeating feature in New York profiles.

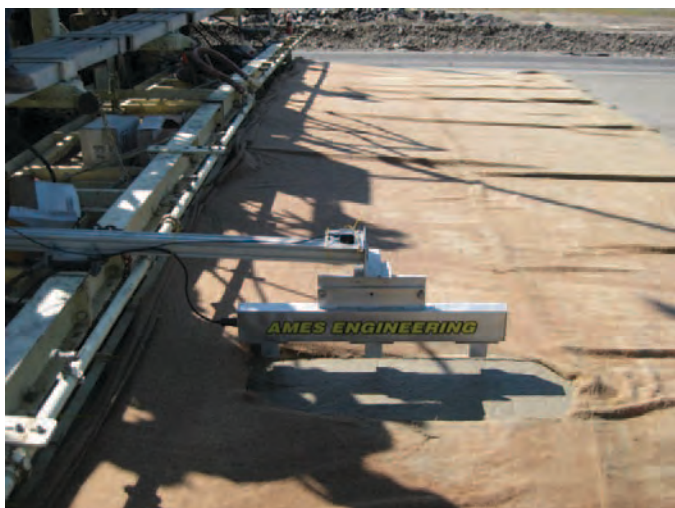
**Figure 2.70. Location of Inertia-Link sensor on paver-mounted Ames Engineering RTP without dowels.**

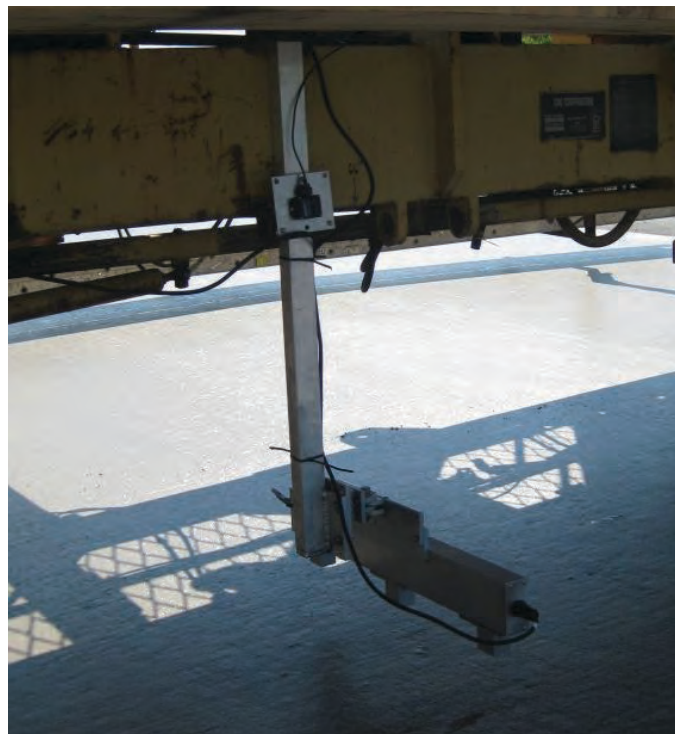
**Figure 2.71. Location of Inertia-Link sensor on bridge-mounted Ames Engineering RTP.**

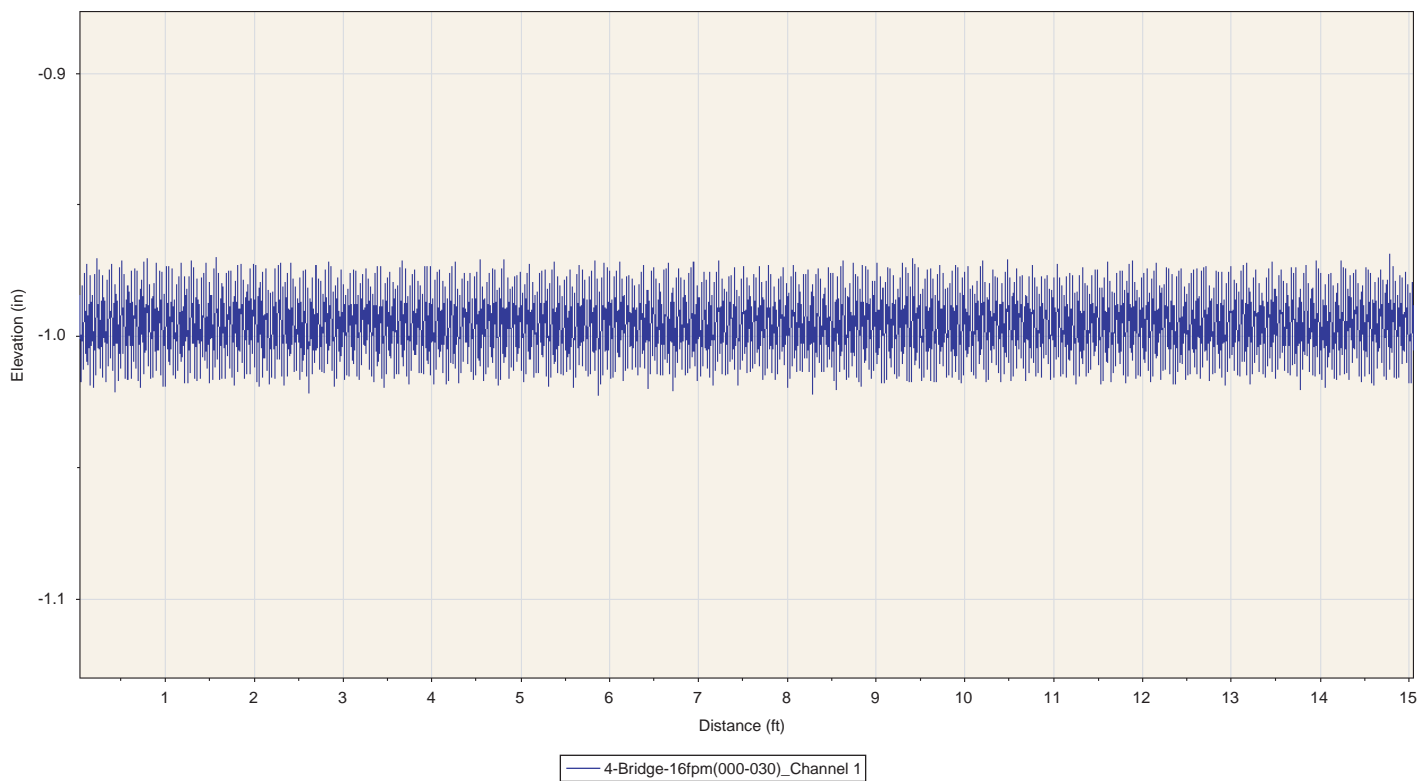
**Figure 2.76. Sample of vertical acceleration data from the bridge moving at 16 fpm (NY-6).**

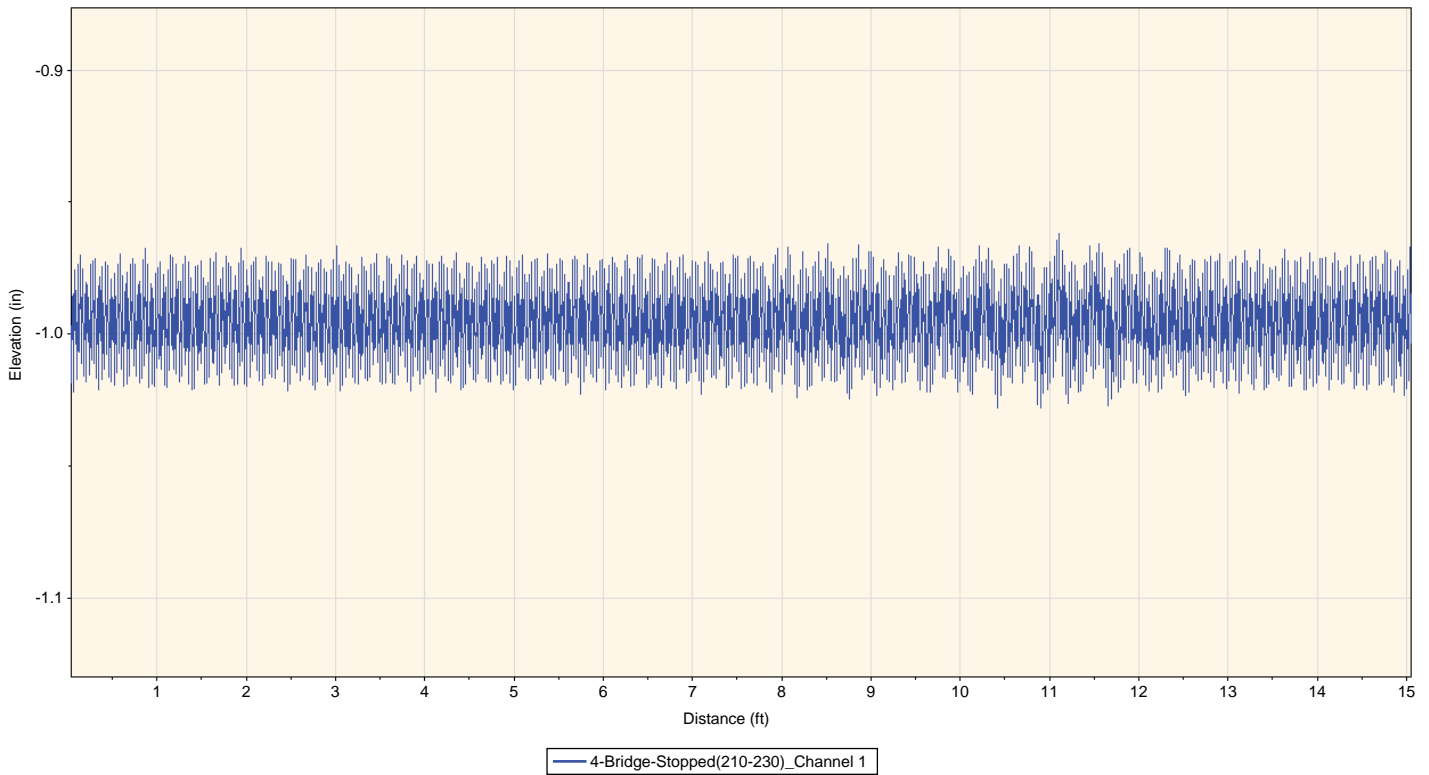
**Figure 2.78. Sample of vertical acceleration data from the stationary bridge (no forward motion) (NY-8).**

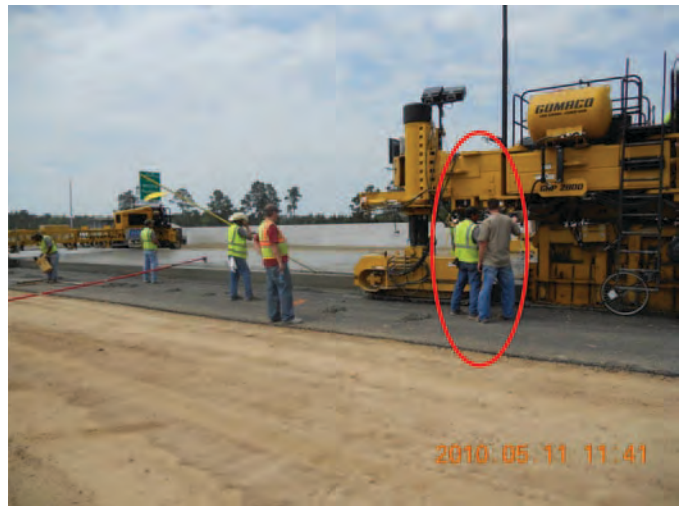
**Figure 4.1. Paving superintendent interacting with the GSI display on the side of the paver.**

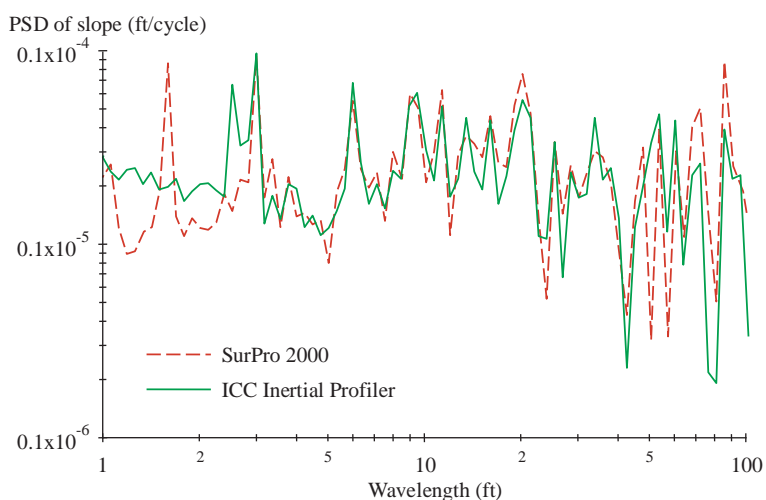
**Figure B.4. PSD (Georgia DOT ICC Inertial Profiler and SurPRO 2000).**

- The ICC inertial profiler measured longitudinal distance that was about 2% shorter than the SurPRO 2000. The analysis sought the optimal adjustment to longitudinal distance before calculating an accuracy score.
- Accuracy and repeatability in the long waveband were below the level that was expected. This is most likely caused by the relatively slow (25 to 30 mph) speed of operation of the profiler.
- Through most of the range that affects the IRI, agreement in spectral content between the ICC inertial profiler and the SurPRO 2000 was good, as shown in Figure B.4. The

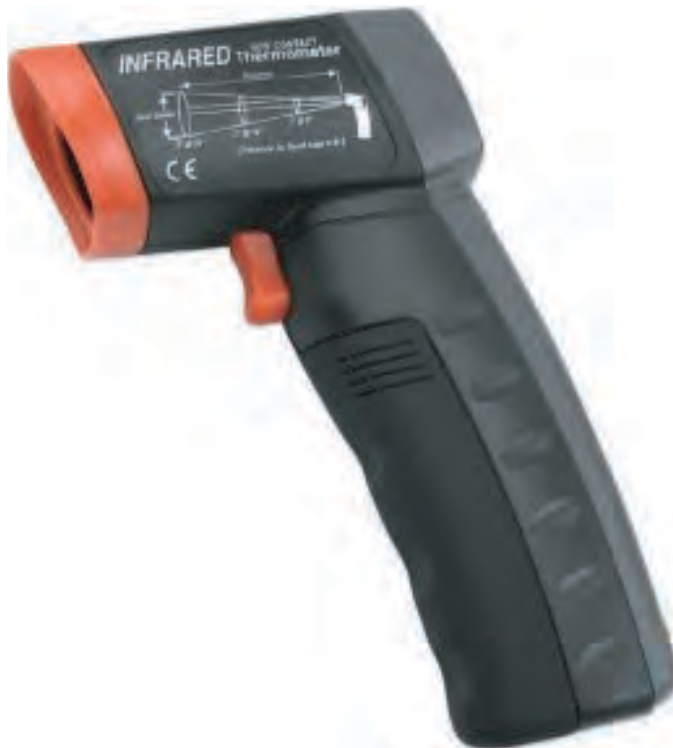
**Figure C.3. Noncontact infrared thermometer for pavement surface temperatures. The manufacturer is Neiko.**

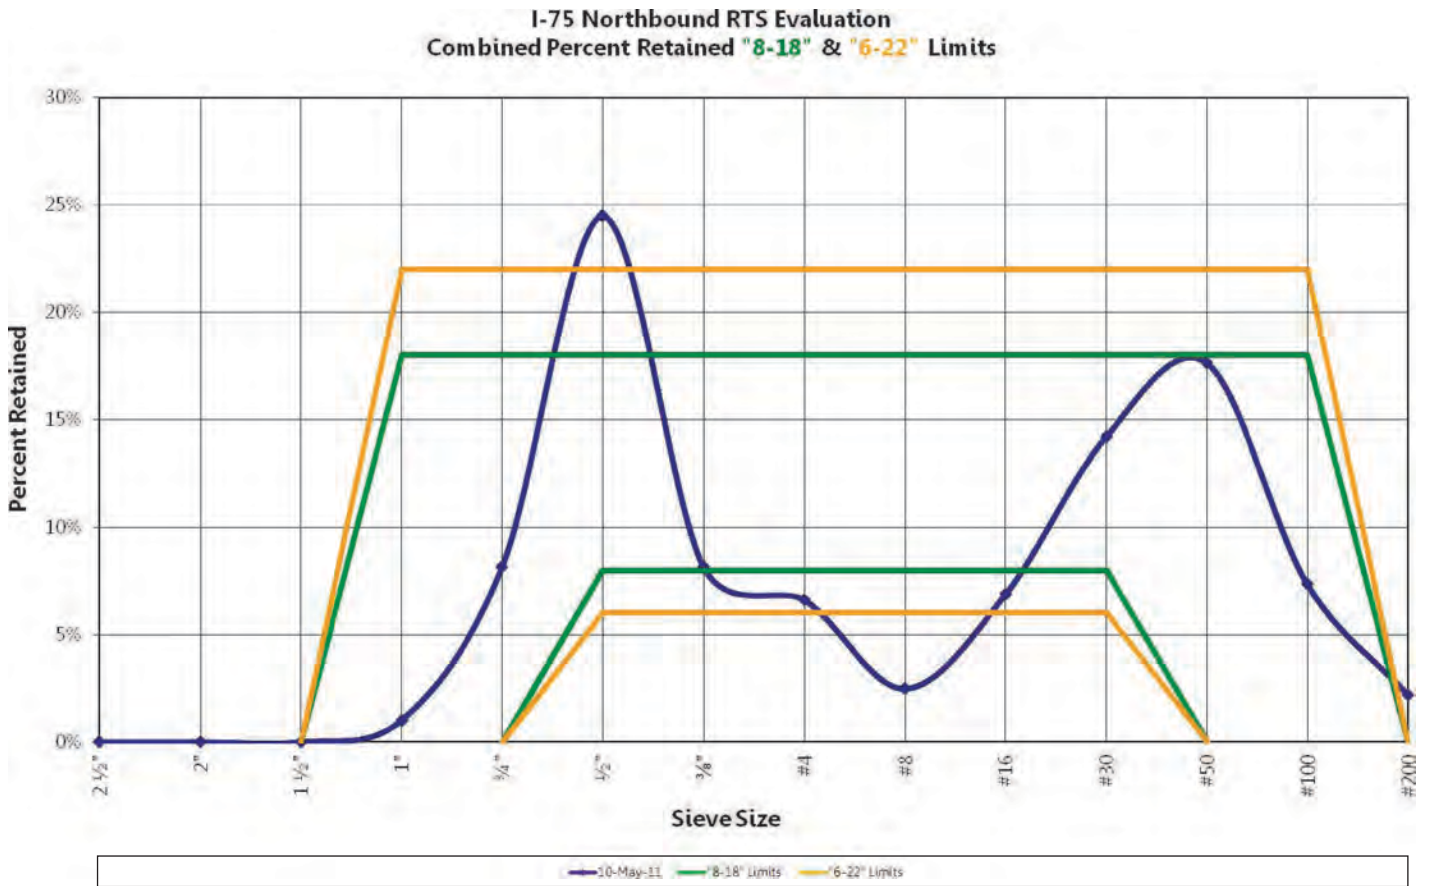
Figure C.7. Gradation as combined percent retained on individual sieves.

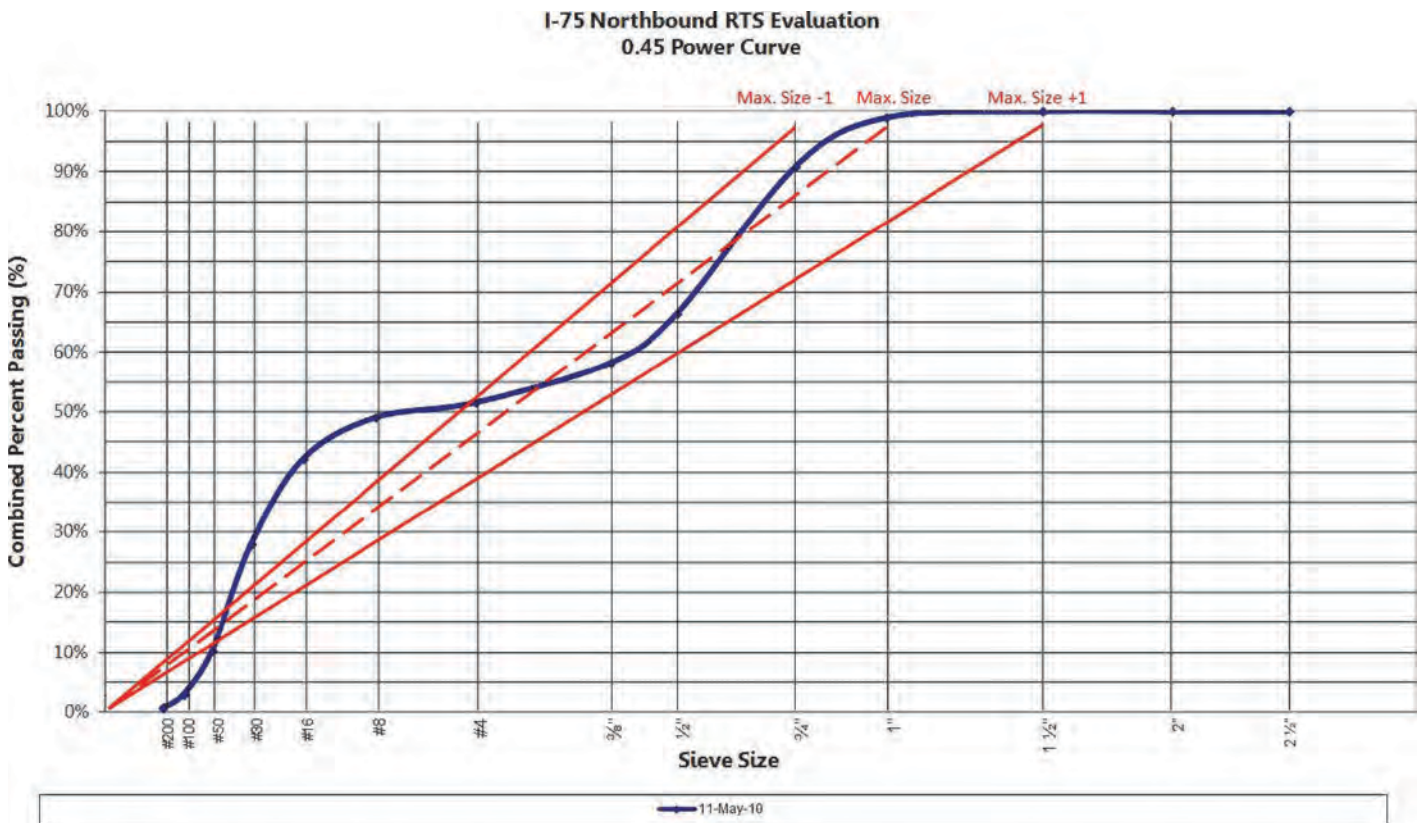
Figure C.8. Gradation on a 0.45 power curve.

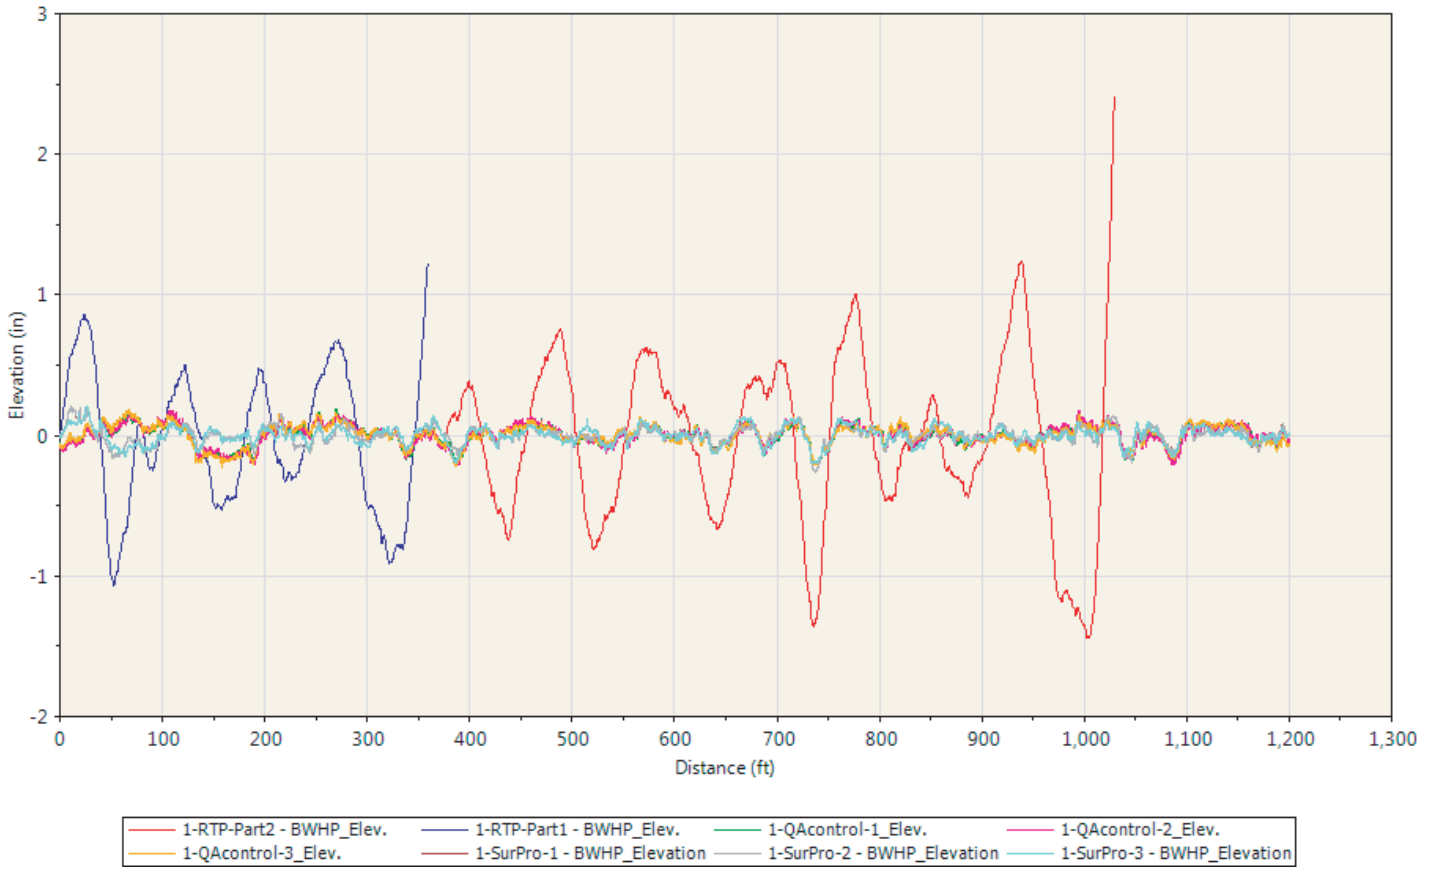
**Figure E.1. Profile elevations Path 1 (real time = RTP and hardened concrete).**

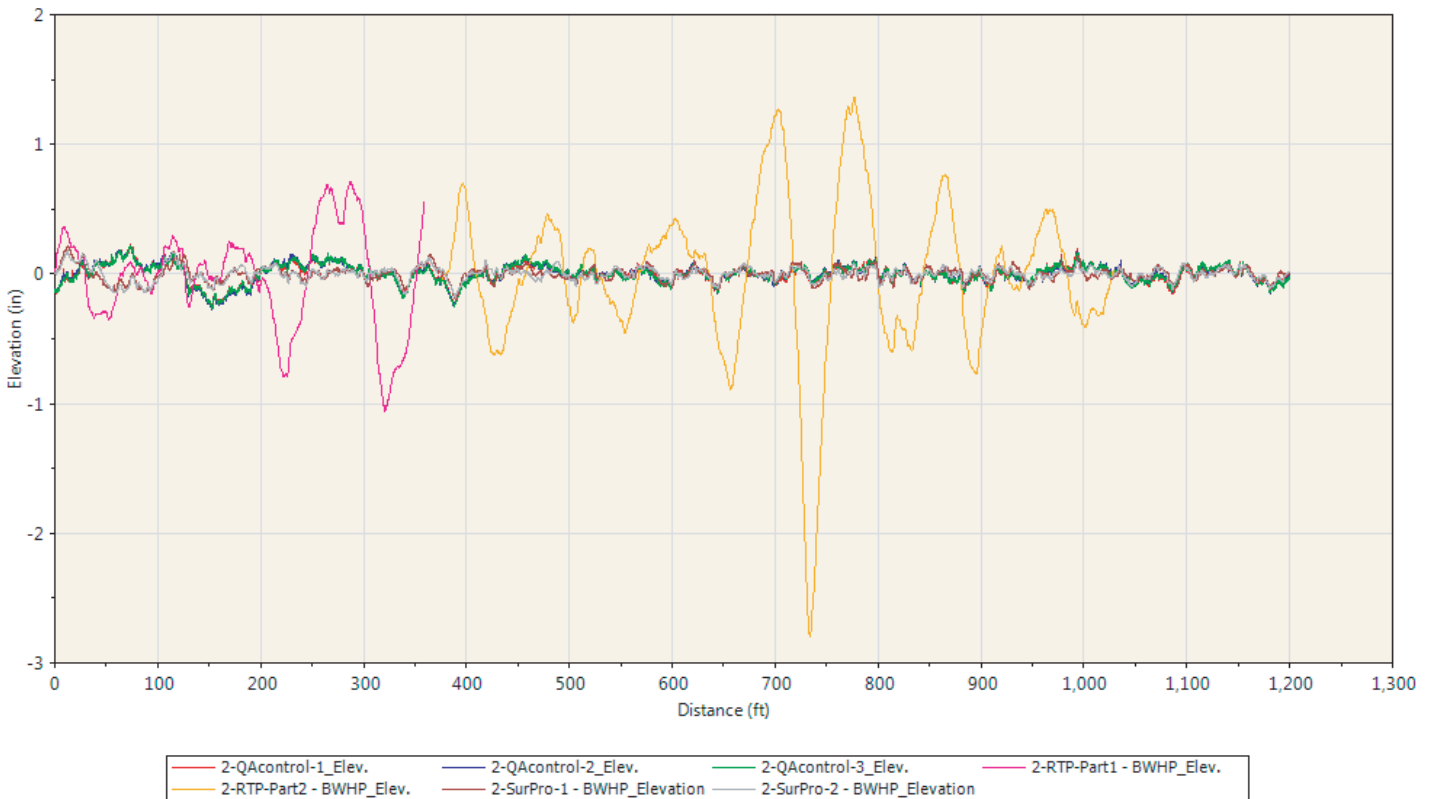
**Figure E.6. Profile elevations Path 2 (real time = RTP and hardened concrete).**

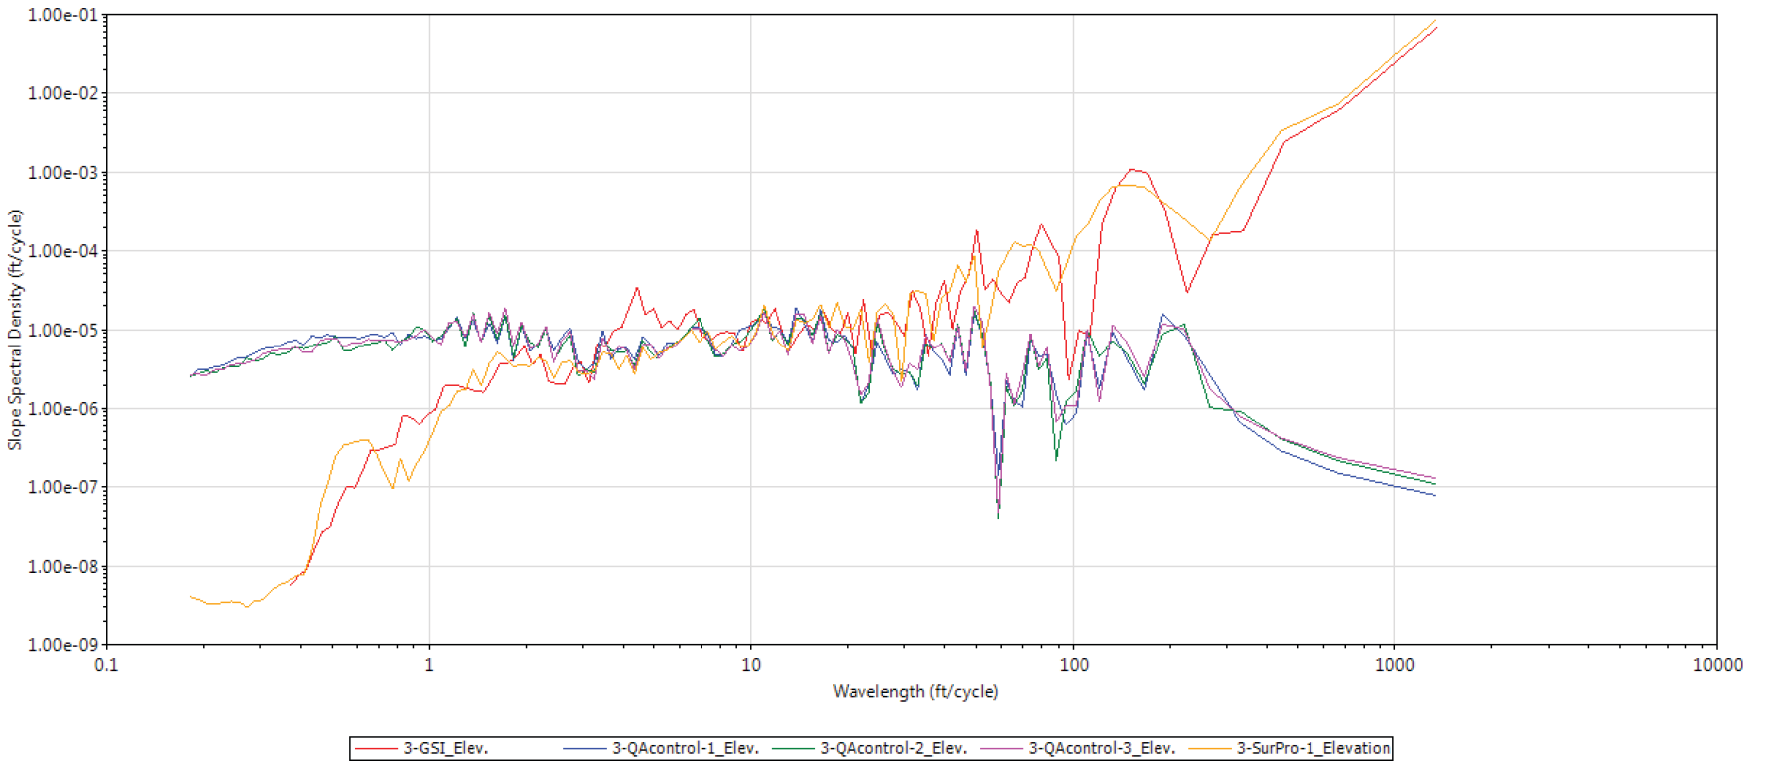
Figure E.15. Path 3 PSD, log scale.

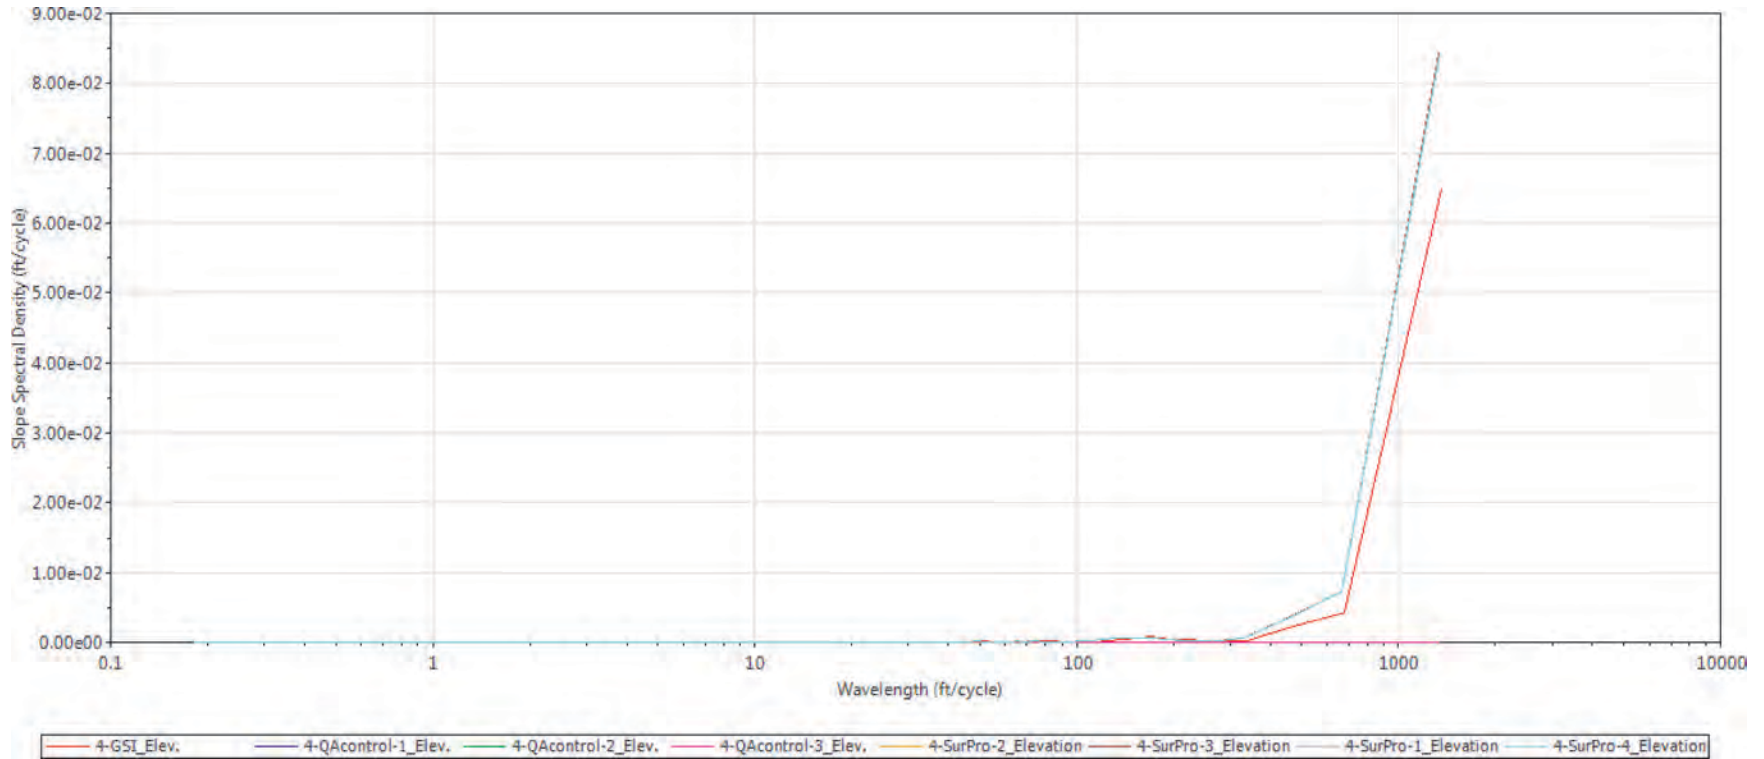
Figure E.19. Path 4 PSD.

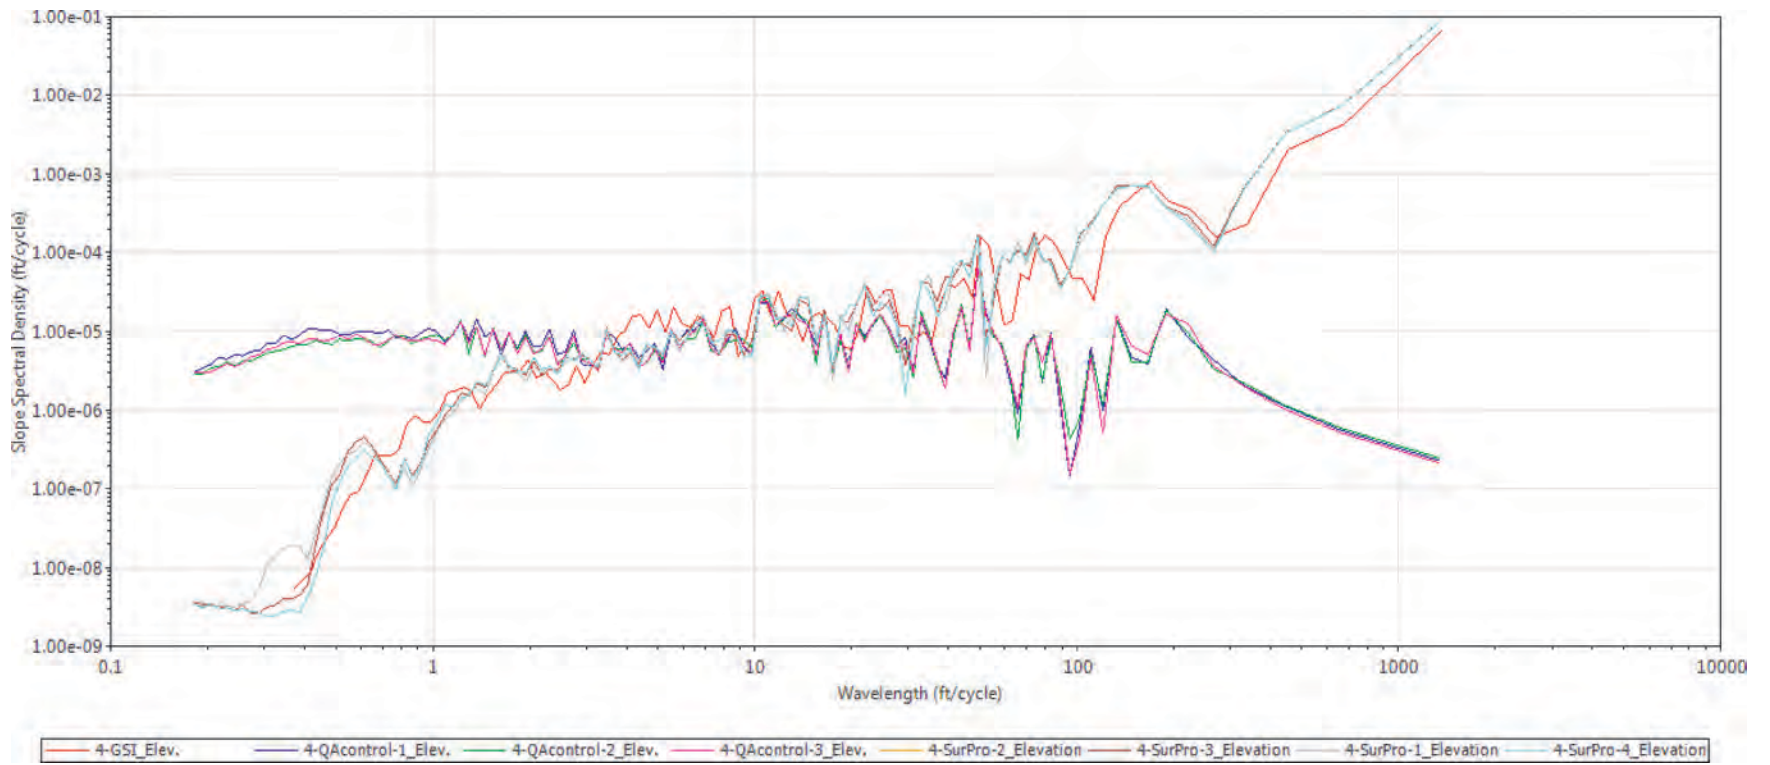
Figure E.20. Path 4 PSD, log scale.

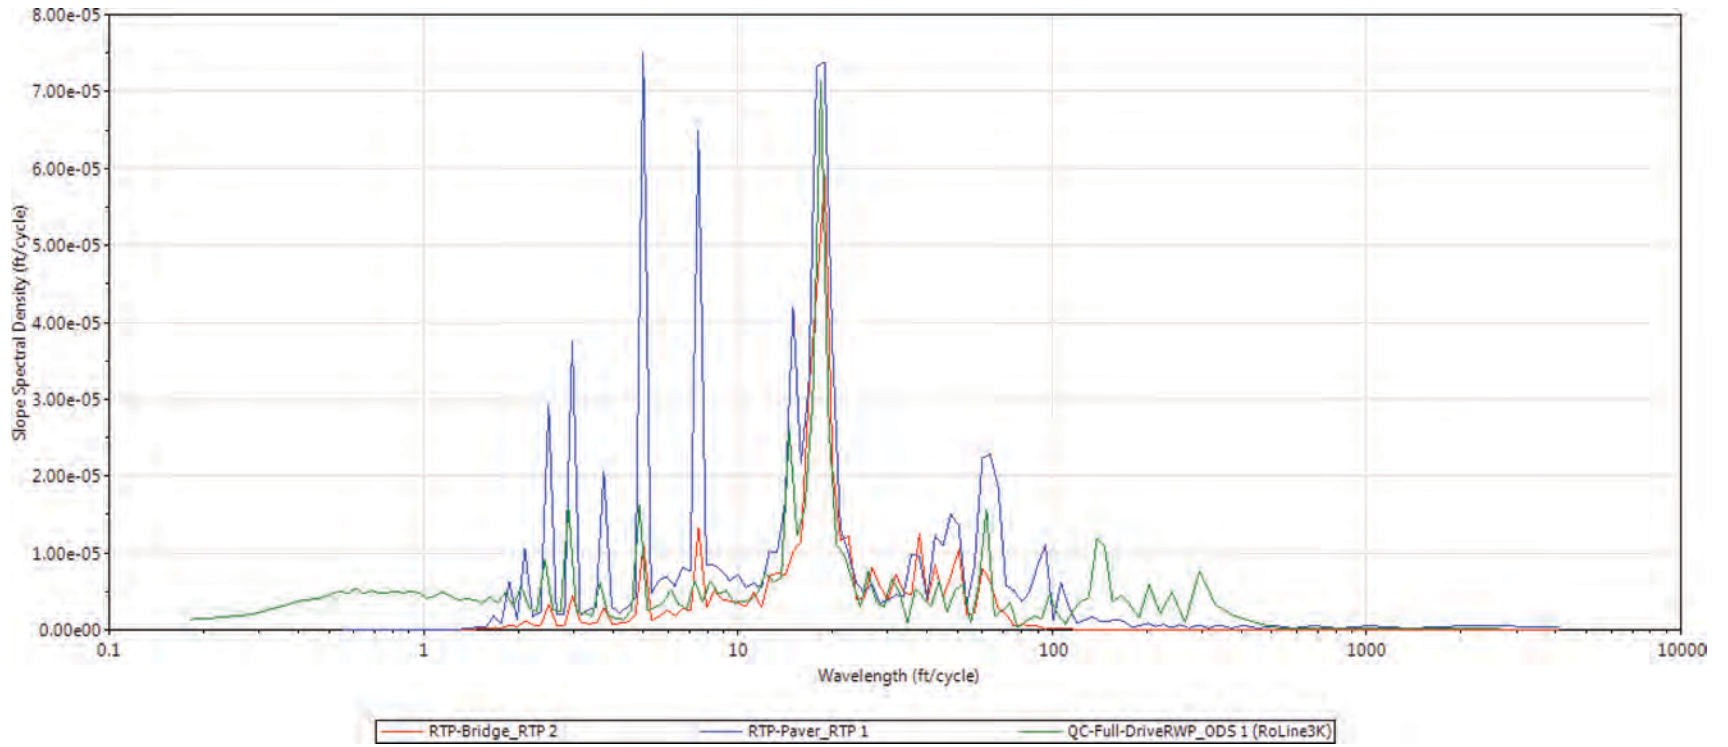
Figure F.4. Right wheelpath PSD.

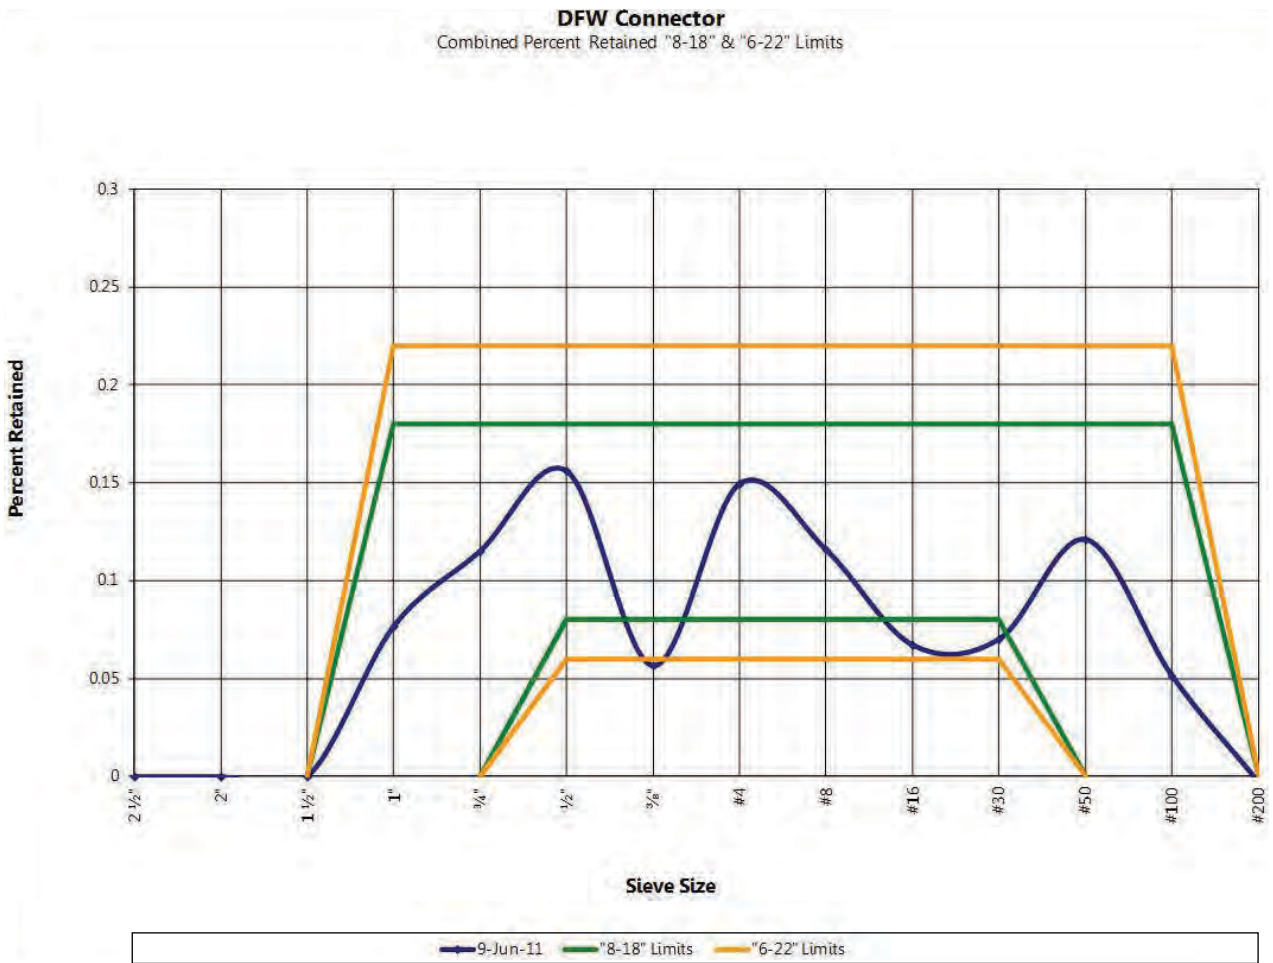
**Figure G.12. Combined percent retained on individual sieves for Texas site.**
