## Real-Time Smoothness Measurements on Portland Cement Concrete Pavements During Construction

**SHRP 2 REPORT S2-R06E-RR-1**

# Real-Time Smoothness Measurements on Portland Cement Concrete Pavements During Construction

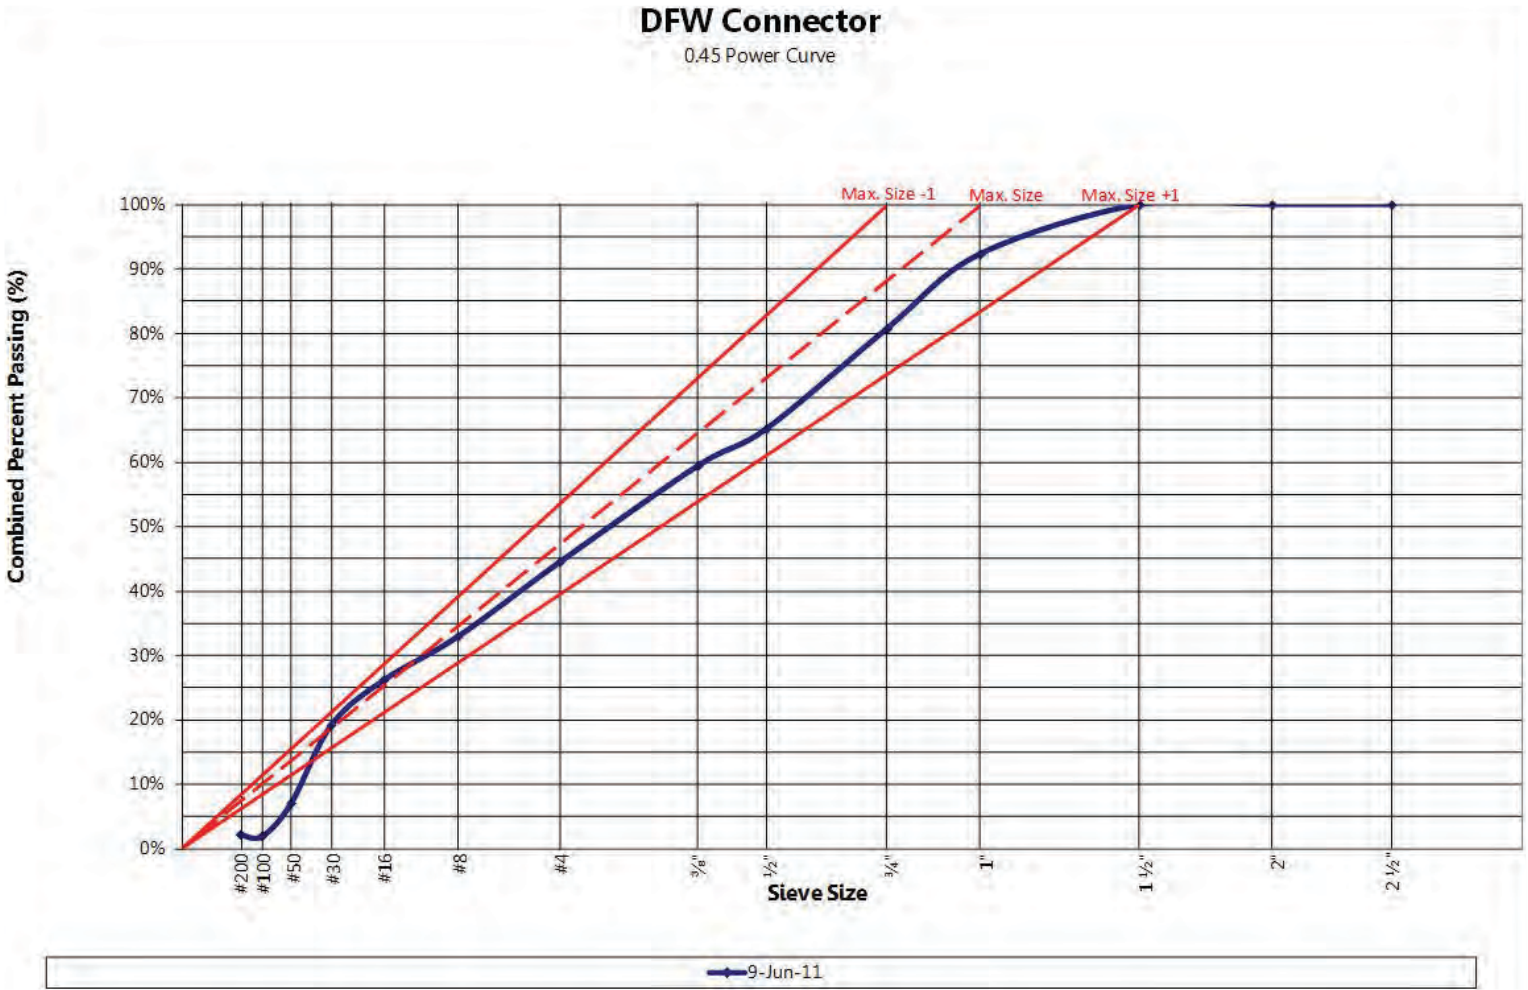
Figure G.13. Plot of the 0.45 power curve for Texas site.

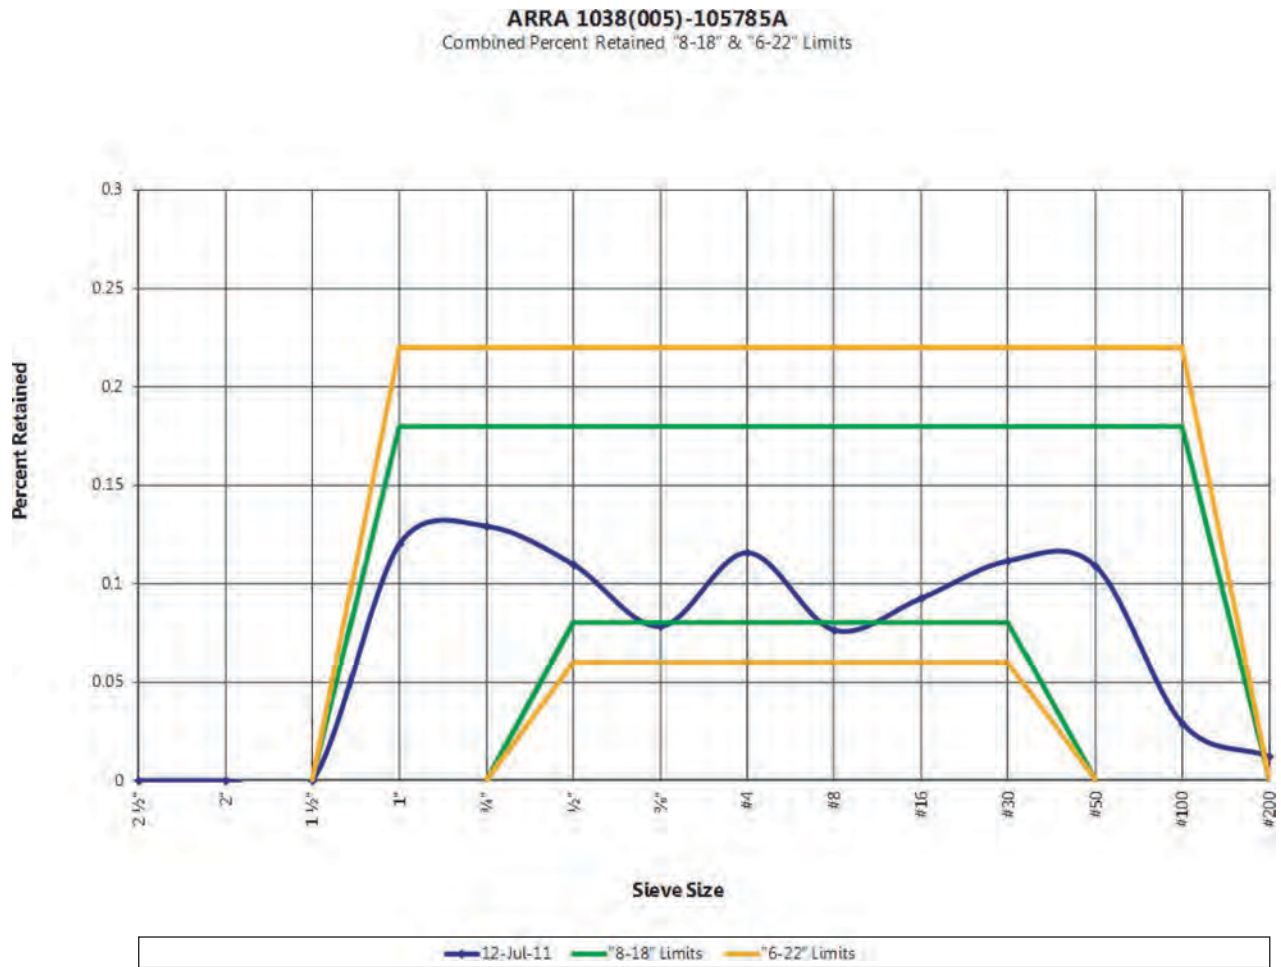
**Figure G.18. Combined percent retained on individual sieves for Michigan site.**
