Treatments Used at Pedestrian Crossings of Public Transit Rail Services

AUTHORS

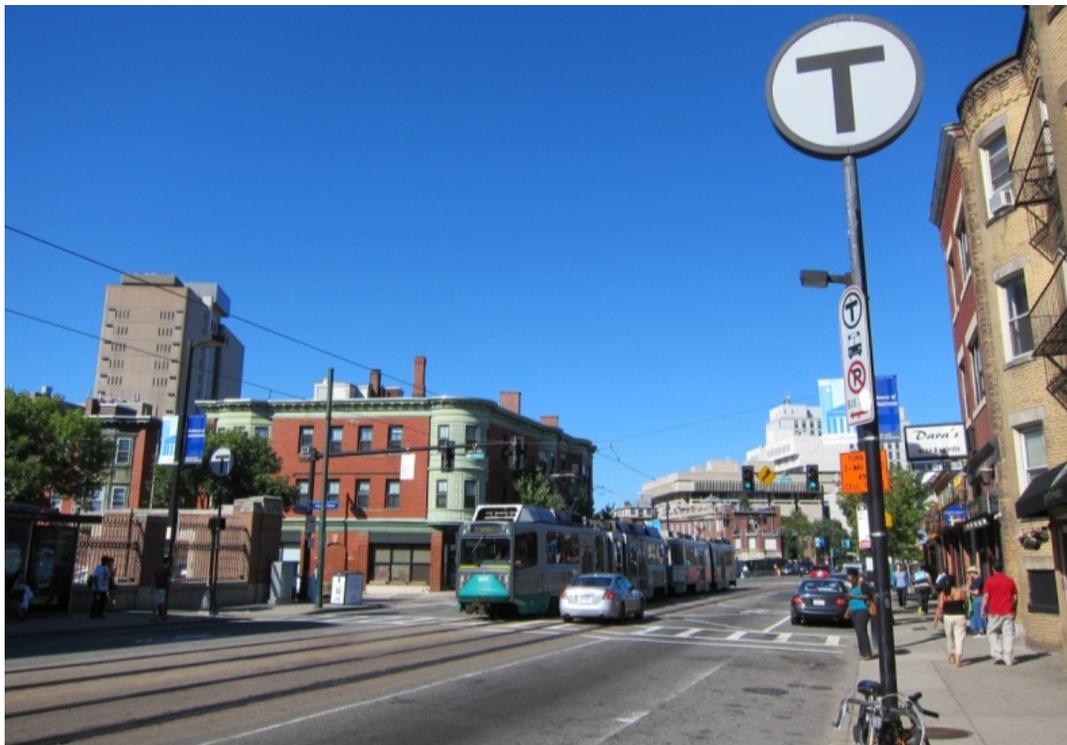
Figure 14. Example of a street running train approaching a pedestrian crossing.

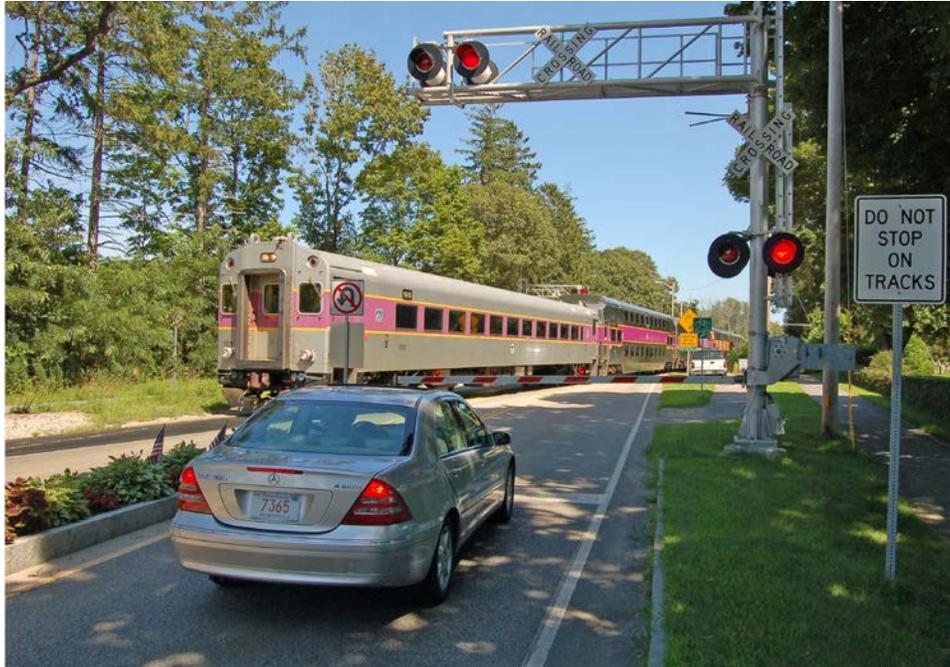
Figure 15. Example of commuter rail.

- The Boston MBTA commuter rail system had semi-exclusive alignment category b.1 separate right-of-way; see example in Figure 15.

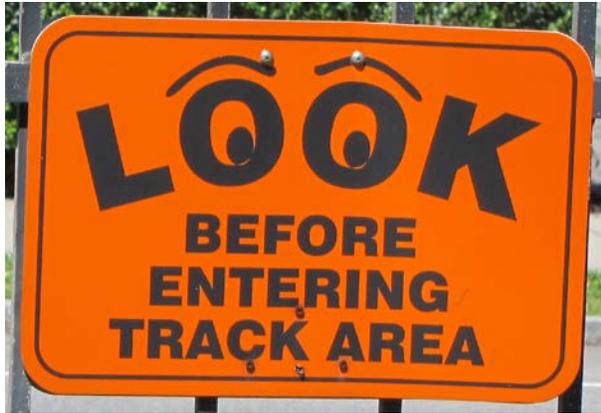
Figure 27. Sign used at several pedestrian-rail crossings.

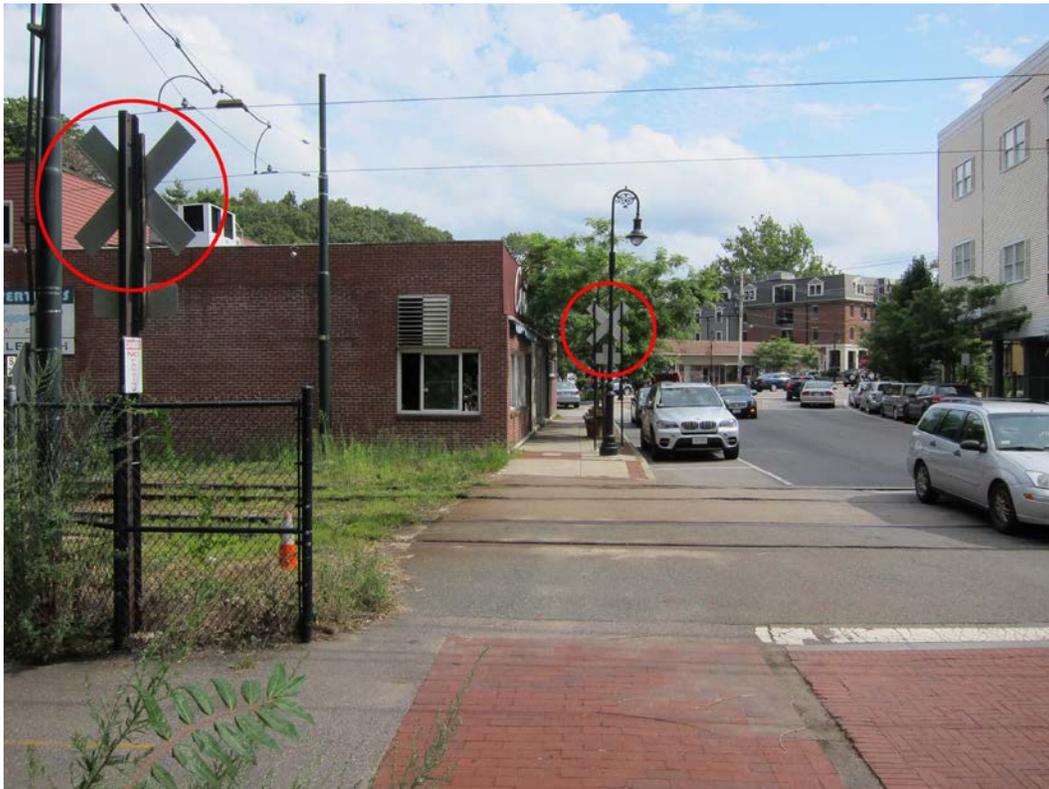
Figure 29. Example where the back, but not the front, of the crossbuck assemblies are present for the pedestrian approach.

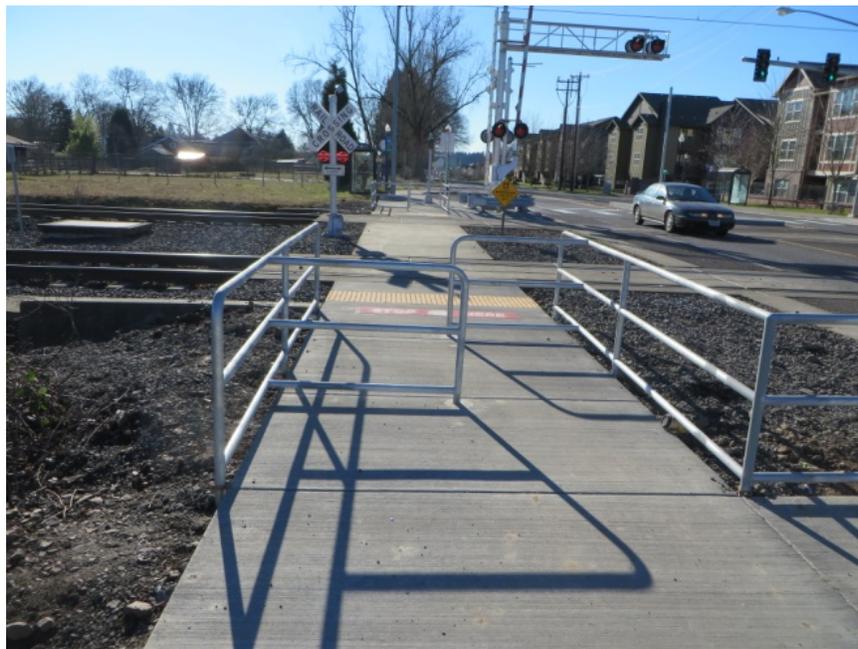
Figure 80. Example of tubular fencing.

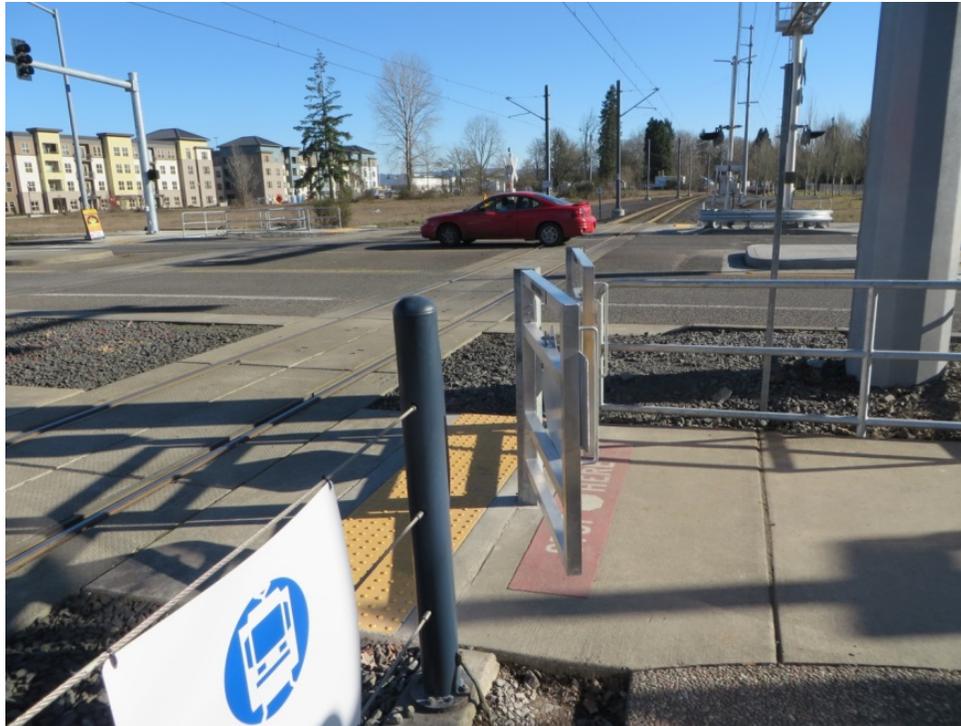
Figure 81. Swing gate being pushed open by wind.

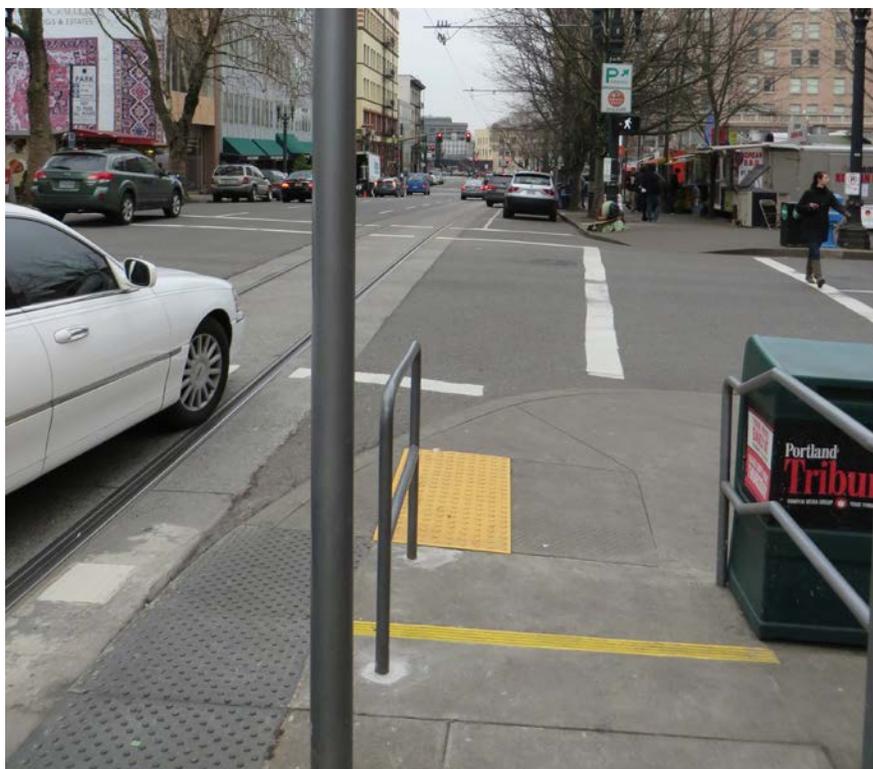
Figure 82. Example of barrier guiding pedestrians to crossing.

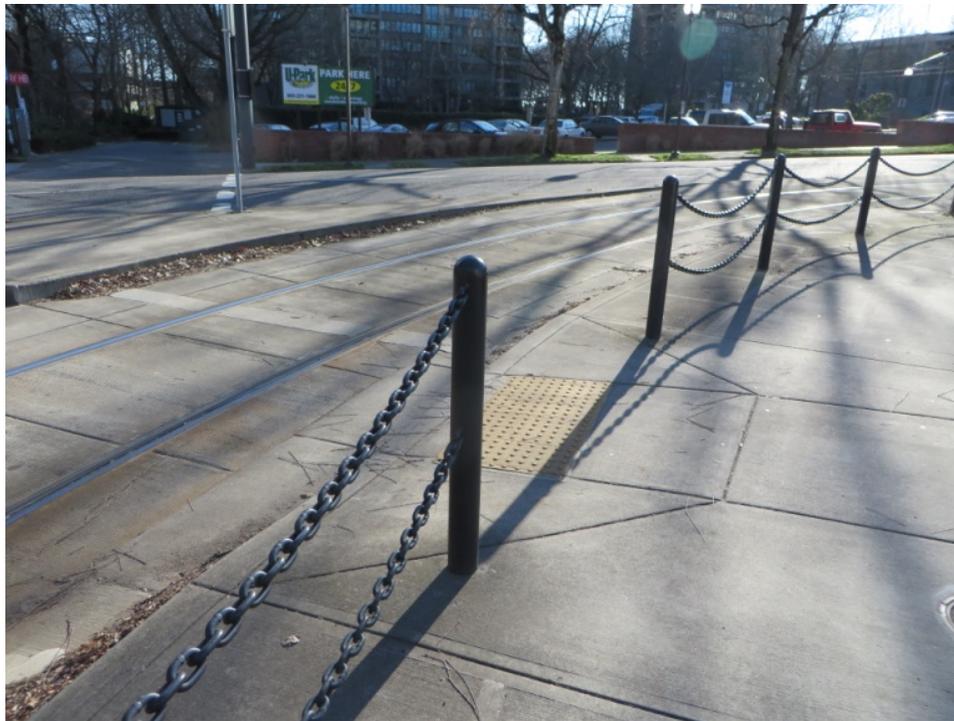
Figure 83. Example of barrier preventing crossing other than at designated spot.

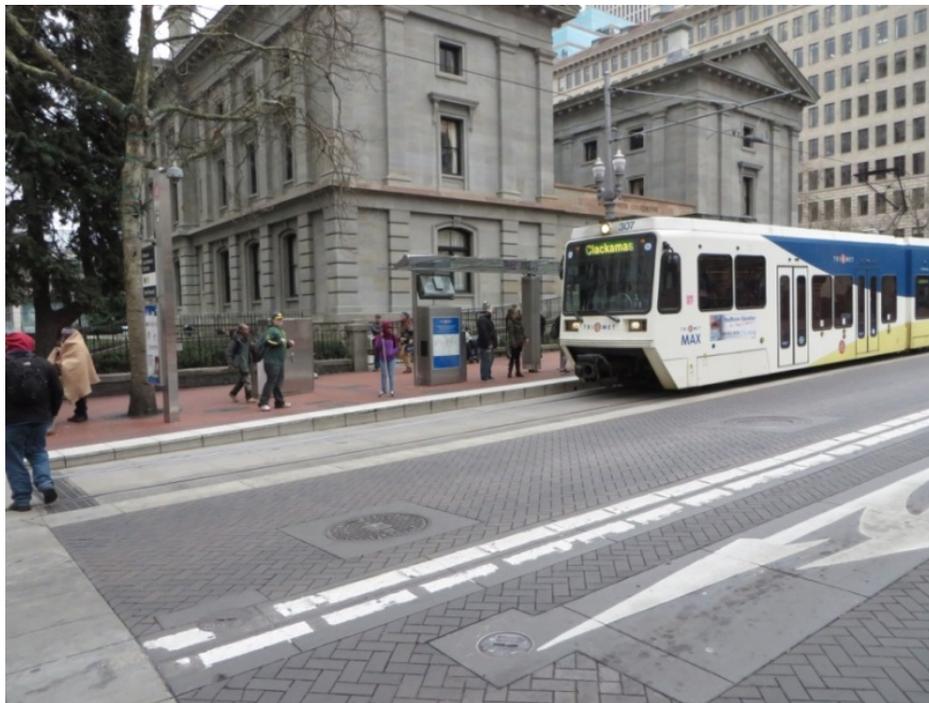
Figure 86. Example of using smooth concrete for train as compared to the brick pattern in neighboring lanes.

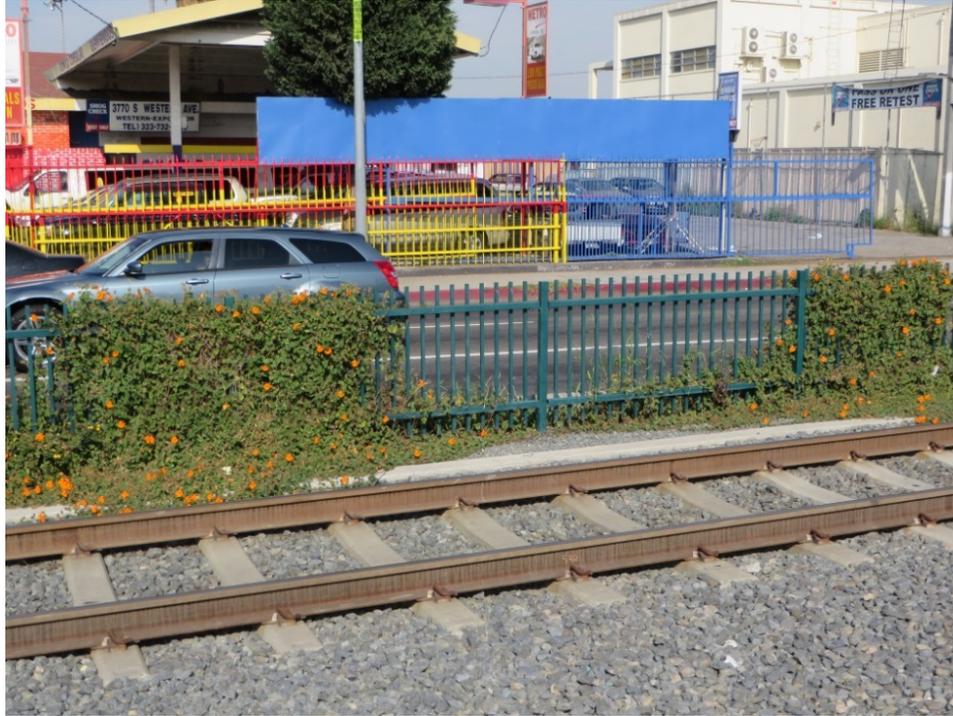
Figure 93. Fencing between roadway and tracks.

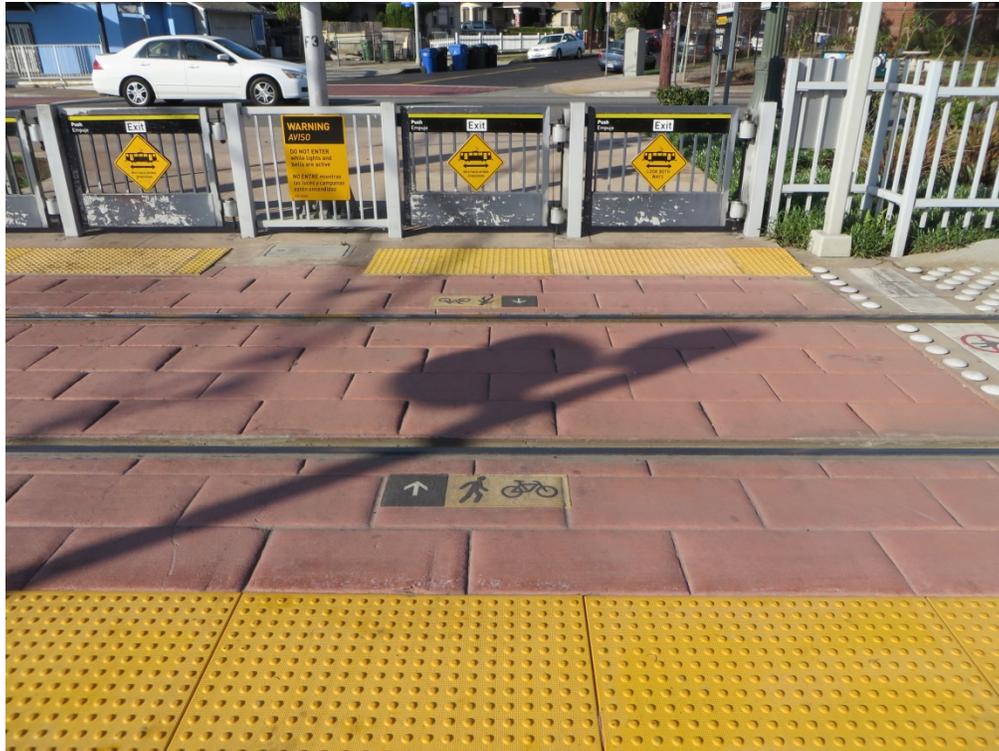
Figure 99. Detectable warning installed inside swing gates.

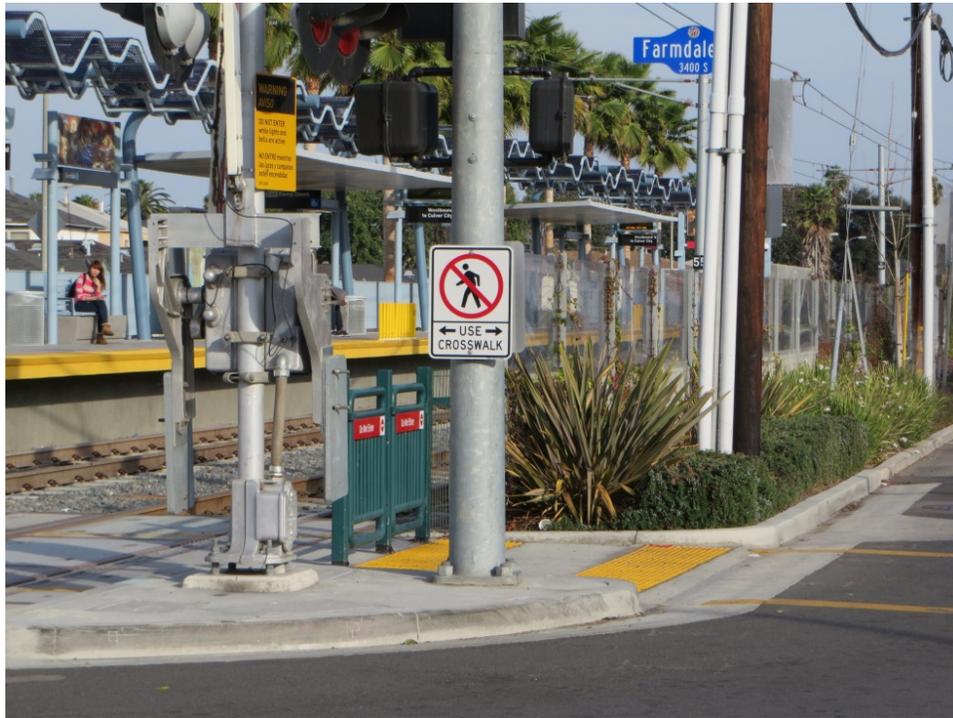
Figure 103. Preferred use of detectable warnings on curb ramp along with swing gate.

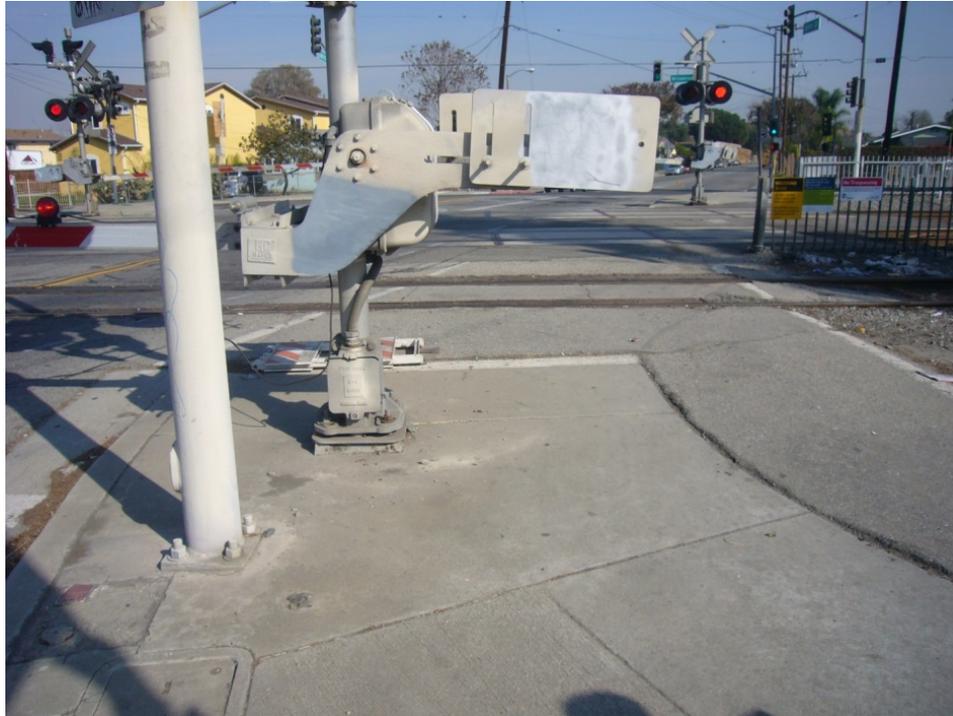
Figure 105. Visually impaired pedestrian has no warning of hazardous counterweight ahead.

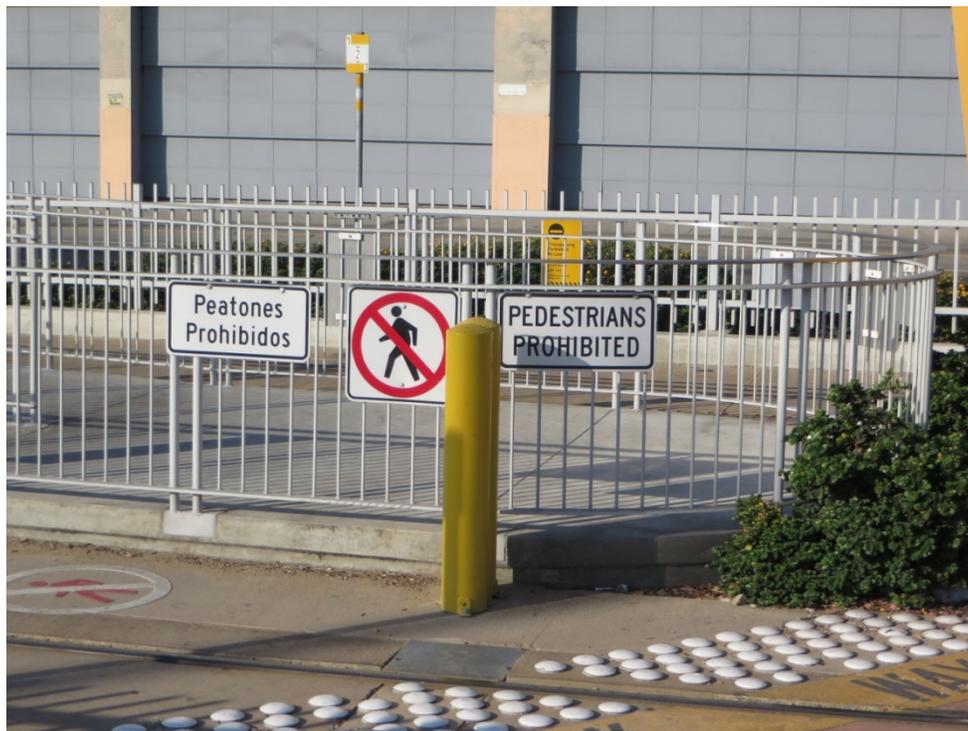
Figure 110. Pedestrian prohibition signing and pavement marking.

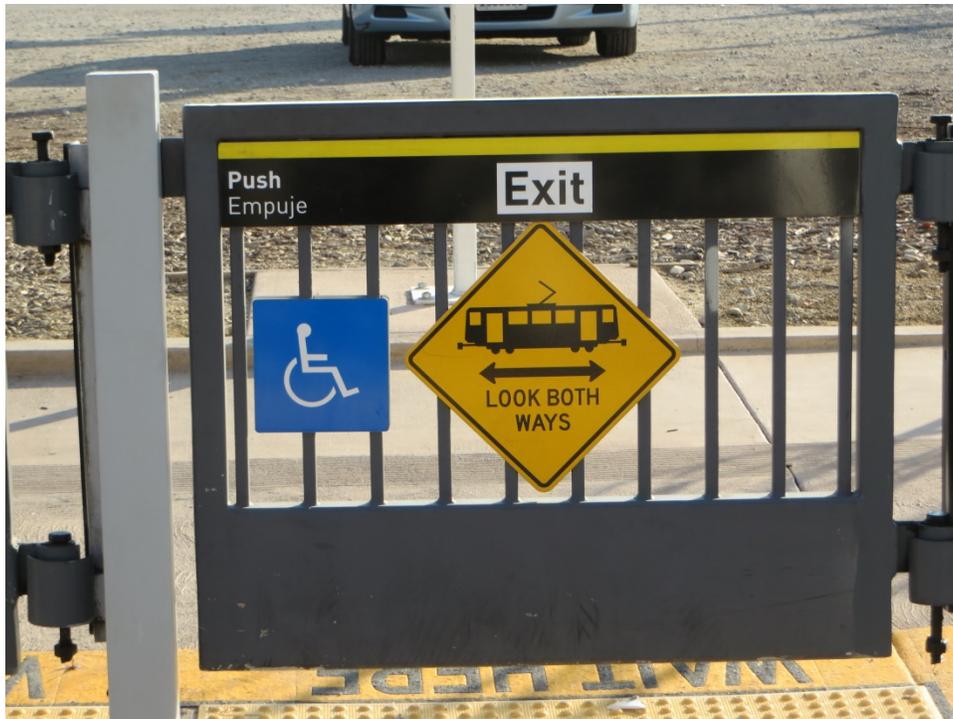
Figure 111. Example of swing gate.

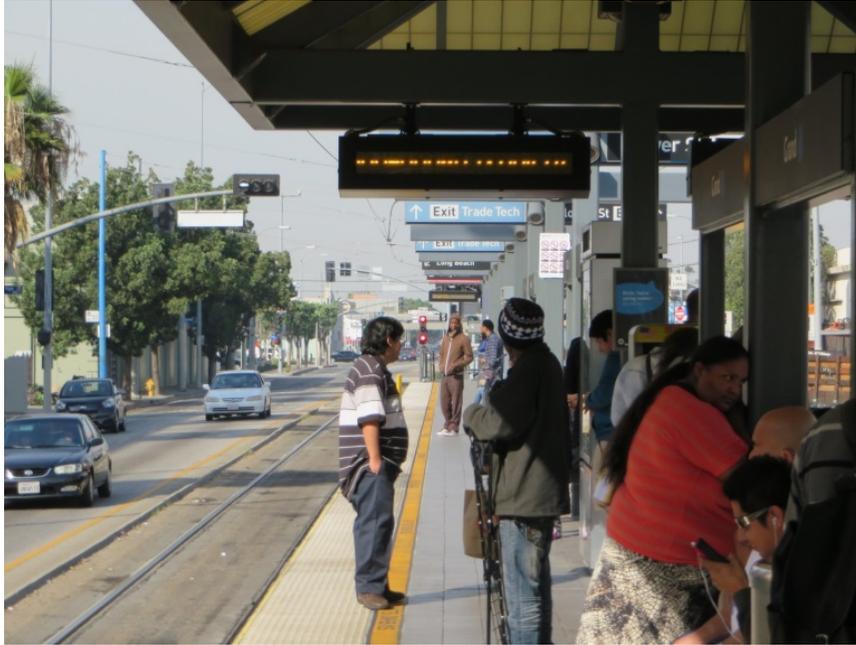
Figure 130. Narrow center platforms allow little room for wheelchairs or pedestrians using guide dogs.

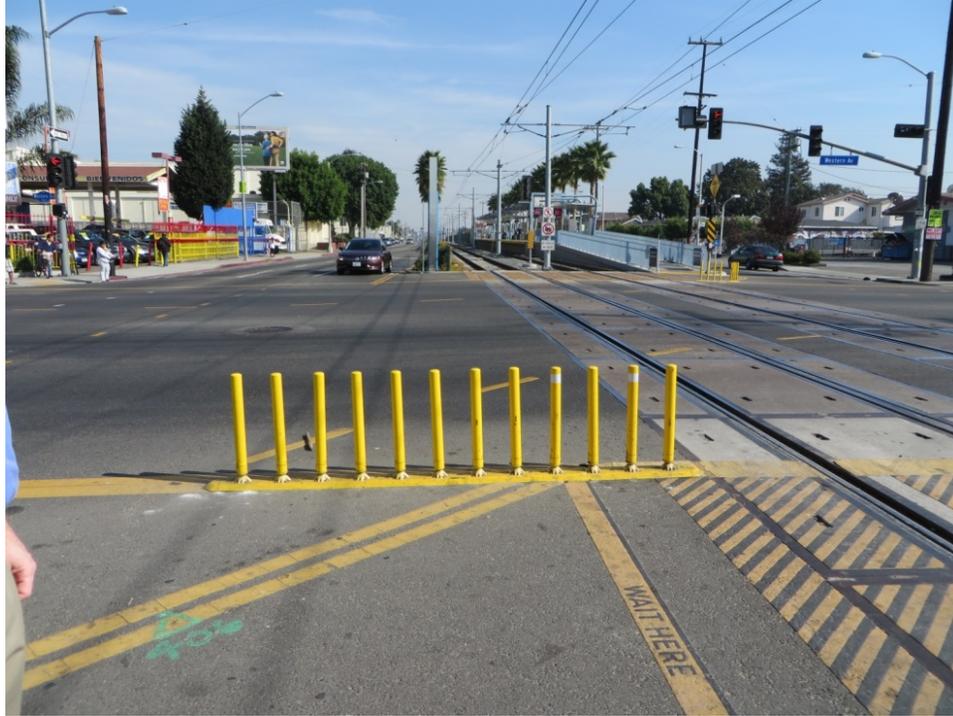
Figure 133. Another example of the flexible delineators.

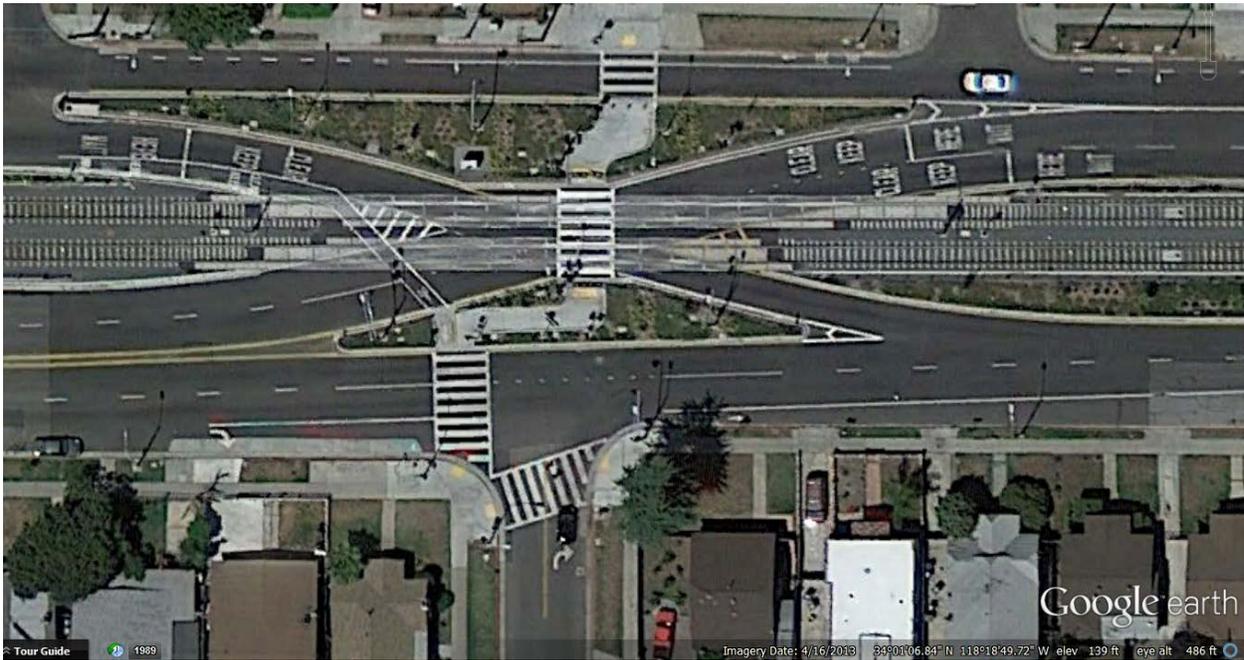
Figure 134. X-shaped crossing at Expo and Grammercy.

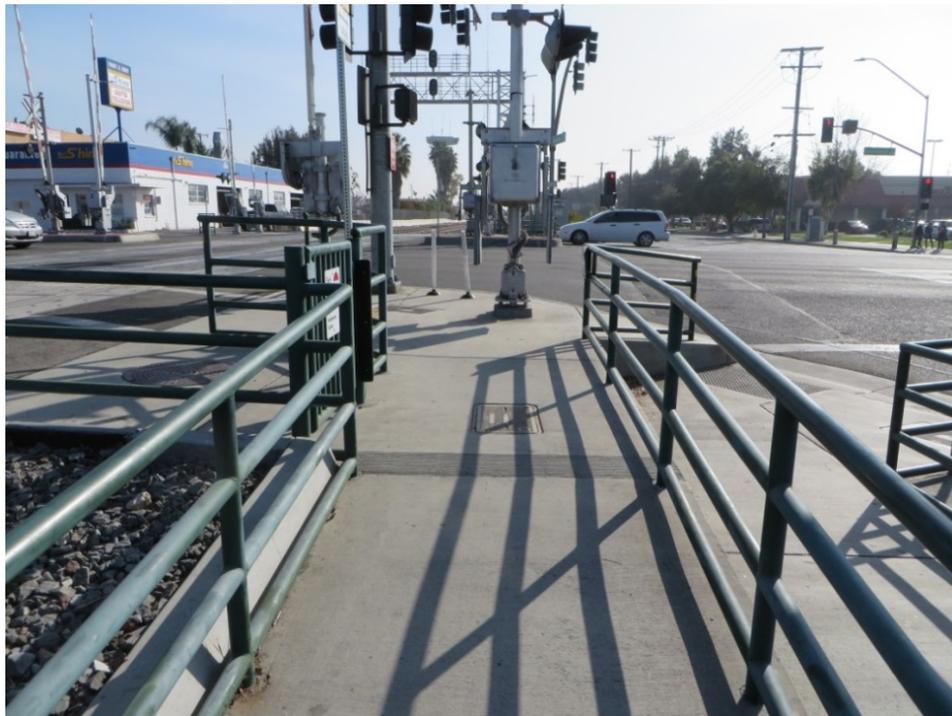
Figure 136. Ramp without attached ADA compliant handrails.

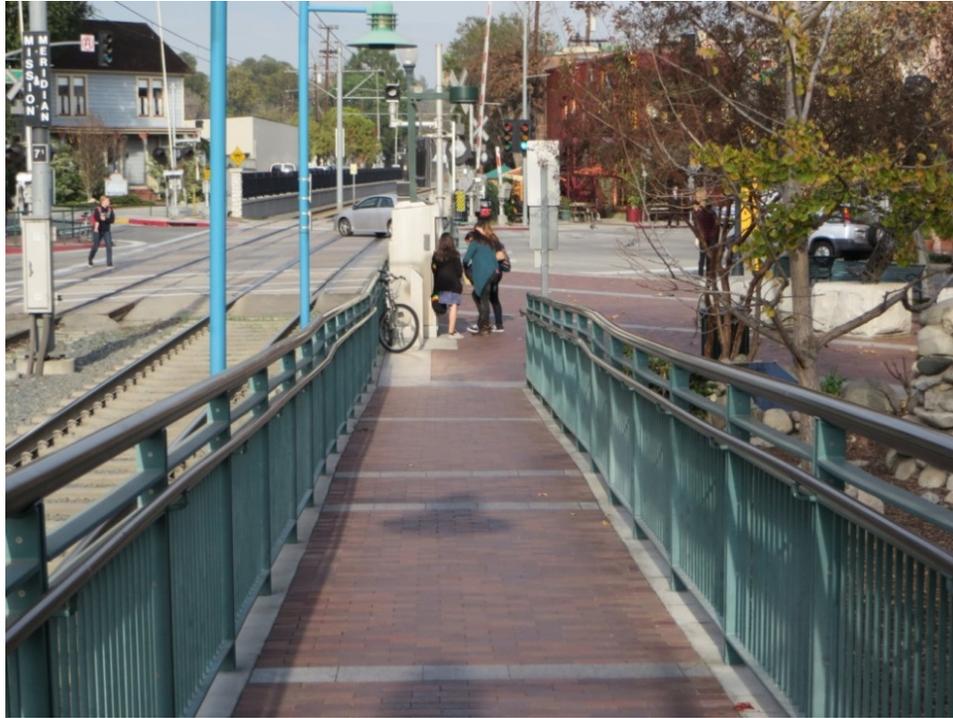
Figure 137. Ramp with attached ADA compliant handrails.

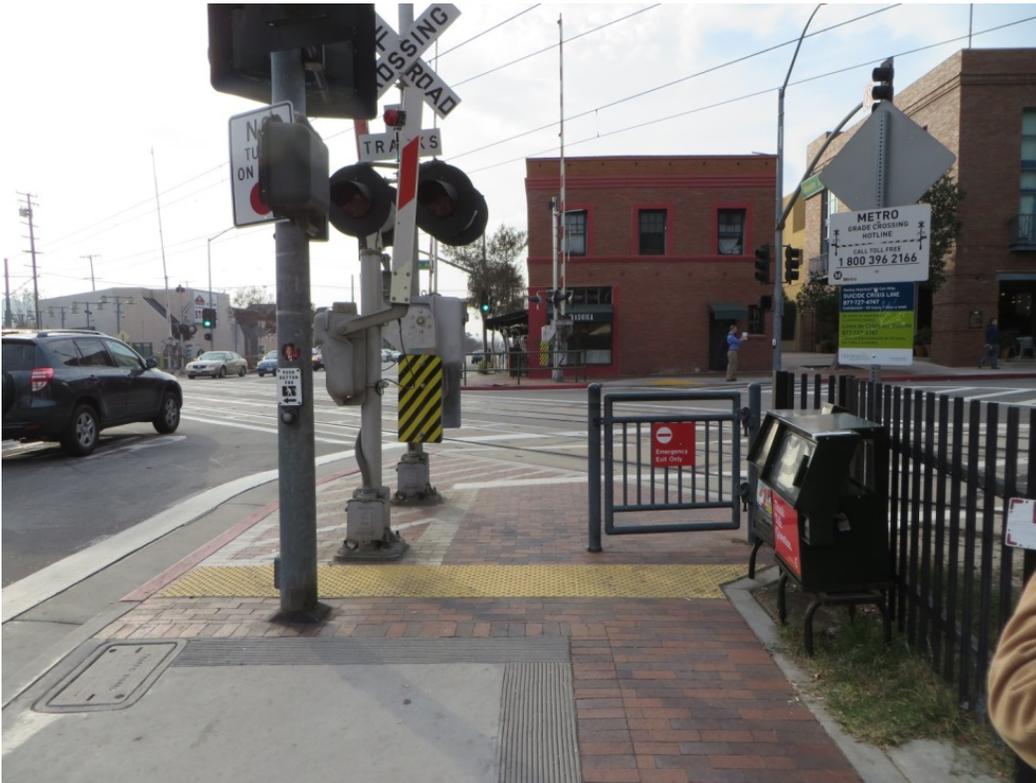
Figure 142. Inadequate cues for direction of crosswalk, which angles to the right away from previous direction of travel.
