UPTEC K 16015

Examensarbete 30 hp
September 2016

Wear on Alumina Coated Tools and the Influence of Inclusions when Turning Low-Alloy Steels

Master Thesis - Chemical Engineering

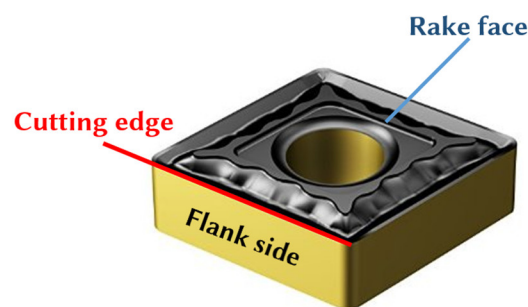
Figure 2.1. Schematic overview of a cutting tool insert

Figure 2.1 displays a general image displaying a modern cutting tool insert. The different sides of the tool are marked in the image.

The tool's top side is denoted as its *rake face*, whilst its sides are referred as its 'flank sides' or 'flank face'. During turning, the conditions at the flank side and rake face will be quite dissimilar from each other since they will be in contact with the workpiece material in different ways.

A patterned geometry can also be seen on the tool's rake face in Figure 2.1. This is an important part of many cutting tools' overall function and consists usually of two features, namely, a positive rake angle and a chip breaker. These serve the common purpose to facilitate the chip formation process on the rake face, in particularly by easing its removal and decreasing the chip's contact length with the tool. These actions tends to result in an overall increase of the tool's wear resistance on its rake face when comparing with tools without a chip-breaking geometry.[10]

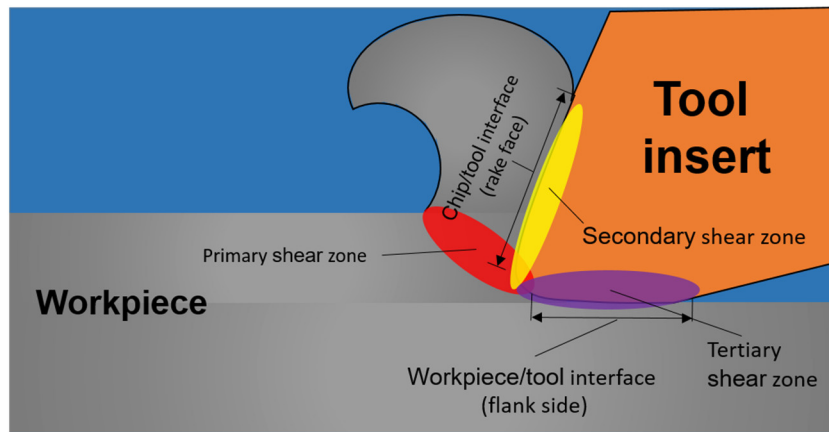
Figure 2.2. Illustrative description of the three different shearing zones developed during a turning process. These zones are all related to the heat generated during the machining process and relate to the wear seen on the tools.

From a machining process, there are mainly three different regions that exist which governs the arisen tribological conditions on the surfaces of the tool. These regions are referred to as 'zones' and are denoted as the primary, secondary and tertiary shearing zone, respectively. In essence, these zones represent the areas where most heat develops during a machining process, and their respective positions can be seen from *Figure 2.2*. The primary shearing zone distinguishes itself for being the only zone that occurs in the workpiece material itself. The other two mentioned zones (i.e. secondary and tertiary) are instead expressing the shearing contact between the tool and the workpiece. Since wear is a contact-governed phenomenon, it is predominantly these two zones where the wear on the tools occurs.

In terms of the secondary shear zone, it expresses the contact that arises from the tool's rake face and the workpiece's chip. The tertiary shear zone expresses a similar situation, yet for the interface between the flank side and the newly machined surface.[18] Since the main interest for this thesis has been to investigate the wear behaviour of the tool's rake face, a detailed description of the secondary shear zone will follow, and the description of flank wear will be left-out for this work.

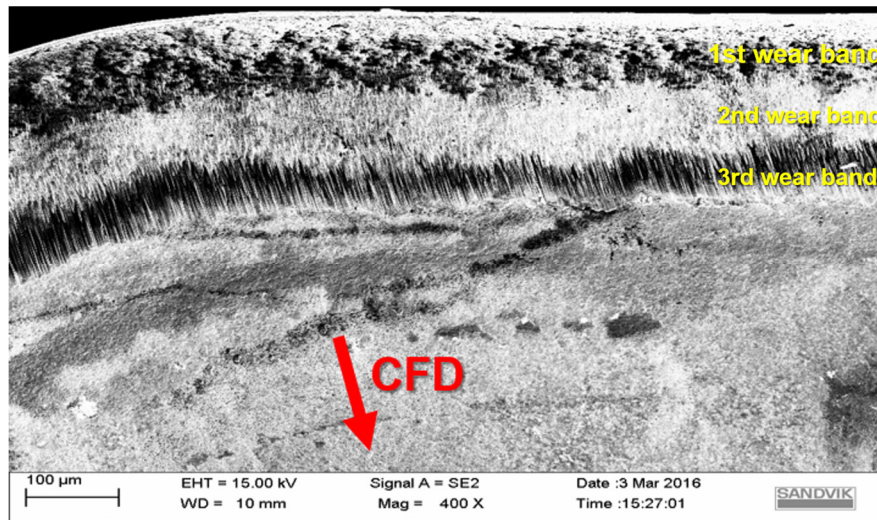
Figure 2.3. SEM-image taken on a cutting tools rake face displaying three characteristic wear-band regions running parallel to the cutting edge and perpendicular to the CFD.

In particular, the simultaneous adhesion and slipping of the chip, in which some parts of the chip sticks to the tool's surface whilst other parts undergo sliding, creates localised stress fields and regions on the tool where the frictional forces are intense yet different from each other[18,23]. This is usually visualized by the formation of distinctive and separated "wear bands" on the rake face, running parallel with the cutting edge and perpendicular to the *chip-flow direction* (CFD). These bands can be seen in *Figure 2.3*.

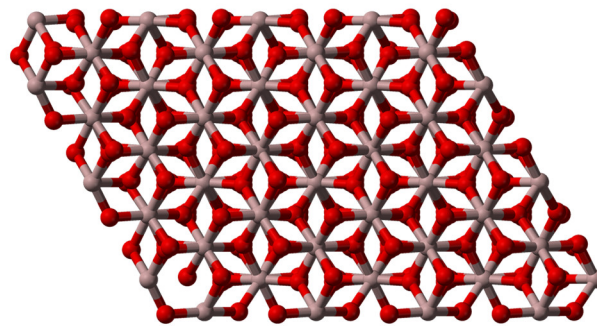
Figure 3.1. Three-dimensional “ball-and-stick” model depicting the atomic arrangement between oxygen (red) and aluminum (grey) in its trigonal crystal lattice. Each aluminum atom is surrounded by 6 oxygen atom which forms a three-dimensional tetrahedron[49]. (Image originating from Wikimedia Commons, used under Public Domain).

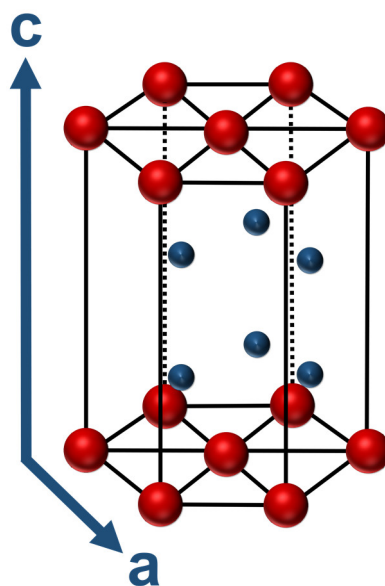
Figure 3.2. Schematic illustration of the structure from an α -alumina single-crystal. Figure displays the relative atomic position between the outer positioned O^{2-} -anions (red) and the inherent Al^{3+} -cations (blue), which are located in a portion of the available octahedral interstices in the crystal’s interior (Illustration made by the author).

For instance, the large divergence in electronegativity between Al^{3+} and O^{2-} (in accordance to the Pauling scale[47]) implicates that these two ions will strongly attract each other. Accordingly, this would energetically favour relatively small ionic bonding distances between them. In the case of alumina crystal, this translates into a compression of the α -alumina crystal's sidewalls, resulting in a typically small a-value (0.475 nm) for the crystal, as seen in *Figure 3.2*. [34,39,40,48]

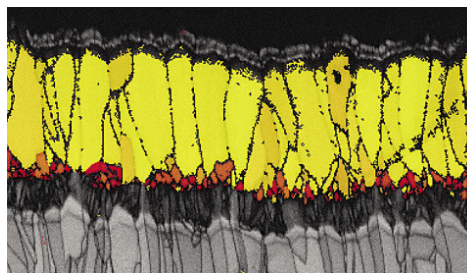
Figure 3.3. EBSD SEM-image displaying colored uni-directional (textured) alumina crystals deposited onto a cemented carbide tool substrate. The yellow-colored grains correspond to a growth direction of the crystals in its [0001] direction. (Image source: www.sandvik.coromant.com/en-gb/knowledge/technologies/inveio)

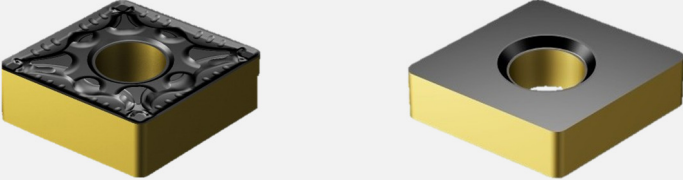
SIZE	120408	
TYPE OF COATING	CVD (Inveio™)	
GRADE	GC4325	GC4325**
SHAPE	CNMG	CNMA
APPEARANCE

SURFACE GEOMETRY	-PM	-KR
TOOL GEOMETRY	Rhombic	Rhombic
ISO-CODE	CNMG120408	CNMA120408
NUMBER OF CUTTING EDGES	4	4
EFFECTIVE CUTTING EDGE LENGTH	12.1 mm	12.1 mm
CORNER RADIUS	0.8 mm	0.8 mm
DENSITY	14.6 g/dm ³	13.8 g/dm ³
HC	14.5	13,6
COM	6.9	6,3
HV3	1484	1493
GRADIENT	25 μm	n/a**
COATING THICKNESS	9 μm multi-layered CVD + 5 μm Al ₂ O ₃ + 1 μm outer TiN layer*	9.5 μm multi-layered CVD + 5 μm Al ₂ O ₃ + 1 μm outer TiN layer*
	<p><i>*The inserts used in this work are post-treated after coating. During the post-treatment the outer TiN-coating (about 1 μm thick) has been blasted away on the rake face.</i></p>	<p><i>**The CNMA type of tools that has been used in this work has been made to have a similar bulk composition to the one of CNMG.</i></p>

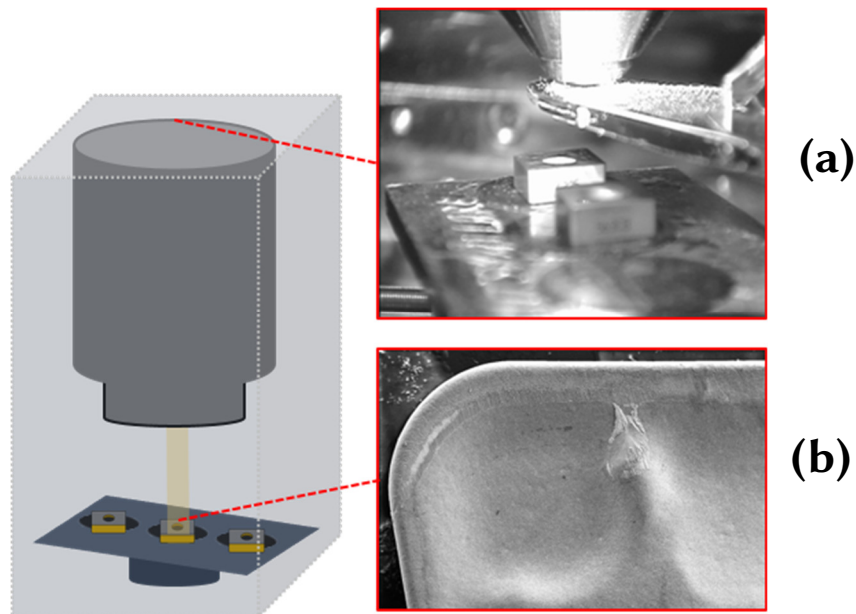
Figure 6.1. Schematic overview of the SEM-imaging of the turned cutting tool inserts. Imaging was performed from a top-down perspective where the tools had been placed on a planar tool-holder, as seen in (a). An example image of the imaged tool's rake face can be seen in (b) where the tool is aligned so that the cutting edge is shown in the uppermost part of the image.

Tools were placed in a planar tool holder and imaged from a top view perspective, according to *Figure 6.1*, in order to obtain a full perspective of the various wear features on the tools rake face. Images were mostly taken by using the backscatter electron detector (BSE) and, when applicable, from the secondary electron detector (SE). The taken pictures were always aligned so that the cutting edge of the tools were displayed on the uppermost part of the images.

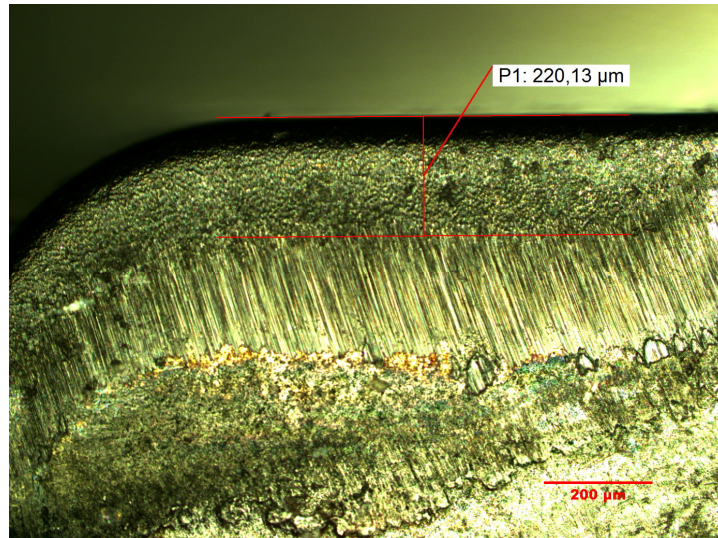
Figure 6.2. LOM-image of a CNMA cutting tool insert from DP2 displaying the location for the performed horizontal cross-section. The cut was placed approximately 220 μm below the main cutting edge of the tool. A second cross-section was made on another tool, which ran perpendicular to the cutting edge instead. This was located 1 mm in from left flank side of the tool.

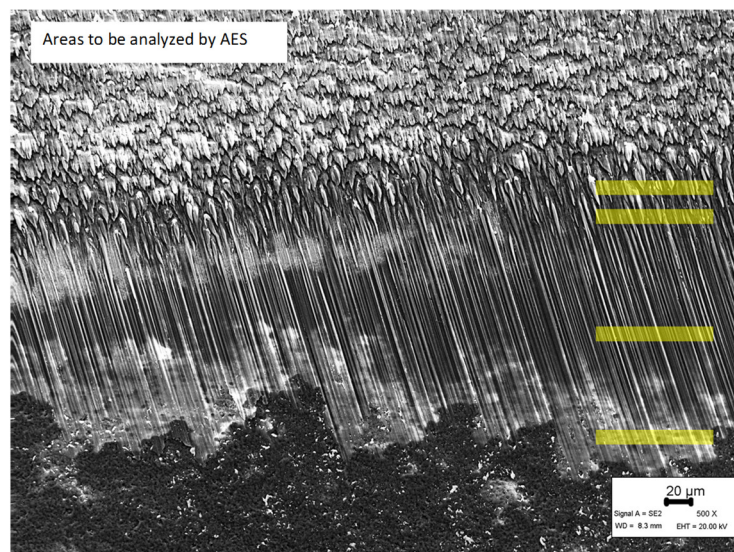
Figure 6.3. SEM image of worn cutting tool insert from DP2 displaying the location of the area of interest chosen for Auger analysis. The yellow fields are numerated as 1-4 from top to bottom in the image. Image taken with the cutting edge horizontally aligned.

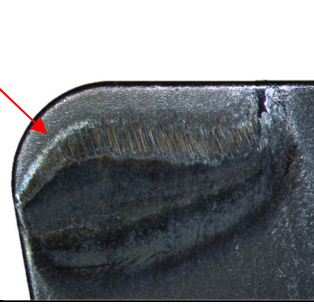
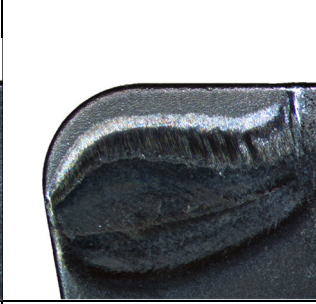
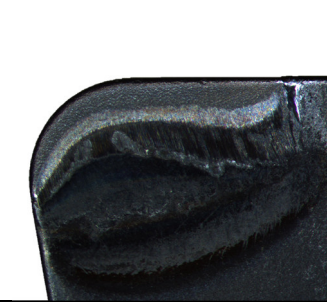
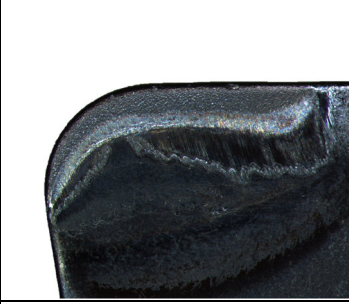
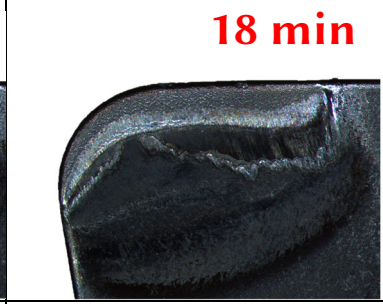
Figure 7.1. SEM image of a worn CNMG type of tool insert. An enlargement of the blue dotted area can be seen in image (a), revealing the formation of three separated wear band regions, each one having its own unique appearance. In (b) an image of a worn CNMA insert can be seen for comparison of the two tool type inserts.

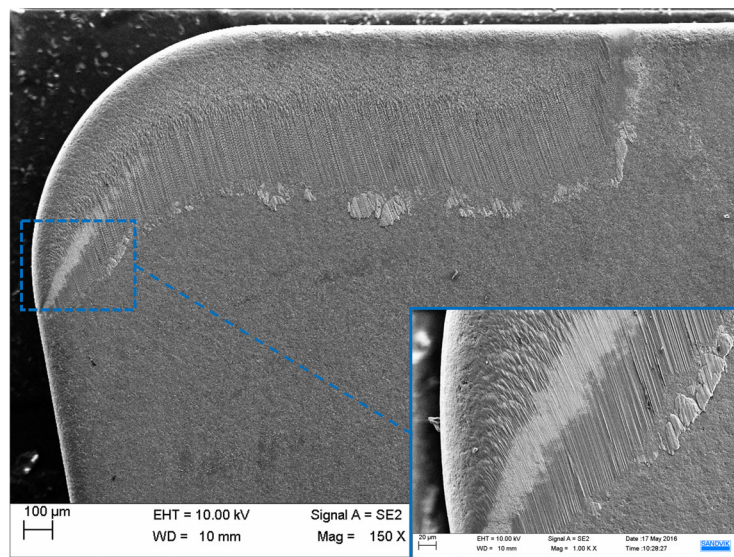
Figure 7.2. SEM image (SE-detector) of initially worn CNMA tool-insert displaying a bright wear area located close to secondary cutting edge of the tool's rake face. The viewed tool had been etched and gold-coated prior to imaging to avoid surface charging effects. The bright worn area was developed in the transitional region between the 2nd and 3rd wear band, thus suggesting that this area demonstrated the fastest initial wear rate on the tool insert.

Figure 7.4. SEM image (BSE-detector) of machined CNMG tool from DP3 where no coolant media had been used. The image clearly demonstrated a much more developed worn “white band”, in comparison with the same tool type where a coolant media had been used in DP2 (see Figure 7.2 for comparison).

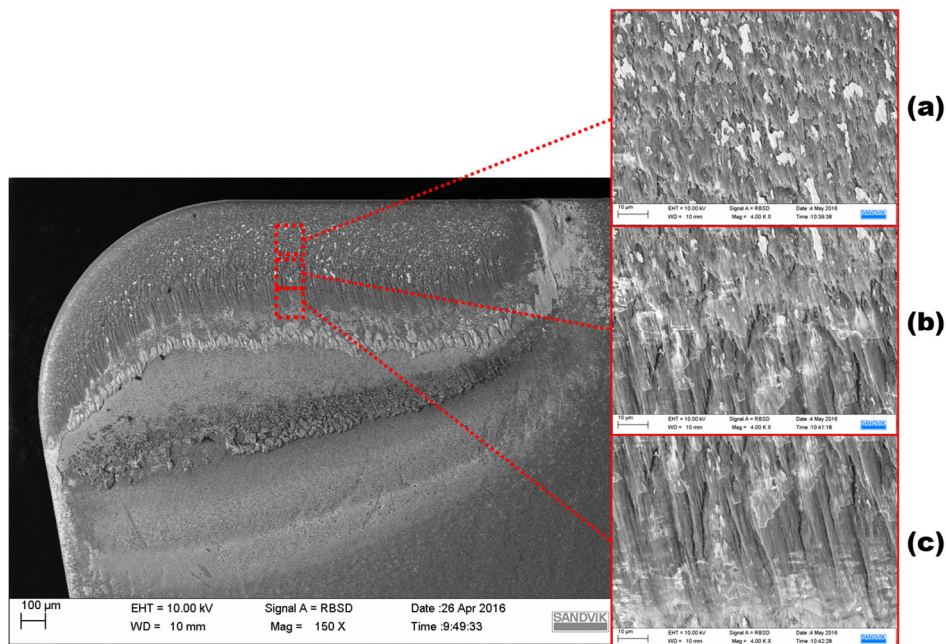
Figure 7.5. BSE-image of a CNMA tool from DP4, displaying a different wear behavior in comparison with the tools used in DP2. No presence of any formed white band in the topmost part of the 3rd wear band can be seen. In comparison with DP2, the arisen wear marks on the tools used in DP4 appeared as being much smoother. The white, hazy area seen in the magnified images are likely adhered material from the workpiece. (a) 2nd wear zone (b) transitional zone between 2nd and 3rd wear band (c) 3rd wear band.

particular, this was demonstrated by the fact that the tools in DP4 did not demonstrate the similar, ordered ‘lamellar structure’ in their 3rd wear band that had appeared on the tools from DP2. Rather, the worn surfaces in the 3rd wear bands on the tools from DP4 seemed to be much smoother and broadened.

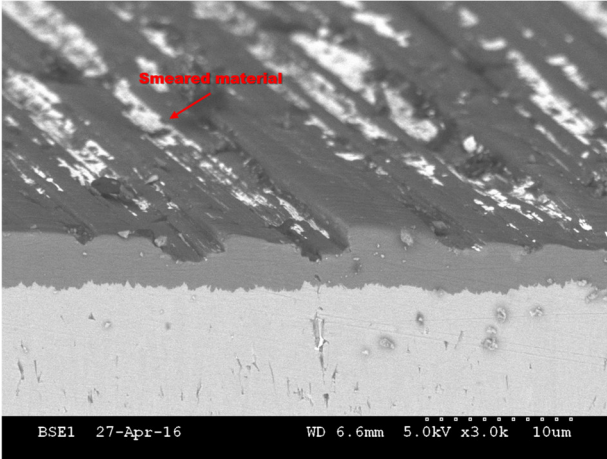
Figure 7.7. Cross-sectional imaging (parallel to the cutting edge) of a CNMA tool displaying the presence of white smeared material accumulated in the formed ridges, located in the transitional region between the 2nd and 3rd wear band. Image from a tool belonging to DP2.

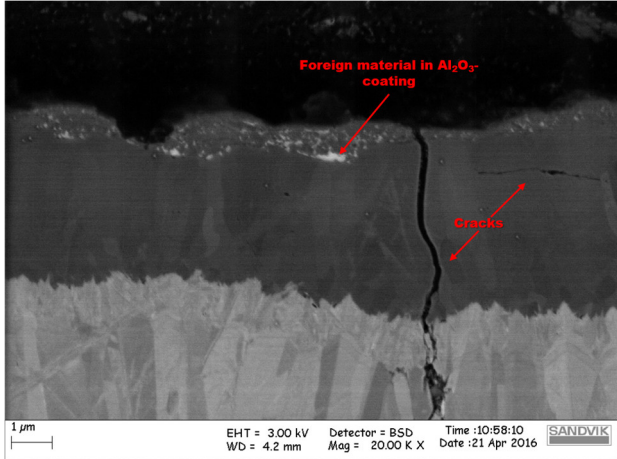
Figure 7.8. Close-up cross-sectional imaging (parallel to the cutting edge) of a CNMA type of tool from DP2 using channeling contrast in order to elaborate the internal structure of the alumina grains in the coating-layer. Bright spots and regions located in the topmost part (\leftrightarrow 1 μm) of the coating layer is clearly distinguishable from the image. The presence of cracks, which are elongated both laterally and vertically, is also visible in the image

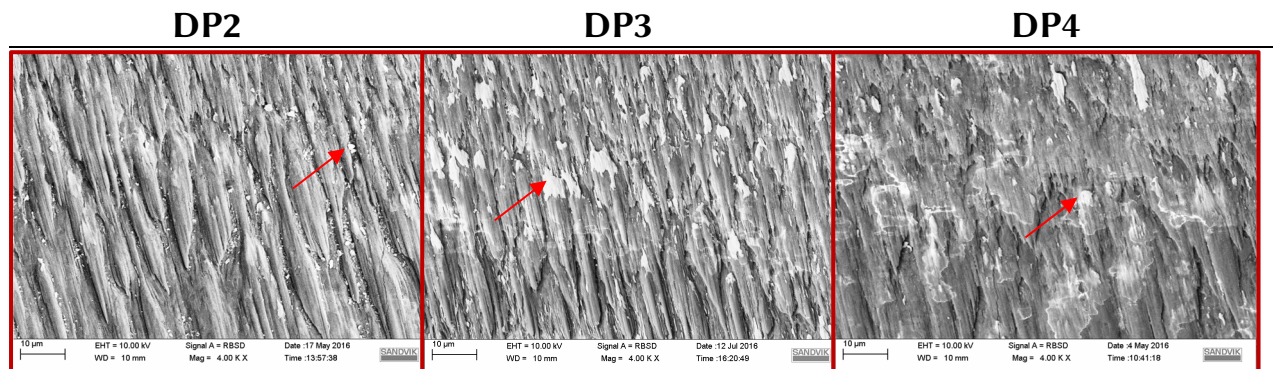
Table 7.2. Images comparing the relative amount of foreign material adhered on the transitional 2nd to 3rd wear band region on CNMG tools from all three performed initial turning tests. Foreign material is marked by a red arrow. A clear deviation between both the amount of adhered workpiece material and its appearance is evident from the images.

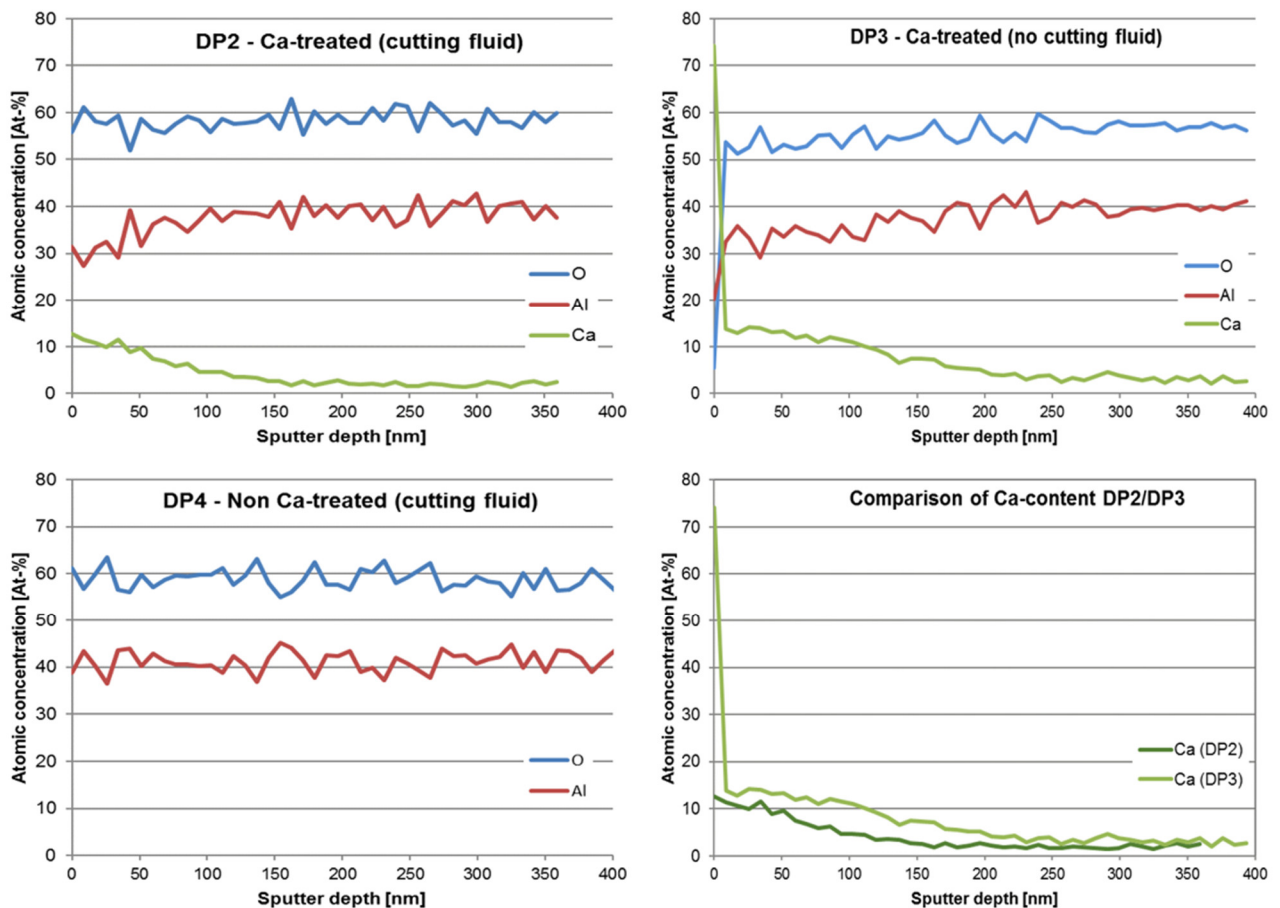
Figure 7.10. Diagrams displaying the relative atomic concentrations [At-%] of elements detected from Auger analysis in Area 4. A significant amount of calcium was found on the tools from DP2 and DP3. A comparison of Ca-content between these tool samples can be viewed from the figure. The tool from DP3 displayed a slightly higher overall Ca-content than the tool from DP2.

The tool from DP4 (non Ca-treated) distinguished itself for being the only tool sample where no calcium content could be detected. This was true for all of the evaluated areas on this tool.

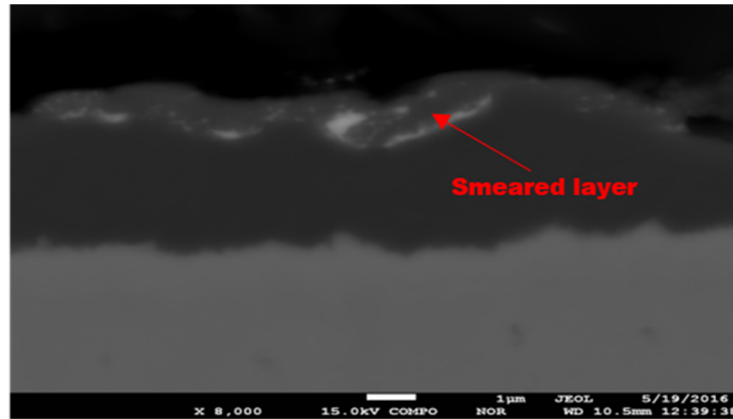
Figure 7.12. Image displaying the 1st map area analysed by the EPMA. A smeared transfer layer having different contrast to the underlying Al₂O₃ coating is clearly visible in the image.

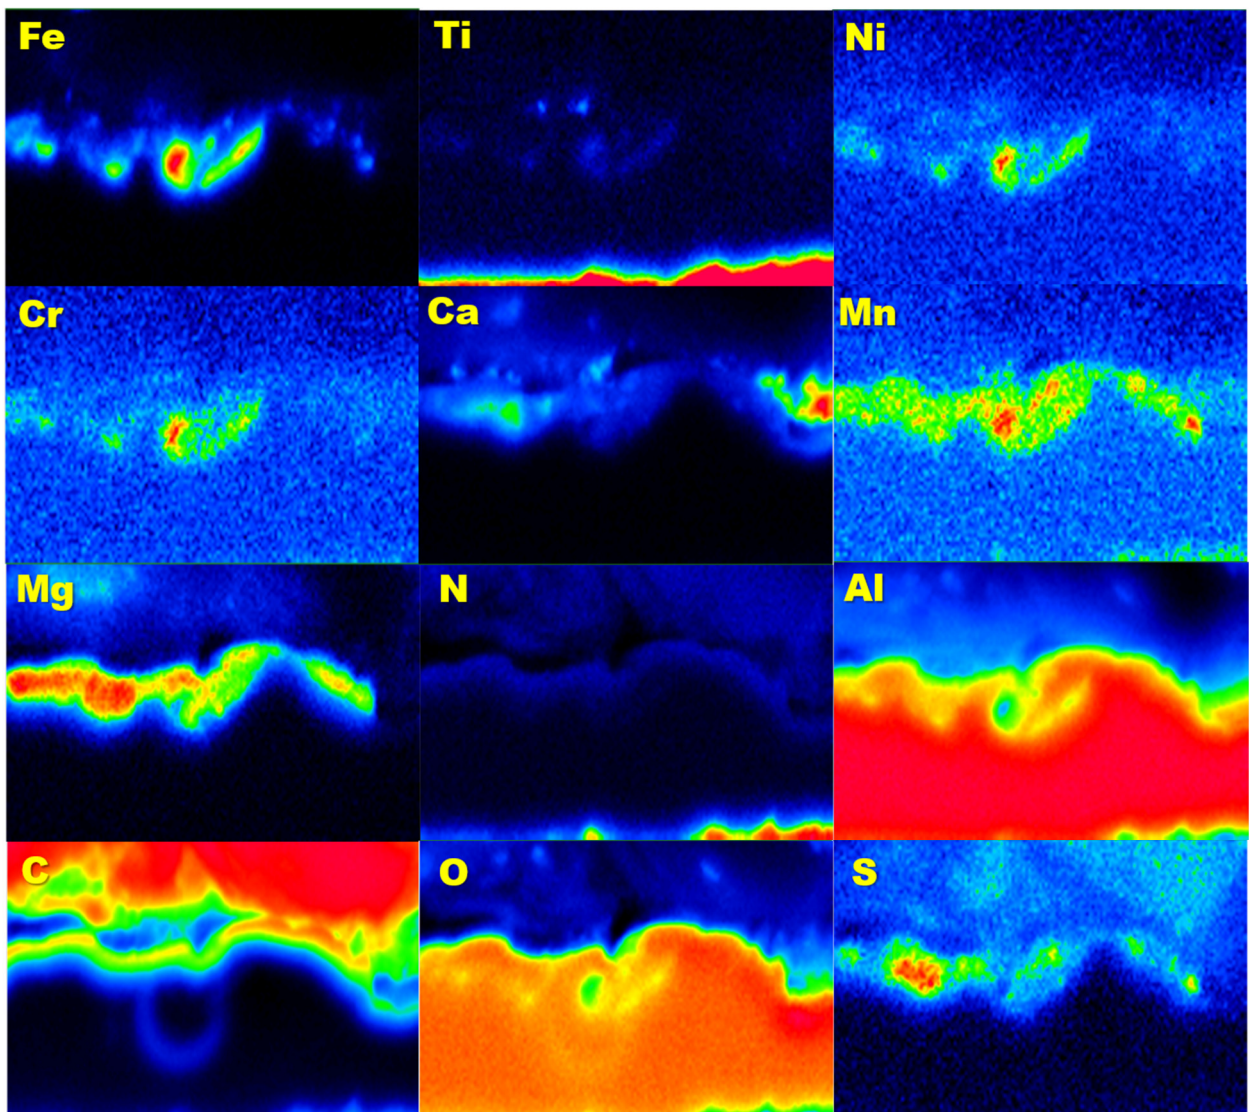
Figure 7.13. Elemental maps obtained from the analysed 1st area which displays the presence of the elements Fe, Ti, Ni, Cr, Ca, Mn, Mg, N, Al, C, O, S, respectively. Concentration follows a spectrum-scale in which red indicates for stronger elemental presence. Note that a quantitative, colour-based comparison of the detected elements between the maps are not possible. This is because the signal from each performed mapping session may represent a different number of registered counts and originate from different channels.

The reader should carefully note that a quantitative comparison between the detected elements in the elemental mappings are not possible, due to the limitations of the used EPMA-equipment. The signal for each detected element may originate from different channels and/or WDS-crystals, meaning that each elemental signal may contain a different number of registered counts. In other words, the colour scheme between two different elemental maps are not equally scaled; the colours may represent very different number of counts and hereby dissimilar elemental concentrations.

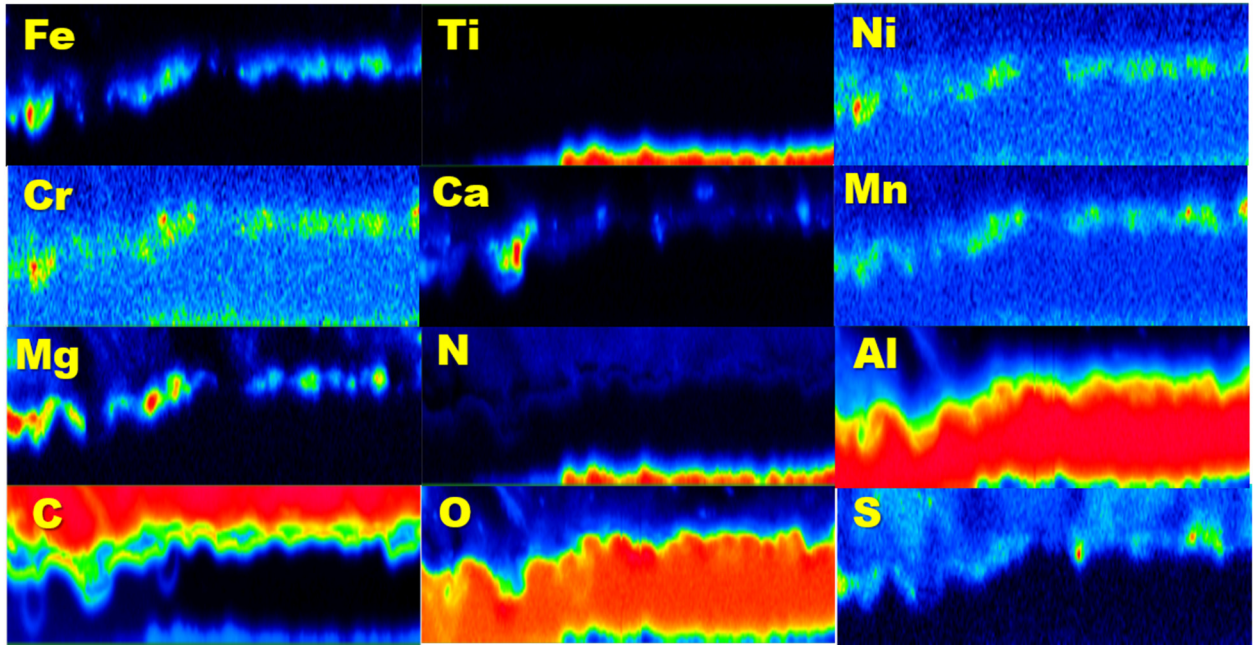
Figure 7.15. Elemental maps obtained from the analysed 2nd map displaying the presence of the elements Fe, Ti, Ni, Cr, Ca, Mn, Mg, N, Al, C, O, S, respectively. Concentration follows a spectrum-scale in which red indicates for stronger elemental presence. Note that a quantitative, colour-based comparison of the detected elements between the maps are not possible. This is because the signal from each performed mapping session may represent a different number of registered counts and originate from different channels.

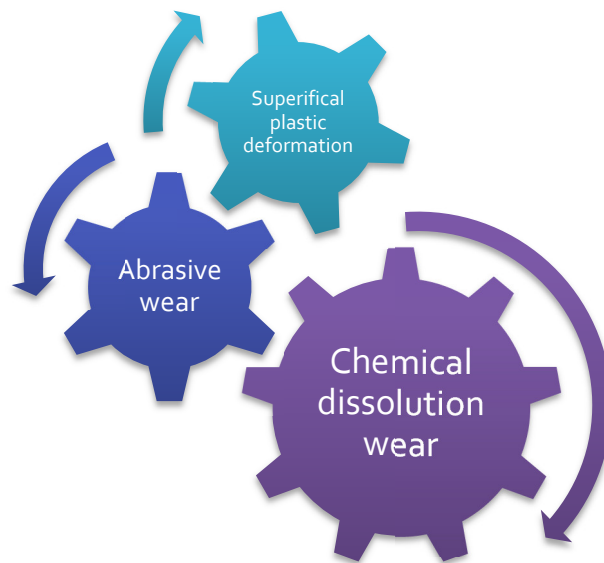
Figure 8.1. Illustration of the three main models acknowledged for describing the wear behavior of alumina-coated tools during metal cutting applications. Each model is here regarded as stand-alone models with little dependency of one another.

From a tribological point of view, these models are all related by their attempts to comprehensively explain the characteristic ‘scorns’ and ‘ridge-like’ wear patterns that tend to appear when steel workpiece materials are being machined. On the rake face, these wear patterns arise exclusively in the 3rd wear band of the tools. As have been demonstrated in the results of this thesis, this area corresponds to the region where the wear seems to be the most pronounced on the machined tools, both initially and at the end of their lifetime. Thus, it may be concluded that the expansion of the 3rd wear band, along with the tribological mechanism(s) that occurs in the beginning of this band, are the most important factors that determines the continuous wear of alumina-coated cutting tools when machining steels.

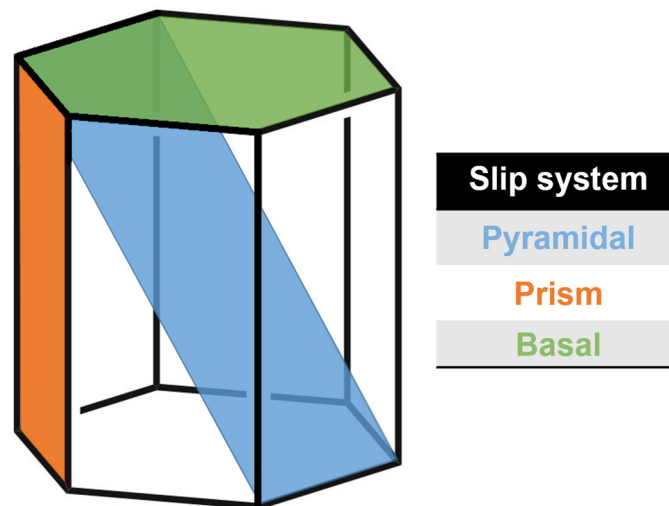
Figure 8.2. Schematic illustration depicting the three different available slip systems (pyramidal, prismatic and basal) present in the α -alumina crystal. Their geometrical expansion and direction is viewed in the figure. At elevated temperatures, such as the ones reached in a metal cutting procedure, the pyramidal slip system is the hardest one to activate, followed by prismatic and then basal.

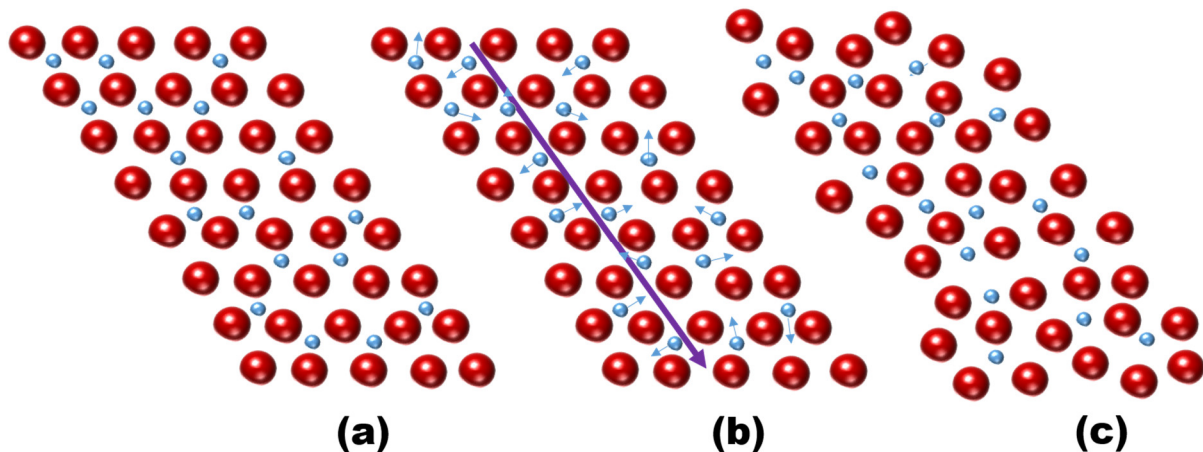
Figure 8.3. Schematic description of an induced amorphisation/nano-crystallisation in a shocked α - Al_2O_3 crystal due to the activation of pyramidal slip systems. In the figure, O^{2-} anions are shown in red and Al^{3+} cations are shown in blue. In (a) an undamaged crystal lattice is shown having an irregular stacking of Al^{3+} anions in the interior of the crystal. When a pyramidal slip is induced in (b) it causes a short-range diffusion of the crystal's intrinsic cations (i.e a “cationic shuffling”) that alters the cationic arrangement in the crystal. This leads to (c) a loss of the long-range periodicity and the short-range stacking sequences of the crystal, thus causing an nano-crystallisation and/or amorphisation of the crystal.
