**Towards practical pressure-based leakage characterisation of water distribution pipes
with a novel pipe condition assessment device**

In partial fulfilment of the requirements for:
Master of Science in Civil Engineering

Submission Date: 01 October 2019
Institution: University of Cape Town
Faculty: Engineering and the Built Environment
Department: Civil Engineering

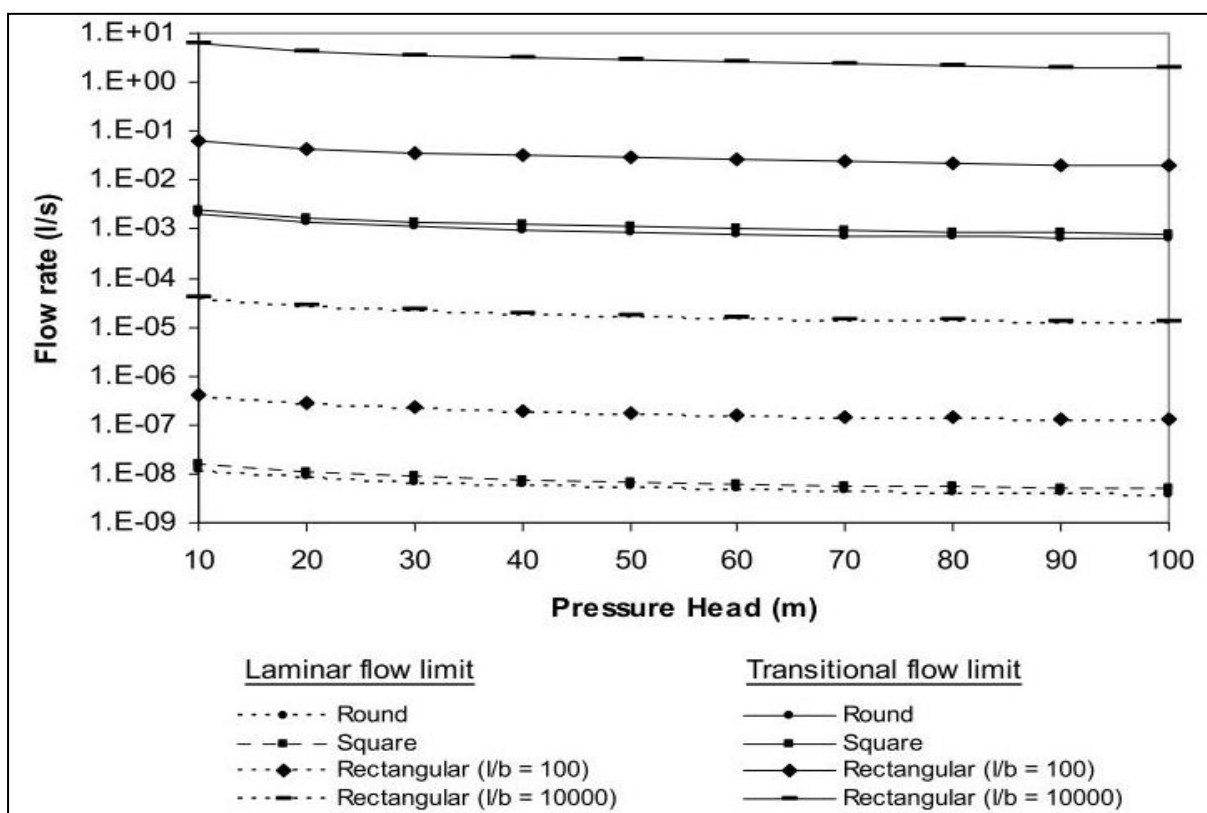
Figure 2-6- Maximum lamina and transitional flow rates for different leak openings (Van Zyl & Clayton, 2007)

From equations 1 and 2, Van Zyl and Clayton (2007) plotted the velocities and the corresponding heads for maximum laminar and transitional flows. The results are shown in Figure 2-6.

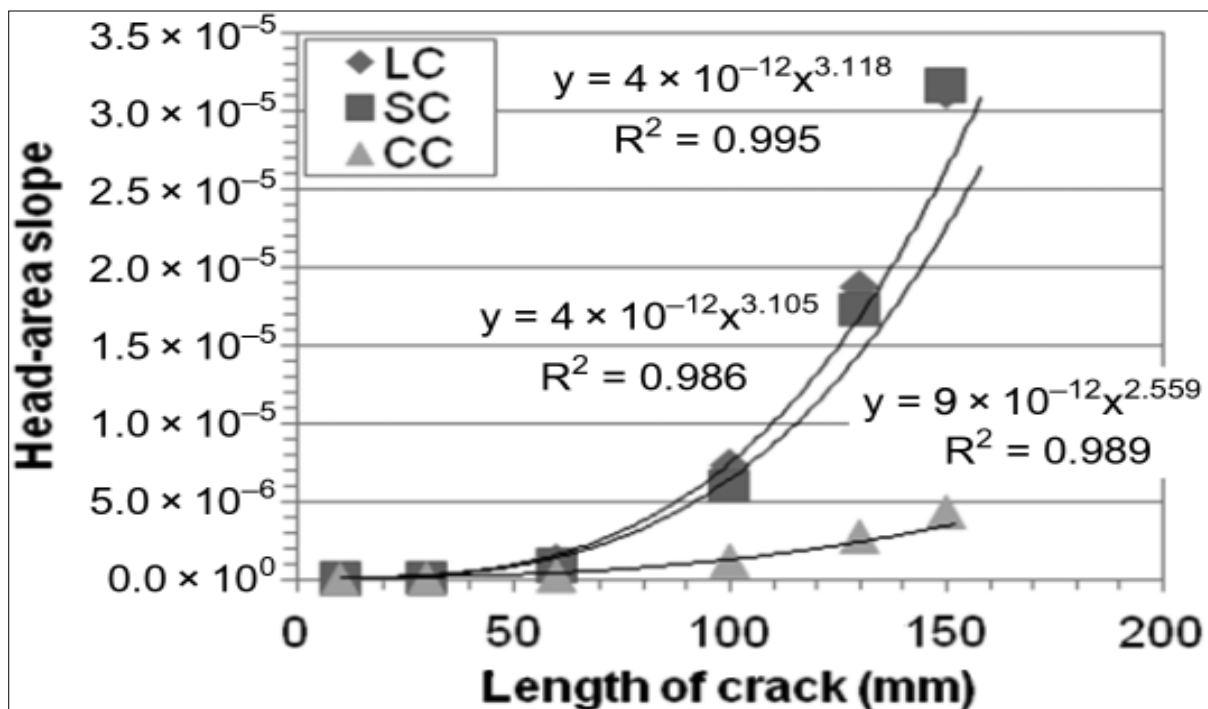
Figure 2-8 - Graph showing the effect crack length has on the head-area slope (Cassa and Van Zyl, 2013)

Cassa and Van Zyl, (2013) resumed the research from 2.2.5.1 and sought to predict the head-area slope, m . Finite element analysis was used to predict the head-area slope for longitudinal and circumferential cracks. Only the linear elastic material behaviour was considered in the study. To obtain an expression to express the head area slope; the impact of loading, pipe material, section and crack properties were investigated. The internal pressure and external stresses were simulated in the model. It was found that the leak area expands linearly with pressure irrespective of pipe material, leak type or loading state. By altering various pipe and leakage parameters, they managed to obtain the relationship of each parameter with head area slope. Figure 2-8 shows how some of these parameters behaved.

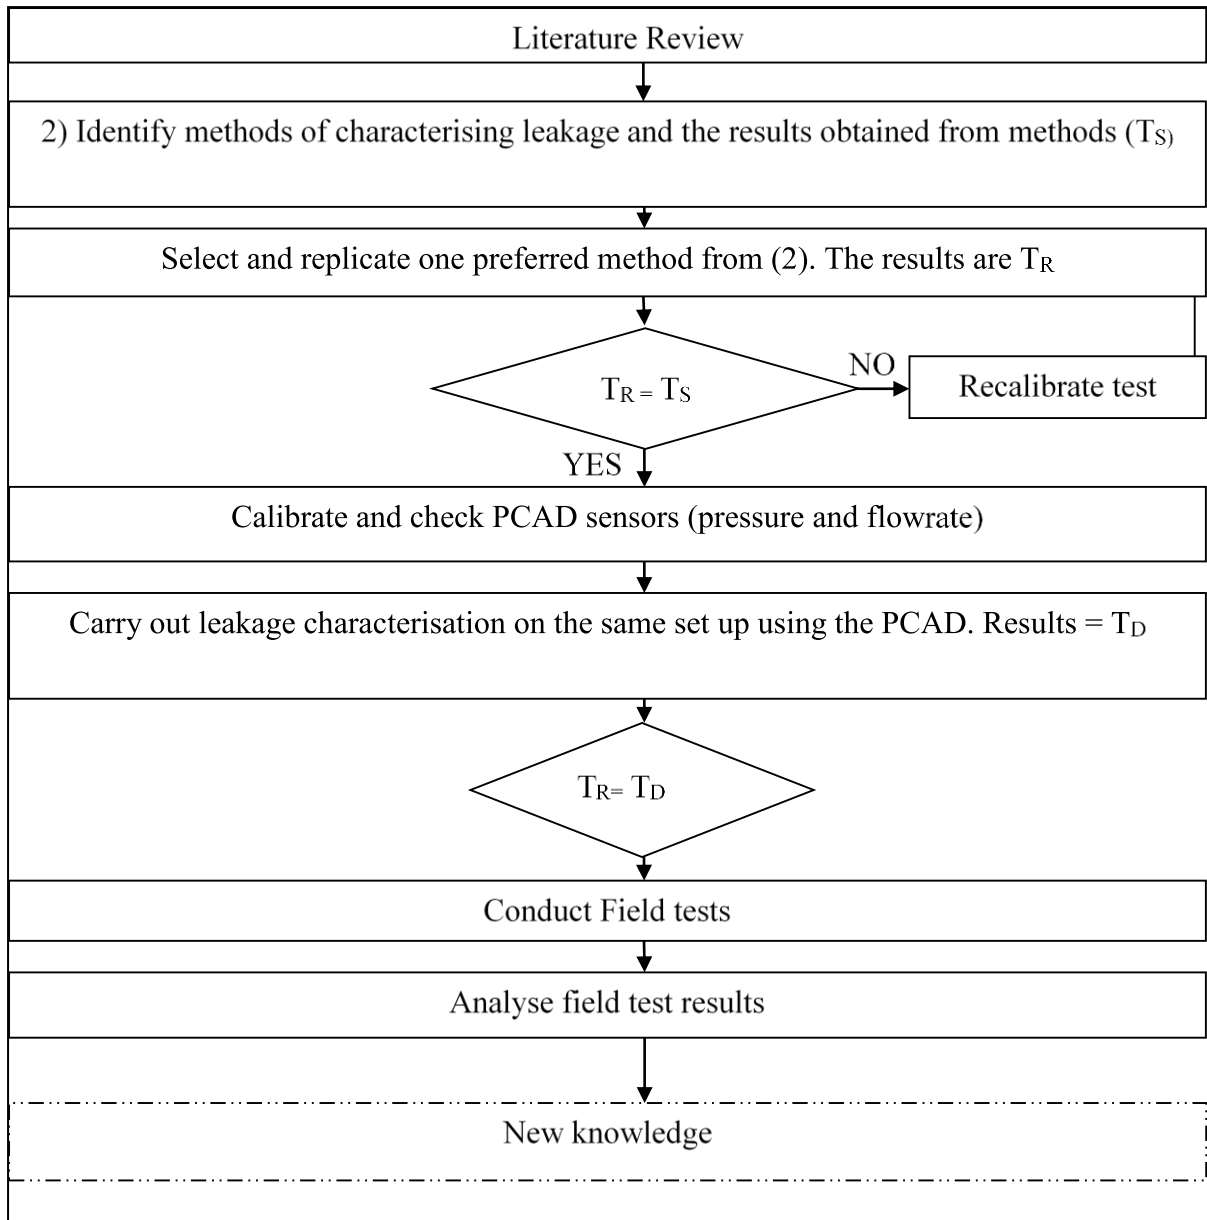
Figure 3-1 - Research Method Flowchart

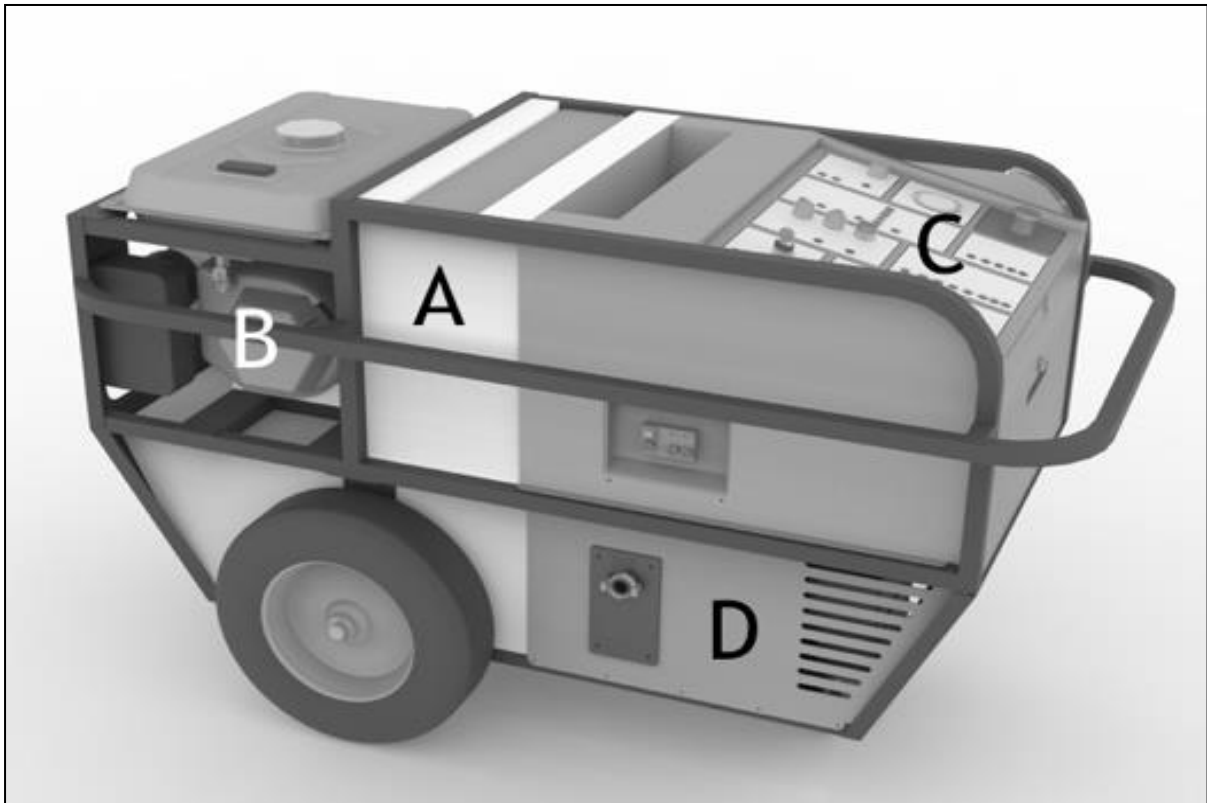
Figure 3-2 - PCAD components (Lopez and van Zyl, 2019)

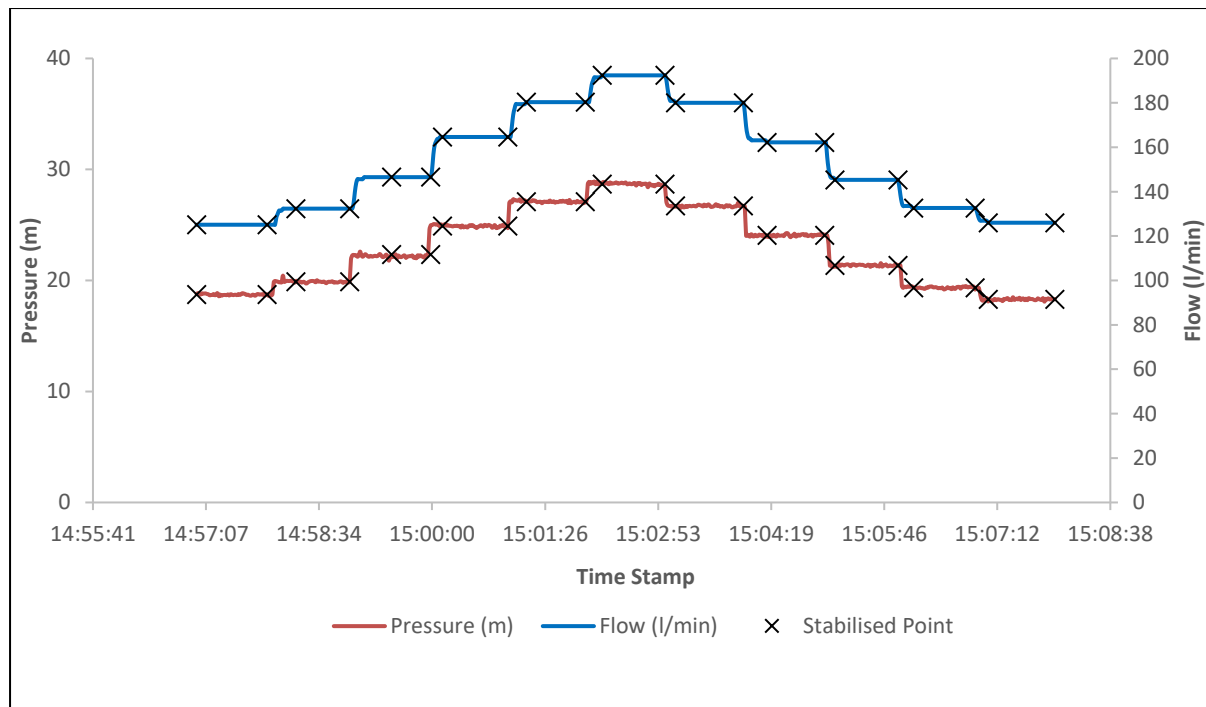
Figure 4-3 - Pressure and flow rate variations during a test

steps. The different pressure steps were obtained by varying the pump speed on the pump controller. The pressure was incrementally increased in 5 steps from the lowest pump speed to the maximum speed, as shown in Figure 4-3.

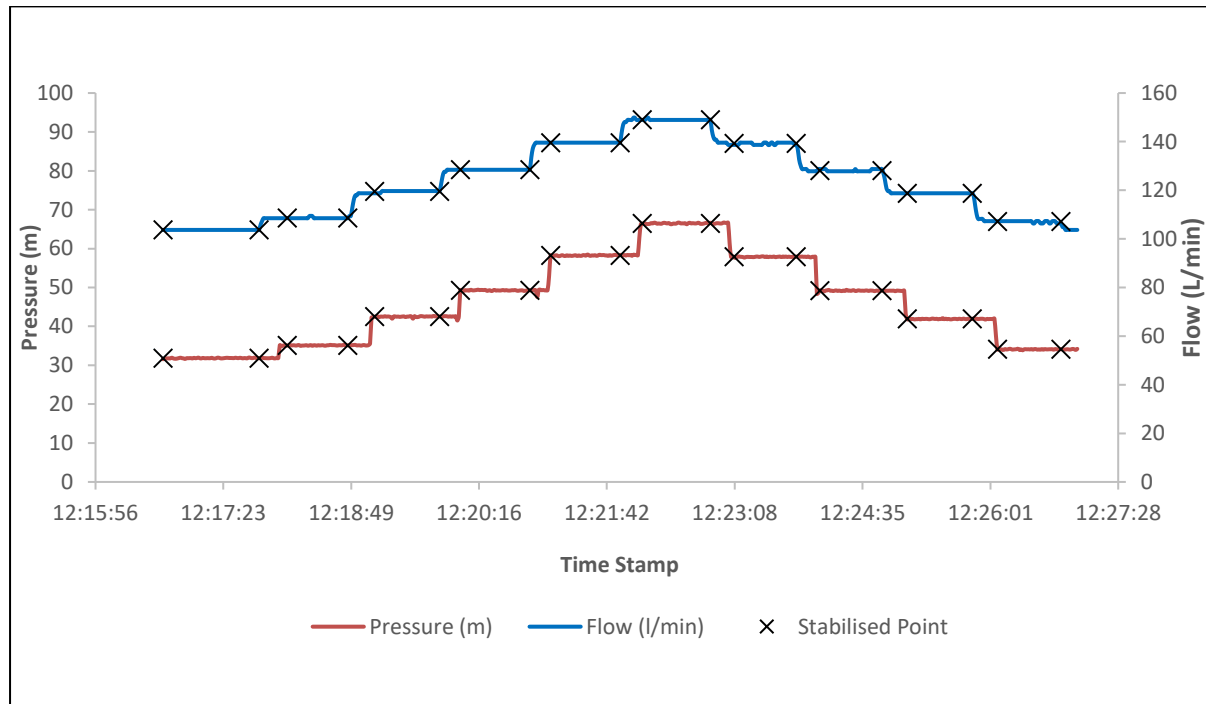
Figure 4-5 - Pressure head-flow rate relationship for a typical test

Ten tests were done on the 12 mm uPVC pipe section, and the following results were obtained. The pressure and flow were recorded, and the stabilised steps defined as periods where the pressure variation was less than 0.1 m were then used to analyse the data. Figure 4-5 shows a typical uPVC round hole pressure and flow relationship at each step.

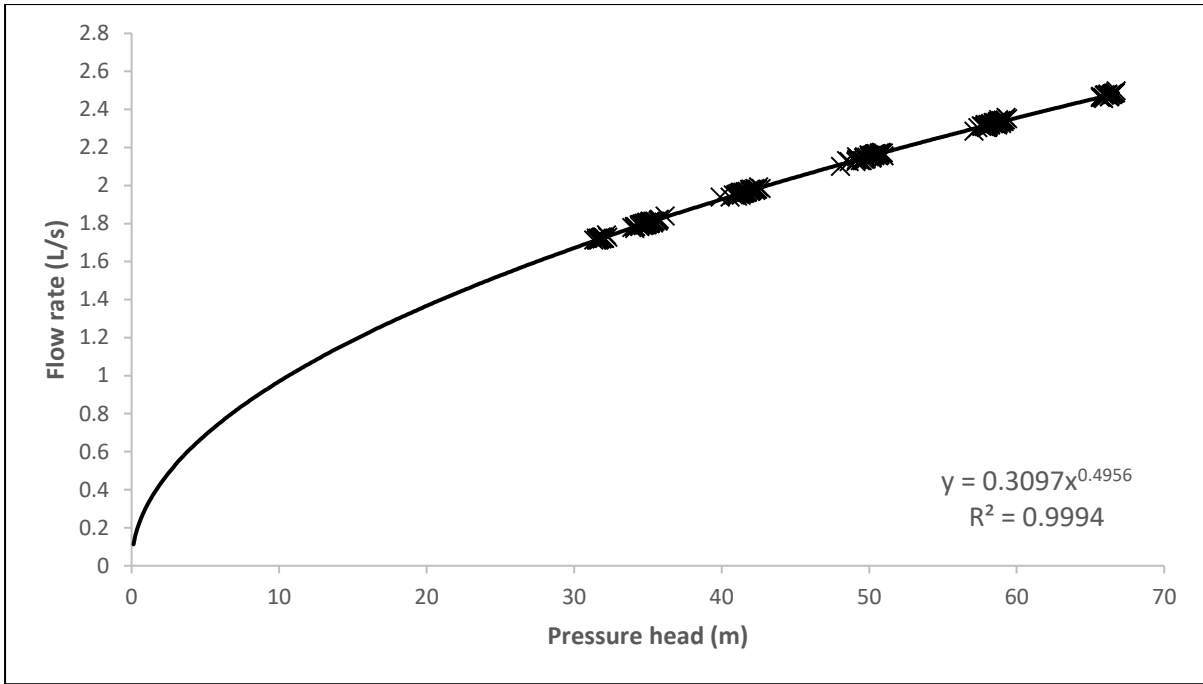
Figure 4-6 - Flowrate-pressure power relationship

The N1 value for the combined data points of pipe sample tests was found to be 0.496. The standard deviation on the N1 value across all tests conducted was 0.0027 and sample variance (variance of the N1 values of the ten conducted tests) of 7.32E-06 (0.002% of the N1 value). This showed little variance in the values found in the tests and represents excellent repeatability and reliability of the conducted tests for the N1 exponent.

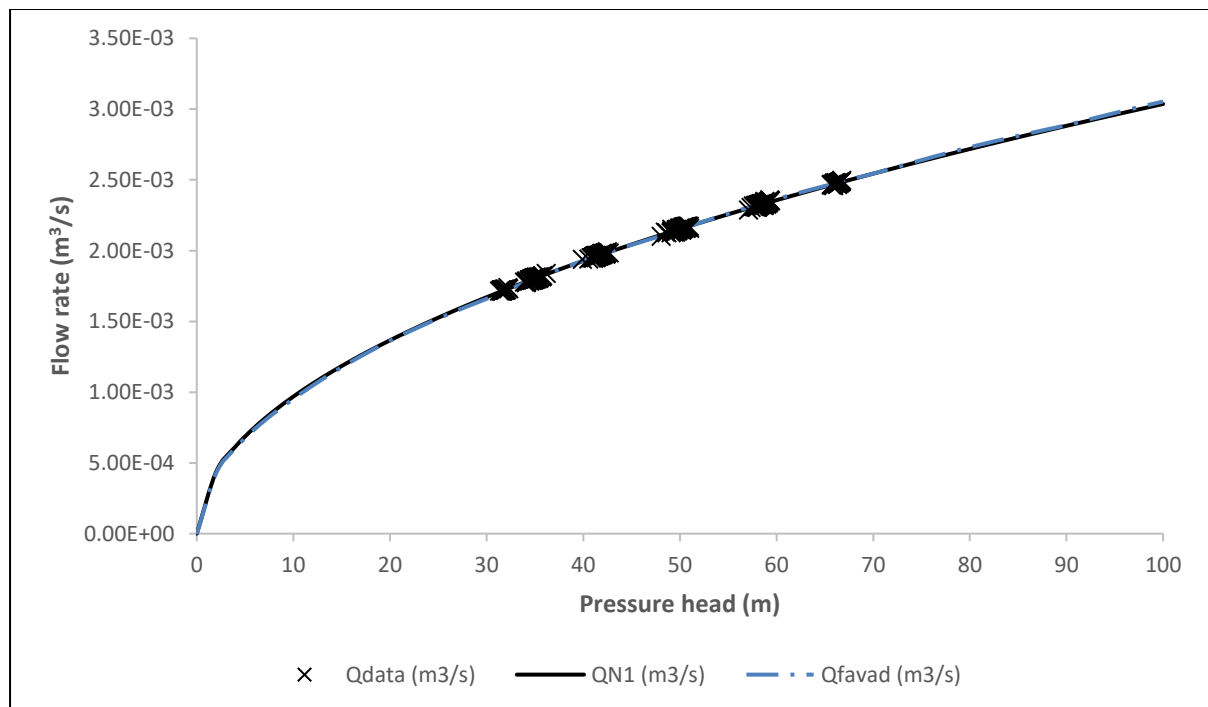
Figure 4-8 - Comparison of the FAVAD and N1 equation flow predictions and observed data

The flow rate predictions of the FAVAD (modified orifice equation) and N1 equations were compared, as shown in the graph in Figure 4-8.

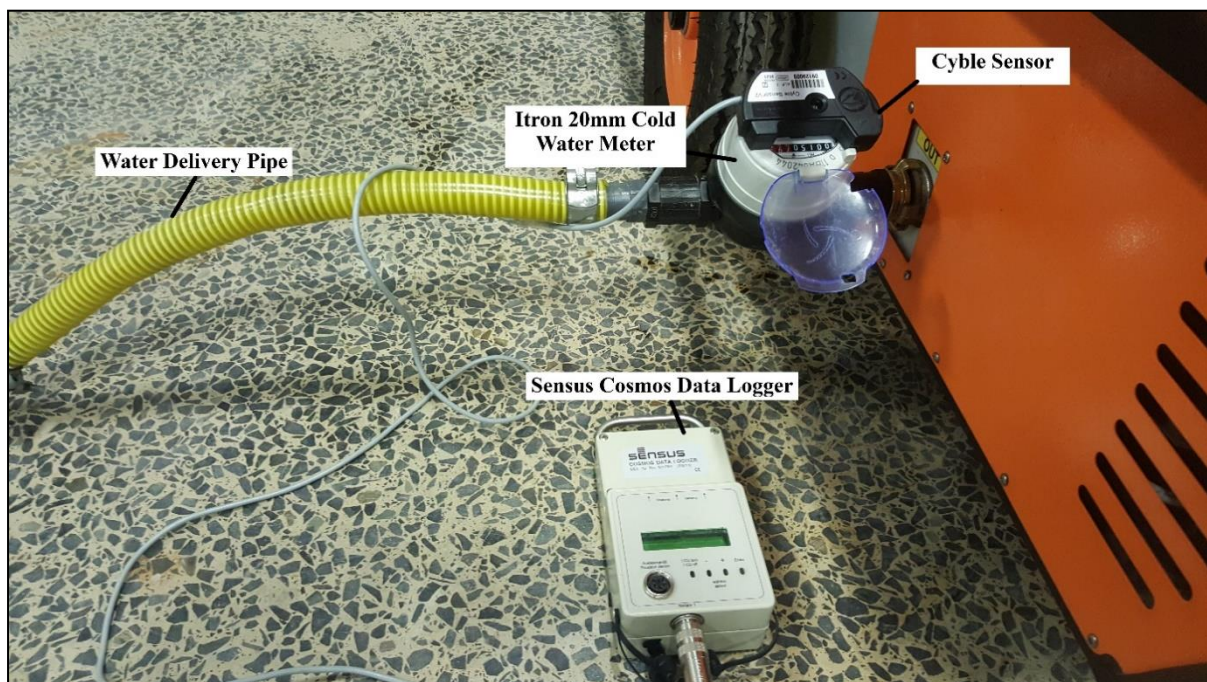
Figure 6-4 - Checking the PCAD's flow sensors

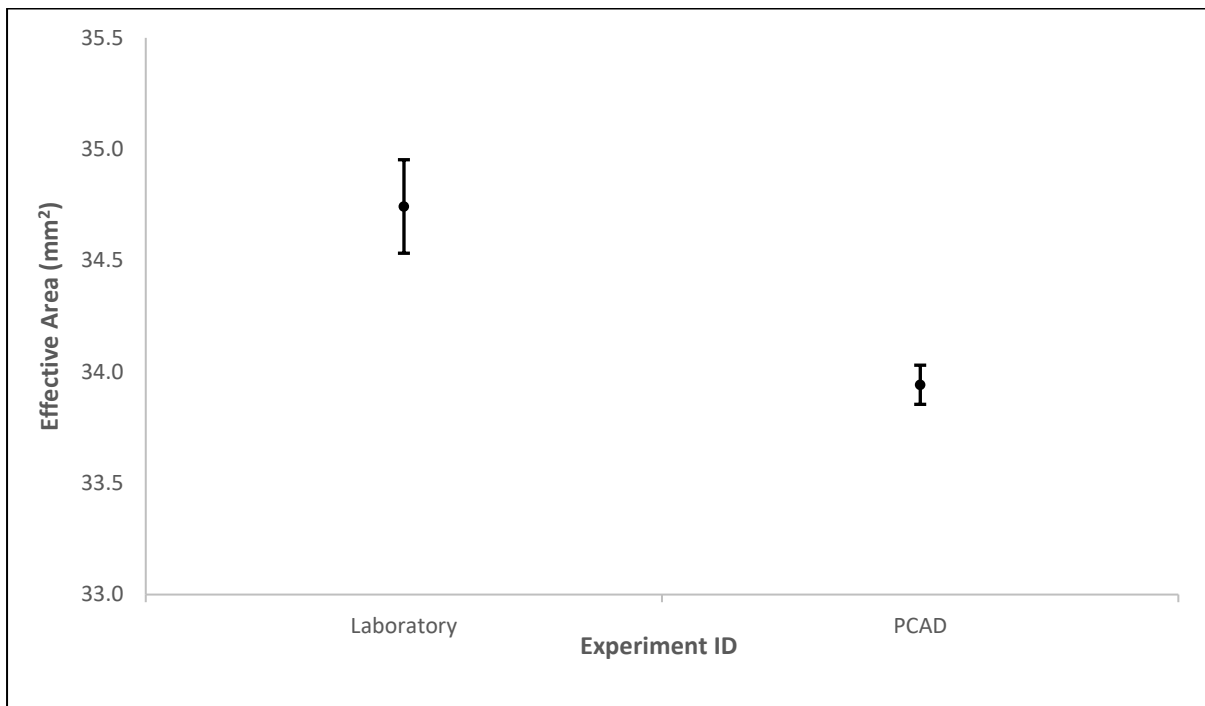
Figure 6-33 - Comparing the effective areas

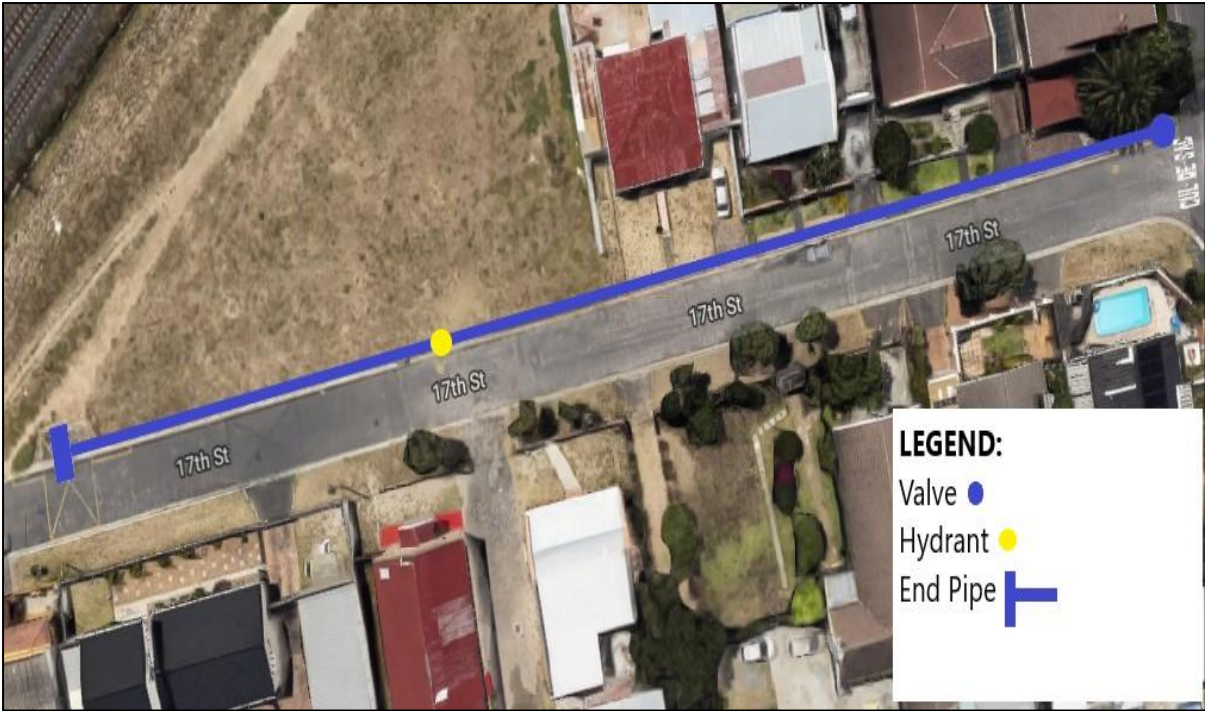
Figure 7-10 - Test pipe located on 6th Avenue and 17th Street, Kensington.
