Earthquake Engineering and Hazards Reduction in China: A Trip Report of the American Earthquake Engineering and Hazards Reduction Delegation Submitted to the Committee on Scholarly Communication With the People's Republic of China (1980)

Earthquake Engineering and Hazards Reduction in China

A Trip Report of the American Earthquake Engineering and
Hazards Reduction Delegation

Edited by Paul C. Jennings

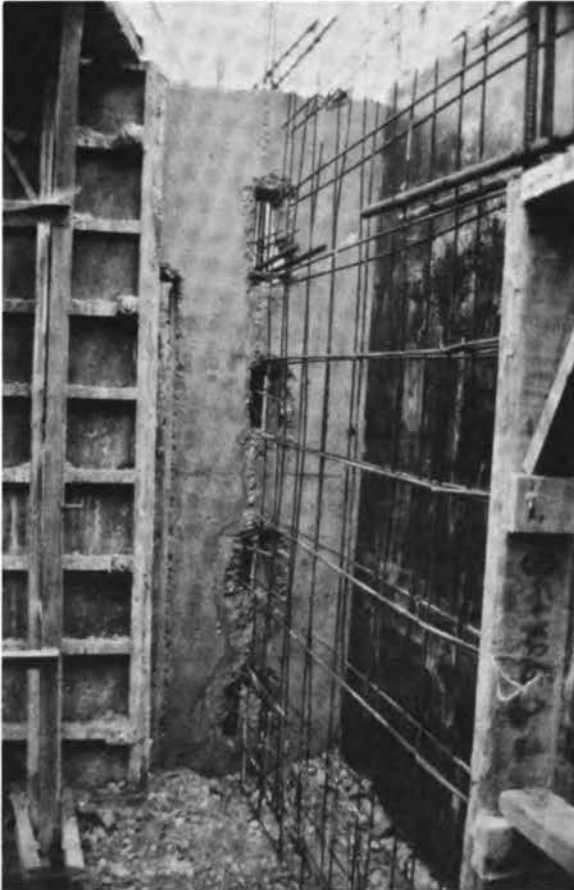
FIGURE 3.16 Preparations for cast-in-place shear walls in an apartment building in Peking. The transverse walls are cast first with blockouts. Forming and reinforcing shown for longitudinal wall are to be cast next. Note the steel wall forms.

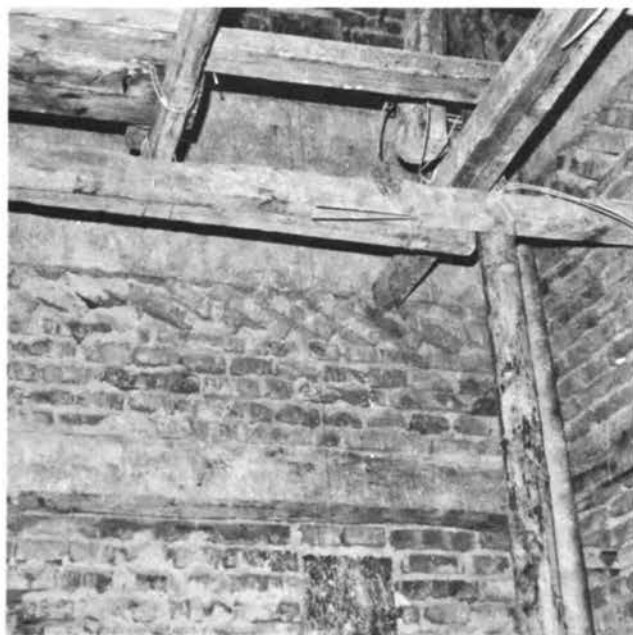
cavity walls as shown in Figure 3.21 with one wythe of brick on the exterior and a lightweight concrete block on the inside; the exterior will be plastered. The interior nonstructural walls are of brick of low quality. For example, Figure 3.22 shows the walls around the elevator enclosure. Note the "leaning soldiers" under the concrete floor beam; this detail was seen often in construction throughout China.

FIGURE 3.22 Interior of elevator shaft of Peking Duck Restaurant showing brick filler walls. Note "leaning soldier" bricks at top, a method of filling space, not a module of brick dimensions.

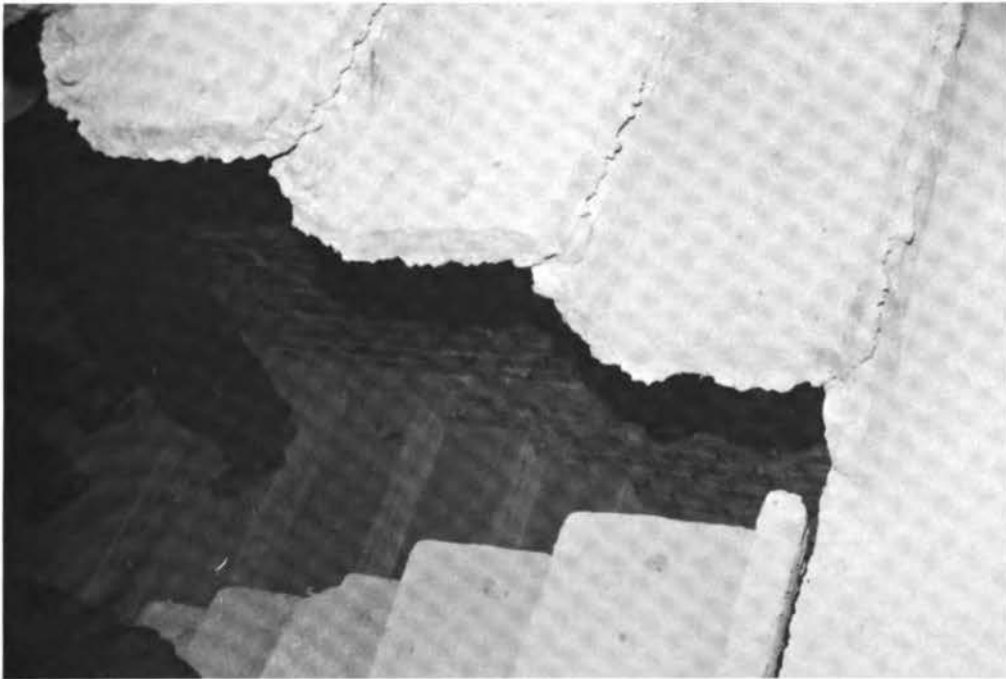
The second project in Harbin was a six-story apartment house shown in Figure 3.28. This is also a masonry bearing wall structure, but in this case the exterior walls are made of 12-in. thick lightweight concrete block using a fly ash aggregate. This provides added insulation for the cold winters (Harbin has the same latitude as Billings, Montana). Interior bearing walls are of brick. In some cases the walls just butt against each other without ties, while at other walls some effort was made to tie the walls together as shown in Figure 3.29. The floor-to-wall detail is similar to that shown in Figure 3.24. An interesting detail was noted at the stair; one riser and one tread were precast as a unit with about 1½-in. thick concrete. In assembly, the units are connected neither to the landing nor the floor slab; each unit cantilevers out of the 8-in. thick unreinforced brick wall (Figure 3.30).

FIGURE 3.30 Harbin apartment building of Figure 3.28. The precast stair units, consisting of one step and one riser, are cantilevered from the unreinforced brick wall.

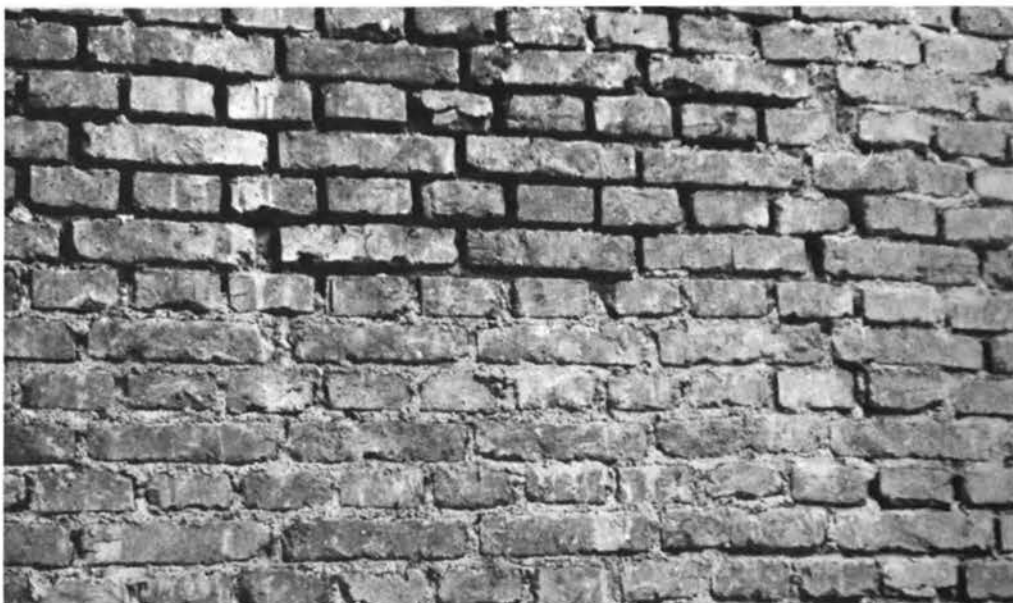
The third project was an almost complete six-story apartment house shown in Figure 3.31. It was a part of a large complex of about a dozen similar buildings. The construction was similar to that discussed above, namely, unreinforced brick bearing walls, precast floor units, precast stairs, etc. A portion of one of the walls is shown in Figure 3.32, illustrating the variability of workmanship in the construction of the wall.

FIGURE 3.32 Apartment building shown in Figure 3.31. At lower left, joints are filled. In upper portion, head joints are open, and bed joints only partially filled.

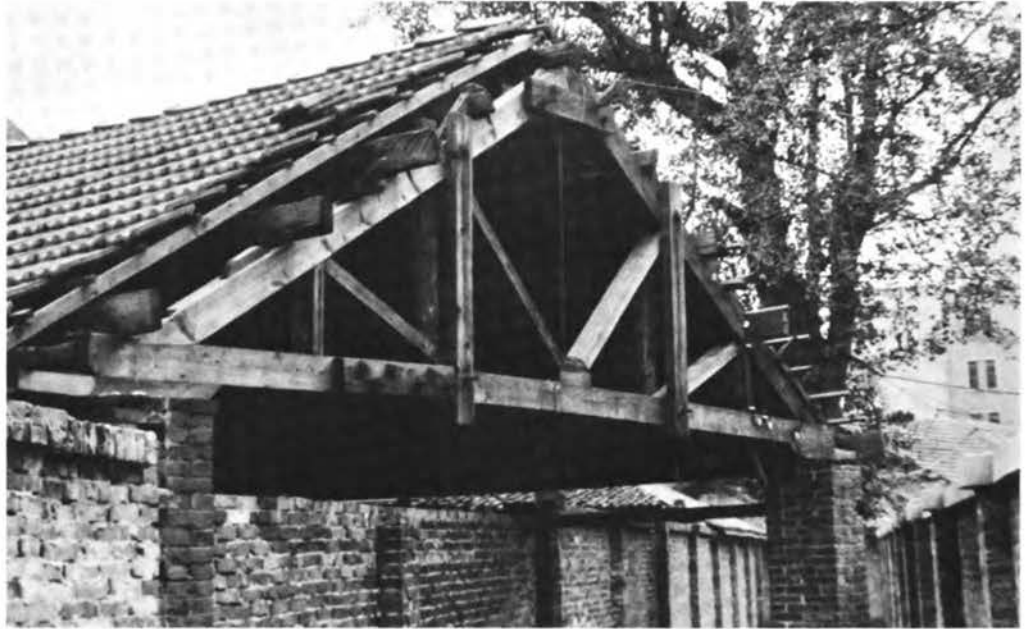
FIGURE 3.35 Timber truss on small building in Chengtu near apartment building of Figure 3.33. Note unreinforced brick columns, which are used extensively in China.

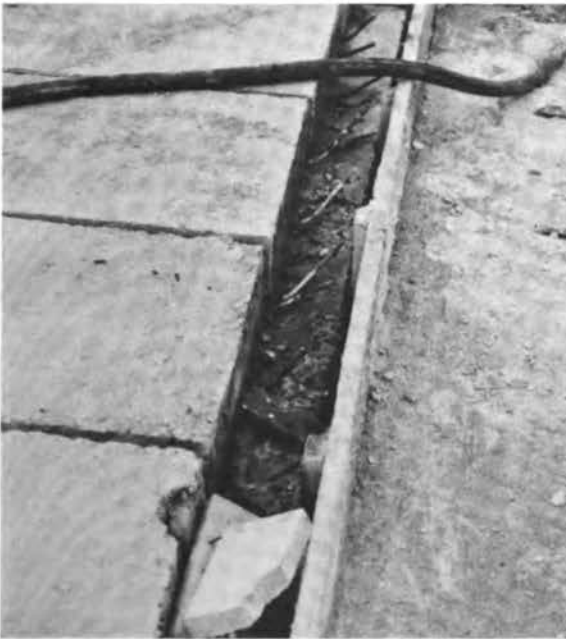
Figures 3.37, 3.38, and 3.39 show views of the building. The concrete frame is cast in place from the third floor up, whereas the first-floor columns and some second-story columns and beams are precast; an example of the connections is shown in Figure 3.40. Floors are precast hollow concrete planks with a topping. When the topping is placed, stirrups (Figure 3.41) from the cast-in-place beam will tie the slab to the beam where the slabs are parallel to the beam, but the tie to the beam that supports the slab appears minimal, as can be seen in Figure 3.42.

FIGURE 3.42 Chengtu office and storage building. The view is near that of Figure 3.41. Ties from the beam are minimal where beam supports slabs.

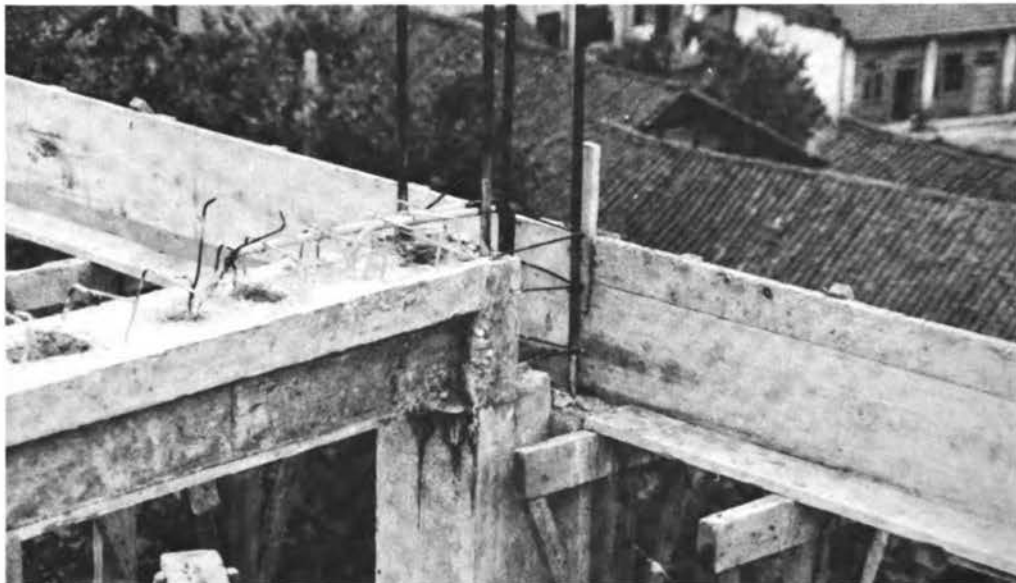
Figures 3.43 and 3.44 show a cast-in-place column and beam and the forms for the cast-in-place spandrel beam that will be poured next. This sequence results in construction joints through the structural joint itself. There is no provision for shear in the joint, and the detailing provides for little ductility.

FIGURE 3.43 The columns and transverse beams have been cast in place in this detail of an upper floor. Forms are in place for the cast-in-place spandrel beam. The joint is integral but a construction joint goes through the center.

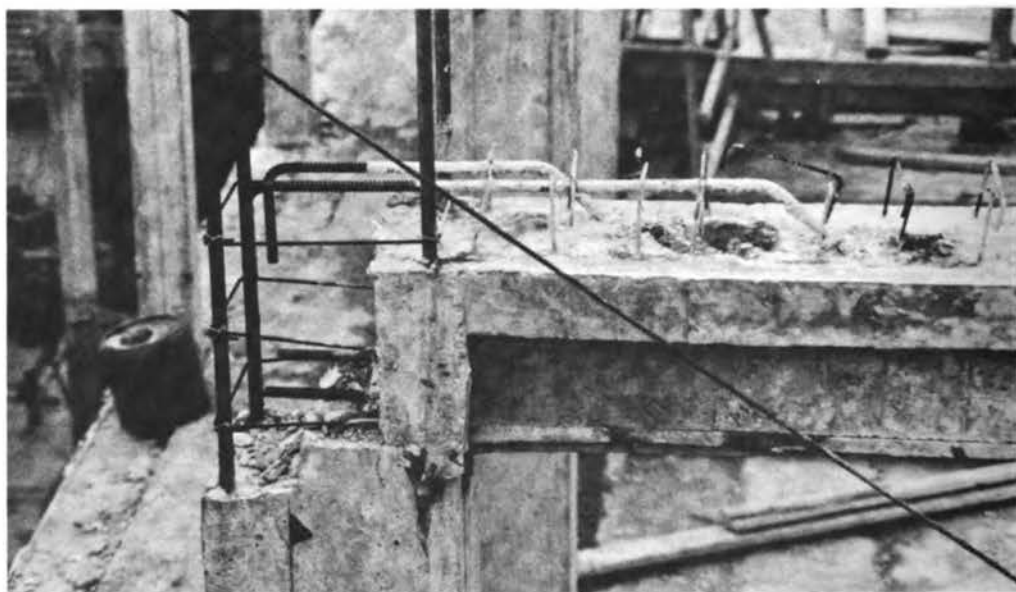
FIGURE 3.44 Upper floor detail of the Chengtu office and storage building. This is the same joint shown in Figure 3.43.

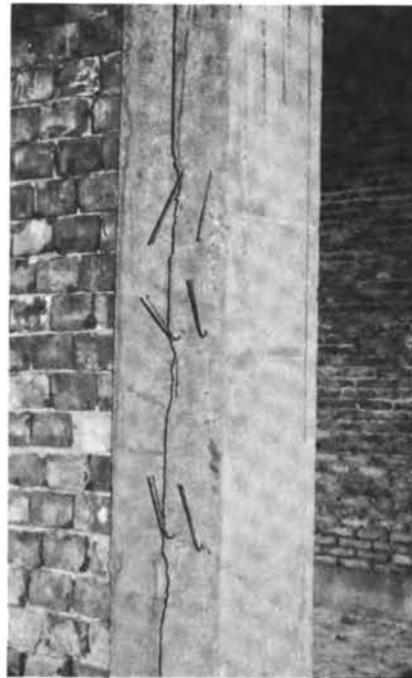
case there are dowels to column but no keys. The construction is illustrated in Figures 3.45 and 3.46. In response to a question about the amount of inspection that is customary, we were told that on this particular project they took samples of the concrete and mortar at each floor and that the job superintendent has special personnel to check the placement of the reinforcing steel. In addition, the design office has three men on the job at all times to inspect the work.

FIGURE 3.46 Brick shear walls in the Chengtu office and storage building had dowels protruding from adjacent columns, but shear keys were not provided.

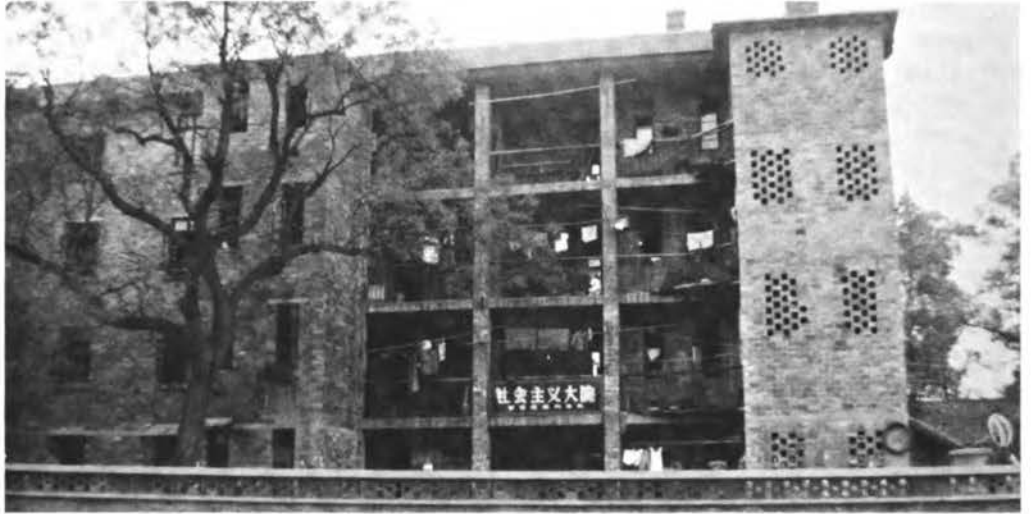
In the same vicinity there were a number of four-story apartments similar to that shown in Figure 3.47. Note the four-story high brick columns.

FIGURE 3.47 Occupied brick apartment house in Chengtu. Note the brick columns.

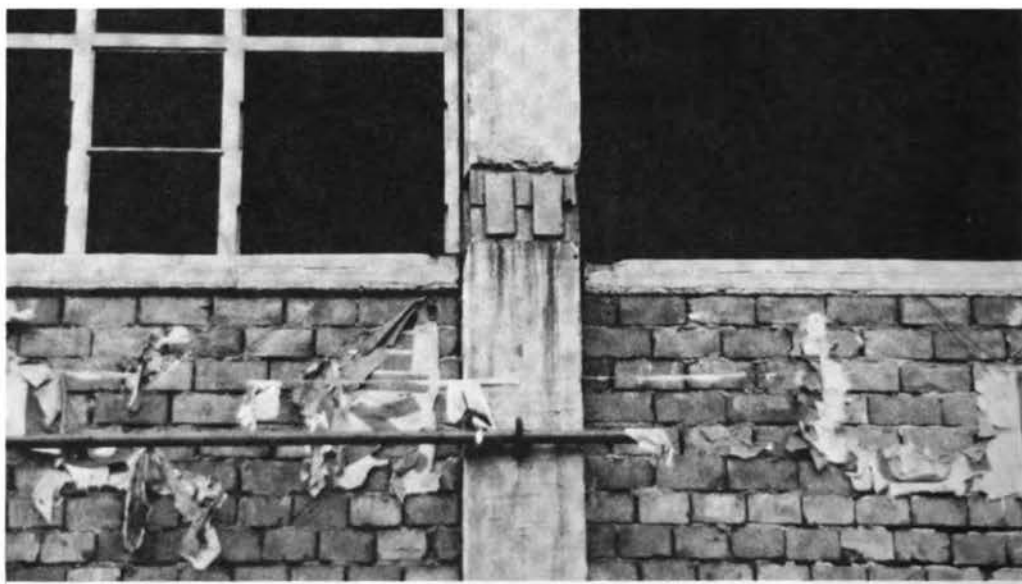
FIGURE 3.50 Precast column connection in one-story portion of Chengtu industrial building.

practices resemble California practice prior to the adoption of current American Concrete Institute and Structural Engineers Association recommendations.

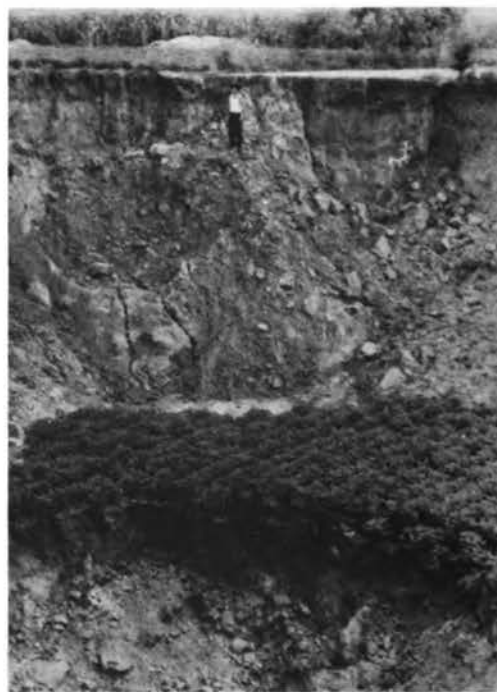
An unusual feature of the Tangshan earthquake was the formation of craters in the countryside. An example of a crater of moderate size is shown in Figure 4.7. A partial view of a very large crater is shown in Figure 4.8. These craters were not associated with the extensive underground excavation for coal mining, but they have not yet been studied thoroughly and the reason for these ground collapses has not been established; one suggestion was that limestone karsts may have been responsible.

FIGURE 4.7 Ground collapse near Tachuangtuo Commune, Kuyeh Hsien. The Tangshan earthquake triggered the formation of a number of such craters. Geological investigations had not yet determined the underlying cause of these craters.

FIGURE 4.8 View of the interior of a very large crater formed near Hsiaotun, Chengchaungtze Commune, north of Tangshan.

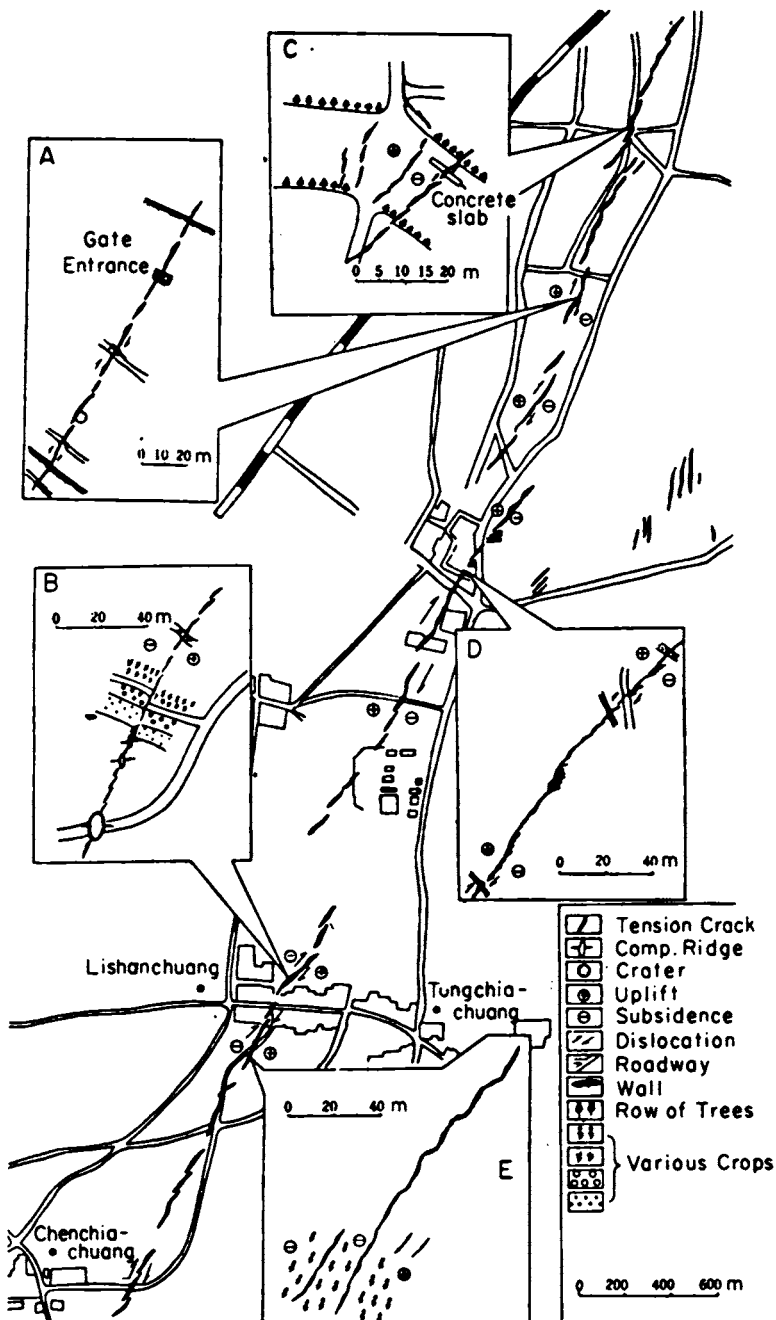
Surface faulting occurred within the city of Tangshan over a length of between 8 and 10 km. Maximum displacement reached 3 m in a right-lateral strike-slip sense. The northwest side was usually raised, and extension of the ground surface over a width of 300 m was as much as 0.5 m. Buildings on the faults were damaged by the slip, whereas farther out, damage was lighter. Damage also was lighter at the ends of the fault segments. The surface faulting developed in five en echelon segments as shown in Figure 4.17. The individual surface breaks had an approximate strike of $N40^{\circ}E$, and the overall zone of surface breaks trended roughly $N30^{\circ}E$. This zone followed essentially the southwestern section of the Tangshan-Kuyeh fault, and surface breaks were developed in the loose Quaternary sediments. Roads and rows of trees were offset (Figures 4.17, 4.18, 4.19, 4.20), and compressional ridges were seen that were consistent with the ENE compressive axis and the NNW tensional axis.

FIGURE 4.17 Surface faulting observed in the city of Tangshan. (A) Tangshan 10 high school; (B) North Lishanchuang; (C) Intersection of Yungung Road and Hoping Street; (D) Tangshan native product warehouse; (E) South Lishanchuang.

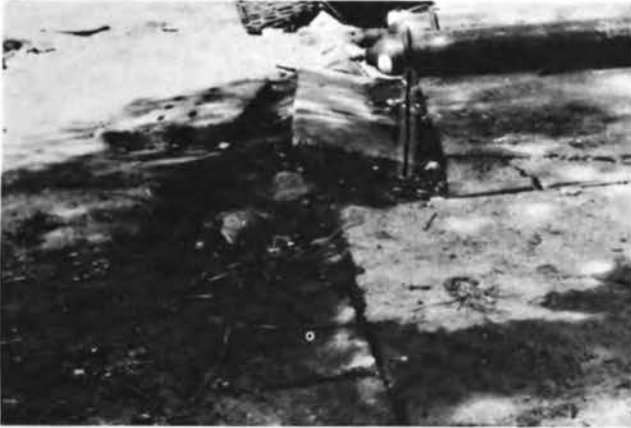
FIGURE 4.18 Surface breaks and compressed pavement over drainage trench in Tangshan.

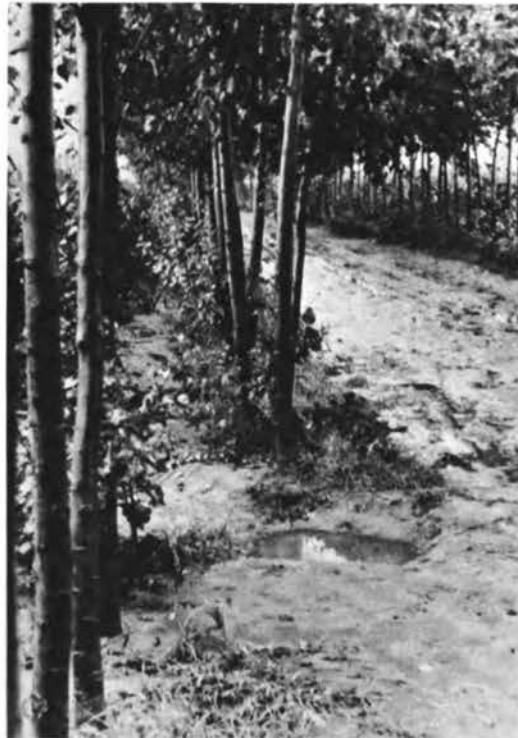
FIGURE 4.19 Offset in row of young trees by surface break near Laoting Hsien (direction N40°W, maximum displacement, 0.8 m).

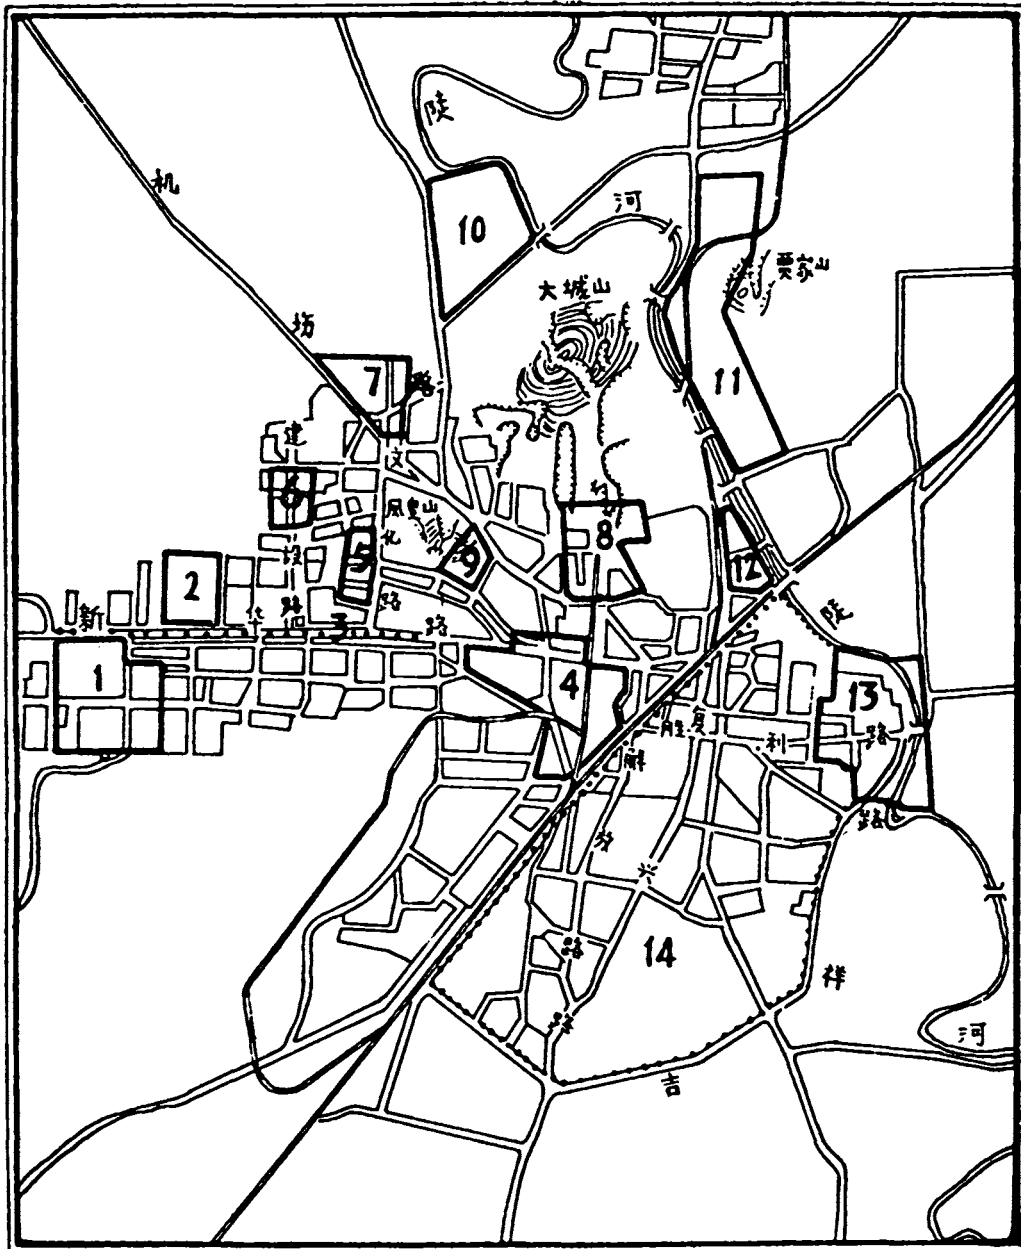
Detailed studies were made of the damage in Tangshan, and the statistics are most impressive. In one study, 14 districts in Tangshan, shown in Figure 4.21 were selected for detailed damage compilations. The results are shown in Table 4.4. There were 352 multistory brick buildings in the 14 districts and of these, 117 collapsed completely, 85 suffered partial collapse, 99 suffered severe damage, 34 sustained moderate damage, 13 sustained slight damage, and 4 received no damage at all. Approximately one third of the buildings were in these 14 districts.

FIGURE 4.21 Plan of Tangshan City showing the 14 districts in which special damage studies were made (Table 4.4). Three hundred and fifty-two multistory buildings in these 14 districts were studied; a total of 916 multistory buildings were in Tangshan. Most of these buildings were unreinforced brick structures.

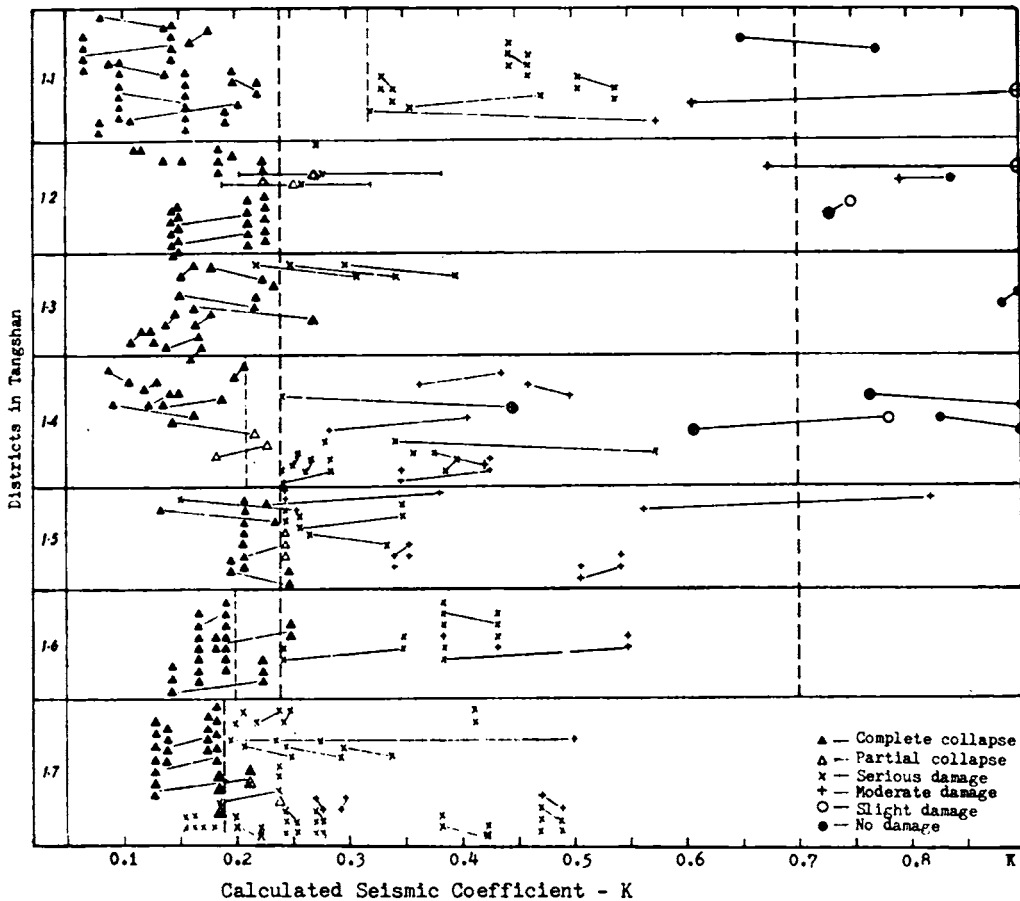
FIGURE 4.22 Plot of seismic coefficients for seven districts in Tangshan. This is a plot of calculated base-shear seismic coefficients, according to the building code, corresponding to the area of shear walls in a story. The minimum base-shear value is plotted except when only one story was damaged, and then the seismic coefficient corresponding to this story is plotted (see Table 4.5 and Figure 4.21). This plot shows clearly how the nominal code strength of the building relates to the degree of damage. When the seismic coefficient was less than about 0.25, most structures collapsed; when the seismic coefficient was greater than about 0.7, the structure survived with little or no damage (from Yang et al., 1978).

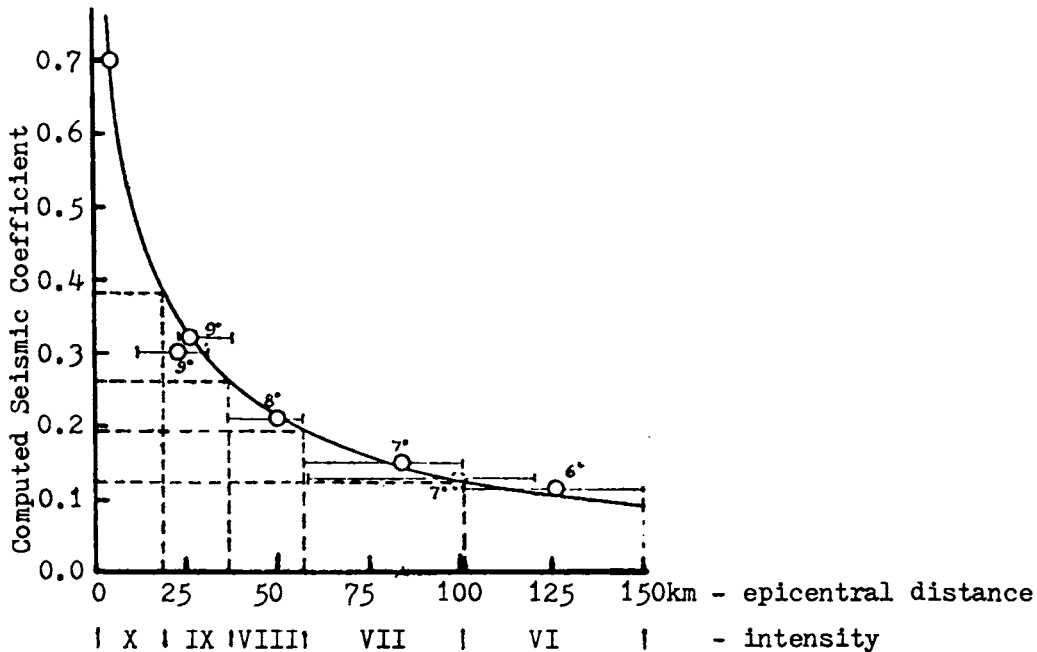
FIGURE 4.23 Plot of seismic coefficient versus intensity that produced the initial cracking, Tangshan earthquake. This is an idealized plot for the Tangshan earthquake, showing the intensity and epicentral distance at which buildings experienced initial cracking (reproduced from Yang et al., 1978).

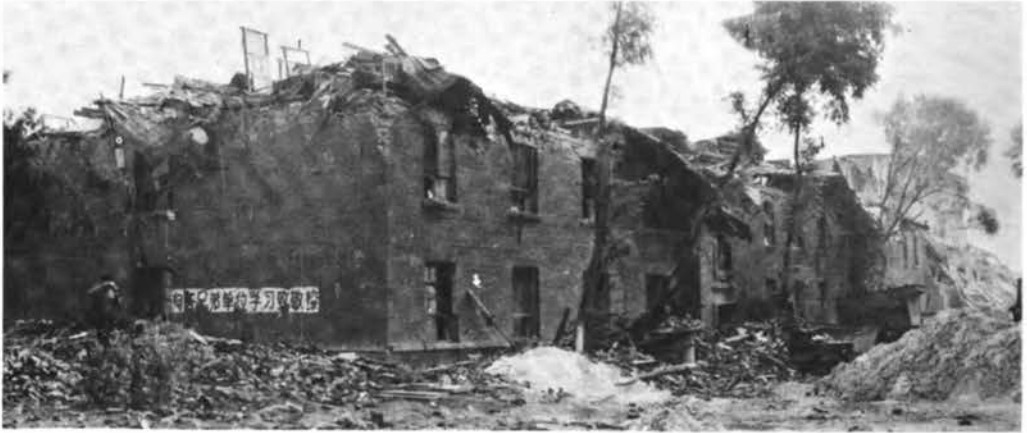
FIGURE 4.25 Collapsed top story of the three-story Kailuan coal mine dormitory, Tangshan.

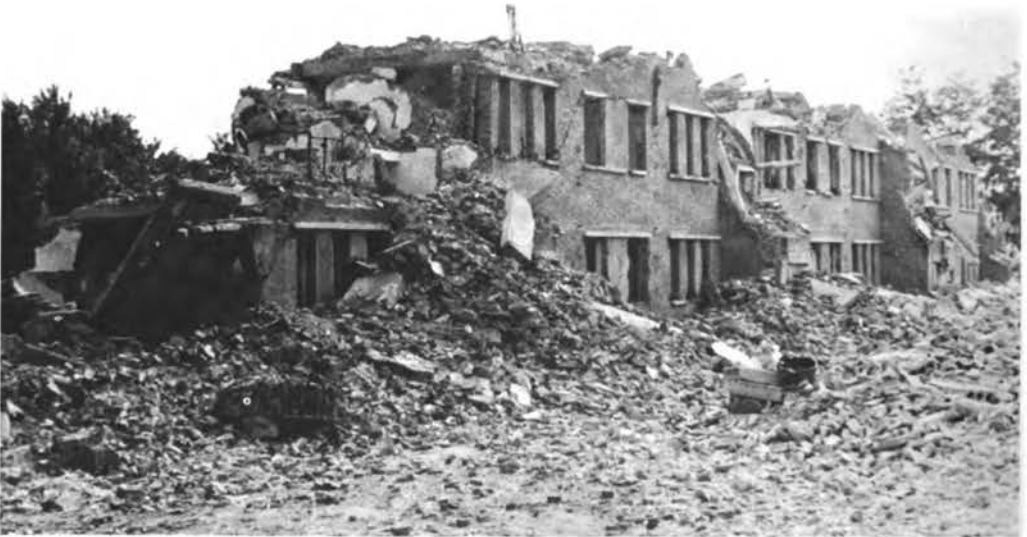
FIGURE 4.26 Collapsed four-story Tangshan Mine-Metal Institute residence building.

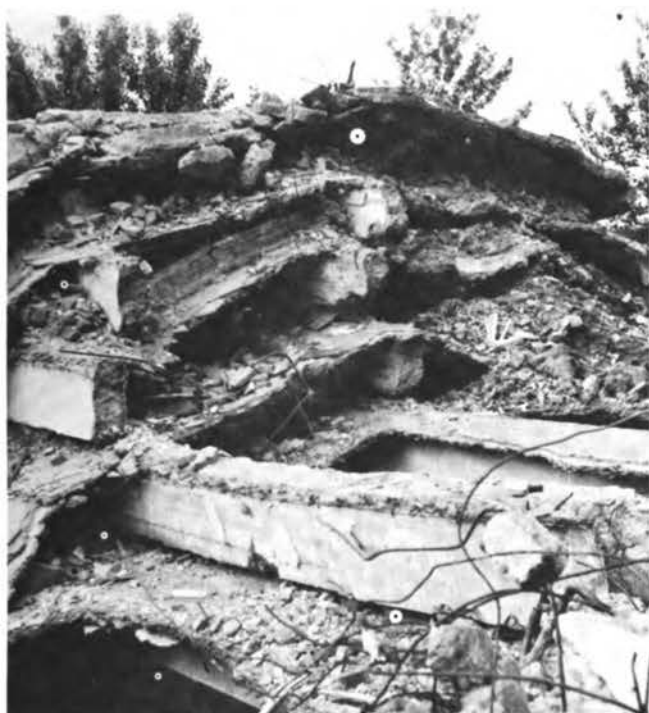
FIGURE 4.27 Collapsed five-story physics-chemistry building of the Tangshan Mine-Metal Institute.

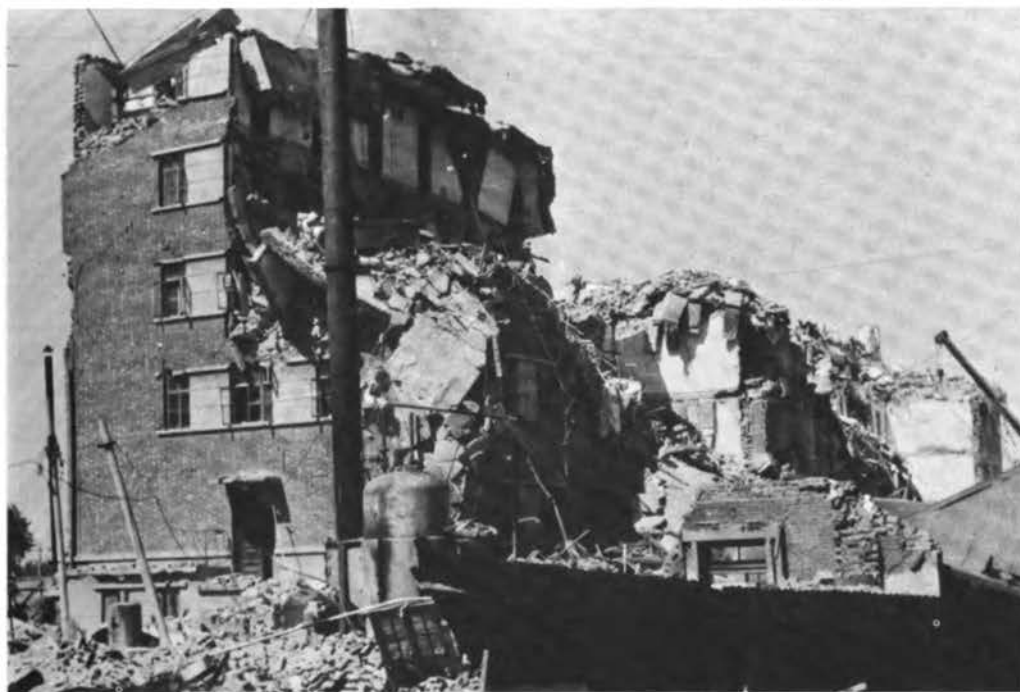
FIGURE 4.29 Collapsed five-story office building, Tangshan. The lower three stories had concrete columns, and the upper two stories were unreinforced brick without concrete columns.

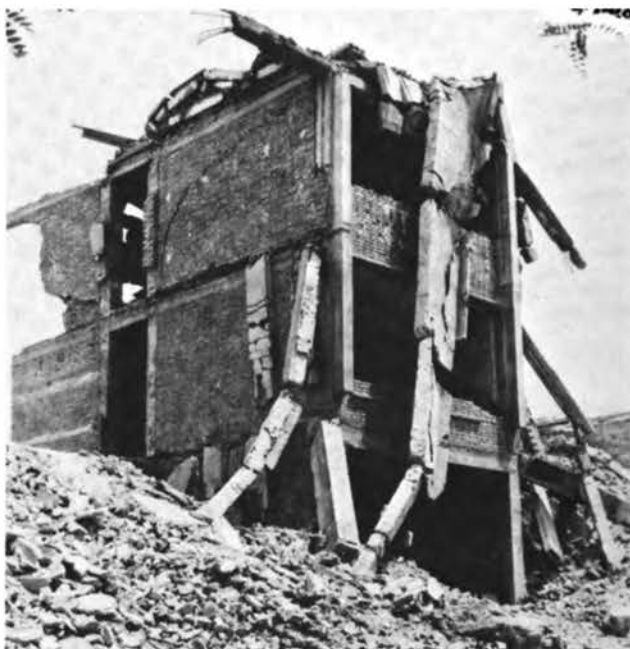
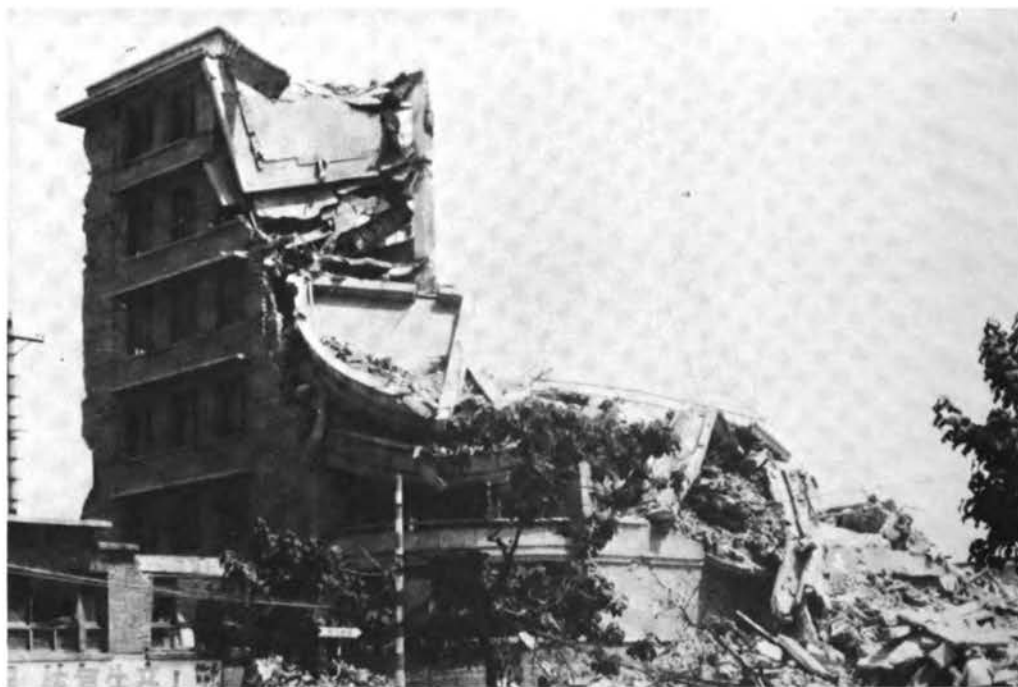
FIGURE 4.30 Collapse of six-story building at the Kailuan coal mine hospital, Tangshan.

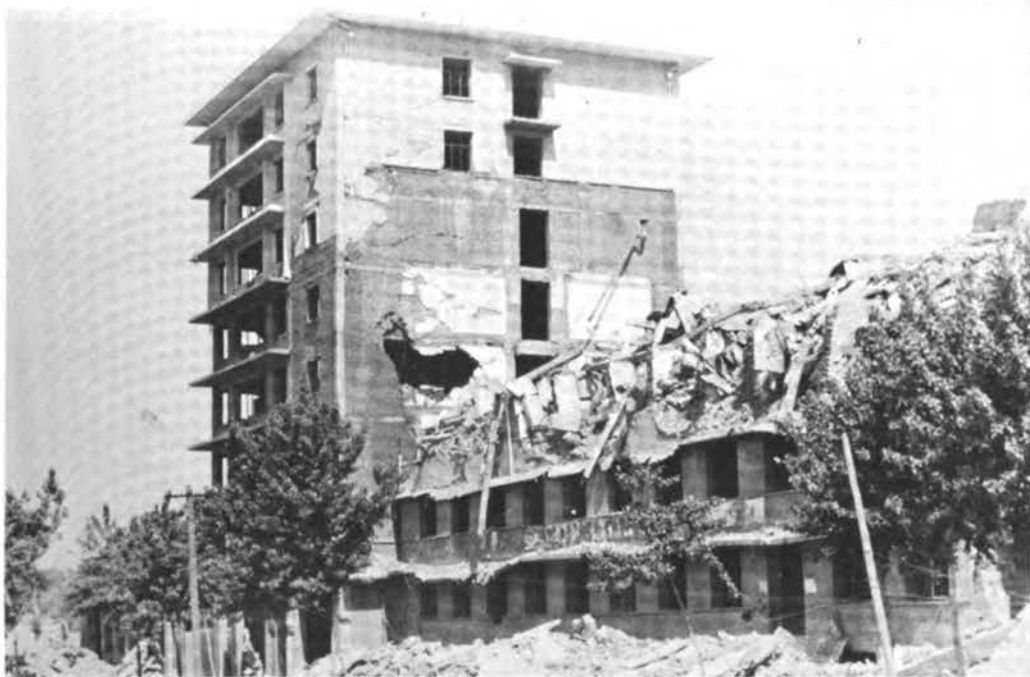
FIGURE 4.33 Collapsed workers' cafeteria building of the Chinkechuang coal mine.

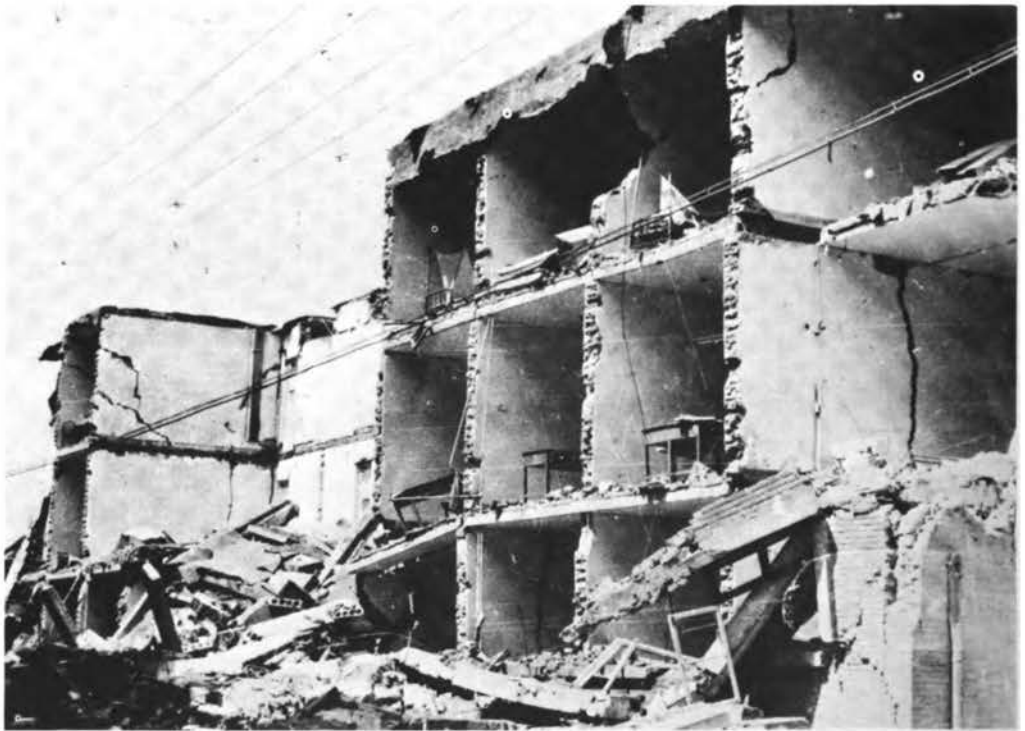
FIGURE 4.34 Partly collapsed residence building showing the type of construction: unreinforced brick bearing walls and precast concrete floor slabs.

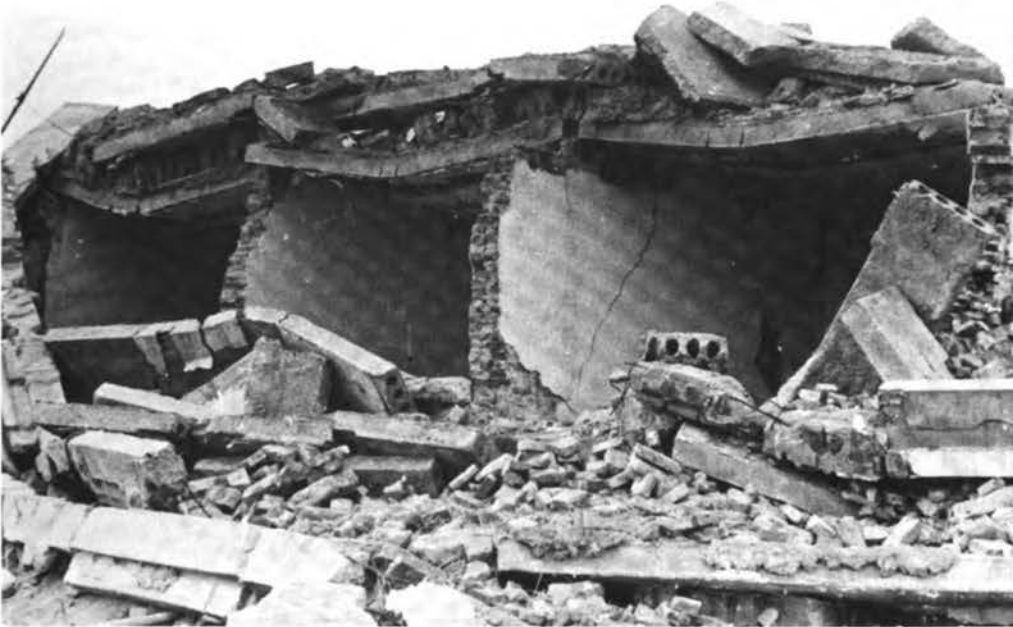
FIGURE 4.35 Collapsed building showing the type of construction: precast concrete floor slabs made of four-hole beams, simply supported on bearing walls.

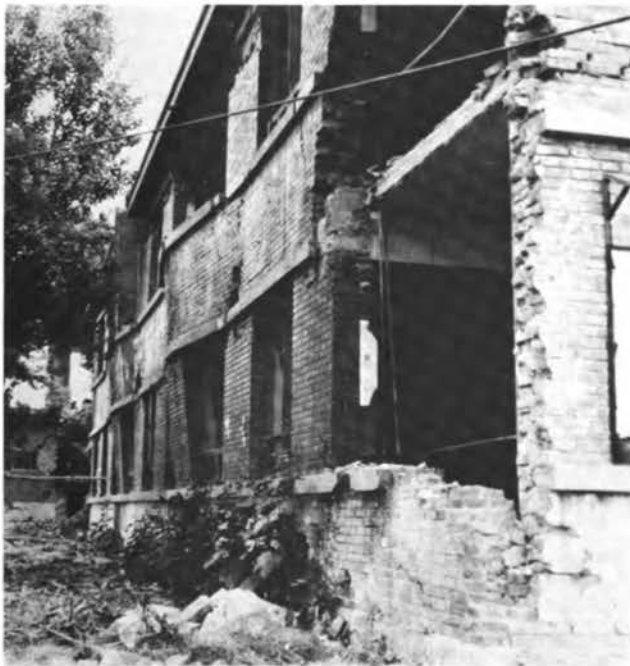
FIGURE 4.36 Badly distorted brick building on the verge of collapse. The second floor appears to be of precast concrete slabs supported on precast concrete beams, which, in turn, are supported on unreinforced brick piers.

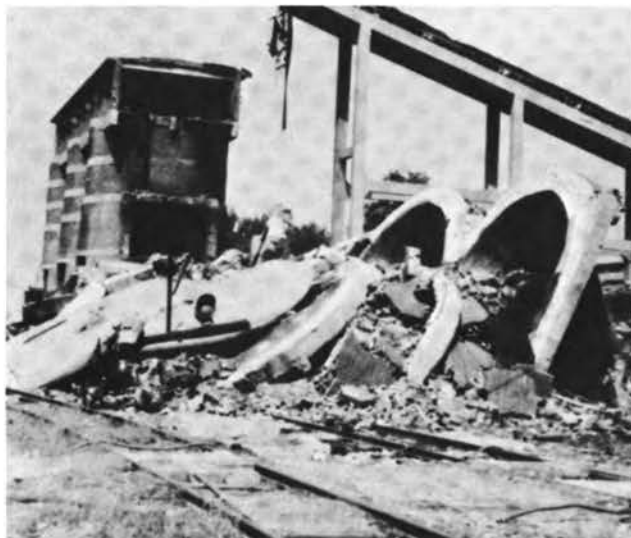
FIGURE 4.37 Collapsed brick cylindrical storage bin at the Fanchuang mine.

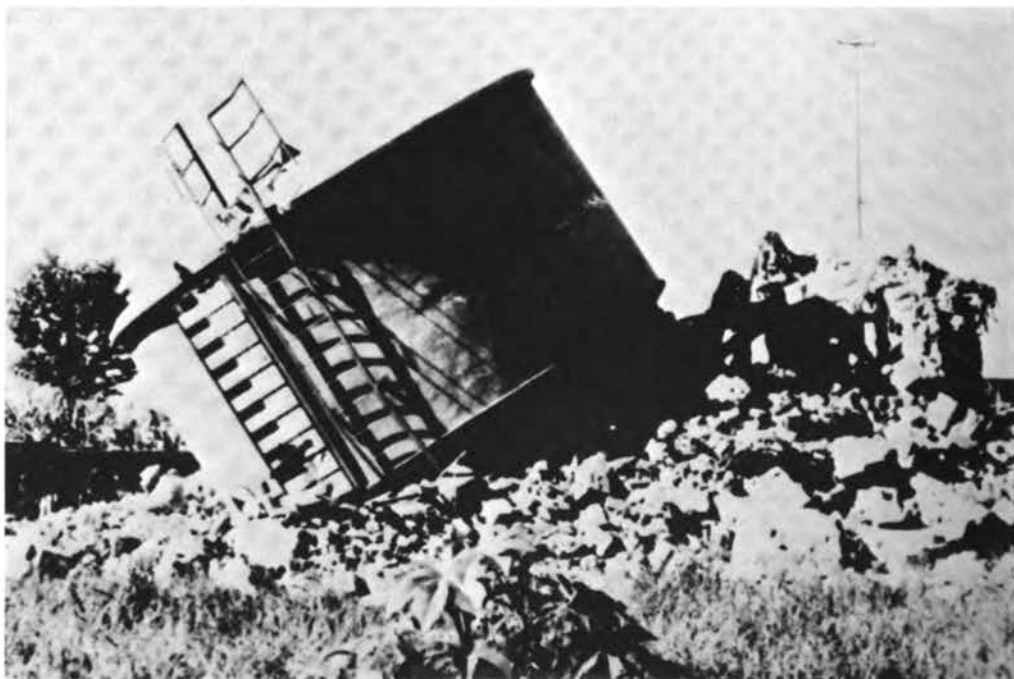
FIGURE 4.38 Collapsed elevated storage tank that had been supported on a brick cylindrical tower, Tangshan scale factory.

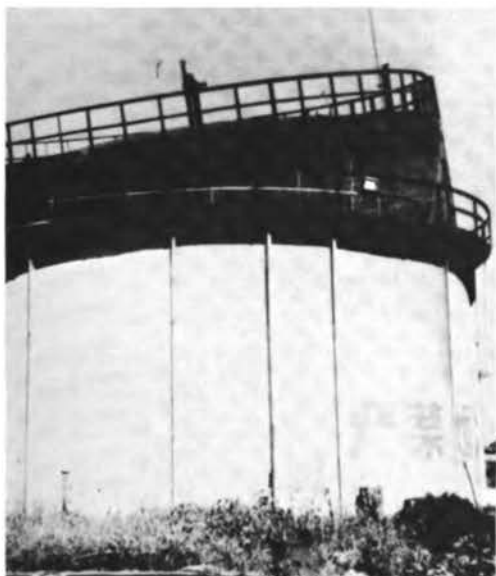
FIGURE 4.39 Damaged gas holder at Tangshan fertilizer factory.

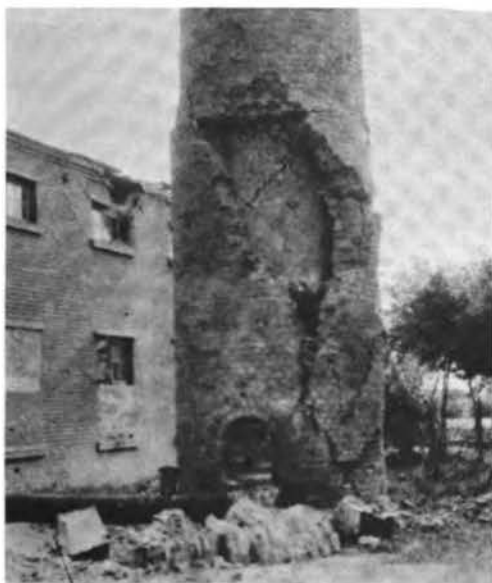
FIGURE 4.41 Damaged brick chimney.

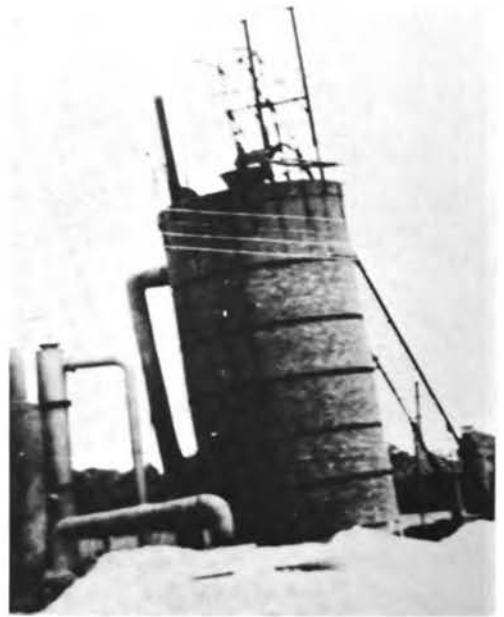
FIGURE 4.43 Tilting of a lime firing tower.

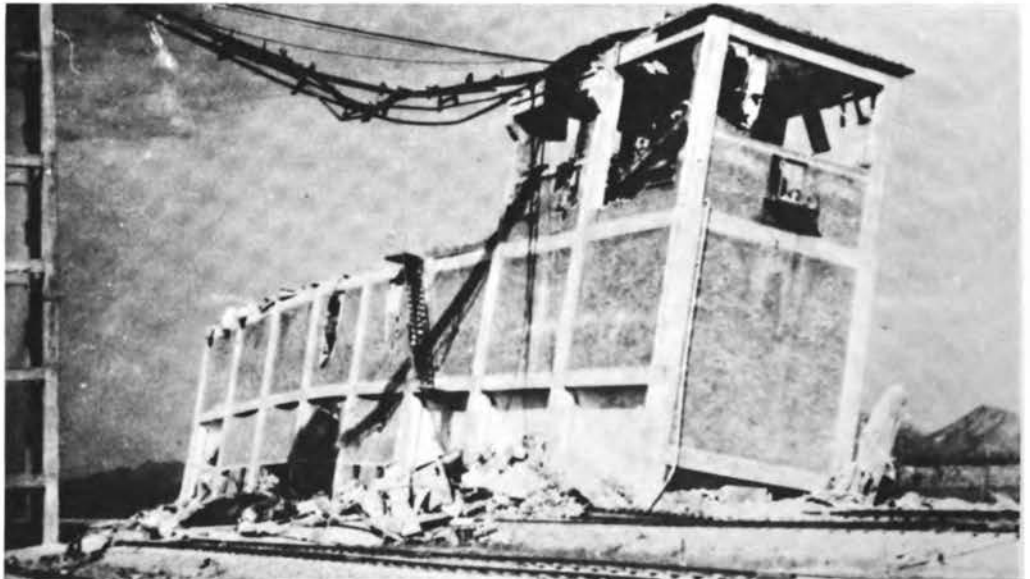
FIGURE 4.44 Collapsed coal storage structure at Chinkechuang.

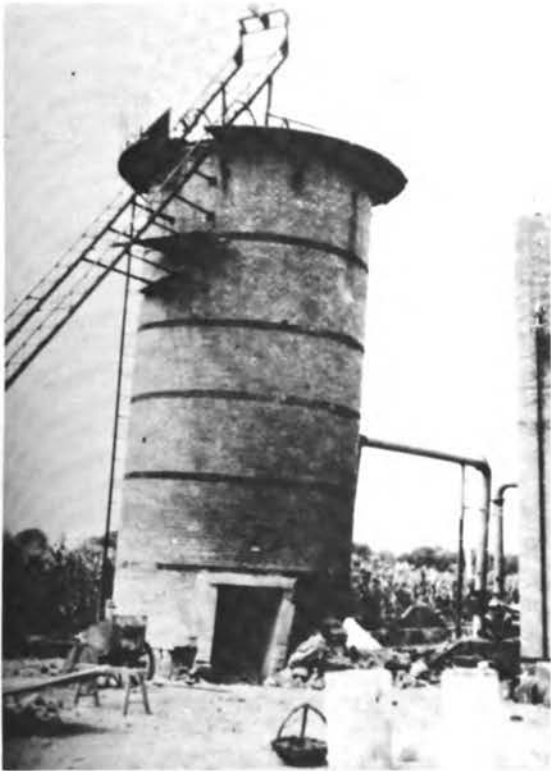
FIGURE 4.45 Tilting of brick cylindrical storage bin.

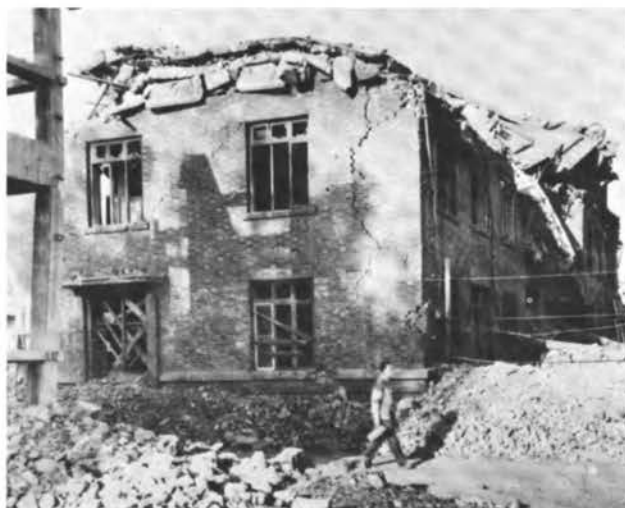
FIGURE 4.46 Partly collapsed five-story building at Coal Mine Design Institute in Tangshan.
