Earthquake Engineering and Hazards Reduction in China: A Trip Report of the American Earthquake Engineering and Hazards Reduction Delegation Submitted to the Committee on Scholarly Communication With the People's Republic of China (1980)

Earthquake Engineering and Hazards Reduction in China

A Trip Report of the American Earthquake Engineering and
Hazards Reduction Delegation

Edited by Paul C. Jennings

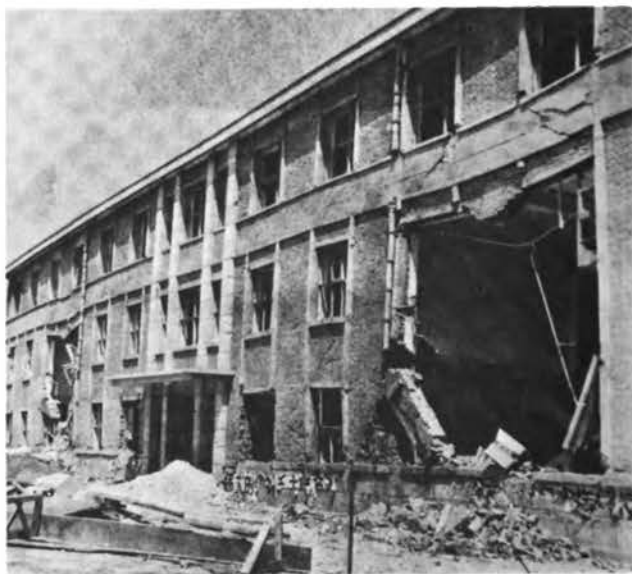
FIGURE 4.48 Damaged building at Kailuan coal mine general hospital in Tangshan.

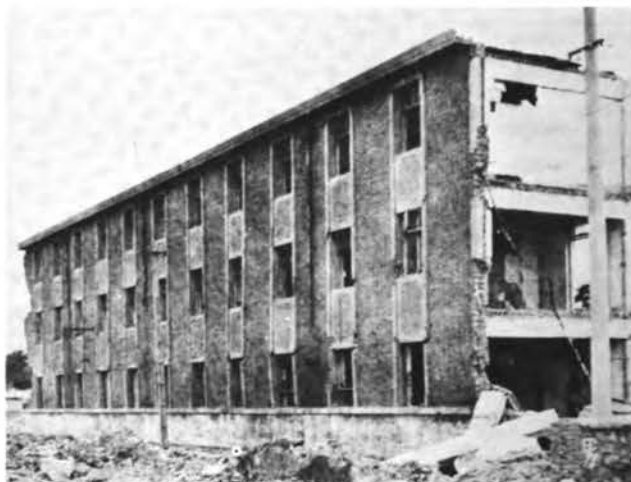
FIGURE 4.51 Damaged car factory dormitory building in Tangshan. The first story was most severely damaged but the building remained standing.

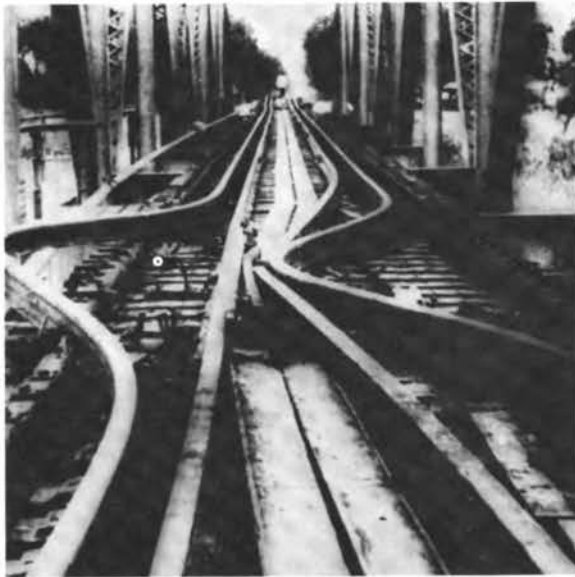
This bridge crossed the Chi Canal at a location where the earthquake intensity was IX. During the earthquake both abutments moved inward and shortened the distance between them by 2.1 m. This compressive movement caused buckling of the steel rails (Figure 4.58) and fracturing of a supporting pier (Figure 4.59).

FIGURE 4.58 Buckled steel rails on railway bridge on Peking-Shanhaikuan line.

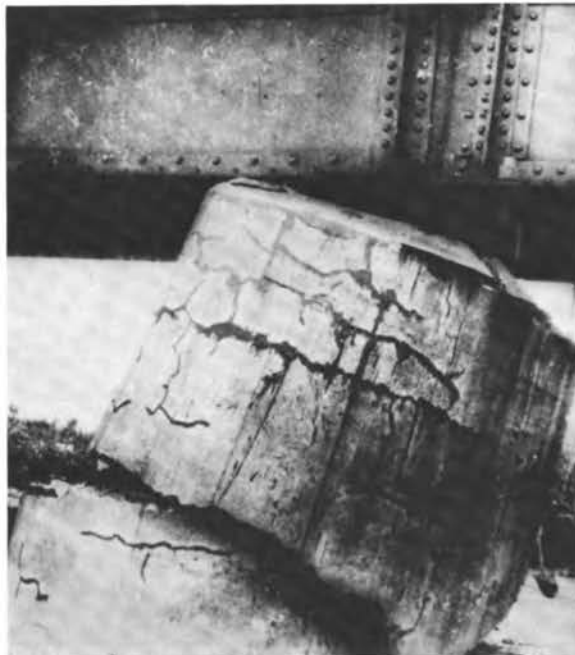
FIGURE 4.59 Broken pier of railway bridge 55 on the Peking-Shanhaikuan line.

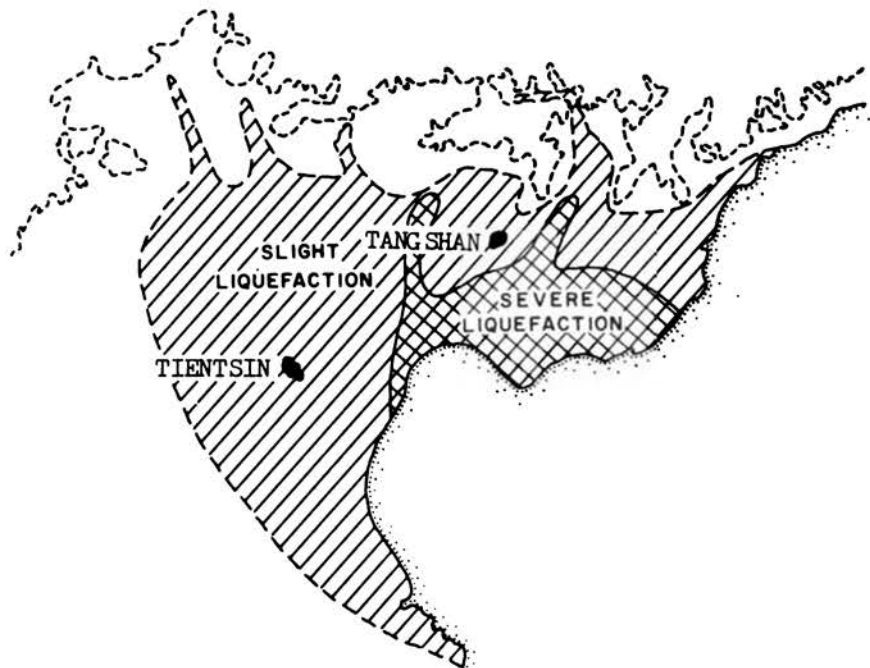
FIGURE 4.60 Map of Tangshan-Tientsin region showing areas of liquefaction.

Occasional instances of sand boils, filling of wells, and bank slumping occurred within the much larger area of "slight liquefaction" shown in Figure 4.60. In Tangshan City, although there was conflicting testimony, the effects of liquefaction apparently were not severe. One report mentioned that the upper portions of some mine shafts were damaged because they passed through liquefied sands, but other engineers said that the sand had not liquefied. A few buildings along the river apparently were damaged by slide failures. Underground pipes received some damage (Table 4.2).

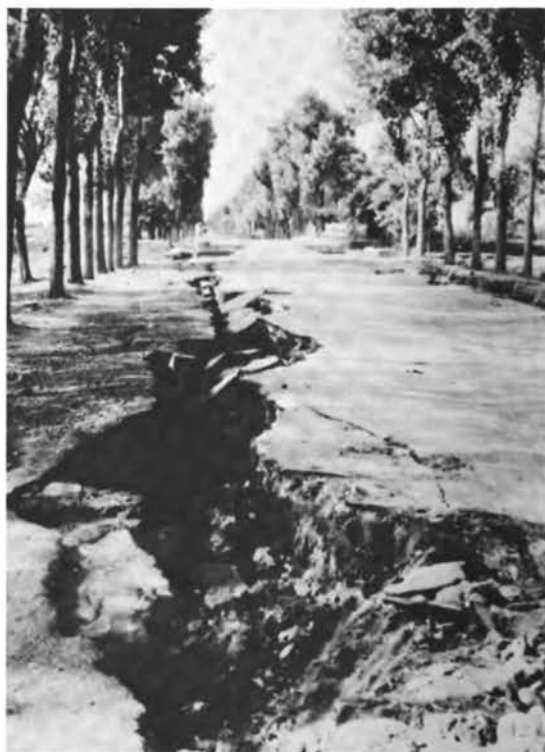
FIGURE 4.63 Damage to a road caused by soil failure.

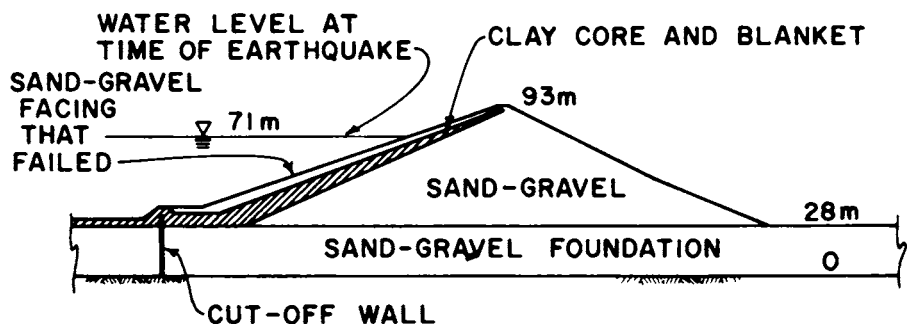
FIGURE 4.65 Cross section of Paiho main dam at Miyun reservoir. During the earthquake the sand-gravel facing on the upstream face of the dam slumped down.

northeast of Peking and about 150 km from the epicenter of the earthquake. The dam was built between 1958 and 1960 and had a maximum height of 66 m and a total crest length of 960 m. It had a thin upstream-sloping clay core with a blanket of sandy gravel 3-5 m thick. A schematic cross section is shown in Figure 4.65. At the end of the earthquake the water level was 21.6 m below the crest. The sand-gravel facing over the clay core failed over almost the entire length of the dam. The upper scarp was close to the water line, ranging as much as 2-5 m above or below the water line. The total volume of slide material was 150,000 m³. The sliding surface was essentially within the sand-gravel layer; the clay core was exposed and scraped only at a few spots. The slope of the clay core beneath the failed facing was 2.8 on 1 while that of the upstream slope was 3 on 1 and then 3.25 on 1. The slide material came to rest on the bottom of the reservoir within 40 m of the heel of the dam. According to witnesses, the failure occurred during the earthquake. Earthquake-induced settlements of the crest reached a maximum of 59 mm, and permanent horizontal displacement had a maximum of 28 mm. This failure is of special interest because strong-motion recordings were made at the dam. According to reports furnished to the delegation, on the ground surface below the downstream toe the peak horizontal accelerations were 0.097 and 0.058g and the peak vertical accelerations were 0.065g. The corresponding peak horizontal accelerations on the crest were 0.128 and 0.16g. The accelerograms recorded on the crest showed apparent periods of about 0.6 s.

The Paiho Dam was repaired by removing the remaining upstream facing, then thickening the clay core to resist cracking, and constructing a new facing using broken rocks with a transition layer of crushed stone between the rocks and the core.

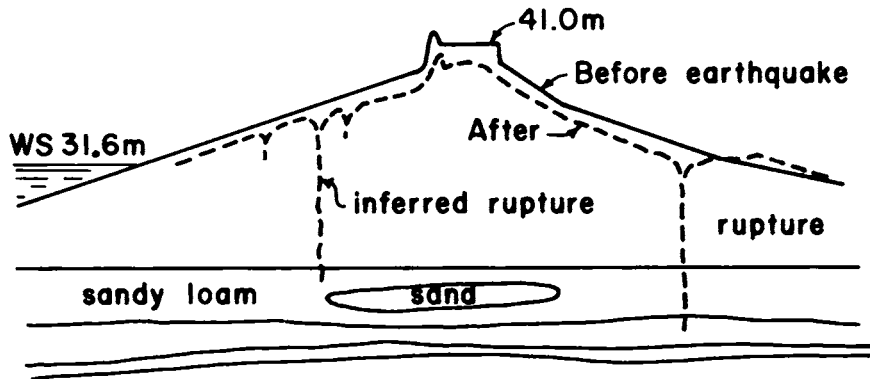
FIGURE 4.66 Sketch showing settlement of the earth dam at Touho reservoir.

the upstream and downstream faces (Figure 4.66), and the crest settled as much as 1 m. Sand boils appeared at the downstream toe and also appeared in adjacent fields. Fortunately, at the time of the earthquake the depth of water in the reservoir was only 10 m. Chinese engineers believe that this failure was the result of liquefaction in the foundation, which consisted of 8 m of cohesive soil overlying 10-12 m of fine sand. Dynamic finite element analyses were made, which, together with test results, indicated that liquefaction should have been expected.

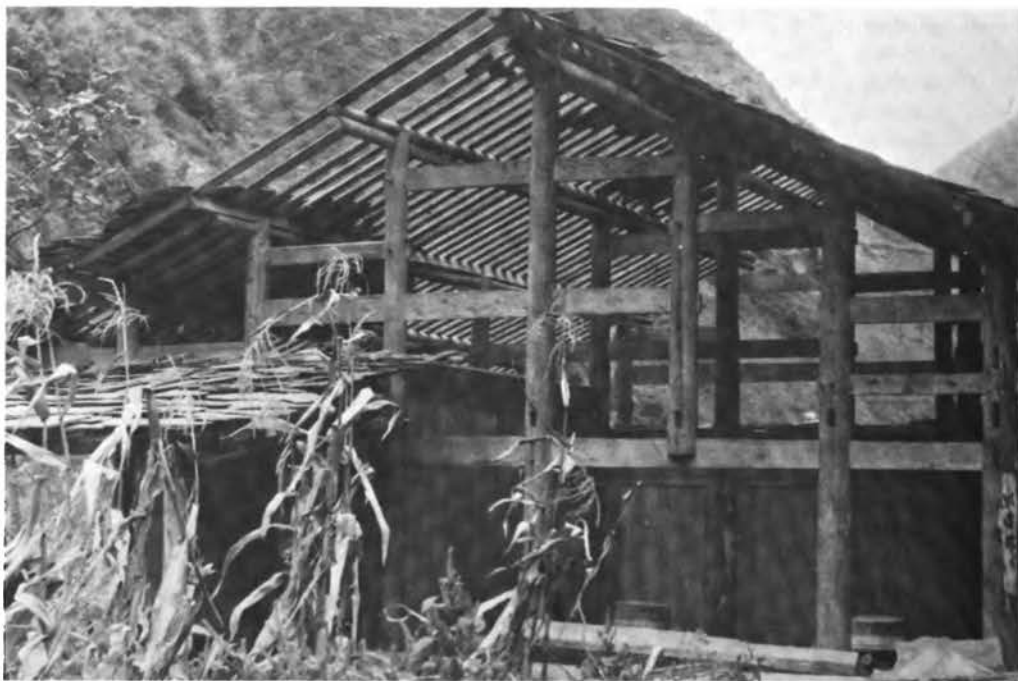
FIGURE 5.11 Wood framing is the most common residential construction in the mountainous epicentral area of the Sungpan-Pingwu (SP) earthquakes.

construction, using dowels of a special type. The infilled walls are generally of wood in the mountainous epicentral area; a few walls are of stone. The roofs are usually of tile, with wood sometimes used. Most of these structures in the Intensity IX zone were damaged, with a few partial collapses. The most common damage was described as a single inclination of the structure (this type of frame would be very flexible). In the Intensity VIII areas, only a small number of such buildings with wooden infilled walls inclined, and there was no damage to this type of construction in areas of Intensity VII. For infilled walls of stone, some walls fell out even in zones with intensities as low as VII. The reasons given for the generally successful performance of this type of housing were its light weight and high ductility. Also, the quality of the construction in the mountainous areas, where lumber originates and is plentiful, is usually better than it is in the cities. The resistance is apparently not a by-product of design for heavy snow loads, as we were told that there is not much snow in this region.

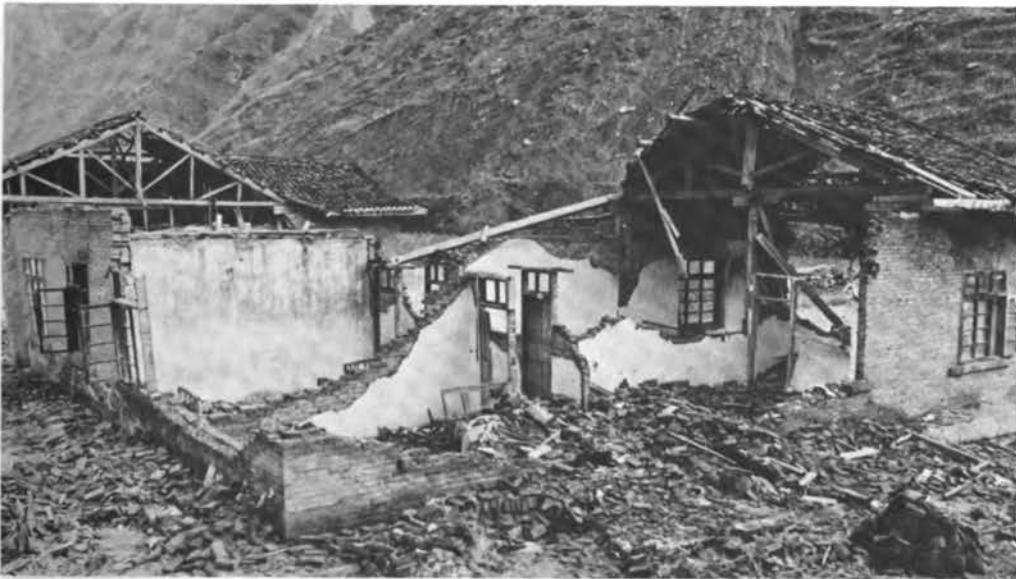
There were a small number of brick buildings in the area of strongest shaking. This second type of construction has a timber roof, brick columns, and brick walls, as shown in Figure 5.12. The external and internal walls were about 12 cm thick and were constructed with lime mortar. The damage to this type of construction was rather heavy: most collapsed in areas of Intensity IX. A small portion suffered partial collapse in areas of Intensity VIII, and most were heavily damaged. Most of this type of construction were cracked in areas assigned as Intensity of VII. The buildings were not designed to resist earthquakes, and were reported to

FIGURE 5.12 A second less common and less resistant type of construction consists of brick columns and walls, with wooden roof trusses.

have low-strength brickwork and construction defects; much earthquake damage was also attributed to the effects of openings for windows and the settlement of foundations.

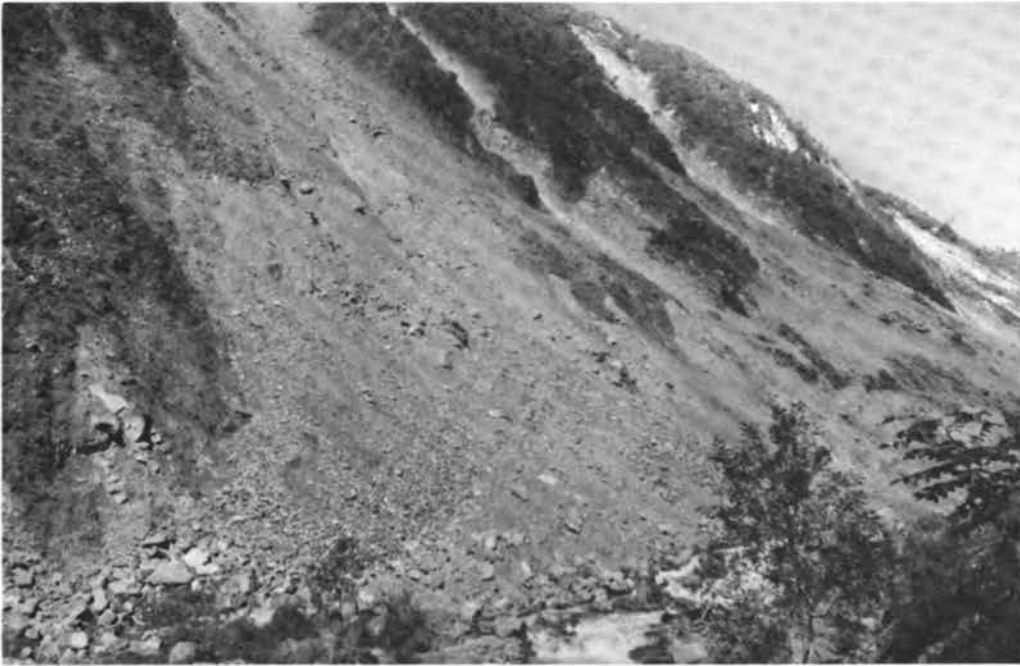
FIGURE 5.14 Rockslide in a canyon, SP earthquake.

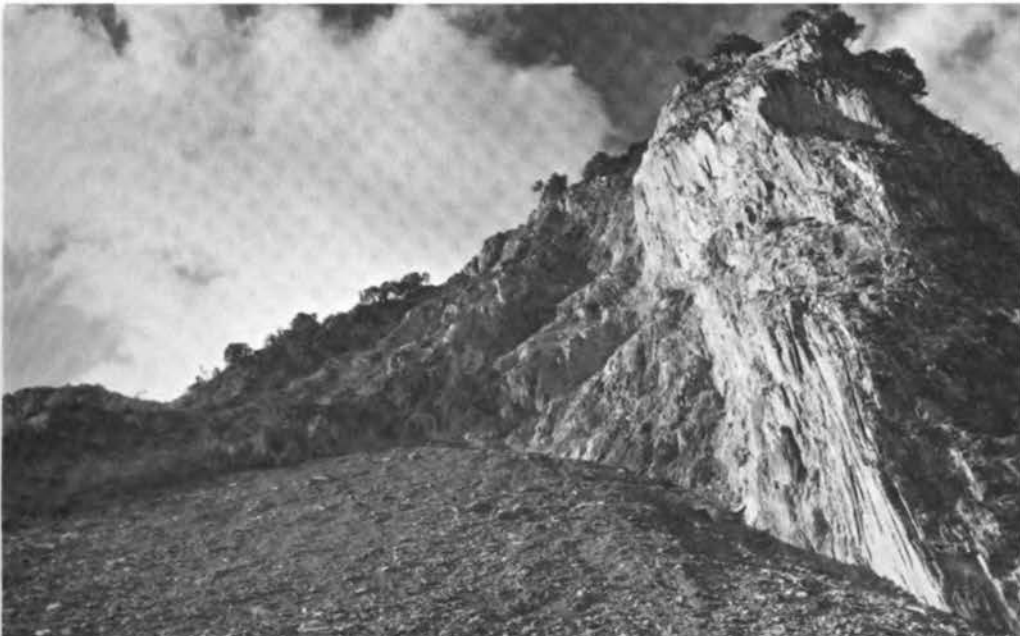
FIGURE 5.15 The head of a rockslide in the mountainous terrain, the SP earthquakes. Slides, without earthquakes, are common in this region.
