California Coastal Erosion and Storm Damage During the Winter of 1982-83

A Reconnaissance Report Prepared by:

Committee on Natural Disasters
Commission on Engineering and Technical Systems
National Research Council

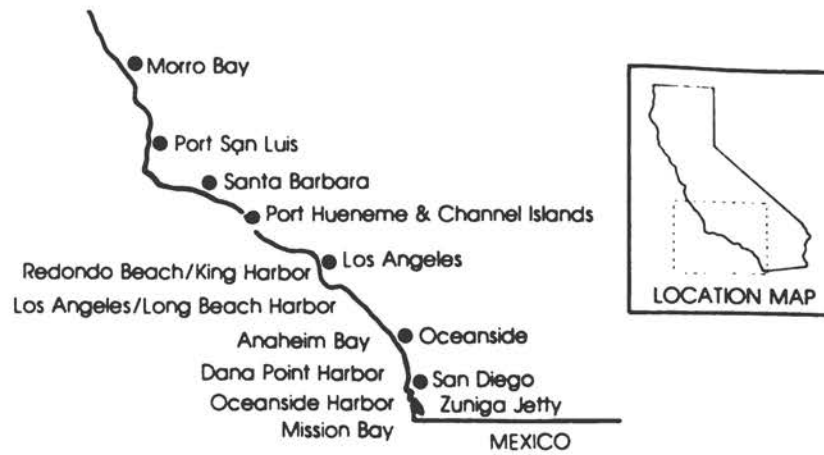
The Los Angeles District of the U.S. Army Corps of Engineers (1983) has detailed the damage to the breakwaters under its responsibility. Table 5 summarizes the locations, character of damage, and repair costs for those structures. Figure 12 shows their locations. The total repair cost is \$17.8 million. In discussing this damage, the Corps comments that the storm waves were "most certainly the largest since 1941, and perhaps the largest since 1838 or before."

FIGURE 12 Locations of damaged breakwaters under the responsibility of the Los Angeles District of the U.S. Army Corps of Engineers.

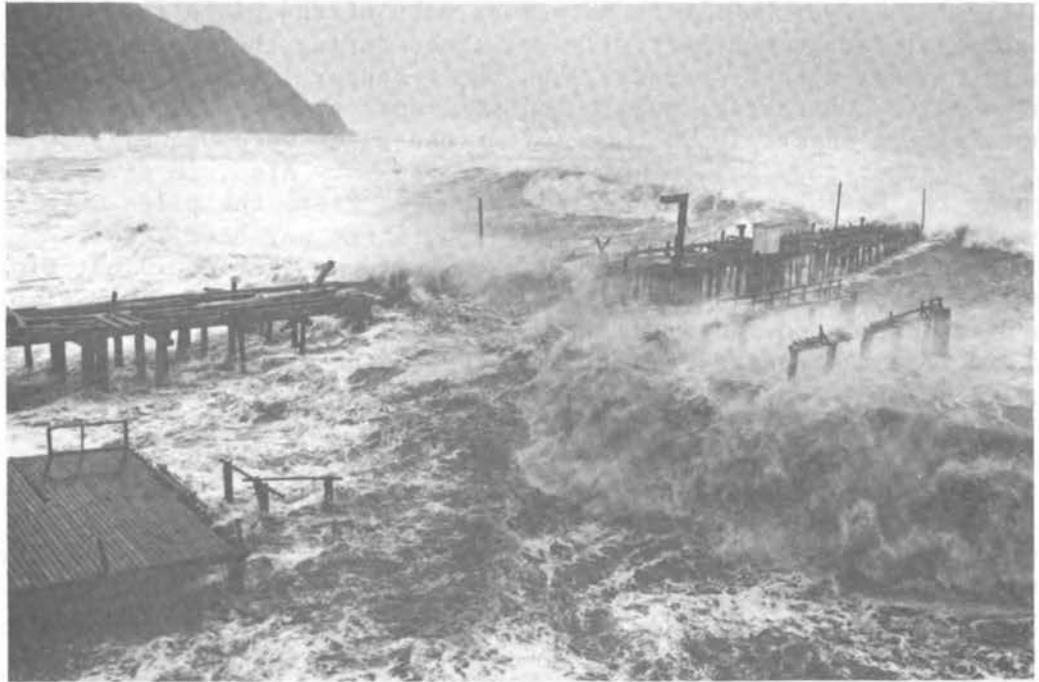
The succession of events was recorded in a series of spectacular photographs presented in Figures 18A-18D. Figure 18A shows a large wave

FIGURE 18A Arena Cove on January 26, 1983. The first very large wave is just hitting the top of the pier. Photograph copyright © Nicholas King.

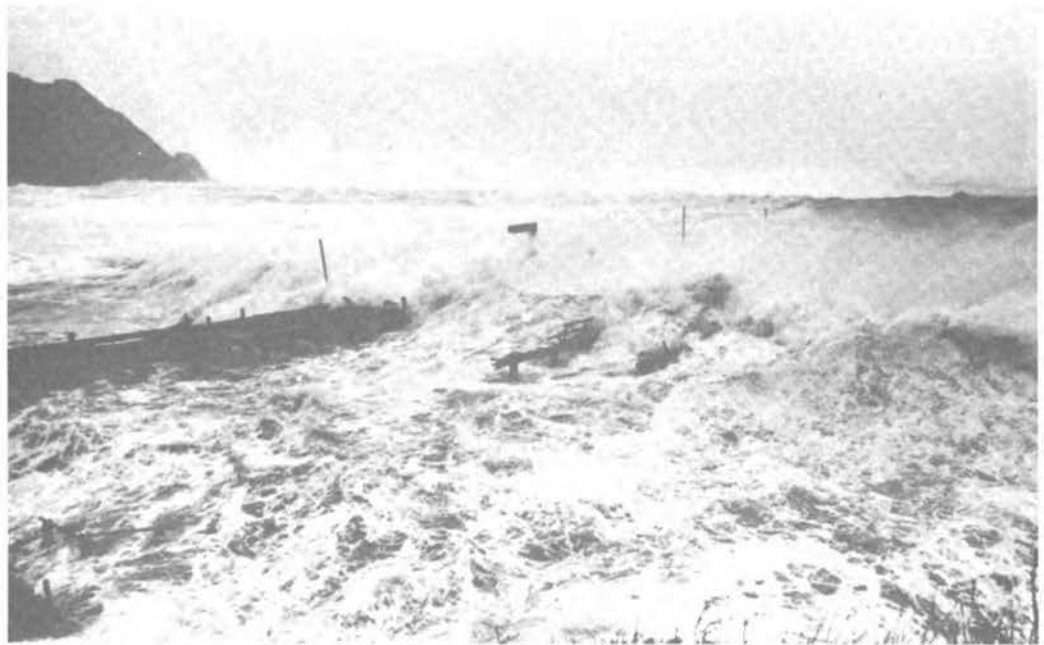
FIGURE 18B Arena Cove on January 26, 1983. The second large wave looms just beyond the end of the pier and stretches across the whole cove. Photograph copyright © Nicholas King.

overtopping a portion of the pier, with the first of the three very large waves just at the seaward tip of the pier. Figure 18B shows a portion of the pier totally submerged under the very large wave, with the following wave rising across the entire width of the cove. Figures 18C and 18D document the damage inflicted by the waves to the fishhouse (in the center), the boathouse (center left), and the cafe (behind the boathouse).

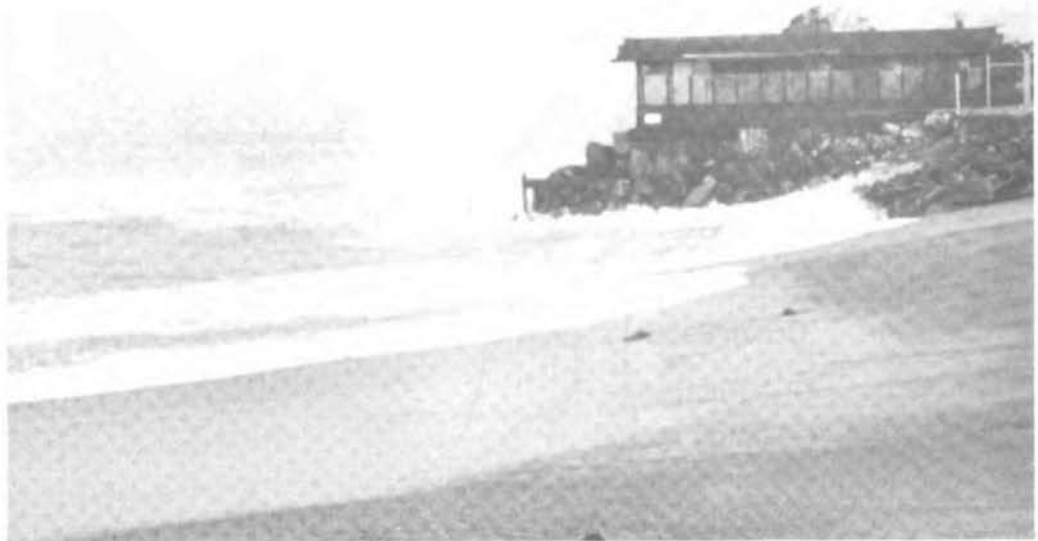
The structures (Figures 25 and 26) consist primarily of single-family dwellings. They have remained largely undamaged because of the presence of very large and high revetments. As shown in the photographs, the beaches are very narrow. At the time of the study team's visit, no well-defined offshore bar was evident, although sand had clearly been transported seaward from the beach. Attempts to control beach erosion at this location by constructing three groins were unsuccessful. Based on model testing conducted at the Waterways Experiment Station, the U.S. Army Corps of Engineers plans to construct a series of offshore breakwaters to control erosion.

FIGURE 25 View of Imperial Beach showing eroded beach and home protected by revetment (photograph was taken at low tide).

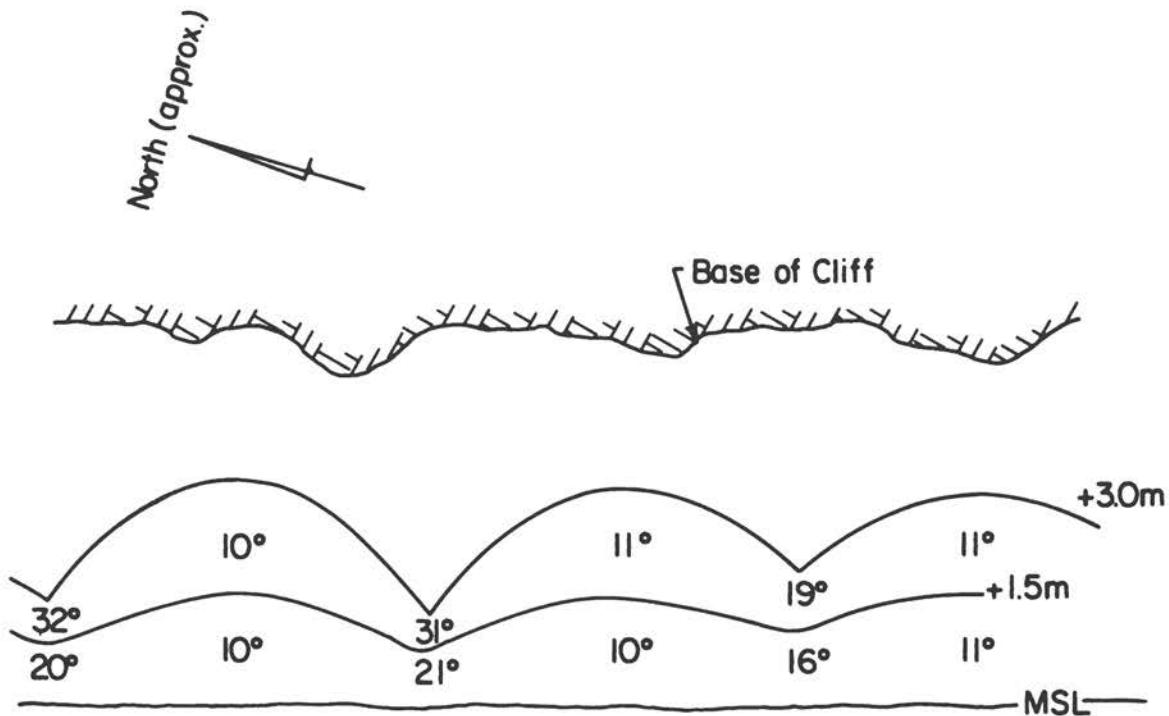
Figure 27, which shows Torrey Pines State Beach toward the south from the access road, contains several features of interest. First, the sand on the beach, at least in places, has been transported and deposited offshore, leaving a more resistant lag deposit of cobbles. Also of interest are the steep cusps that have been formed of the cobbles. The average slope of the horns and swales of these cusps is 25° and 10° , respectively. Figure 28 presents a sketch of the cusp geometry.

FIGURE 28 Approximate planform geometry of the cusps at Torrey Pines Beach on March 9, 1983. Most of the cobbles on the upper portion of the beach were about 6 cm in diameter. The local beach slope was about 21°.

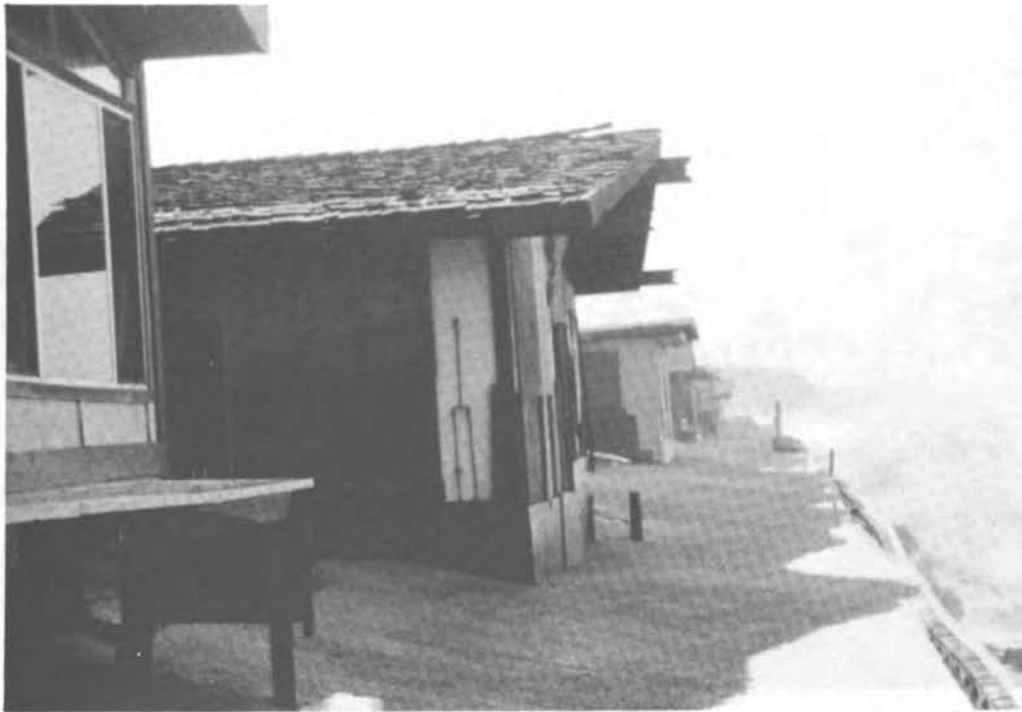
At a trailer park in Capistrano Shores, a vertical wooden seawall had been constructed to limit erosion. As shown in Figures 33 and 34, high tides and breaking waves transported water over the seawall. This caused loss of backfill material and damage to the trailers near the shore.

FIGURE 34 Capistrano Shores in the same vicinity as Figure 33.

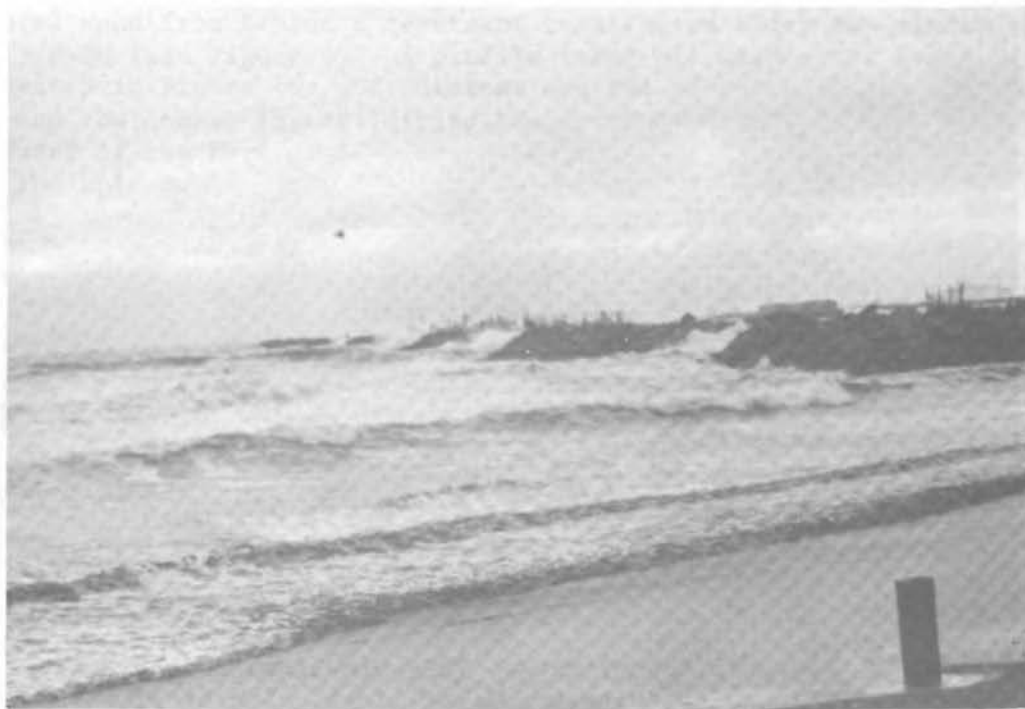
FIGURE 38 The south jetty at the entrance to Anaheim Bay.

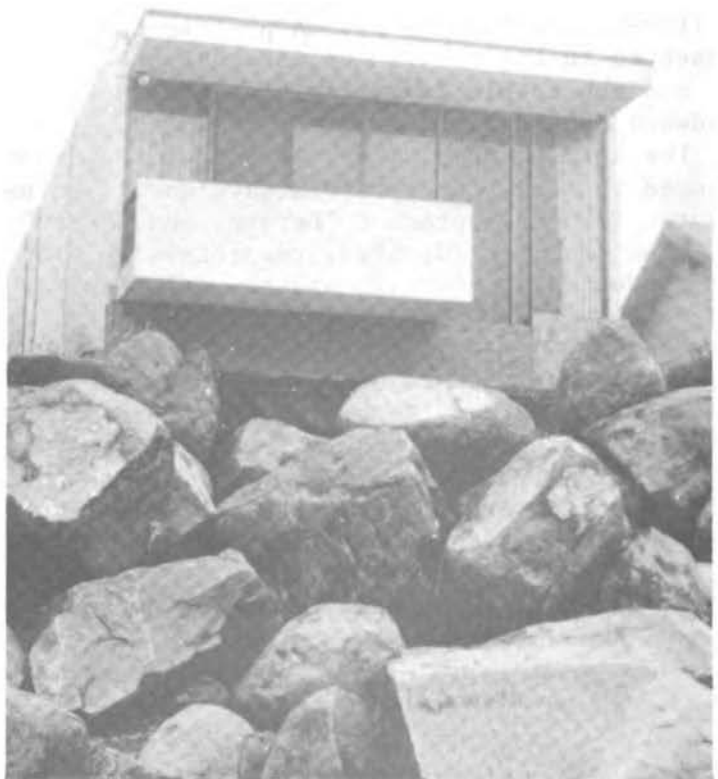
winter storms, including the most recent, had destroyed a number of homes, although most of the debris from these homes had been removed prior to the visit. Figures 41 through 45 show some of the remaining evidence of damage.

FIGURE 42 Heavy revetment fronting a dwelling in Malibu Beach.

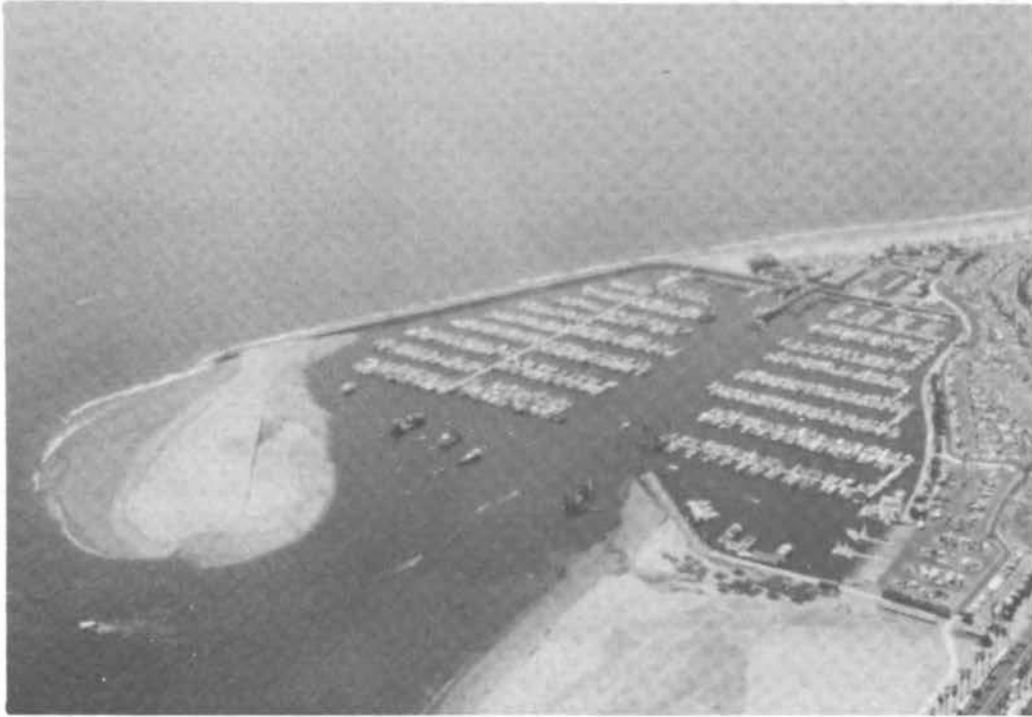
The Santa Barbara area includes Leadbetter Beach (extending from Santa Barbara Point to the west and to the shore-connecting leg of the breakwater to the east), the outer leg of the breakwater, the spit in the lee of the breakwater, and East Beach (extending from the harbor entrance to the east). Figure 47, a photograph taken in 1979, shows part of this area. Figure 48 shows this same area after the winter of 1982-83.

The spit in the lee of the tip of the Santa Barbara breakwater was reduced in elevation by storm wave energy to below mean sea level. Figures 47 and 48 present "before" and "after" oblique aerial views in 1979 and on March 12, 1983, respectively. The flight on March 12, 1983, was conducted at low tide and the spit was barely emergent. At high tide the spit was completely submerged.

FIGURE 47 The Santa Barbara area looking southwest. The Santa Barbara breakwater with lee spit and East Beach can be seen in this 1979 photograph.

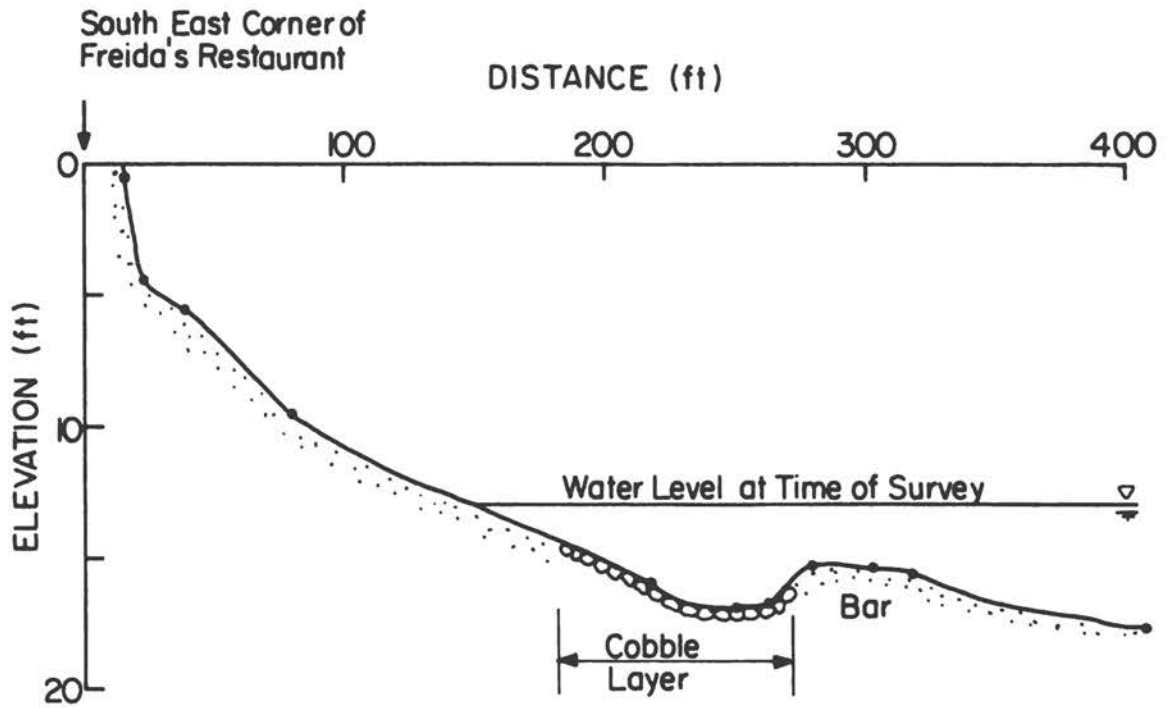
The most impressive effect of the storms of 1982-83 on the Santa Barbara area was the extent of erosion on Leadbetter Beach. The pocket beach had eroded back well beyond limits that have occurred over at least the past several decades. This undermined the parking lot and removed sand from behind a revetment constructed after the winter storms of 1979-80 (see Figure 9). A profile taken off Leadbetter Beach is presented in Figure 49. Of interest are the presence of the offshore bar and the cobble layer limiting the depth of the trough immediately landward of the bar.

FIGURE 49 Profile taken off Leadbetter Beach in Santa Barbara on March 12, 1983, at 2:30 p.m. The profile heading was 170°.

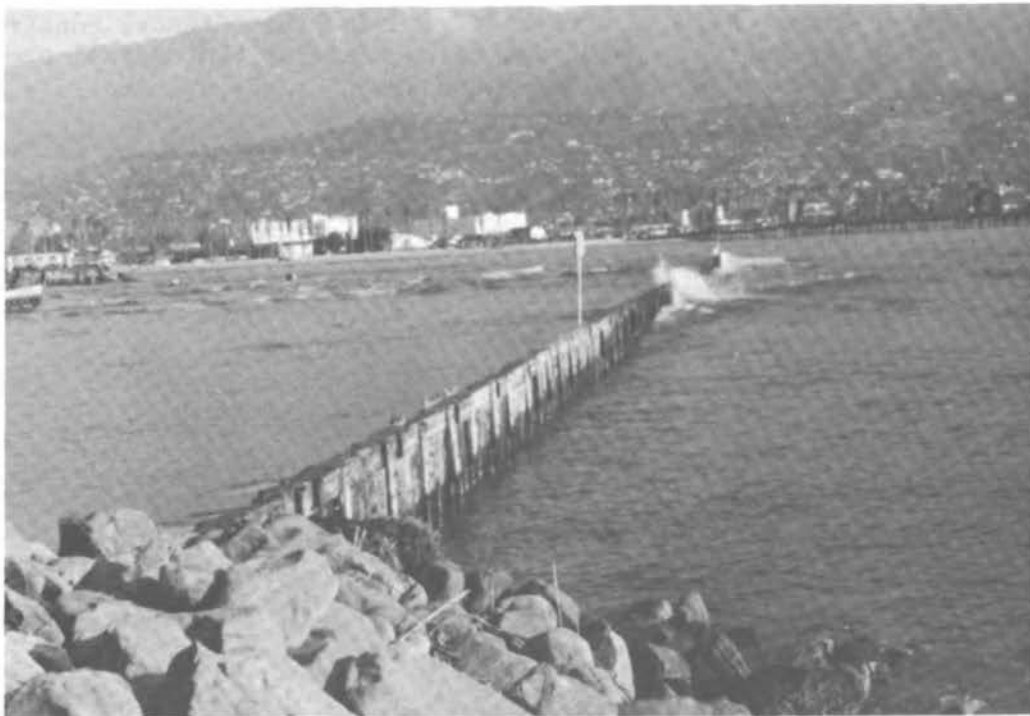
Figures 50 and 51 present views looking west along Leadbetter Beach. In addition to undermining the parking lot, erosion caused a number of palm trees to be lost. Figure 52 shows the timber sheet-pile structure extending north from near the tip of the Santa Barbara breakwater. Usually there is a sand spit on both sides of the timber structure up to 1 m above the mean high water level.

FIGURE 52 View looking north from the base of the timber sheet-pile structure that extends north from the Santa Barbara breakwater.

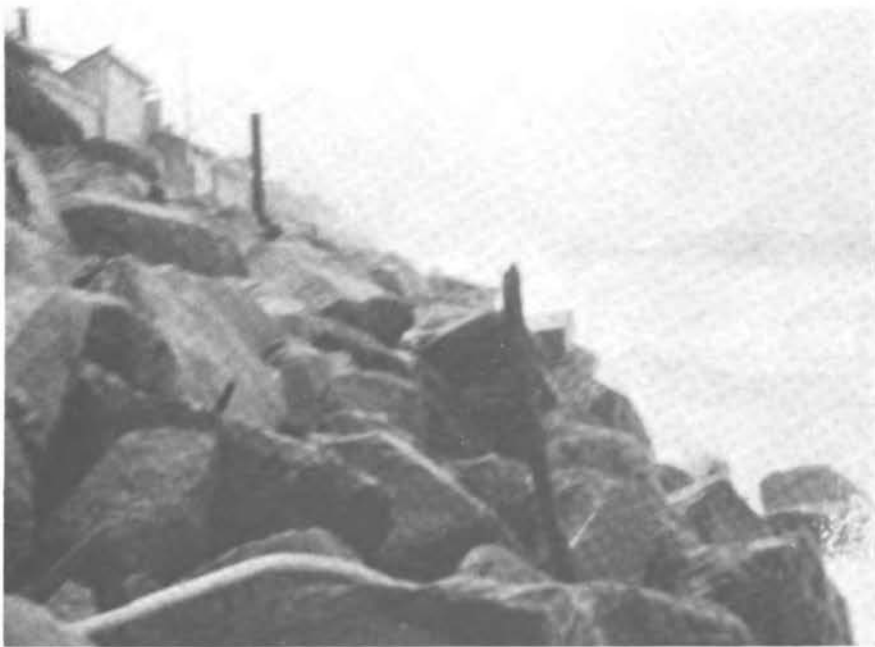
A number of houses have been constructed along relatively narrow Rio Del Mar Beach in the Via Gaviota and Seascape subdivisions. A fairly substantial revetment, shown in Figure 54, was constructed to protect some of these homes. Where the revetment is not present, some homes were destroyed (see Figures 55, 56, and 57). In other areas the sand elevation decreased by approximately 2 m (see Figure 58).

FIGURE 54 Heavy revetment protecting upland structures in Rio Del Mar Beach.

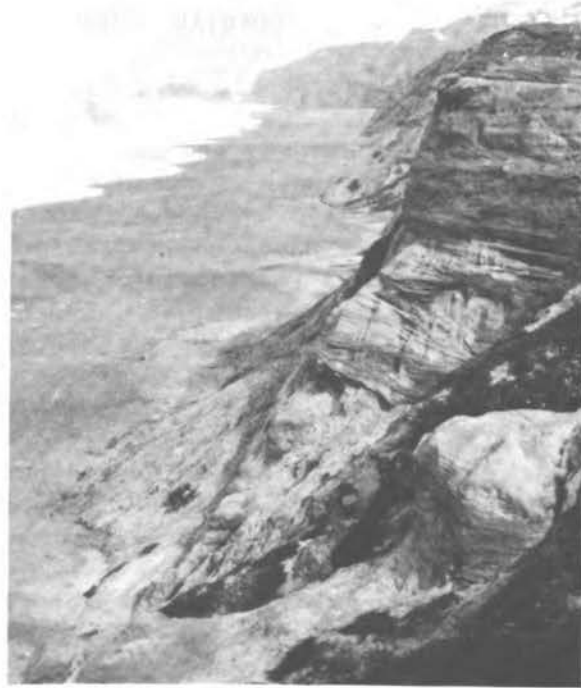
Coastal cliffs are a common landform along large sections of the geologically young California coast (see Figure 71). The cliffs are the result of active erosion, being subject to periodic retreat during stormy periods. Many of the cliffs consist of relatively soft sandstones, siltstones, and shales, which are highly susceptible to erosion from wave action and surface runoff. Thus in this context the cliff erosion from the winter storms of 1982-83 could and should have been anticipated in many cases. The problem of coastal cliff erosion and retreat is well understood qualitatively and described in the literature (Griggs and Johnson, 1979). However, because the episodes of retreat are relatively infrequent and the overall rate is deceptively slow, property owners tend to have a false sense of permanency and security.

FIGURE 71. Steep cliff in weak sandstone at Pacifica. Note the wide beach and talus at the base of the slope.
