Building Damage in South Carolina Caused by the Tornadoes of March 28, 1984 (1985)

Building Damage in South Carolina Caused by the Tornadoes of March 28, 1984

**Peter R. Sparks, Department of Civil Engineering, Clemson University,
Clemson, South Carolina**

**Committee on Natural Disasters
Commission on Engineering and Technical Systems
National Research Council**

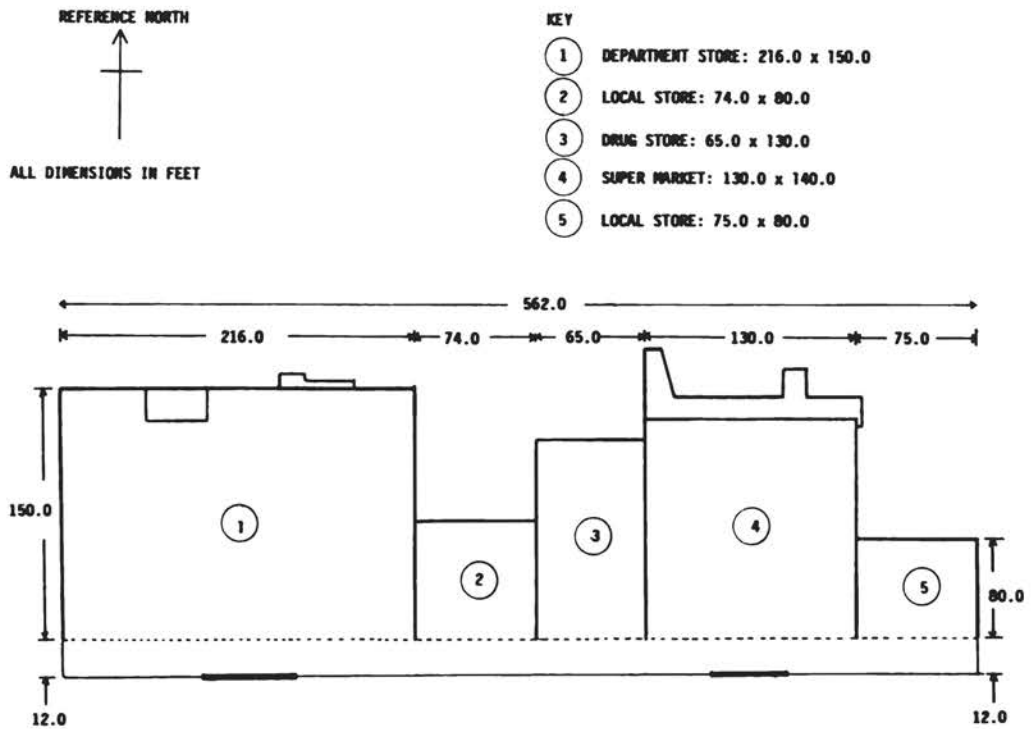
FIGURE 33 Plan of Northwood Village Shopping Center in Bennettsville.

Figure 33 shows an overall plan of the shopping center. The structural system consisted essentially of a built-up roof system overlaying rigid insulation and a 1.5-in.-deep corrugated metal deck of 22 gage galvanized steel. The metal deck was spot welded to bar joists (metal truss rafters) that spanned between girders or between girders and masonry walls. Figure 34 shows a roof framing plan. The girders themselves were supported on 5-in.-diameter columns or by masonry walls. The front wall of the building consisted of glass or 4-in. brick with an 8-in. backup wall of hollow concrete masonry units. The side, rear, and partition walls consisted of 12-in. hollow concrete masonry units. A bond beam was provided on the front and rear walls, and the masonry units were filled with concrete for a few courses where girders or bar

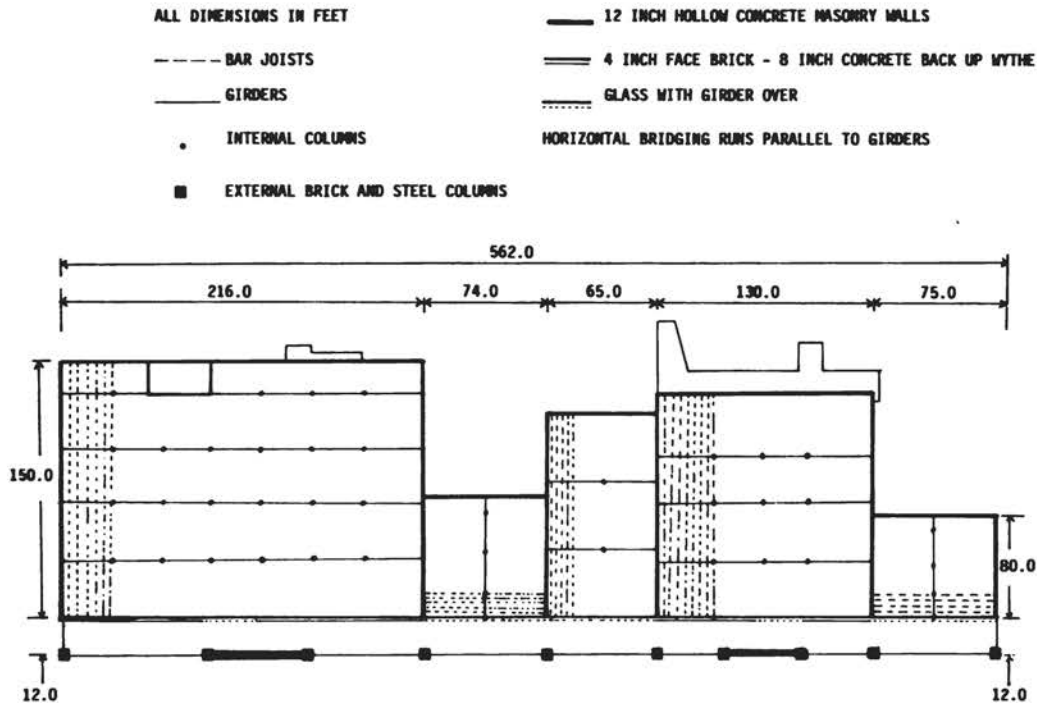
FIGURE 34 Framing plan of Northwood Village Shopping Center.

joists were supported by walls without bond beams. Control joints were provided in the walls at intervals of between 20 and 30 ft. Horizontal truss reinforcement was provided in alternate courses. No vertical reinforcement was provided. The walls ranged in height from 16 to 20 ft.

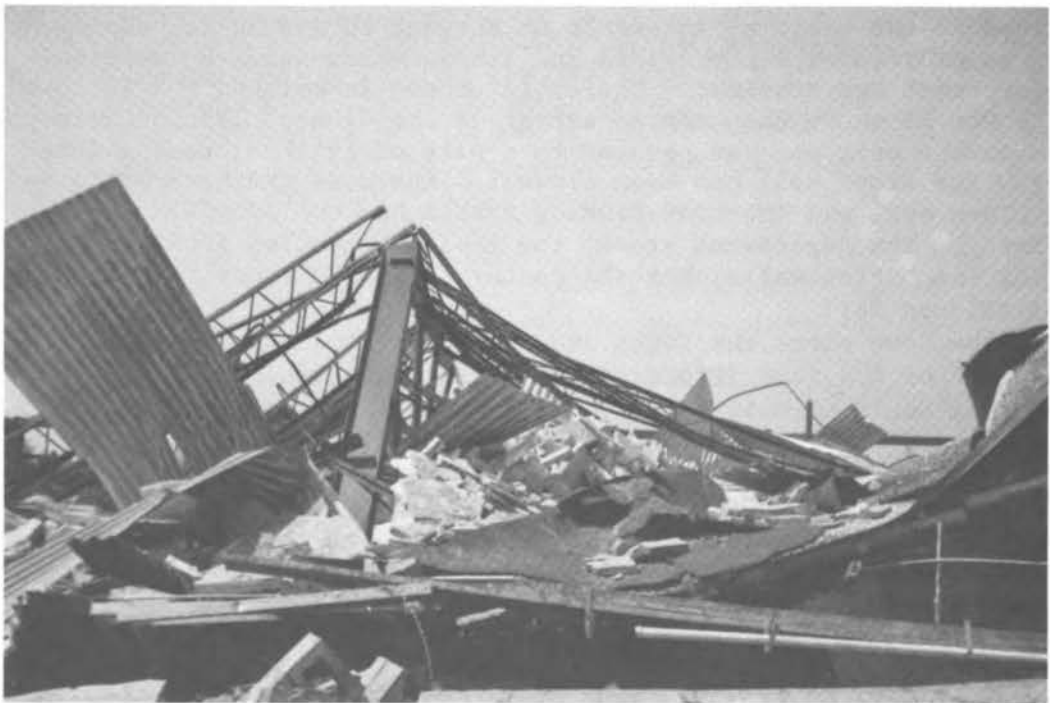
FIGURE 36 Surviving framing in local store.

Next to the department store, the small unoccupied local store lost all its supporting walls, but the center line of columns remained upright (Figure 36).

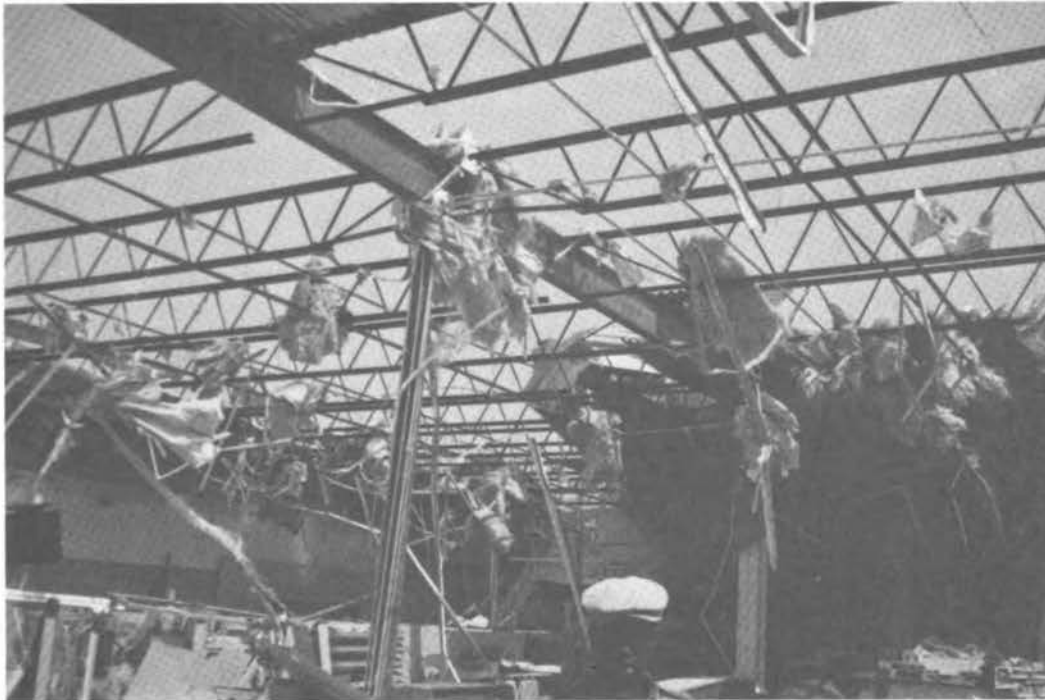
FIGURE 41 Surviving roof system in hardware store.

The local hardware store at the extreme east end, not shown in Figure 35, suffered relatively minor damage. The front wall, consisting mainly of glass, failed, and some metal decking was removed from the roof, but the roof framing remained intact (Figure 41). This was also the only part of the shopping center where there was any trace of the

front canopy (Figure 42). Although the wind speeds were undoubtedly lower at this end of the building, the orientation of the roof members in this building and the unoccupied store differed from that of the three larger stores. The main girders ran from front to back in the smaller stores and from side to side in the larger ones.

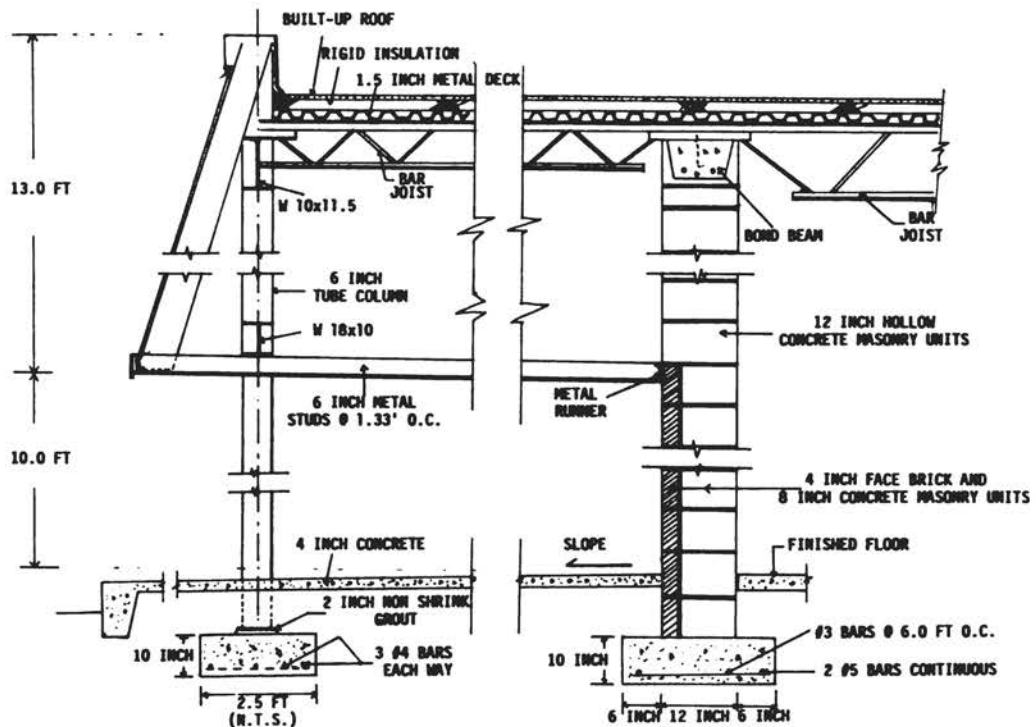
FIGURE 44 Detail of front wall (as designed).

These loads would have been well distributed to the front and back walls, where bond beams were provided (Figures 44 and 45). On the side walls, where no bond beam existed, the load distribution would have been limited (Figure 46). In any case, the roof was extremely light and the vertical loads carried by the walls were small. This had a detrimental effect on the ability of the walls to perform another function, that of resisting the wind loads. In this respect, they had to be capable of transferring the load either directly to the ground or to the roof. Here the metal decking acting as a shear diaphragm would have transferred the loads to the side walls. Functioning as very deep shear walls, these walls would finally have transferred the rest of the wind load to the ground.

Another factor that may have contributed to the failure was the fact that the canopy had not been built as shown in Figure 44, but had been replaced by inferior wood framing as shown in Figure 42. Without the restraint and shelter provided by this canopy, the front wall of the department store possessed very little wind resistance.
