## **Hurricane Elena, Gulf Coast: August 29 - September 2, 1985**

Committee on Natural Disasters, National Research Council

Volume Two  
HURRICANE ELENA, GULF COAST  
AUGUST 29-SEPTEMBER 2, 1985

Peter Sparks (Team Leader),  
Department of Civil Engineering, Clemson University, South  
Carolina  
Earl J. Baker,  
Department of Geography, Florida State University, Tallahassee  
James Belville,  
Forecast Office, National Weather Service, Sterling, Virginia  
Dale C. Perry,  
Department of Construction Science, Texas A&M University,  
College Station

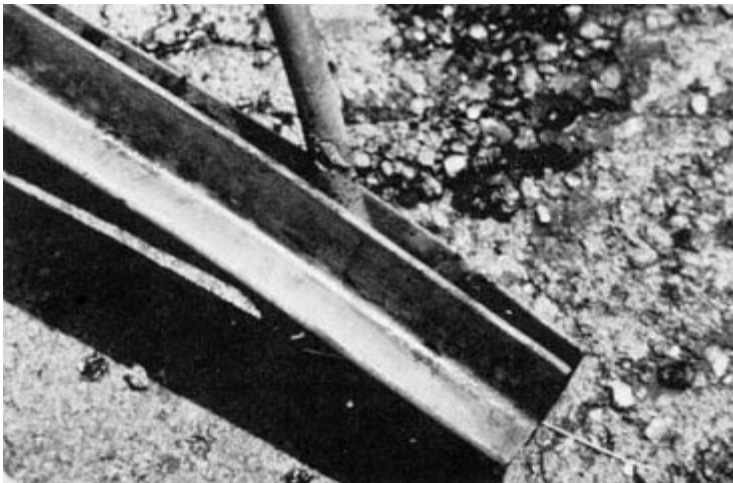
The glass appears to have failed first, the roof was then stripped off, and a side wall collapsed, taking with it a transverse girder (Figure 4-7). The bar joists in some instances had simply been laid on the girders without welding (Figure 4-8). At the front of the store the bar joist bearing plates had been set in mortar, which apparently had not adhered well to the block or bars (Figure 4-9). This type of anchor has negligible uplift resistance. The walls did not contain bond beams with reinforcement to which the anchor bars could have been welded or wrapped around.

This building is a good example of one in which the components probably met the code requirements (with the possible exception of the unreinforced masonry walls), but the structural system proved inadequate because of poor connections. This was also true of many small, nonengineered commercial structures using unreinforced masonry walls with steel or wood roof construction (Figures 4-10 and 4-11).

Figure 4-8  
Bar-joist-to-wall connection, Payless Shoe Store, Pascagoula.

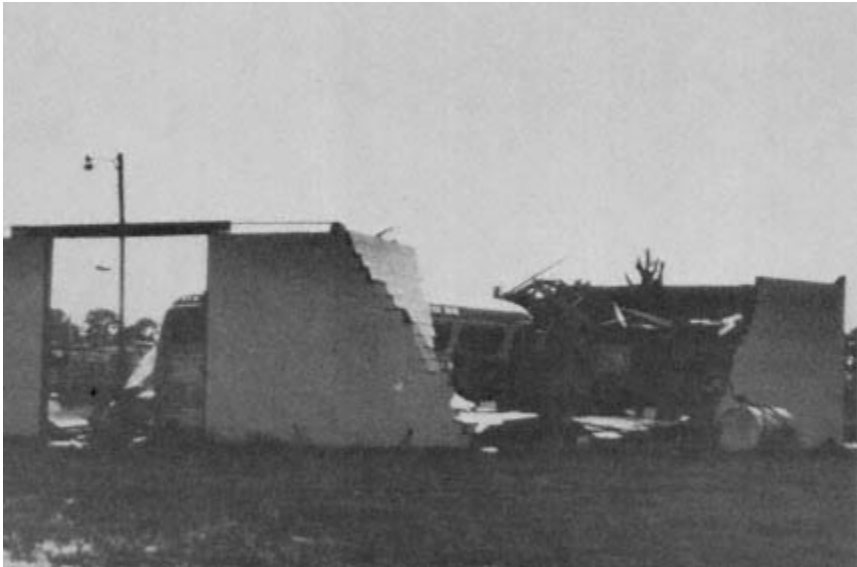
Figure 4-11  
Collapse of masonry-walled garage following loss of roof, Pascagoula.

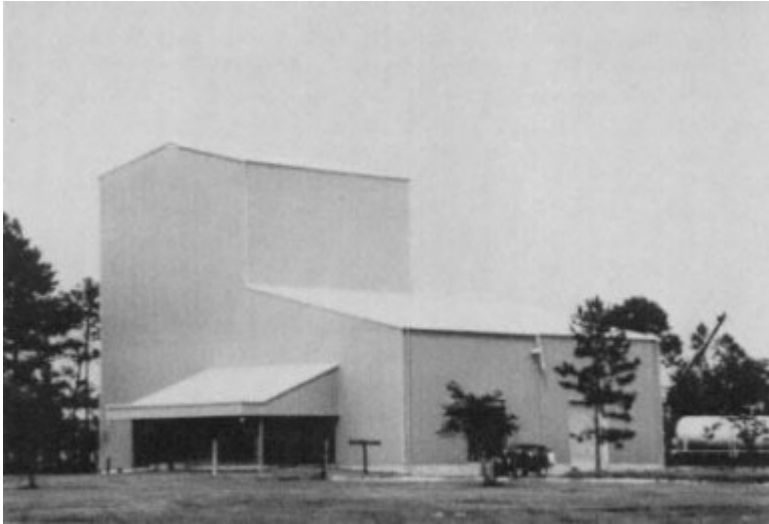
Figure 4-21  
Preengineered metal building in Gulfport. No wind damage observed.

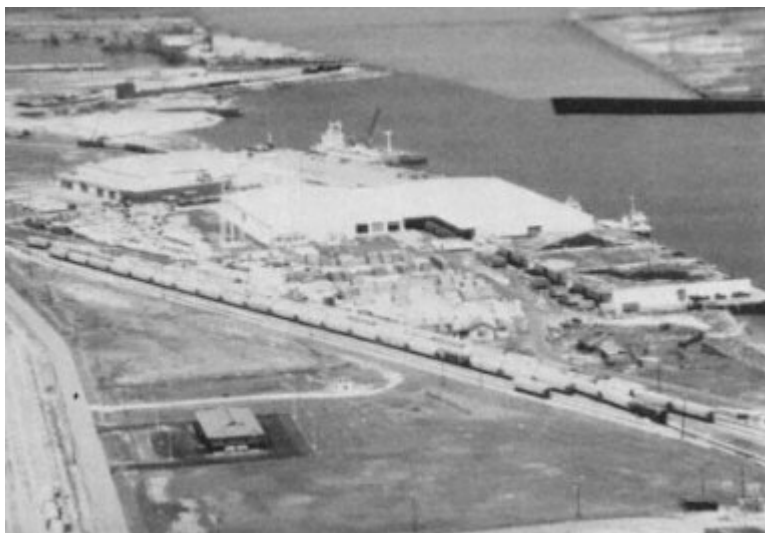
Figure 4-23

Nonetheless, the increasing customer demand for roofs meeting the UL specification has resulted in a reduction of hurricane damage for engineered metal buildings. Experience has shown that these structures generally perform adequately except when fasteners and sheeting are underdesigned, leading to domino-type failures of roofs and walls. The ability of most metal roof systems to maintain watertightness resulted in minimal damage to building contents and lower business interruption costs, in contrast to the performance of the roofs of the metal buildings in the center of [Figure 4-23](#) with the conventional built-up flat roof on the right.

Preengineered metal buildings and conventional construction on west bank of Ingalls Shipyard. Note wind damage to built-up roof and absence of damage to metal roofs.

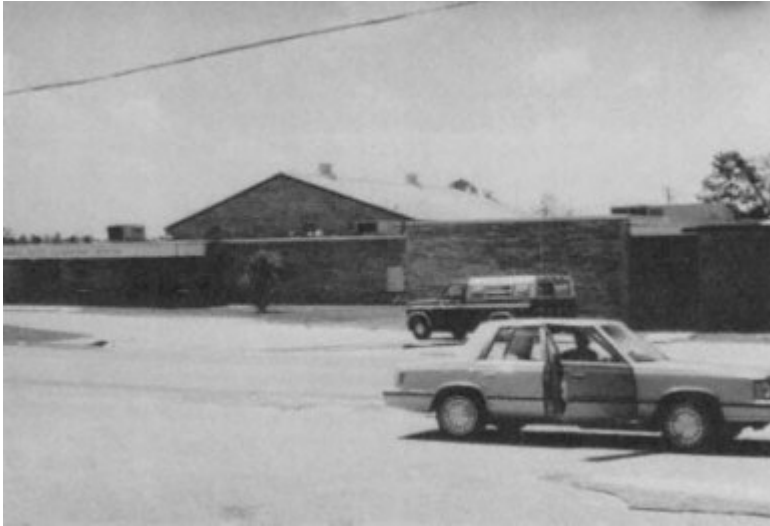
As noted earlier, school buildings performed very poorly. It is noteworthy, however, that many metal multipurpose school buildings sustained little if any damage ([Figure 4-24](#)). Also, the performance of preengineered churches was satisfactory ([Figure 4-25](#)). The motel shown in [Figure 4-26](#), a typical of other motels in this area, suffered damage only to the exterior logo and was returned to service immediately after restoration of electrical power.

Figure 4-24  
Orange Grove Elementary School in Lyman. No damage to multipurpose metal building.

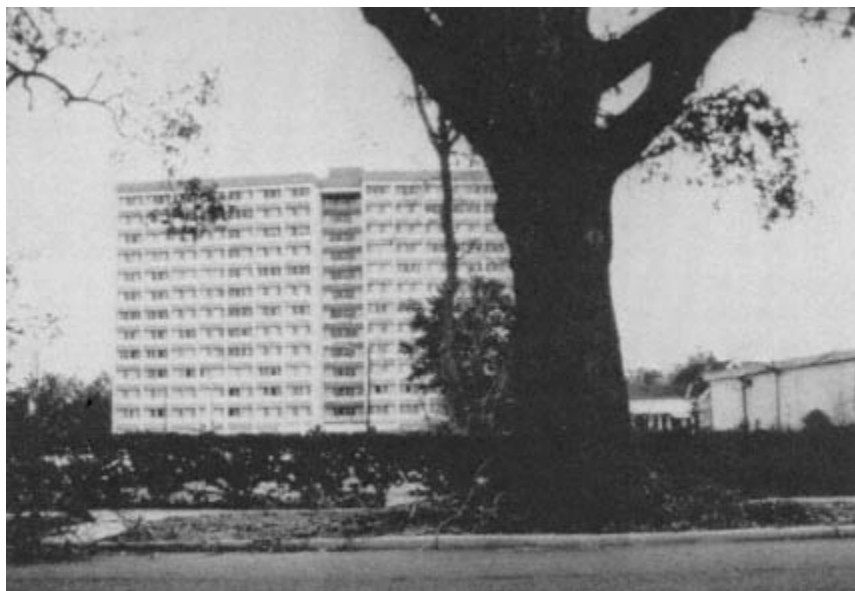
A number of multistory buildings, including an apartment building in Ocean Springs (Figure 4-29) and hospital buildings in Gautier, Ocean Springs, Biloxi, and Gulfport, sustained virtually no damage except that an occasional window was broken by windborne debris. The large industrial complex east of Pascagoula provided a very exposed location for a large number of both fully-engineered and preengineered buildings (Figure 4-30). Only very minimal damage was reported in this area.

Figure 4-29  
High-rise apartment building in Ocean Springs. Building sustained no wind damage.

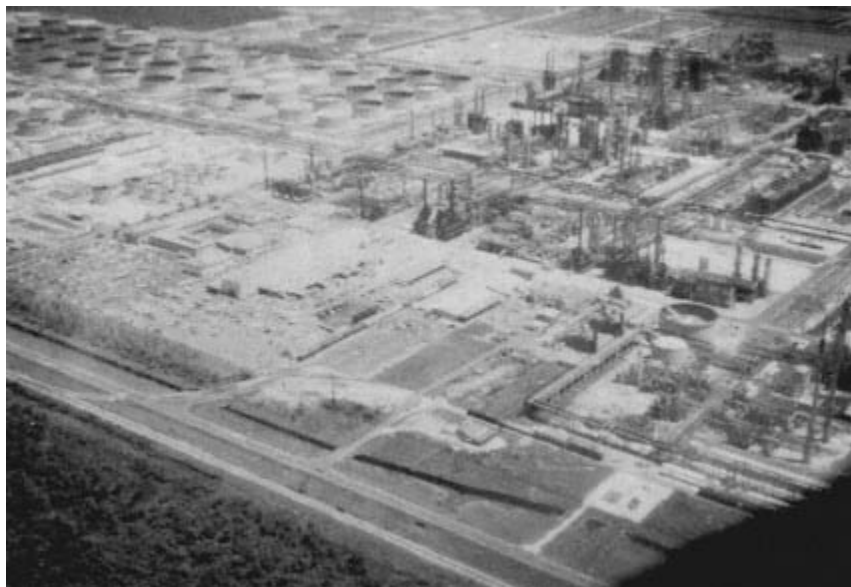
Figure 4-30  
Aerial photograph of Bayou Casotte Industrial Park east of Pascagoula. Only minimal wind damage reported.

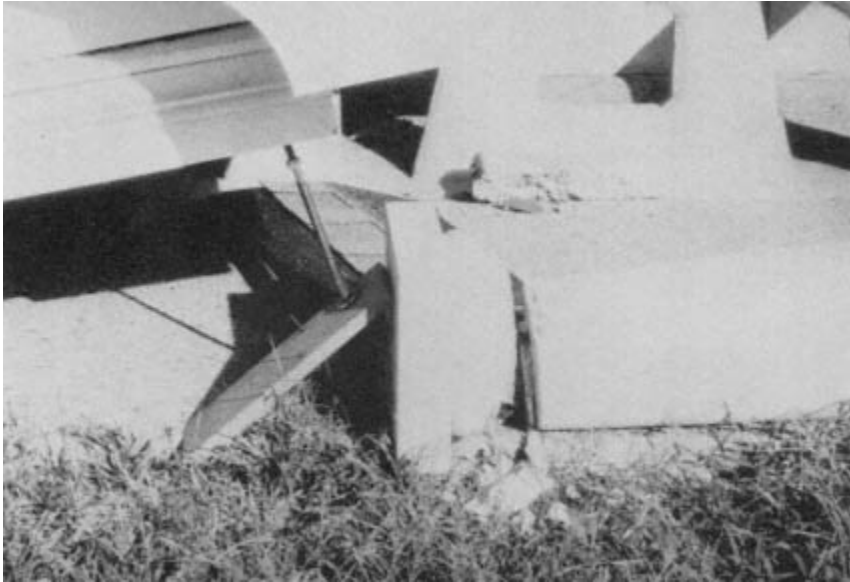
A rest area located on either side of Interstate Highway 10 north of Moss Point provided a siting for a large number of open shelters (Figures 4-31, 4-32, and 4-33) consisting of small timber-framed roofs supported on precast concrete columns. The post-and-lintel framing provided little moment resistance either to the bases of the columns (Figure 4-32) or at the roof-to-column connections (Figure 4-33), and all units collapsed in the storm. Despite being rather elaborate structures, they offered little lateral resistance and could well have constituted a hazard to travelers under much less than hurricane-force winds.

Figure 4-33  
Column-to-roof connection of shelter of [Figure 4-31](#).

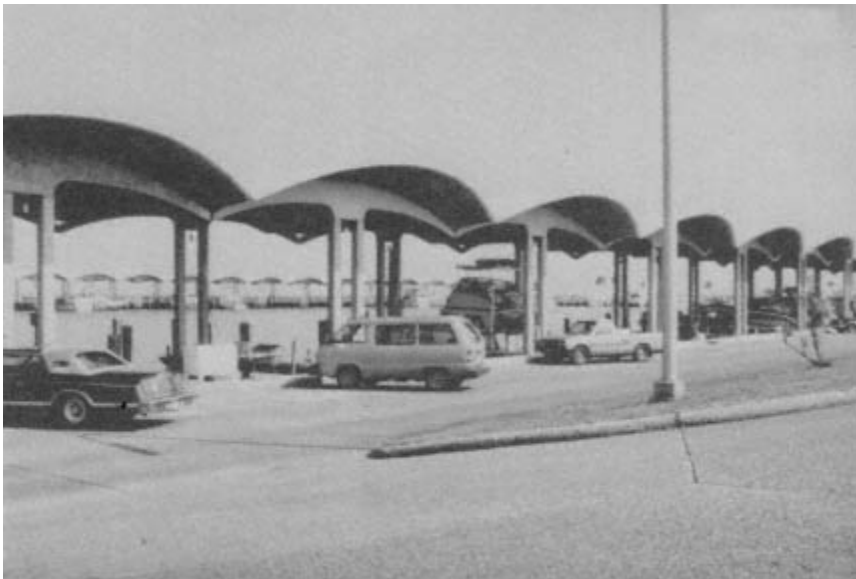
The Broadwater Reach Marina in Biloxi survived this storm and Hurricane Frederic with virtually no damage (Figure 4-36). Although of an unusual shape and in a very exposed location, these relatively heavy concrete-shell roofs had apparently been properly designed to resist the expected wind loads.

Figure 4-36  
Broadwater-Beach Marina in Biloxi/Gulfport area. Precast concrete shelters sustained no damage.

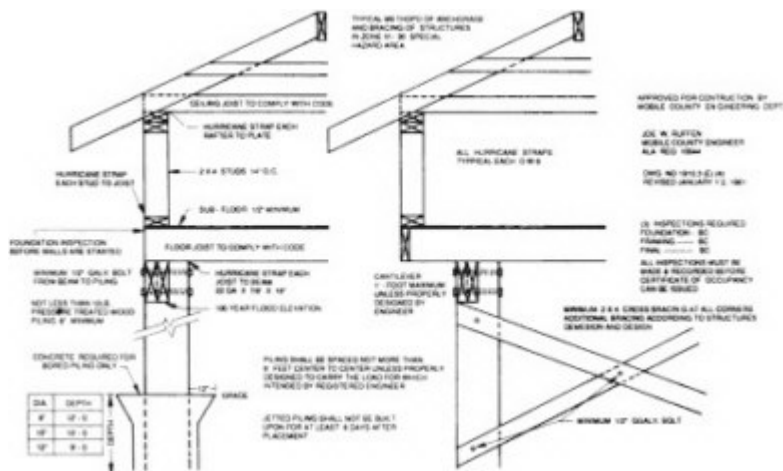
In wood-framed residential construction, the county requires that hurricane anchors or straps be used to connect each rafter to the top wall plate and that each stud be strapped to a floor joist (Figure 4-37). These regulations, while not the most stringent used by coastal communities, are typical of the regulations used by the more progressive jurisdictions.

Figure 4-37  
Requirements for wood-framed residential construction, Dauphin Island.

It must be emphasized that [Table 4-7](#) refers to a rather modest span of 24 ft, with joist spacing of only 16 inches. As land values have risen, beach houses have become larger, and prefabricated trusses spaced at 2 ft on center have become more common. For such a spacing and a 40-ft span, the uplift forces per connection might be as high as 1.5 kips, or more than four times the allowable capacity of a light-duty hurricane anchor. Clearly, something more than an instruction to "hurricane strap each rafter to plate" ([Figure 4-37](#)) is required.

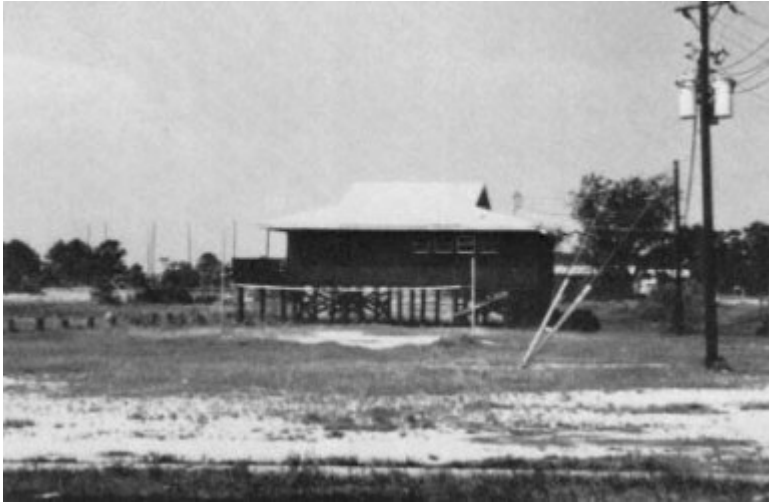
There was virtually no damage to houses in the densely wooded area toward the eastern end of the island. On the more exposed eastern tip of the island, the older military buildings at Fort Gaines, including some dating back to the Spanish-American War, survived with little damage apart from some loss of the waterproof covering of the roofs (Figure 4-38). Newer buildings constructed by the University of Alabama in the style of elevated beach houses suffered only minor vent damage (Figure 4-39).

Figure 4-39  
Well-constructed modern building, near Fort Gaines, Dauphin Island.

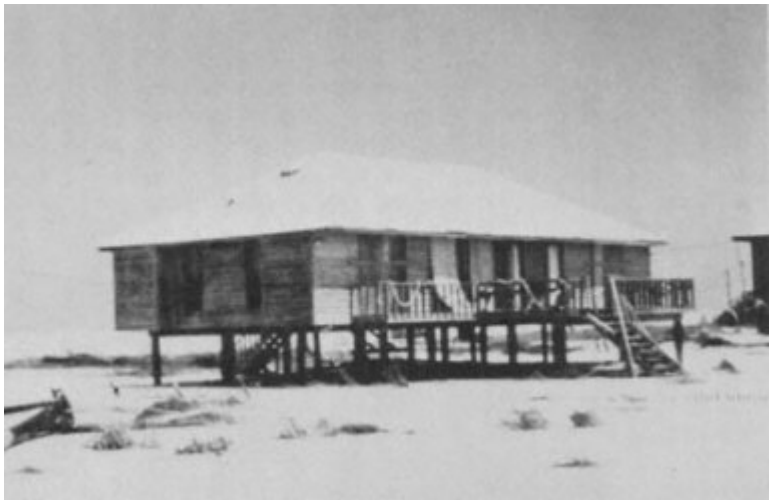
Nevertheless, in these areas many buildings survived with minor shingle damage or no damage at all. These buildings usually had steep-pitched roofs, and many had hipped roofs, including some that probably predated any building control. Nearly all had protected windows, and those that had large porch overhangs had them securely bolted to columns (Figures 4-40 and 4-41).

Figure 4-40  
Undamaged older beach house with steep-pitched roof and protected windows, Dauphin Island.

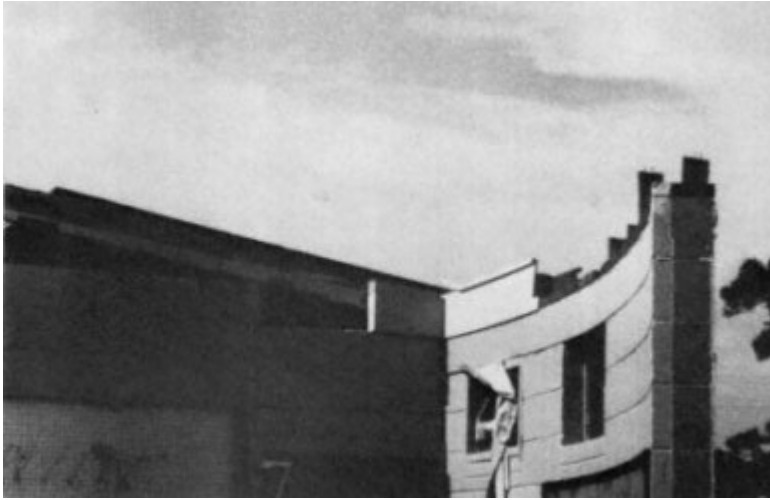
A few other types of buildings did sustain some damage. The Isle Dauphin Country Club lies to the south of the forest cover, among the dunes in an exposed location. The roofing membrane had been removed from most of the buildings. Also, a large portion of a wood roof deck was removed from the most windward building ([Figure 4-44](#)) in an area with a large overhang. [Figure 4-45](#) shows a detail of the roof-to-wall connection, clearly unsuitable for the high uplift forces.

Figure 4-44  
Loss of roof, Isle Dauphin Country Club, Dauphin Island.

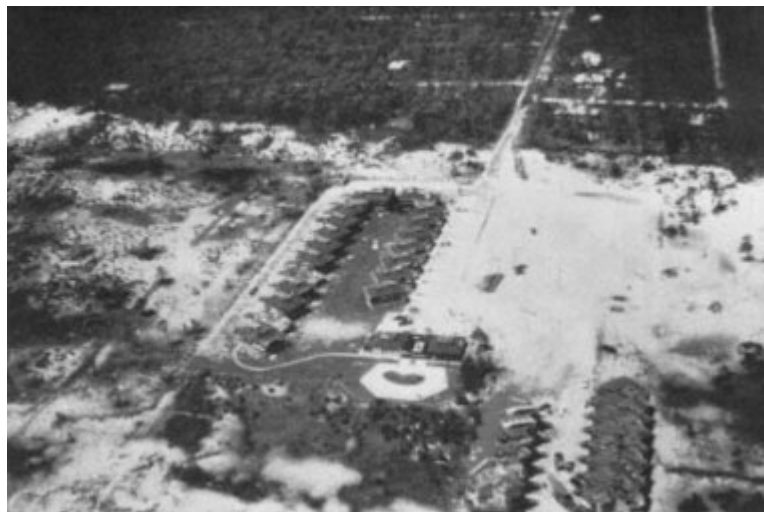
Figure 4-46  
Dauphin Beach Surf Club (left) and Sand Castle Condominiums (right), Dauphin Island.

ings, the Dolphin Surf Beach Club and the Sand Castle Condominiums (Figure 4-46). The former was built about 1970. The buildings are not elevated above the 100-year flood level. Although the high-water mark did not reach the buildings in this storm, they were damaged by water in Hurricane Frederic. Metal straps could be observed tying the roofs to the walls, but the masonry appeared to have been inadequately tied to the stud walls. Similar observations could be made for the upper siding. In one location, the loss of the windward wall precipitated the loss of the the roof.

The Sand Castle Condominiums had just been completed. Figure 4-46 shows the extensive roof damage. The roof trusses had apparently been well secured to the framing system, but the roof sheathing had not been properly nailed to the trusses.

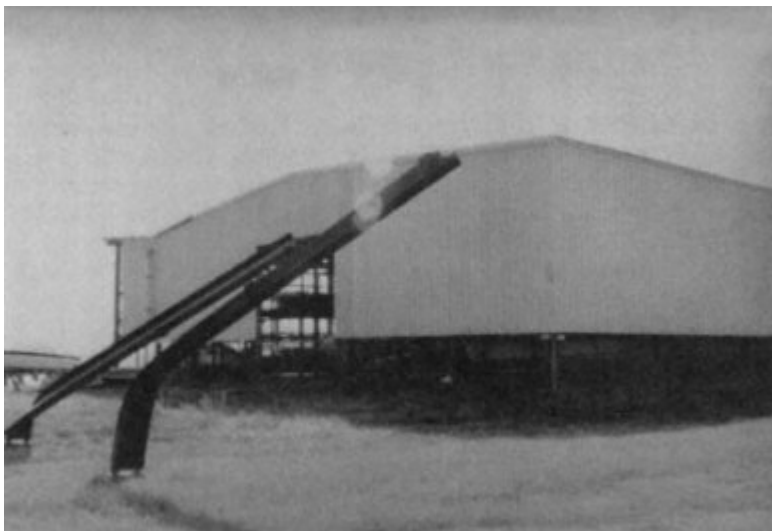
Figure 4-48

the island to the mainland. A metal-clad, timber-framed boat storage facility had been completely destroyed in Frederic and was replaced with the preengineered building shown in [Figure 4-48](#). Only superficial damage to cladding was observed, in contrast with the severe damage to the adjacent sign. Of interest is the fact the building had been designed in accordance with the 1974 revisions to the 1973 Standard Building Code (SBC2), but for a wind speed of 120 mph for the cladding and 140 mph for the primary framing; the pressure coefficients selected were based on one wall being open. As seen in [Figure 4-48](#), the walls are free of cladding near the ground. This would have served to prevent any significant increase in internal pressure during the passage of Elena. Other preengineered building was located a short distance from the boat storage facility and experienced minor loss of trim ([Figure 4-49](#)).

This preengineered metal boat storage facility on Dauphin Island suffered only minor damage in Hurricane Elena. (Note damage to sign in foreground.)

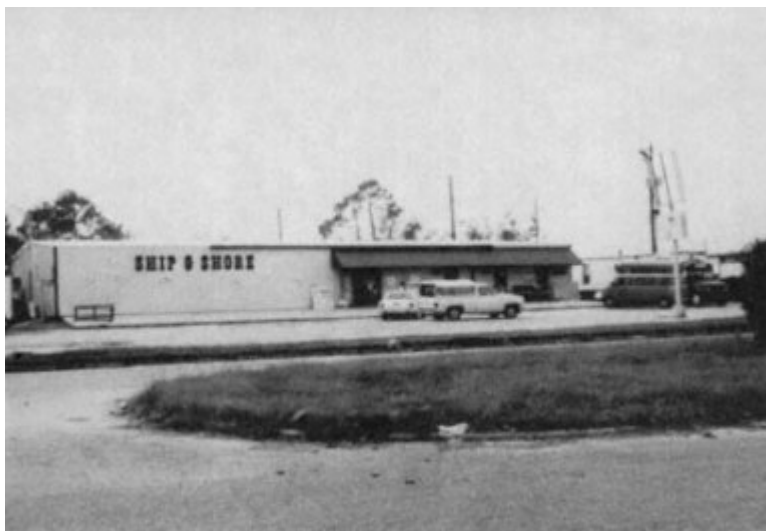
Figure 4-49

Undamaged modern metal building, Dauphin Island.  
(Note properly designed canopy.)

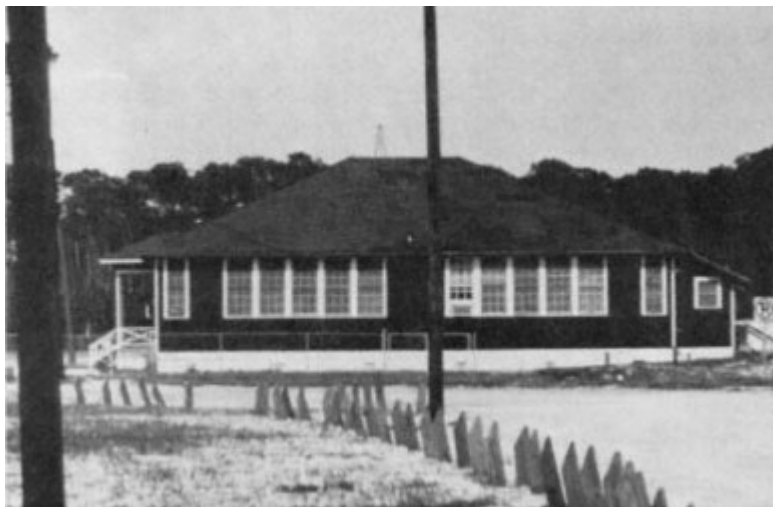
Considering the damage sustained by many schools on the mainland, it is interesting to note that the small wooden school on Dauphin Island survived with very little damage, as it had in Hurricanes Frederic and Camille ([Figure 4-50](#)). Yet, it probably experienced the highest wind speed of any school affected by Elena and probably had the smallest amount of professional input in its design. It did, however, have a fairly heavy, steep-pitched hip roof that generated little if any uplift. This is in stark contrast to the

Figure 4-50  
Dauphin Island School.

lightweight fiat roofs of the damaged schools that would have been subjected to significant uplift forces.

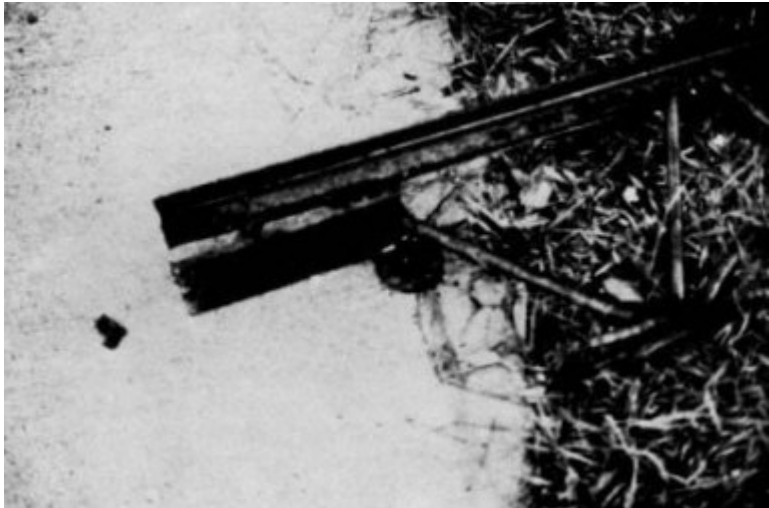
Figure A-2  
Bar joist-wall connection—Pascagoula Vocational High School.

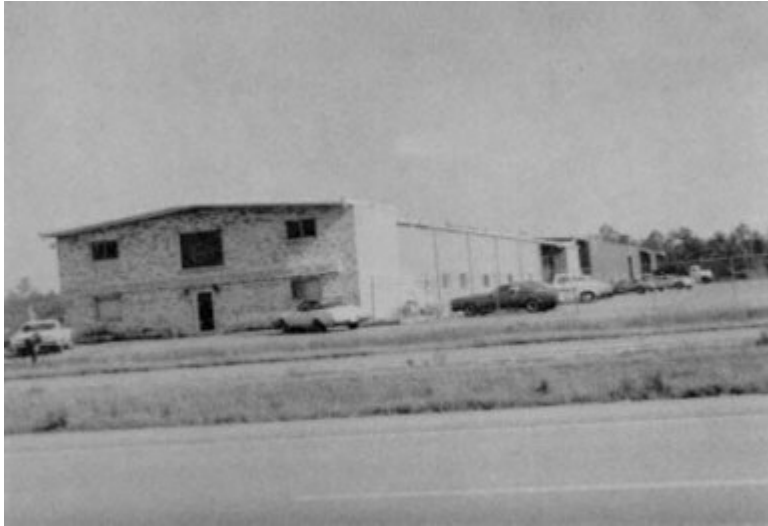
Figure C-5  
Metal building clad with masonry veneer located in Gautier.

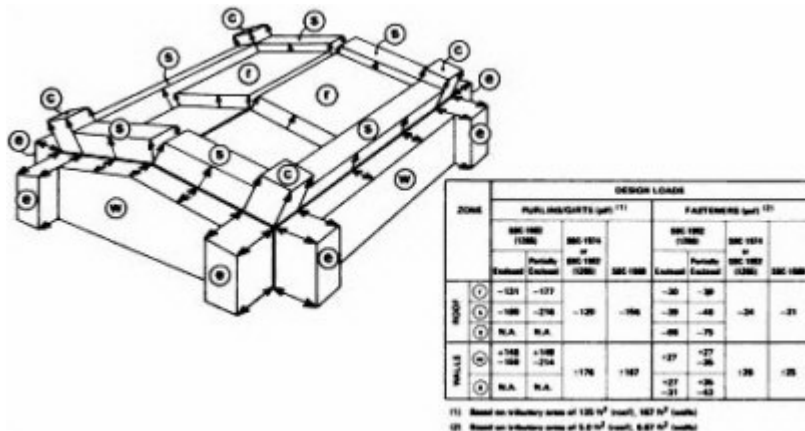
Figure C-6  
 Design loads for strut purlins of metal building system.

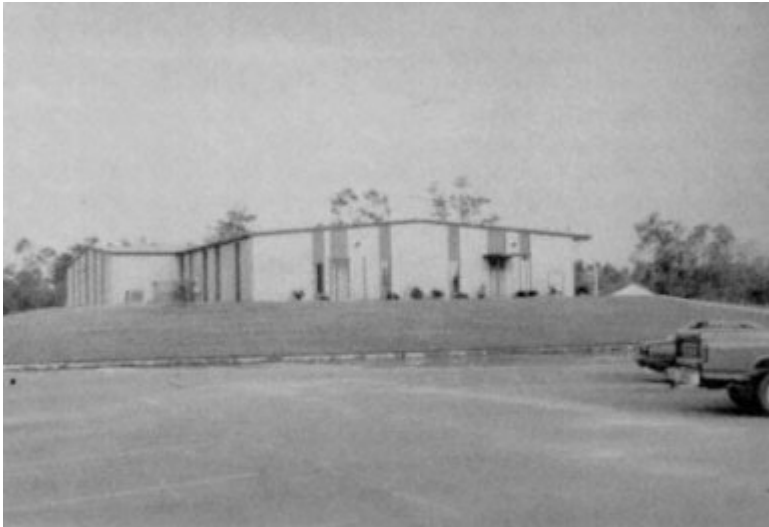
Figure C-10  
New, undamaged, preengineered metal building located adjacent to building in [Figure C-8](#). Note absence of overhead doors and large glazed areas. Building was sited in more severe wind exposure.
