Hurricane Hugo, Puerto Rico, the Virgin Islands, and Charleston, South Carolina, September 17-22, 1989

Committee on Natural Disasters, Board on Natural Disasters, National Research Council

NATURAL DISASTER STUDIES

Volume Six

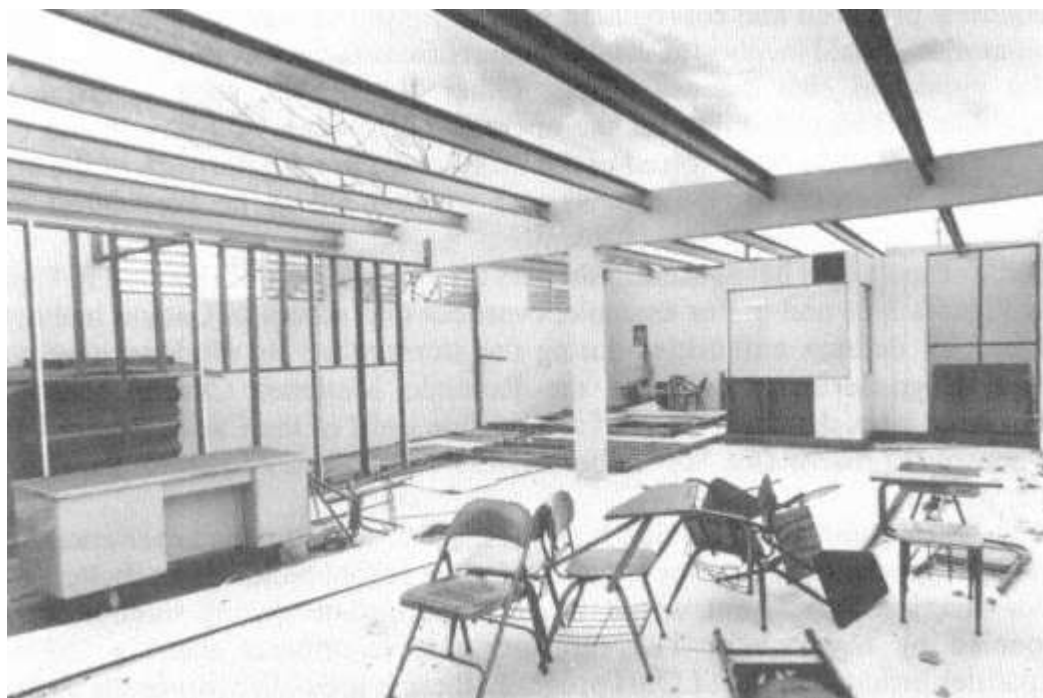
Some schools now being used as shelters are not safe, as documented in [Figure 3-1](#) and [Figures 3-2a and b](#). For example, evacuees to a school in Catano had to be moved by civil defense authorities during the storm when its windows gave way. Hurricane Hugo seriously damaged the Rosendo Matienzo Cintron school in Luquillo; large trees damaged the roof and outside walls of the Carlos Rivera Ufret middle school (*El Nuevo Dia*, September 21, 1989, p. 11; and *El Vocero*, September 20, 1989, p. 10).

Figure 3-1 Vocational School in Fajardo, Puerto Rico used as a shelter during Hurricane Hugo.

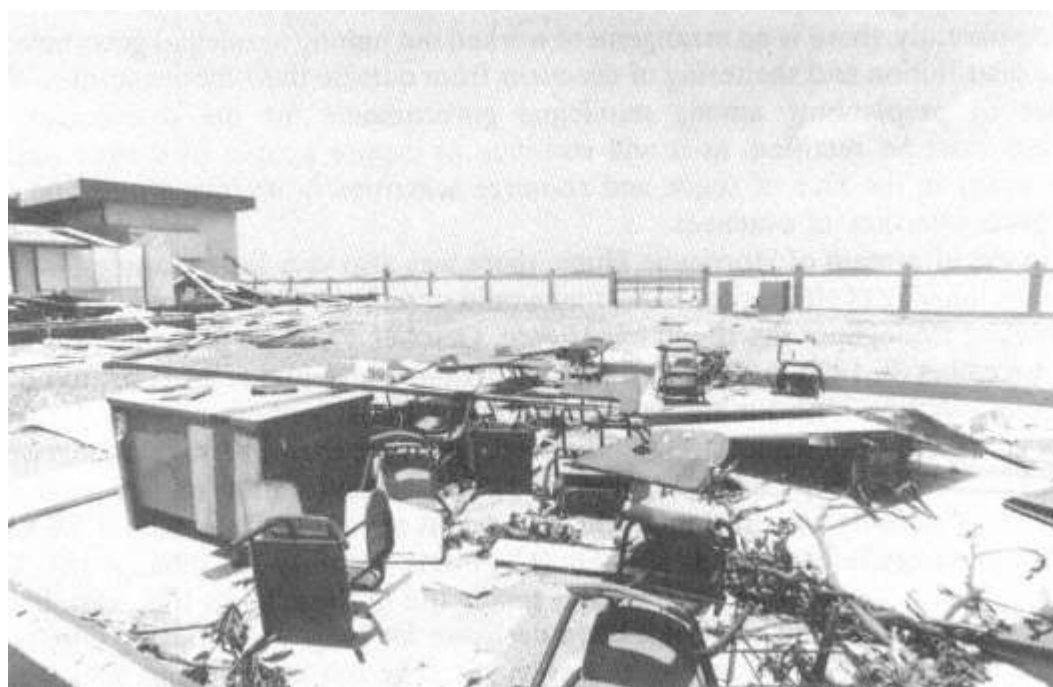
Figure 3-2a One view of the Rosendo Matienzo Cintron School in Luquillo, Puerto Rico, used as a shelter during Hurricane Hugo (first photo).

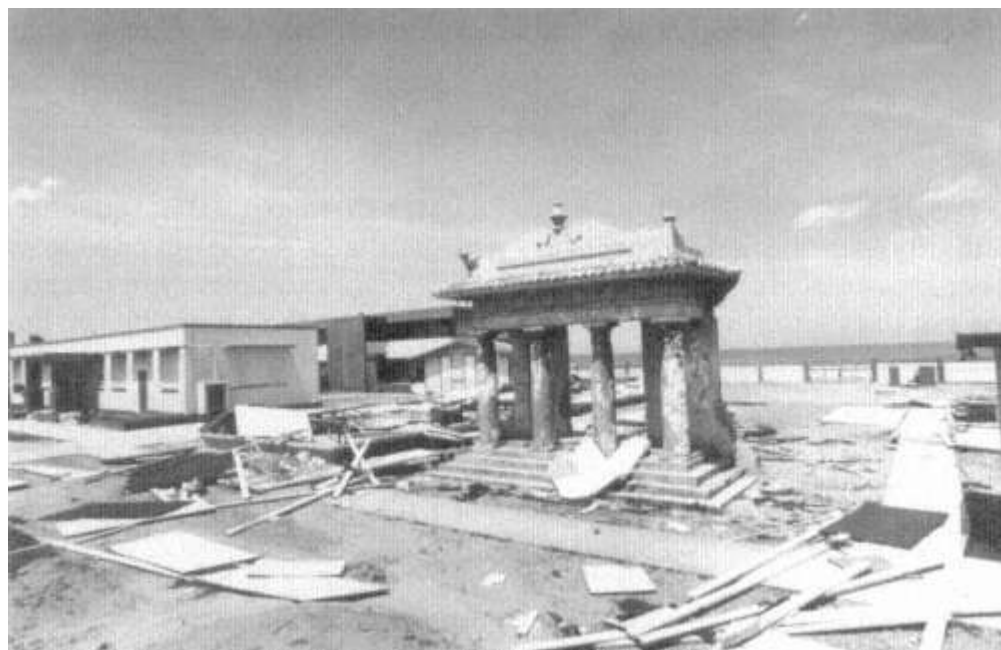
Figure 3-2b A second view of the Rosendo Matienzo Cintron School in Luquillo, Puerto Rico, used as a shelter during Hurricane Hugo.

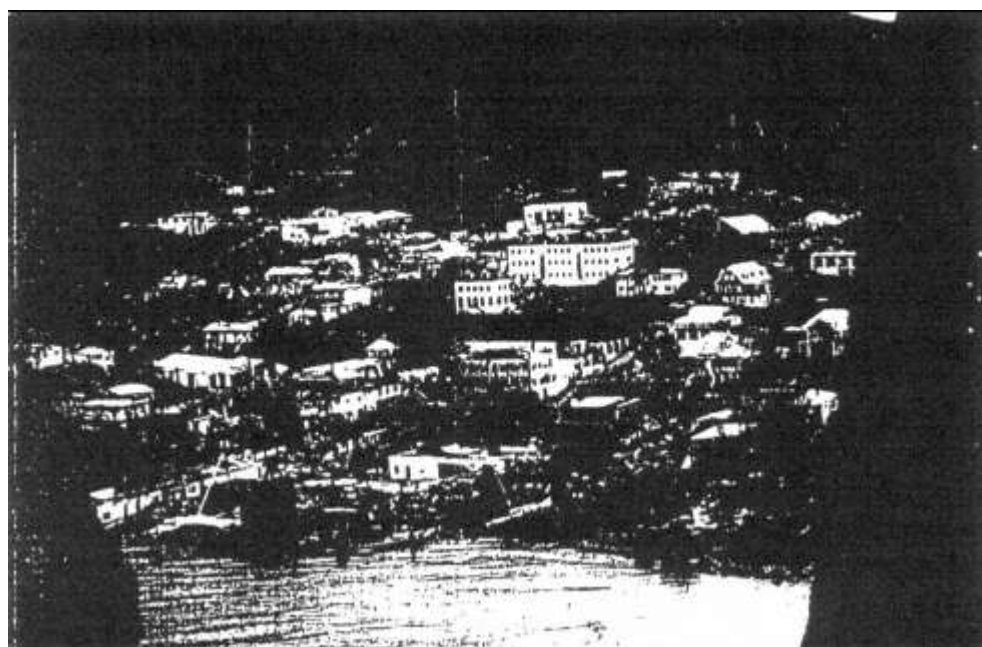
Figure 4-5 Christiansted business district.

Part of the Christiansted business district is shown in [Figure 4-5](#). Some of the buildings exhibiting little damage are more than 200 years old. Beached boats and debris provide an indication of the extent of storm surge and wave runup.

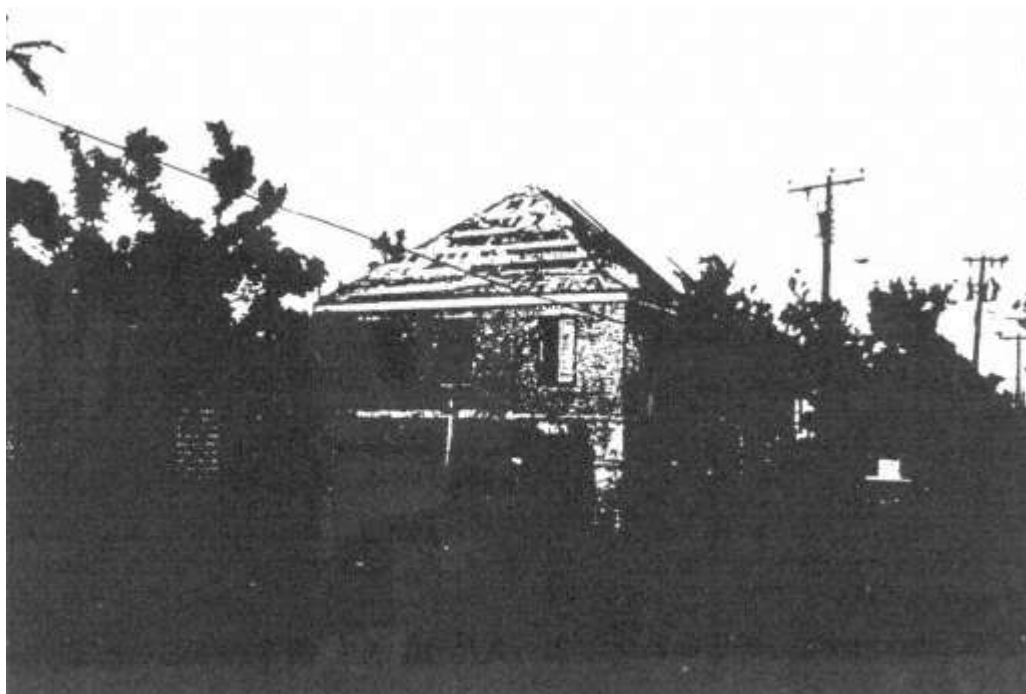
Figure 4-14
Historic building in downtown Frederiksted, St. Croix.

[Figure 4-14](#) shows a historic building in downtown Frederiksted. It is likely that this building has been exposed to several hurricanes in its lifetime, and loss of part of the roof structure may be due as much to lack of maintenance as to strong winds. The view is to the northwest, and the building was exposed to damaging winds from first the northeast and then the southwest.

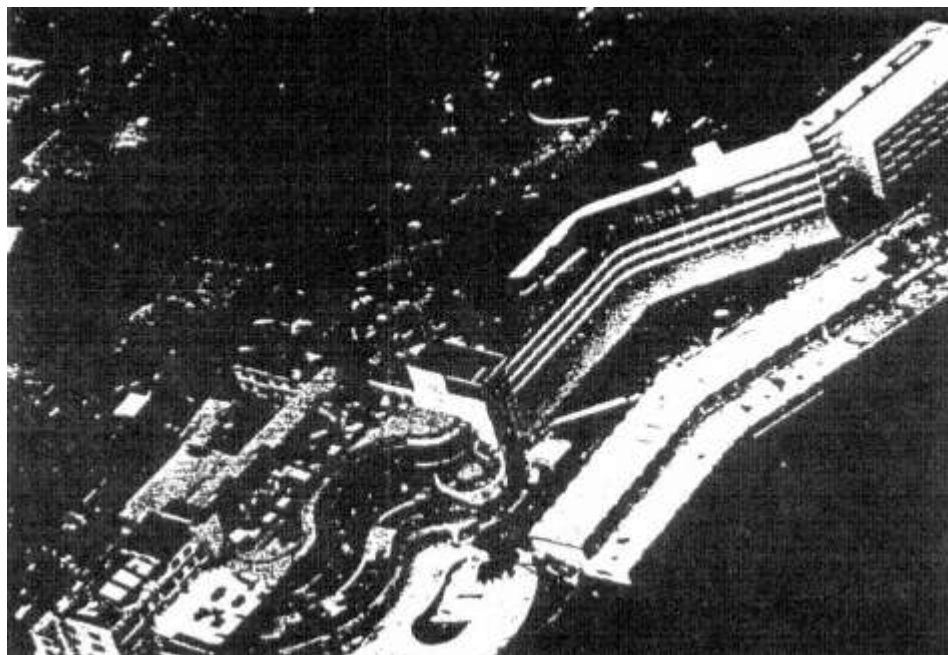
Figure 4-15
Resort hotel, St. Thomas.

The resort hotel shown in [Figure 4-15](#) is directly northwest of Charlotte Amalie in the approximate center of St. Thomas. The view is to the north, and the strongest winds were from right to left in the figure. Although not shown in the figure, the terrain in the windward direction is conducive to channeling of the flow, and this probably contributed to the locally heavy damage.

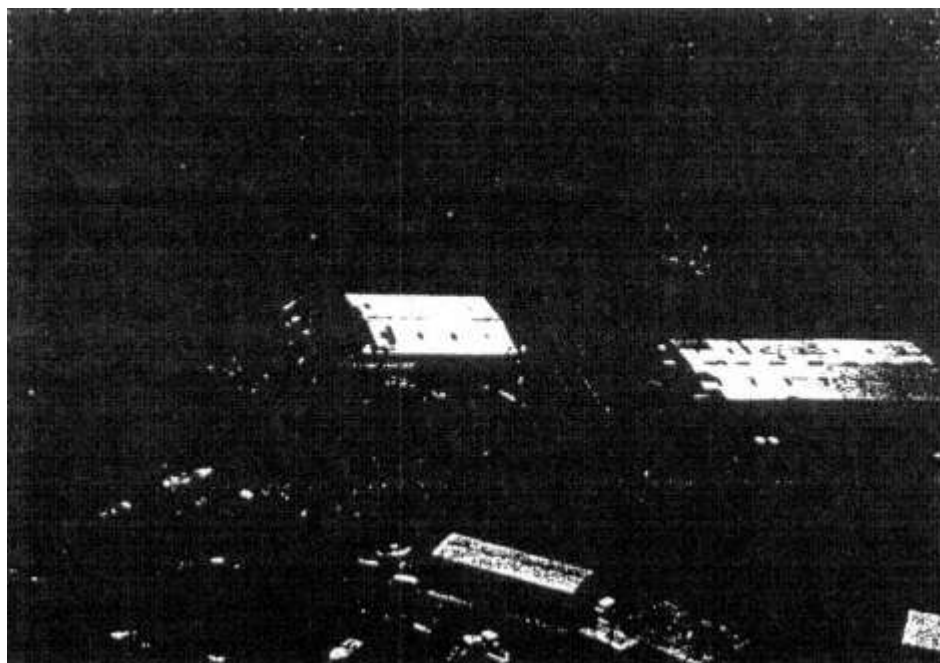
Figure 4-16
Marine service center, St. Thomas.

The marine facility shown in [Figure 4-16](#) is located in the southeast sector of the island. Note that the building in the foreground does not appear to have been damaged, while those in the background have lost roof sheeting along the windward edge.

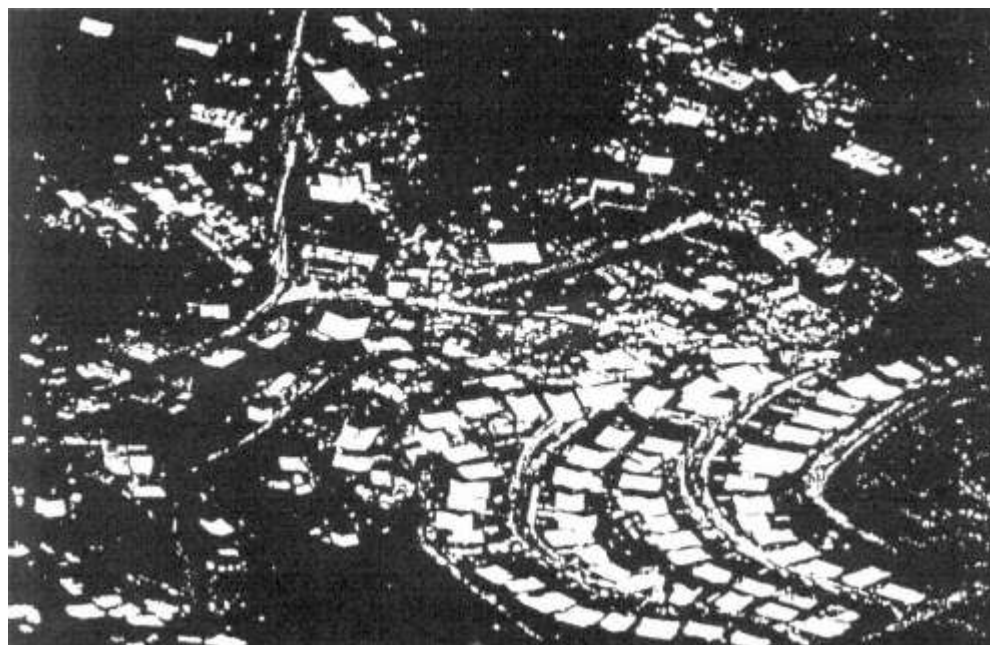
Figure 4-17
Housing development near Charlotte Amalie, St. Thomas.

Figure 4-17 shows a housing development in the hills behind Charlotte Amalie. The houses in the background appear to be undamaged, while some of those in the foreground have suffered almost total destruction. It is not clear whether this selective damage is due to terrain effects or is the result of a microburst. Because microbursts are highly localized wind phenomena, their occurrence depends on the coincidental existence of a surviving anemometer in the proper location. This was not the case in Puerto Rico. Therefore, though the observed damage suggests a likely microburst near Charlotte Amalie and elsewhere, the occurrence of microbursts in Puerto Rico is only a matter of informed speculation.

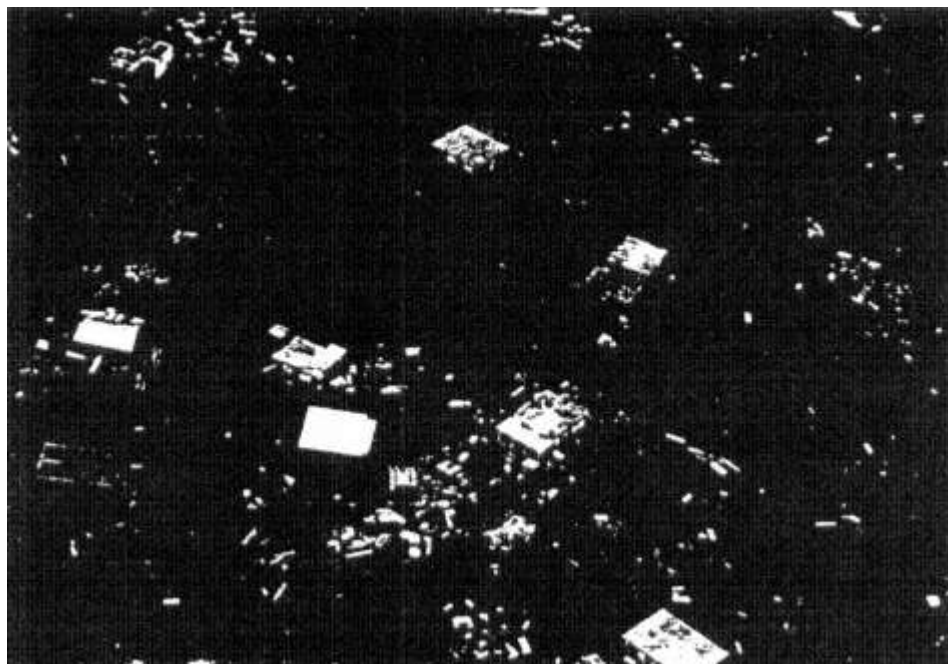
Figure 4-18
Houses on post-and-beam supports, Vieques.

This island is to the south and west of the storm track and, therefore, likely experienced less severe winds than did Culebra. Figure 4-18 shows a housing area where the individual units were cleanly removed from their concrete post-and-beam supporting systems. It was not possible to conduct a ground survey of Vieques, but it appears that the floor-to-frame connection details in this case need to be improved. Figure 4-19 shows another residential area that suffered severe damage. The damage pattern suggests the possibility of locally intense winds due to microbursts.

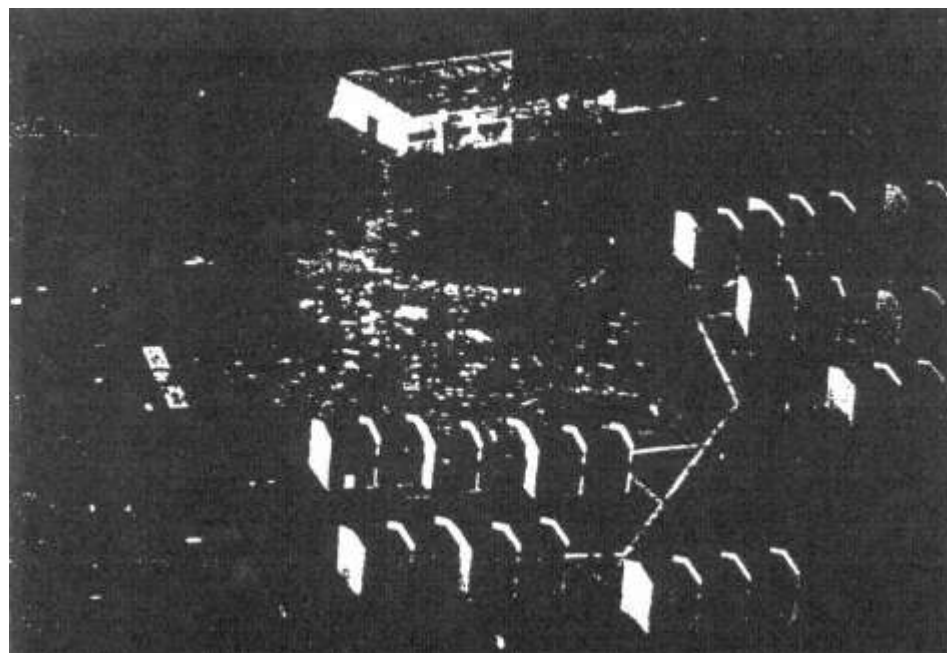
Figure 4-20
Commercial development near Esperanza, Vieques.

Figure 4-20 shows a commercial development near Esperanza on the south coast of Vieques. The large building in the center of the photograph is an old factory building that was being renovated for use as a resort hotel. The building at the top of the figure has lost all of its roof sheeting.

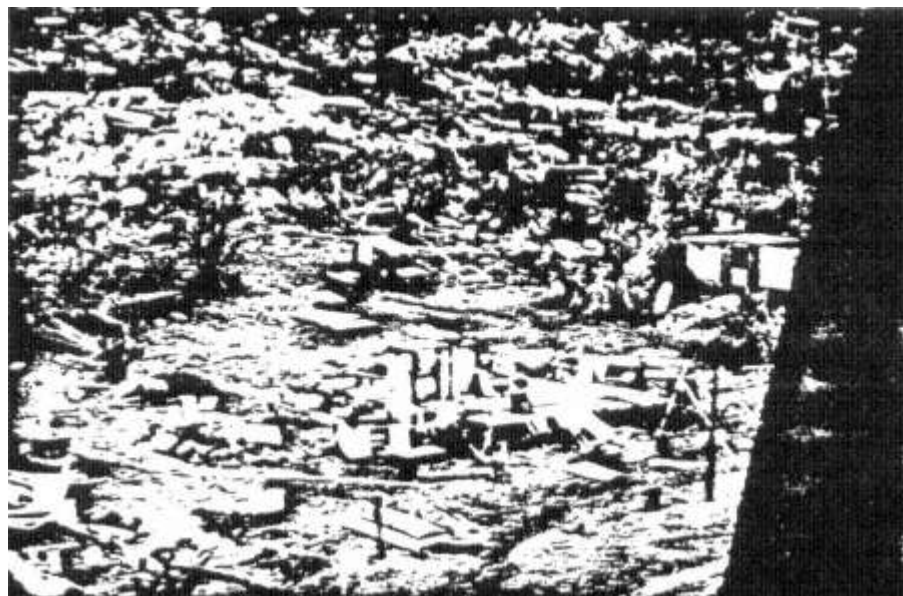
Figure 4-21
Housing development next to airport, Culebra.

The island of Culebra experienced severe damage from winds that were only slightly less intense than those on St. Croix. Figure 4-21 shows a housing area adjacent to the local airport that was totally destroyed. The quality of construction was poor, and it is doubtful that there was any attempt to comply with the Puerto Rico Building Regulation. In addition, the terrain slopes steeply upward to the west, which is very likely to have caused an acceleration of the intense easterly winds from Hugo. Directly to the south of this area is the Ensenada Honda, where many small watercraft sought refuge from Hugo and were either sunk or driven ashore by the strong easterly and southeasterly winds. Figure 4-22 shows several small craft beached along the north shore of Ensenada Honda. At the west end of Ensenada Honda is the town of Culebra. The aerial view in Figure 4-23 shows wind damage in the central business district and more small craft driven ashore by the strong easterly winds.

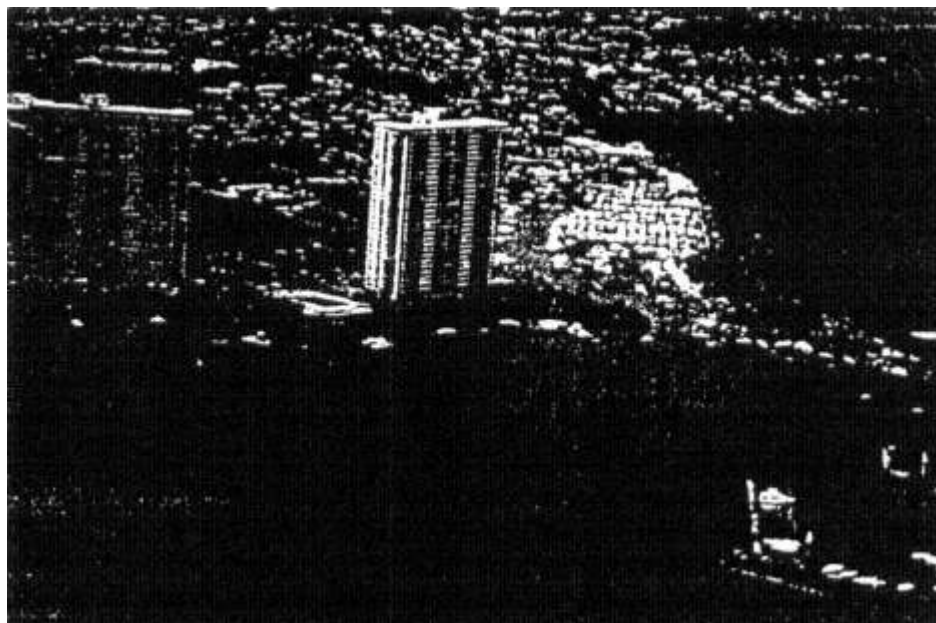
Figure 4-24 Dos Marinas, Fajardo, Puerto Rico.

Figure 4-24 shows two reinforced concrete buildings on the east coast of Puerto Rico between Cape San Juan and Fajardo. The building on the right was oriented so that the strongest winds from the north were blowing directly onto its broad face. Post-storm inspectors found that the windward curtain walls on many floors near the top of this building had failed, and that the interior partitions and leeward curtain walls were subsequently blown out. Figure 4-25 shows a partition wall near ground level that developed a diagonal tension crack under wind load. Figure 4-26 shows a shearwall of the building oriented so that the strongest winds came from left to right. Note the evidence of movement in the horizontal construction joint. Figure 4-27, which is a photograph of the same wall, shows damage to the perimeter beams under the floor slabs caused by transverse displacement of the building. The adjacent shearwalls showed no signs of distress.

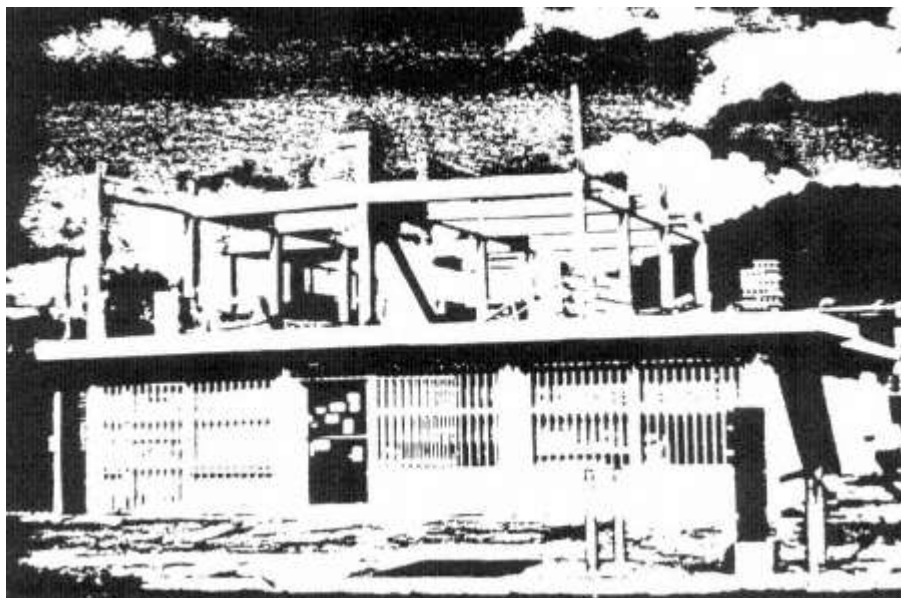
Figure 4-28 Reinforced concrete house under construction, Puerto Rico.

The house shown in Figure 4-28 is typical of a class of structure in Puerto Rico that performed extremely well in Hurricane Hugo. The walls are either cast-in-place

concrete or constructed of concrete masonry units with integral reinforced concrete columns and perimeter beams. The roof slab is 100 to 125 mm thick. As with the highrise reinforced concrete buildings just described, the seismic requirements of the building code governed the design, and the substantial dead loads made this type of structure highly resistant to Hugo's wind forces. Observed damage was limited to inadequate attachment of door and window frames to the concrete walls and perimeter beams. One of these houses is shown under construction in [Figure 4-29](#).

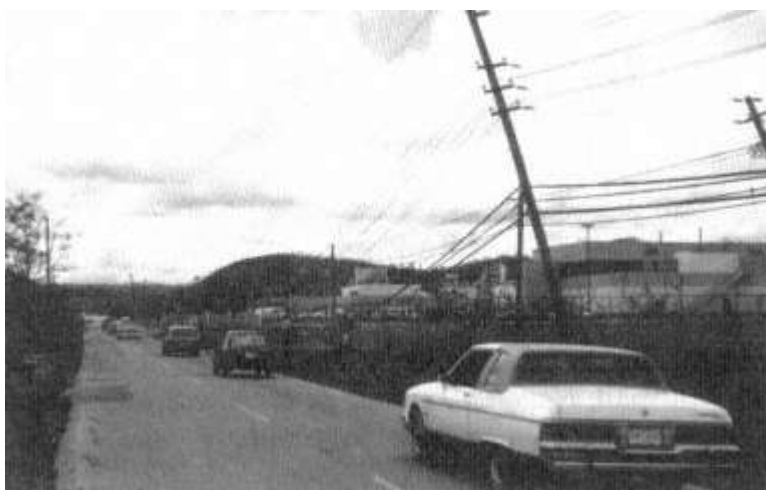
Figure 5-1
Downed power lines east of San Juan.

Electrical distribution systems were the lifelines that suffered the greatest damage in Hugo. It was not possible to study this problem in detail in the Virgin Islands, but it is believed the damage in northeastern Puerto Rico, as well as the emergency response efforts, were typical. [Figure 5-1](#) shows downed power lines directly east of San Juan, where the sustained winds probably did not exceed 70 knots (81 mph). Under these conditions, it is unexpected that such widespread failure

should occur. Fallen trees and other wind-blown debris collecting on the conductors contributed to line failures. However, the great majority of downed lines in Puerto Rico were in open areas and failed because the poles were carrying too many conductors. Failed poles included conventional treated-timber poles as well as prestressed concrete poles. Channeling of wind through hilly terrain was observed to have intensified damage in several places. Winds were channeled through some small hills with enough velocity to snap these large electric-supply poles. No trees in those areas fell on the electric lines; they were toppled by wind force alone. Less than 100 m to the east, in the shadow of the hills, a satellite dish remained, undamaged, atop a building.

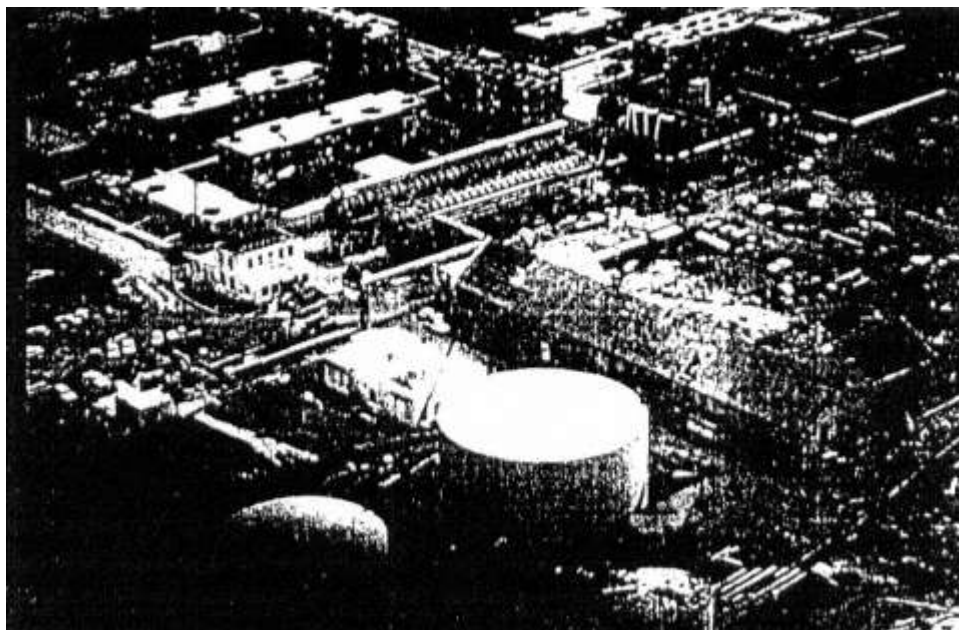
Figure 5-3 WAPA Richmond facilities, Christiansted, St. Croix.

At least two significant water supply failures occurred during the passage of Hugo. On St. Croix, the Virgin Islands Water and Power Authority (WAPA) power and water distillation facilities, located on the west side of Christiansted, were knocked out of operation. An aerial view of the facility looking to the east is shown in [Figure 5-3](#). The fuel oil tank in the bottom center of the picture ruptured, and the containment, which was intended to function in such an emergency, also failed, probably before the tank ruptured. The result was a serious oil spill in the waters of Christiansted Harbor.

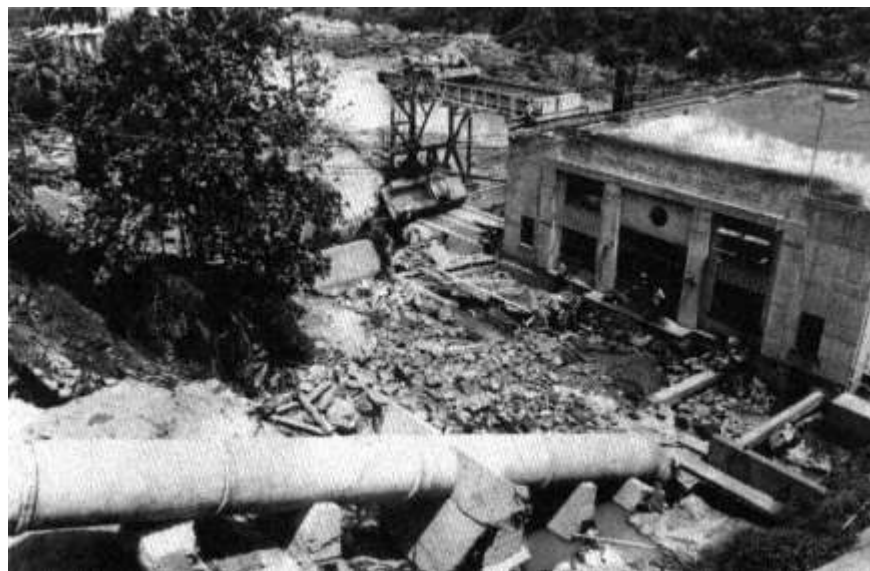
Figure 5-5 El Carraizo pumping plants, San Juan water supply.

The other important failure of the disaster preparedness programs in Puerto Rico was the interruption of water services to the San Juan metropolitan area for 9 days as a result of the flooding of El Carraizo pumping plant, shown in [Figure 5-5](#). The dam supplies San Juan's drinking water. During the emergency, some of the floodgates were inoperable, which caused water to spill over the dam, flooding the electric motors in the pumping plant and interrupting water services. The risk had been known for some time; a FEMA Interagency Hazard Mitigation Report had

identified the problem at El Carraizo Dam, as well as other potential flood sites throughout the island, as early as 1985. The CND investigative team confirmed FEMA's finding that the channels and flood-control structures near the Municipality of Catano were not adequately maintained. In the case of El Carraizo Dam, FEMA "uncovered many serious problems, including an earthen left bank which may be subject to erosion, an inadequate spillway, heavy siltation, rust deterioration of auxiliary floodgates, and a number of other serious maintenance/operations problems" (FEMA, 1985, p. 12).

At El Carraizo Dam, as with other dams in Puerto Rico, there is a significant potential for a truly catastrophic incident. Because the dam is only approximately 2 km upstream from the town of Trujillo Alto, tens of thousands of people could have perished if it had collapsed. Fortunately, the expected amount of rainfall did not materialize at that location. The dam's catchment area managed to withstand almost 2 inches of rain during Hugo. The situation at El Carraizo was similar to the tragedy on Las Americas Expressway near the Coamo River on the southern coast of Puerto Rico. On October 7, 1985, the Coamo River Dam overflowed, collapsing a span of the expressway and sending 29 persons to their death. In both cases, ample warnings about the unsafe conditions existed (FEMA, 1985, p. 35).

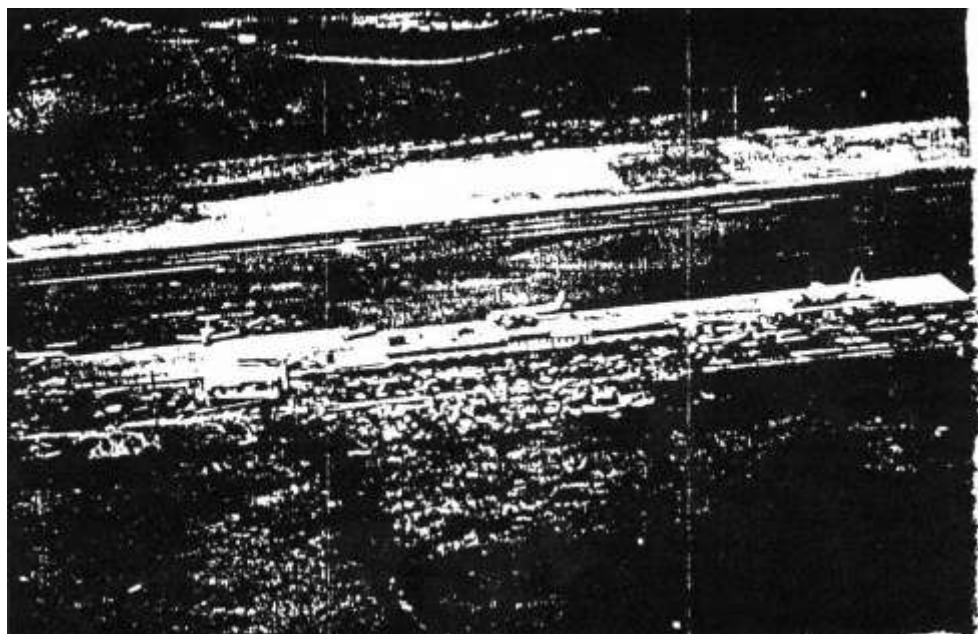
Figure 5-7
Alexander Hamilton Airport, St. Croix.

Airports and aircraft in Hugo's path suffered considerable damage. FAA facilities at Alexander Hamilton Airport on St. Croix were heavily damaged, and most of the aircraft guidance equipment had to be replaced. The control tower, which sits on top of the terminal building, lost all of its cab windows, and much of the instrumentation and communications gear suffered water damage. Although the airport was open to light aircraft almost immediately after the passage of Hugo, it was 6 days before a temporary air traffic control tower was operational. Military navigation and communications gear was used in the interim. A photograph of the airport terminal building taken 5 days after the passage of Hugo is shown in [Figure 5-7](#). Not shown in the picture are numerous private and commercial aircraft that were destroyed on the ground. As of March 1990, the terminal building and control tower were back to normal service.

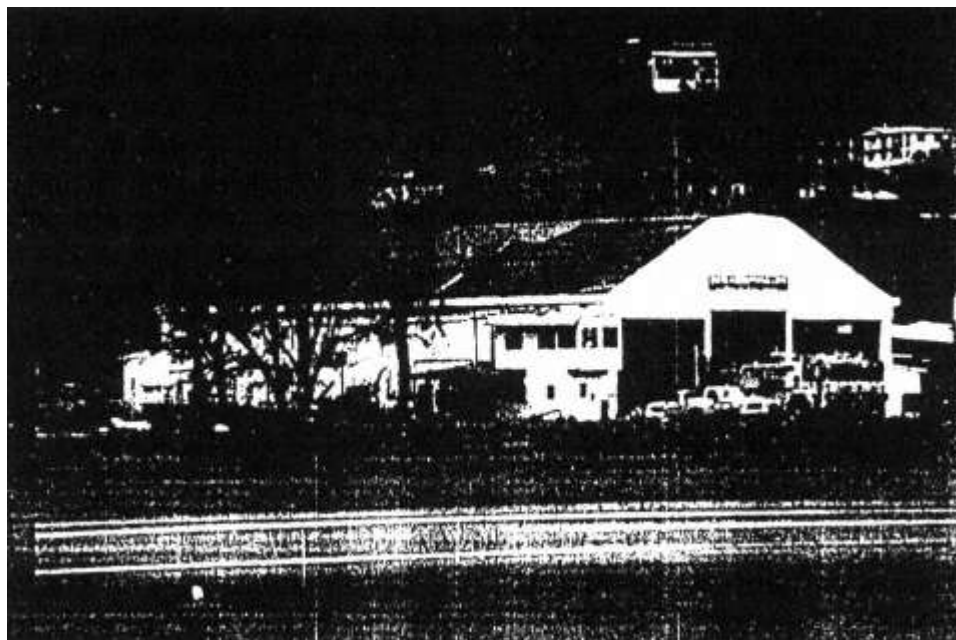
Figure 5-9
Airport fire and rescue station, St. Thomas.

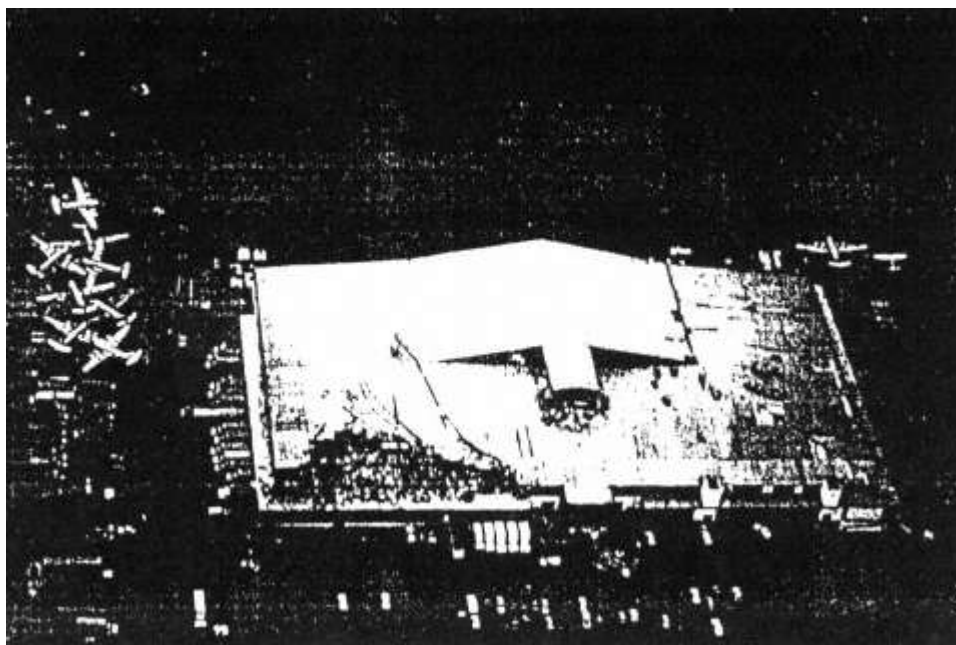
Figure 5-10
Cargo building, San Juan International Airport.

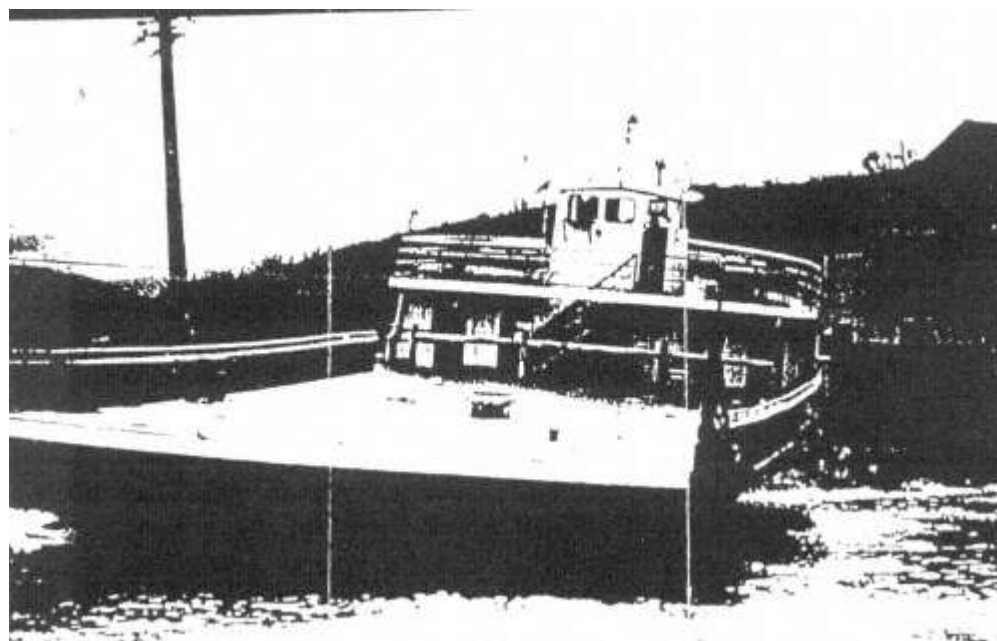
Ferry service between Puerto Rico and the islands of Culebra and Vieques was disrupted for several days. Typical of the damage caused by Hugo is the grounded ferry boat at Fajardo, shown in Figure 5-12. Two ferries were washed ashore, so there was only one trip per day from Fajardo to the islands. On September 27, 1989, the *San Juan Star* estimated over \$50 million in losses to boats and another \$25 million in damage to marinas.

Figure 5-12 Beached ferry boat, Fajardo, Puerto Rico.

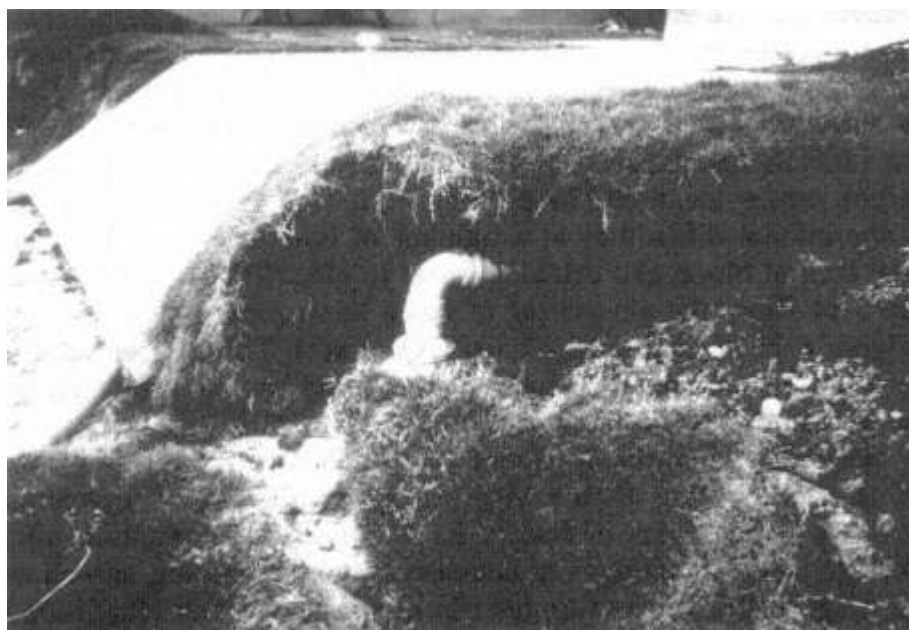
[Figure 5-14](#) shows the uncovering of waste water pipes in the Isla Verde area (see also [Figure 6-15](#) in [Chapter 6](#), Coastal Processes). These pipes were buried in the sand in front of condominiums and are a potential hazard if the lines break and waste water contaminates fresh water.

Figure 5-14 Wastewater pipes, Isla Verde.

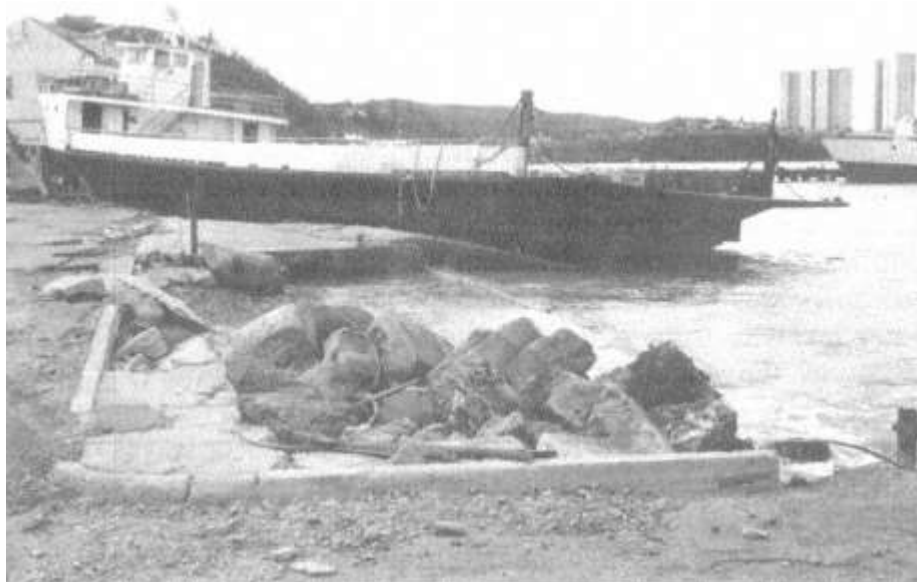
In Fajardo, the surge was high enough to ground one of the large ferries that serve Vieques and Culebra ([Figure 6-4](#)). Many boats were destroyed in a supposedly "hurricane-proof" harbor of Ensenada Honda on Culebra. [Figure 6-5](#) shows some of the boats that were floated inland and grounded by the storm surge. It is also evident in the photo that storm-surge waters did not penetrate very far inland in this steep setting. [Figure 6-6](#) shows a similar example at the south shore of St. Croix. [Figure 6-7](#) illustrates the situation on the northern shore of St. Croix, west of Christiansted.

Figure 6-4 Grounded ferry in Fajardo.

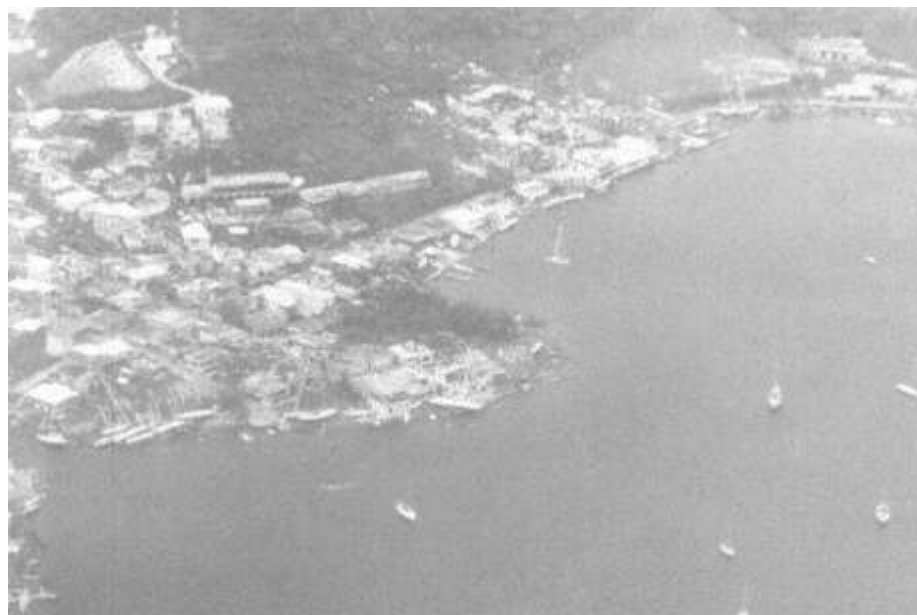
Figure 6-5 Ensenada Honda, the "hurricane proof" harbor of Culebra, showing ships grounded by storm surge. notice that ships did not float very far inland—testimony to the small penetration of storm surge owing to the steep terrain.

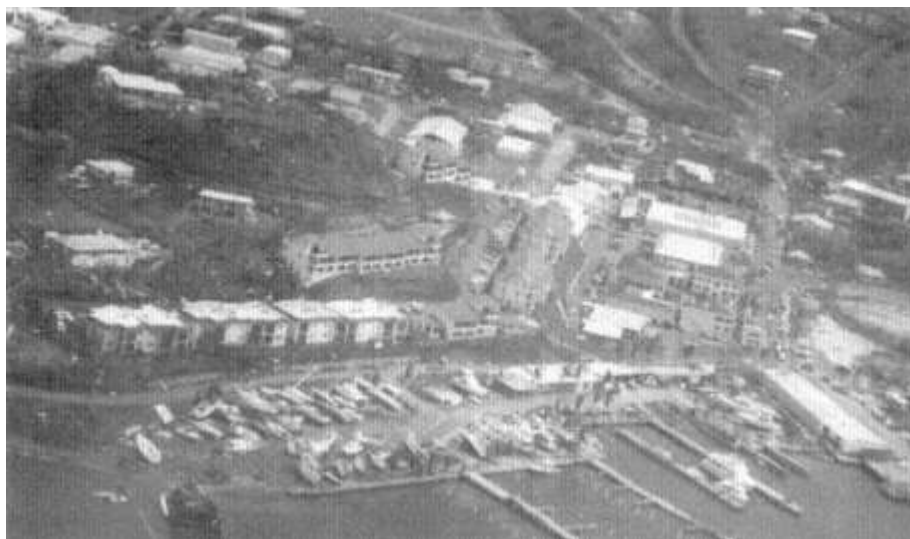
Figure 6-6 Boats washed ashore by storm on the southern shore of St. Croix. As in [Figure 6-5](#), storm surge did not penetrate very far inland. Courtesy: Richard Marshall, 1989.

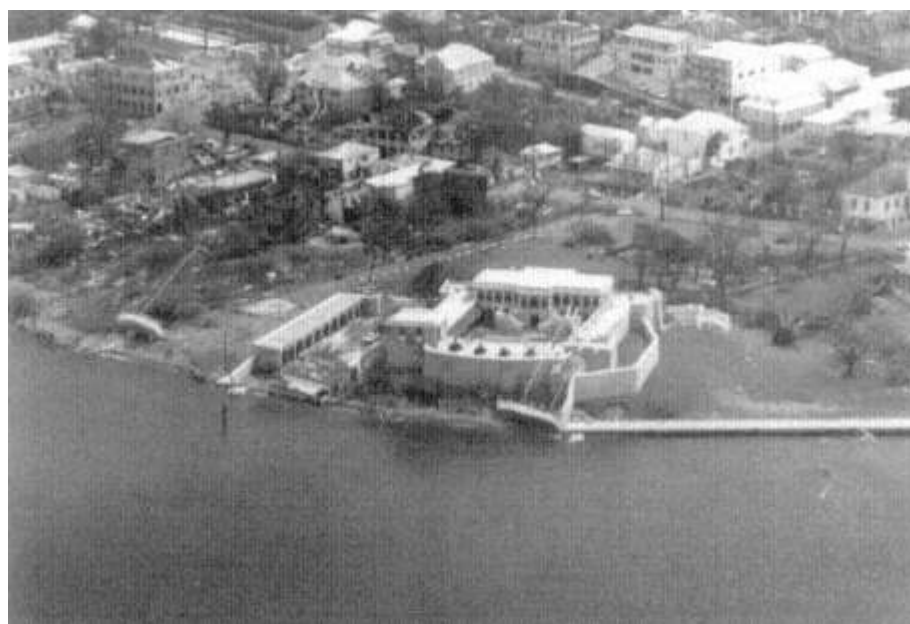
Figure 6-7 St. Croix, northern shore, west of Christiansted. Reduced penetration of storm surge owing to steep terrain (see also [Figures 6-5](#) and [6-6](#)). Courtesy: Richard Marshall, 1989.

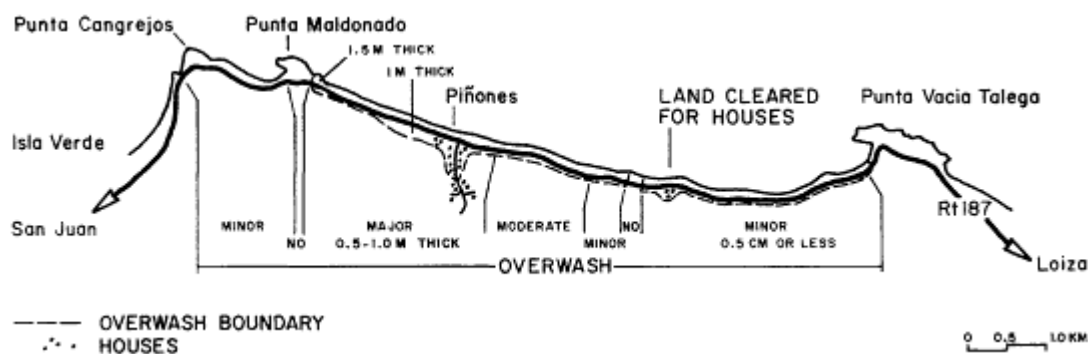
The section of the coast from Boca de Cangrejos, near the Luis Munoz Marin International Airport, east to Punta Vacia Talega, in the area of Pinones, suffered extensive coastal erosion. Overwash covered Route 187 at the shorefront—the only road in this area—with up to 1 m of sand in places but did not penetrate very far inland, barely over the road in many places. The extent of shoreline affected by overwash was a stretch approximately 10 km long. Figure 6-8 shows sand overwash penetration and thickness for the Pinones area.

Figure 6-8 Overwash sand penetration and relative thickness for Pinones area.

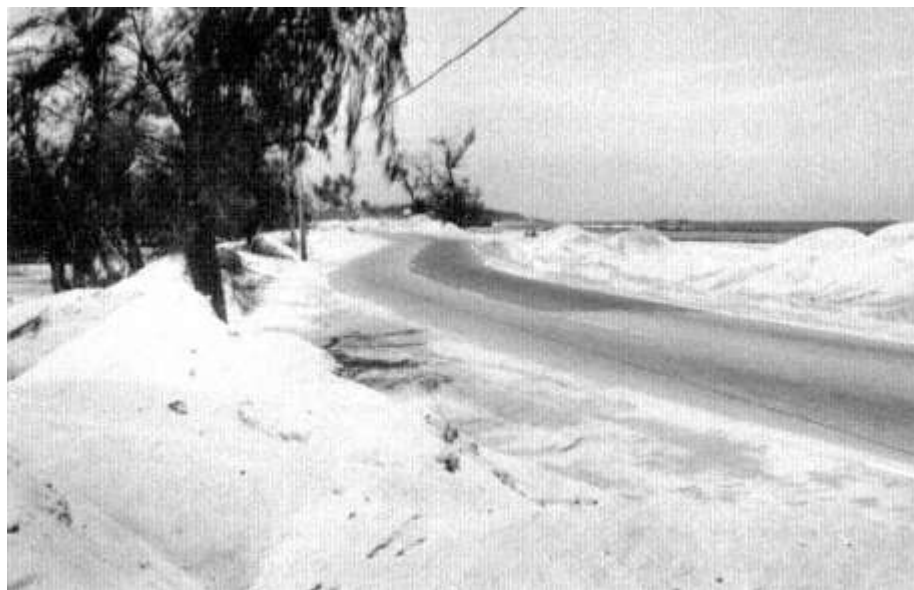
Sand that was overwashed during the course of Hugo has been permanently removed from the beach system. In an undeveloped setting, this sand would be available to be blown into dunes and to add elevation to the coastal lowlands. On developed shorelines, however, the overwash sand is often regarded as "in the way" and quickly cleared off roads, used for construction, or dumped in empty lots. It is important, especially on shorelines prone to erosion, that overwash sand be returned to the beach system as a means of beach reconstitution. To the credit of the PRDNR, heavy equipment was in the Pinones area moving some of the overwashed sand back to the beach within 1 week of the storm. This should continue throughout the affected areas of Puerto Rico. Figure 6-9 shows one of many piles of overwash sand in the Pinones area.

Figure 6-9 Overwash sand piled up along Route 187 in Pinones.

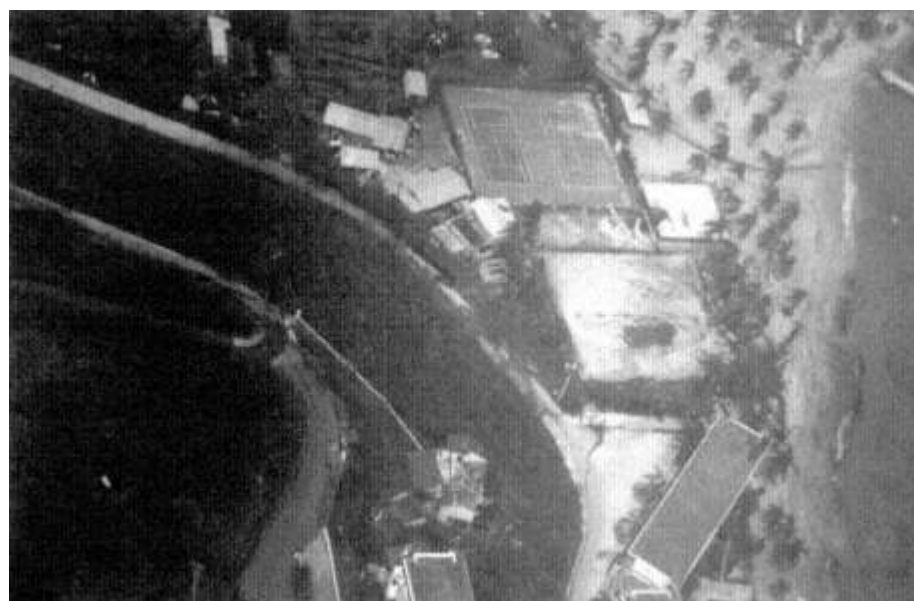
Figure 6-10 Sand overwash on the eastern shore of St. Croix. Courtesy: Richard Marshall, 1989.

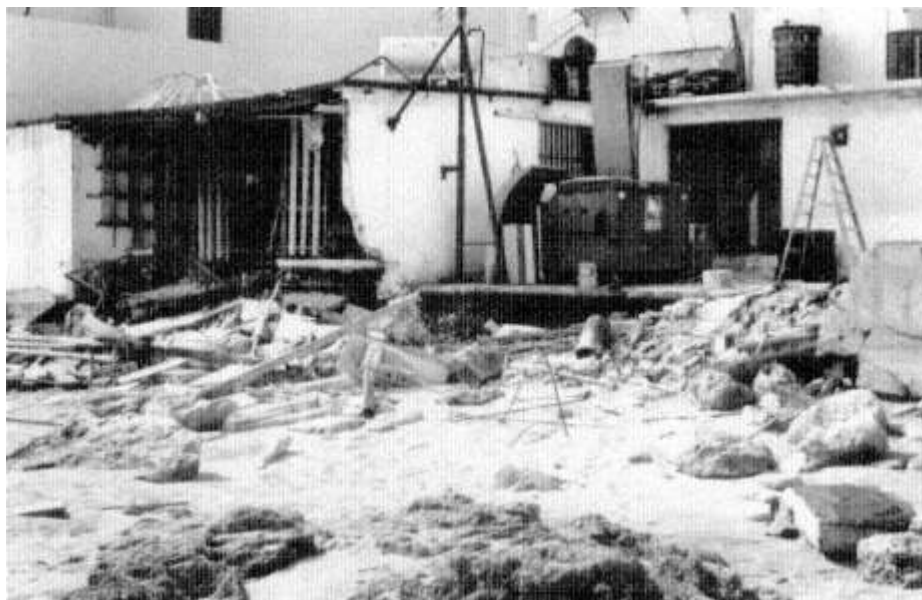
In the Condado, the Oasis Restaurant's front wall was destroyed (Figure 6-11). Figure 6-12 demonstrates the power of storm waves. The boulder in the photo was lifted from the beach and over a 1-m wall into this park, which is immediately west of the Oasis Restaurant. Shoreline retreat during the storm, in addition to collapsing walls, exposed tree roots, as shown in Figures 6-13 and 6-14 from Punta las Marias. Shoreline erosion also exhumed infrastructure, as shown in Figure 6-15 at Punta el Medio in Isla Verde. The shoreline at Punta Uvero east of Loiza was heavily armored with a boulder revetment, but only in front of some of the houses. Over the years, the shoreline has continued to erode past the revetted section. Hugo destroyed the boulder revetments and most of the first row of structures (Figure 6-16). A mobile home park on the beach in Loiza was destroyed, mostly by wind force, though much wave damage to the dunes in the area was noted. This is one of a very few mobile home parks known in Puerto Rico.

Figure 6-11 Destroyed front of Oasis Restaurant in the Condado.

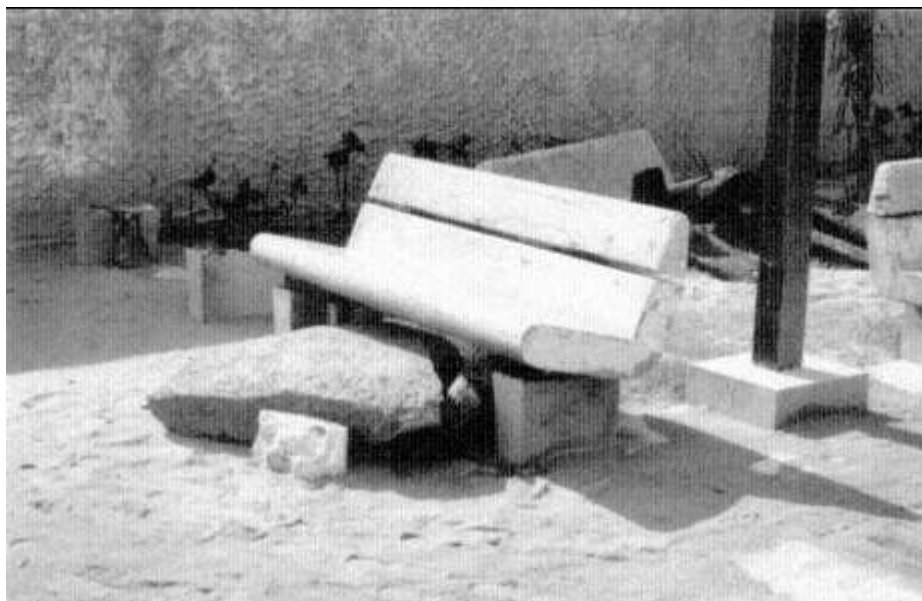
Figure 6-12 A boulder that had been thrown over a 1-m wall in the Condado. Site is immediately west of the Oasis Restaurant shown in [Figure 6-11](#).
