Hurricane Hugo, Puerto Rico, the Virgin Islands, and Charleston, South Carolina, September 17-22, 1989

Committee on Natural Disasters, Board on Natural Disasters, National Research Council

NATURAL DISASTER STUDIES

Volume Six

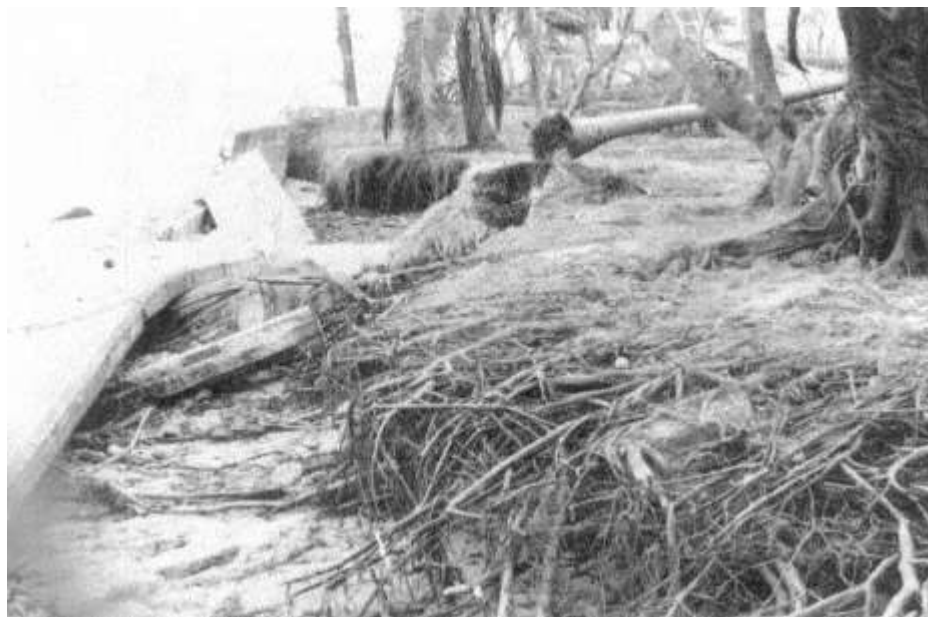
Figure 6-13 Shorefront in Punta las Marias, Calle Almendro, showing unearthed tree roots, toppled seawall, and shoreline retreat.

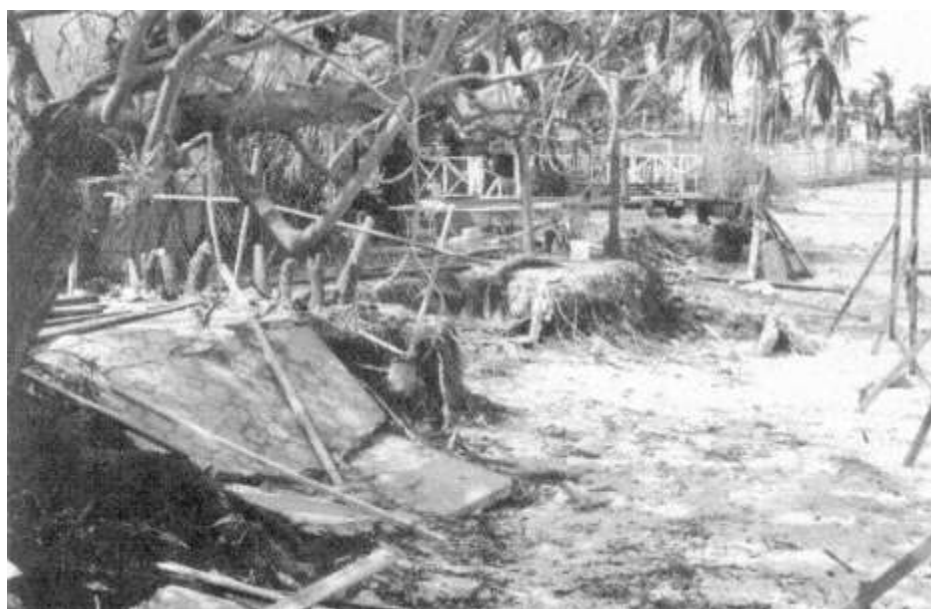
Figure 6-14 Punta las Marias area, same vicinity as [Figure 6-13](#), showing retreat of shoreline.

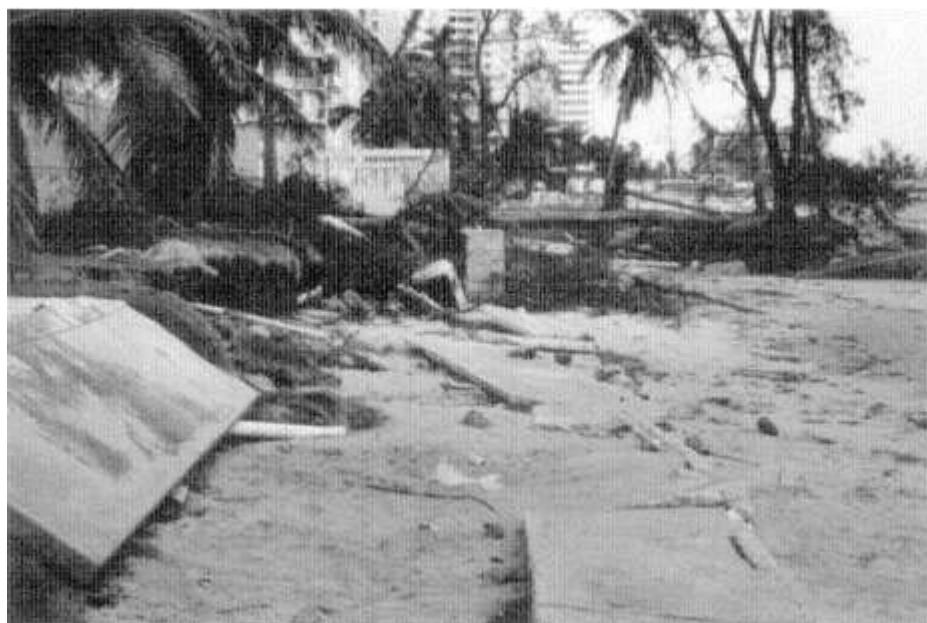
Figure 6-15 Punta el Medio area in Isla Verde showing unearthed water and waste pipes.

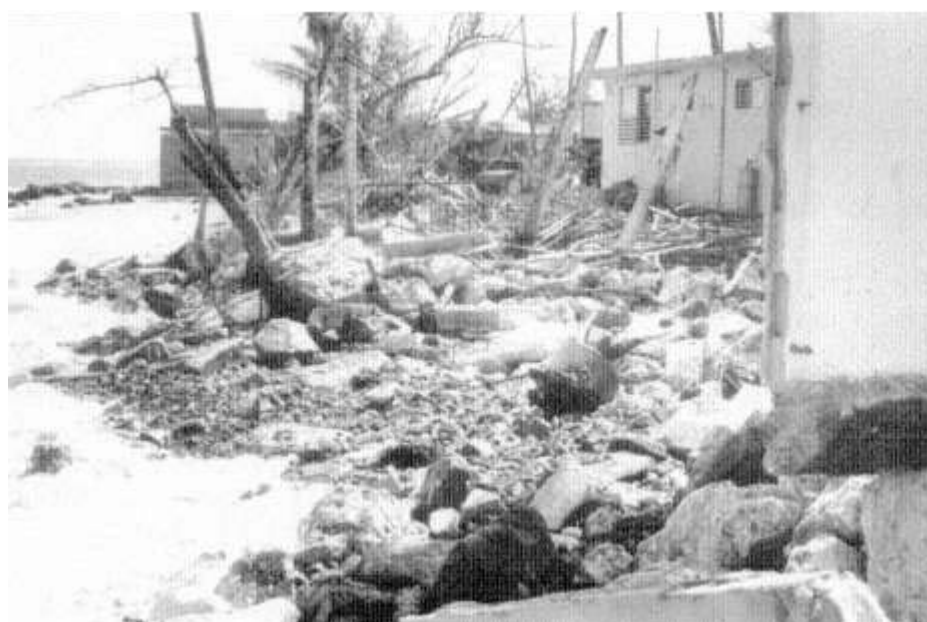
Figure 6-16 Punta Uvero area showing destruction of revetment and first row structures.

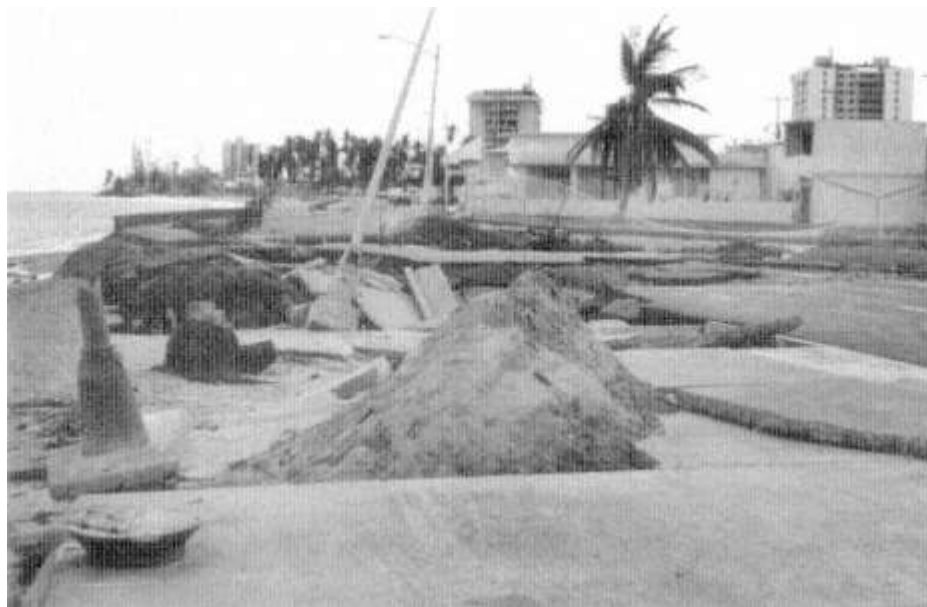
The Barbosa Park beach in Ocean Park is a very popular one in the San Juan area. The shoreline here retreated about 10 m during Hugo. Sidewalks were undermined and utility poles were toppled (Figure 6-18). This was also a site of extensive sand overwash.

Figure 6-18 Barbosa Park shoreline after Hugo.

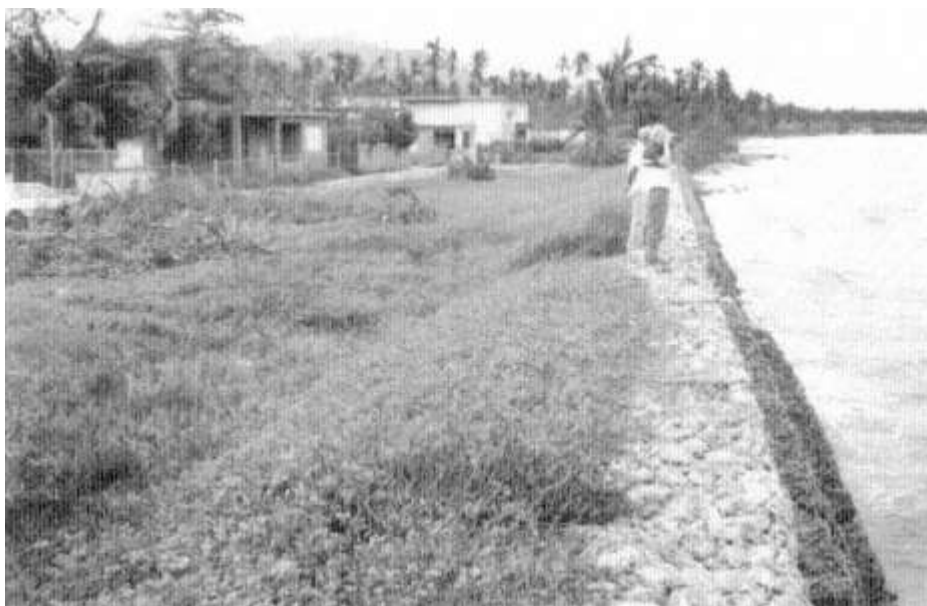
The beach in front of a gabion wall at Playa de Humacao on the east coast disappeared during Hugo (Figure 6-19). The wall was built after Hurricane David in 1979 to protect mostly single-story homes and businesses. The structures were largely

Figure 6-19 The gabion wall at Playa de Humacao. The beach is gone, and waves will now begin to attack the wall directly. Some beach rebuilding is expected naturally, though how much is impossible to predict.

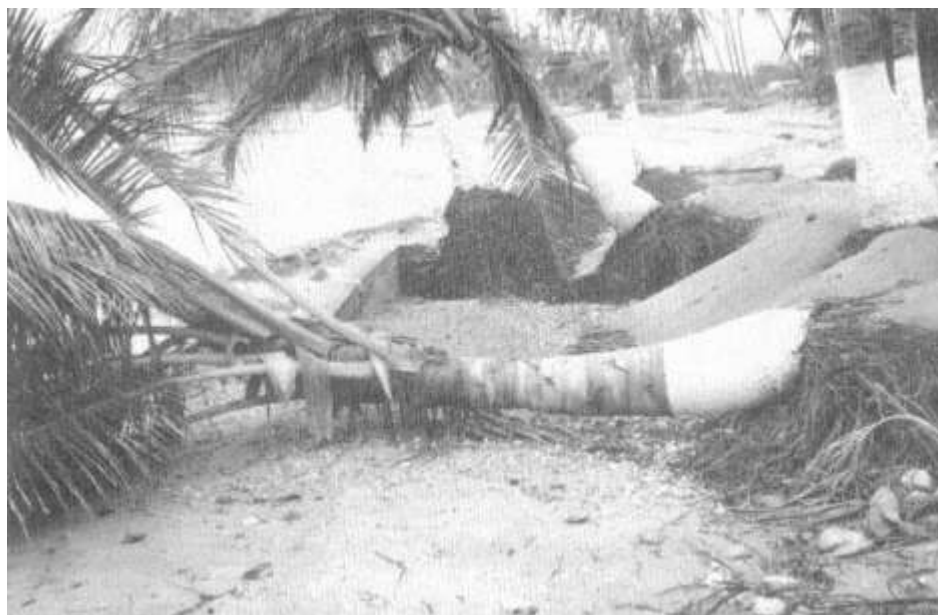
The privately owned Caribe Playa Sunbeach Resort, near Cabo Mala Pascua on the south coast, historically suffers from beach erosion during tropical cyclones, and Hugo was no exception. The owners replenish the beach as necessary with sand from other parts of their property to provide an aesthetically pleasing shorefront. Figure 6-20 shows downed palm trees, as well as a seawall and gravel beach (normally covered) that were exhumed during Hugo. New sand already emplaced only 3 days after Hugo can be seen in the right-hand side of the photo. Interestingly, some stretches of sandy beaches (i.e., Taino Park, east of Punta Piedrita) actually accreted during Hugo.

Figure 6-20 Shorefront of Caribe Playa Sunbeach Resort near Cabo Mala Pascua. Seawall and gravel beach are kept covered by owners' efforts of replenishing the beach with sand taken from elsewhere on their property.

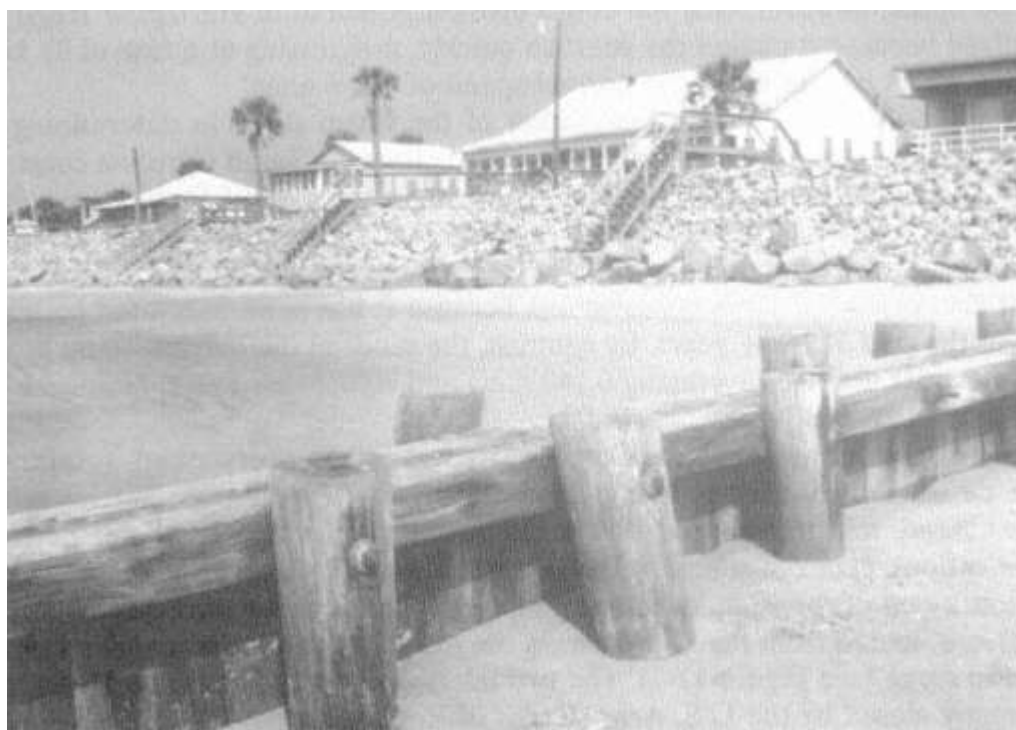
Before Hurricane Hugo, there was essentially no beach along the developed portion of Folly Island (Figure 11-3). Residents had resorted to dumping large stones and concrete rubble on their beaches to form riprap revetments, so that the shore was heavily armored. These preparations were largely ineffective, as the high surge allowed the storm waves to overtop these coastal engineering structures and inflict heavy damages to the beachfront houses.

Figure 11-3 Pre-storm (July 1989) conditions at Folly Island, showing the limited dry beach area. Courtesy of Tony Pratt.

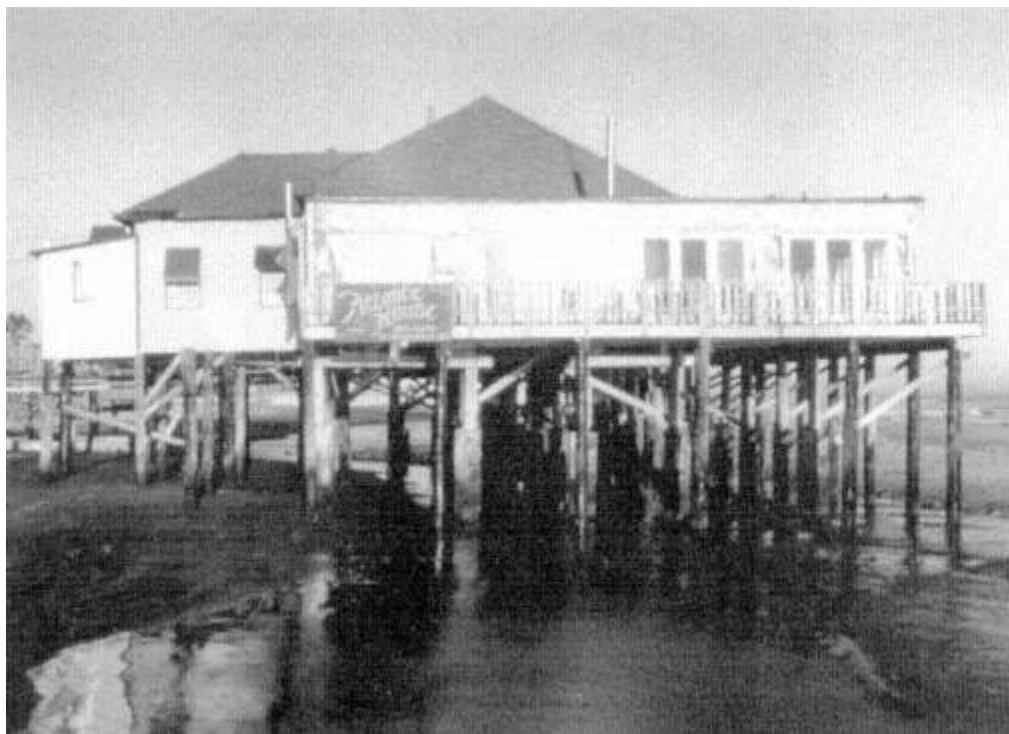
Figure 11-4a Pre-storm photograph of the Atlantic House restaurant.

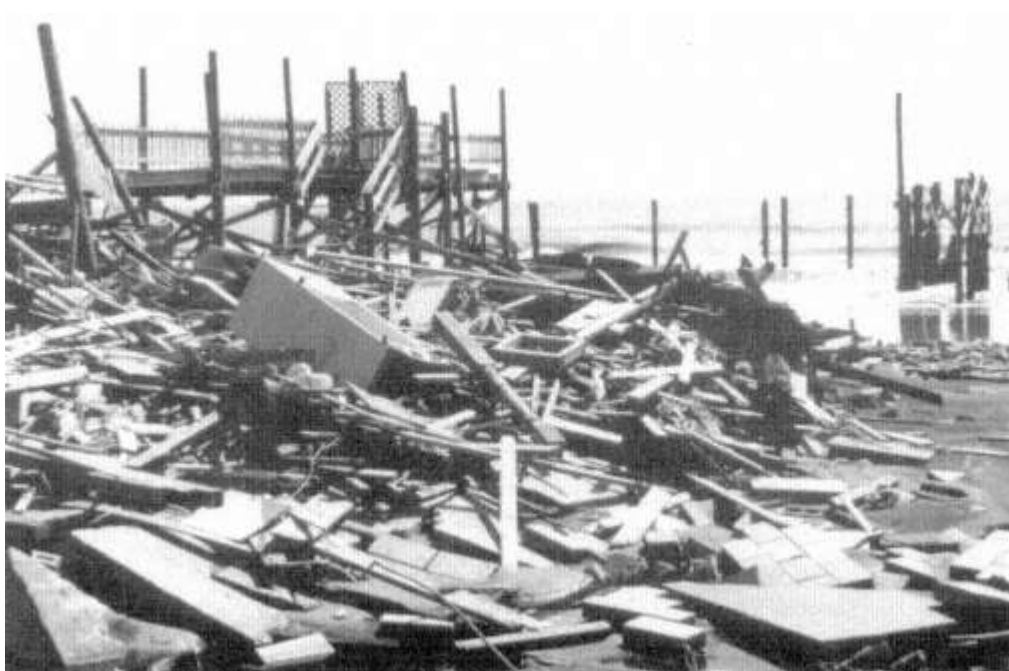
The Atlantic House, a local landmark and popular seafood restaurant on Folly Beach, was completely destroyed by Hurricane Hugo (Figure 11-4). In actuality, a much smaller hurricane could have claimed this building, as the restaurant was sitting on piles fully in the ocean water during normal tides. The incessant erosion had gradually whittled away the beach so that a ramp over the water was necessary in order to reach this restaurant. While it was the hurricane that swept away the building, it was the long-term erosion that set it up for eventual destruction.

Figure 11-4b Post-storm photograph of the Atlantic House restaurant.

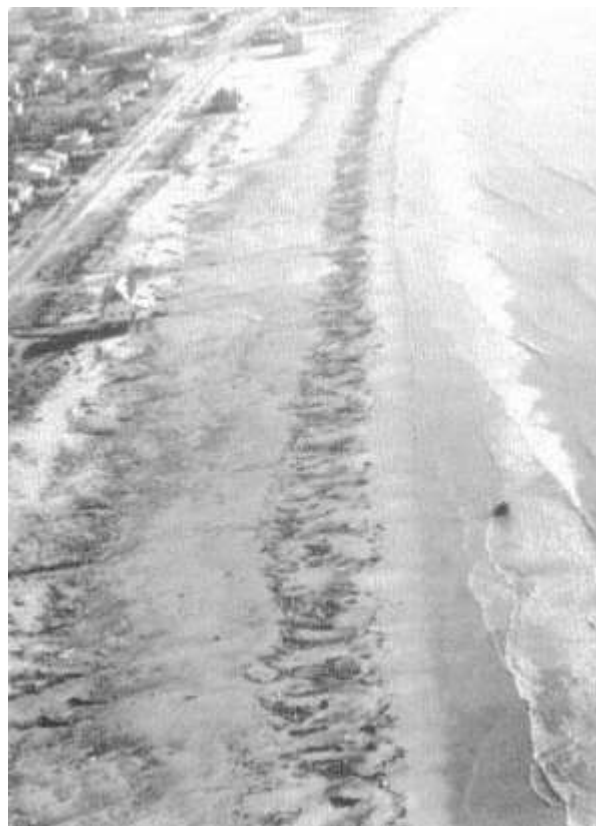
Figure 11-5 A wide beach and dune field prior to the storm protected beachfront houses at Isle of Palms.

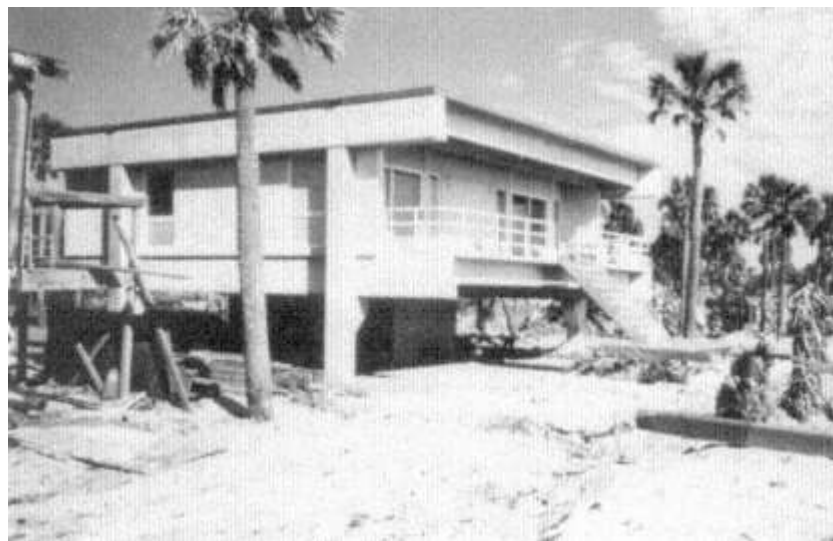
Figure 12-1 shows a frame structure with four concrete columns seated on four 14-inch-square piles. After discussions with the design architect and the county building inspector, the investigative team concluded that this structure fared well for five reasons:

1. sufficient elevation (bottom of support beam at elevation 15 ft MWL)
2. deep and strong piles (22-ft plus 5-ft tip)
3. simple and strong connections
4. low profile and low roofline
5. very rigid main columns.

Figure 12-1 A concrete residential structure on Folly Island survived with in an area of heavy destruction.

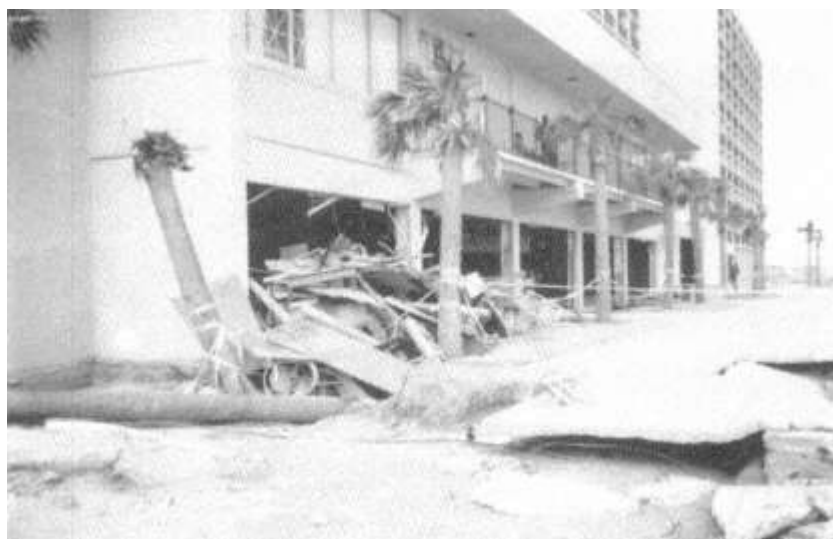
The Holiday Inn is the only substantial commercial building along the open coast. It is a relatively new structure, built about 5 years ago. The building is at an exposed location with receding shorelines on both sides. The front is protected by a retaining wall and heavy revetment. The building, nevertheless, sustained heavy water damage. Practically all the ground-floor facilities were destroyed (Figure 12-2). Erosion behind the retaining wall was significant, causing the concrete deck to collapse and undermining the swimming pool. The seawall cap was partially destroyed by wave impact. The water damage was certainly heavier than one would expect for structures of this type built at such a recent date. The team identified three factors that contributed to the heavy damage:

1. The elevation of the structure and the protective seawall were inadequate for the surge level associated with Hugo.
2. There is no fronting beach to dissipate wave energy, causing heavy wave runoff and overtopping.
3. The structure protrudes beyond the adjacent shoreline, and there is no return wall to protect its flanks.

Figure 12-2 Water damage to the ground-level units and waterfront amenity facilities at the Holiday Inn on Folly Island. This damage was typical of that suffered by highrise hotels and condominiums.

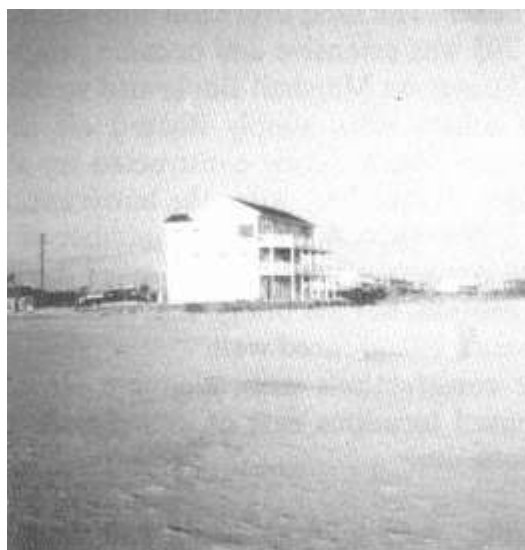
Figure 12-3

The Sea Cabin Condominiums at Ocean Boulevard and 14th Avenue sustained heavy water damage. The entire complex was prefabricated modular units seated on a pile foundation. The ground units and the end unit were severely damaged. Inadequate elevation and poor structural member connections were the main reasons for failure. Two exposed structures on Ocean Boulevard (nos. 126 and 912) stood with little visible damage from wind or water. (Figure 12-3 shows the post-storm condition of no. 912.)

Both structures were built by the same contractor, and the structures appeared to exceed the current building code requirement. Class "B" piles (120-inch-diameter from butt end and 14-inch-diameter above ground) with 3/4-inch steel diagonal bracings were used. Frames were connected throughout with 1/2- and 3/4-inch plywood using 16d galvanized nails at 4-inch intervals around corners to ensure shear rigidity. Hurricane clips were properly installed at critical connection points around roof frame and at pile-beam junctions. Roof tiles were properly nailed to 5/8-inch roof plywood. A ridge vent was installed to relieve pressure differences. As a consequence, only a minimal number of roof tiles were missing, uncharacteristic of the general extensive roof damages in this region. Members that are subject to wind-induced lift force were connected by galvanized screws instead of nails.

A well constructed, pile-supported, wooden frame residential structure on Isle of Palms fared very well, even in an exposed location.

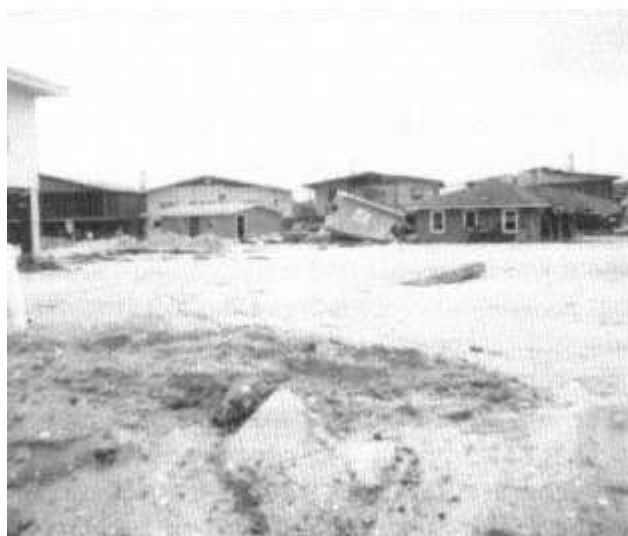
Figure 12-4 Sand overwash on second row of houses (north of Waccamaw Avenue), Garden City.

Judging from the crushing pattern and the type of pier breakage, waves might have overtopped the structures.

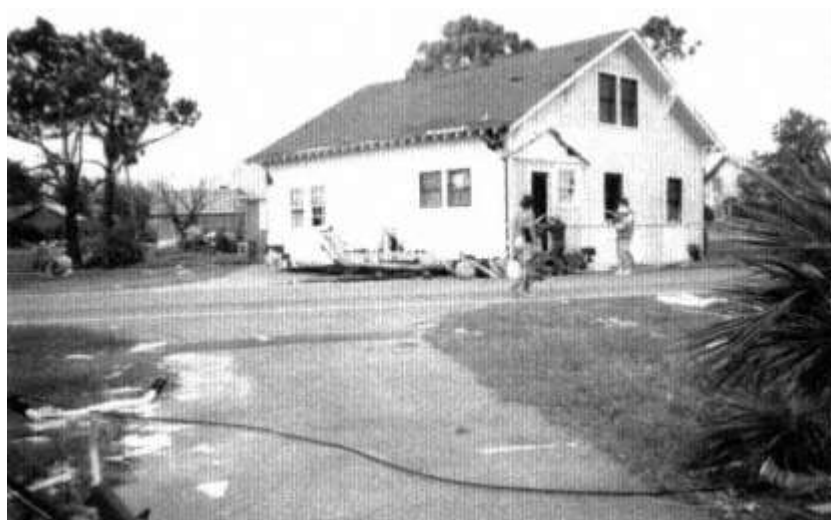
Slab-on-grade and poured footings were repeatedly found to be unfit for coastal application. This type of foundation is particularly vulnerable to hurricanes such as Hugo that generate high storm surges. Structures on such foundations have very little chance to escape severe damage if the water level is higher than the foundation. Two common modes of structural failure were observed: total destruction by dynamic forces (Figure 12-6) or separation and transportation by flood waters (Figure 12-7a and b).

Figure 12-7a Structure built on slab floated away from foundation and deposited 100 ft away.

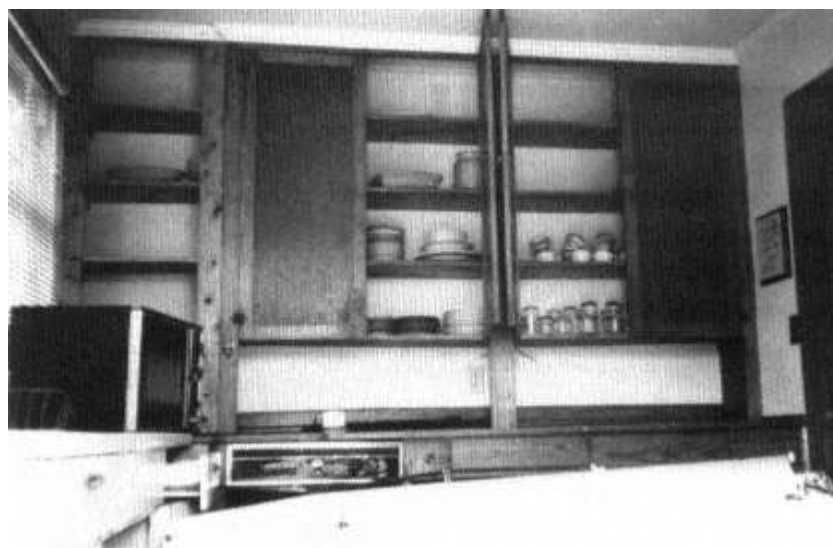
Figure 12-7b The arrangement inside the kitchen of the same structure remained undisturbed.

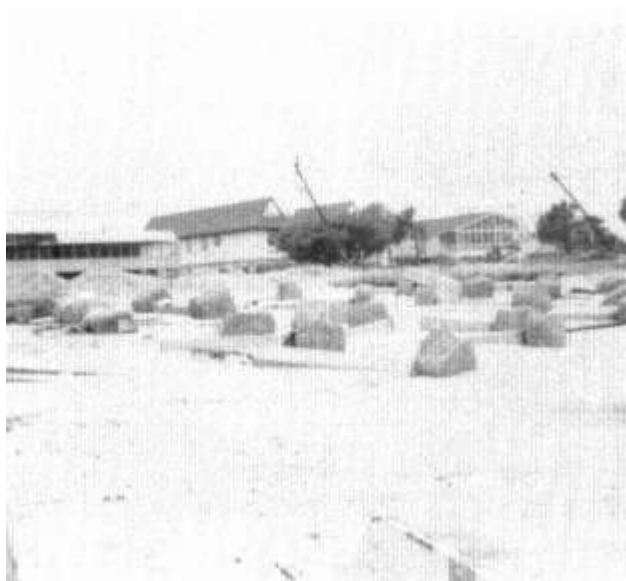
FEMA's guidelines and most building codes permit pier foundations for residential buildings. The Hugo experience showed that this type of foundation is very vulnerable in the dynamic water force zone. The inherent problem of this type of foundation is the shallowness of the footings that are typically dug and poured in place. As the overburden material began to erode, the footings simply toppled, as shown in [Figure 12-8](#). Bulky shallow footings fared the worst, as they often promoted local scouring of up to 1 to 1.5 ft ([Figure 12-9](#)).

Figure 12-8 Shallow pier footings uprooted.

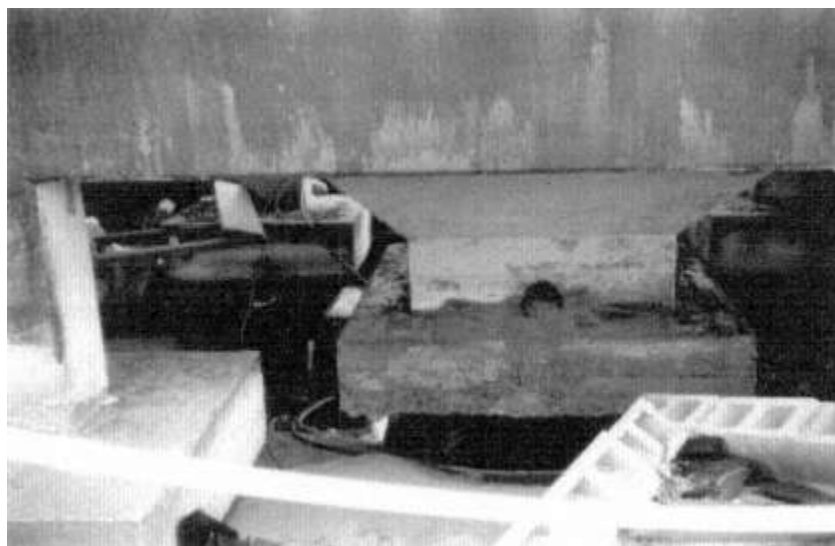
Figure 12-9 Bulky shallow footing promoted scouring around it.

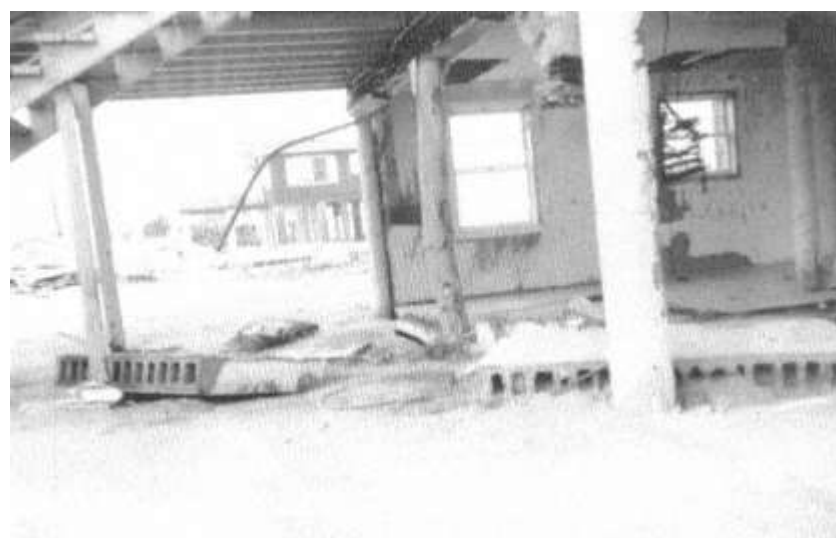
Figure 12-11a Poured concrete piers buckled under lateral load.

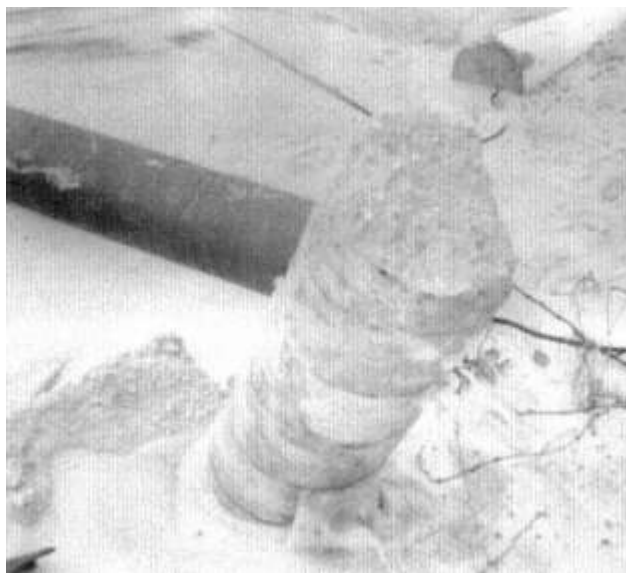
Figure 12-11b Broken piers revealed inadequate placement of reinforcing bars.

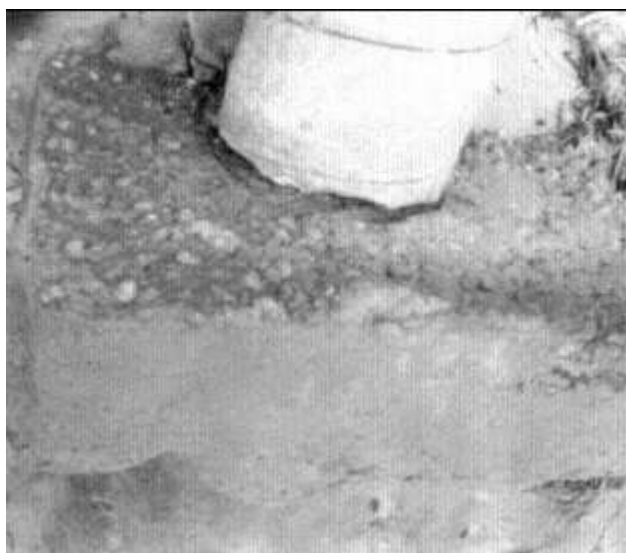
Figure 12-12 Bad joint between pier and footing was a common cause of failure.

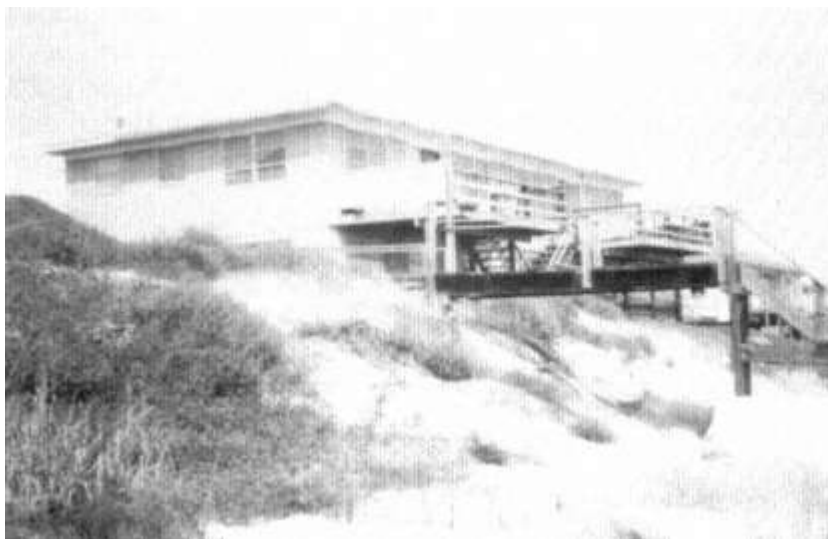
Figure 12-13a House with access ramp to beach (prior to Hugo).

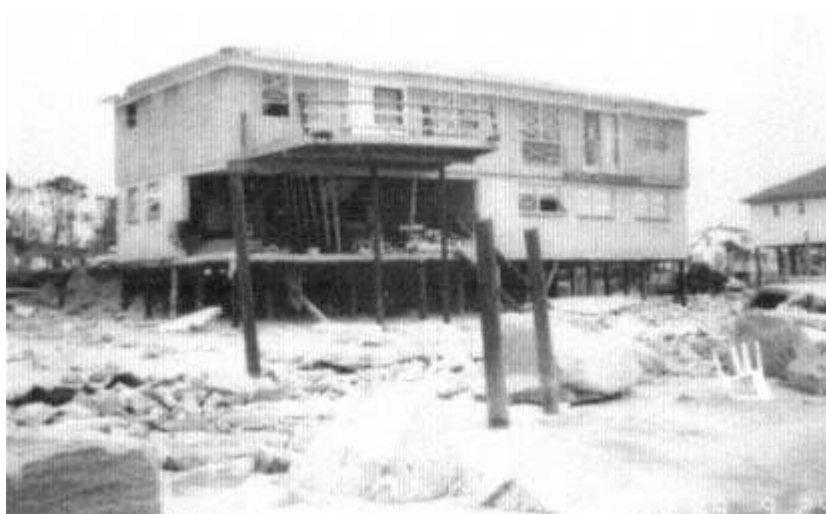
A surprising amount of damage was caused by failures of appurtenant structures. Decks with access ladders or ramps to the beach were extremely vulnerable. They were not designed to resist water forces, yet most of them were secured to the main structures. Water forces would most certainly destroy them, puncturing or tearing apart that portion of the main structure connected to them (Figure 12-13). Structural accessories such as ground floor garage doors, air conditioners, water tanks, and nonbreakaway walls contributed to additional damage to the main structures. Revetment armor units sometimes behaved like missiles powered by waves, as discussed earlier.

Figure 12-13b The access ramp washed into the house as a result of wave force.

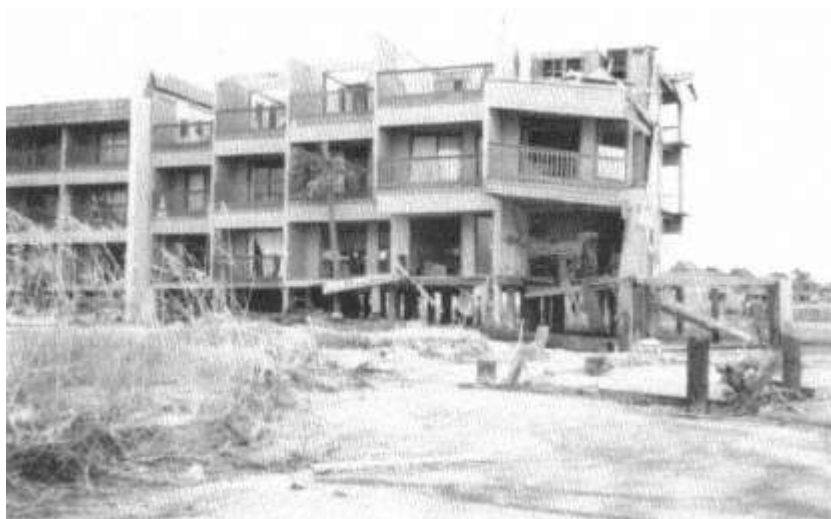
improper connections between floor beams and foundations allowed structures to float away, collapse, lean, or shift. Figure 12-14 shows an example of a modular unit completely separated from the foundation piles. Improper nailing practice or inadequate nail size were the prevailing cause of member separations under minor shift (Figure 12-15). Missing or inadequate hurricane clips was also problem. Mobile home tiedowns were found to be common. Very few mobile home units were found near the coast. One small mobile home park south of Myrtle Beach did suffer heavy damage, but this was mainly because of low elevation, rather than inadequate tiedowns.

Figure 12-14a Modular unit construction with poor connections.

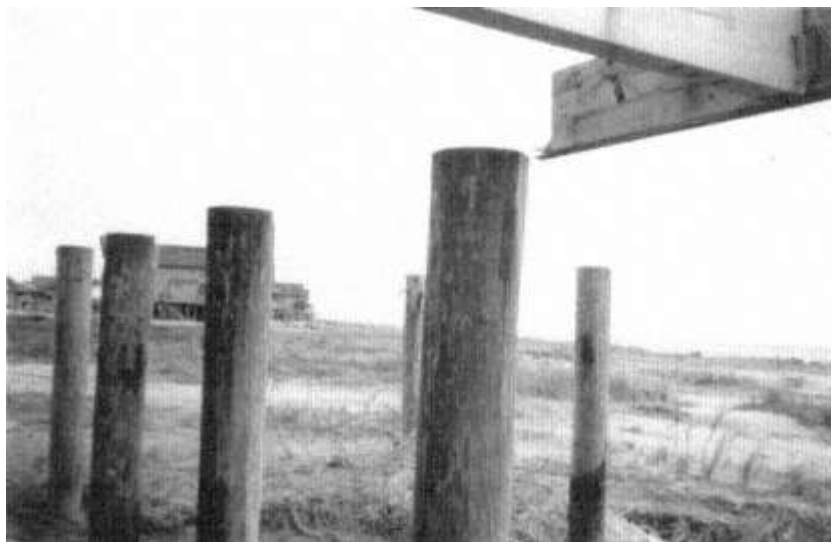
Figure 12-14b The end unit of the modular structure simply disconnected from the piles.

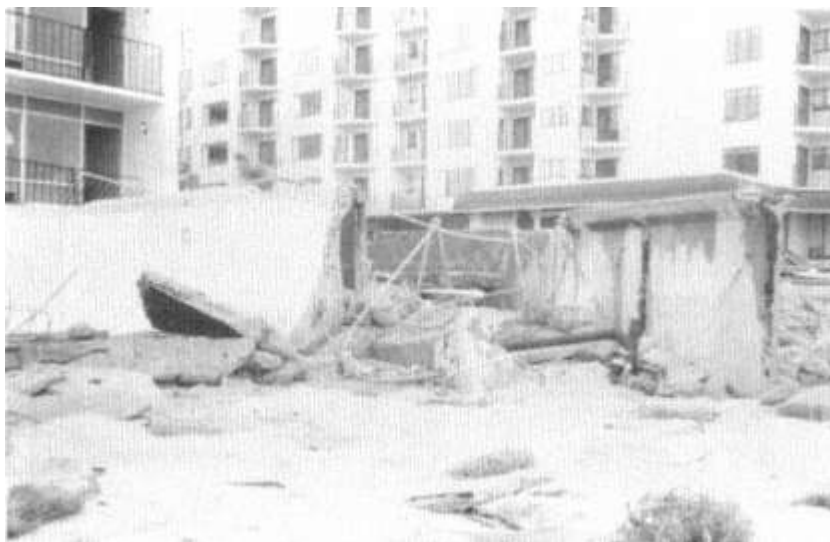
Seawalls are numerous in the affected region. Most of them can be more accurately characterized as landscaping retaining walls, and did little to protect upland structures from water damage. Scouring behind seawalls due to overtopping was the most common damage observed, and led to failures of decks and pools or collapsed the seawalls themselves (Figure 12-16). In addition, most of the return walls were underdesigned, resulting in numerous failures (Figure 12-17). Once the

Figure 12-16 Overtopping induced seawall failure.

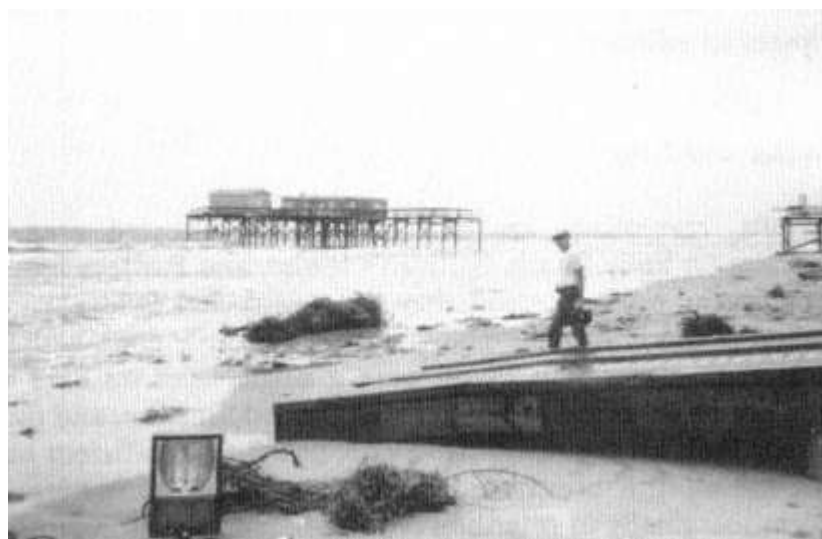
Practically all the piers along this coast sustained severe damage or were totally destroyed. The few surviving had their midsections across the surf zone destroyed (Figure 12-18), which seemed to indicate where the most destructive water force had occurred. However, the extent of damage to these piers may make salvage efforts uneconomical.

Figure 12-18 Piers with midsection missing revealed the location of maximum dynamic force to be in surf zone.

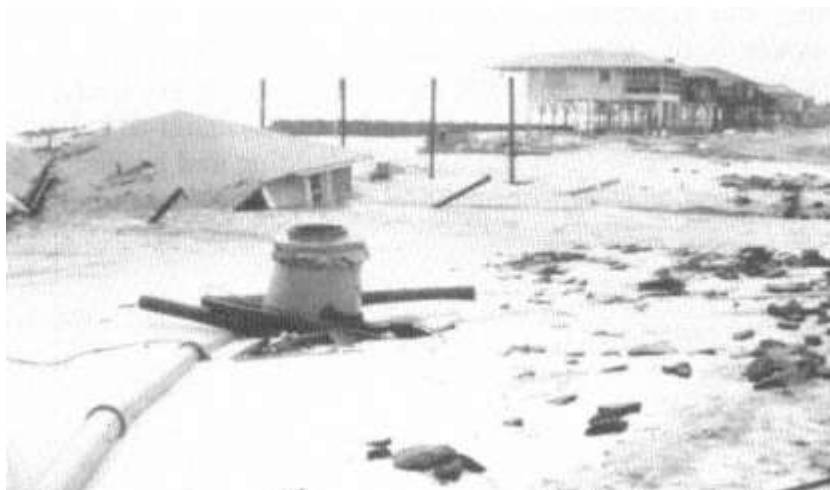
Figure 14-1 shows a location on Pawleys Island, South Carolina, where the roadway, electric lines, underground telephone lines, and water and sewer lines were destroyed by Hugo. Although this was an extreme case, similar damages occurred throughout the South Carolina barrier islands. The damage to lifelines on the barrier

Figure 14-1 Destruction of roadway, electric lines, underground telephone lines, and water and sewer lines on the south end of Payleys Island.

islands was so extensive that most systems needed major repair, and the electric power supply system needed to be completely rebuilt. On Folly Island, a washed out roadway severed a natural gas supply line. Since the gas had been shut off prior to the storm, a dangerous situation was avoided. Damage to the natural gas supply system was generally confined to the barrier islands.

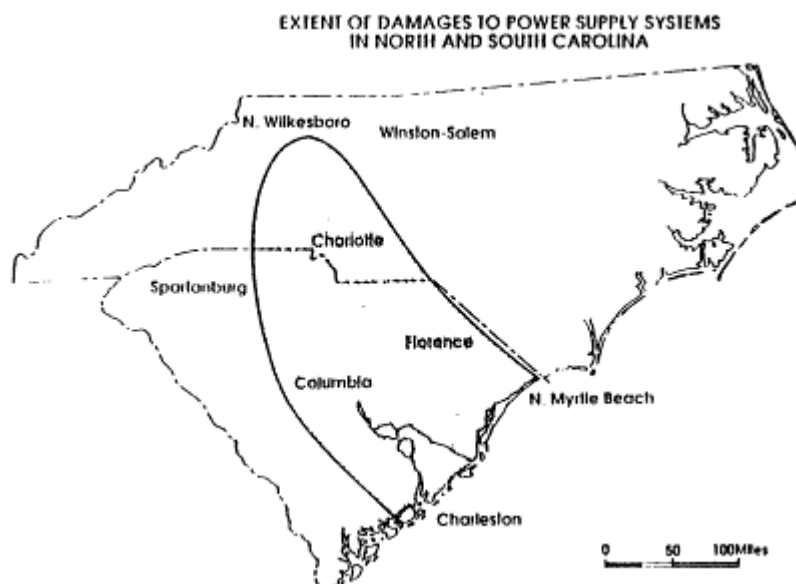
Unlike other storms, Hugo maintained significant winds far inland. At the Charlotte airport, approximately 180 mi inland from Hugo's landfall, 83-mph winds were recorded. [Figure 14-2](#) shows the extent of damage to electric power supply systems resulting from Hugo. The damage area shown in [Figure 14-2](#) incorporates about 25,000 mi² and illustrates the extent of downed power lines.

Figure 14-2 Extent of damage to electric power supply systems.

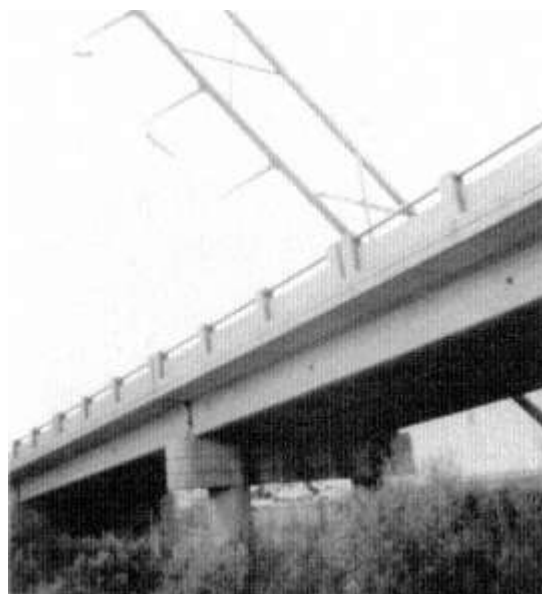
Transmission lines with metal support structures remained intact, while those constructed of timber were heavily damaged. In some cases, the actual timber poles were broken, but the dominant failure mode seemed to be a foundation failure due to insufficient embedment of the poles. Several utility personnel reported that the ground was saturated prior to the storm. Figure 14-3 shows a timber transmission line structure leaning against a highway entrance ramp in Charleston.

Damages to transmission lines caused significant delay in restoring power to the affected areas. In the absence of transmission-line failure, work could have begun immediately on distribution lines. It was necessary to spend several days repairing downed transmission-lines before work could begin on the distribution system. In the Charleston area, which had extensive transmission-line damage, it took 3 days to restore power to hospitals, 6 days to the water treatment plant, and 7 days to the wastewater treatment plant. Hospitals, water treatment plants, and wastewater

Figure 14-3 Timber transmission line support structure leaning against roadway in Charleston.

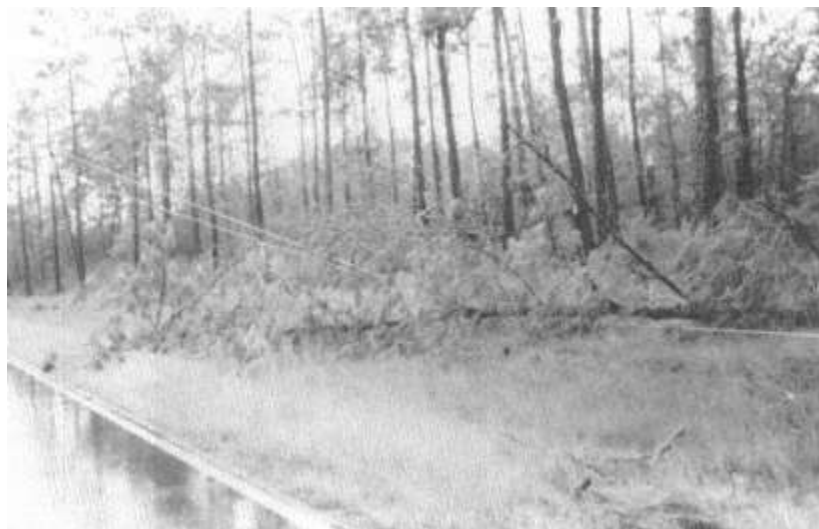
Distribution systems from the South Carolina coast to about 50 mi north of Hickory, North Carolina, were essentially destroyed by the storm. Several utility personnel commented that their job was not to repair the system, as had been anticipated, but to rebuild the distribution system completely. On the mainland, the major damage to the distribution system was caused by fallen trees. The areas of South and North Carolina impacted by Hugo were heavily wooded with pine trees. These trees typically snapped off about 10 to 20 feet above the ground and brought down any power line in their path. [Figure 14-4](#) shows a typical power line downed by a tree about 60 mi inland. Only a small percentage of the affected inland distribution lines were toppled by wind alone ([Figure 14-5](#)).

Figure 14-4 Distribution line downed by pine tree 60 mi inland.

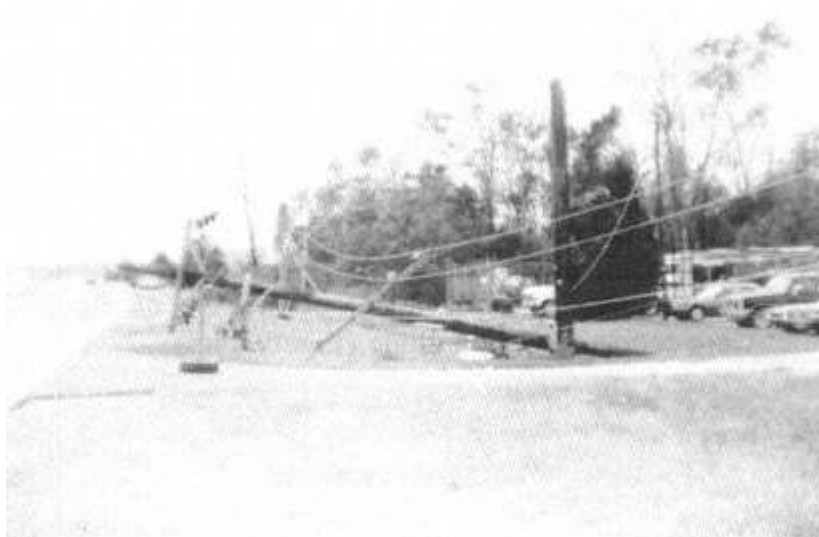
Figure 14-5 Distribution line downed by wind 10 mi inland.

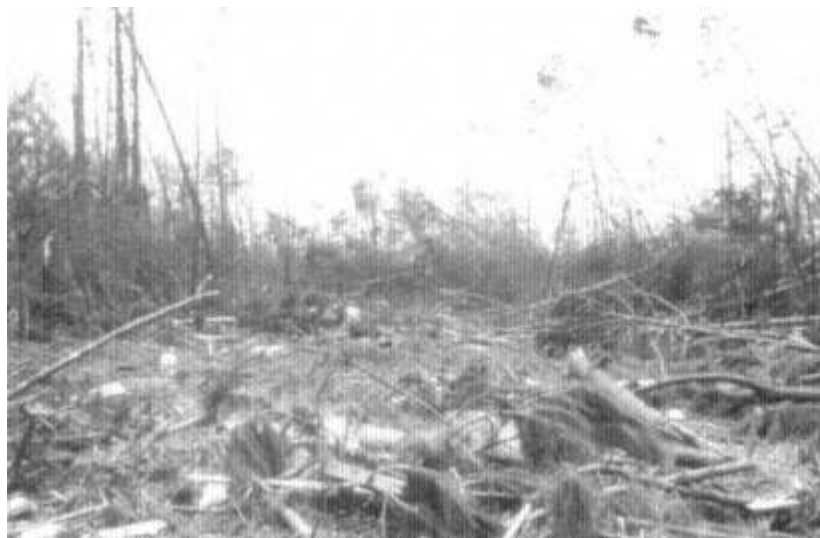
Hugo caused minor structural damage to mainland roads and bridges. Debris was the primary problem caused by the storm on mainland highway systems (Figure 14-6); destruction of signs and signals was also a factor (Figure 14-7).

Debris on the roadways hampered emergency crews and delayed repairs to other lifelines. In many situations utility repair crews had to clear paths to damage sites before they could begin actual repair work. A shortage of chain saws was reported in many instances. Lack of signs made it difficult for repair crews who had arrived from other areas to locate damaged power lines. Missing signals and signals without power caused congestion and impaired safety.

Figure 14-6
Typical roadway immediately after passage of Hugo.
Courtesy of Southern Building Code Congress International, Inc.

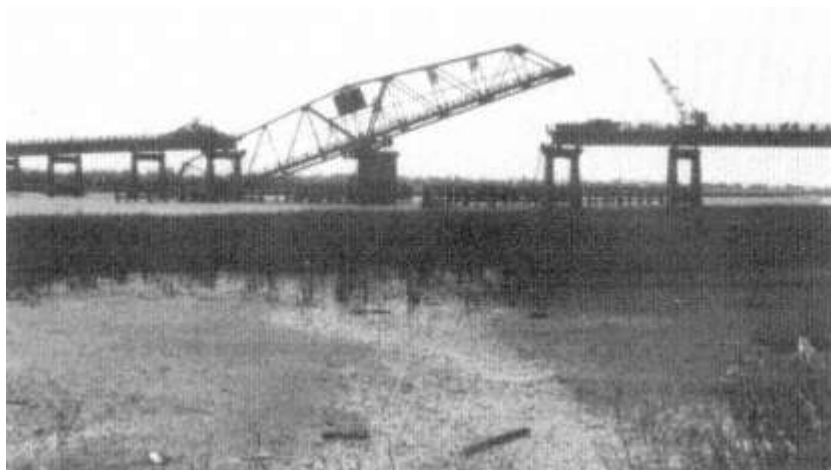
Probably the most visible transportation lifeline failure was the Ben Sawyer Memorial Bridge (Figure 14-8), which connects Sullivans Island and the Isle of Palms to the mainland. The bridge failure caused access problems after the storm, which severely hampered the recovery effort on the islands.

Figure 14-8 Ben Sawyer Memorial Bridge to Sullivans Island and Isle of Palms.
Courtesy of Southern Building Code Congress International, Inc.

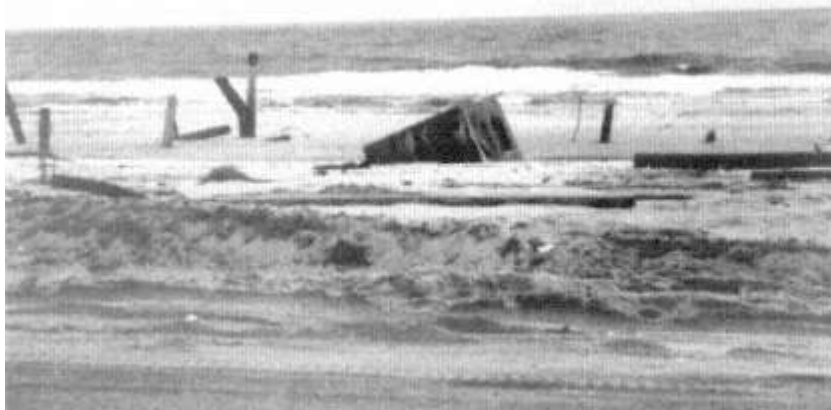
In rural areas and on several barrier islands, septic systems were not able to handle normal loads because of ground saturation. On some barrier islands, severe beach erosion exposed septic tanks, leading to health concerns. Figure 14-9 shows an exposed septic tank on Folly Island. In the Charleston area the wastewater treatment plant was without off-site power for 7 days. During this period the plant operated with emergency on-site generators, which were adequate for the reduced load resulting from the lack of pressure in the water supply system.

Figure 14-9 Exposed septic tank on Folly Island.
