Macondo Well Deepwater Horizon Blowout: Lessons for Improving Offshore Drilling Safety

LESSONS FOR IMPROVING
OFFSHORE DRILLING SAFETY

Committee on the Analysis of Causes of the
Deepwater Horizon Explosion, Fire, and Oil Spill to
Identify Measures to Prevent Similar Accidents in the Future

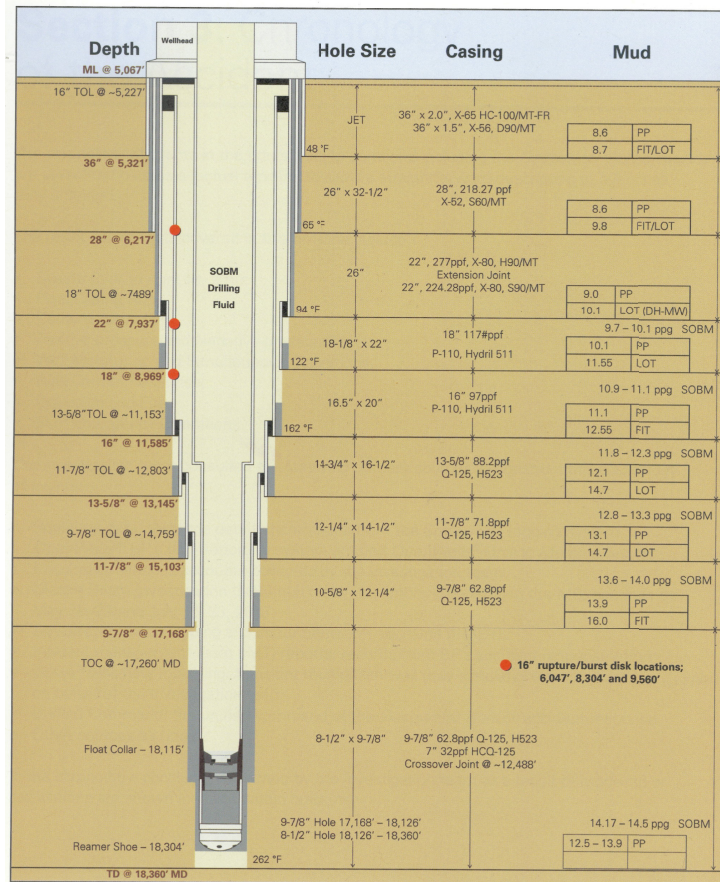
FIGURE 2-2 Final wellbore architecture for Macondo well. Source: BP 2010, p. 19. Reprinted with permission; copyright 2010, BP.

1. Measurements showed that pore pressures were increasing at a faster rate than anticipated, combined with a period of lost circulation of drilling mud at 12,350 feet, indicating that the well could not be continued without setting protective casing. The 16-inch liner was set at 11,585 feet to seal off this section of the well. The setting depth of this liner was 915 feet shallower than planned.

2. In the course of drilling at 13,250 feet, a kick occurred, and the lower annular blowout preventer (BOP) was closed in response. During well control operations, the drill string became stuck and was severed at 12,147 feet. The drill string and hole below 12,147 feet were abandoned, and subsequent well drilling deviated slightly to go around the abandoned materials left in the original hole. The $13\frac{5}{8}$ -inch liner was run at 13,145 feet, which was shallower than planned, to allow the well to be drilled safely past the higher-pressure reservoir that had been encountered. The $11\frac{7}{8}$ -inch liner was used at 15,103 feet to seal the reservoir and allow for the use of higher mud weights than had been anticipated. Mud weight was to be kept between the curves for pore pressure and fracture pressure, as shown in Figure 2-3.

3. The 9 7/8-inch casing (originally planned as the production casing) was used as a liner at 17,168 feet to drill the final section of the well safely, where the use of higher mud weights was expected in continuing the well to the planned depth of 19,650 feet.

occurred. The shallowest possible escape point would have been 7,937 feet had a rupture disc and the top of the 18-inch liner failed (see Figure 2-2). This is about 2,937 feet below the ocean floor. Depending on the flow rate, pressure, and formation type, flow at this point might find a pathway to the ocean floor and cause a breach outside of the well. Therefore, a more robust design from a downhole blowout point of view would be to lower the possible point of escape from the wellbore to a deeper point where eventual breaching at the seafloor is impossible or at least very unlikely. This could be done by running a deeper casing string as a long string rather than as a liner and sealing it in the wellhead.

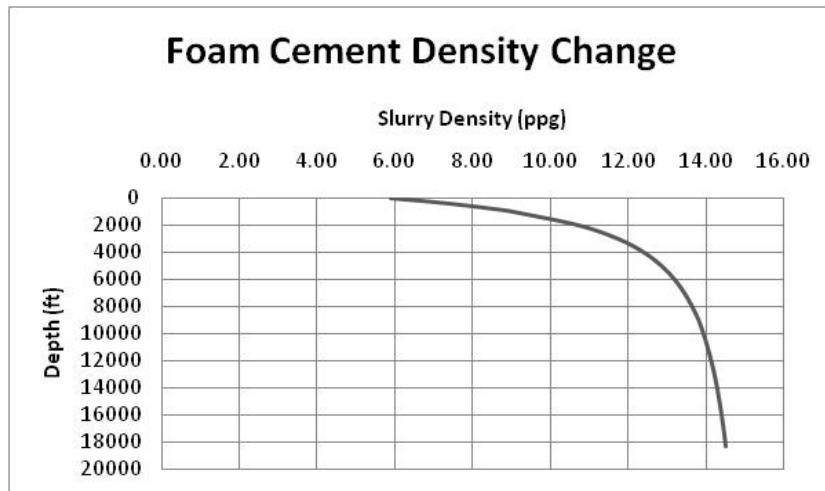
FIGURE 2-6 Calculated foam density versus depth during pumping. Source: Committee.

To make a foamed cement slurry that has a density of 14.5 ppg at the bottom of the well, the foam quality⁷ had to be 17.4 percent at bottom hole conditions of 245°F and 13,321 psi (see Appendix D for the calculations).⁸ At the surface, where the conditions in the mixer were about 600 psi and 60°F, the foam quality had to be 66 percent, producing a foamed slurry of about 6 ppg, to allow for the substantial compression and heating that were to occur as the foam was pumped to the bottom of the well. (For reference, freshwater has a density of 8.33 ppg.) Figure 2-6 shows the calculated foam density versus depth.

Once mixed, the foam was immediately pumped into the well, where pressure and temperature increased with depth, changing the foam quality and slurry density all the while. The shear associated with fluid movement down the inside of the pipe would act to break up large bubbles, which immediately reform as smaller bubbles so long as agitation is taking place.

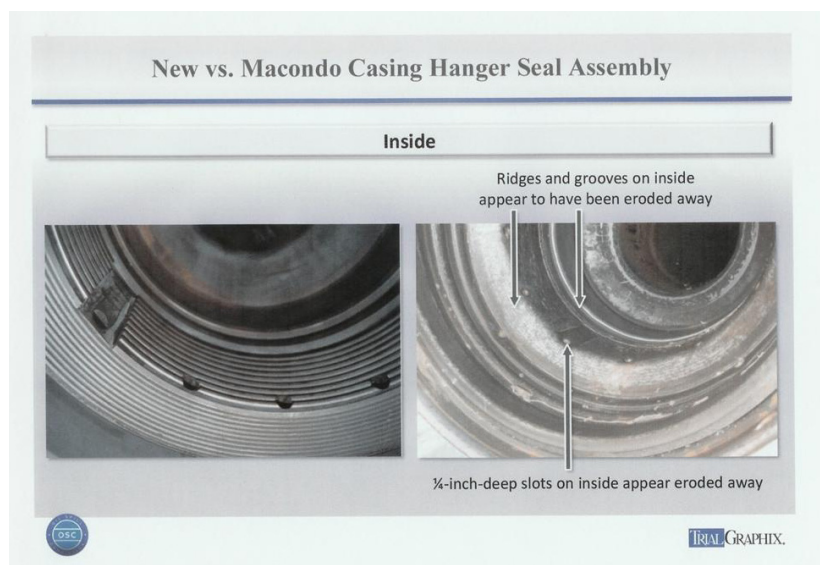
FIGURE 2-9 View inside casing hanger. Source: Presidential Commission 2010, Slide 118.

Identification of the probable hydrocarbon flow path up the Macondo well can provide insights for well design considerations to enhance the safety of drilling operations. Pictures of the long string casing hanger that was recovered, shown as Figure 2-9, indicate that hydrocarbon flow was up the inside of the casing, because the inside of the hanger showed signs of fluid erosion while the outside did not. However, under the correct circumstances, flow could have been up the annulus. Because the lockdown sleeve was not installed, the margin of safety against the potential for flow up the annulus was reduced.

This type of circulation was not done completely at the Macondo well to reduce the possibility of exceeding the fracture pressure because of unforeseen pressure surges. This decision by BP also cut down on the time spent circulating. Failure to perform the minimum circulation could leave debris inside the casing or annulus that may plug it. Any hydrocarbons in the annulus may result in a well control problem.

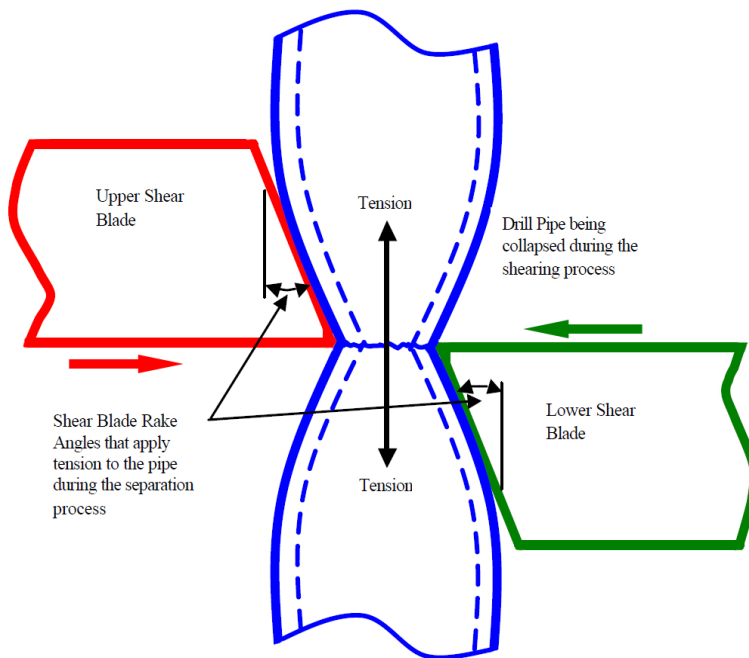
FIGURE 3-3 Upper and lower shear blades crushing the drill pipe and beginning the shearing (or breaking) operation. Source: West Engineering Services, Inc. 2004, p. 2-2. Reprinted with permission; copyright 2004, West Engineering Services, Inc.

- In the cutting process, the shear rams collapse or mash the pipe, and as the pipe is crushed, the blade angle pulls the metal into tension and breaks it in a tensile mode of failure (Figure 3-3). Depending on the ram blade design, the blade can flatten the pipe to a great extent, which in turn can prevent the ram from closing completely and sealing even if the pipe is centered.

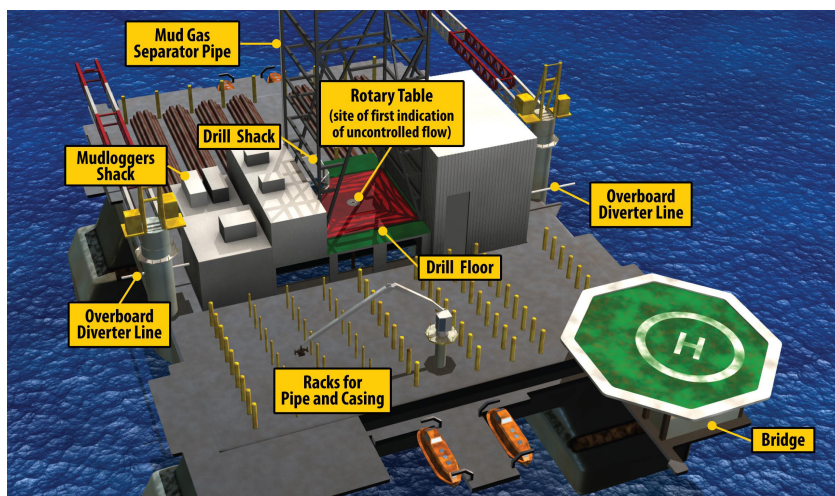
The only path, other than straight up through the derrick or through the MGS system vents, through which uncontrolled hydrocarbon flow could have been directed is through 14-inch diverter lines, which were positioned to send the flow overboard at about derrick floor level (see Figure 4-2). Testimony cited above indicates that this did not occur, and why there was no hydrocarbon flow along that path remains an unresolved question.¹⁰ According to BP's analysis, the overboard diverter flow of hydrocarbons might have delayed the formation of the explosive cloud that surrounded the rig (BP 2010, 128).
