Guidebook for Mitigating Fixed-Route Bus-and-Pedestrian Collisions

TCRP REPORT 125

**Guidebook for Mitigating Fixed-Route
Bus-and-Pedestrian Collisions**

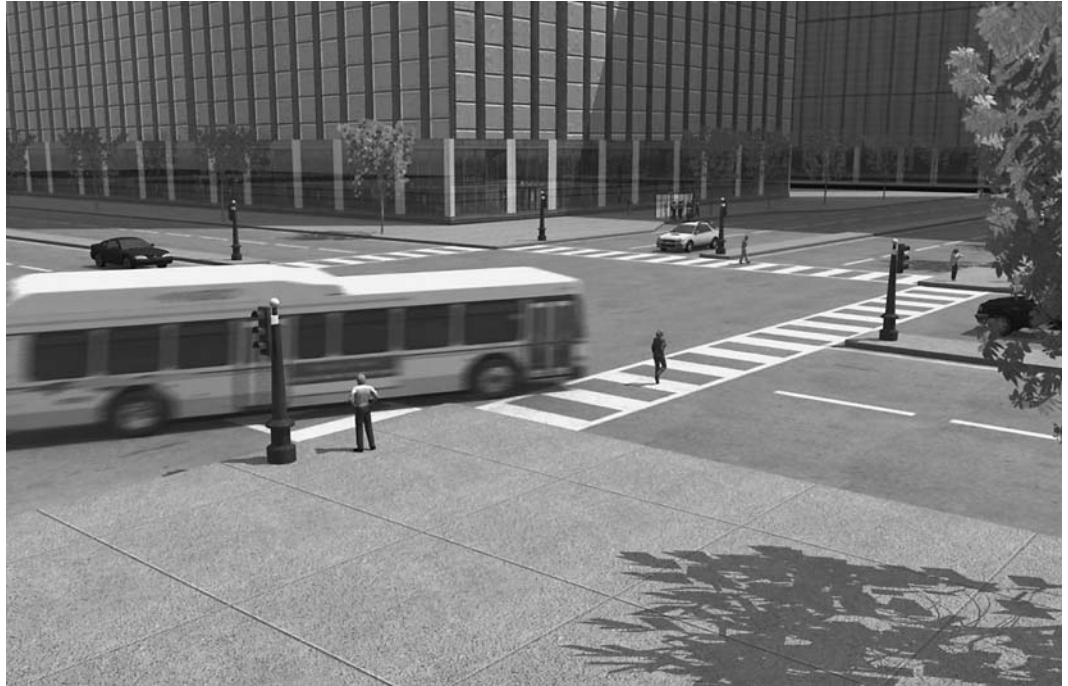
Figure 1-1. *Illustration of Collision Type 1—collision between pedestrian and right-turning bus.*

One variation of this collision type occurs when the bus, turning right, strikes a pedestrian who is waiting on the curb or who has just stepped from the curb into the roadway to begin crossing. In this case, the pedestrian is hit by the side of the bus near the rear. It should be noted that this particular variation was only reported as common by one transit agency and one stakeholder group.

Another variation of this collision type occurs when the bus is making a right-turn-on-red. In this case, the pedestrian is struck in the opposing crosswalk (the one perpendicular to the bus) with the front of the bus before the bus begins the turn.

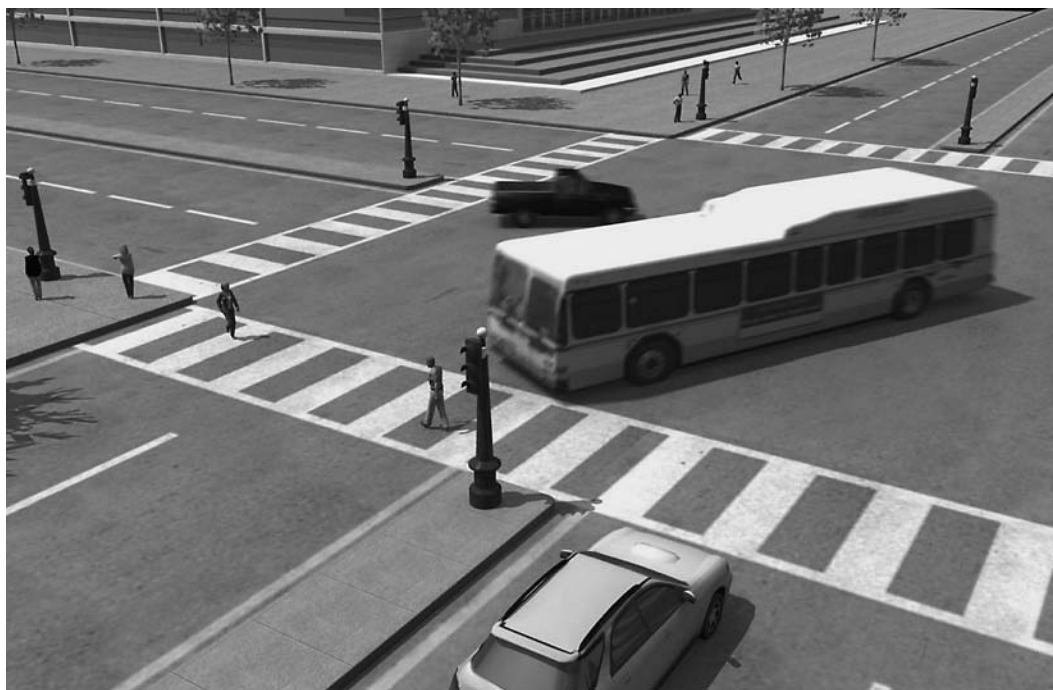
Figure 1-2. *Illustration of Collision Type 2—collision between pedestrian and left-turning bus.*

Collision Type 2 occurs when a pedestrian is crossing the street in the crosswalk and a bus operator is making a permitted left turn onto the street that the pedestrian is crossing, as illustrated in Figure 1-2. Of the incident reports reviewed, 36 (22%) occurred when the bus was turning left.

This potential conflict between a pedestrian and a left-turning vehicle is intrinsic to many signalized intersections with pedestrian signals. This is because the pedestrian WALK phase occurs simultaneously with the permitted left turn phase for traffic (i.e., green ball). When there is a

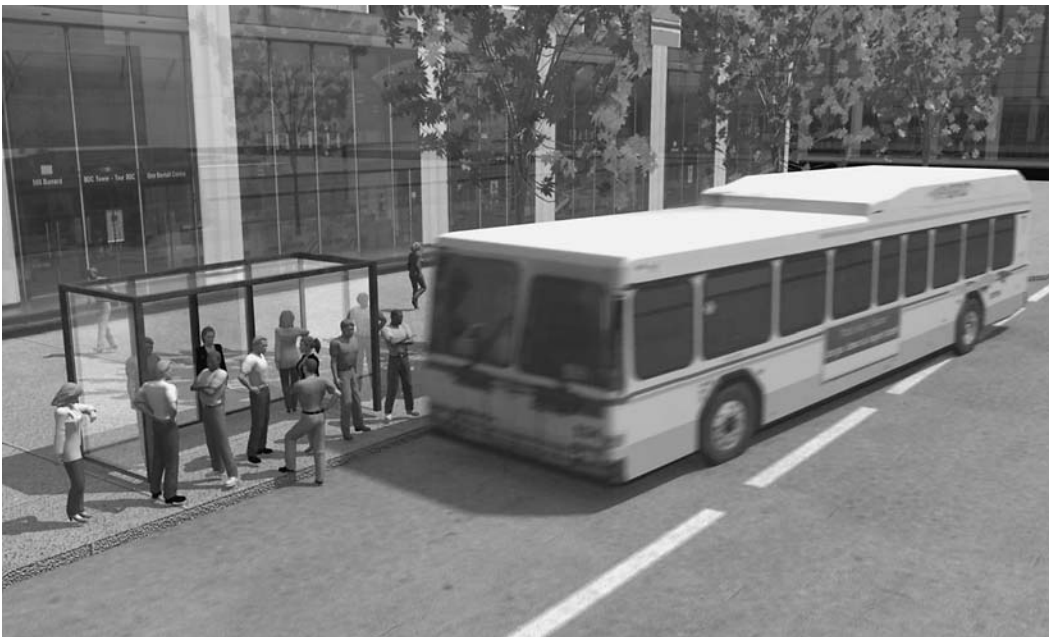
Figure 1-3. *Illustration of Collision Type 3—collision between pedestrian and bus pulling into bus stop.*

- Pedestrians standing too close to the roadway as the bus arrives at the stop,
- Pedestrians pushing as the bus arrives at the stop, or
- Conflicts between intending passengers and passing pedestrians.

All of these situations can result in a pedestrian accidentally making contact with a bus in or near the roadway as the bus is pulling into the stop.

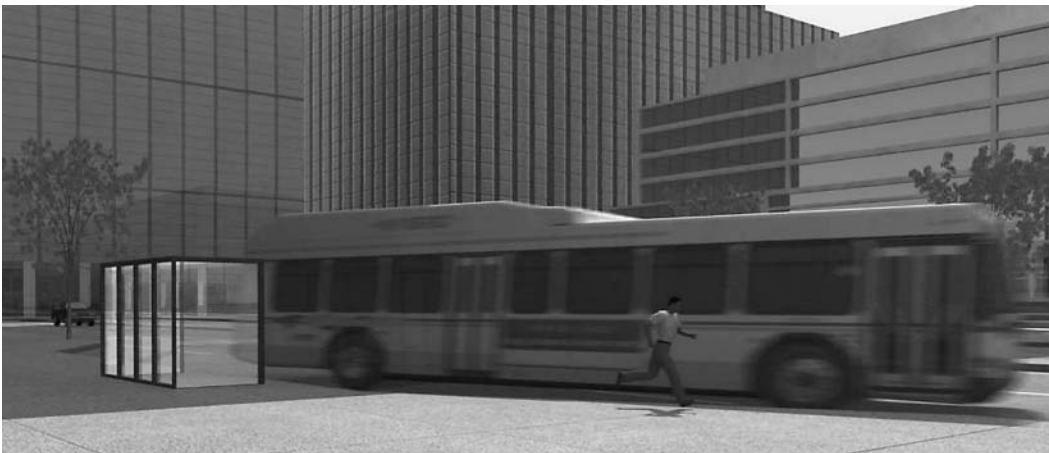
Figure 1-4. Illustration of Collision Type 4—collision with pedestrian running alongside bus when pulling away from a bus stop.

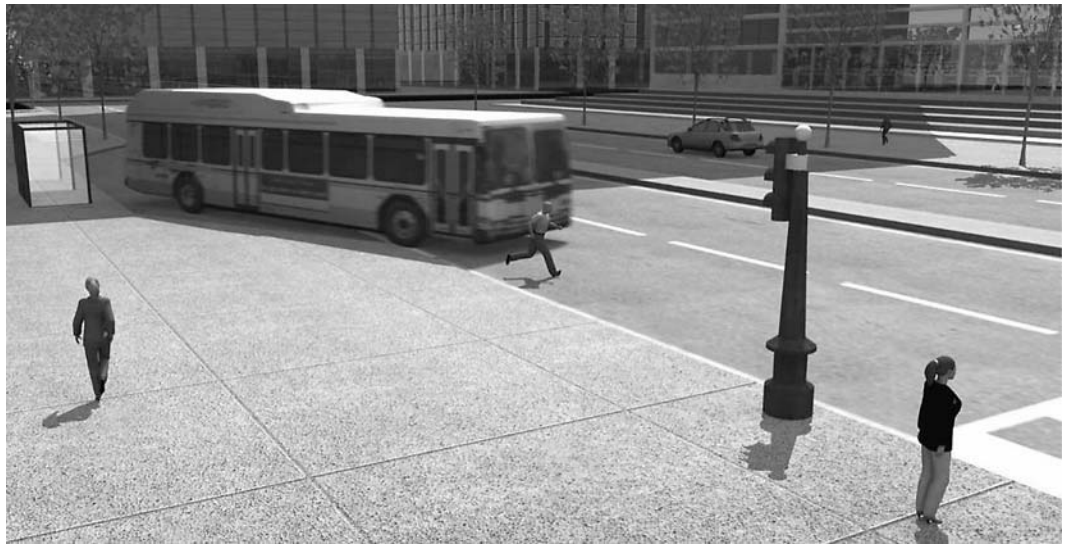
Figure 1-5. Illustration of Collision Type 4—collision with pedestrian crossing in front of bus when pulling away from a bus stop.

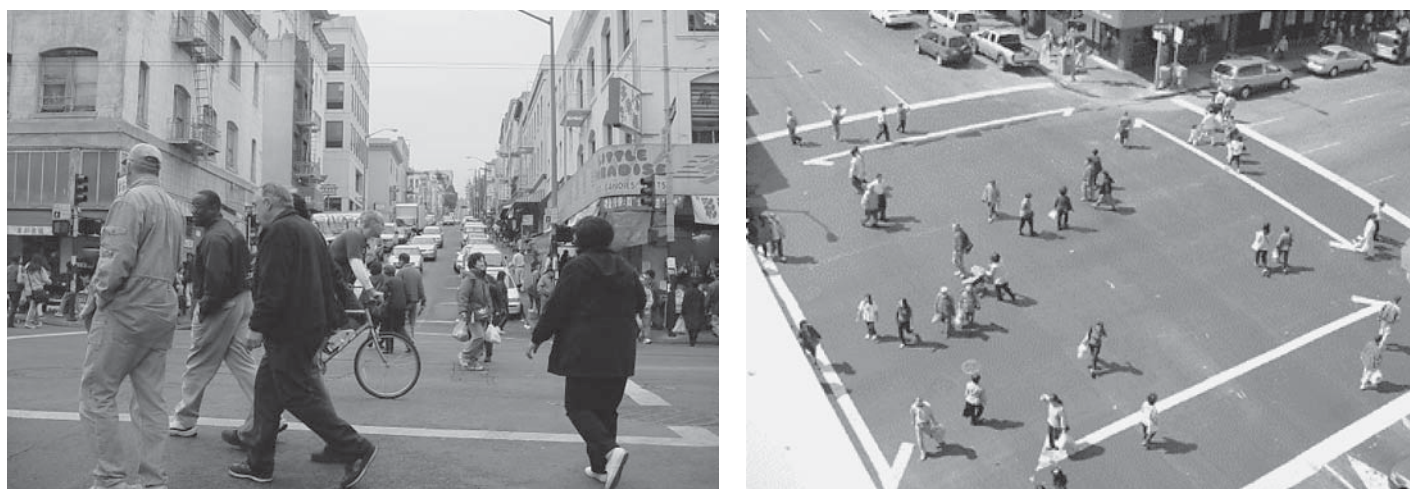
Figure 2-4. Pedestrian scramble—street view (left) and top view (right).

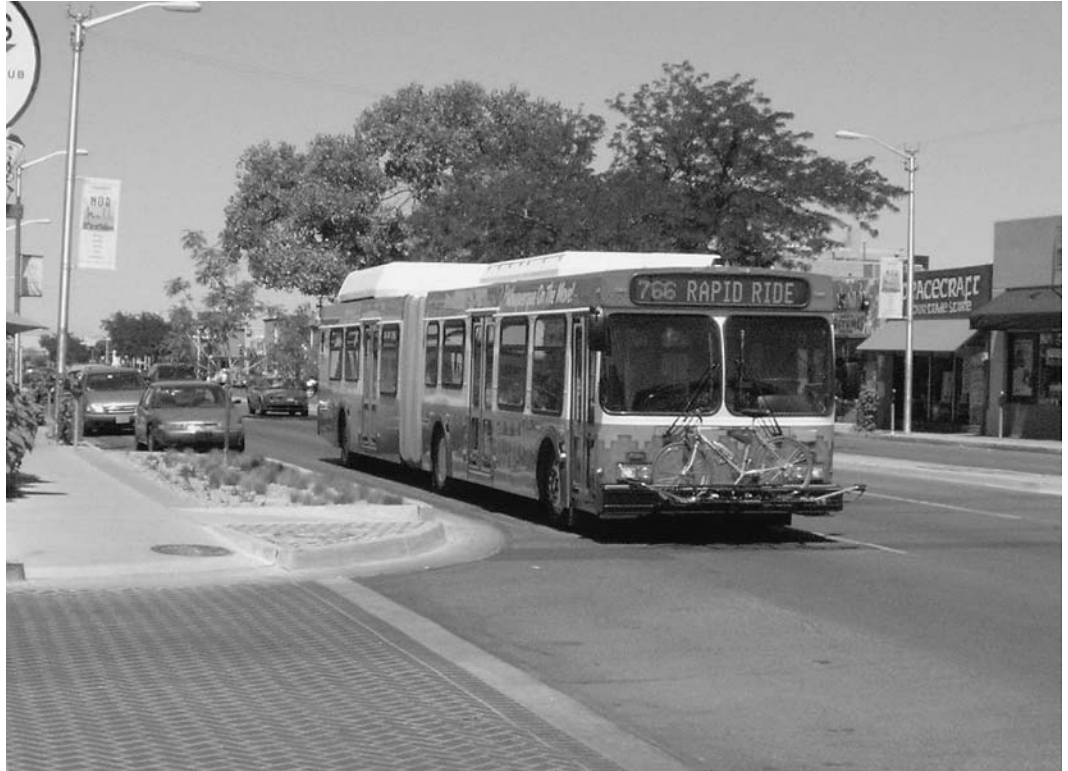
Figure 2-5. Intersection bulb-out.

Local and state roadway traffic engineering and roadway design are usually the responsibility of the transportation section within the local government and state, respectively. The cost of improvements can be minimized when incorporated during the early stages of roadway improvement projects. Implementation costs range from low for signal timing, striping, and traffic signs (no cost to hundreds of dollars); to moderate for special traffic signals and pedestrian channelization treatments (thousands of dollars); to high cost for major geometric treatments such as bulb-outs (\$150,000–\$250,000 per intersection).

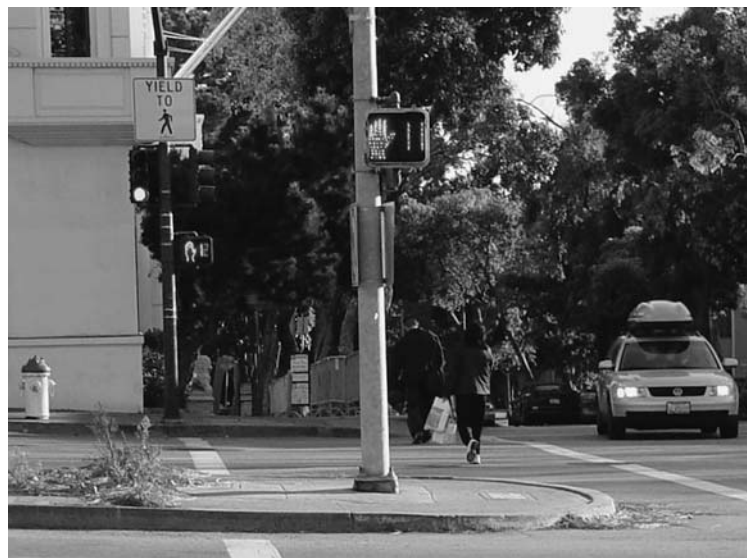
Figure 2-6. Pedestrian countdown signals.

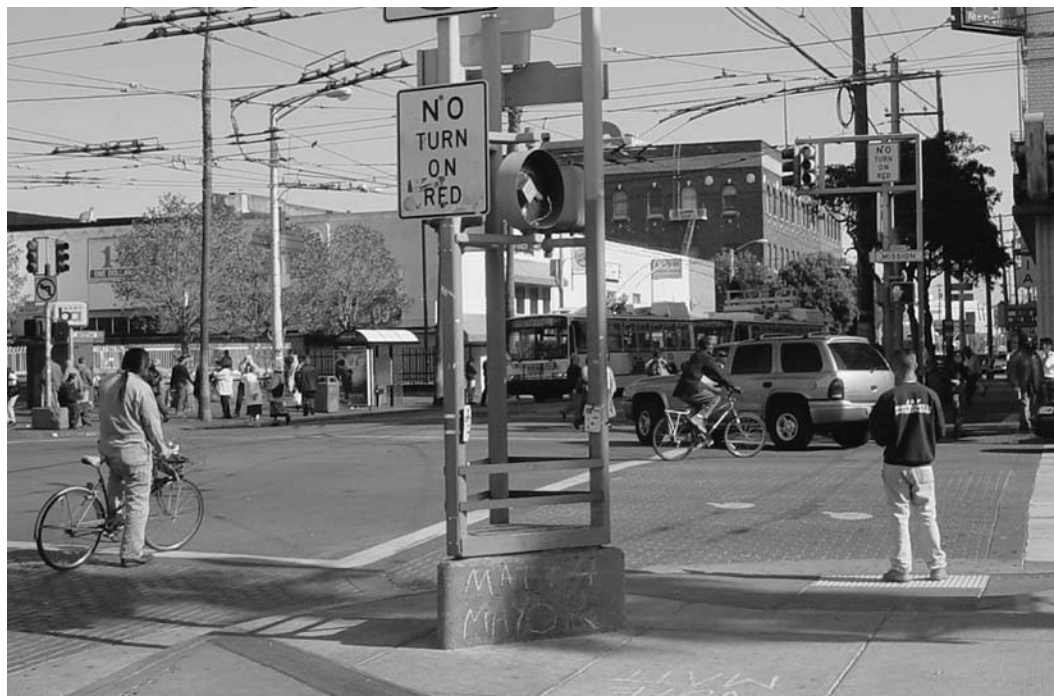
Figure 2-7. Static NO TURN ON RED sign.

- Install a static NO TURN ON RED sign (see Figure 2-7). This sign prohibits vehicles from making right turns when the traffic signal is installed in an effort to reduce potential conflicts between vehicles turning right on red and pedestrians crossing at the intersection.
- Install a dynamic NO RIGHT TURN ON RED sign or NO TURN ON RED sign (see Figure 2-8). This sign is activated either by the pedestrian push button or by automated pedestrian detection (e.g., infrared). When activated, the dynamic traffic signal displays the words

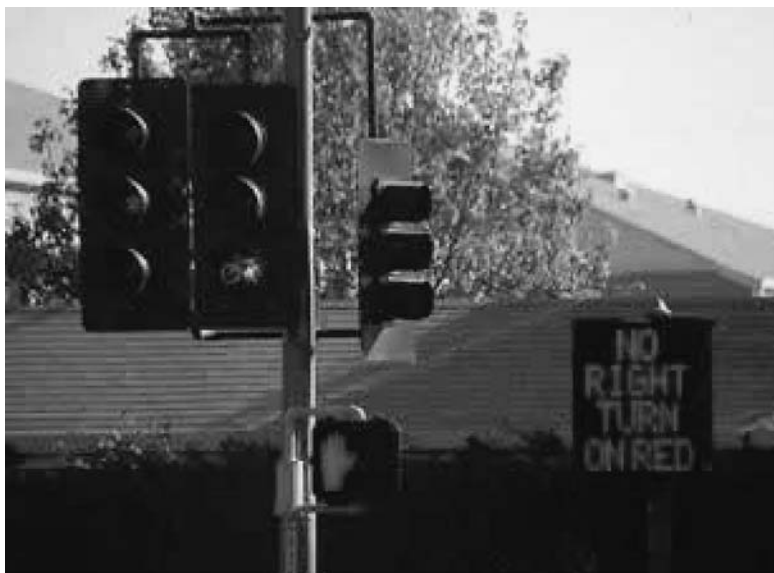
Figure 2-8. Dynamic NO RIGHT TURN ON RED sign.

NO TURN ON RED to vehicle operators, prohibiting this maneuver and protecting pedestrians from potential conflicts with turning vehicles. The advantage of the dynamic sign is that operators are permitted to turn right on red when pedestrians are not present.

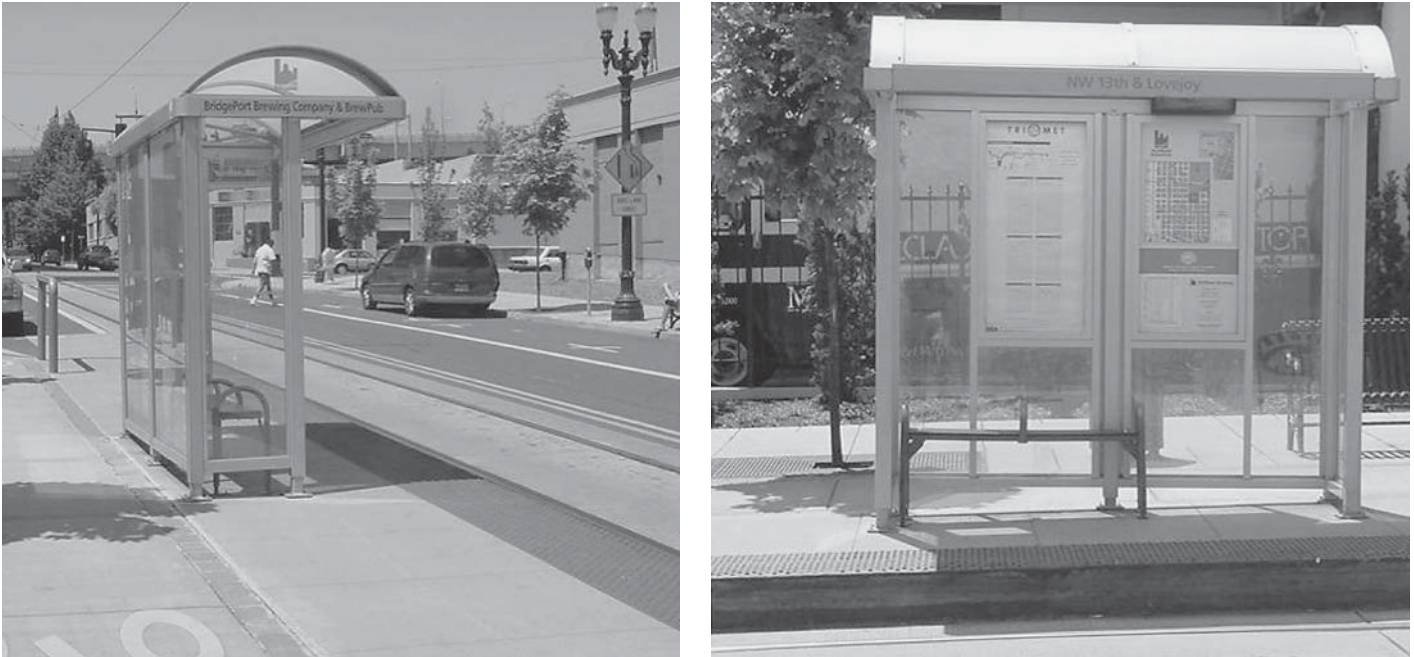
Figure 2-9. Application of tactile strips at a transit stop.

pedestrians. They may be a potentially effective method for keeping pedestrians away from the edge of the road (e.g., at intersections where buses are turning right) and for reducing the chance of pedestrians slipping and falling under a bus at bus stops and terminals. It is important to consider ADA standards and guidelines if implementing tactile strips.

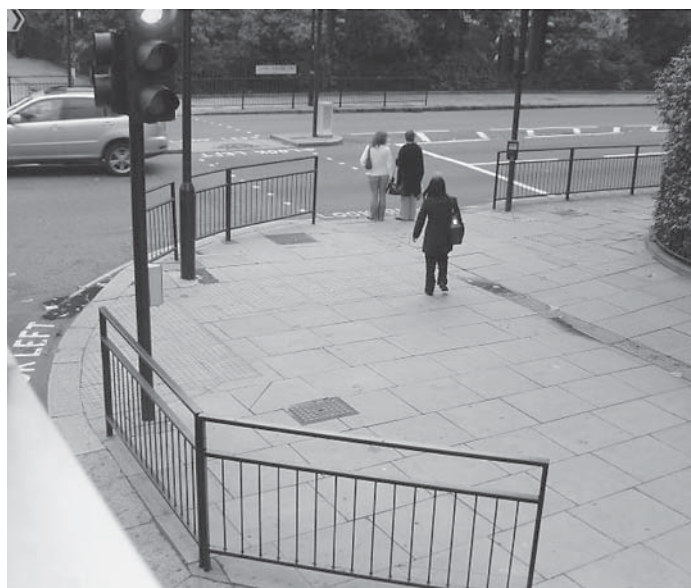
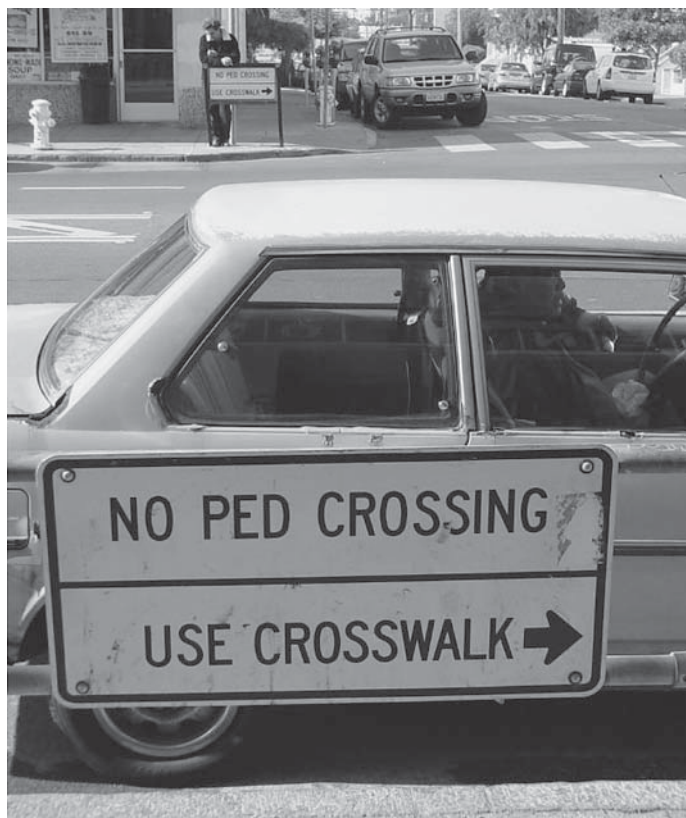
Figure 2-10. Applications of pedestrian channelization—fences (left) and signs (right).

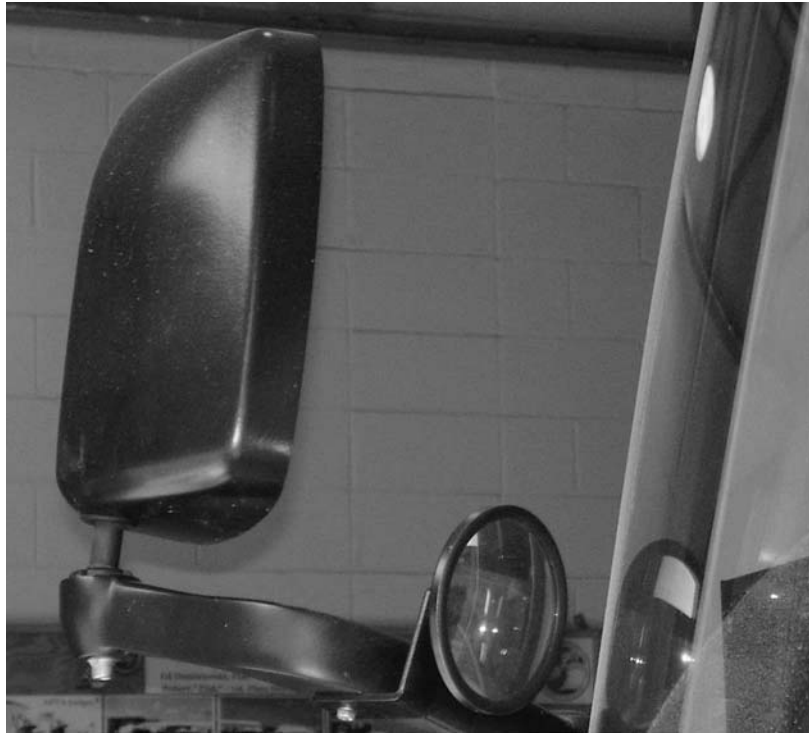
Figure 2-11. Convex mirror on right side with downward slant.

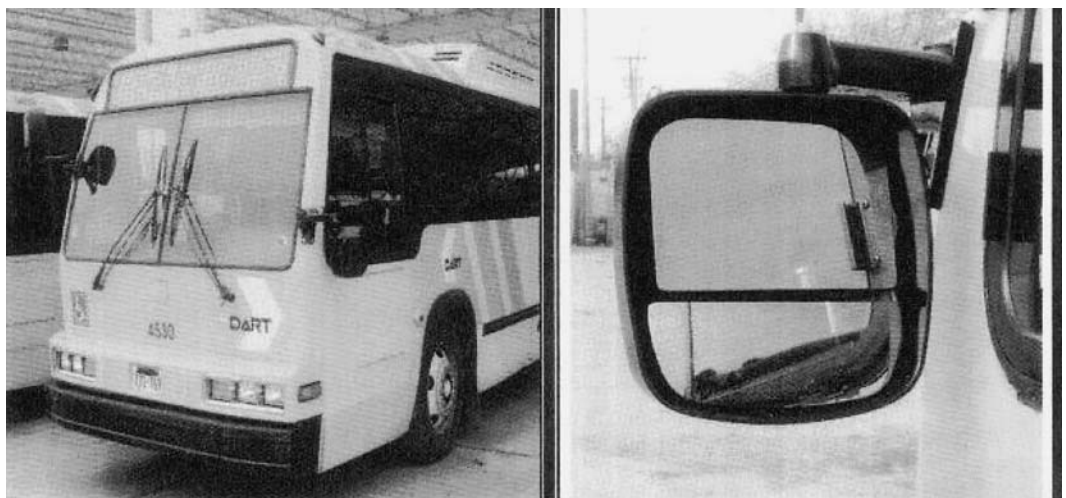
Figure 2-12. Dual left-side mirrors oriented downward and placed lower on bus.

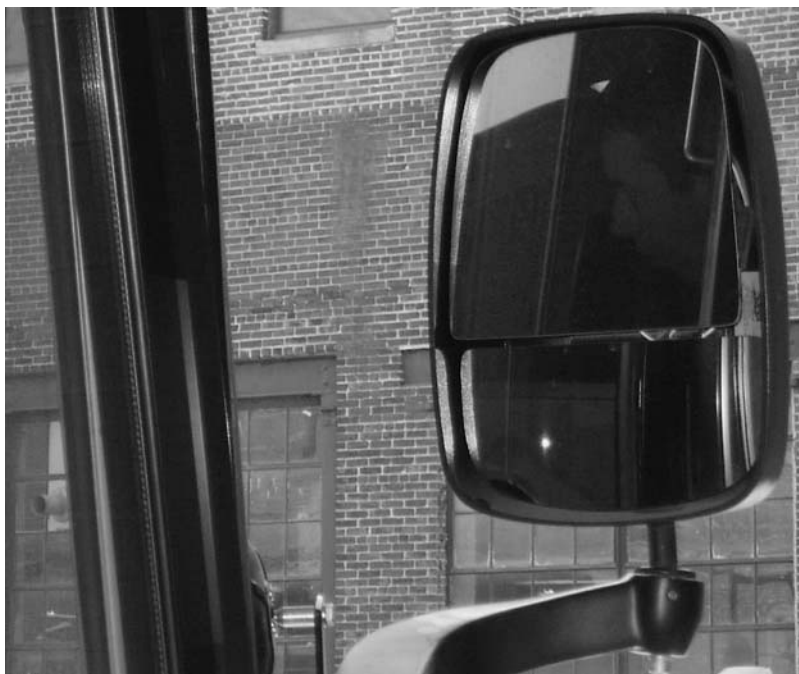
Figure 2-13. Dual mirrors in single housing (flat mirror on top).

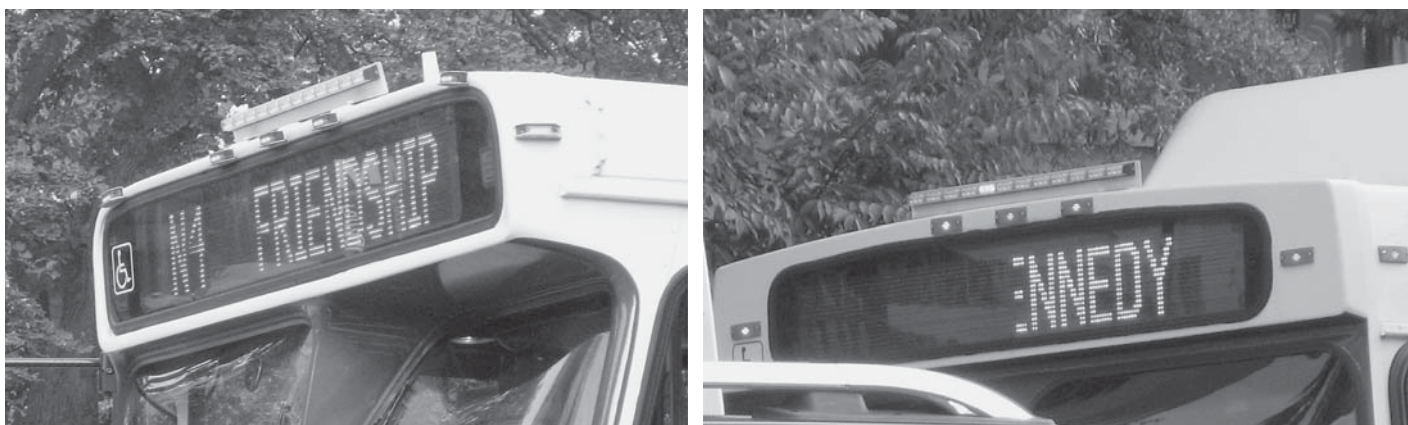
Figure 2-15. LED light strip on front-top of bus.

LED light strip on front-top of bus (see Figure 2-15)	To get the attention of pedestrians and ultimately to improve safety	A LED strip of flashing lights across the front (top) of bus. Unlike the one single strobe light atop buses (as noted in previous application), these lights move back and forth and are meant to increase awareness about the presence of buses when it’s dark. See further details in Section 3.1.3.6.	Currently being tested
Side strobe lights (see Figure 2-16)	To indicate to motorists and pedestrians that a bus is making a turn	Two lights are placed on each side of 40-foot buses. Three lights are placed on each side of the articulated buses. Lights are controlled by the turn signal and flash at a higher frequency than a typical turn signal. The articulated buses also have an audible signal during right turns, which is the same beep signal that is used to indicate that the ramp is being deployed. The 40-foot buses are not equipped with audible signals to avoid unwanted noises in residential areas and where pedestrian traffic is low.	Not reported

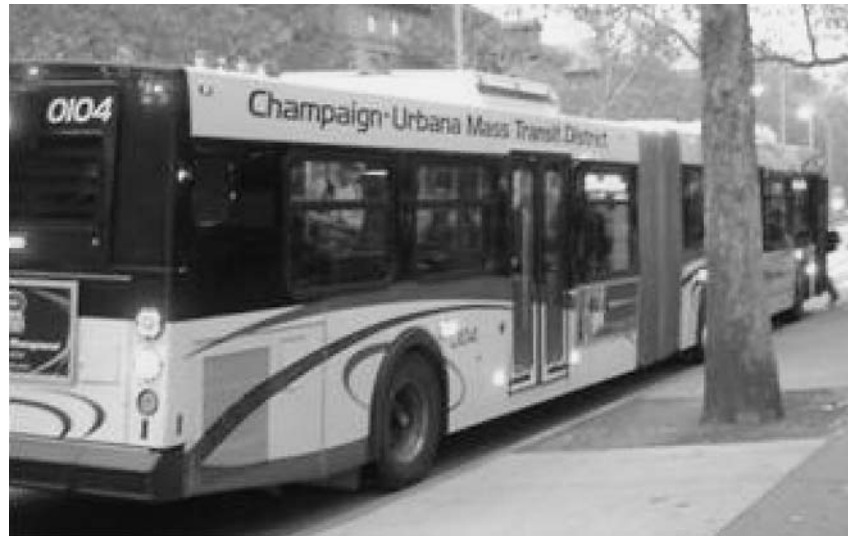
Figure 2-16. Side strobe lights.

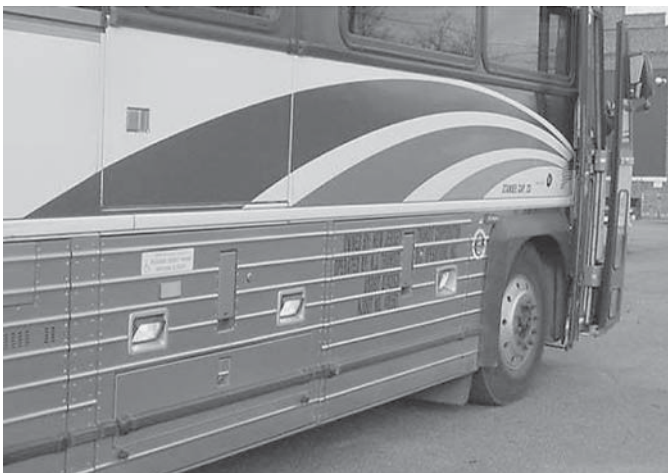
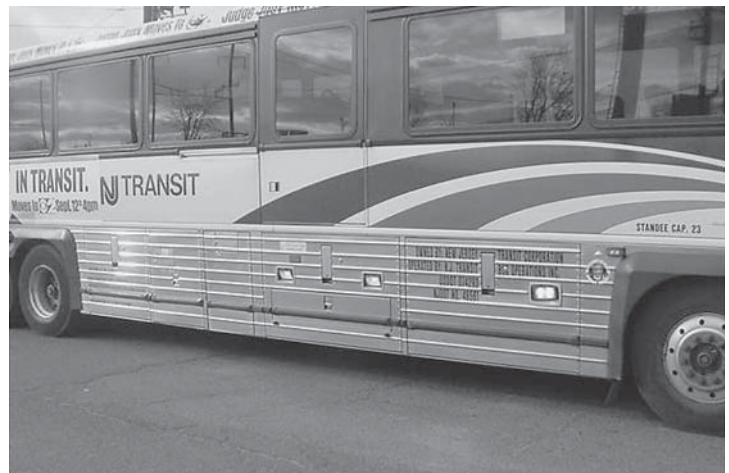
Figure 2-17. Bus curb lights.

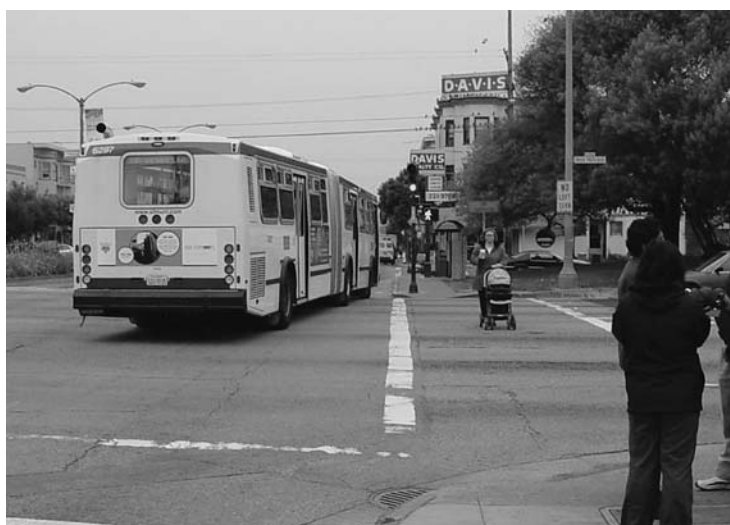
Figure 2-18. Bus stop located on far-side of intersection.

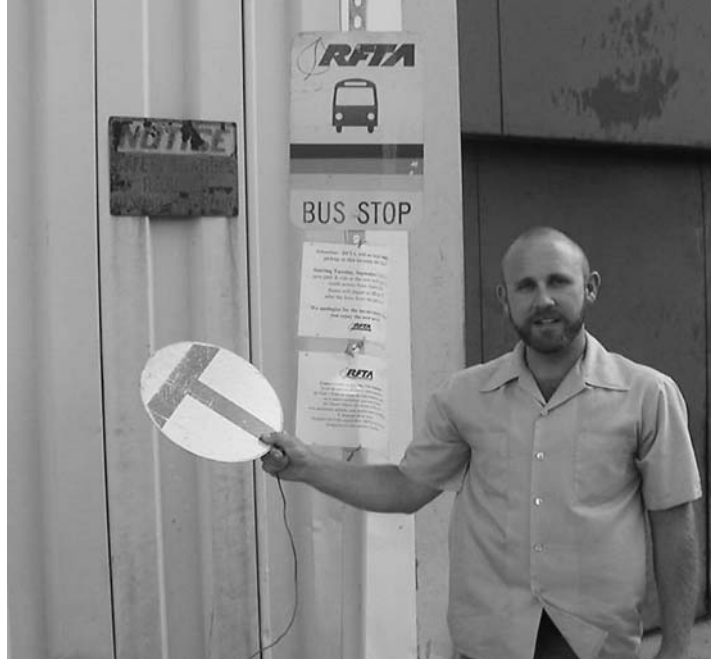
Figure 2-19. Retro-reflective paddle.

Retro-reflective bus stop signs	To increase the visibility of the bus stop	Signs designating the bus stop location that are high in retro-reflectivity.	Rated a 2 or 3 for reducing collisions Reportedly much better than the standard <i>Manual for Uniform Traffic Control Devices (MUTCD)</i> bus stop signs in terms of visibility
Solar-powered shelter lights	To provide light for pedestrians and bus operators	The lights put out a subtle glow rather than a glare, just enough to light the shelters. The shelters are solar powered. One drawback is that chemicals used to treat snow and ice on roads interfered with functioning of solar panels and electronics. One agency reported they had to clean them twice a day and eventually stopped using them.	Not reported
Pocket and pen lights (see Figure 2-21)	To allow a bus driver to see more easily a rider waiting at a bus stop	Small hand-held light that pedestrians can activate when walking to and from a stop and standing at the stop. Operators hand them out primarily to riders who catch the bus in dark conditions.	Rated a 5 for bus stops on rural and high-speed roads although difficult to rate because agency rarely has a bus and pedestrian collision. Very high public acceptance—“people love them,” according to the director of the transit agency.

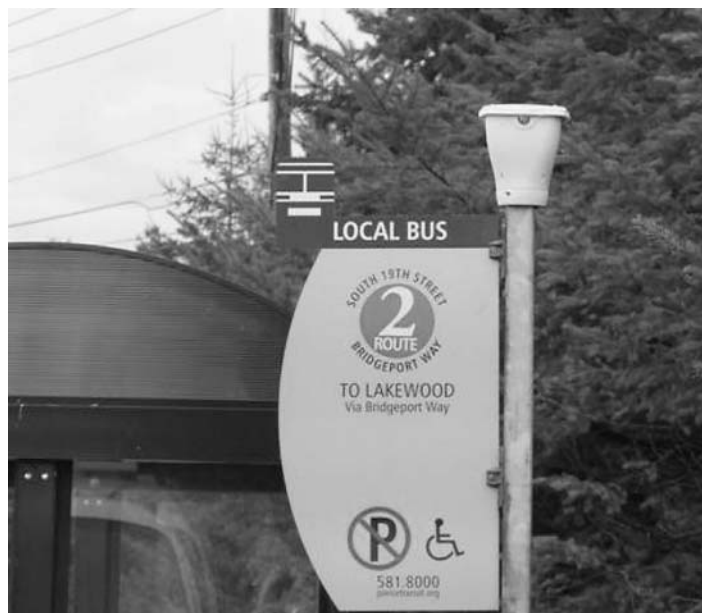
Figure 2-20. Bus stop flashing beacon.

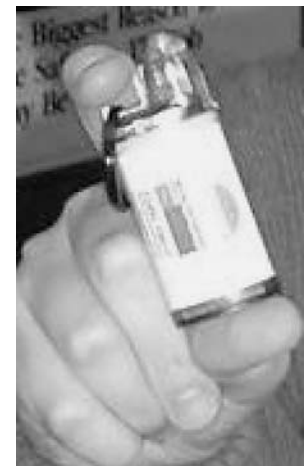
Figure 2-21. Pocket light.

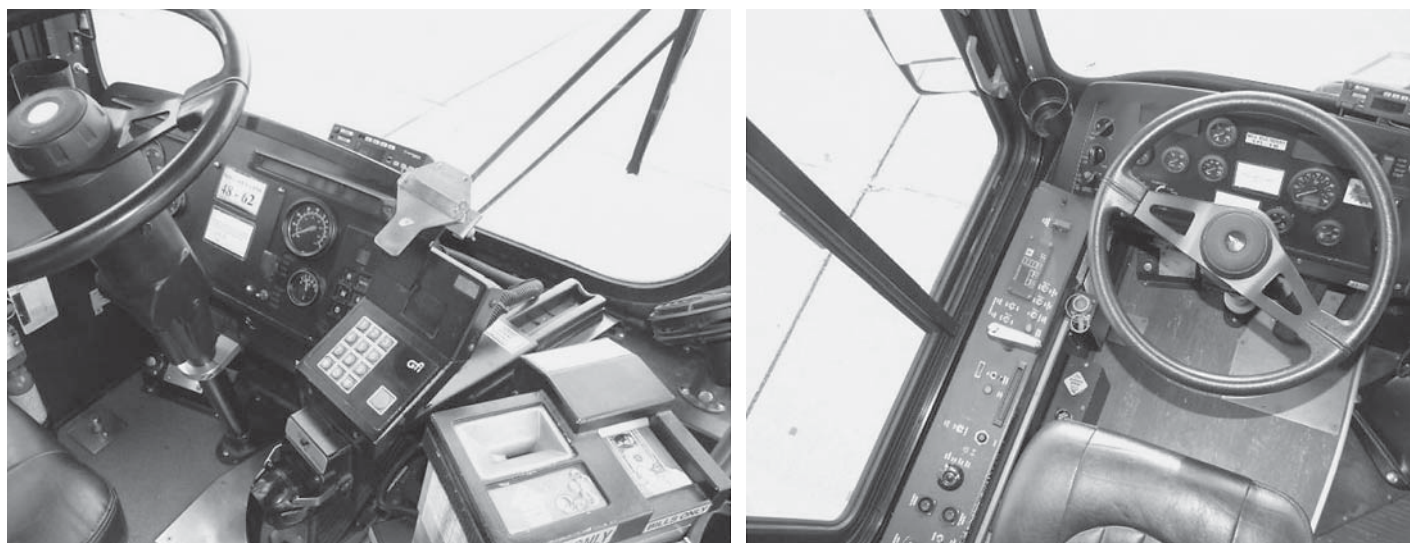
Figure 2-22. Example of new interior operator compartment design.

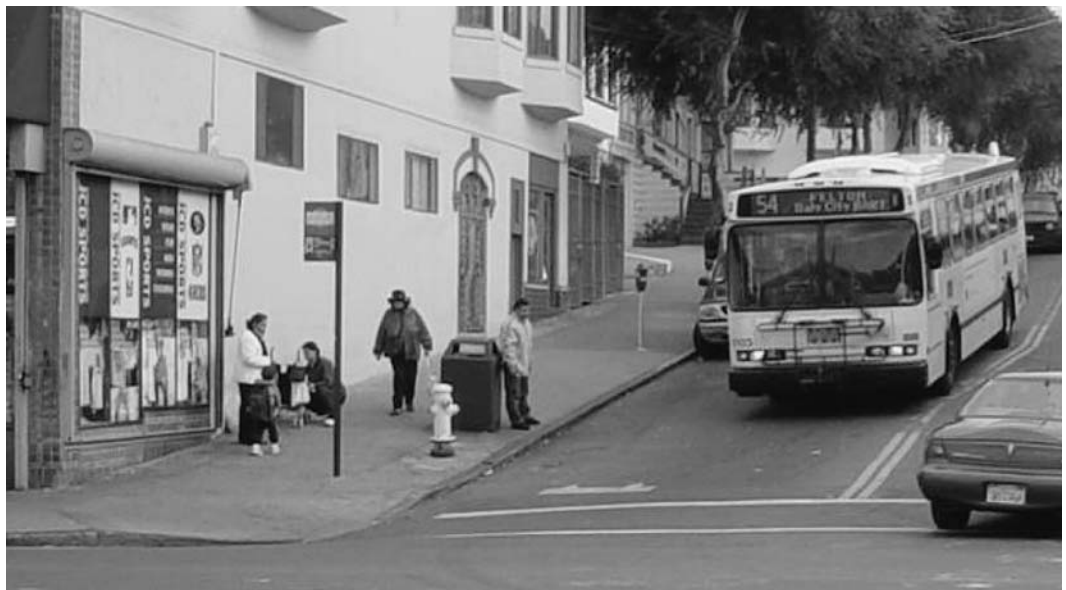
Figure 2-23. Sidewalk obstructions near bus stop.

A few agencies and stakeholders suggested keeping intersections and sidewalks free of obstacles and objects—such as trash receptacles or fire hydrants—near bus stop locations (see Figure 2-23). Freeing sidewalks of obstacles could have several positive benefits:

- Increasing the amount of space where intending passengers wait and other pedestrians pass by, reducing conflicts between the two;
- Reducing visual obstructions that can block operators' views of pedestrians; and
- Reducing the objects that pedestrians could trip on or run into, both of which could result in them falling into the roadway or in front of oncoming buses.

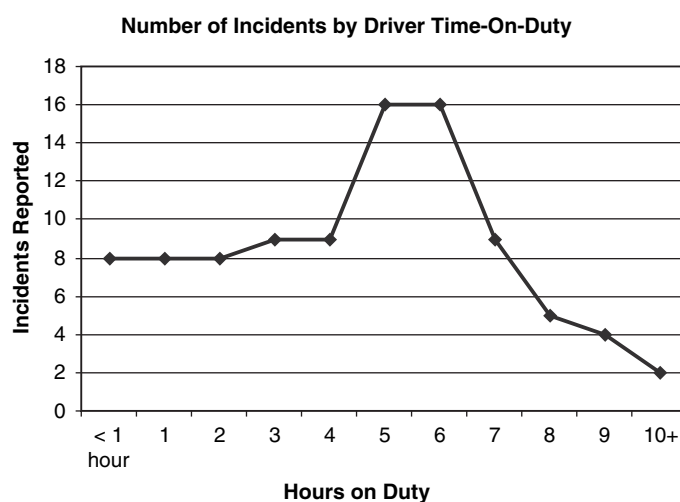
Figure 4-1. Number of bus-and-pedestrian collisions by driver time on duty.

dents compared with the number of hours on duty remained steady (at about 8 to 9 incidents) for every hour worked until 5 hours. After 5 hours on duty, the number of incidents almost doubled. At 5 and 6 hours on duty, the number of incidents jumped to 16. Above 6 hours on duty, the number of incidents begins to fall. This drop is most likely due to the fact that there are fewer shifts that extend beyond 6 to 7 hours.

Analysis of the collision data showed that operator time on duty does in fact appear to play a role in the occurrence of bus-and-pedestrian collisions. The length of time that the operator was on duty was reported in 94 of the incident records. As shown in Figure 4-1, the number of inci-
