## Accessible Pedestrian Signals: A Guide to Best Practices (Workshop Edition 2010)

Web-Only Document 150:

Contractor's Guide for NCHRP Project 3-62A  
Submitted November 2009

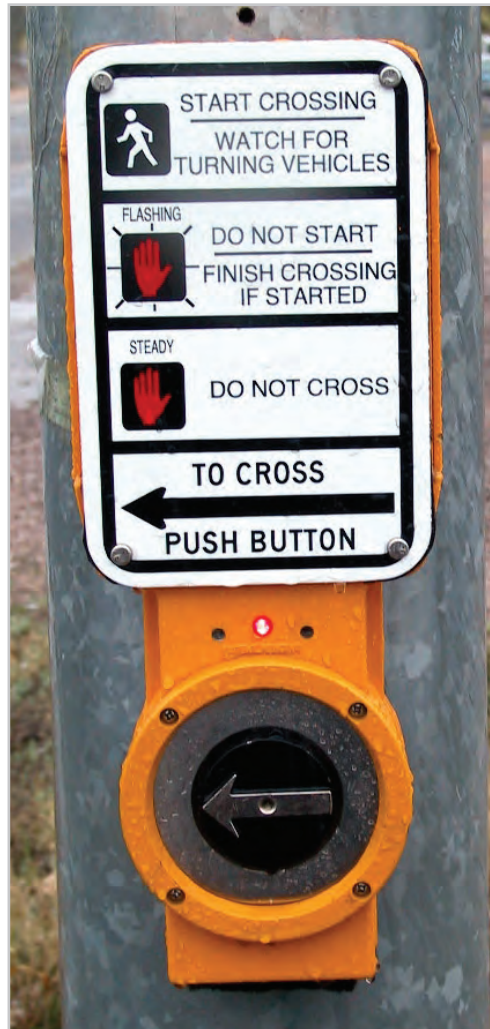
**Figure 1-3. Pushbutton-integrated APS**

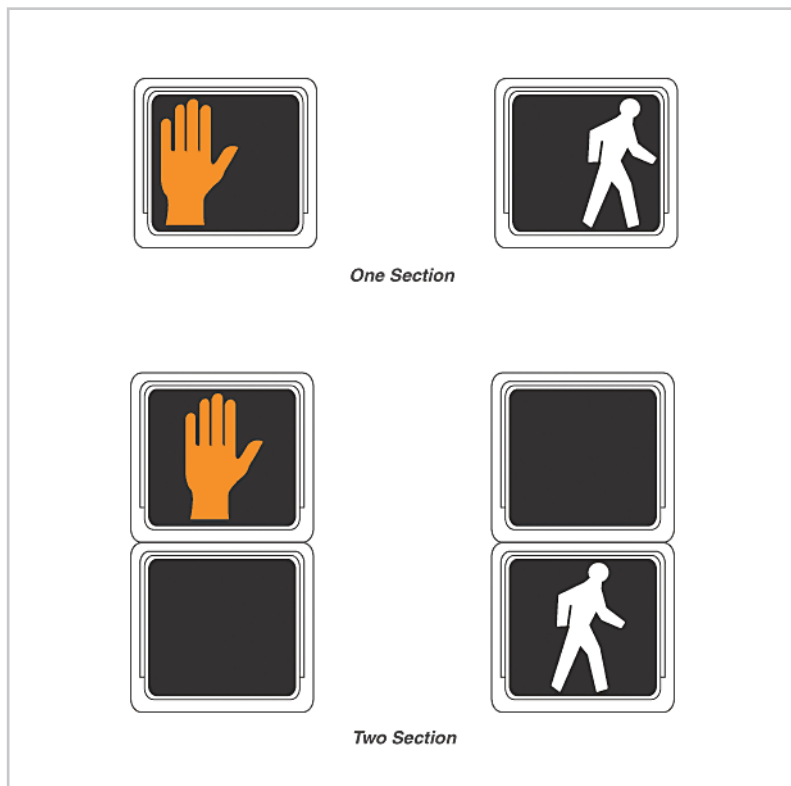
**Figure 3-7. Typical pedestrian signal symbols**

- WALK interval—White WALK or symbol of a person walking issued to indicate that pedestrians should begin crossing, after yielding to vehicular traffic still legally in the crosswalk.
- Change interval—Orange flashing DONT WALK or symbol of a flashing hand is used when pedestrians are not supposed to begin a crossing because there is not enough time left in the phase for most pedestrians to get all the way across the street. Pedestrians that have already begun to cross should finish crossing.
- DONT WALK interval—Steady orange DONT WALK or symbol of a hand is used when pedestrians are not supposed to be in crosswalk.

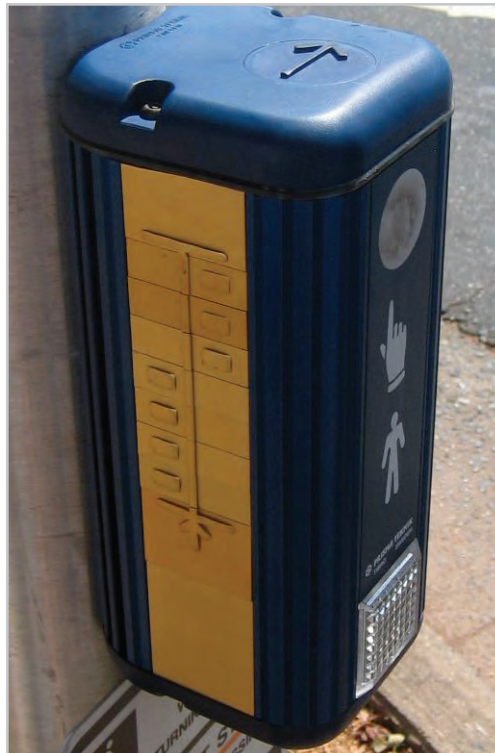
**Figure 4-4.** The tactile arrow is located on top of this APS housing (note the lack of necessary color contrast between the arrow and housing)

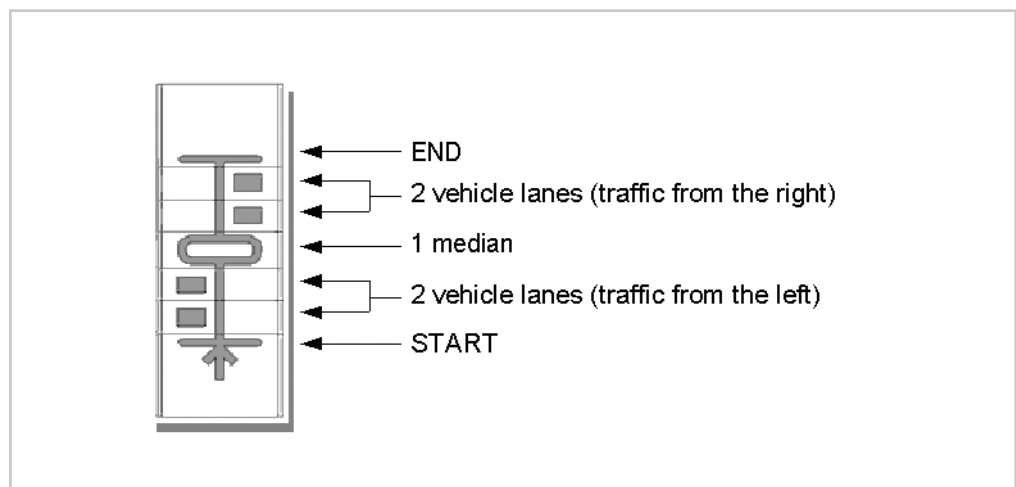
**Figure 4-7.** This tactile map from a Swedish APS is read from the bottom to the top and indicates lanes as they would be encountered by pedestrians

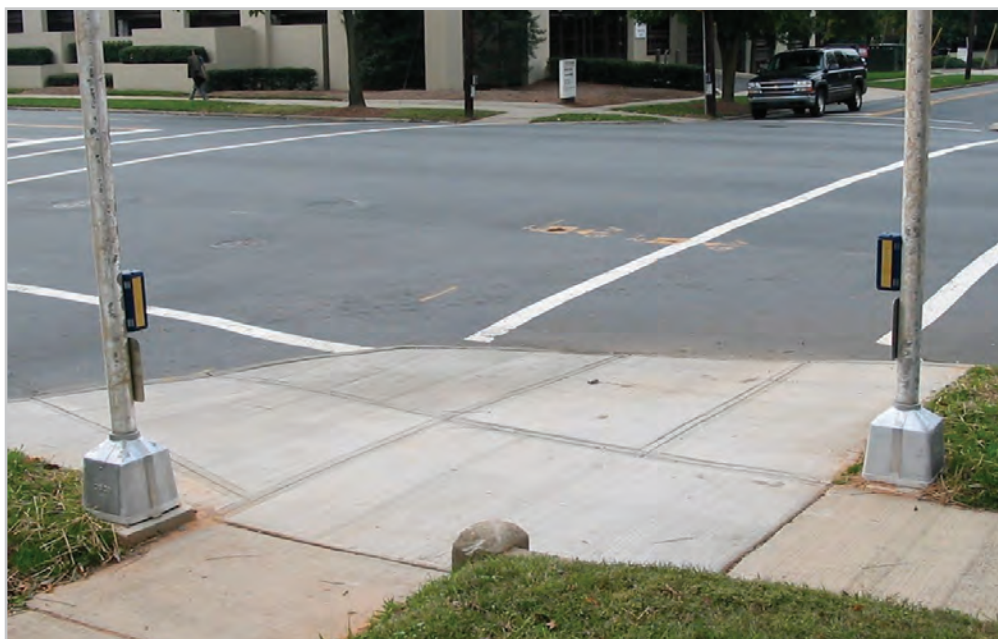
**Figure 6-13.** APS installed in this reconstruction location are in accordance with the Draft PROWAG in that they are beside a level landing and separated from each other by at least 3 m. Both APS are located on the intersection side of their poles.

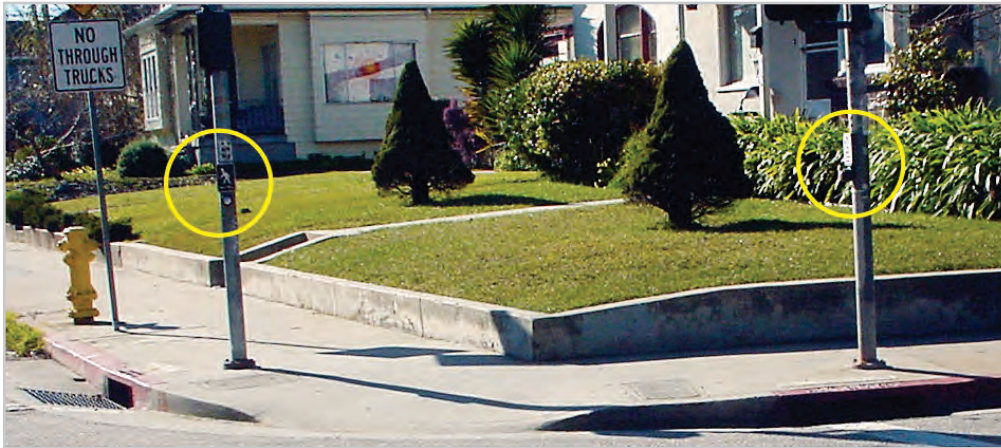
**Figure 6-15. Well-located pedestrian signal poles provide APS audible indications from the optimal location, close to the pedestrian waiting area**

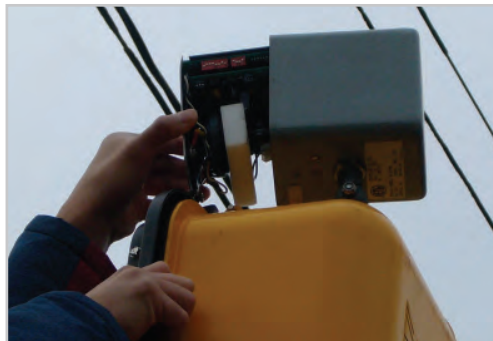
**Figure 6-18. APS device with control board in pedhead-mounted speaker (speaker opened for illustration)**

Some APS have a control board that is completely contained within the pushbutton. Other APS require a separate control board that is mounted in the pedhead (see Figure 6-18), while still others require a control unit mounted in the controller cabinet. The control board often includes voice or sound chips and switches to control volume, microphone response and other features.

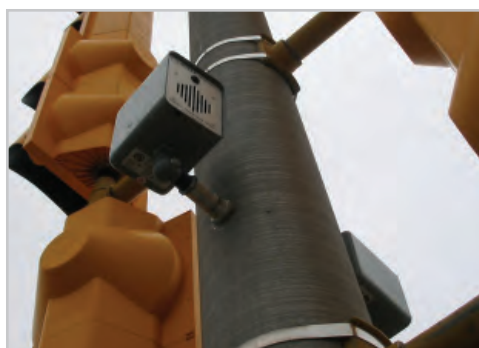
**Figure 6-21. APS speaker mounted directly to the metal pole for more support during high wind**

If an area typically experiences high winds, it may be necessary to mount the APS speaker on a strong surface. Engineers in Nova Scotia found that speakers mounted on the plastic pedhead were prone to cracking off during times of high wind. Their solution was to mount the speakers directly to the metal pole, as shown in Figure 6-21.

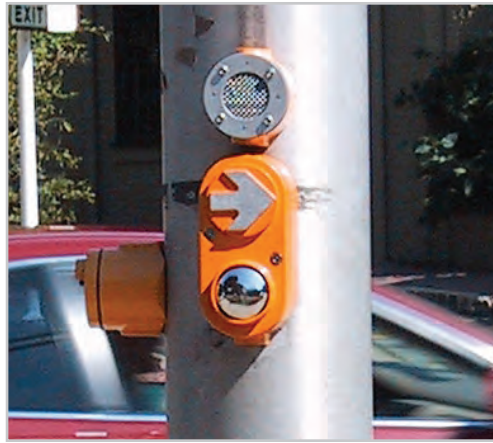
**Figure 6-22.** The direction of the cast-in-place arrow on this device must be specified when ordering

In areas where pushbuttons are installed on wooden poles, the wiring usually runs within a conduit on the outside of the pole. A mounting bracket is needed on some devices for wiring the pushbutton. This bracket needs to be ordered with the APS.

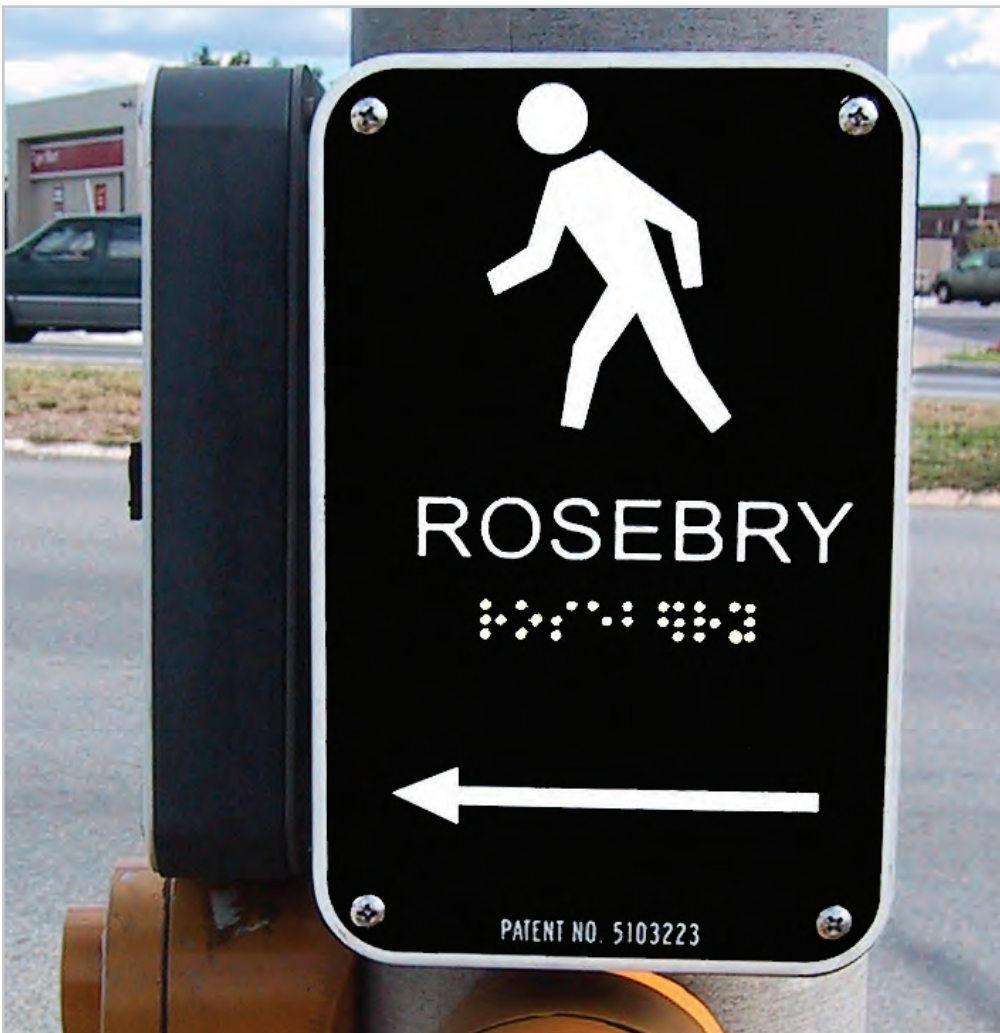
Figure 6-32. Braille label is below the raised print street name

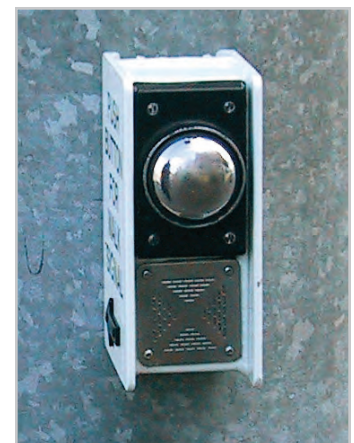
**Figure 6-36. H-frame APS mounted to pole**

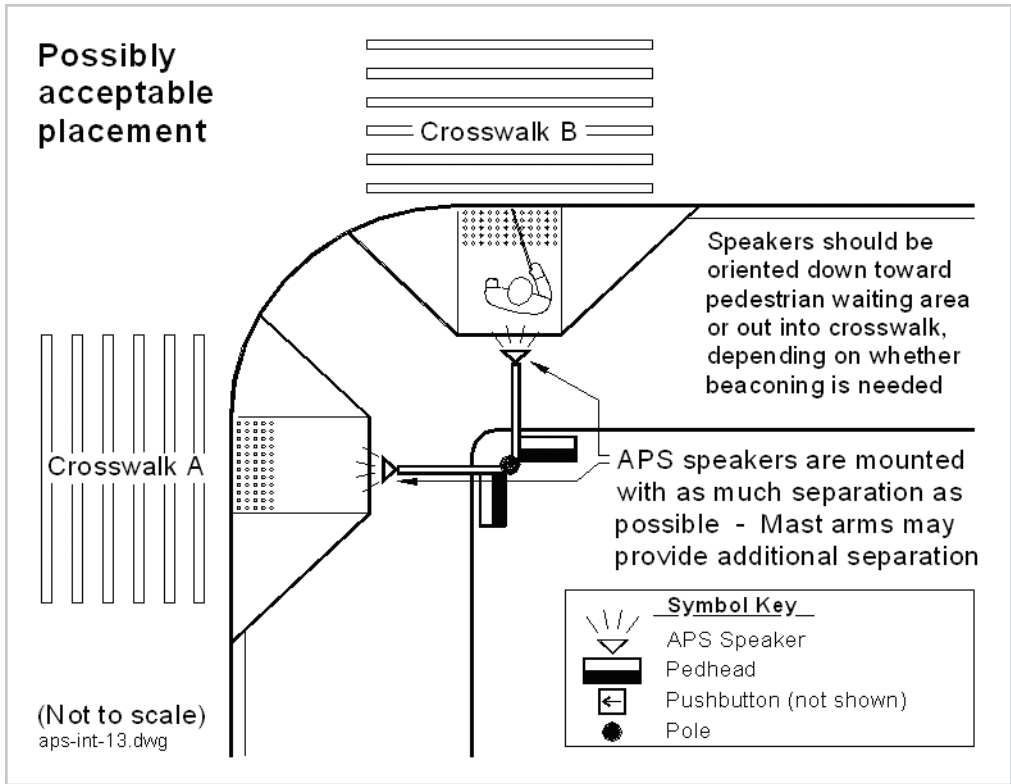
**Figure 6-48. Possibly acceptable placement for pedhead-mounted APS using mast arms to provide additional separation**

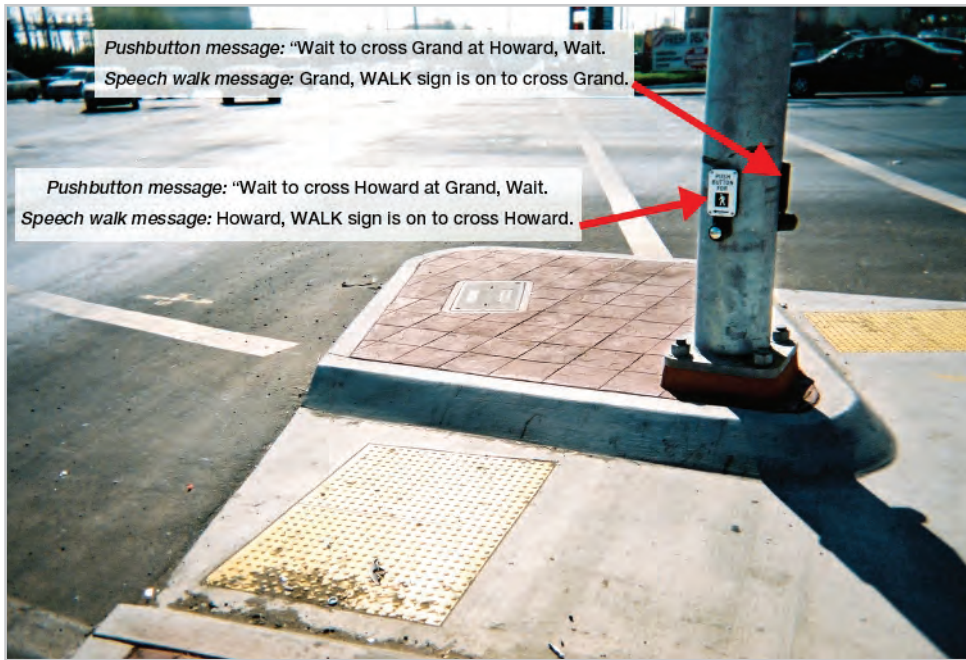
**Figure 6-52. Example of pushbutton information messages and speech WALK messages for two APS located on the same pole**

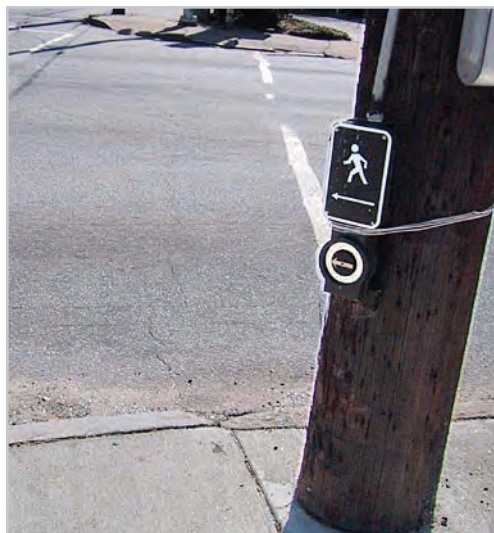
**Figure 7-13. APS was temporarily replaced on the pole, but the tactile arrow points to the center of the intersection, rather than being aligned with the direction of travel on the crosswalk.**

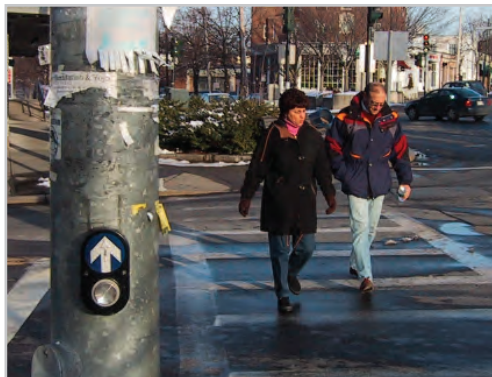
**Figure 9-6. Panich APS for crossing the stem of a “T” intersection.**

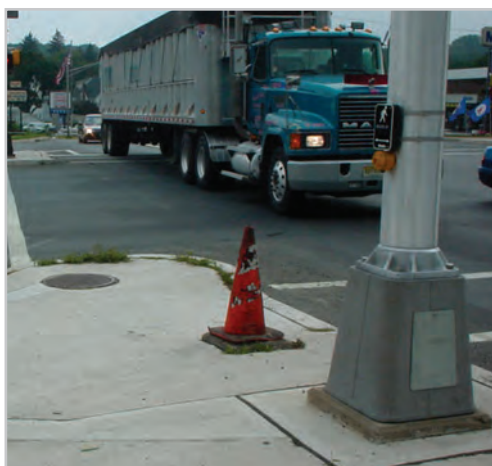
**Figure 9-8. Installation of two pushbuttons on a single pole (only a single push-button is visible in the photo). While the push-button is in line with the crosswalk, the pedestrian must travel over 10 feet before reaching the street and the beginning of the crosswalk.**

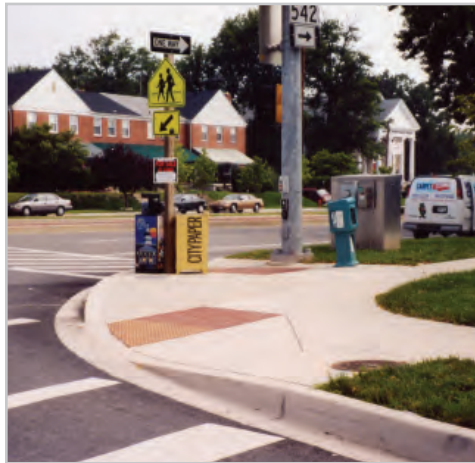
Figure 9-16. APS installed on signal pole beside crosswalk waiting location.

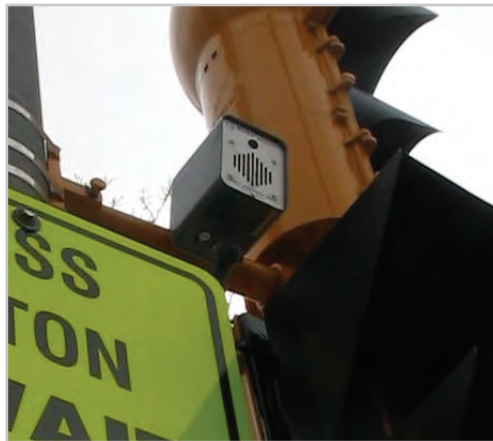
**Figure 9-21. APS speaker mounted on signal head support arm.**

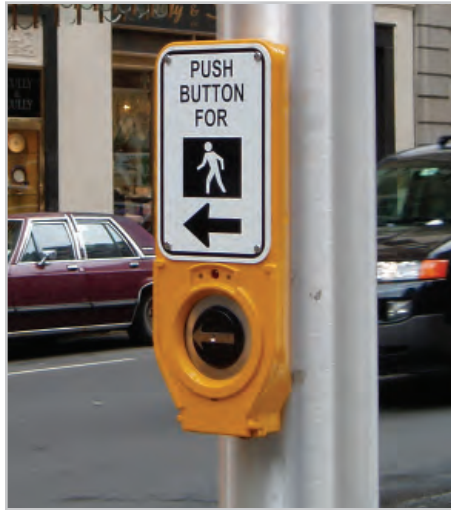
**Figure B-11. Polara Navigator APS mounted on pole**

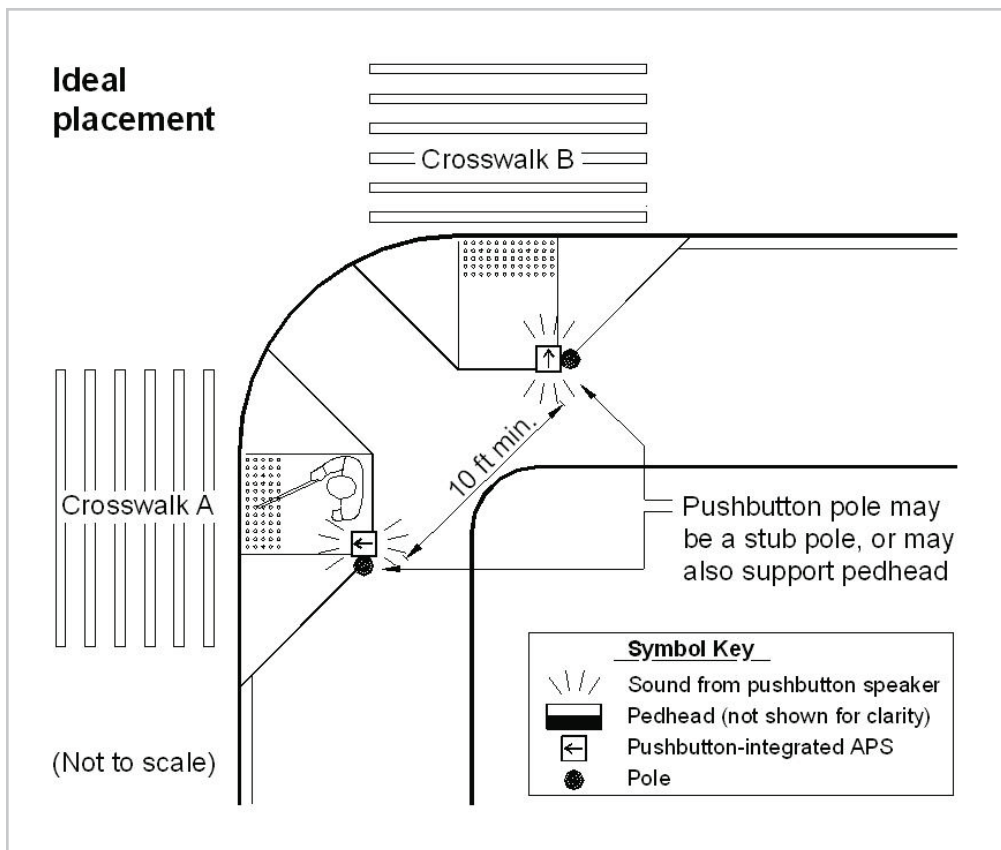
**Figure C-2. Optimal location of pushbutton-integrated APS.**

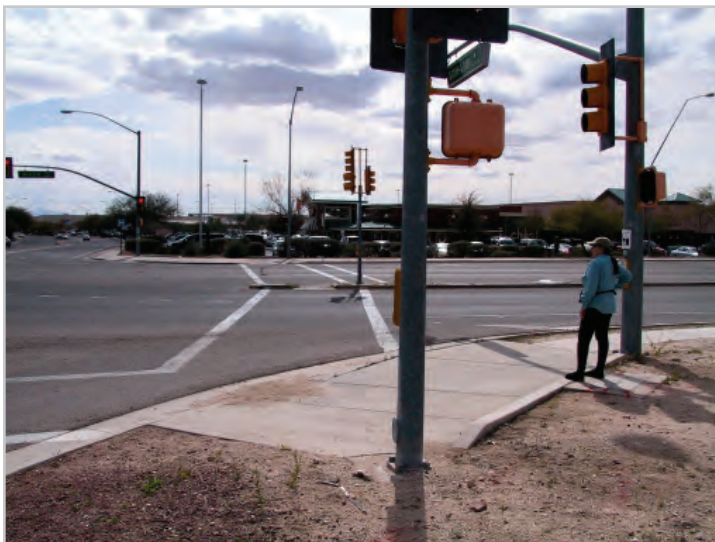
**Figure D-7.**  
This crosswalk is defined as skewed because it is timed for median crossing (two-stage) and a blind pedestrian might miss the median due to the bent crosswalk.

Skewing can also occur at crosswalks where the pedestrian walk signal only gives enough time for the pedestrian to reach a median. In this case, the blind pedestrian must be able to find the median to wait for the next signal cycle. A skewed or bent crosswalk may cause the pedestrian to miss the median. In this situation, the crosswalk is defined as skewed (Figure D-7).

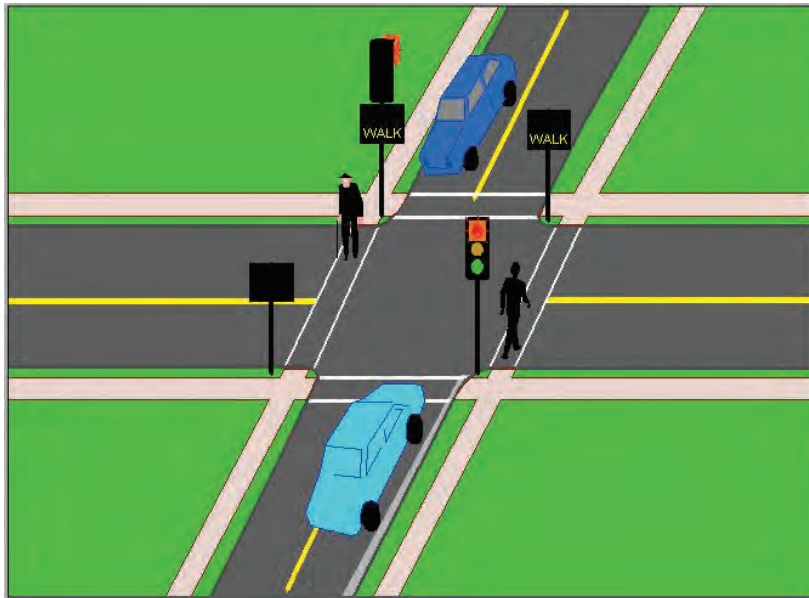
**Figure D-9.**  
**Leading Pedestrian**  
**Interval (source:**  
**Insurance Institute for**  
**Highway Safety)**

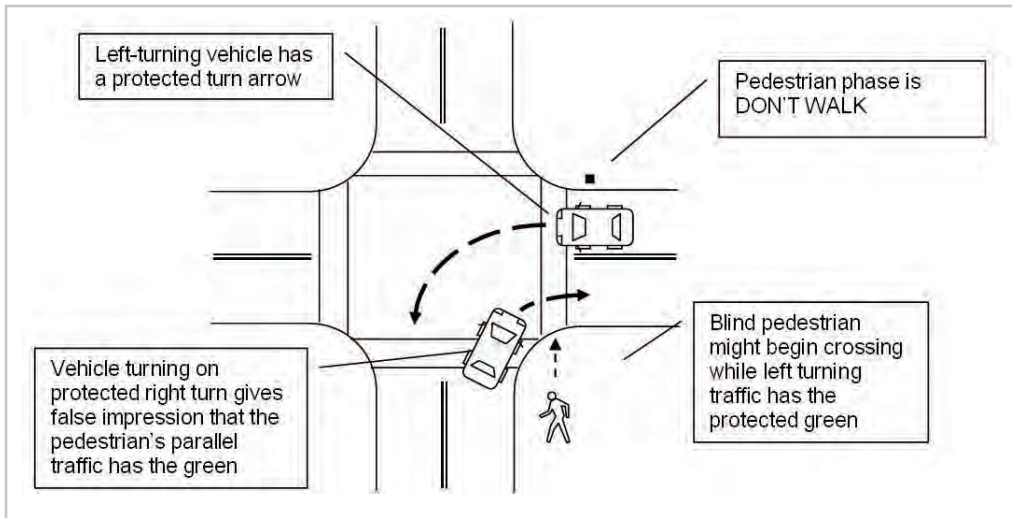
**Figure D-12.**  
Protected right turn phase can mislead blind pedestrians
