Guidebook on Pedestrian Crossings of Public Transit Rail Services

TCRP REPORT 175

**Guidebook on Pedestrian
Crossings of Public Transit
Rail Services**

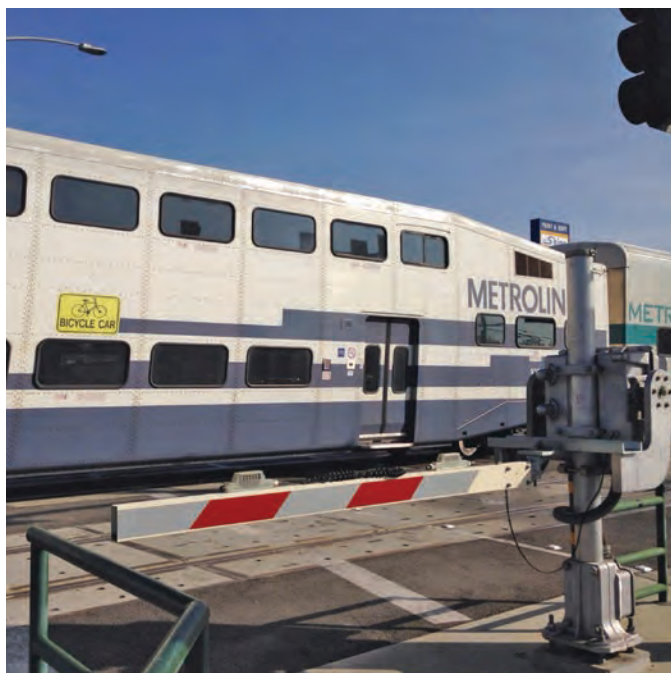
Figure 5. Example of commuter rail in Los Angeles.

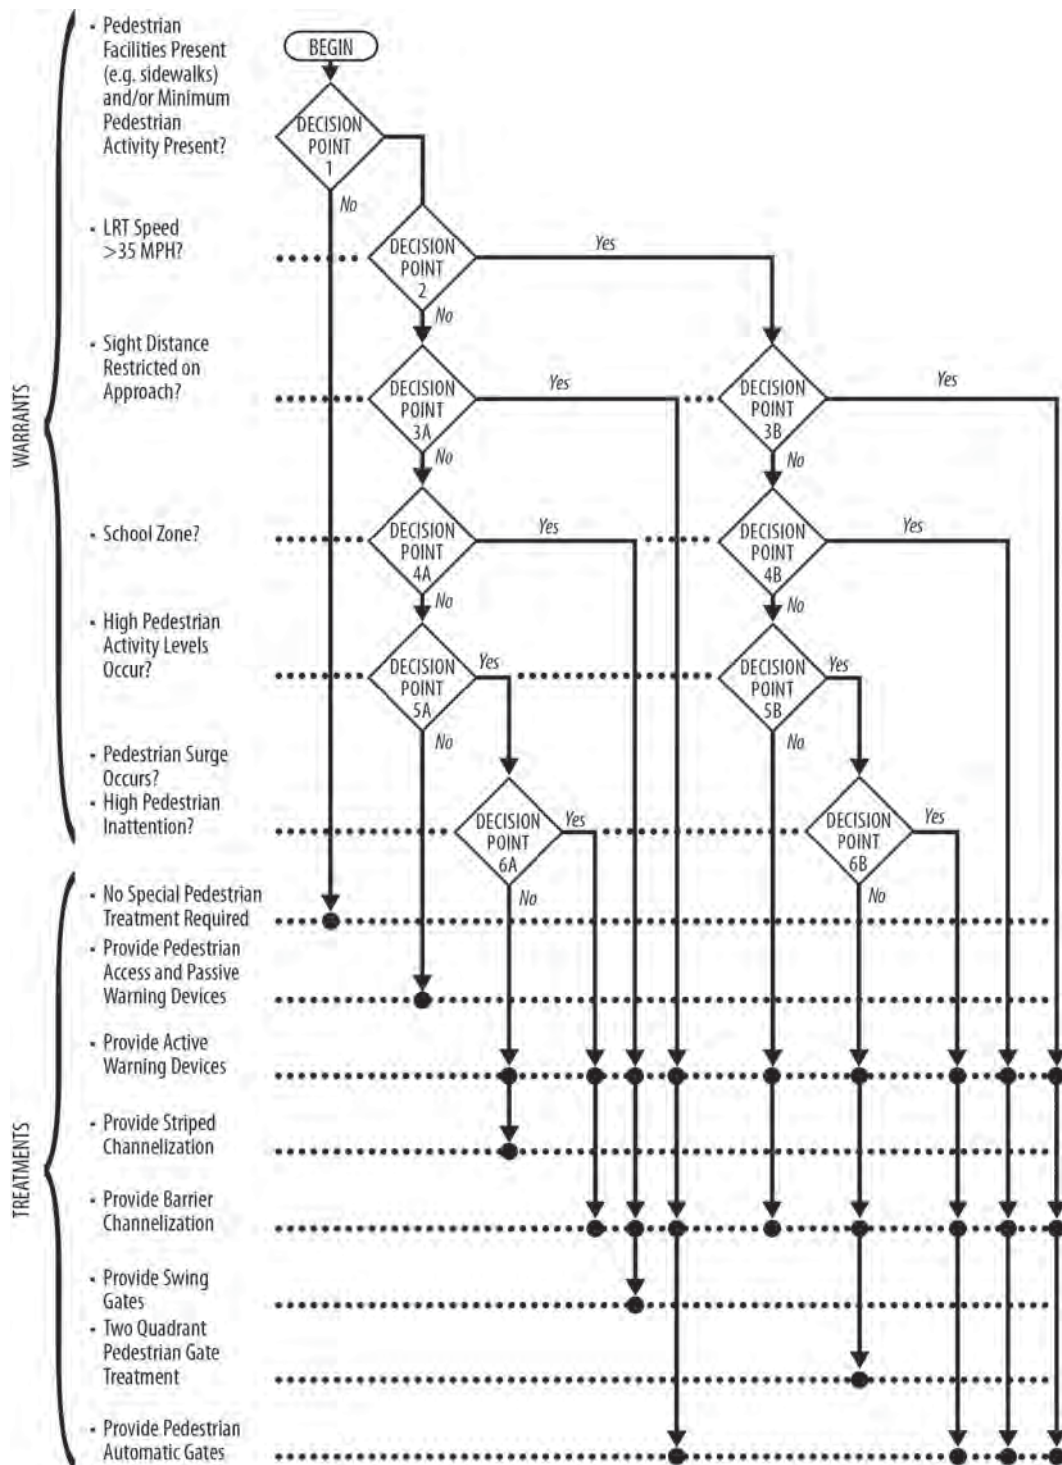
The authors of *TCRP Report 69* emphasize, as indicated in Figure 16, that there are numerous possible outcomes based on responses to the six decision points. In the least restrictive condition with at least some minimal level of pedestrian activity—a crossing with relatively low activity levels, not located in a school zone, where LRT speed does not exceed 55 km/h (35 mph), where sight distance is good, and where no other factors warrant special consideration—the recommended practice is to provide a pedestrian route and passive warning devices at the crossing. In the most restrictive conditions—a crossing where LRT speeds exceed 55 km/h (35 mph), sight distance is inadequate, the crossing is located in a school zone, and pedestrian surges or high

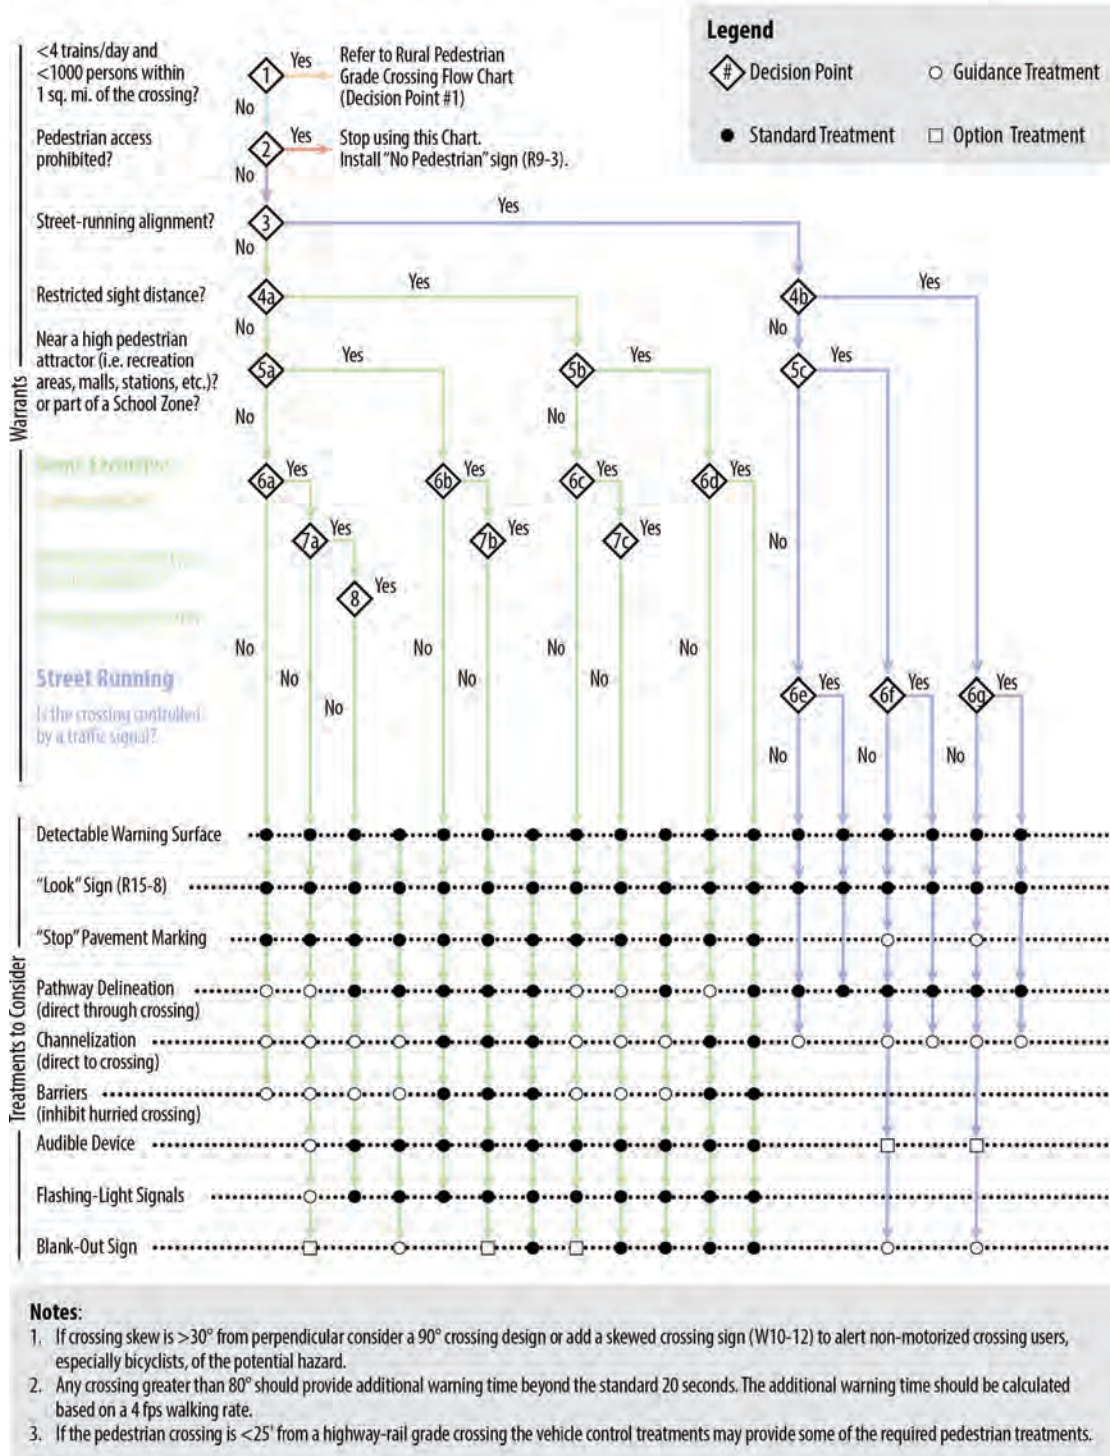
This flow chart is a companion to the UDOT Pedestrian Grade Crossing Manual. It is intended as a tool to guide designers in the selection of appropriate control devices at pedestrian grade crossings. Final treatment selection should be determined through an engineering study.

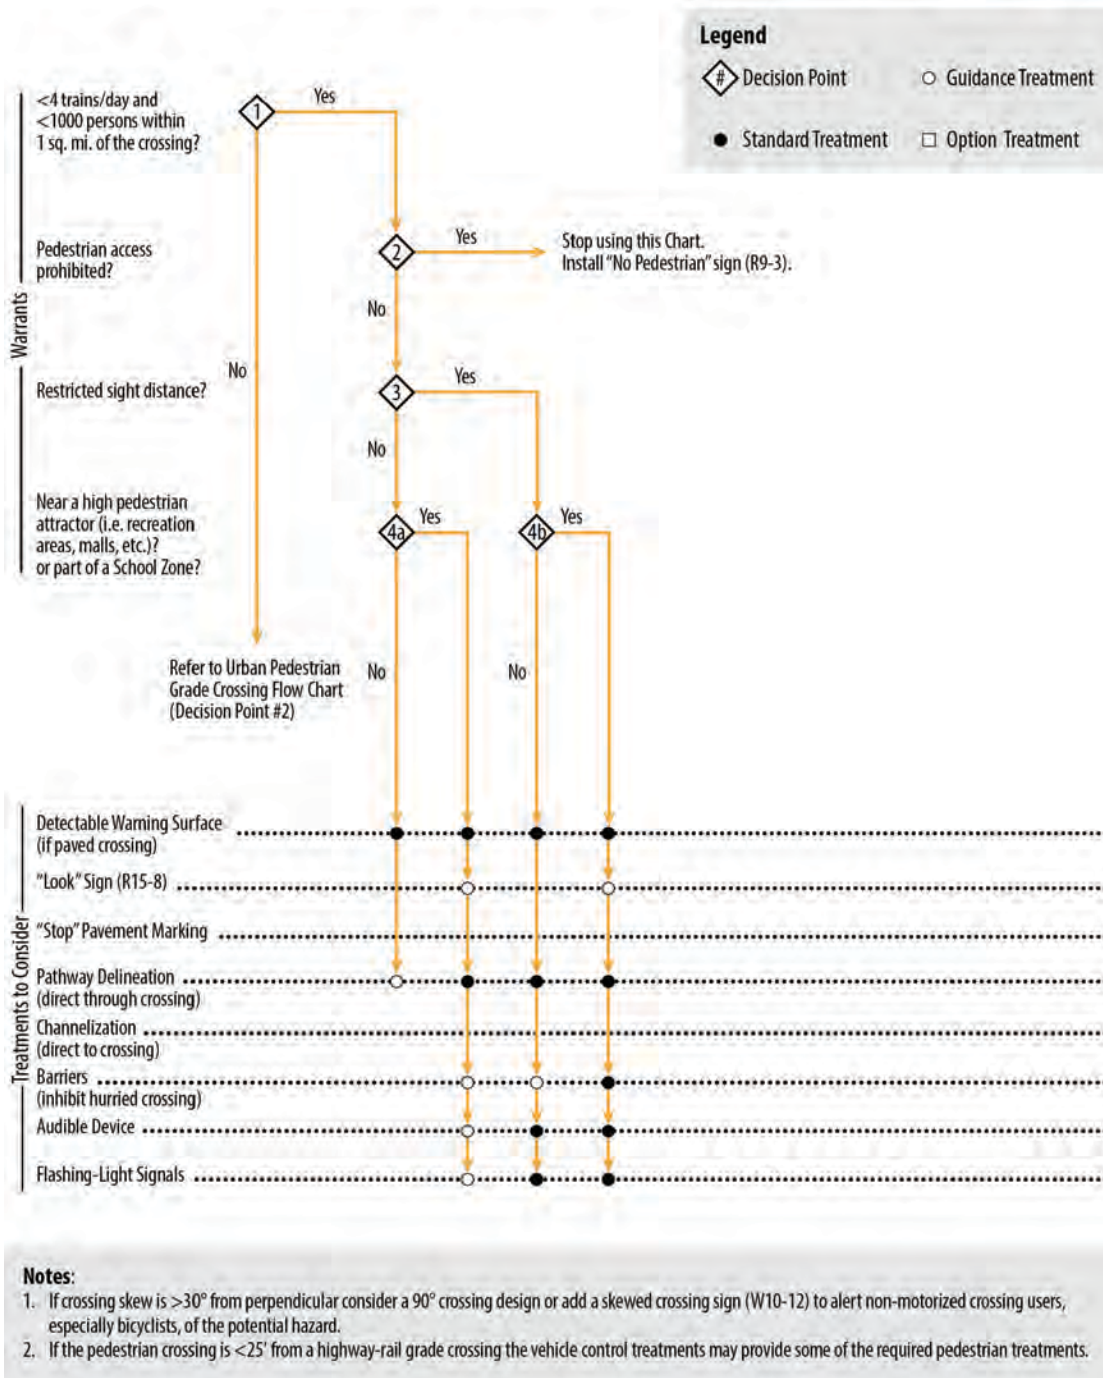
This flow chart is a companion to the UDOT Pedestrian Grade Crossing Manual. It is intended as a tool to guide designers in the selection of appropriate control devices at pedestrian grade crossings. Final treatment selection should be determined through an engineering study.

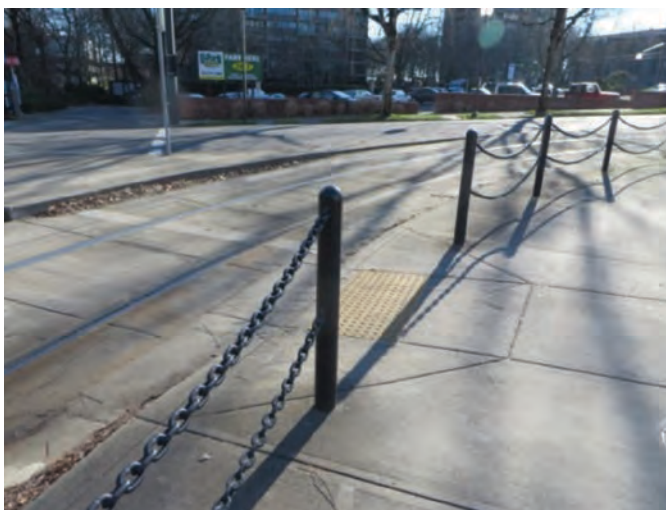
Figure 27. Example of bollards with chains used to restrict movement.

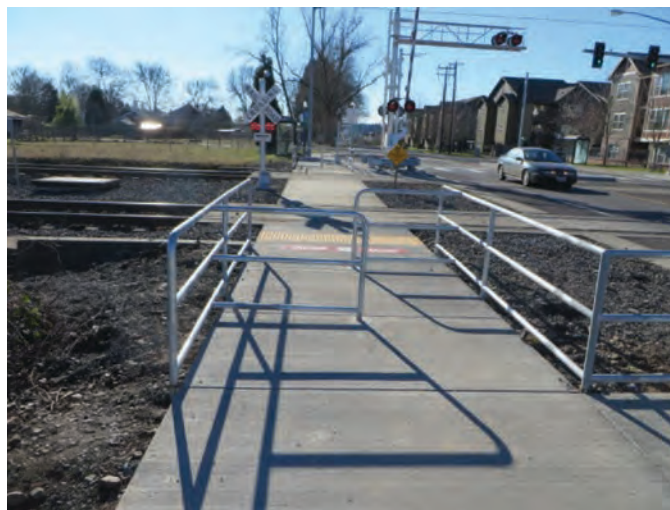
Figure 34. Example of railing used between fences to slow and reorient pedestrians at a crossing.

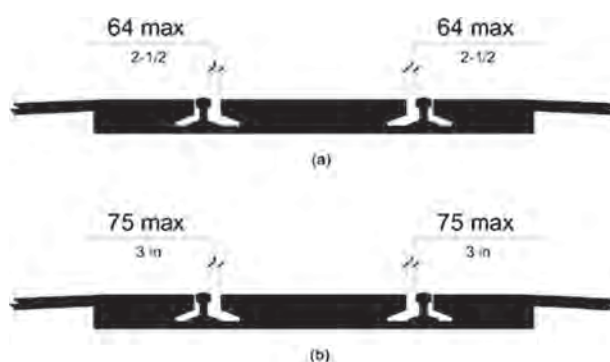
Wheels are much more likely to be entrapped when crossings are diagonal. Therefore, where tracks must be crossed on a diagonal, flangeway fillers are especially needed. When the crossing is not at 90 degrees, a wide crossing can enable wheelchair users to orient their chairs to approach the rails at 90 degrees.

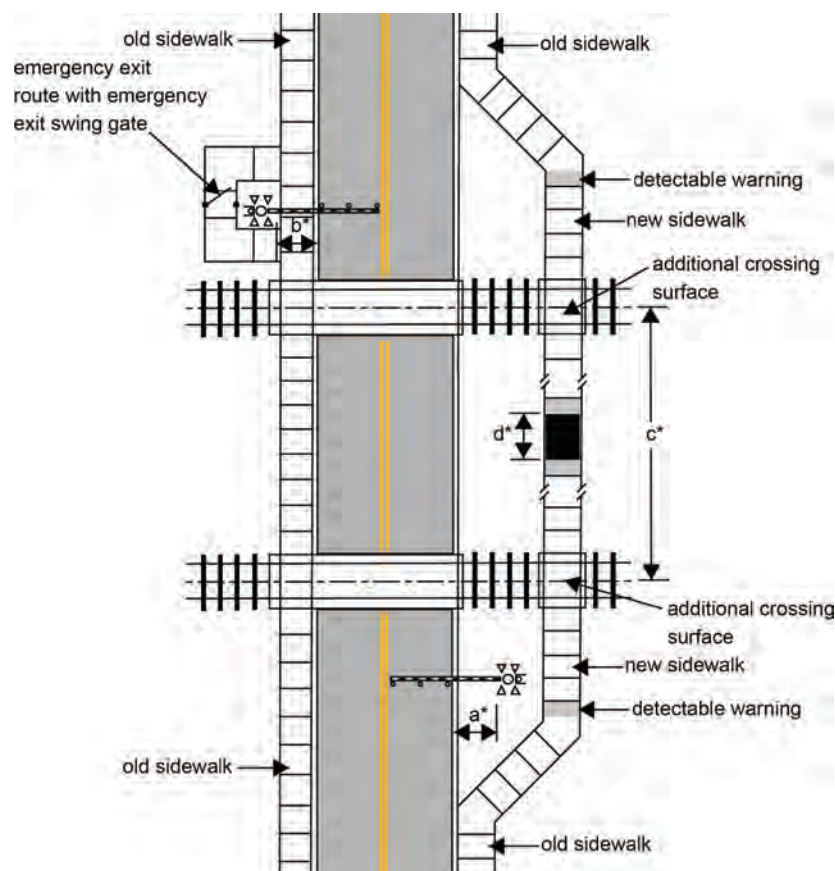
One of the changes the Railroad/Light Rail Transit Technical Committee (59) has proposed for the MUTCD (8) is to include a figure that shows an example of a refuge area (see Figure 57).

- NOTES:
- a = Clearance distance from face-of-curb to warning device, 2 ft with a sidewalk relocation.
 - b = The existing sidewalk location requires greater than 2 ft clearance, pushing the warning device farther away from the traveled way.
 - c = Between track centers. If 38 ft or greater, optional additional detectable warnings with optional refuge area may be used.
 - d = Refuge area between tracks, 48 in. minimum.

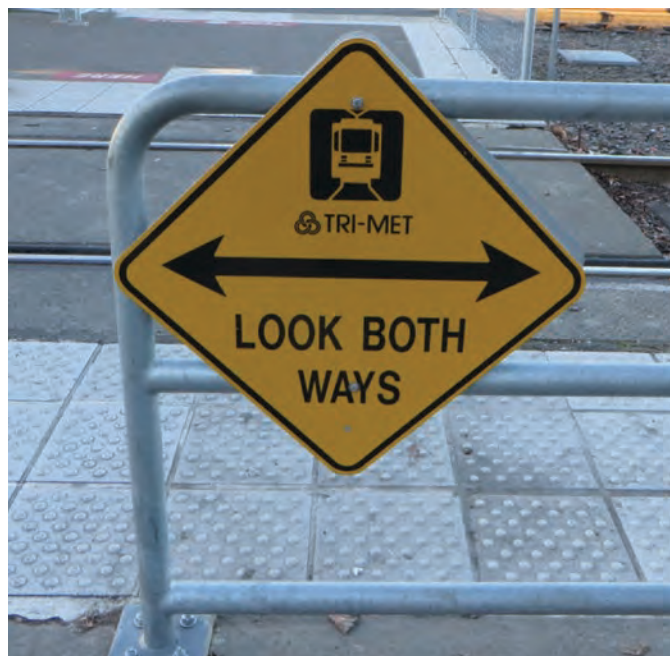
Figure 65. Example of the MUTCD LOOK sign (left side) and Tri-Met LOOK BOTH WAYS sign (right side) at a Portland crossing.

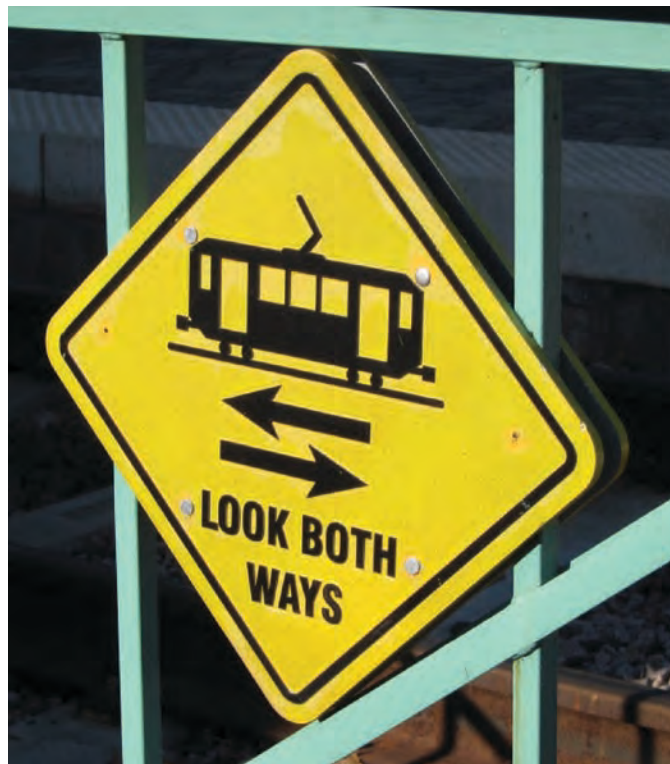
Figure 68. Example of a LOOK BOTH WAYS sign used on the roadway in Los Angeles.

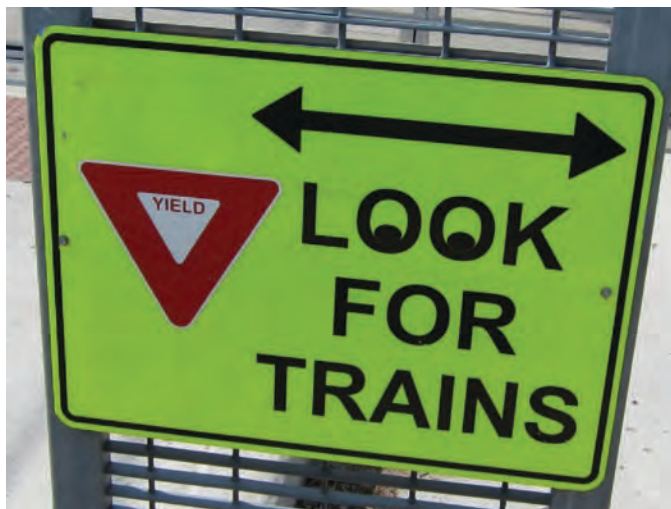
Figure 70. Sign used at several pedestrian-rail crossings in Boston.

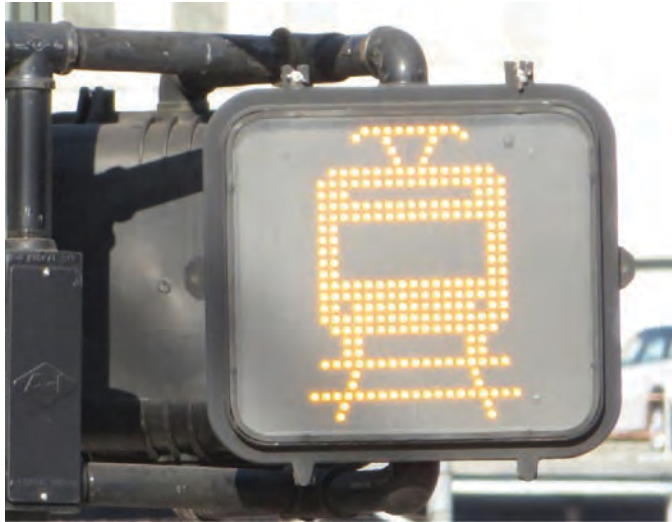
Figure 94. Closeup of a countdown indication used in conjunction with a blank-out sign.

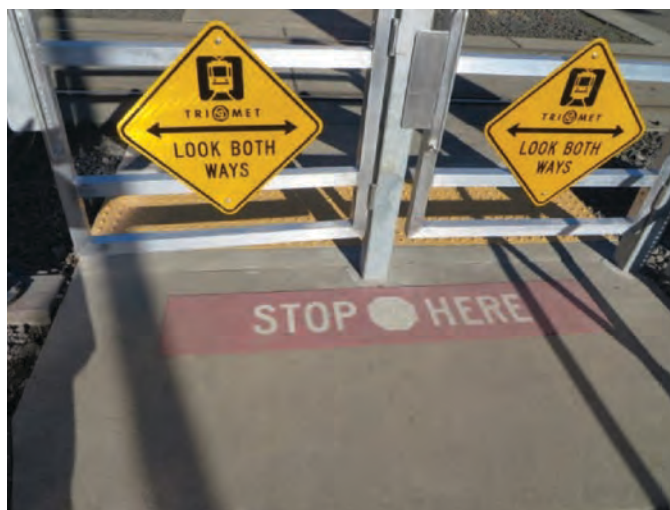
Figure 102. Example of STOP HERE pavement marking used with detectable warning at a Portland station pedestrian crossing.
